**Peer Review Draft**  
**STAFF REPORT**  
**TO SUPPORT THE**  
**TECHNICAL SEDIMENT**  
**TOTAL MAXIMUM DAILY LOAD**  
**FOR THE**  
**UPPER ELK RIVER**

March 4, 2013

State of California  
North Coast Regional Water Quality Control Board  
5550 Skylane Boulevard, Suite A  
Santa Rosa, California 95403  
707-576-2220  
[www.waterboards.ca.gov/northcoast](http://www.waterboards.ca.gov/northcoast)

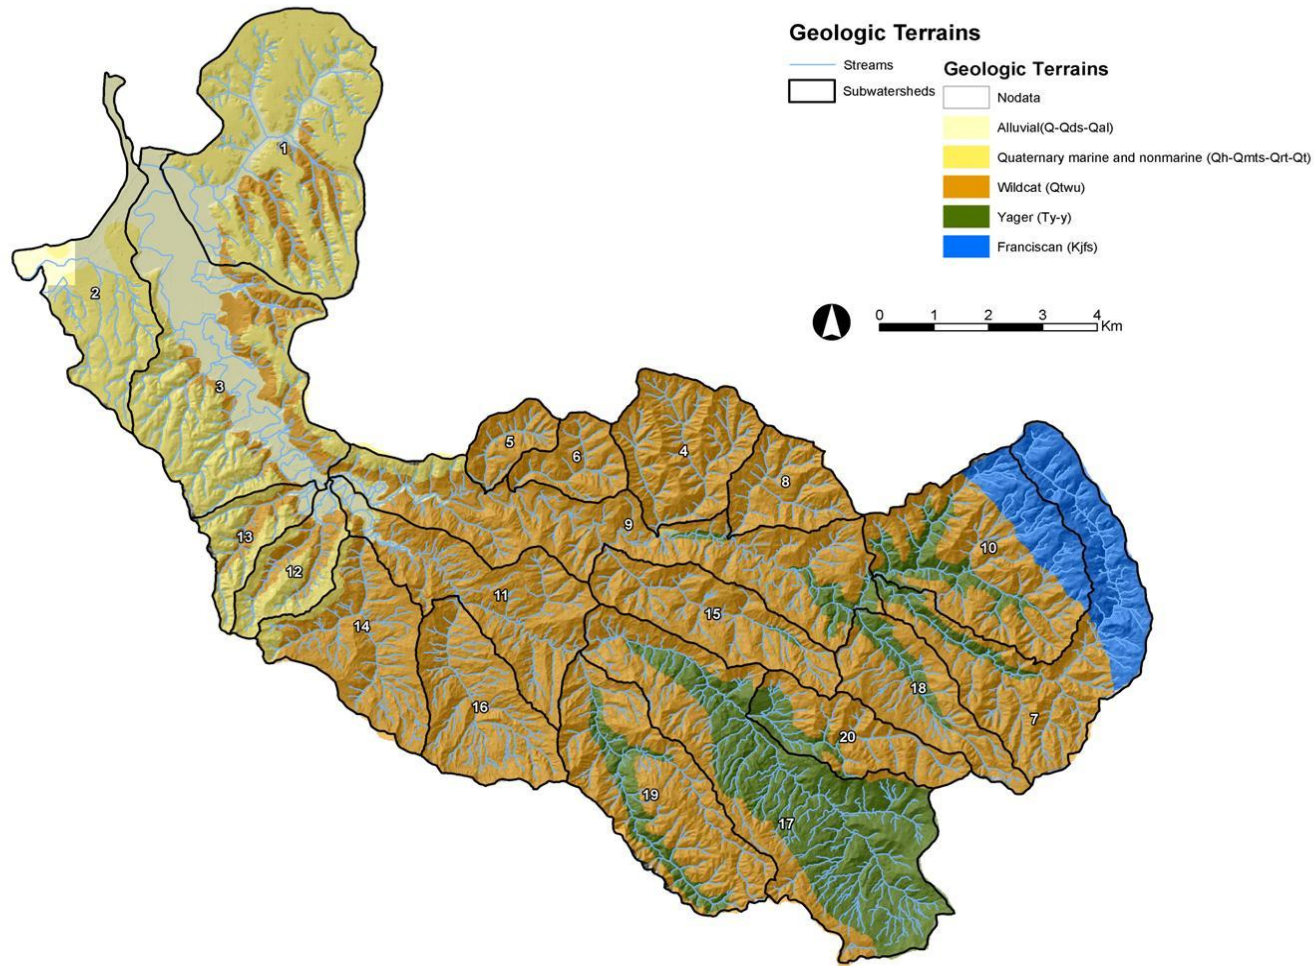
Figure 2.3 Geologic terrains (formations) in the Elk River watershed<sup>24</sup> (Stillwater, 2007).

<sup>24</sup> Subbasin numbers correspond to those identified in Figure 1.2.

Geologic formations (terrains) in the Elk River watershed were mapped by McLaughlin et al. (2000) and Marshall and Mendes (2005) and modified by Stillwater Sciences (2007) as part the TMDL analyses (Figure 2.3). Geologic formations in the Upper Elk River are composed primarily of "young" and erodible rock types. These formations include 1) the Franciscan Complex Central Belt, 2) Yager terrane, 3) Wildcat Group, and 4) Hookton Formation, which due to its relatively young age was grouped with the marine and riverine deposits for consideration in the development of the TMDL.

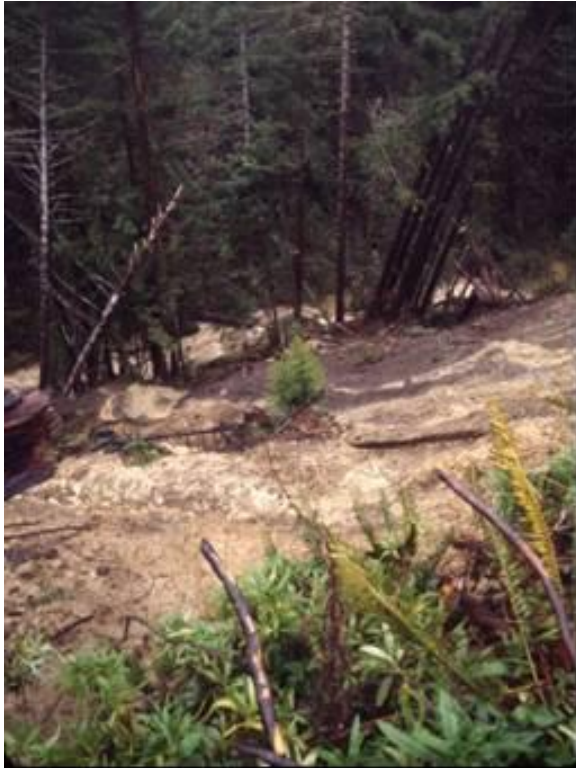
**Figure 2.6** Landslide delivering into South Fork Elk River, originating from THP 96-059 (Photo by Elmer Dudik, February 23, 1997).

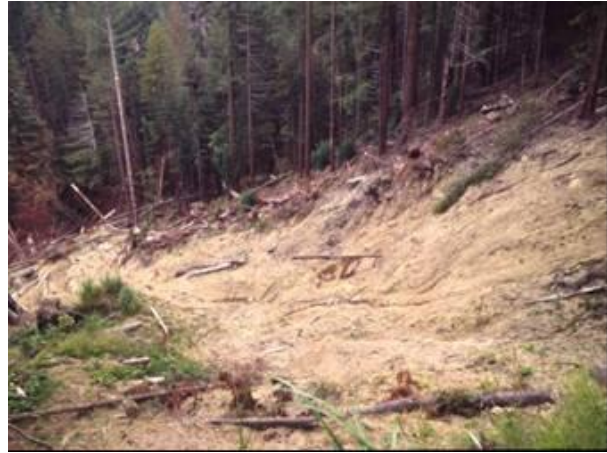
**Figure 2.7** Landslide into West Fork Bridge Creek, originating from THP 1-95-097 and identified in CAO 1-97-115. (Photo by Elmer Dudik, September 9, 1997)

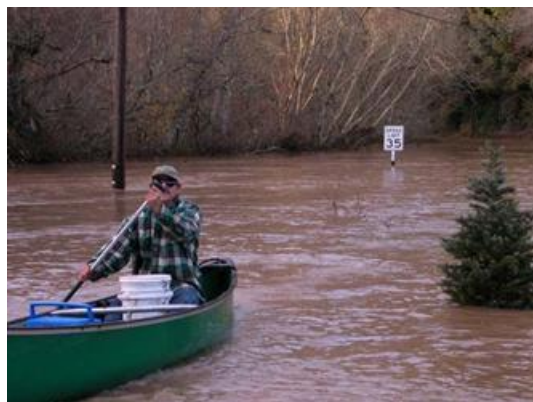
**Figure 3.1 Lower North Fork Elk River during Dec 29, 2003 flood (photo part of Regional Water Board public files.)**

River community. Examples of nuisance flooding conditions in the community of Elk River are depicted in Figures 3.1 and 3.2.

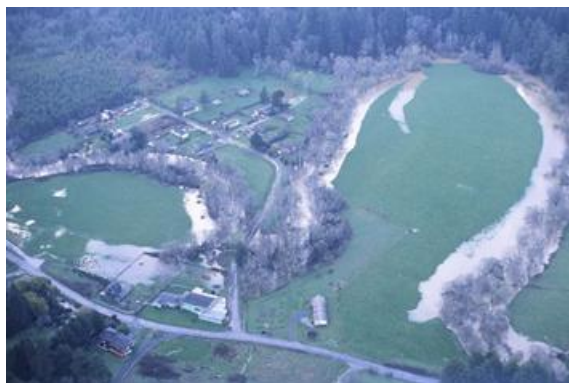
**Figure 3.2 Upper Mainstem Elk River at Elk River Courts, located at the downstream extent of the Upper Elk River Waterbody. (Photo courtesy of Humboldt County Public Works Dept, taken February 18, 2004).**

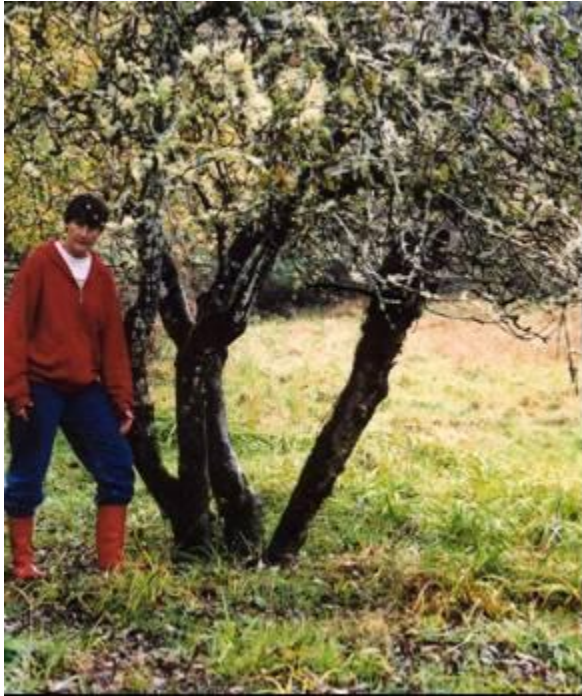
**Figure 3.5 Resident Kristi Wrigley at her family’s 100-yr old North Fork Elk River apple orchard indicating the height above the ground surface that the apple tree branches spread from the trunk. The 2.5 foot tall trunk is now buried in sediment. (Photo by RCAA NRS staff, December 16, 2003)**

The sediment supply in Upper Elk River has overwhelmed the transport capacity of the river resulting in rapid channel and floodplain aggradation. Deep pools and gravel bars have been filled in and silted over, respectively. The naturally steep stream banks and low terraced floodplains that defined the former bankfull channel have been inundated with repeated deposition of excessive amounts of very fine sand and silt-sized sediment. The broader floodplain is also routinely covered in silty deposits during overbank flooding events.

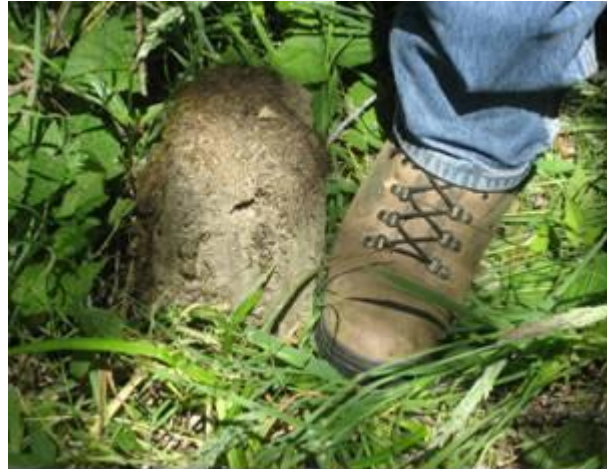
**Figure 3.6 Fence post on North Fork Elk River buried approximately 4 foot in sediment (Photo by Adona White, 2008).**

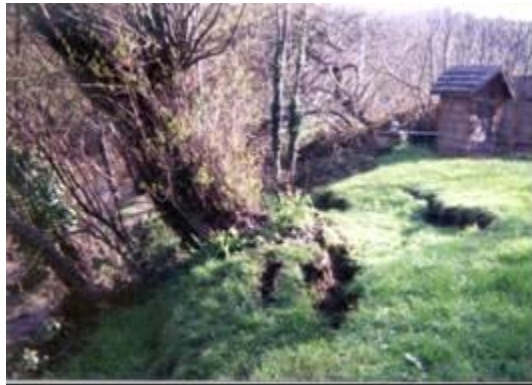
Figure 3.7 Bank slump on Upper Mainstem Elk River (Photo by Nancy Sievert, 2003).

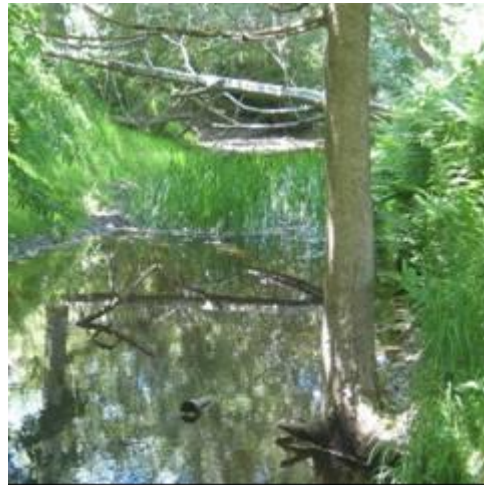
Figure 3.8 Grass colonizing channel on lower North Fork Elk River near the confluence with South Fork (Photo by Adona White, 2008)

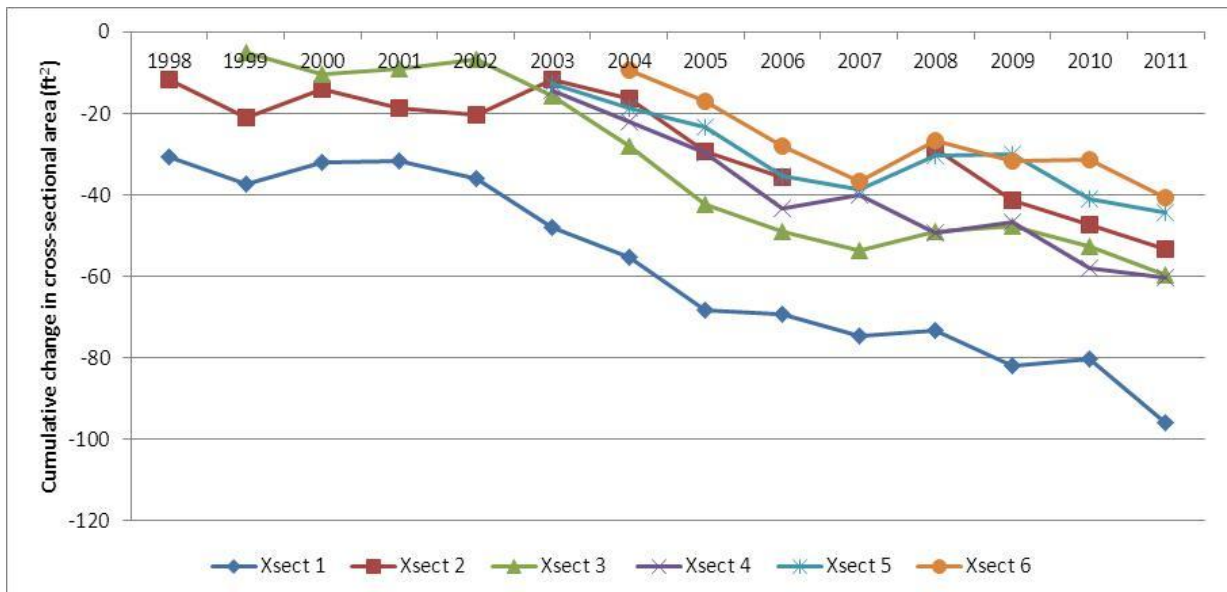
Figure 3.11 Cumulative change in cross-sectional area 1997-2011 at ATM Station 14 (located on lower North Fork Elk River).

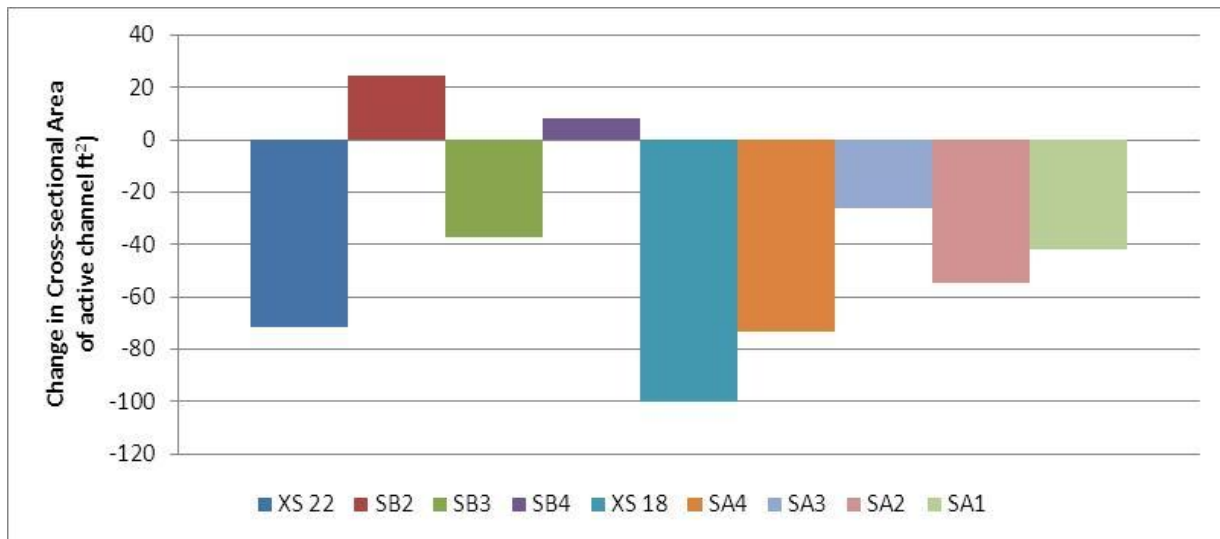
Figure 3.17 Cumulative change in cross-sectional area of active channel on South Fork Elk River (Salmon Forever, 2001-2008).

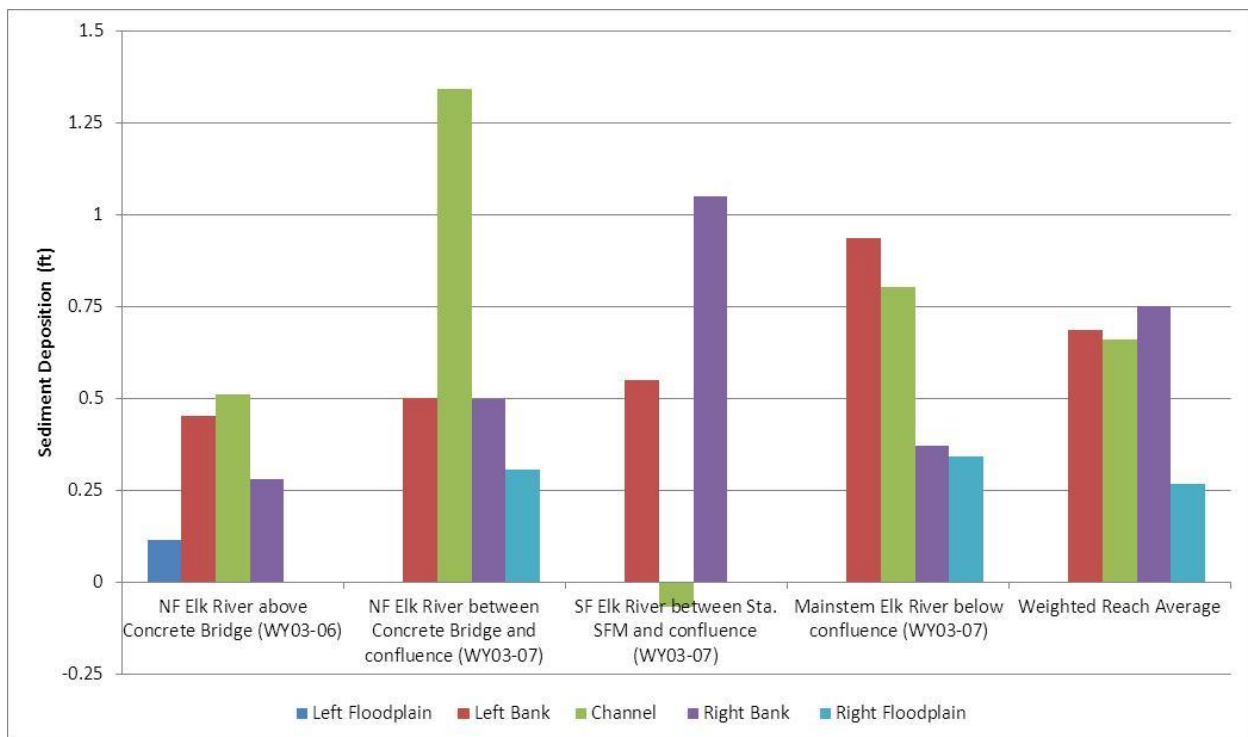
Figure 3.18 Measured deposition at cross-sections on right and left floodplain and banks (left as observed facing downstream) and channel bed (Salmon Forever 2003-2007).

2011). Additionally, staff evaluated the Salmon Forever cross-sections to determine the depth of sediment deposition and scour on the channel bed, banks, and floodplain areas (Figure 3.18).

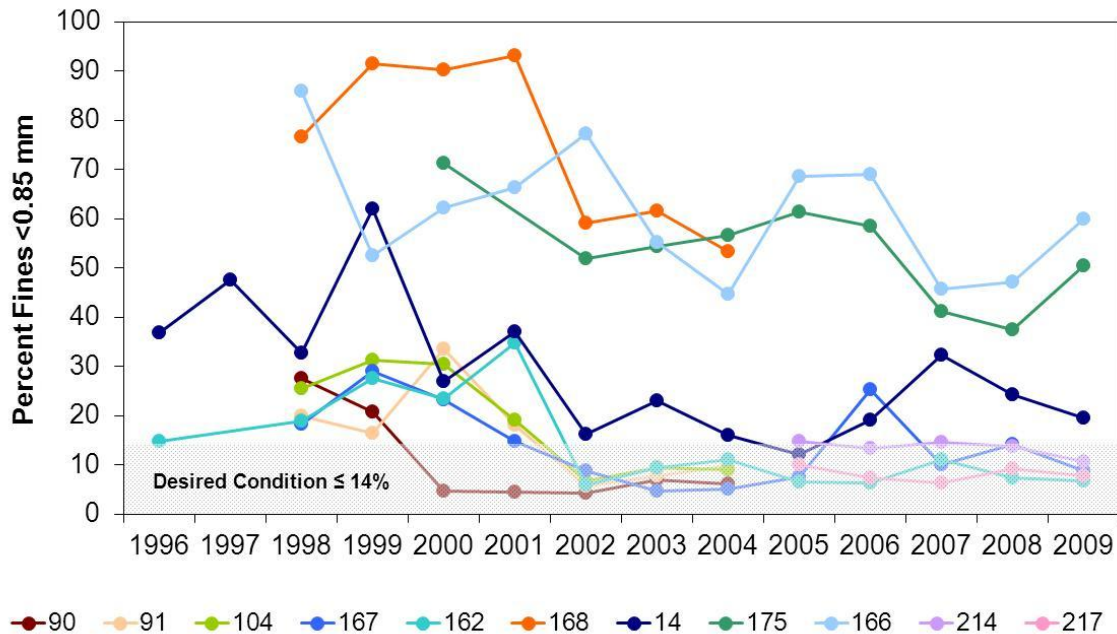
Figure 3.19 Percent fines <0.85 mm in Elk River (HRC ATM sites).

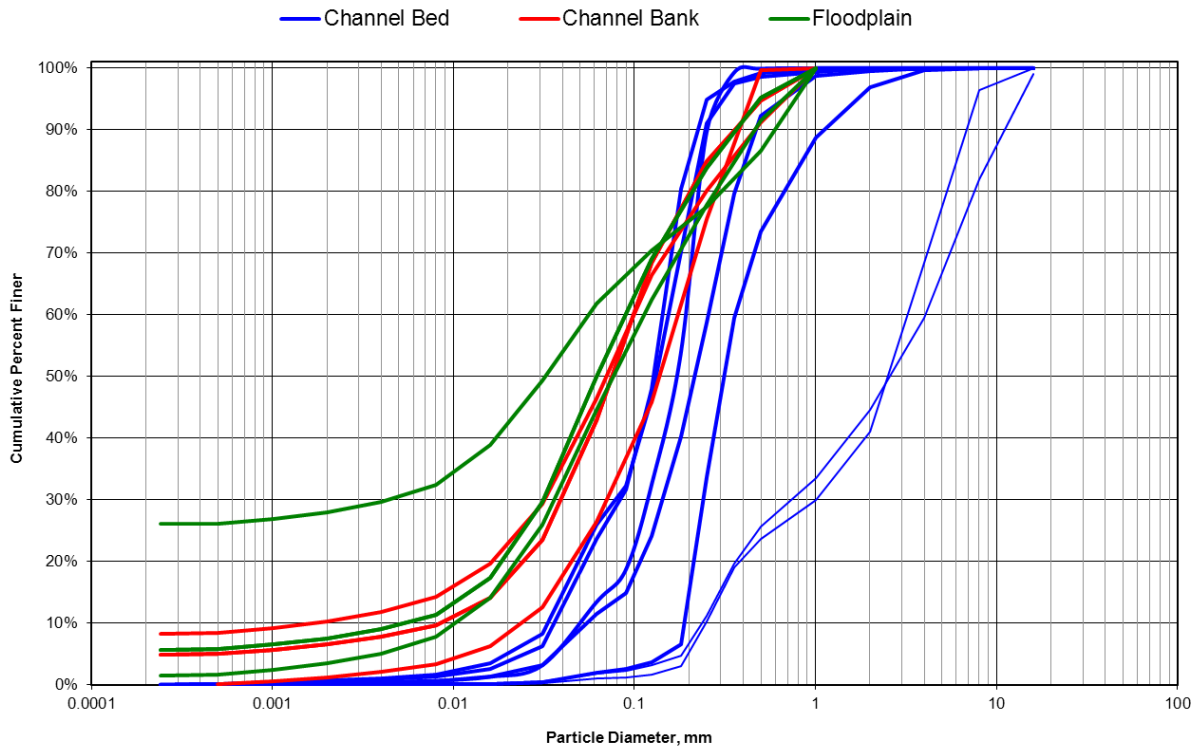
Figure 3.22 Particle size distributions of bulk samples from channel bed, channel bank and floodplain sediment deposits.

majority of the bed is comprised of very fine sand and silt and the channel banks and floodplain are comprised of silty sand.

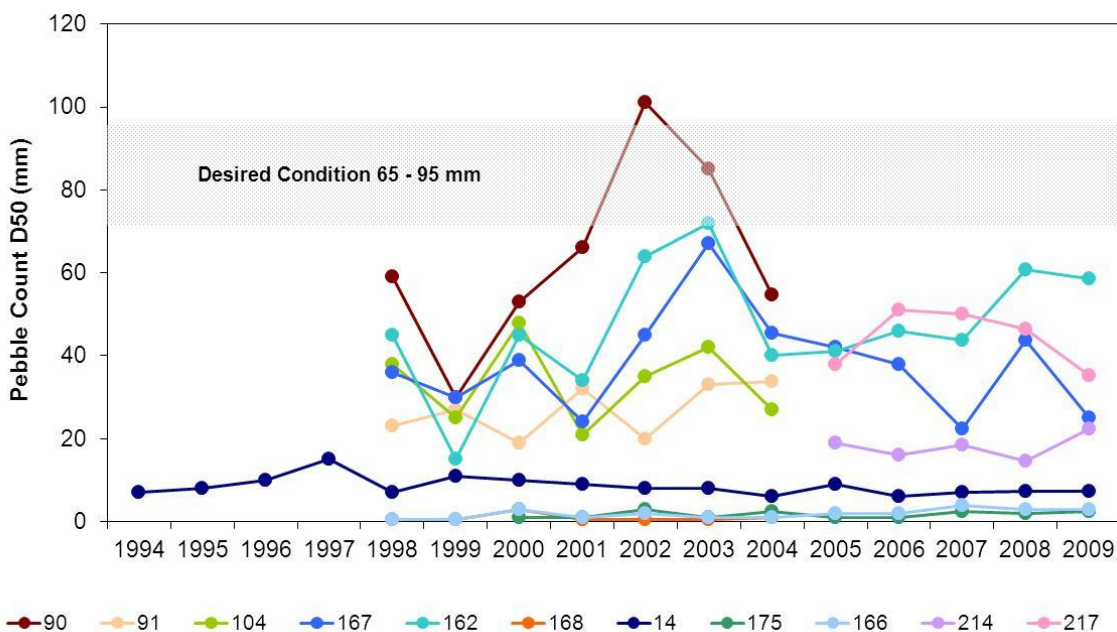
Figure 3.24 Pebble count D<sub>50</sub> conditions in Upper Elk River (HRC).

D<sub>50</sub> is a measure of the particle size distribution of the surface of a streambed, specifically the particle size for which 50% of the sample has a diameter smaller than the D<sub>50</sub> value. The channel bed surface layer is typically coarser than the underlying layers as fines are more readily winnowed away by streamflow. Characterization of the channel material is a useful tool for evaluating biological function and channel stability. In some cases, the surface layer can act as an armor layer, if it persists through transport events. As of HRC's 2009 annual monitoring report, 100% of the measured stations did not meet the desired condition of 65-95 millimeters (mm). In 2000-2001, only Station 166 (located in the upper portion of the watershed) met the desired condition. Otherwise, none of the stations met the desired condition for all other years reported (Figure 3.24).

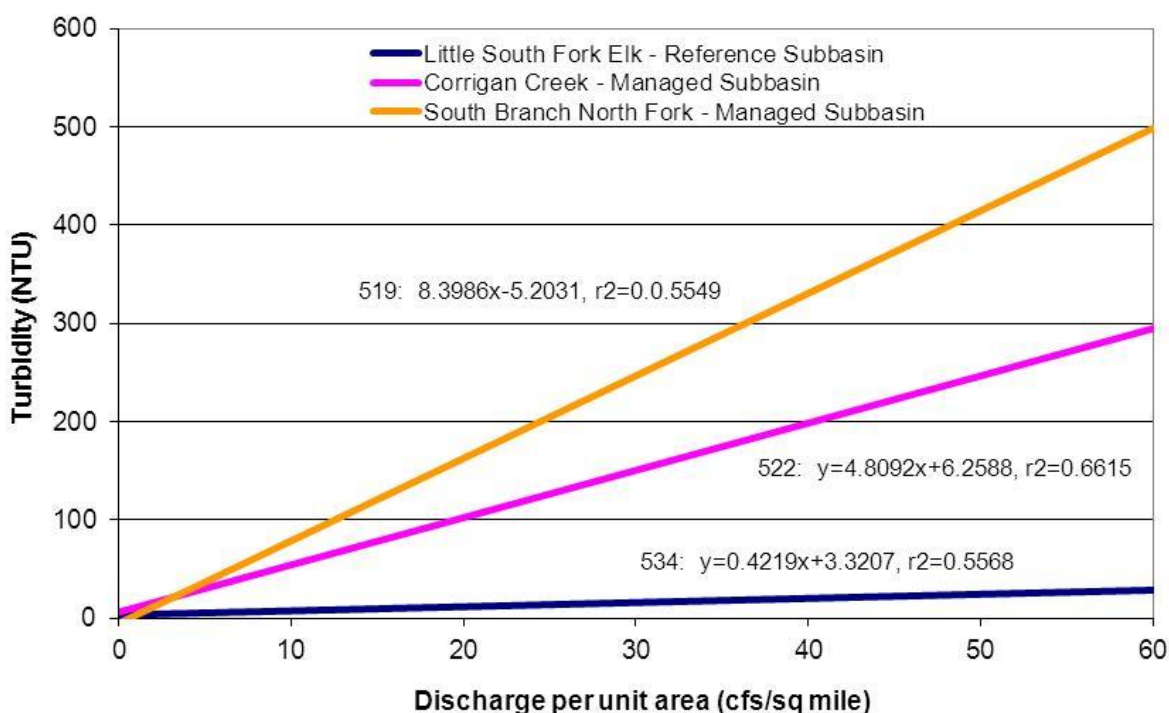
Figure 3.31 Comparison of ratings curves for three subbasins in Elk River.
