Bank Erosion Surveys

**Elk River Bank Erosion Void Assessment
and Bank Erosion-Related Wood Inventory
Humboldt County, California**

June 2008

Prepared by:
Eileen Weppner, Professional Geologist #7587
Pacific Watershed Associates
Arcata, CA

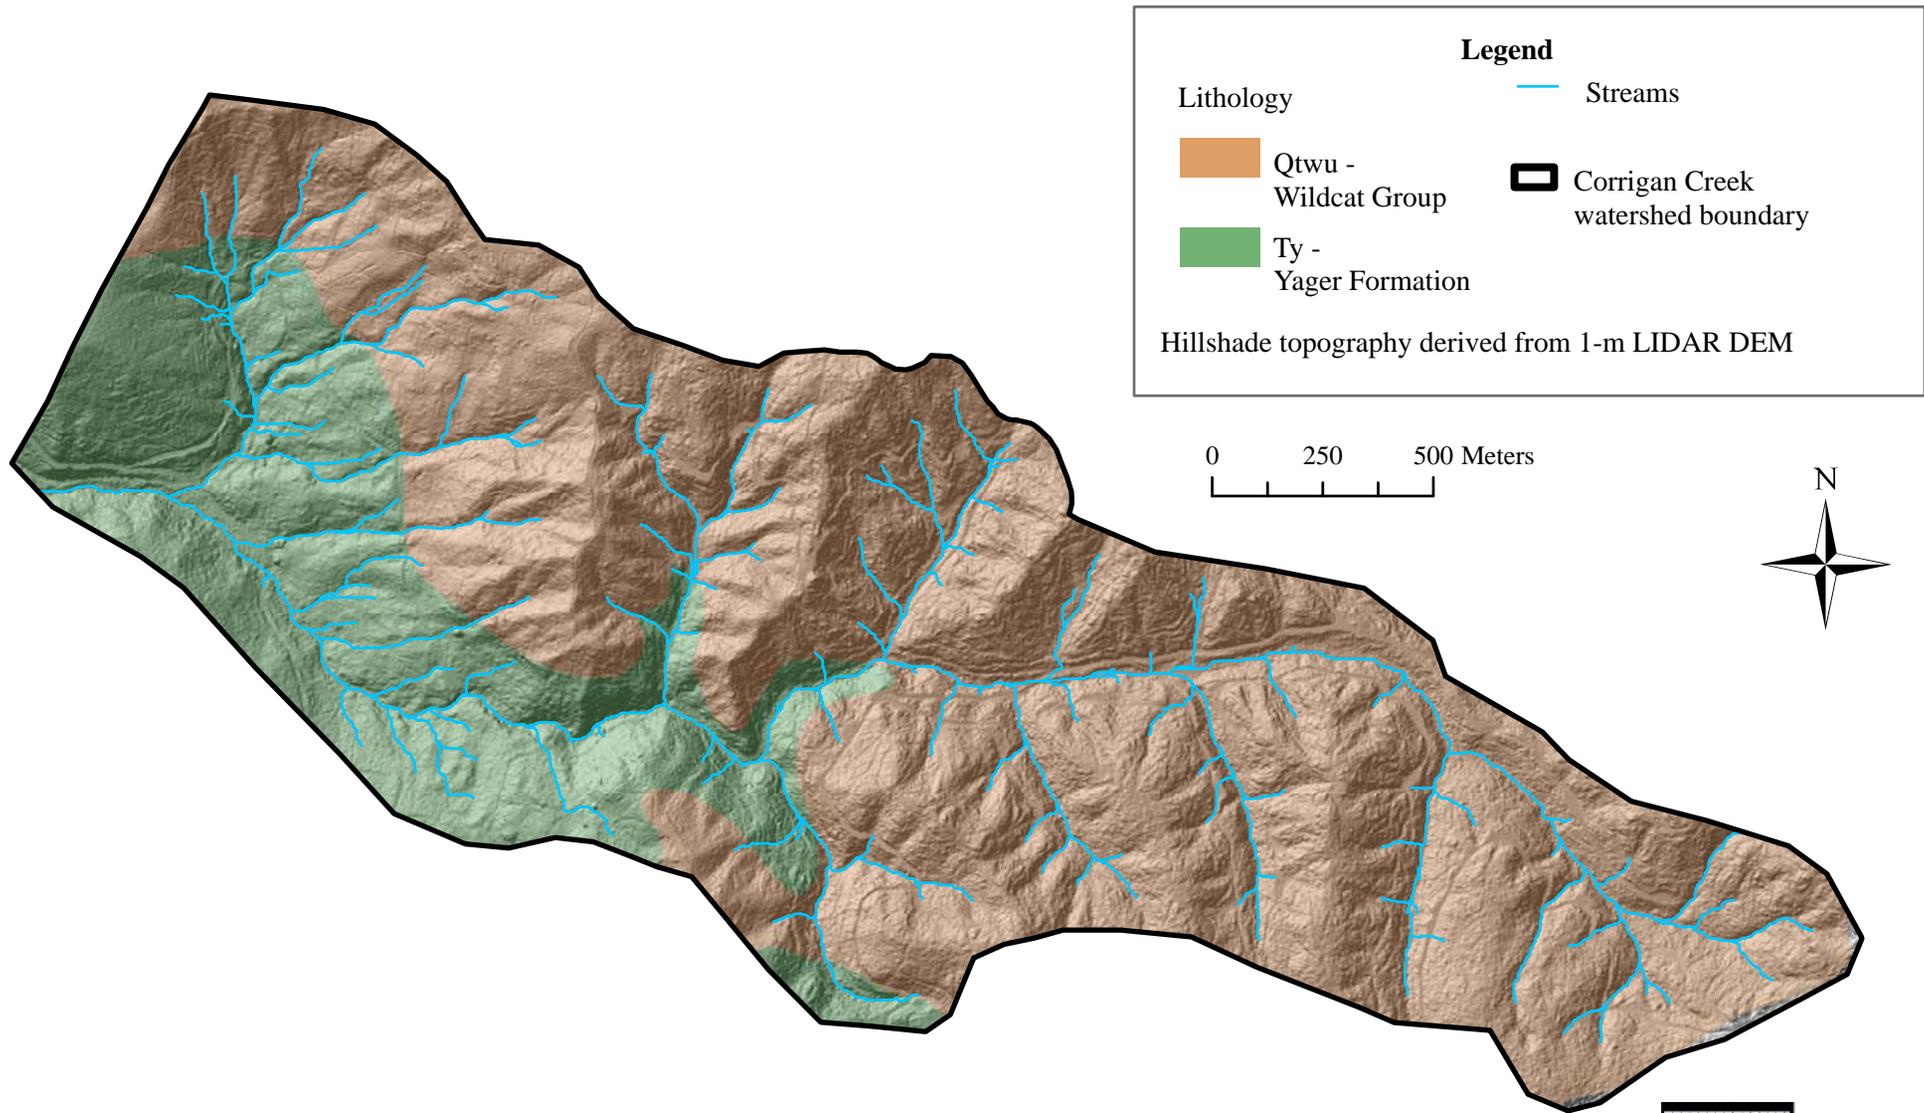
Figure 2a. Corrigan Creek Lithology, Bank Erosion Void and Bank Erosion-Related Wood Inventory, Elk River Watershed, Humboldt County, California.

The distribution of lithologic units within the Elk River bank erosion and wood inventory study area is illustrated in Table 1 and Figures 2a - 2c. The lithology for the study area was compiled from the “Maps and GIS data for the Elk River Watershed, Humboldt County, California, Watershed Mapping Series” prepared by the California Geological Survey (Marshall et al. 2005).

Ty –The Yager terrane (y1 of McLaughlin et al. 2000) consists of well indurated and highly folded arkosic sandstone and argillite (Marshall et al. 2005). Sandstone within the Yager terrane develops sharp ridge crests and cliffs and well incised drainages (Maps 2a – 2c). The argillite component is highly sheared and prone to slaking and deep weathering. The Yager terrane can develop rotational debris slides in steep convergent topography that may channelize creating debris torrents along watercourses. Between 18% and 31% of the subwatershed area within Corrigan Creek, Little South Fork Elk River, and South Branch North Fork Elk River is underlain by the Yager terrane (26%, 31%, and 18%, respectively) (Table 1; Maps 2a – 2c)

QTWu – The undifferentiated Wildcat Group (included in QTW of McLaughlin et al. 2000) unconformably overlies the Yager Formation and consists predominantly poorly to moderately consolidated marine and non marine siltstone and fine grained silty sandstone with lenses of pebble conglomerate (Marshall et al. 2005). The undifferentiated Wildcat Group sediments weather into non plastic clayey silts and clayey sands that are prone to both deep seated rotational and translational mass wasting, as well as shallow debris landsliding on steep slopes (Marshall et al. 2005). Between 69% and 82% of the subwatershed area within Corrigan Creek, Little South Fork Elk River, and South Branch North Fork Elk River is underlain by Wildcat group sediments (74%, 69%, and 82%, respectively) (Table 1; Maps 2a – 2c).

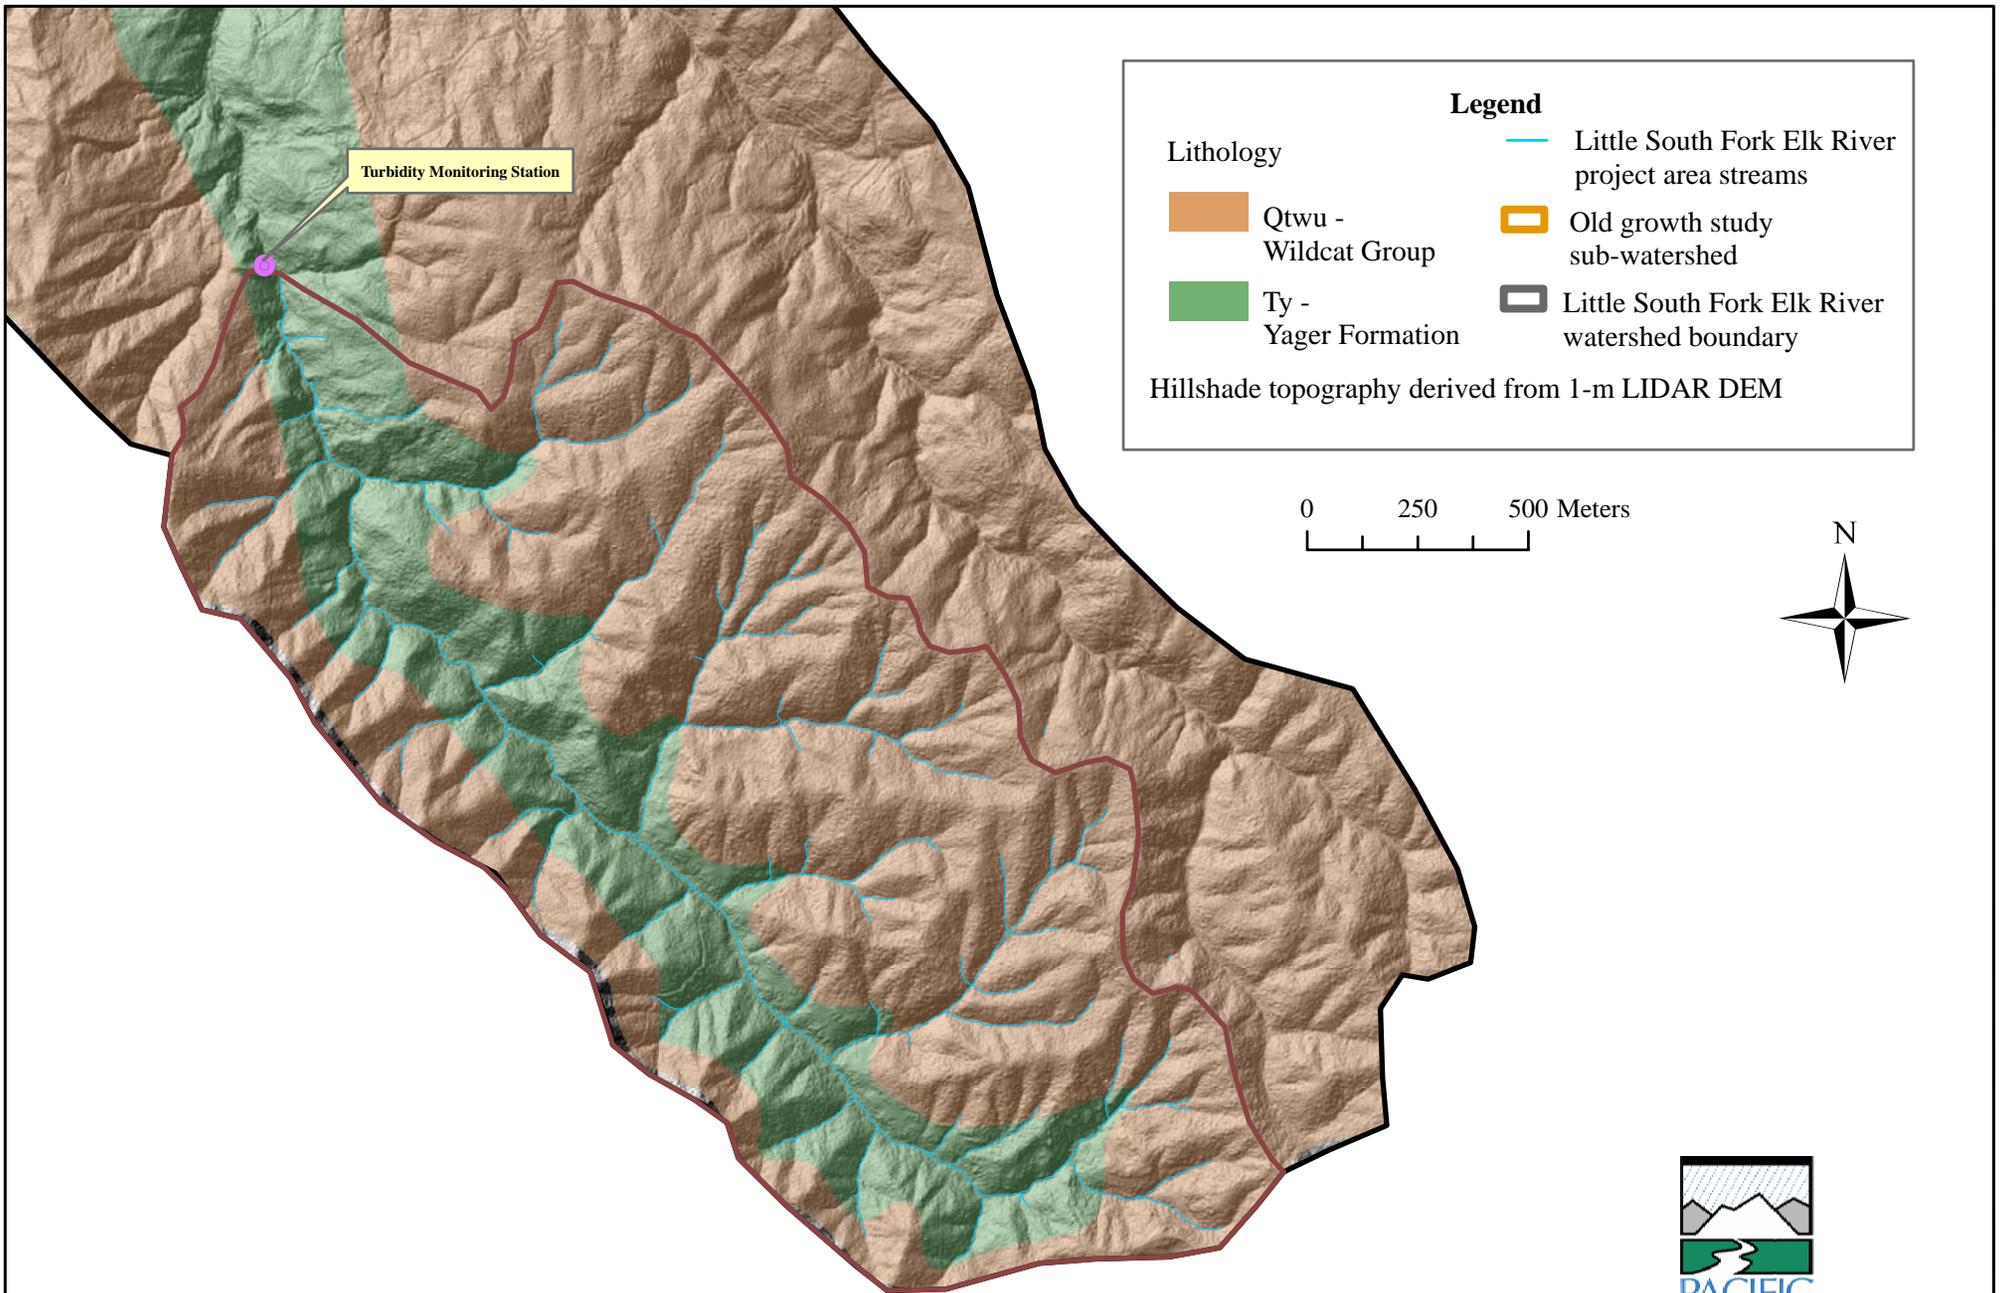
Figure 2b. Little South Fork Elk River Lithology, Bank Erosion Void and Bank Erosion-Related Wood Inventory, Elk River Watershed, Humboldt County, California.

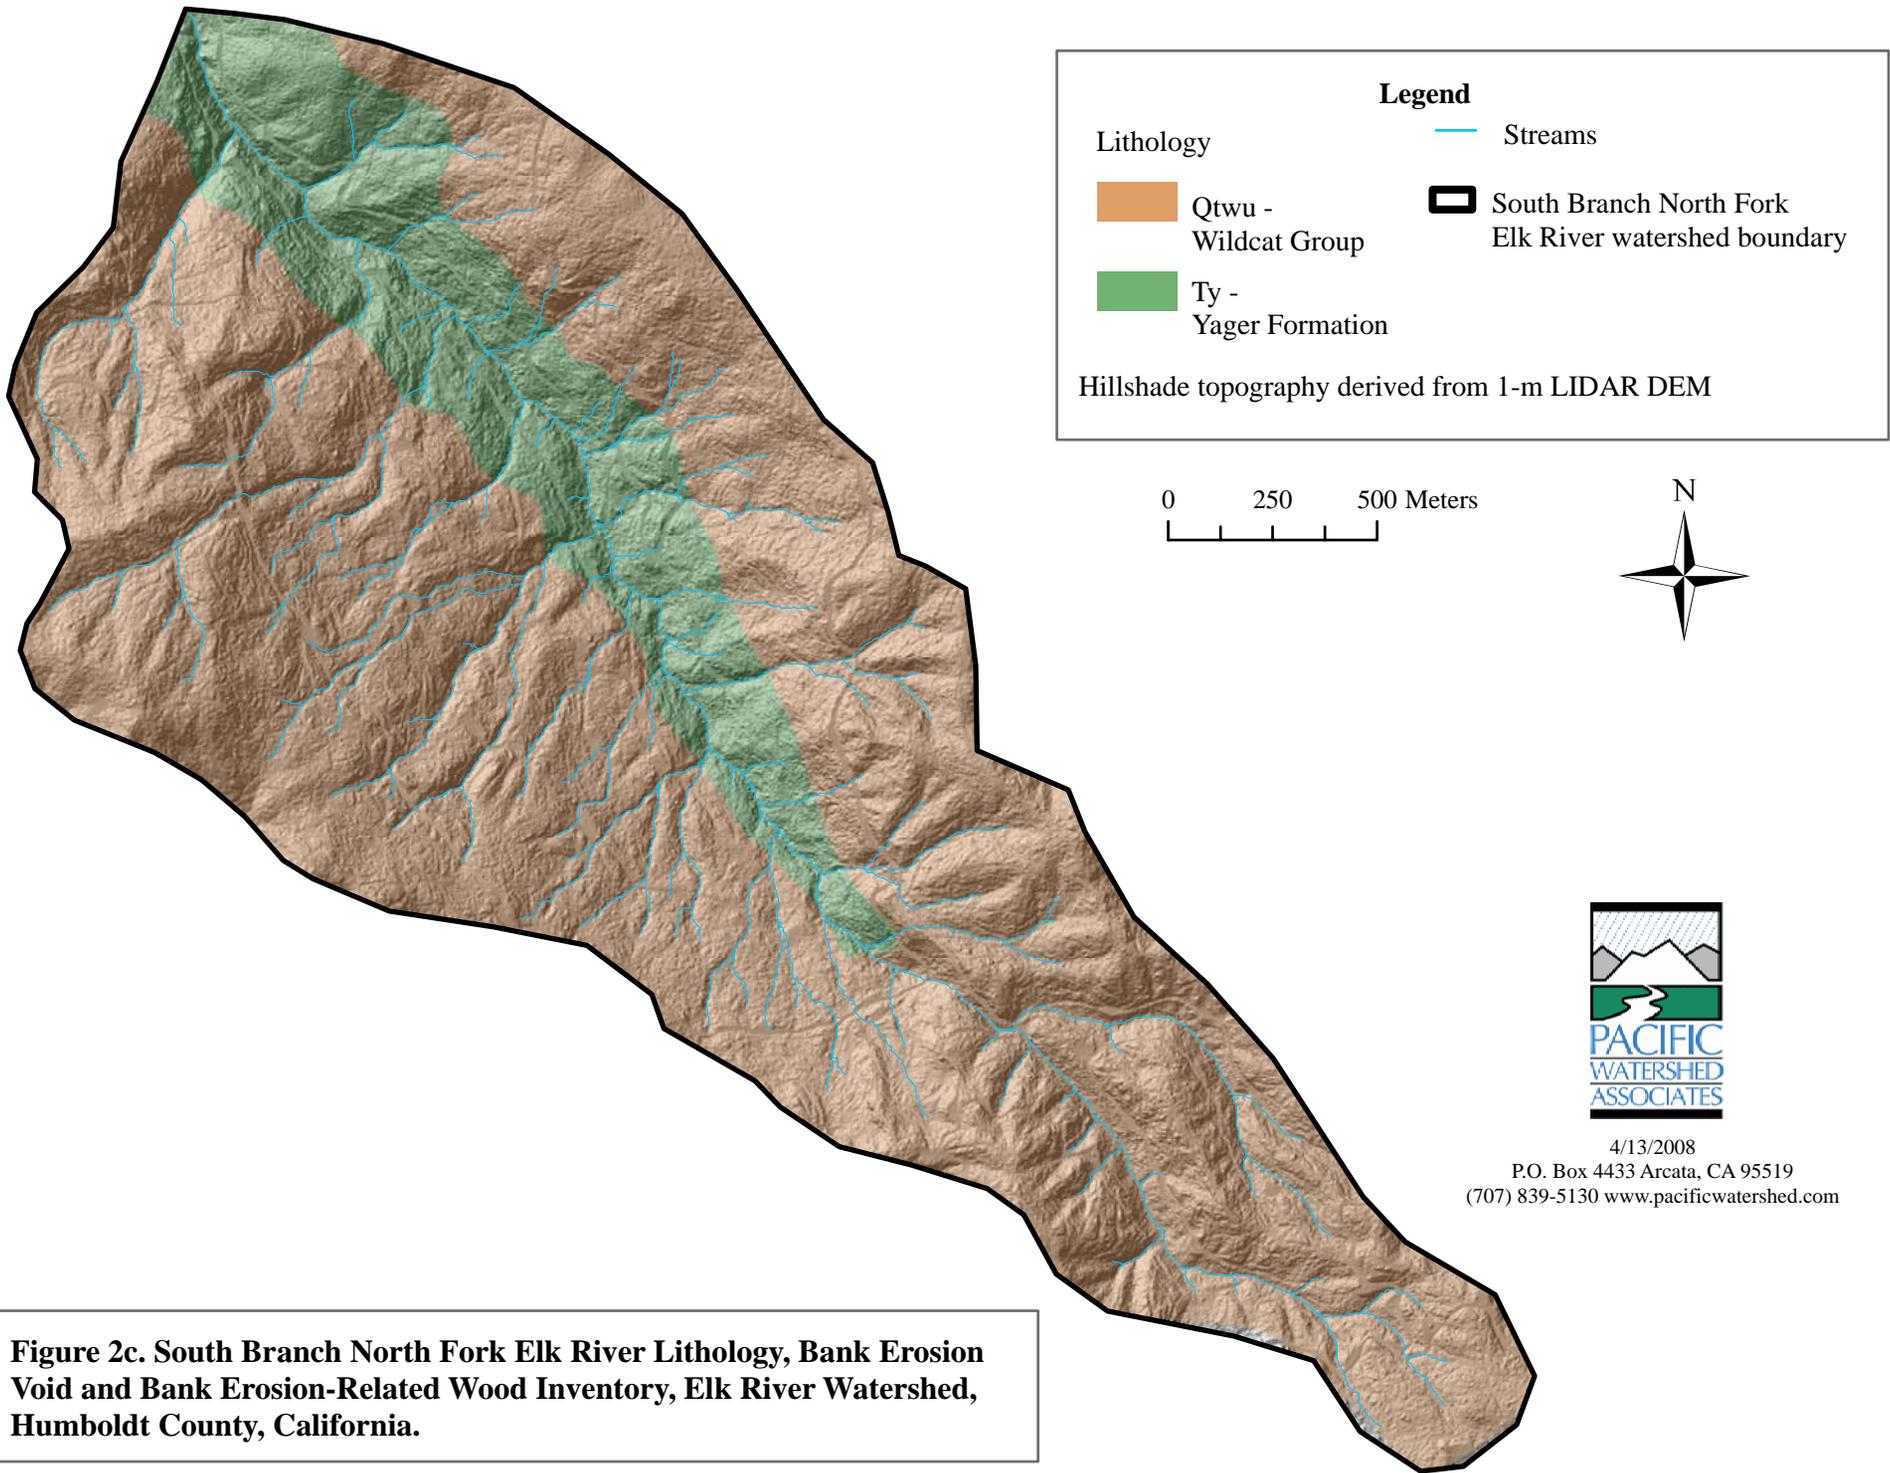
Figure 2c. South Branch North Fork Elk River Lithology, Bank Erosion Void and Bank Erosion-Related Wood Inventory, Elk River Watershed, Humboldt County, California.

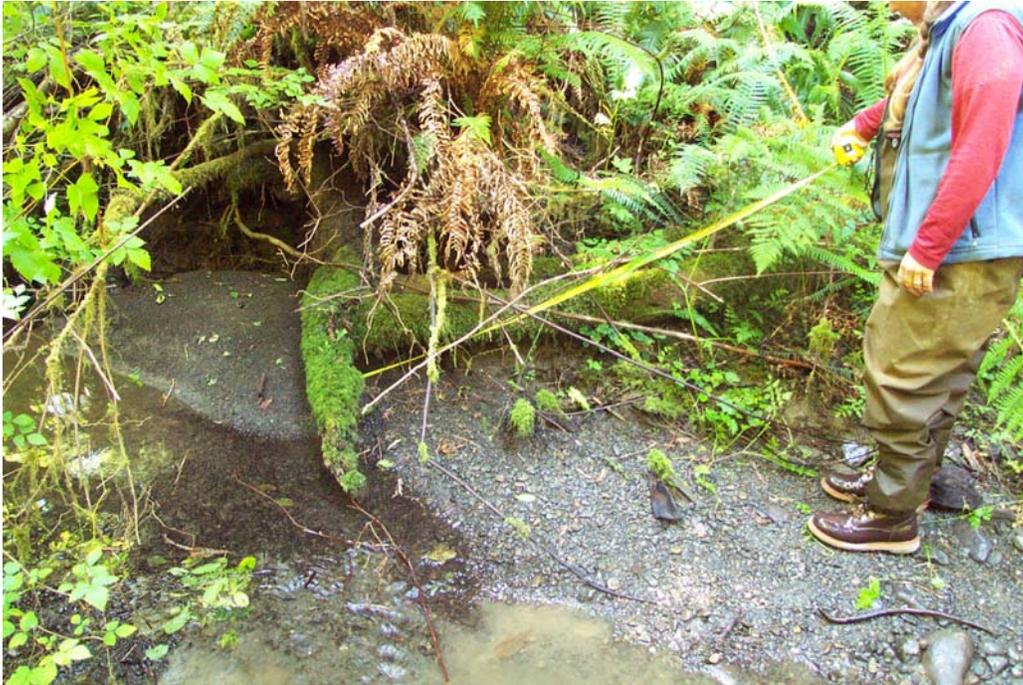
Figure 3. Example of bank erosion recruited wood in the Elk River watershed. Wood piece is connected to stream bank.

Bank erosion-related wood was also inventoried and mapped along the sample stream reaches in the three study subwatersheds. To be considered bank erosion-related wood, wood pieces must show evidence of roots connected to the stream bank, or a root wad in the channel with evidence of adjacent bank erosion (Benda and Associates 2004) (Figure 3). Wood from other sources (i.e. natural mortality, landslides, wind throw, or other unknown processes) were not inventoried as part of this project. The minimum bank erosion-related wood size identified as part of this project was approximately 8 centimeters in diameter and 1.8 meters in length. Additional attributes that were collected for the bank erosion-related wood budget are also listed below.

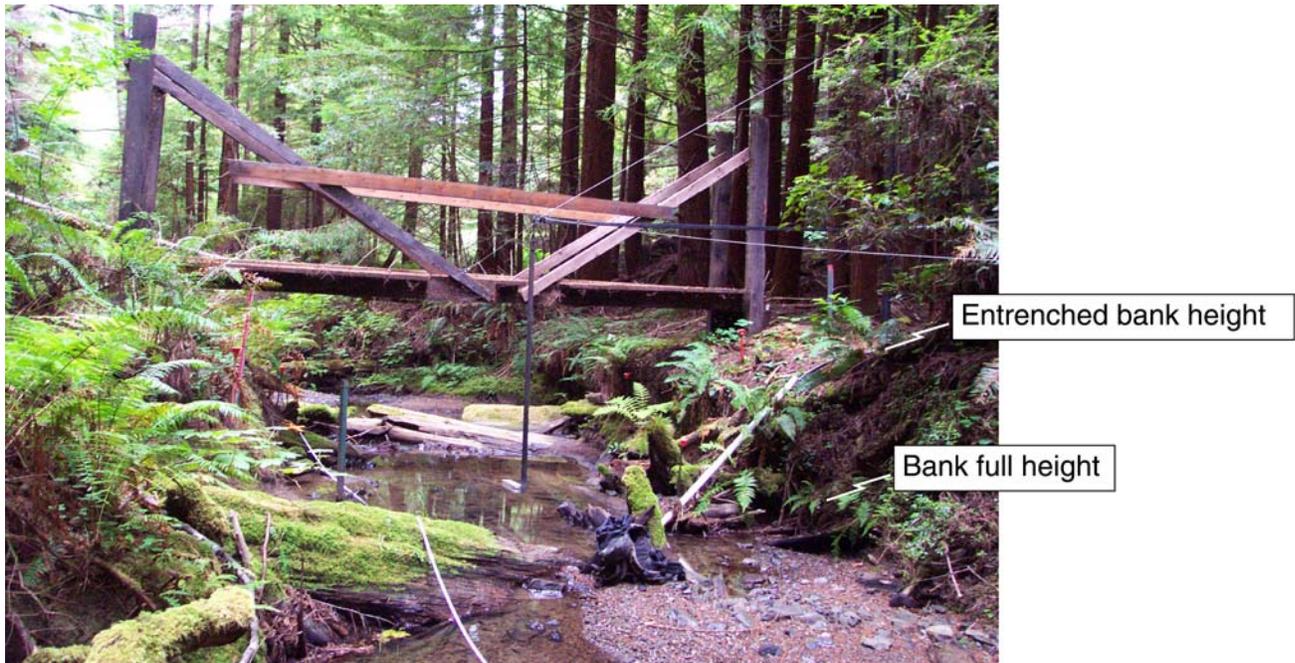
Figure 4. Fifth order stream exhibiting stream channel entrenchment caused by a combination of channel down cutting and geologic uplift. Bank full height is located approximately 1 m below entrenched bank height. The photo point was taken looking downstream at the turbidity station on Corrigan Creek

stream channels where the bank full height (2 yr flood recurrence interval) is below the point where the top of the stream bank intercepts the hillslope (Figure 4). The entrenched bank height was used to determine bank erosion estimates for this study, because it is assumed that bank erosion occurring at the bank full height will result in undercutting of the entire entrenched stream bank. Drainage density refers to the average drainage density for 2nd order and higher stream channels for each of the three study subwatersheds.

For 1st order streams, erosion estimates were calculated using Equation 3, and substituting a soil creep rate for the bank erosion rate (E). The soil creep rate used in this study was estimated at 1.6 mm/yr and was derived from the Surface Erosion Module of the PALCO Upper Eel River Watershed Analysis (PALCO 2007). Swanston et al. (1995) estimated creep rates from 1.0 to 2.5 mm/yr in Redwood Creek, which is approximately 55 kilometers north of the watershed in this study. The PALCO Upper Eel River watershed analysis used an average soil creep rate of 1.6 mm/yr for North Coast California watersheds (PALCO 2007). This appeared to be an adequate estimate for the Elk River bank erosion void and wood inventory study due to the lack of pertinent soil creep data for the three study areas. The average bank heights used for the 1st order stream channel refer to the average bank full stream bank height, not entrenched bank height. First order streams do not exhibit entrenched stream channels due to low stream power (Figure 4).

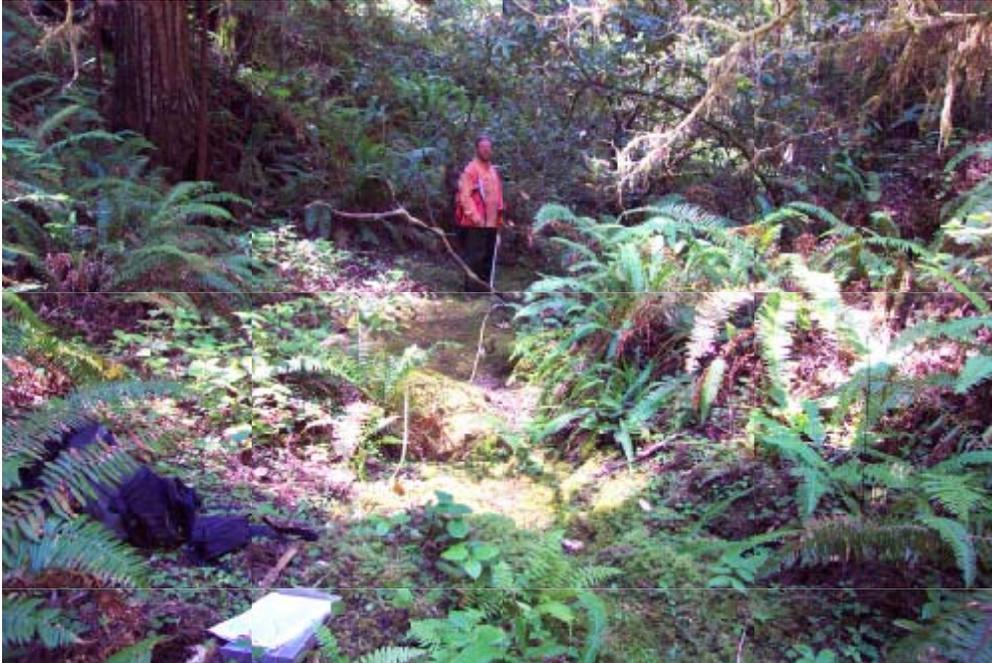
Figure 5. First order stream in Little South Fork Elk River exhibiting bank full dimensions, but no stream channel entrenchment. Bank full height is approximately 5 cm – 8 cm (<2”).

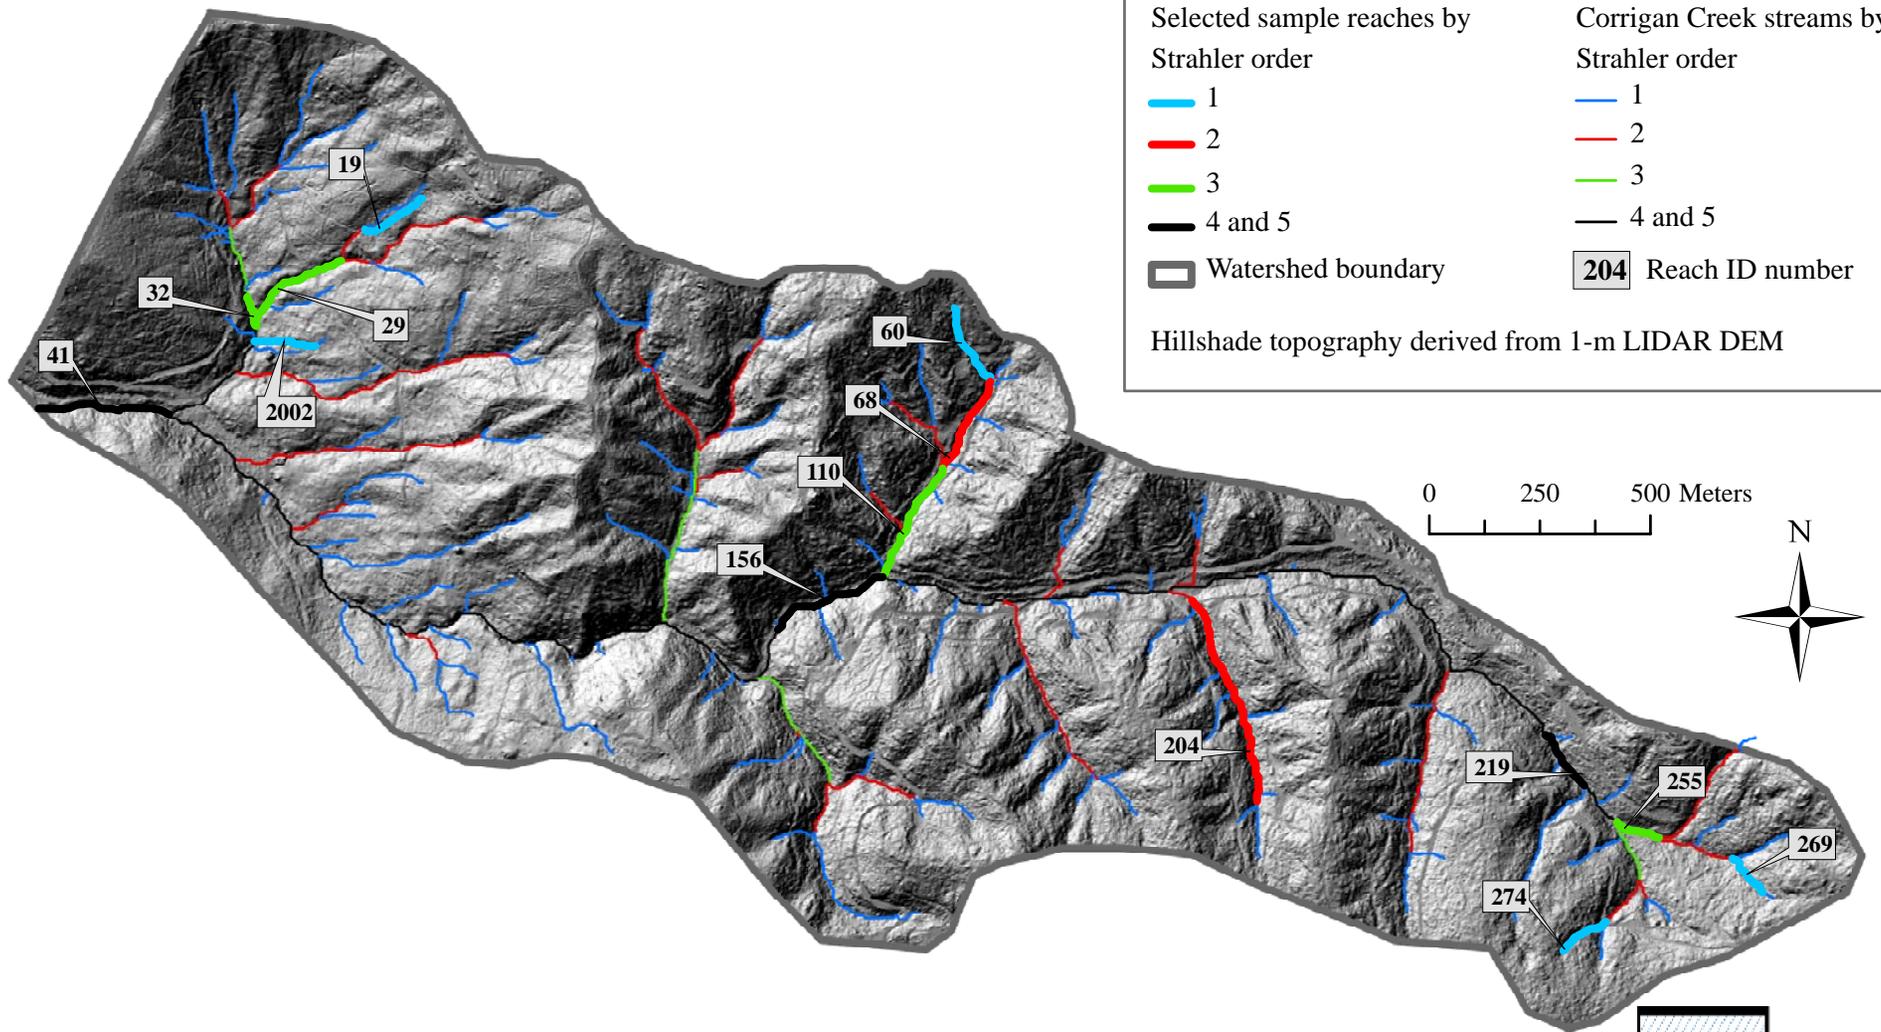
Figure 6a. Corrigan Creek selected inventory stream reaches, bank erosion void and bank erosion-related wood inventory, Elk River Watershed, Humboldt County, California.

Table 2 describes the physical characteristics of the sample reaches for each study subwatershed. A total of 14 sample reaches were inventoried in the Corrigan Creek subwatershed with an average reach length of 215 m (Figure 6a). Approximately 750 m of stream reaches were inventoried in each of the 4 Strahler orders (1st, 2nd, 3rd, and 4th and higher) (Table 2). The dominant stream channel substrate within this subwatershed is primarily composed of a mixture of sand, gravel, and cobble (Table 3). The channel morphology of sample reaches within Corrigan Creek first order channels was observed as a mixture of bedrock cascades and channels that exhibited subsurface flow. Many of the first order channels within the Elk River watershed exhibit intermittent surface and subsurface flow. These first order channels typically show higher incidence of channel incision and vertical collapse due to subsurface flows.

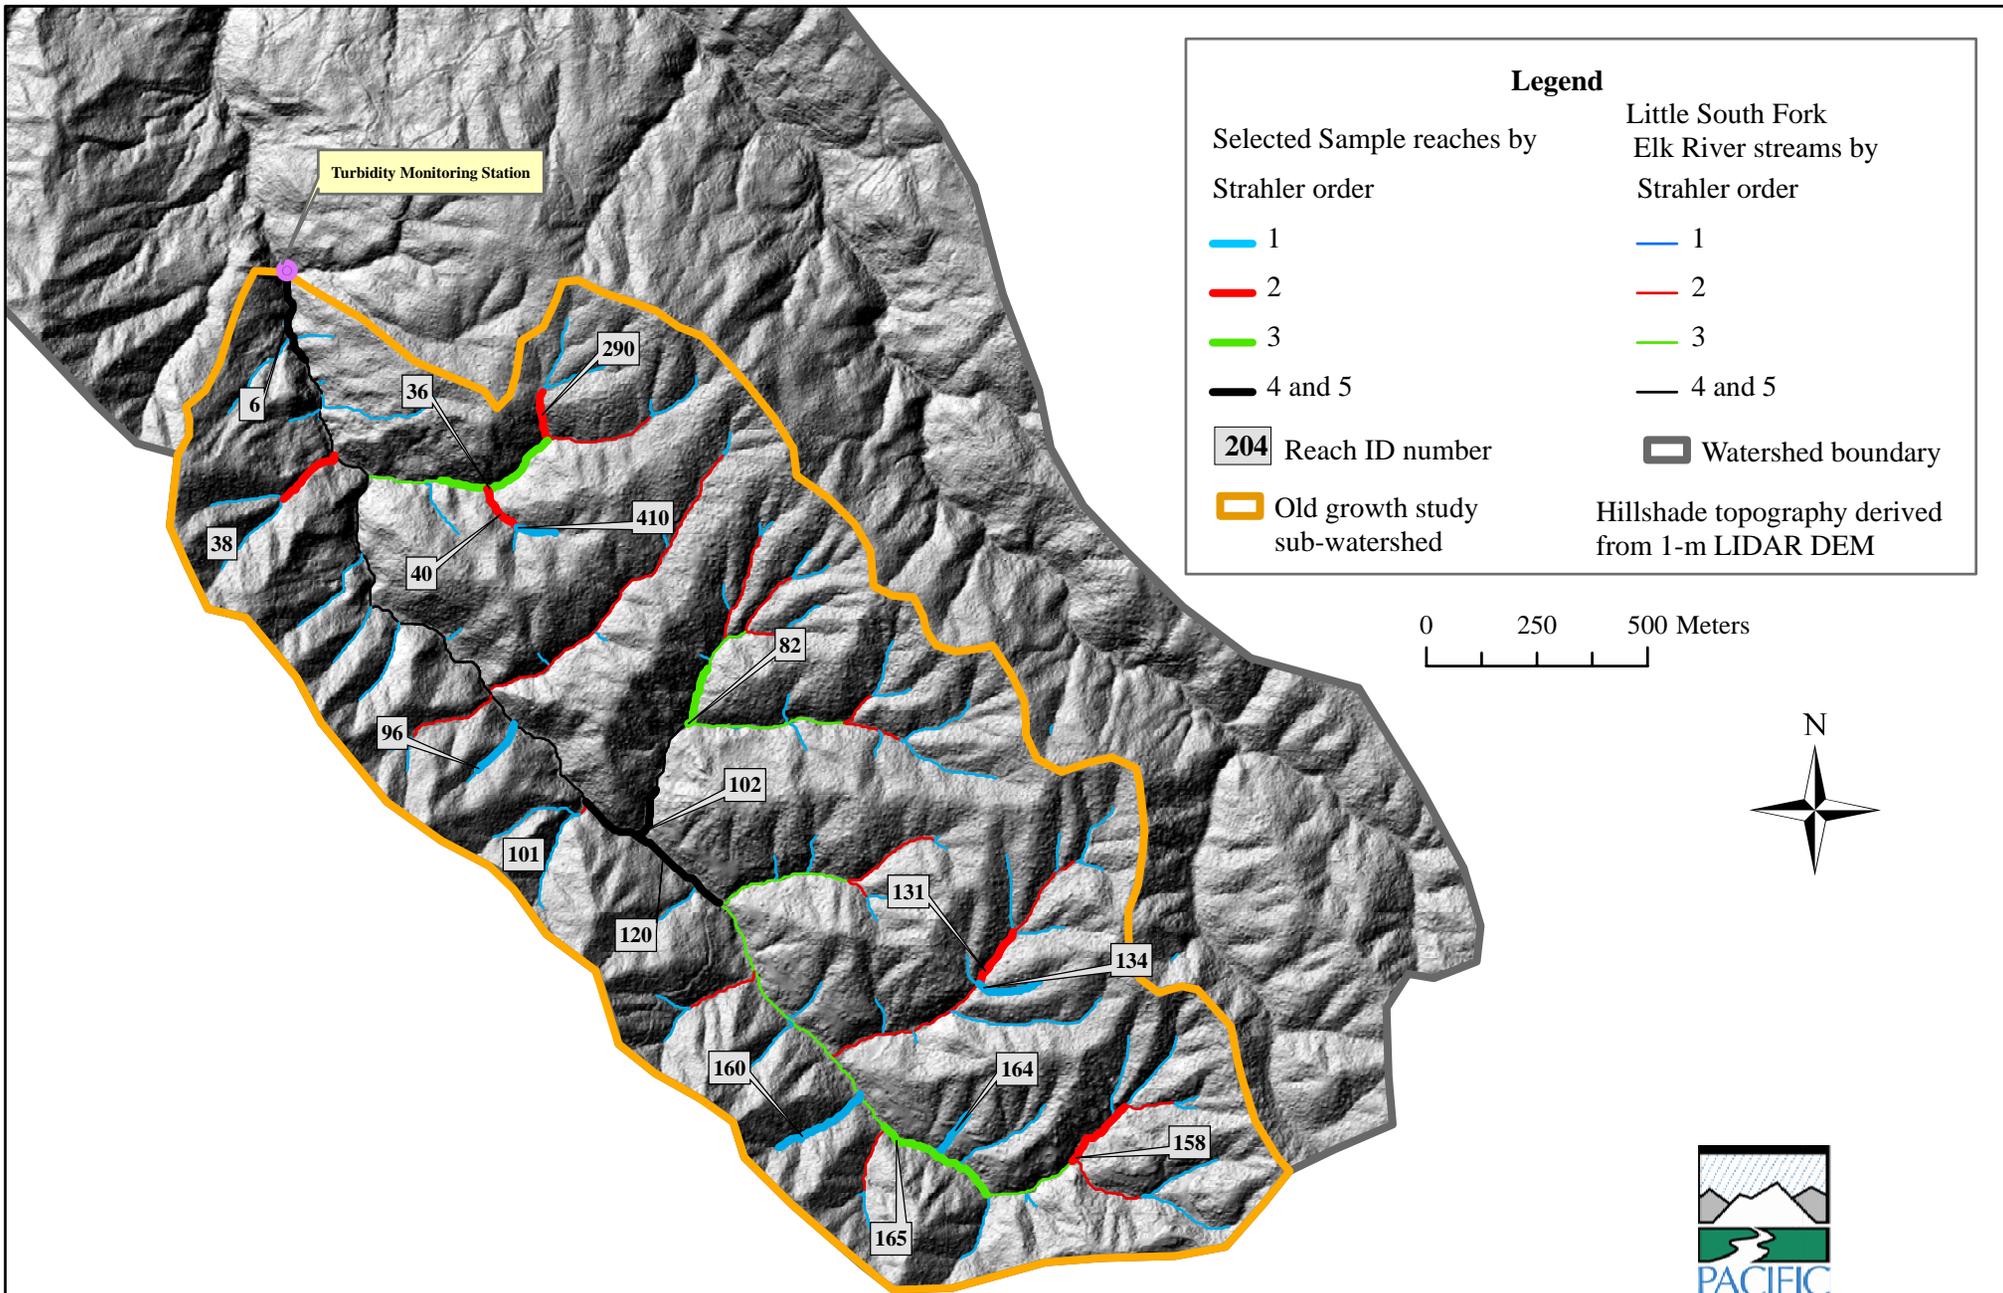
Figure 6b. Little South Fork Elk River Selected Inventory Stream Reaches, Bank Erosion Void and Bank Erosion-Related Wood Inventory, Elk River Watershed, Humboldt County, California.

Seventeen (17) randomly selected stream reaches were inventoried in the Little South Fork Elk River subwatershed upstream from the turbidity station (Figure 6b). Inventoried stream reach length within this study area averaged approximately 176 m. Approximately 900 m of 1st order, 590 m of 2nd order, 750 m of 3rd order, and 760 m of 4th order and higher stream reaches were inventoried in this subwatershed (Table 2). The dominant channel substrate observed in the Little South Fork Elk River inventoried stream reaches is composed primarily of sand with minor amounts of cobble and gravel. The channel morphology of 1st and 2nd order channels within this subwatershed were dominated by subsurface flow. The channel morphology observed in the 3rd and 4th order and higher inventoried stream reaches was dominantly low gradient riffle, with the 4th order and higher reaches located in the mainstem of the Little South Fork Elk River (Table 3 and Figure 6b).

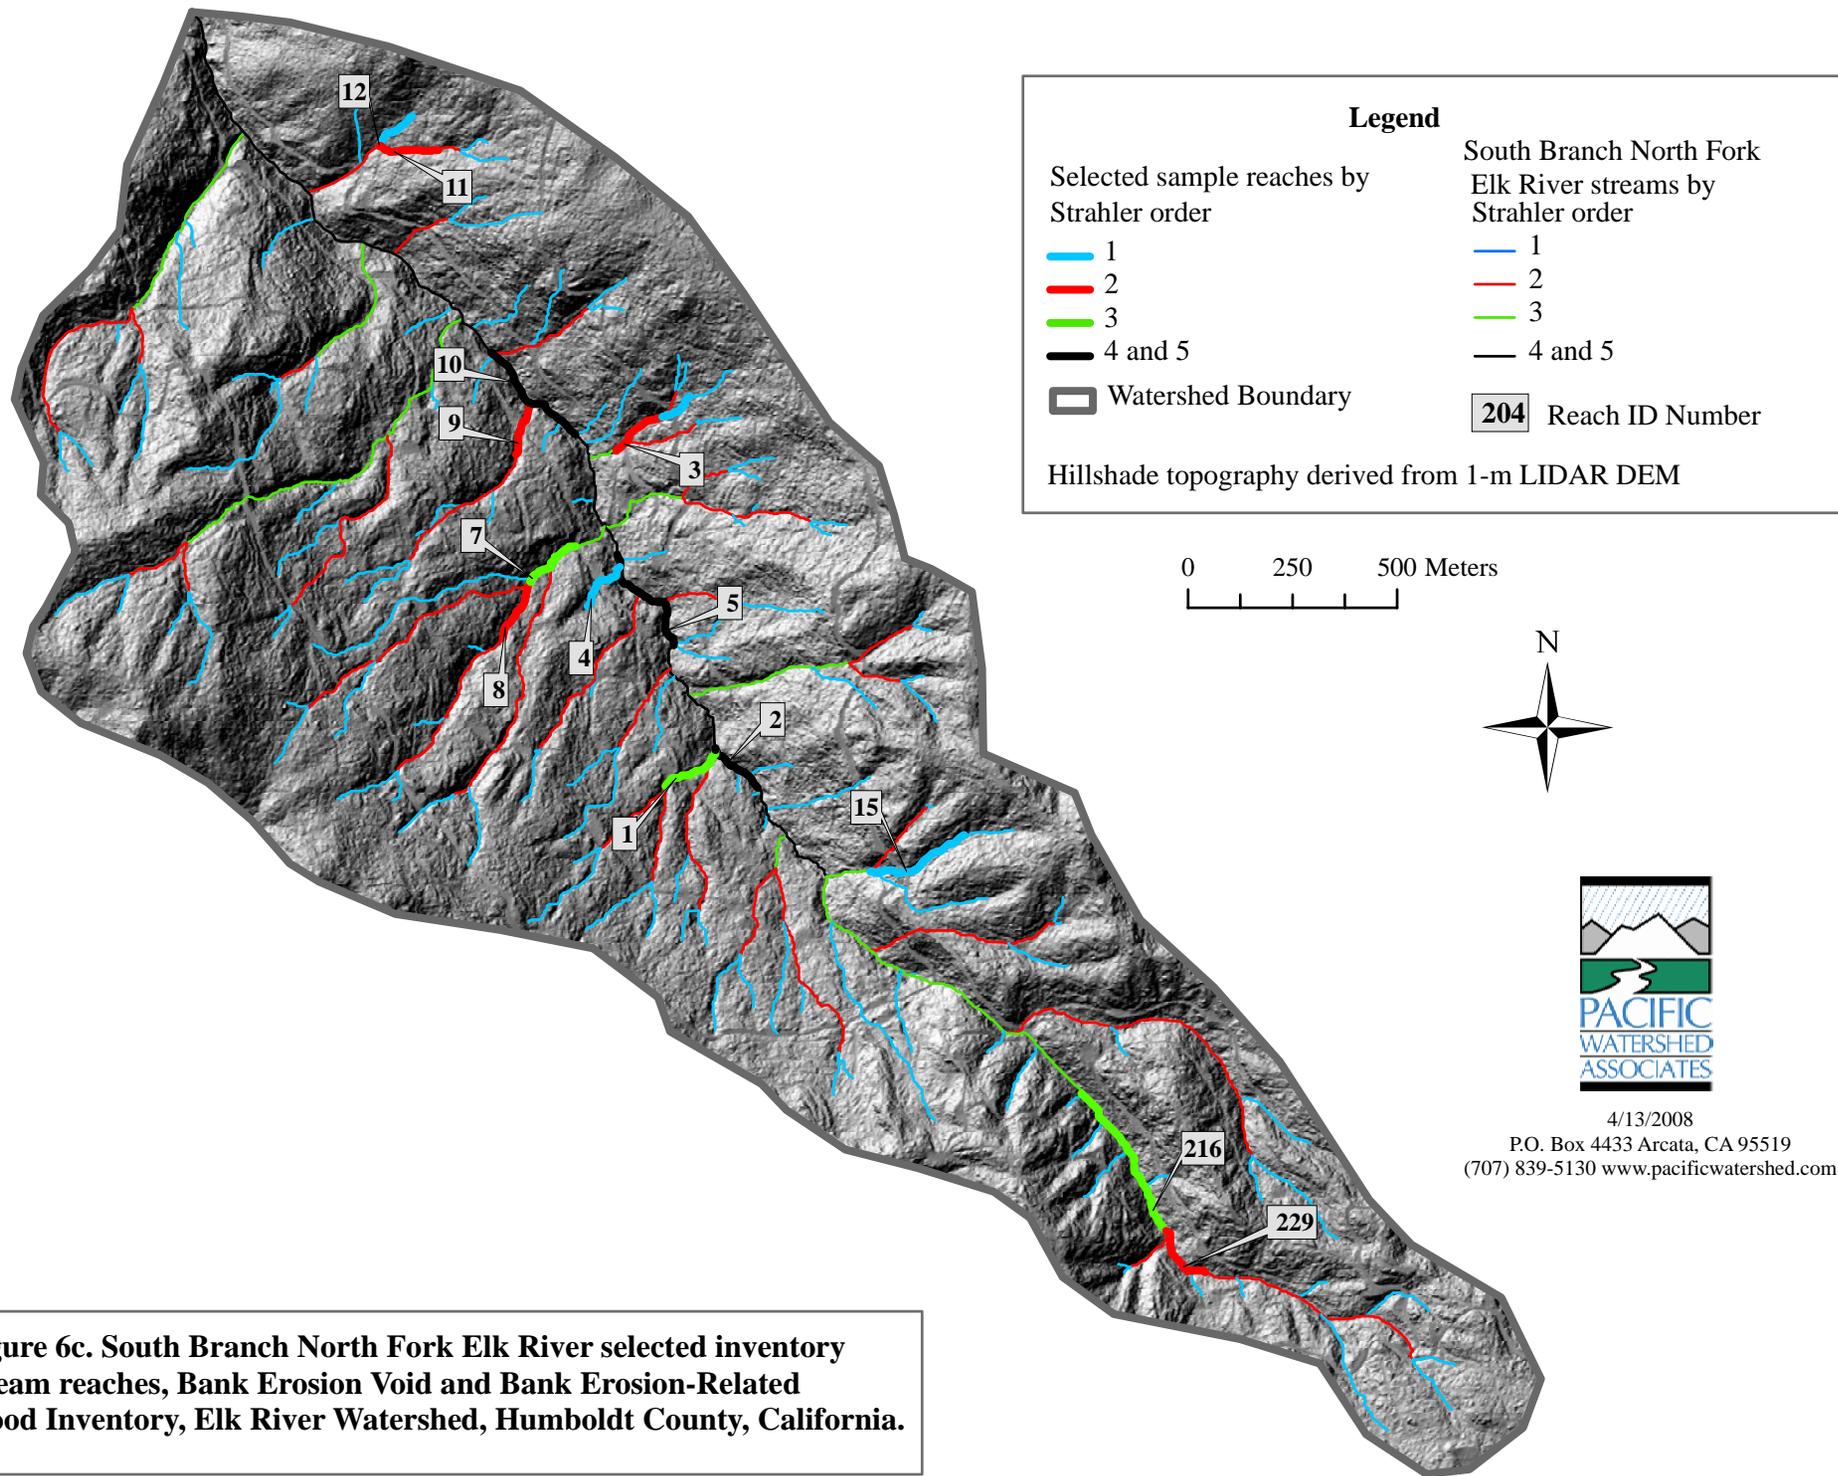
Figure 6c. South Branch North Fork Elk River selected inventory stream reaches, Bank Erosion Void and Bank Erosion-Related Wood Inventory, Elk River Watershed, Humboldt County, California.

Fourteen (14) sample reaches were inventoried in the South Branch North Fork Elk River with an average reach length of 206 m (Figure 6c). Approximately 620 m of 1st order, 750 m of 2nd order, 750 m of 3rd order, and 760 m of 4th order and higher stream reaches were inventoried in this subwatershed (Table 2). Similar to Corrigan Creek, the dominant channel substrate within the South Branch North Fork Elk River sample reaches was observed as a mixture of sand, gravel and cobble. The channel morphology of 1st order channels within this subwatershed was observed as primarily subsurface flow and high gradient riffle. Second (2nd) and 3rd order inventoried reaches exhibited less subsurface flow and were dominated by bedrock cascades and high gradient riffles. Finally, 4th order and higher order stream reaches within this subwatershed were located in the mainstem of South Branch North Fork Elk River and exhibited a mixture of channel morphologies including bedrock cascade, and high and low gradient riffles (Table 3 and Figure 6c).

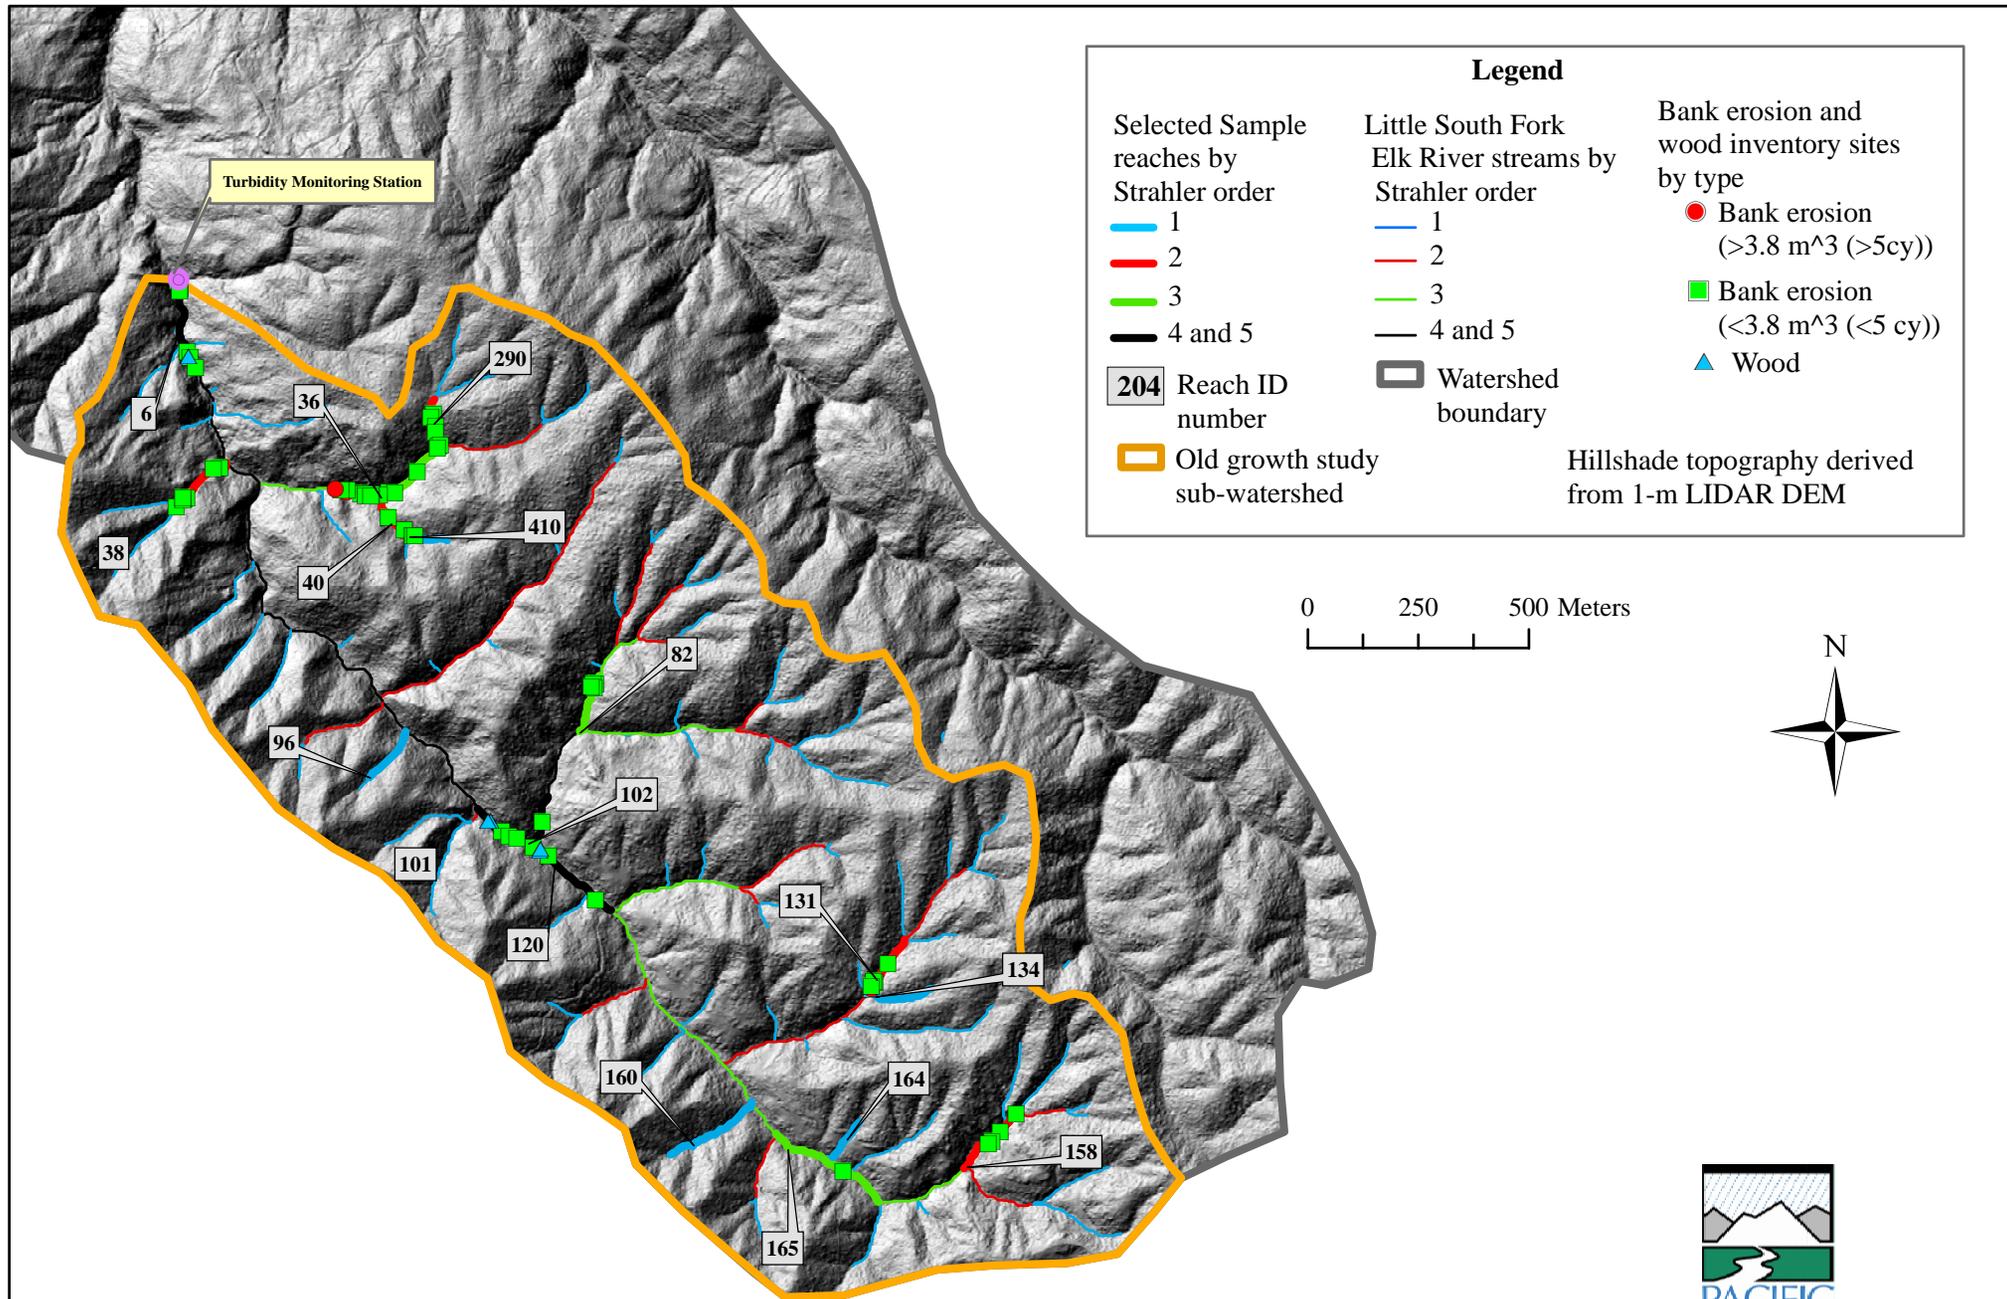
Figure 7b. Little South Fork Elk River site locations, bank erosion void and bank erosion-related wood inventory, Elk River watershed, Humboldt County, California.
