Bank Erosion Surveys

**Elk River Bank Erosion Void Assessment
and Bank Erosion-Related Wood Inventory
Humboldt County, California**

June 2008

Prepared by:
Eileen Weppner, Professional Geologist #7587
Pacific Watershed Associates
Arcata, CA

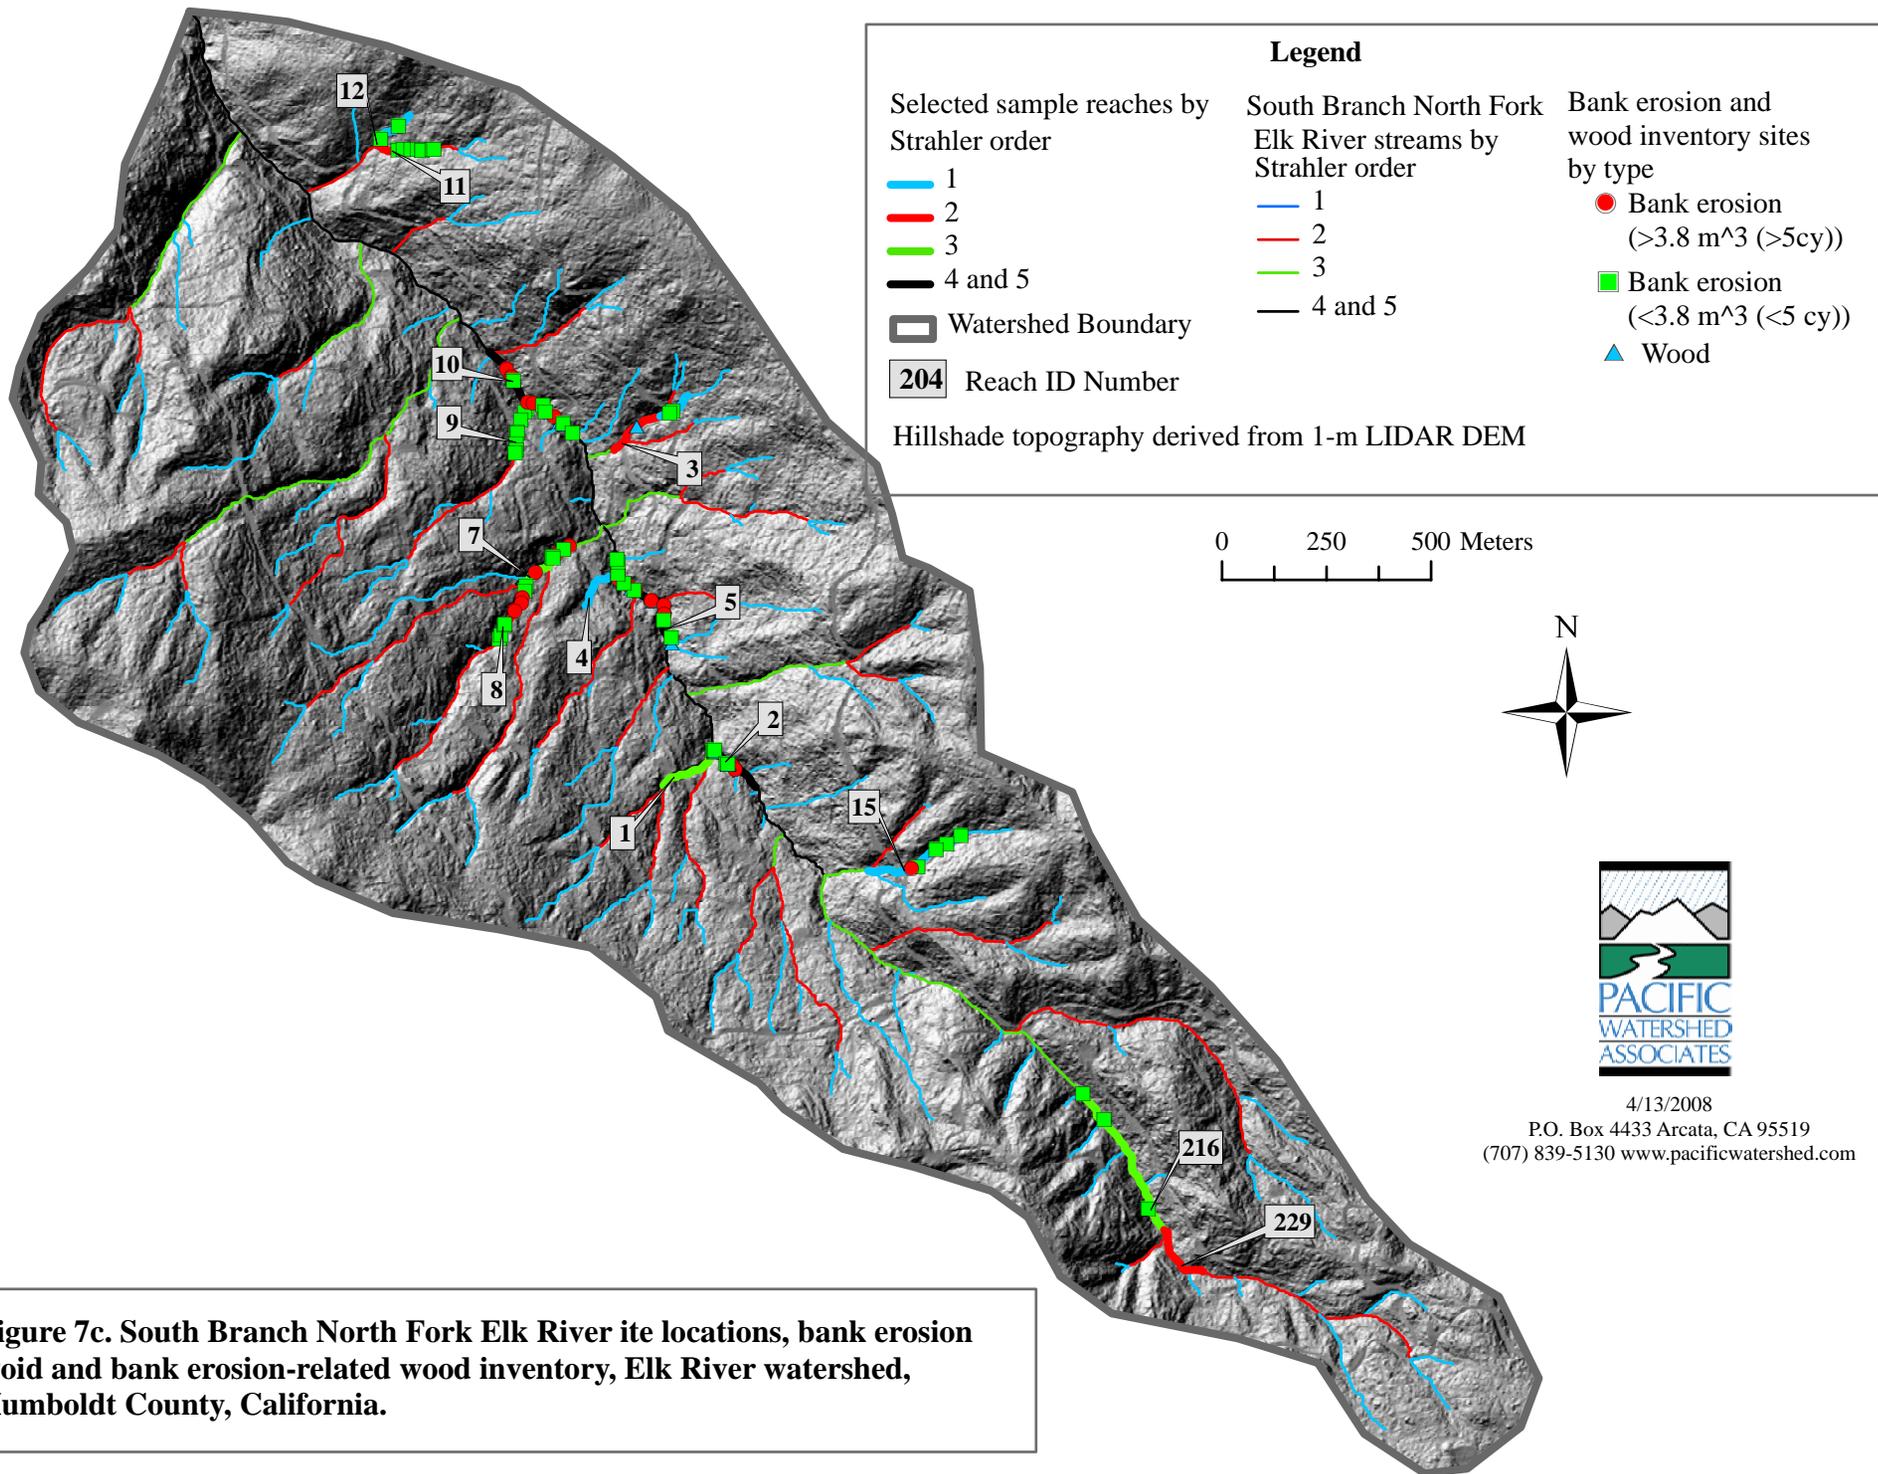
Figure 7c. South Branch North Fork Elk River ite locations, bank erosion void and bank erosion-related wood inventory, Elk River watershed, Humboldt County, California.

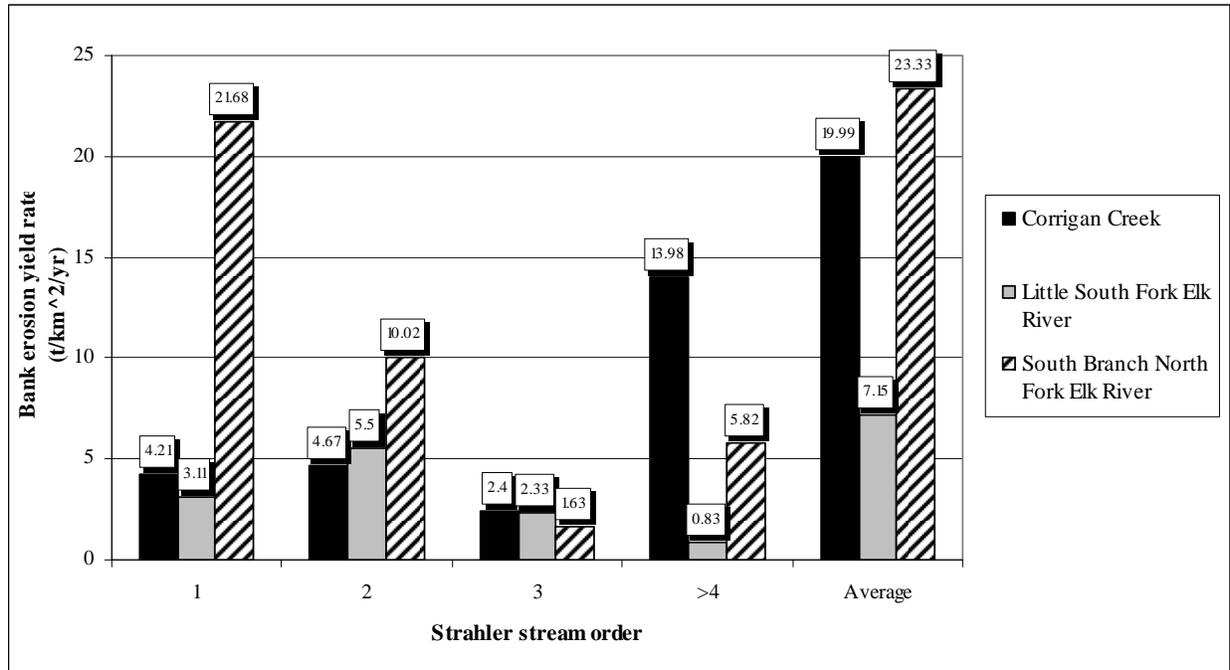
Figure 8. Bank erosion sediment yield rates by Strahler stream order and subwatershed developed from the bank erosion void assessment.

Comparing bank erosion yield rates by stream order, the South Branch North Fork Elk River produced the highest bank erosion yield rate (21.68 t/km²/yr) from 1st order stream channels. This rate is between 81% and 86% higher than the bank erosion yield rates observed in 1st order streams in the Little South Fork Elk River and Corrigan Creek (3.11 t/km²/yr and 4.21 t/km²/yr, respectively) (Table 6 and Figure 8). The second highest bank erosion rate (13.98 t/km²/yr) by Strahler stream order was observed in 4th order and higher streams within the Corrigan Creek subwatershed (Figure 8).
