**CALIFORNIA REGIONAL WATER QUALITY CONTROL BOARD  
SAN FRANCISCO BAY REGION**

**COMPLAINT R2-2014-1030  
ADMINISTRATIVE CIVIL LIABILITY  
IN THE MATTER OF**

**CALIFORNIA WATER SERVICE COMPANY  
UNAUTHORIZED DISCHARGE OF CHLORAMINATED POTABLE WATER TO  
POLHEMUS AND SAN MATEO CREEKS  
SAN MATEO COUNTY**

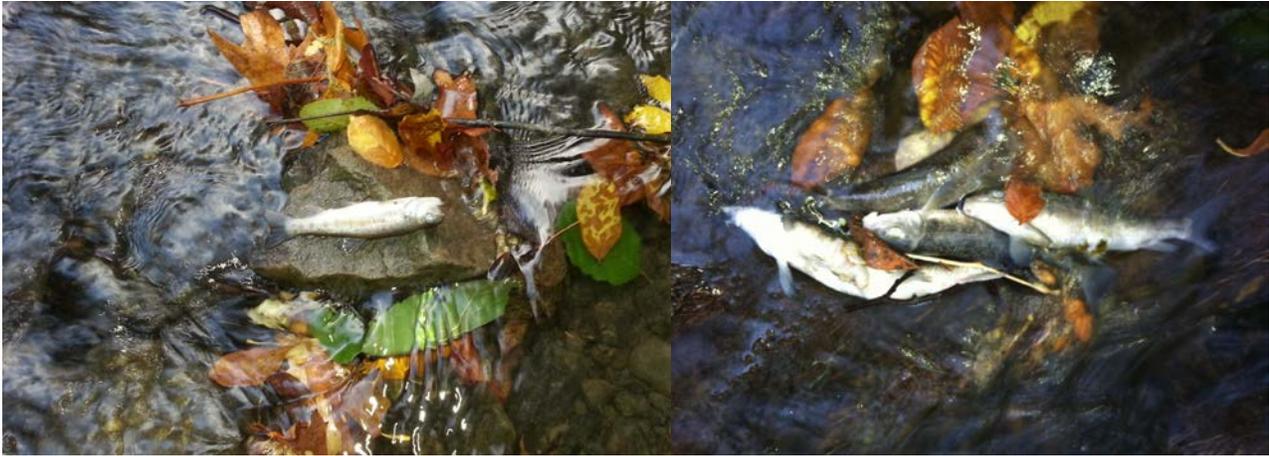
Figure 2. Dead fish noted by SFPUC employee Britt Brown, located just downstream of CS2 transmission line crossing San Mateo Creek.

On the morning of Tuesday, October 29<sup>th</sup>, just prior to conducting a routine fish population survey on San Mateo Creek, SFPUC biologists were notified by Britt Brown, an SFPUC CMB employee, that there were dead fish in the creek. He had noted the fish while overseeing contractors conducting routine vegetation maintenance along the creek bank, near Casey Quarry, just downstream of the CS2 transmission pipeline (Figure 1). SFPUC Biologists confirmed that there were 5 dead fish in the stream; one trout (*O. mykiss*) and four Sacramento Sucker (*C. occidentalis*) (Figure 2).

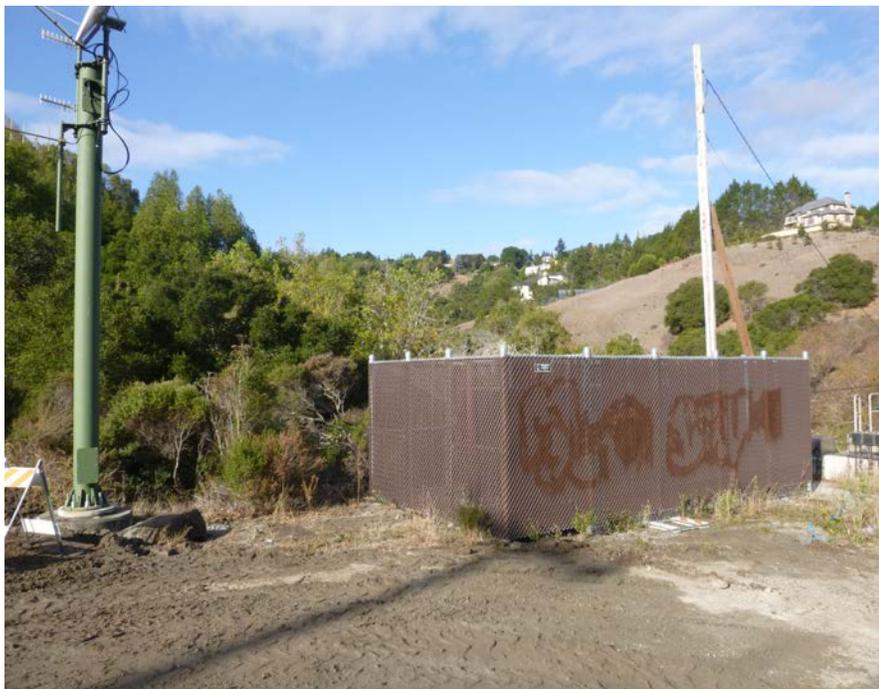
Figure 4. Cal Water facility on Polhemus Road, adjacent to Polhemus Creek, stream right.

At 1002, SFPUC biologist Randall Renn arrived at the Cal Water facility on Polhemus Rd. (Figure 1) and noted the ground appeared both saturated and recently graded (Figure 4). The creek bank just below the graded area was heavily eroded with large amounts of fine sediment observed in and around the creek and, what appeared to be, dechlorination tablets were observed placed in various locations along the eroded hillside (Figure 5). He then surveyed downstream along Polhemus Creek to the confluence of San Mateo Creek. No aquatic vertebrates or invertebrates (crayfish) were noted. He then proceeded upstream along San Mateo Creek, for a total of approximately 0.37 miles (Figure 1, Survey B), where numerous live fish, including trout, were noted.

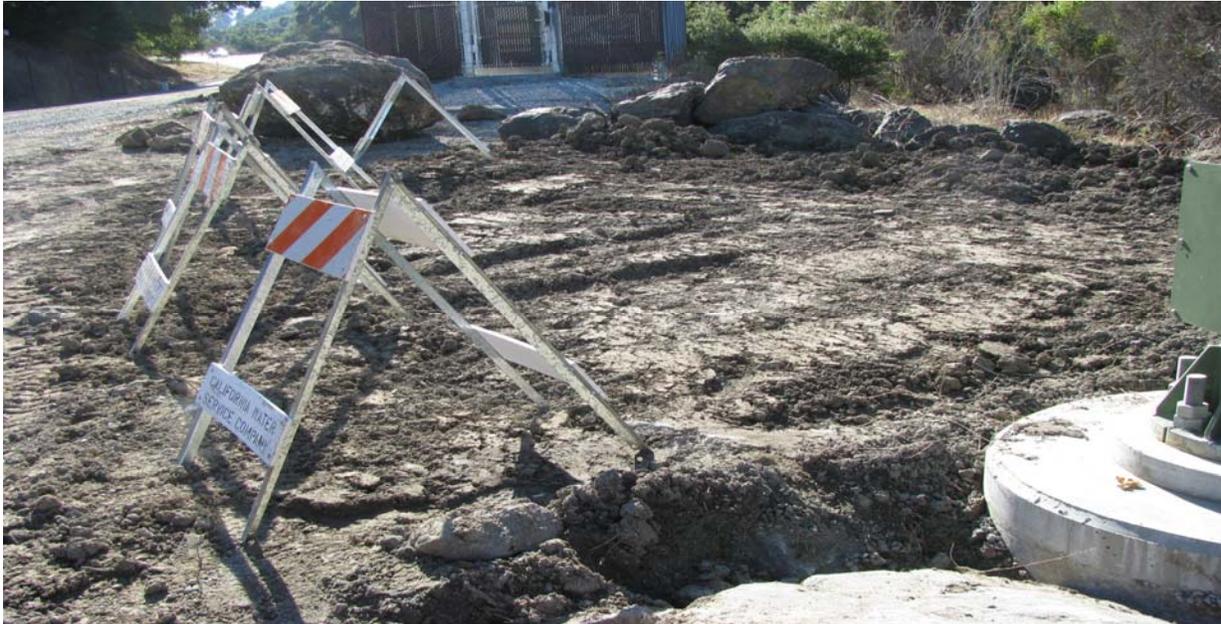
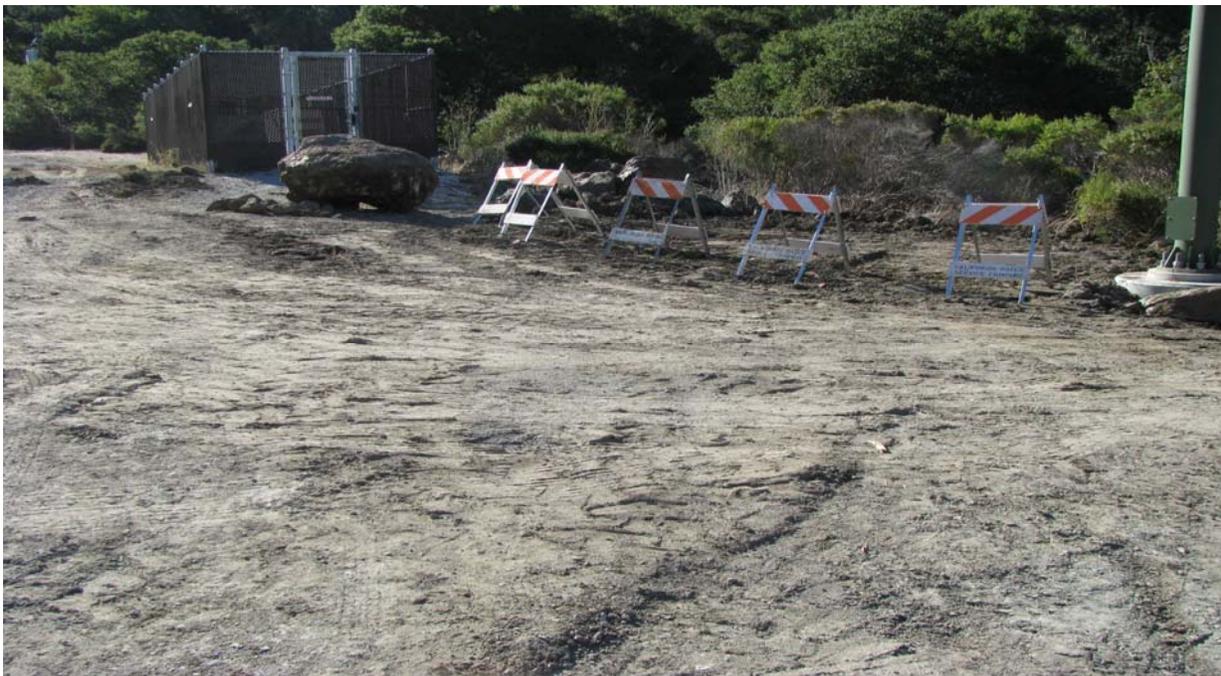
Photographs 1 and 2: The point of discharge, less than three feet from the top of Polhemus Creek bank. The green vegetation outlines the creek, and Cal Water's pump and control system that is inspected daily is right upgradient of the enclosure shown in the upper corner of photograph 2.

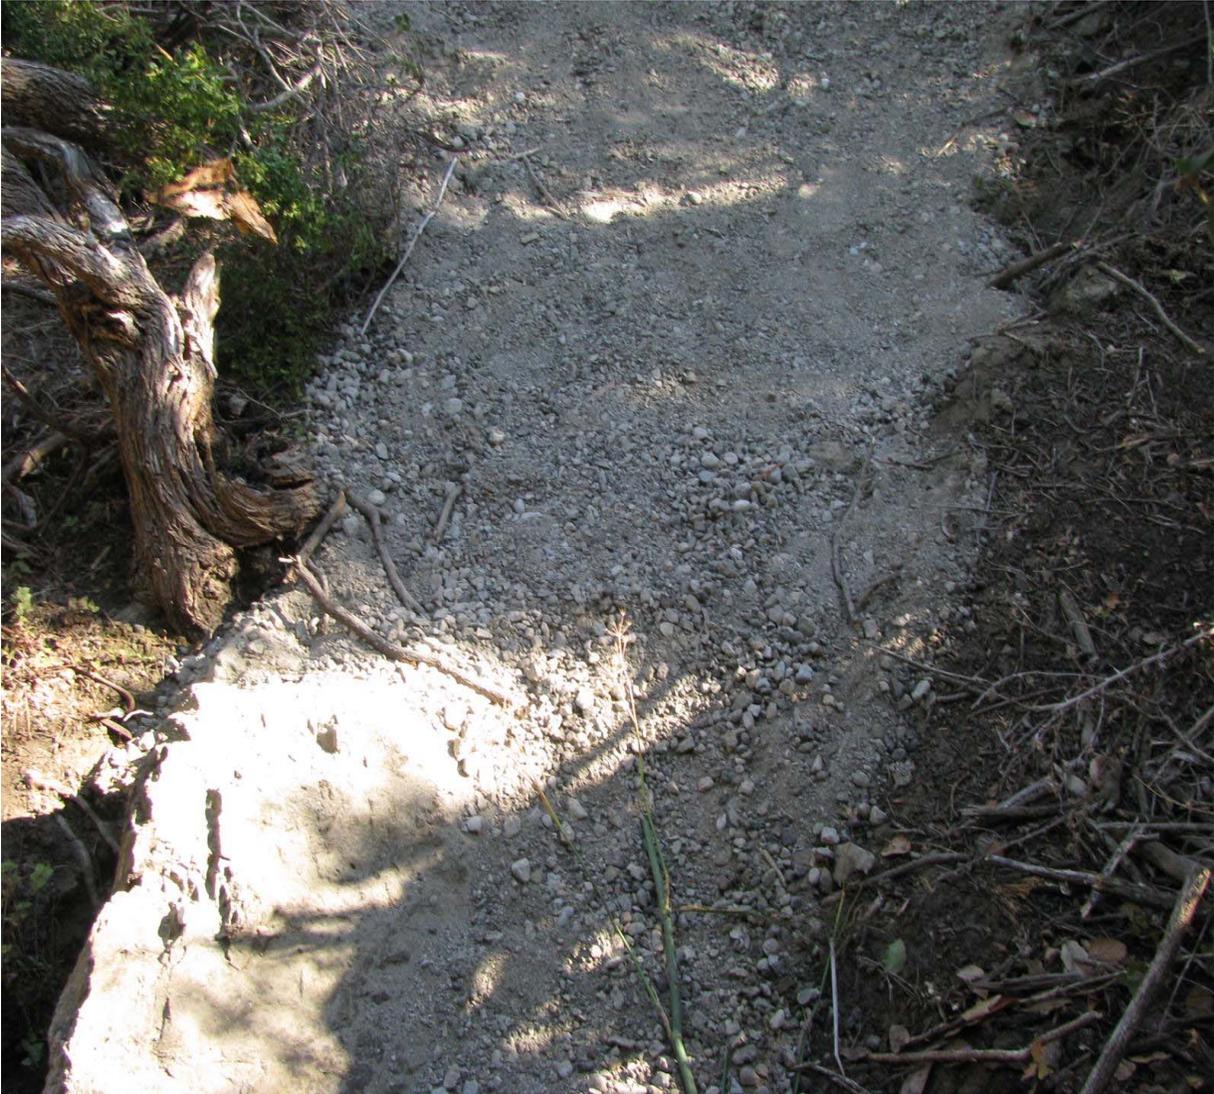
8. The discharge also caused significant bank erosion and sedimentation at the discharge site and downstream (see photographs 3-7 of Regional Water Board staff inspection report photographs dated November 1, 2013, documenting erosion and turbid water observed). The discharge rate for the chloraminated water release was approximately 2,280 gallons per minute, almost seven times higher than ambient creek flows. These increased flows eroded the stream bed and banks thereby increasing turbidity and depositing sediment downstream. High turbidity can impair the feeding ability of fish and interfere with fish respiration; excessive sedimentation can impair fish spawning and rearing habitats.

Additionally, the discharge also caused significant bank erosion in Polhemus Creek and subsequently sediment deposition in both Polhemus and San Mateo creeks. (See photographs 3-7 of Attachment B, Regional Water Board staff inspection report photographs dated November 1, 2013, documenting erosion and turbid water observed.) The average discharge flow rate was approximately 2,280 gallons per minute<sup>1</sup>, which is almost seven times higher than the ambient creek flow rate<sup>2</sup>. The increased discharge eroded the stream bed and banks thereby increasing turbidity and depositing sediment downstream. High turbidity can impair the feeding ability of fish and interfere with fish respiration; excessive sedimentation can impair fish spawning and rearing habitats.

Photograph 3: Recent backfill of an erosion gully caused by the discharge.

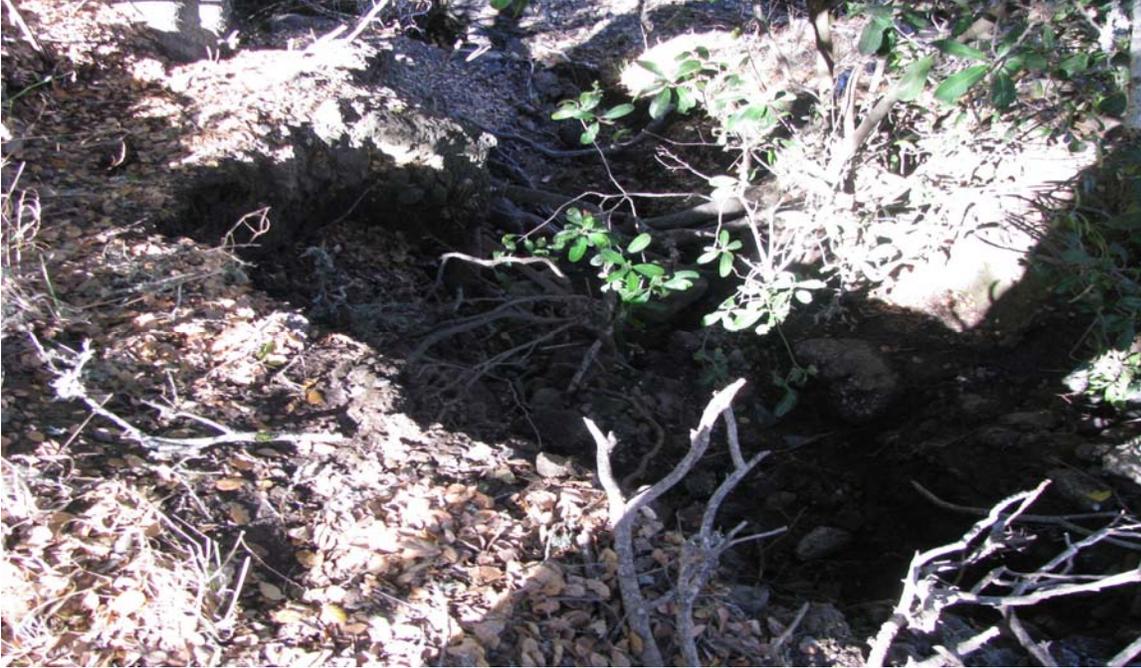
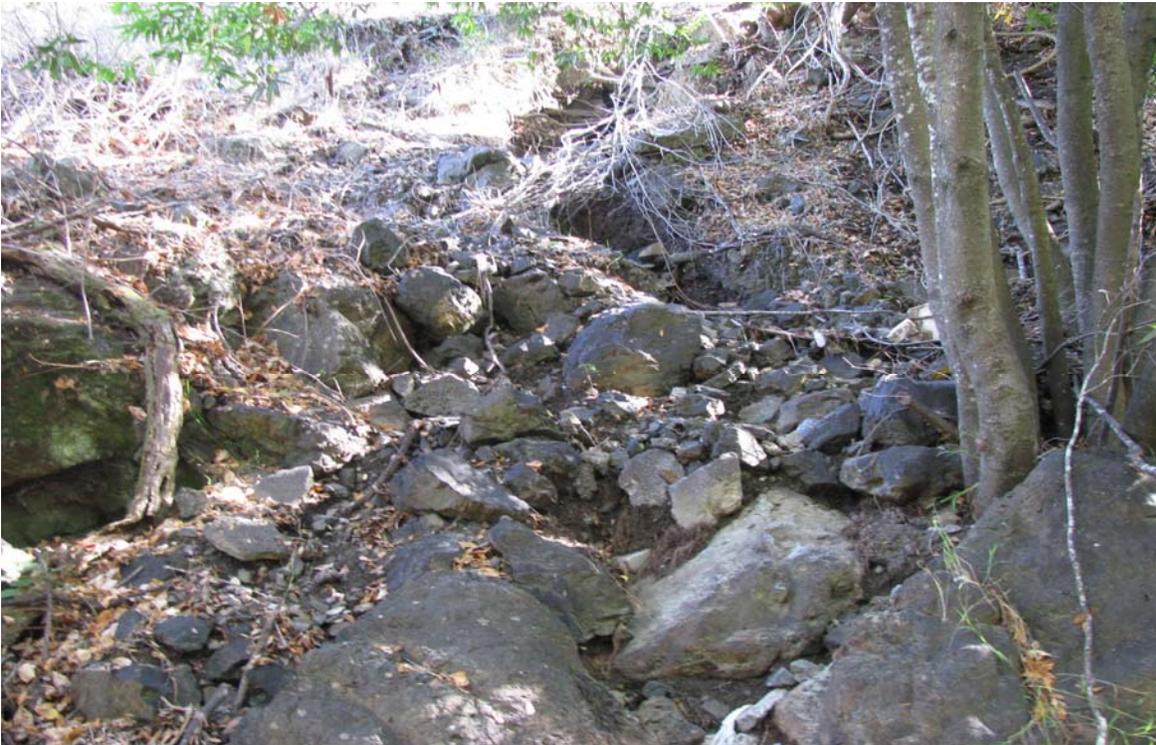
Photographs 4 and 5: Recent erosion of creek banks downstream from the point of discharge (Photographs 1 and 2).

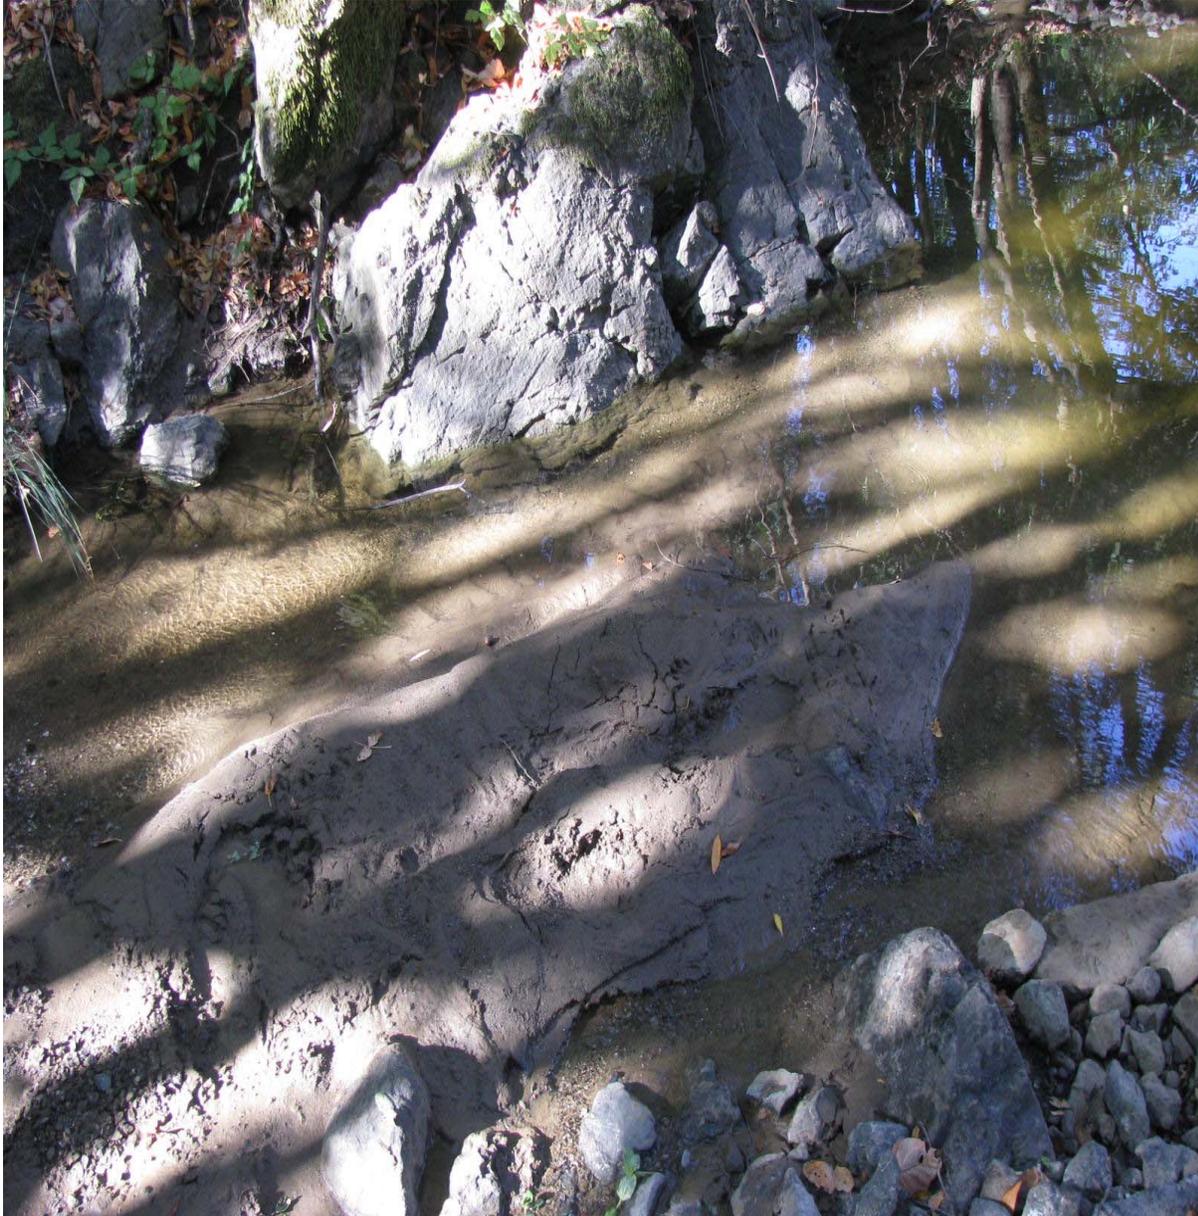
Photograph 6: A recent sediment deposition in a pool along Polhemus Creek, downstream of the point of discharge (Photographs 1 and 2).

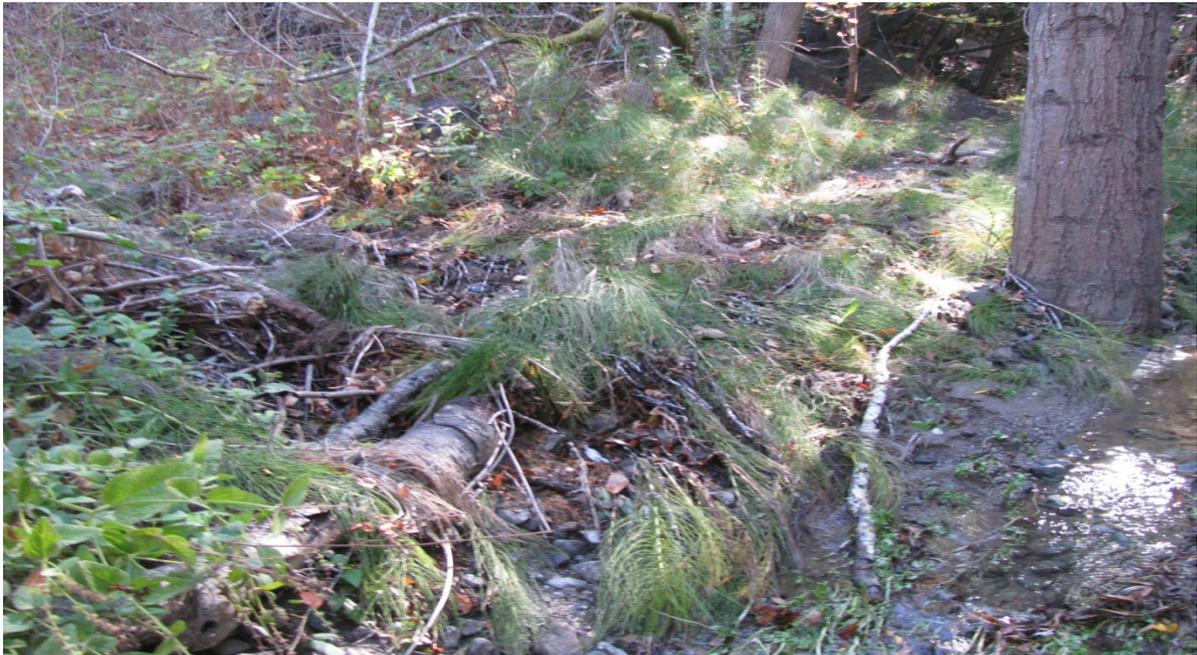
Photograph 7: Vegetation in the flood zone flattened by the discharge.

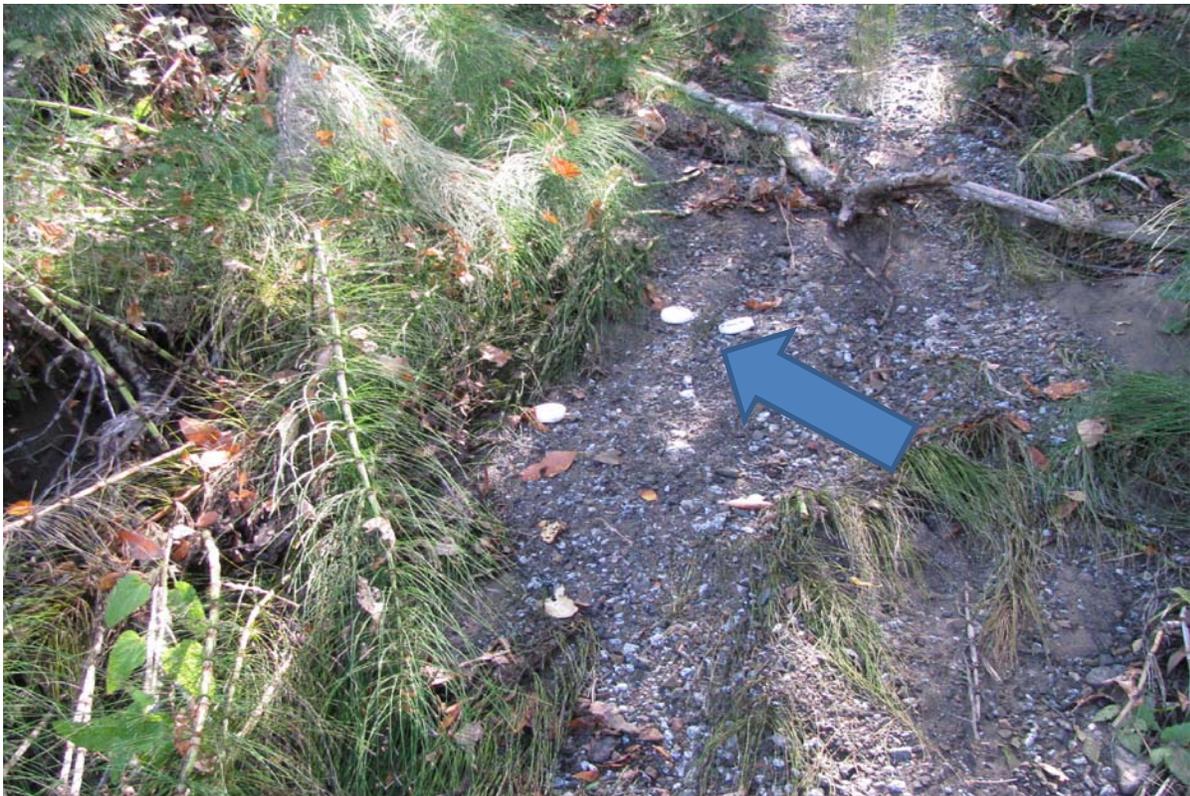
Photograph 8: Arrows show the locations of three undissolved dechlorination tablets in the creek that were placed by a Cal Water spill response crew.

Given the relative proximity of the discharge point to Polhemus and San Mateo creeks, there was little opportunity to “cleanup” or mitigate impacts to the creeks. Cal Water did deploy dechlorination tables in its response on October 28, 2013, immediately prior to closing the valve and stopping the discharge. Cal Water did not inspect far downstream on Polhemus Creek, and it

did not inspect San Mateo Creek at all, and Cal Water did not make any attempts to place dechlorination tablets in the creeks.
