TMDLs for Salts (EC), Chloride, Sodium and Boron in the Santa Maria River Watershed

Kickoff Meeting March 19, 2015

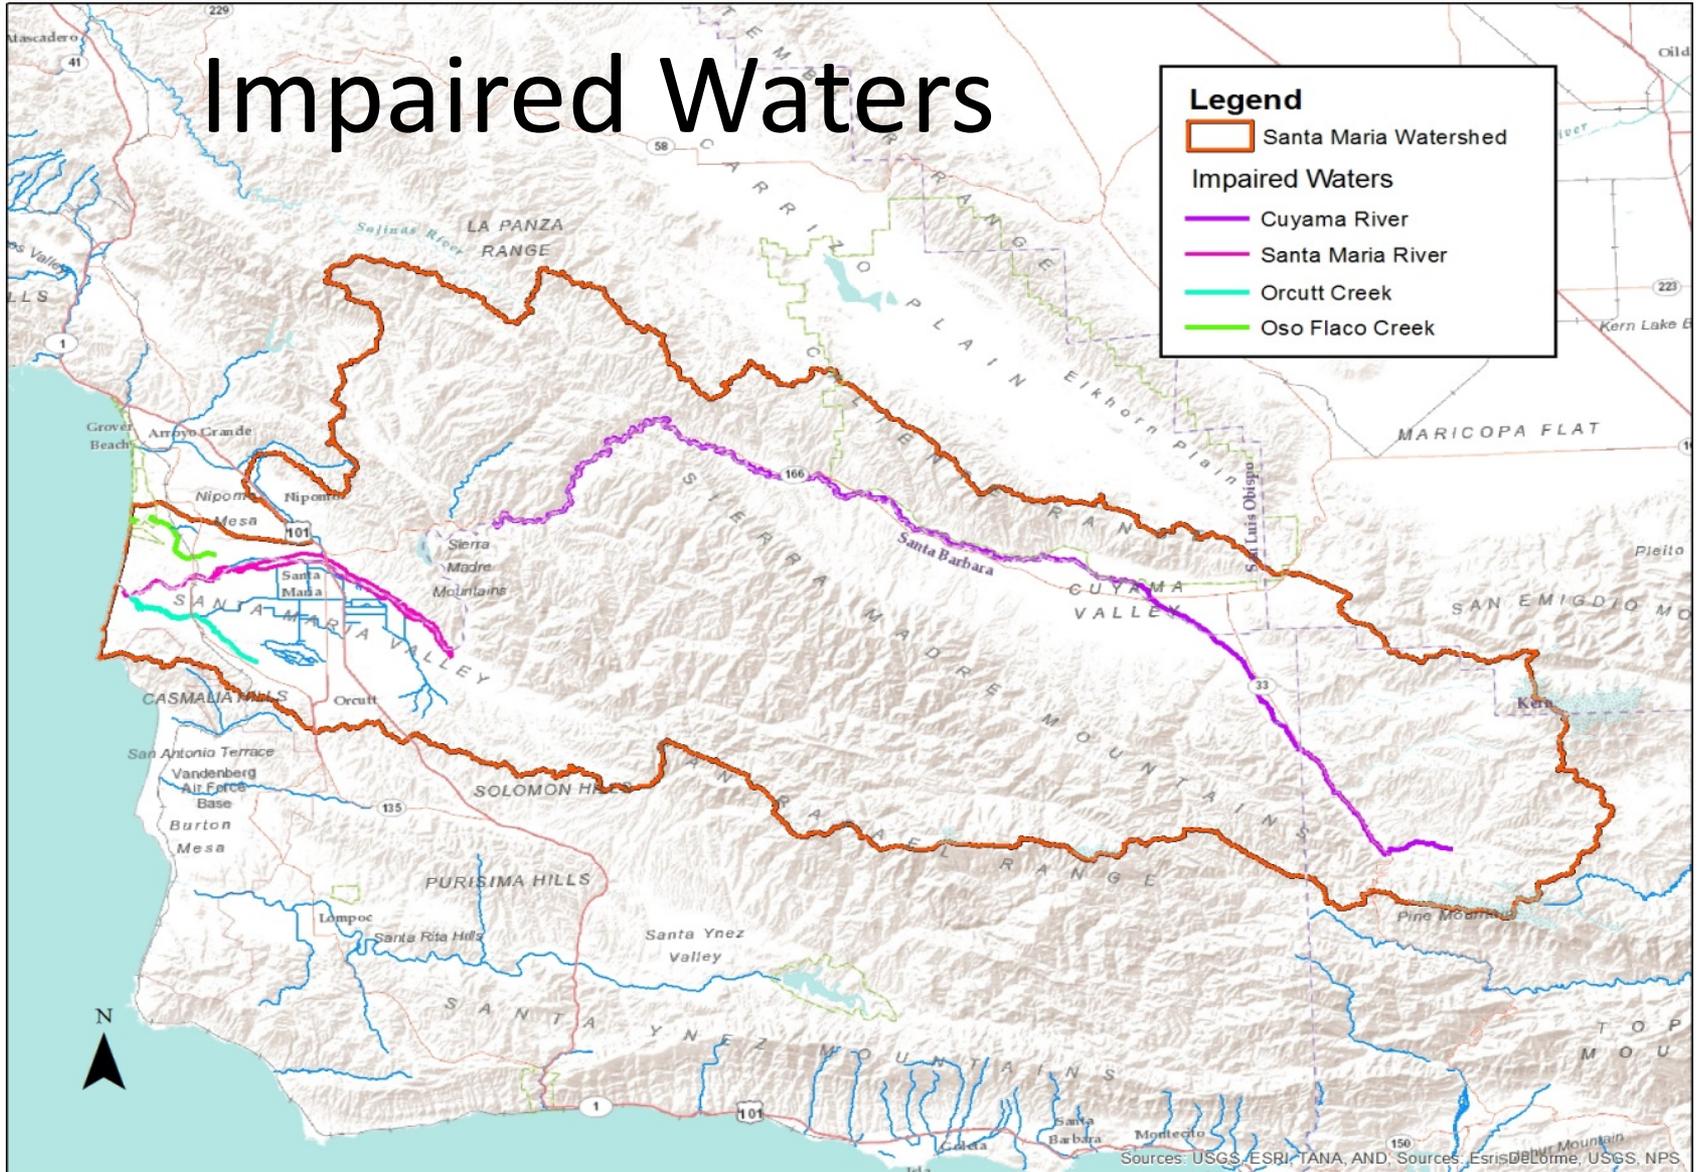
Impaired Waters

Santa Maria Watershed
- Impaired Waters**
-

Cuyama River
-

Santa Maria River
-

Orcutt Creek
-

Oso Flaco Creek

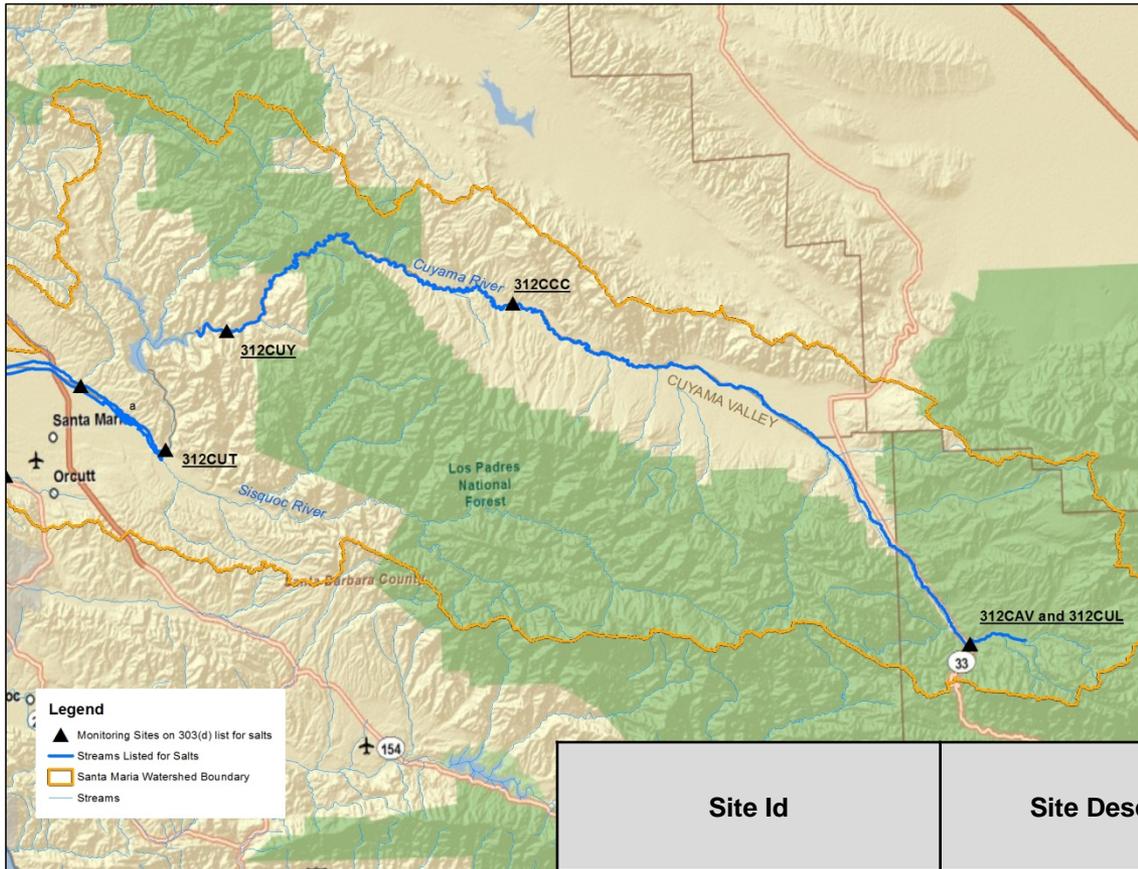
Site Id	Site Description	Excedances
312CUT	Cuyama River below Twitchell at White Rock Lane	Sodium
312CUY	Cuyama River d/s Buckhorn Road	Sodium
312CCC	Cuyama River d/s Cottonwood Canyon	Boron, Chloride, Sodium, Ec
312CUL	Cuyama River above Lockwood turnoff	
312CAV	Cuyama River at Highway 33	Sodium

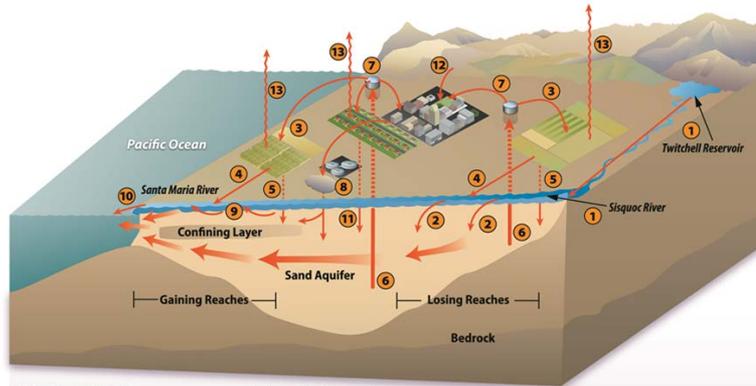
TMDL Assessment

| 1 Surface water inflow | 7 Pumped water supply |
| 2 Recharge from river (losing stream) | 8 Wastewater discharge to percolation ponds and springfields |
| 3 Irrigation | 9 Groundwater discharge to stream (gaining reach) |
| 4 Agricultural return flow | 10 Discharge to Pacific Ocean |
| 5 Agricultural percolation | 11 Lawn percolation |
| 6 Groundwater pumping | 12 Imported water |
| | 13 Evapotranspiration |
