DRAFT CLEAN UP AND ABATEMENT ORDER NO. R4-2014-XXXX COMMUNITY RECYCLING & RESOURCE RECOVERY, INC. AND CROWN DISPOSAL CO., INC. 9189 DE GARMO AVENUE, LOS ANGELES, CALIFORNIA (WDID NO. 4 19I004715): OPPORTUNITY TO SUBMIT COMMENTS AND EVIDENCE

CLEANUP AND ABATEMENT AND CALIFORNIA WATER CODE
SECTION 13267 INVESTIGATIVE ORDER NO. R4-2014-XXXX
REQUIRING

FOR THE PROPERTY LOCATED AT:
9189, 9147 AND 9143 DE GARMO AVENUE, 11300 PENDLETON STREET, AND
11219, 11213, 11211, 11201 RANDALL STREET
SUN VALLEY, LOS ANGELES COUNTY, CALIFORNIA, 91352

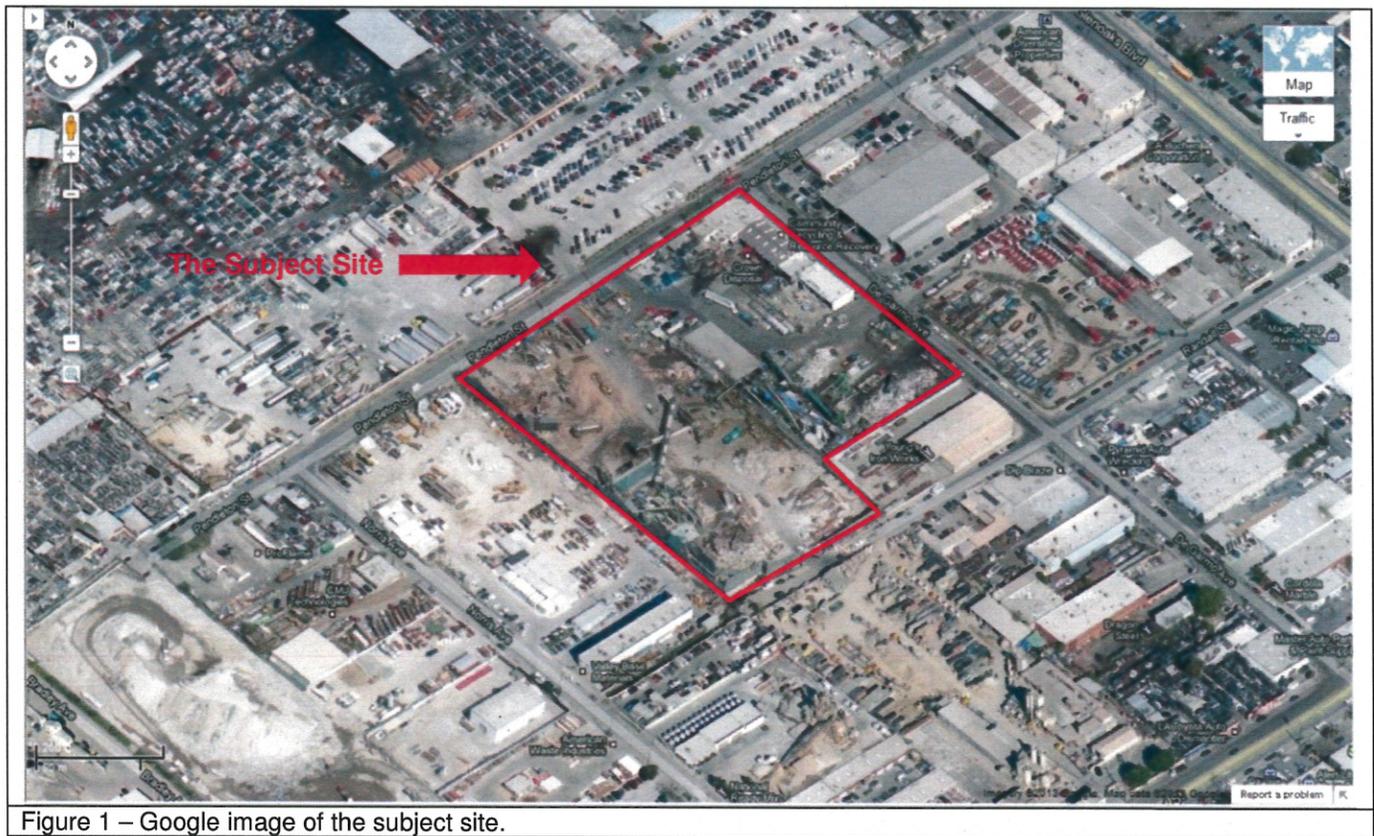
The subject facility is a waste recycling/transfer station and truck yard. It is about 8.5 acres, located east of De Garmo Avenue, between Pendleton Street and Randall Street in Sun Valley, California (figure 1). The recycling/transfer operation is conducted by Community Recycling & Resource Recovery, Inc. (Community Recycling) and the truck yard operation is conducted by Crown Disposal Company, Inc. (Crown Disposal). Community Recycling and Crown Disposal are sister companies, both operating at subject site.

Figure 1 – Google image of the subject site.

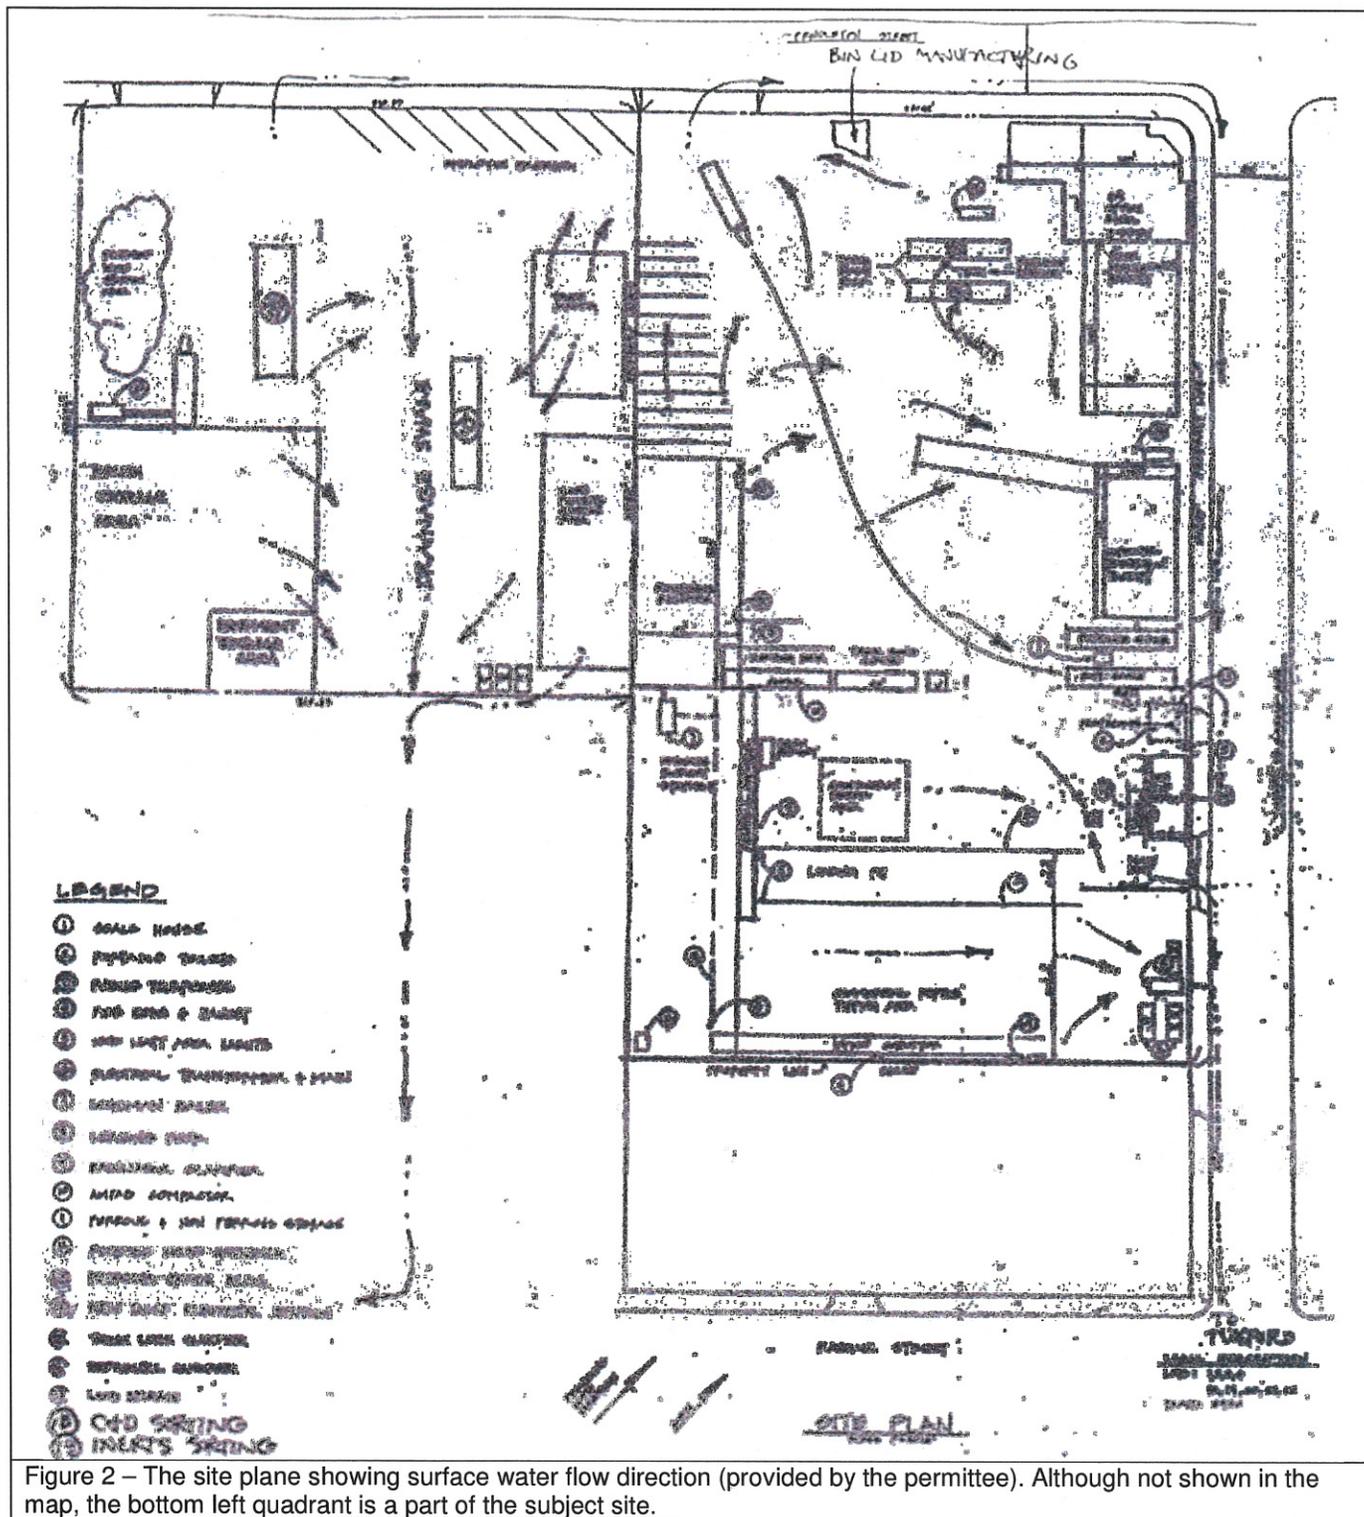
Figure 2 – The site plan showing surface water flow direction (provided by the permittee). Although not shown in the map, the bottom left quadrant is a part of the subject site.

The majority of stormwater from the northeastern portion sheet flows toward an inlet located between the tipping area and the De Garmo Avenue exit/entrance (figure 2 and photo 14). Water collected by the inlet is conveyed to the eastern clarifier. Only an area in the northern part of the southeast portion drains directly onto Pendleton Street (figure 2). This area is uncovered and uncontained and used to store rusted spare parts and components (photo 15).

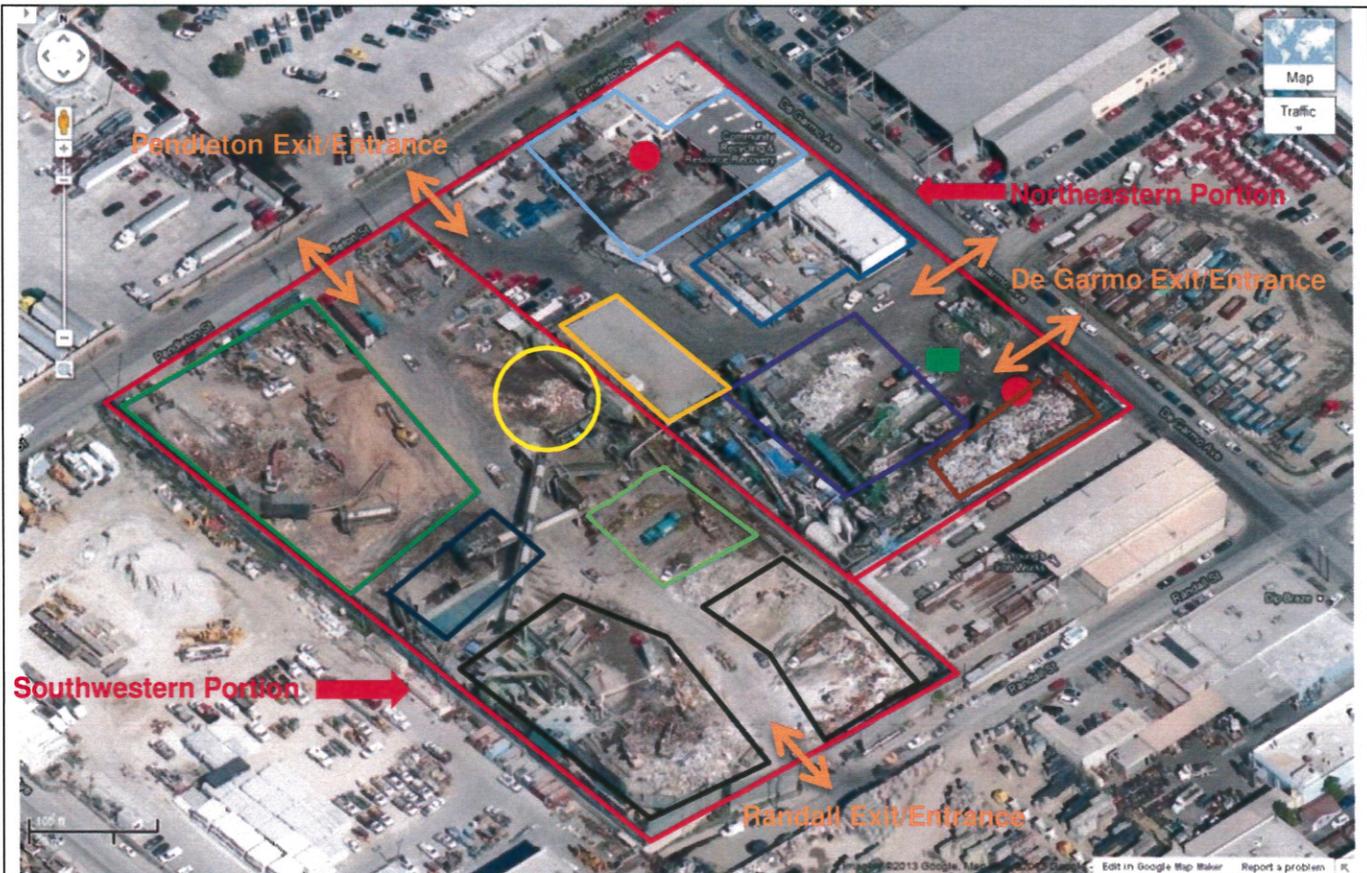
Figure 3 – Google image of the subject site used to demonstrate the subject site’s layout.

- Light Blue Outline: Truck Yard
- Dark Blue Outline: Plastic Film Processing and Pellet Production Area
- Purple outline: Tipping Area
- Orange Outline: Covered Area for Recovered Bale Paper Storage
- Brown Outline: Food Waste
- Dark Green Outline: City Trimmings
- Light Green Outline: Private Trimmings
- Yellow Outline: Produce Waste
- Navy Blue Outline: Processed Trimmings
- Black Outline: Construction Waste
- Red Solid Circle: Clarifier
- Green Solid Square: Inlet to Eastern Clarifier

In front of the tipping area is an area where recovered plastic films are washed, processed, and converted into plastic pellets (figure 3 and photo 9). The water from washing the films is collected through an inlet and reused in the process (photo 10). Plastic pellets are produced indoors and no pellets were observed outdoors (photo 11). Southeast of the plastic pellet production area is an exit/entrance onto De Garmo Avenue (figure 3). This is where stormwater discharges onto De Garmo Avenue. It is also sampling location 2. Immediately southeast of this exit/entrance is where food waste is piled (figure 3 and photo 12). I observed a very strong rancid scent in this area. Food waste is piled adjacent to De Garmo Avenue and adjacent to one of the inlets of the eastern clarifier (photo 13).

Trimming from the city are stored at the western corner of the site, which is pervious (figure 3 and photo 16). There is an exit immediately adjacent to this area which lacks tracking controls. As a result, sediment is tracked off the site (photo 17). Unsalable produce is received from super markets and is stored at a location east of the trimming storage (figure 3 and photo 18). I observed a very strong rancid odor in this area. Liquid from the expired produce accumulated underneath the pile is pumped into an above ground holding tank next to the pile of expired produce. This liquid is hauled off site via trucks to be mixed with compost. Adjacent to the expired produce area is an area where private trimmings are received and piled (figure 3 and photo 19). The trimmings are processed and prepared to produce compost. The processed trimmings are stored across the private trimming receiving area and ready to get hauled off site via trucks (figure 3 and photo 20). The southern part of the southwestern portion is dedicated to construction material. Construction refuse is brought in through the Randall Street exit/entrance, via trucks and piled immediately adjacent to the exit/entrance (figure 3 and photo 21). The refuse is then processed and segregated for recycling, based on composition and use and stored northwest of the receiving area (figure 3 and photo 22). Municipal tap water is sprayed over the construction waste for dust control (photo 23). Additionally, a cloth curtain is used around the construction waste receiving area to contain the dust on site (photo 24).

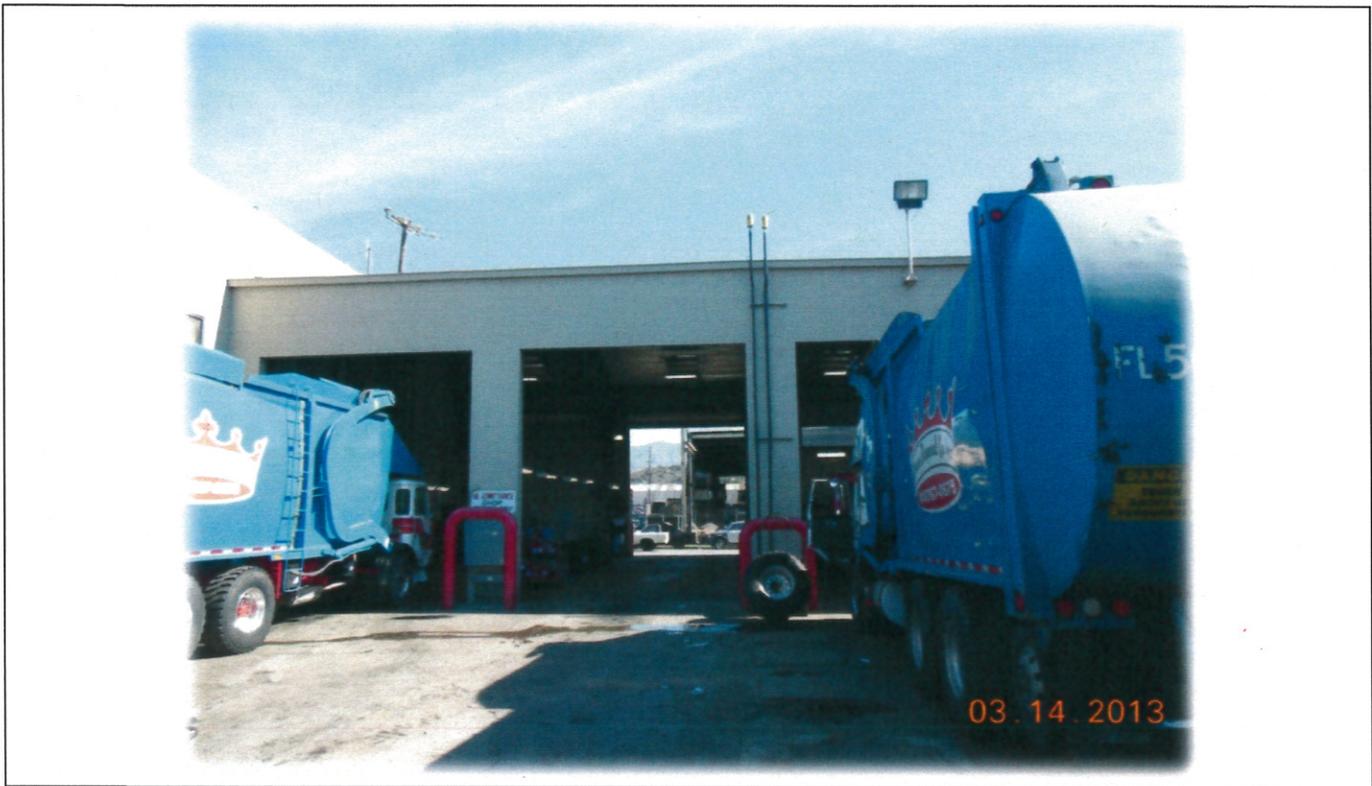
Photo 1 – Covered truck maintenance area used by Crown Disposal's trucks.

The office building, truck yard and maintenance shop, and machine shop are located at the northern corner. Most of the truck maintenance activities are conducted indoors (photo 1). However, I observed some maintenance activities conducted outdoors (photo 2). The truck yard also contains an uncovered diesel pump, which is fed by an underground diesel tank (photo 3). Stormwater from the truck yard is conveyed to the northern clarifier, as mentioned in the Facility Information section above (photo 4). Waste material brought to the site via collection trucks is received in the tipping area, which is located almost at the center of the site, in the northeastern portion (figure 3, photos 5 and 6). Waste is sorted and stored in different locations for either recycling or transfer to landfill. Immediately northwest of the tipping area is a covered structure where bales of recovered paper are stored (figure 3 and photo 7). I observed an uncovered diesel pump with several uncontained chemical containers stored next to this covered structure (photo 8).

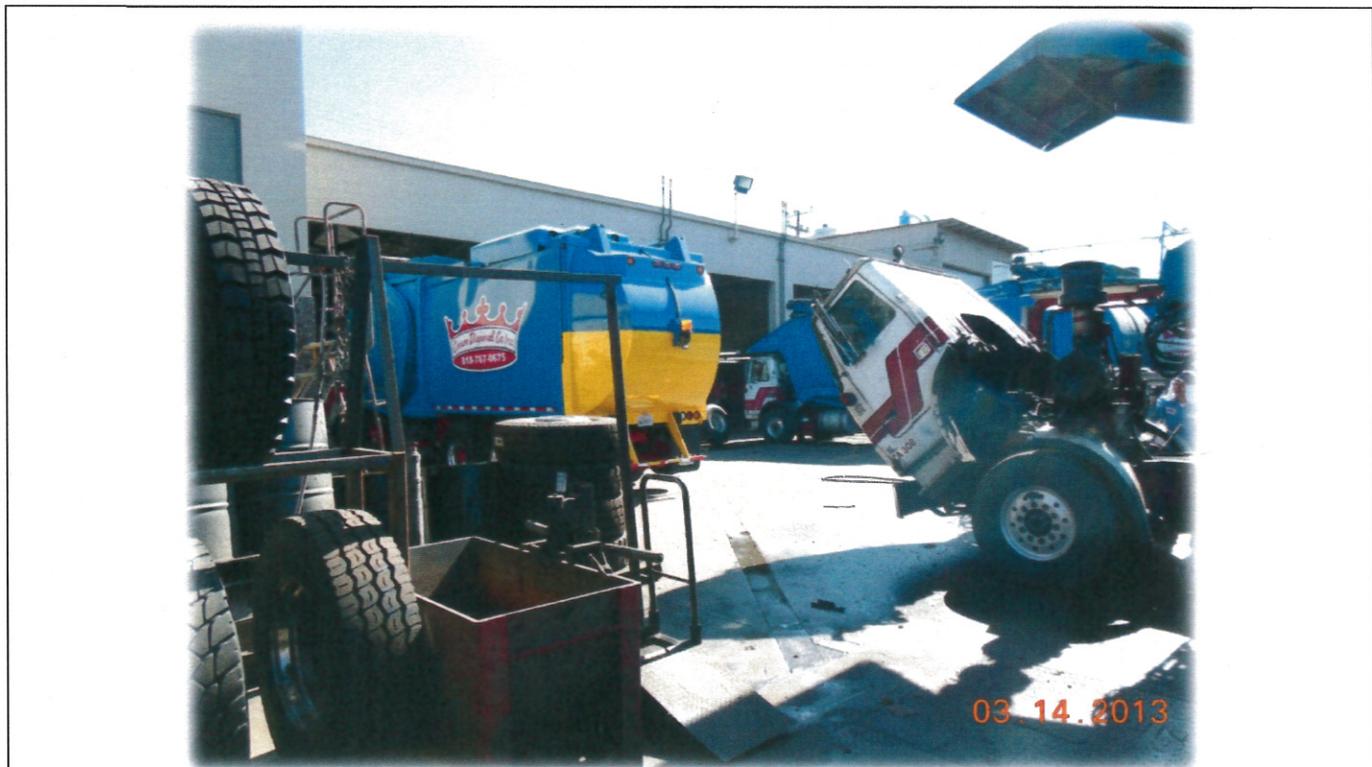
Photo 2 – Some truck maintenance was observed being conducted outdoors.

- Vehicle maintenance conducted outdoors. This is in violation of General Permit Sections A.8.a.iv, b.i, and iii.
- Fuel and Chemical containers stored outdoors without containment. This is in violation of General Permit Sections A.8.a.iv, b.i, iii, and iv.

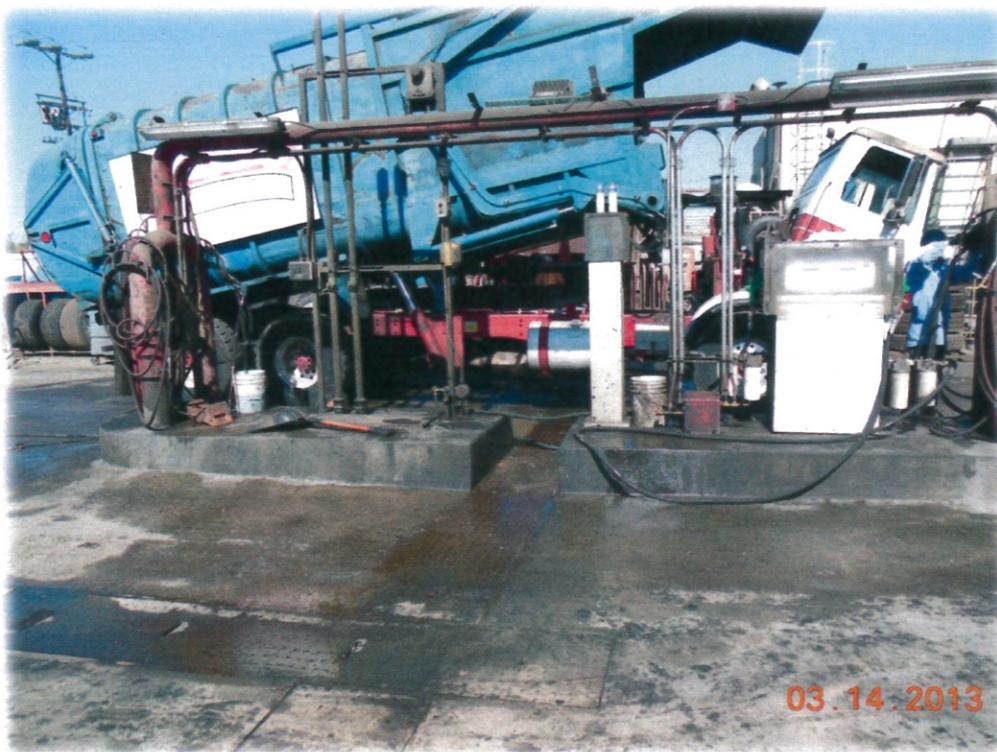
Photo 3 – An uncovered diesel station in the truck yard. Metal plates with inlets cover the trenches that convey surface water to the northern clarifier.

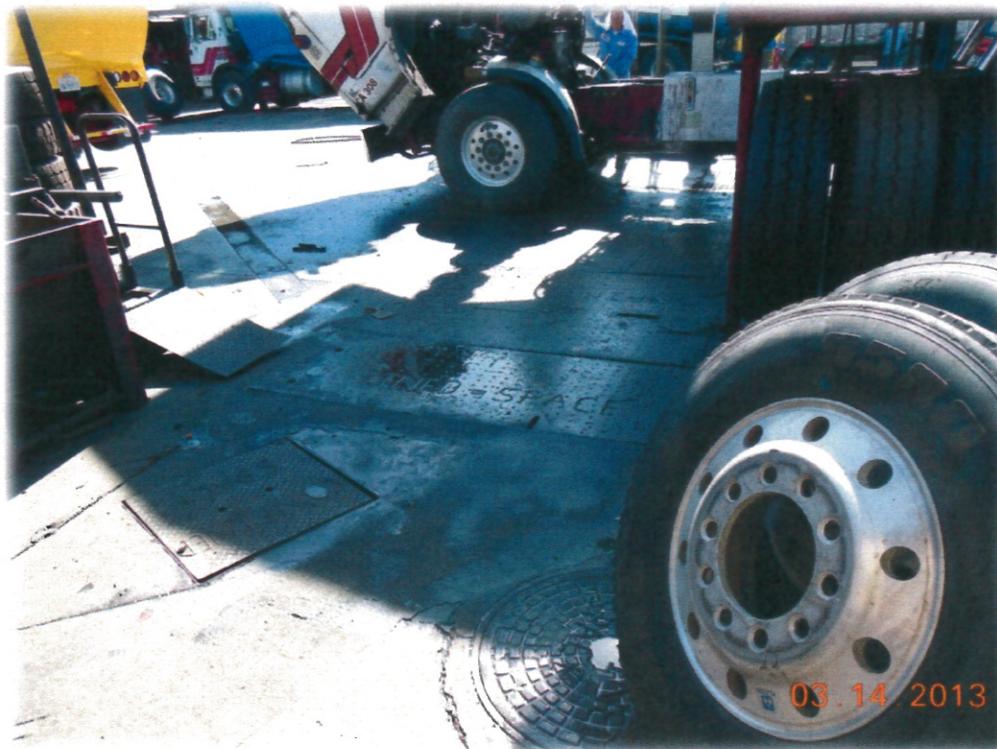
Photo 4 – The northern clarifier's first stage cover.

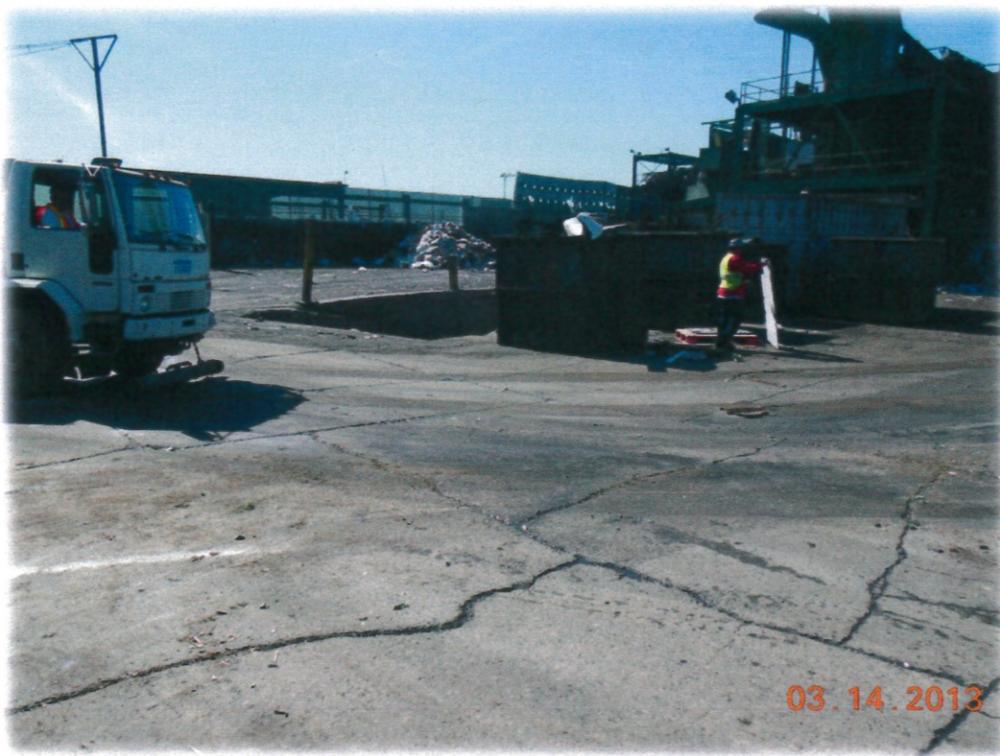
Photo 5 – Southern half of the tipping area. Left side of the photos shows the sweeper truck in operation.

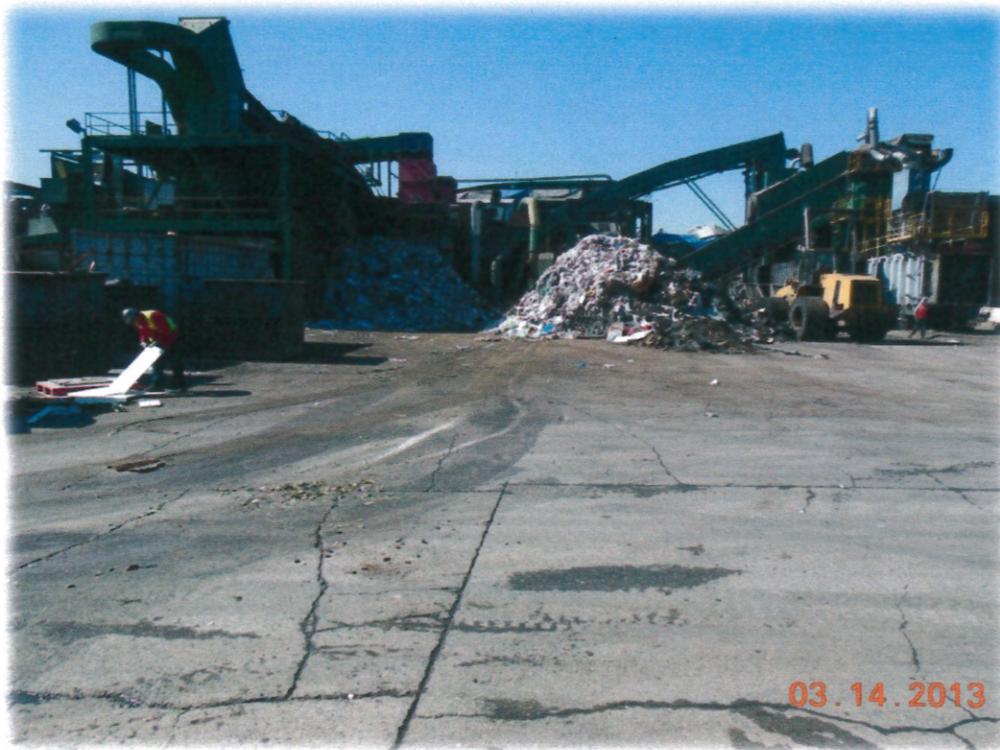
Photo 6 – Northern half of the tipping area. Received waste is sorted and distributed using conveyer belts and bulldozers.

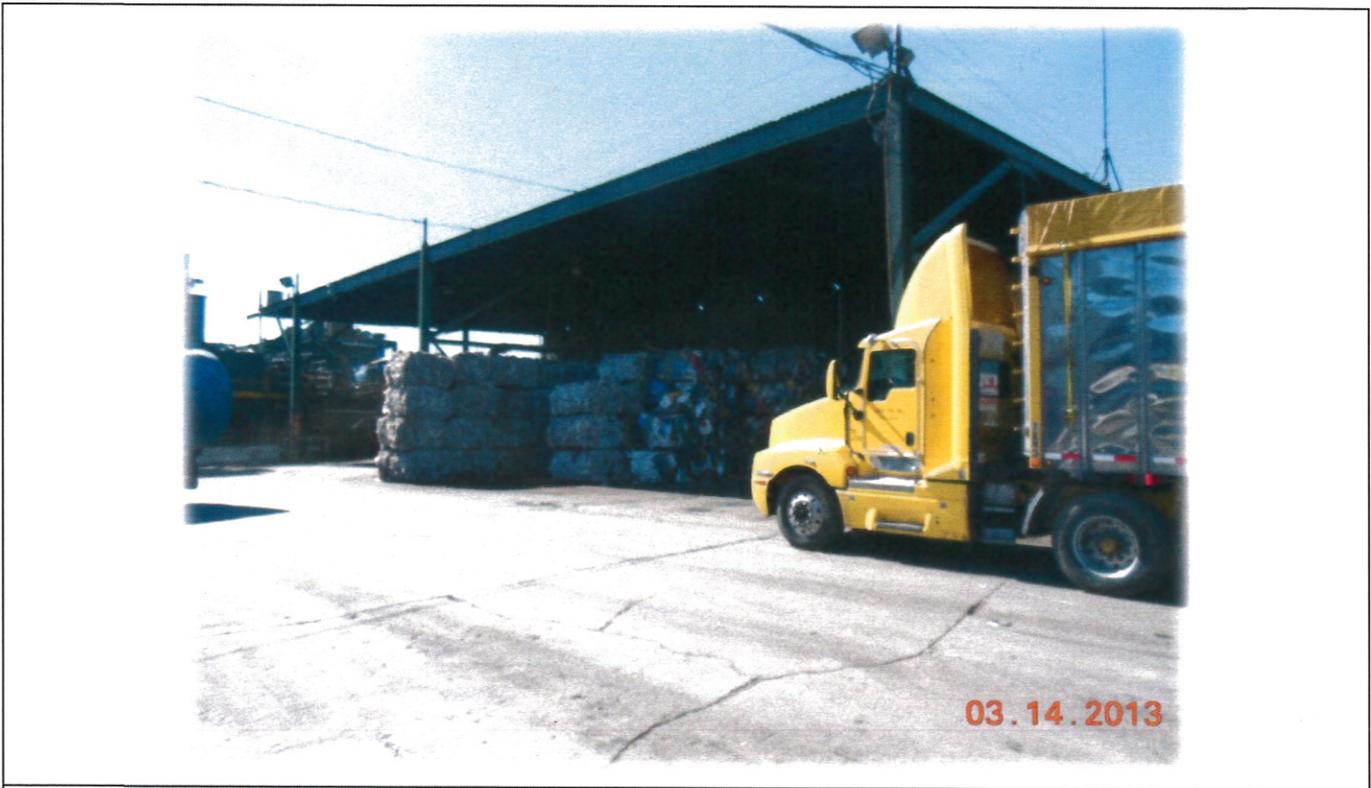
Photo 7 – The covered area where bales of recovered paper are stored before shipment.

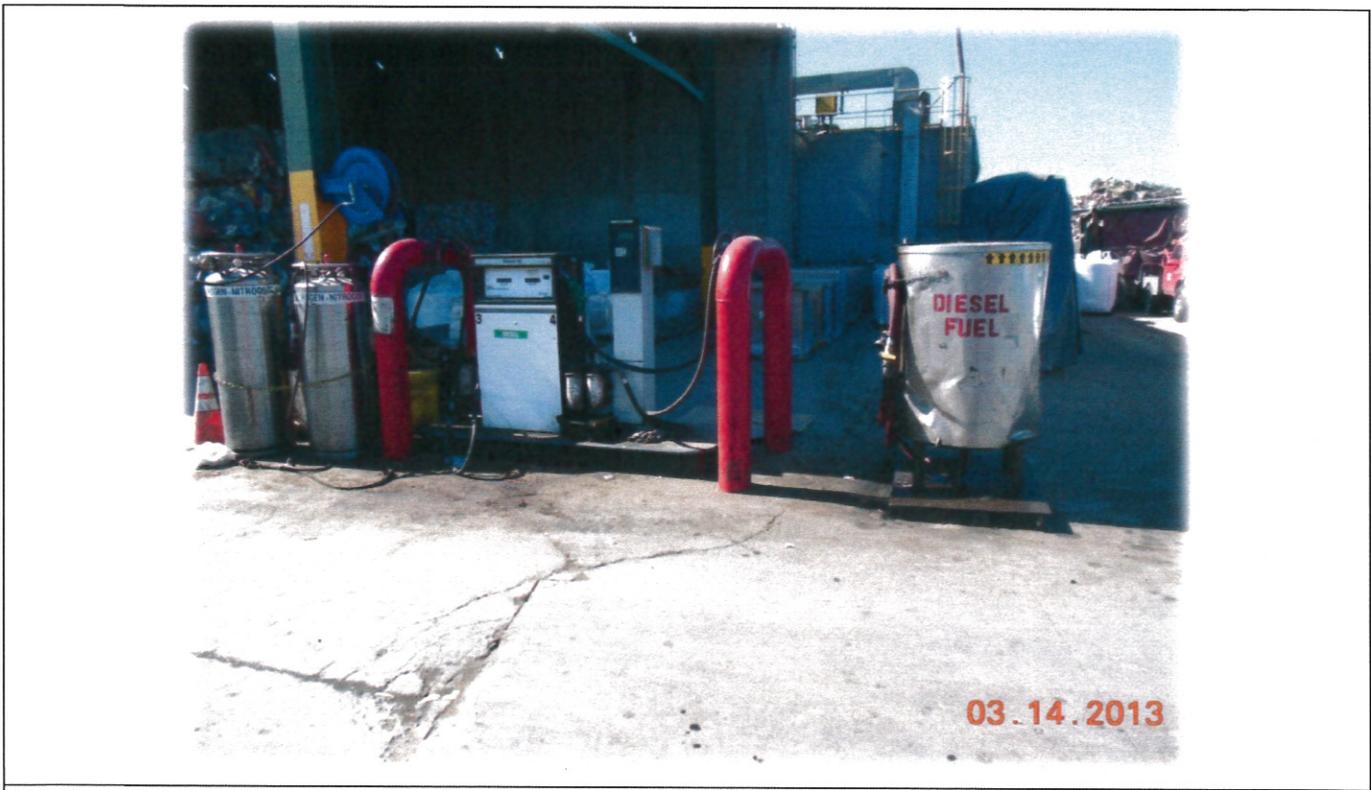
Photo 8 – A pump station located next to the covered area depicted in photo 7. The station is uncovered and uncontained. Also, a diesel fuel and two chemical containers are stored without secondary containment.

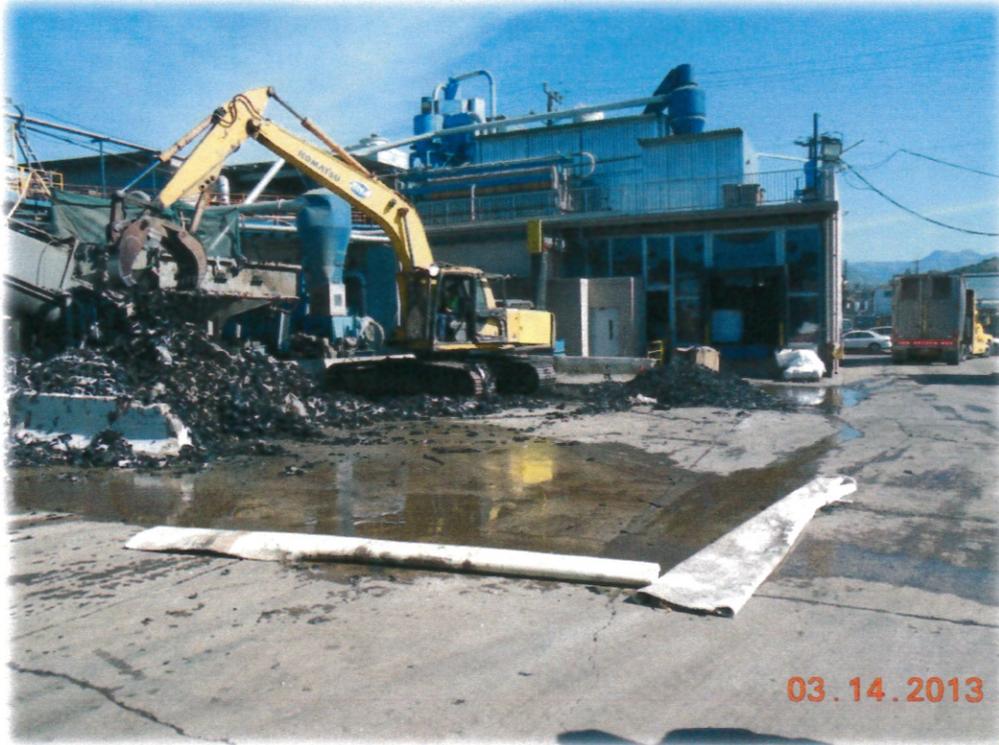
Photo 9 – An area where plastic films are washed and prepared for plastic pellet production.

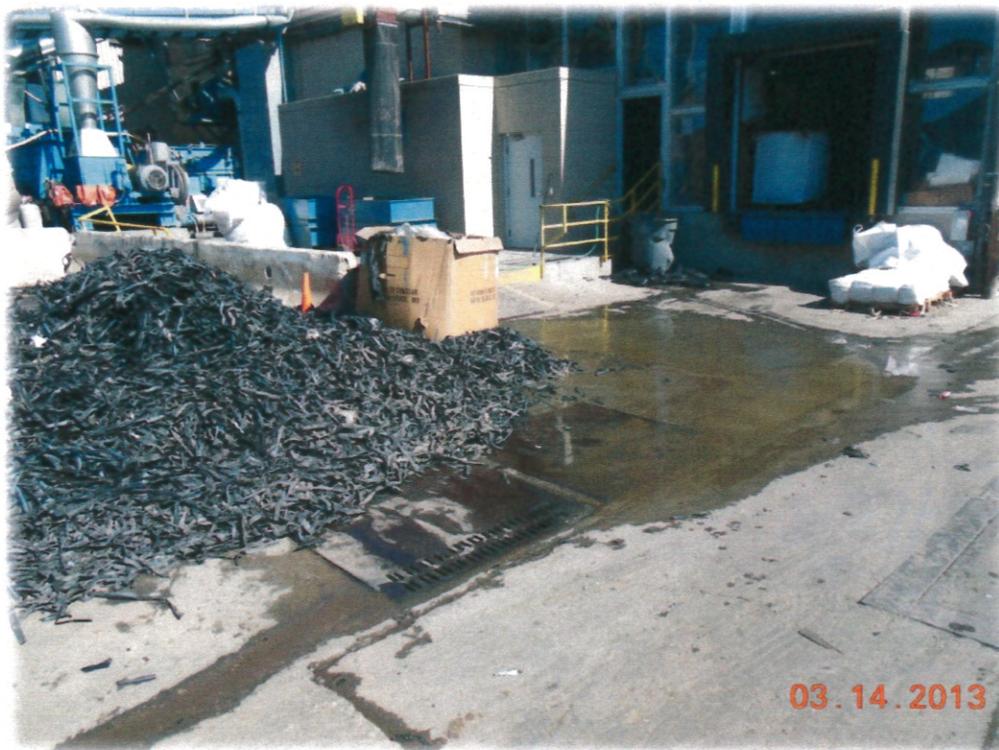
Photo 10 – Runoff from the plastic washing process is collected via an inlet and returned to the washer.

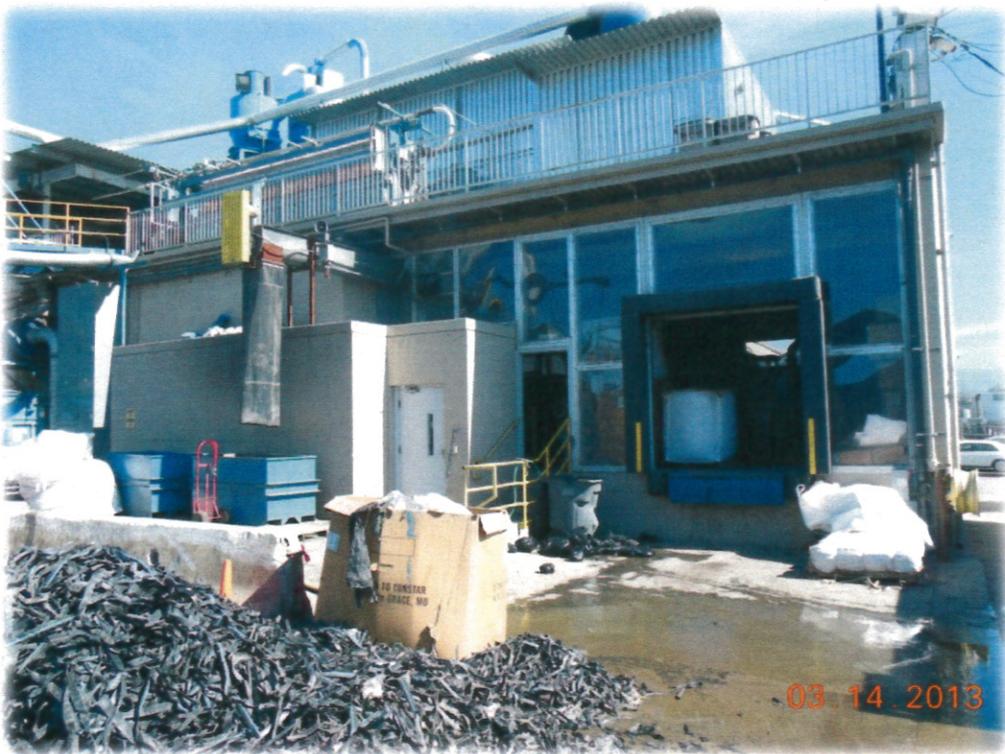
Photo 11 – The building in which plastic pellets are produced.

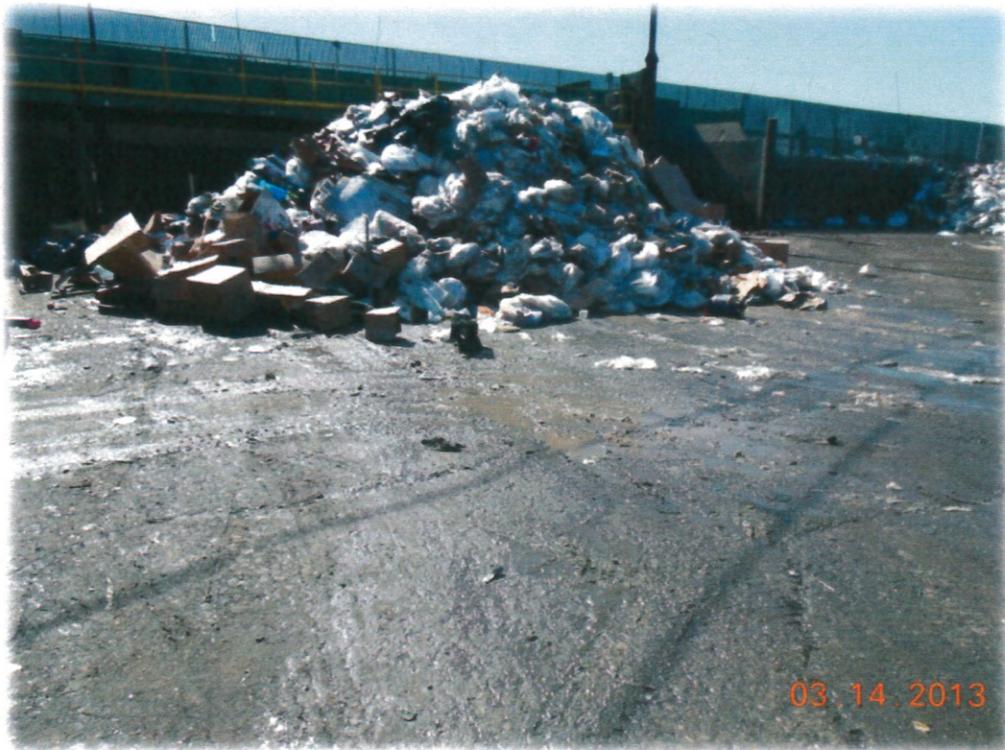
Photo 12 – Restaurant food waste is piled at the eastern corner of the site.

- Piles of waste stored outdoors without containment. This is in violation of General Permit Sections A.8.a.iv, vi, b.i, and iii.
- Inadequate sediment and tracking controls to retain sediment on site. This is in violation of General Permit Section A.8.a.viii.

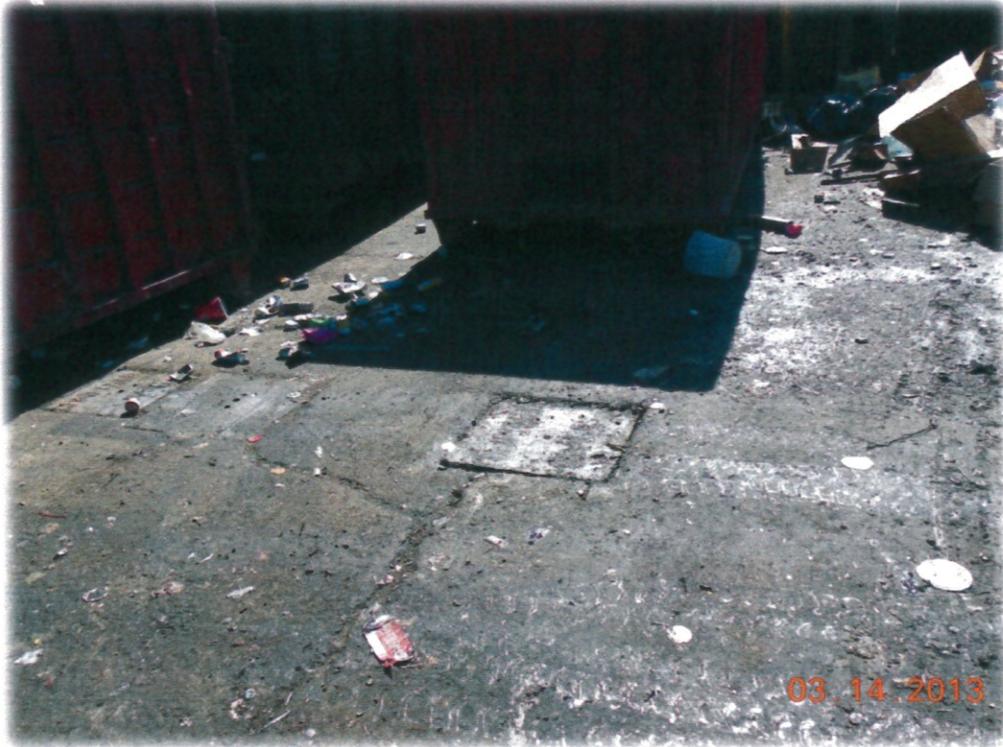
Photo 13 – The eastern clarifier’s cover, immediately adjacent to the pile of food waste depicted in photo 12.

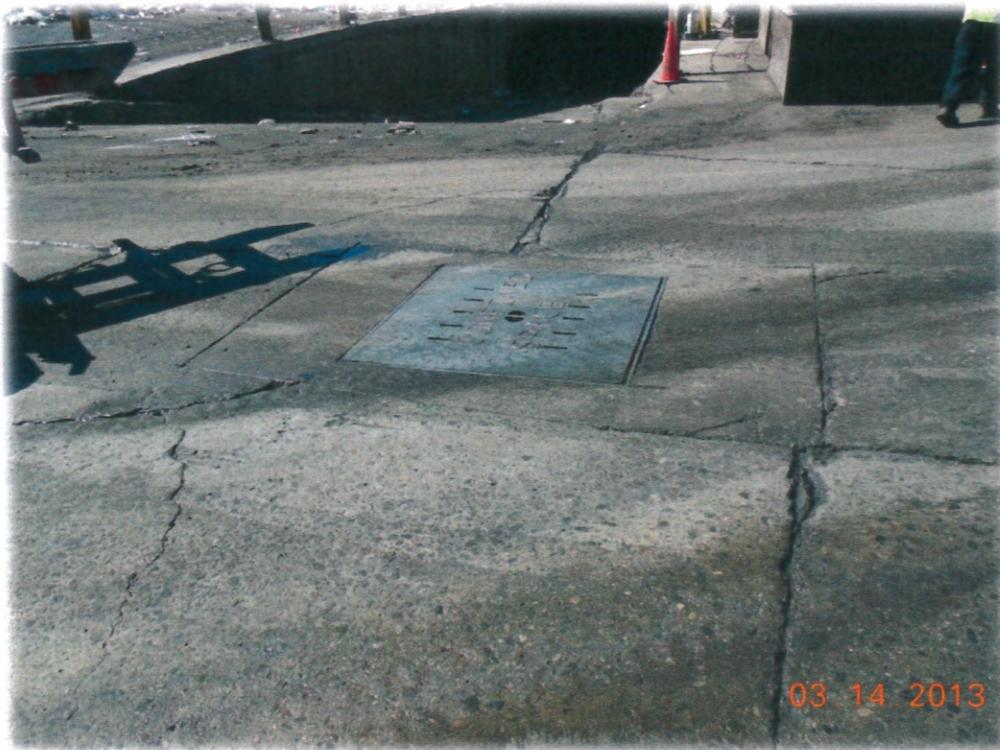
Photo 14 – Main surface water inlet in the northeastern portion.

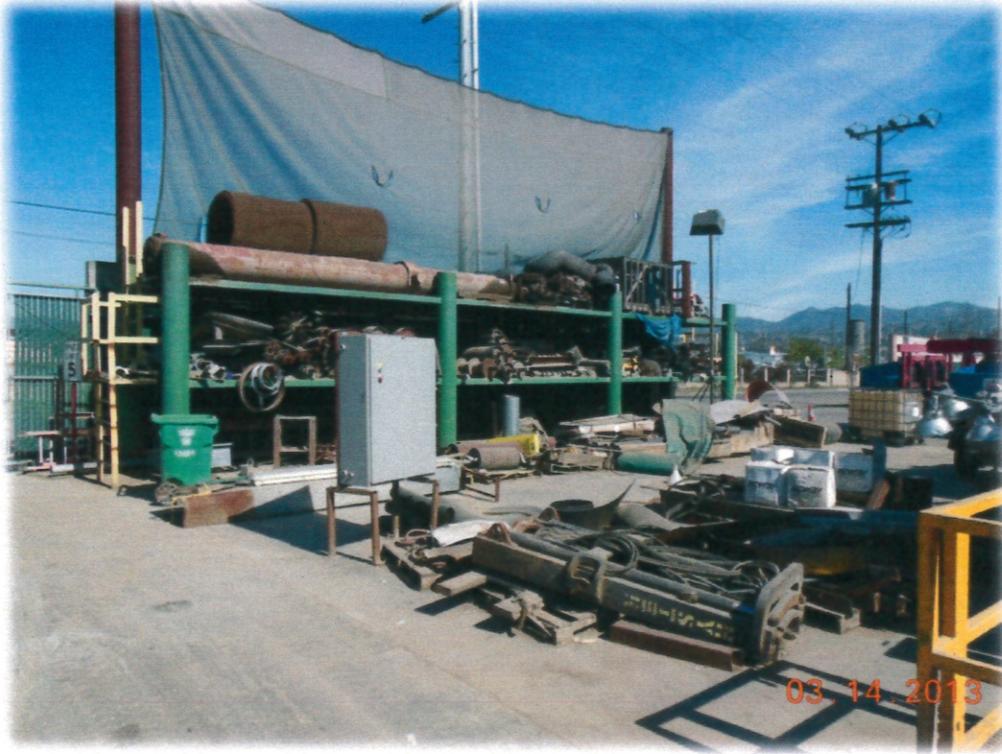
Photo 15 –Rusted metal and spare parts stored outdoors, in an unconfined area.

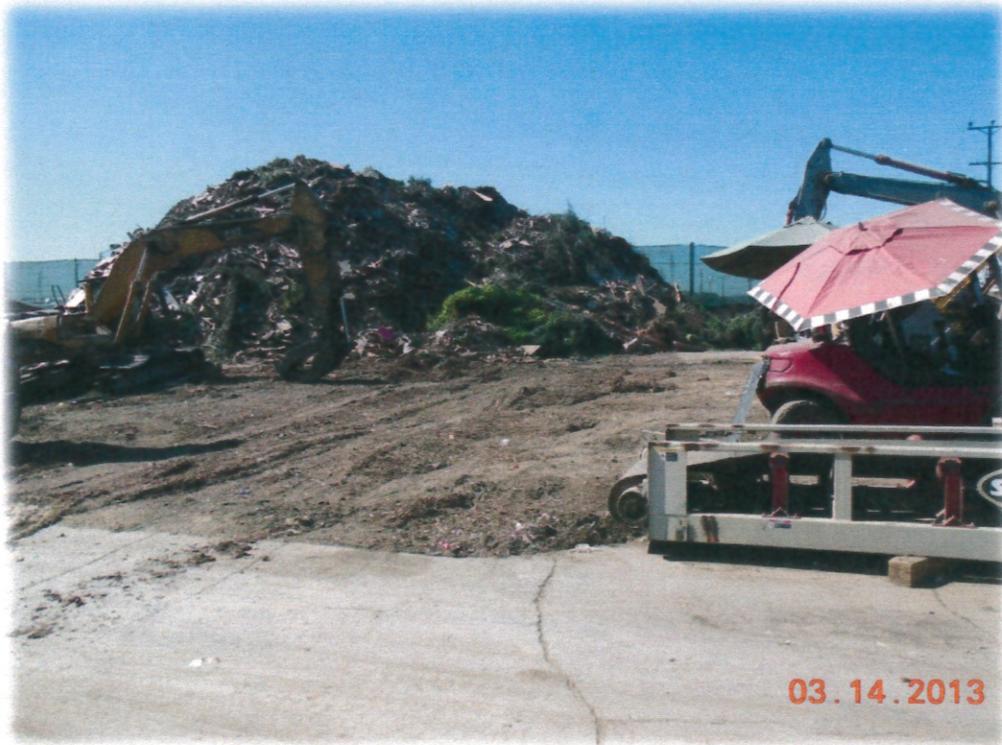
Photo 16 – City trimming storage area. The ground in this area is composed of loose soil.

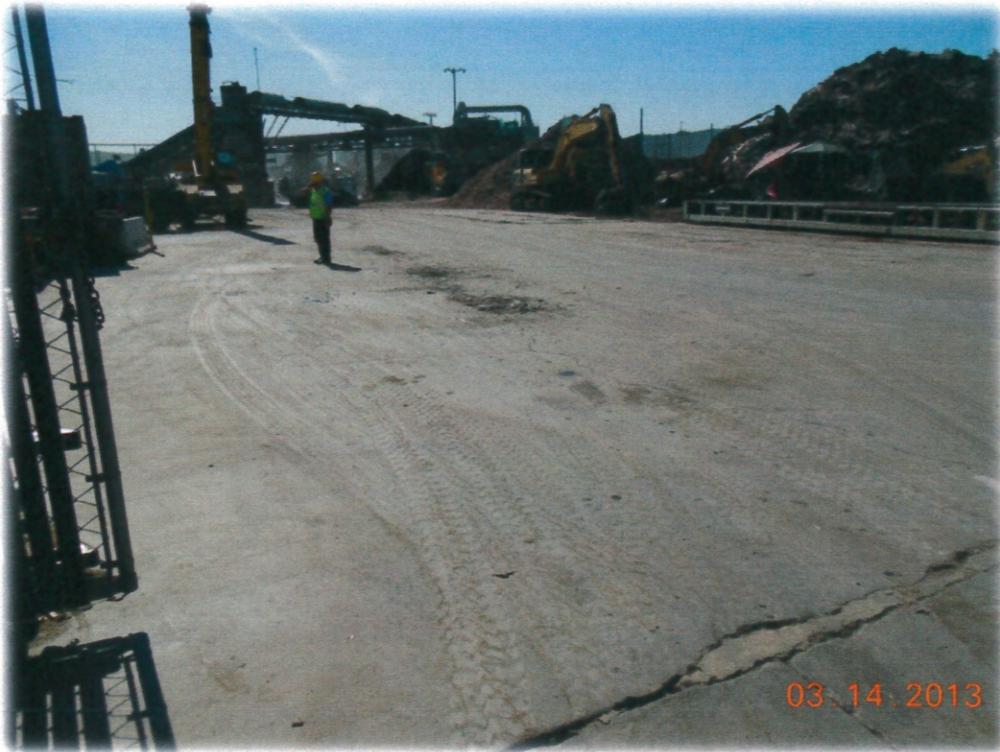
Photo 17 – An exit/entrance onto Pendleton Street, located adjacent to the city trimming storage area. Tire tracks on the concrete indicate tracking of loose soil onto Pendleton Street.

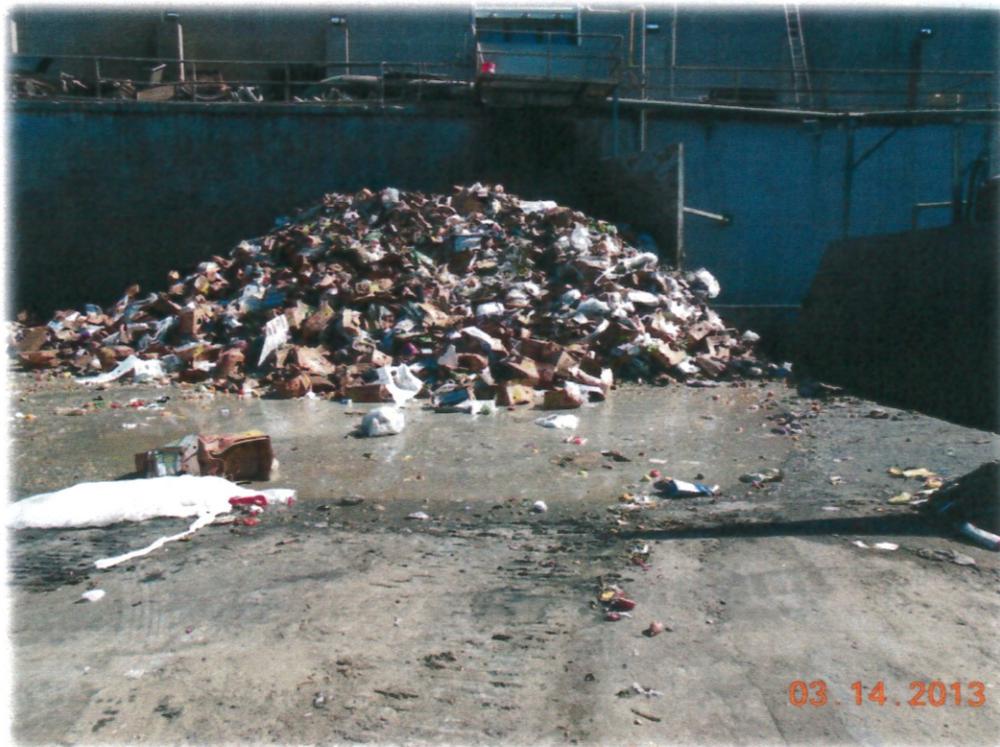
Photo 18 – Produce waste stored on the ground. The liquid accumulated at the bottom is pumped into a holding tank and hauled off site for compost production.

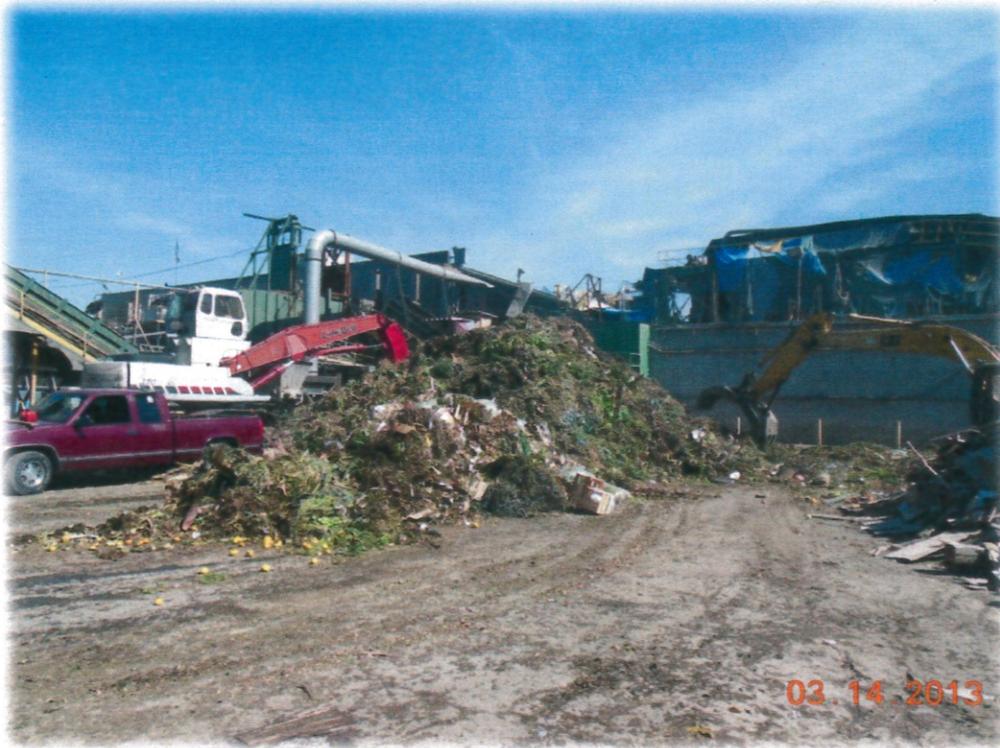
Photo 19 – Receiving area for waste and vegetative trimmings. Area is exposed and uncovered.

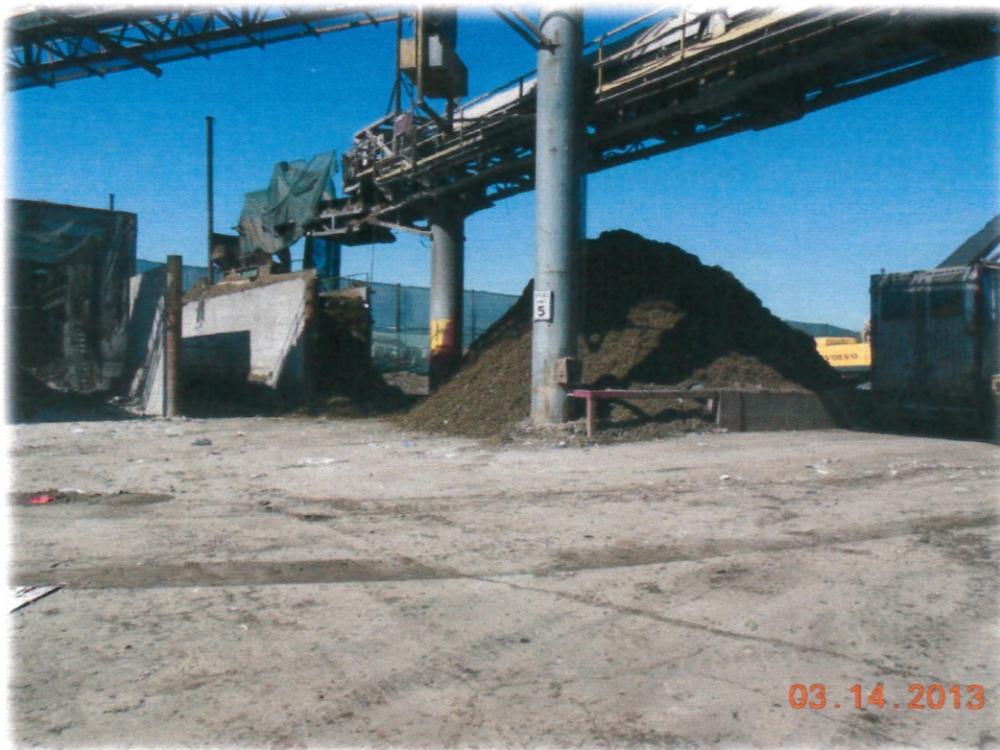
Photo 20 – A pile of processed trimming prepared to be hauled off site for compost production.
