DRAFT CLEAN UP AND ABATEMENT ORDER NO. R4-2014-XXXX COMMUNITY RECYCLING & RESOURCE RECOVERY, INC. AND CROWN DISPOSAL CO., INC. 9189 DE GARMO AVENUE, LOS ANGELES, CALIFORNIA (WDID NO. 4 19I004715): OPPORTUNITY TO SUBMIT COMMENTS AND EVIDENCE

CLEANUP AND ABATEMENT AND CALIFORNIA WATER CODE
SECTION 13267 INVESTIGATIVE ORDER NO. R4-2014-XXXX
REQUIRING

FOR THE PROPERTY LOCATED AT:
9189, 9147 AND 9143 DE GARMO AVENUE, 11300 PENDLETON STREET, AND
11219, 11213, 11211, 11201 RANDALL STREET
SUN VALLEY, LOS ANGELES COUNTY, CALIFORNIA, 91352

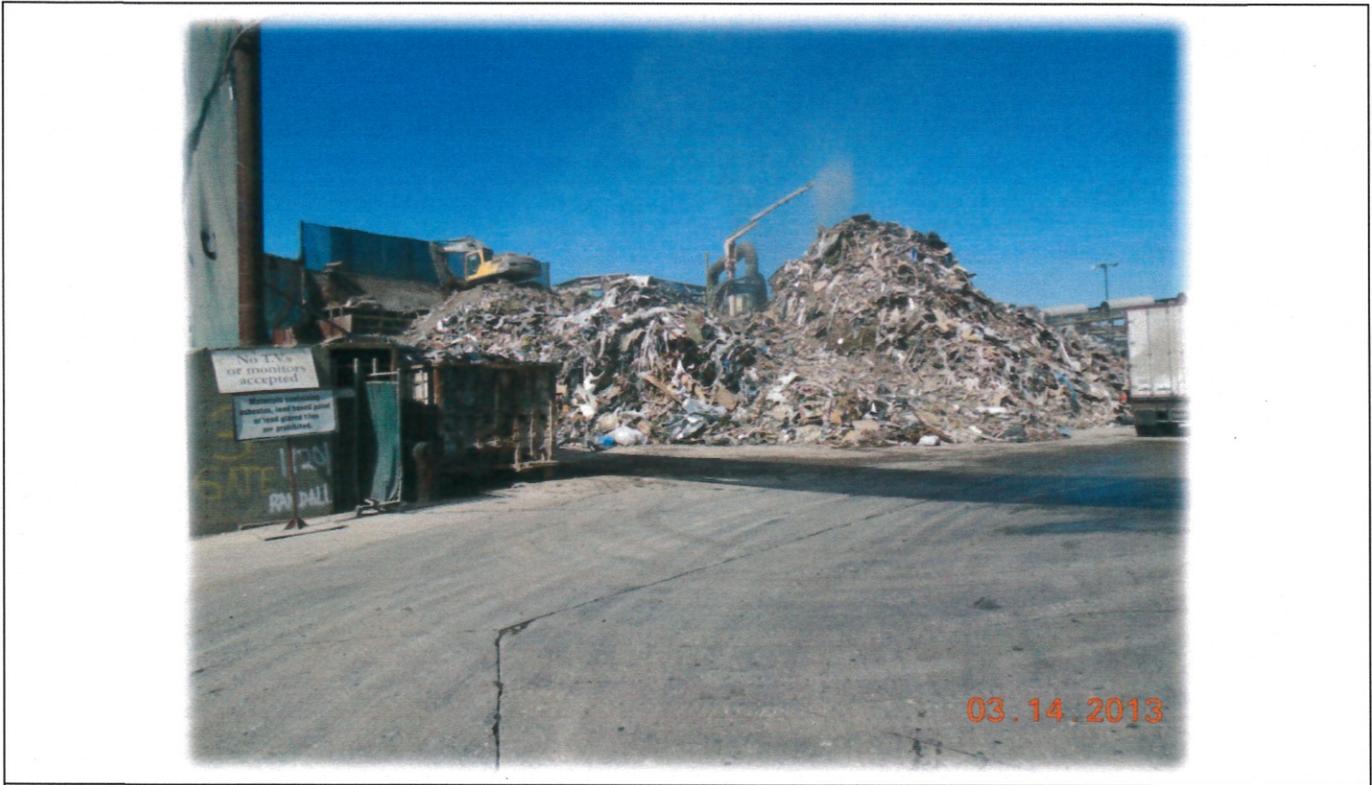
Photo 21 – An exposed pile of construction waste material located adjacent to the Randall Street exit/entrance.

- Piles of waste stored outdoors without containment. This is in violation of General Permit Sections A.8.a.iv, vi, b.i, and iii.
- Inadequate sediment and tracking controls to retain sediment on site. This is in violation of General Permit Section A.8.a.viii.

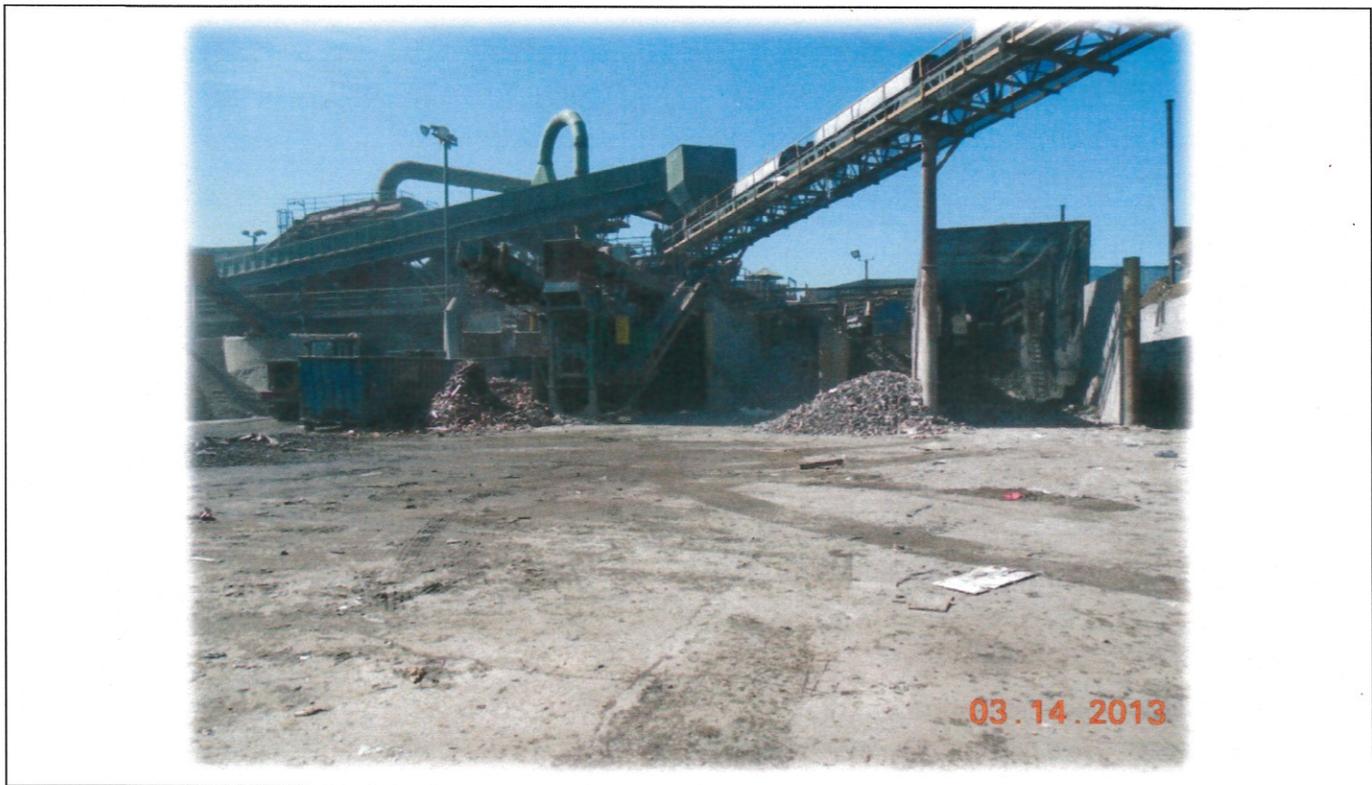
Photo 22 – Exposed piles of sorted and segregated construction material were observed on the ground.

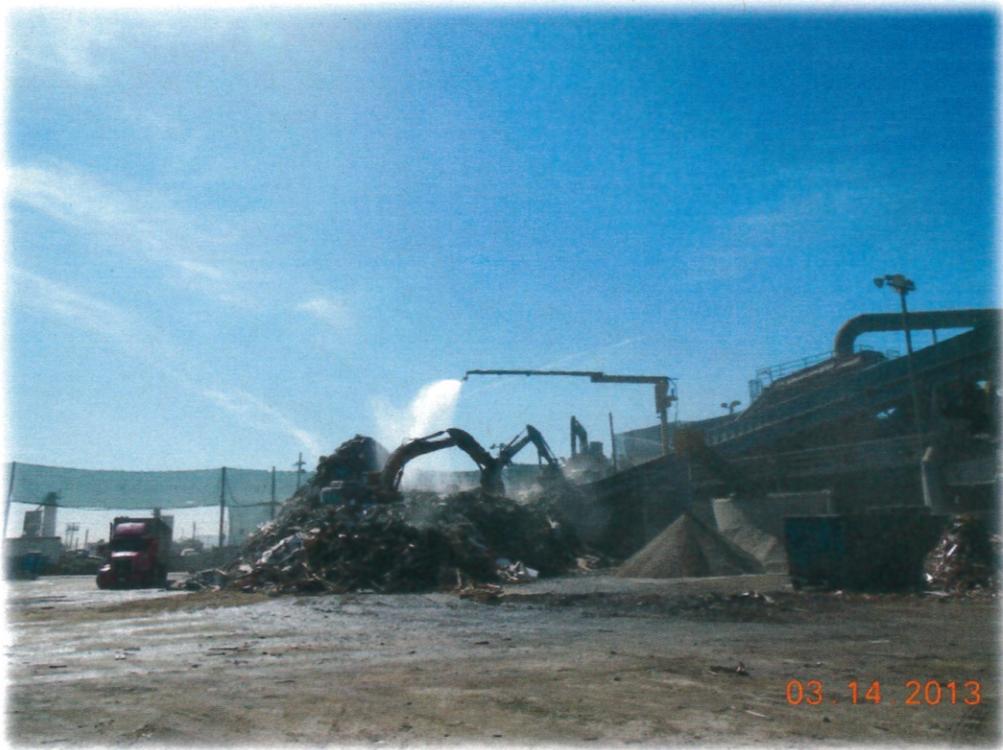
Photo 23 – Water being sprayed over the construction waste for dust control.

- Non-stormwater is sprayed over construction refuse and discharged directly onto city streets. This is in violation of General Permit Section A.6.a.v.

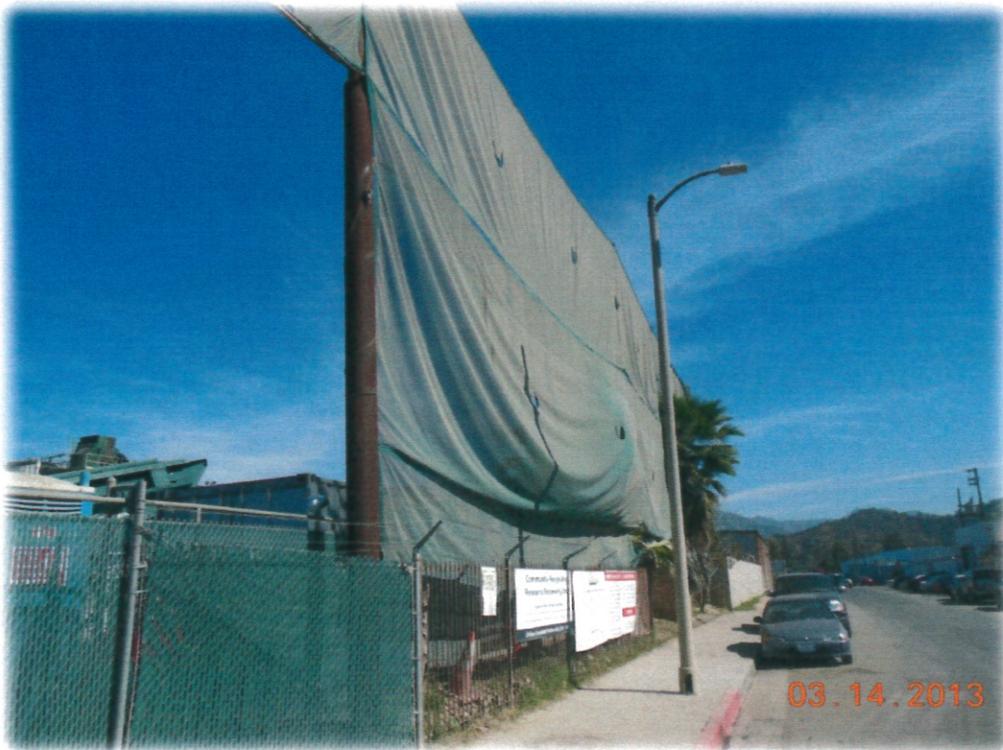
Photo 24 – A cloth screen hung along the site's boundaries around the construction waste to contain dust on site.

Trimming from the city are stored at the western corner of the site, which is pervious (figure 3 and photo 16). There is an exit immediately adjacent to this area which lacks tracking controls. As a result, sediment is tracked off the site (photo 17). Unsalable produce is received from super markets and is stored at a location east of the trimming storage (figure 3 and photo 18). I observed a very strong rancid odor in this area. Liquid from the expired produce accumulated underneath the pile is pumped into an above ground holding tank next to the pile of expired produce. This liquid is hauled off site via trucks to be mixed with compost. Adjacent to the expired produce area is an area where private trimmings are received and piled (figure 3 and photo 19). The trimmings are processed and prepared to produce compost. The processed trimmings are stored across the private trimming receiving area and ready to get hauled off site via trucks (figure 3 and photo 20). The southern part of the southwestern portion is dedicated to construction material. Construction refuse is brought in through the Randall Street exit/entrance, via trucks and piled immediately adjacent to the exit/entrance (figure 3 and photo 21). The refuse is then processed and segregated for recycling, based on composition and use and stored northwest of the receiving area (figure 3 and photo 22). Municipal tap water is sprayed over the construction waste for dust control (photo 23). Additionally, a cloth curtain is used around the construction waste receiving area to contain the dust on site (photo 24).

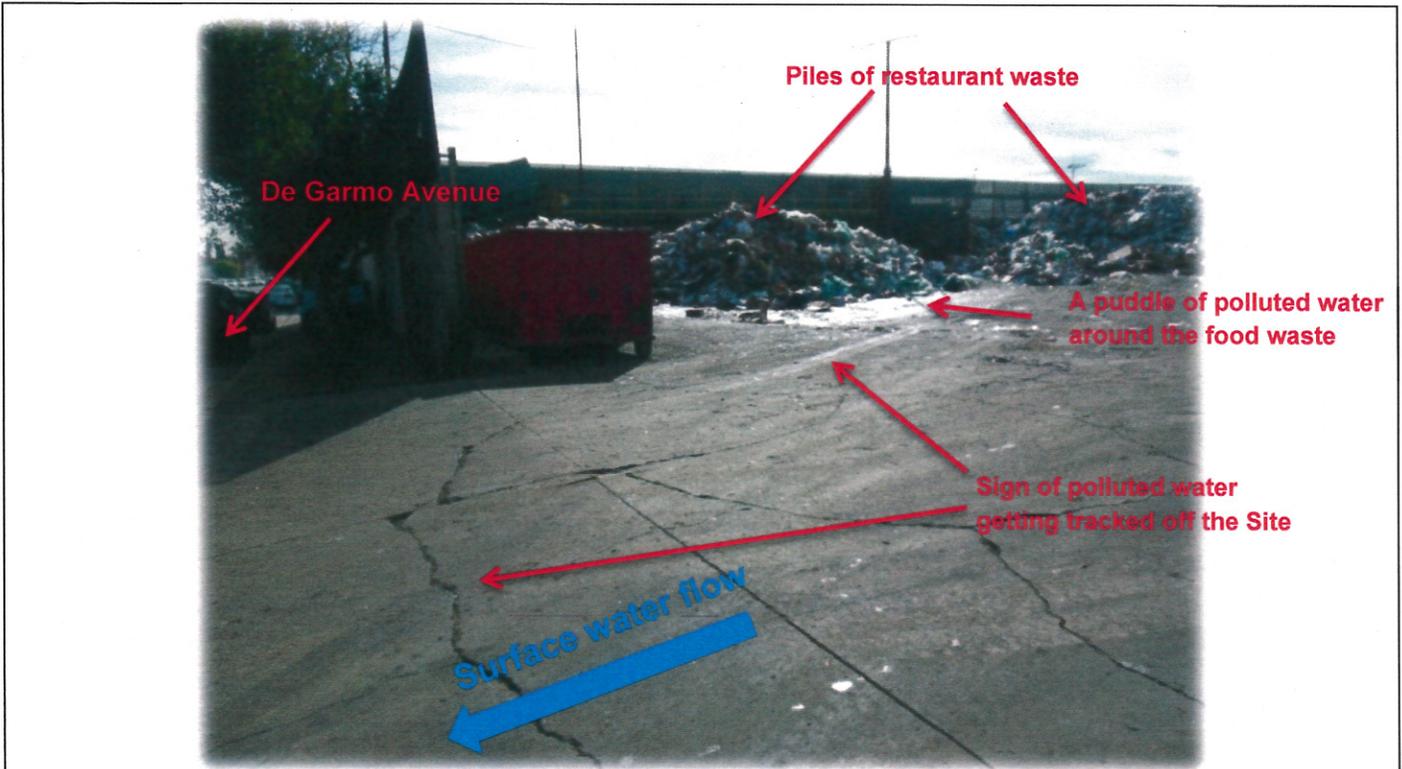
Photo 1 – Standing on De Garmo Avenue, facing south. Piles of restaurant waste are located as close as about 55 feet away from De Garmo Avenue. Track-off of polluted water onto De Garmo Avenue was evident.

After I left the Site, I walked around the Site for an off-site inspection. While on public roads, I took photos of the Site. I observed sources of pollution stored within close proximities to public roads, sediment track-off onto public roads, and evidence of non-stormwater discharge onto public roads (photos 1 through 4).

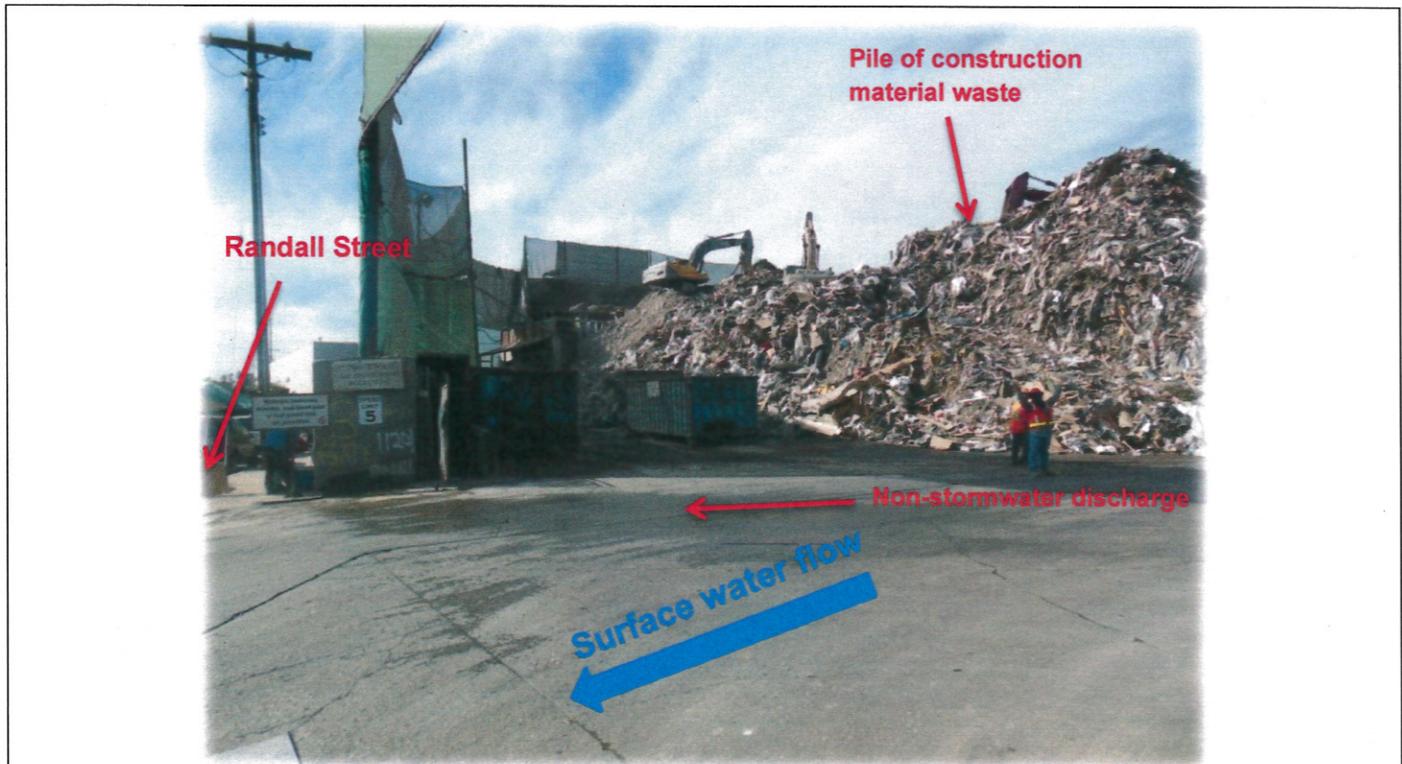
Photo 2 – Standing on Randall Street, facing west. A large pile of construction material waste located as close as about 80 feet away from Randall Street. Evidence of non-stormwater discharge onto Randall Street was observed.

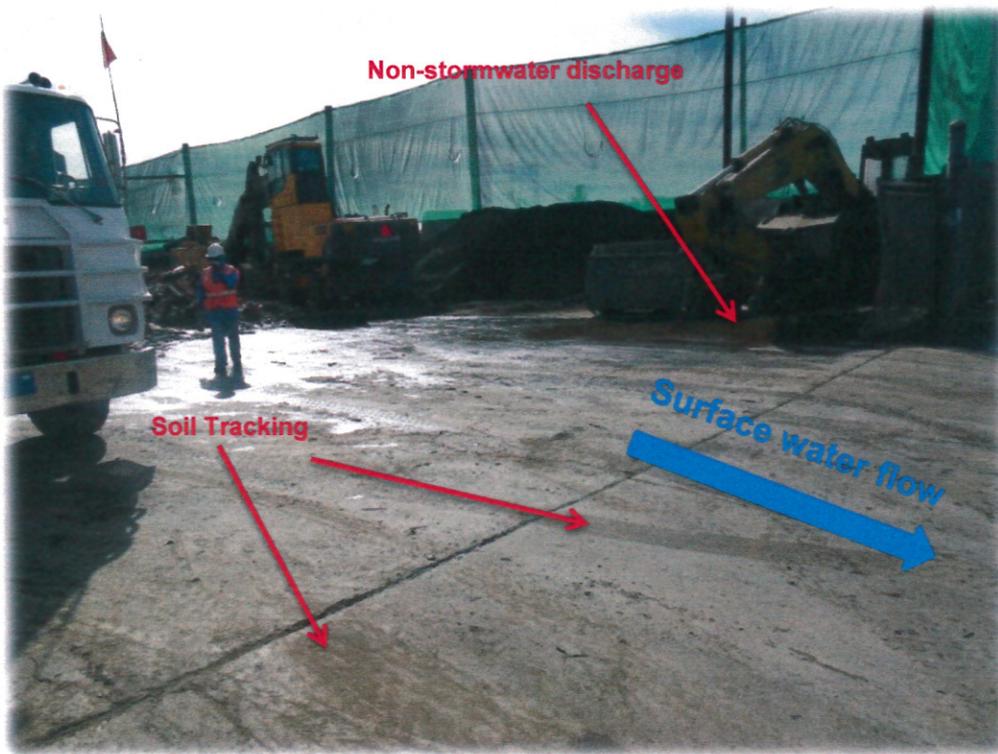
Photo 3 – Standing on Pendleton Street, facing south. A pile of soil located about 30 feet away from Pendleton Street. Evidence of non-stormwater discharge and soil track-off onto Pendleton Street was observed. Pendleton Street is to the right of the photo.

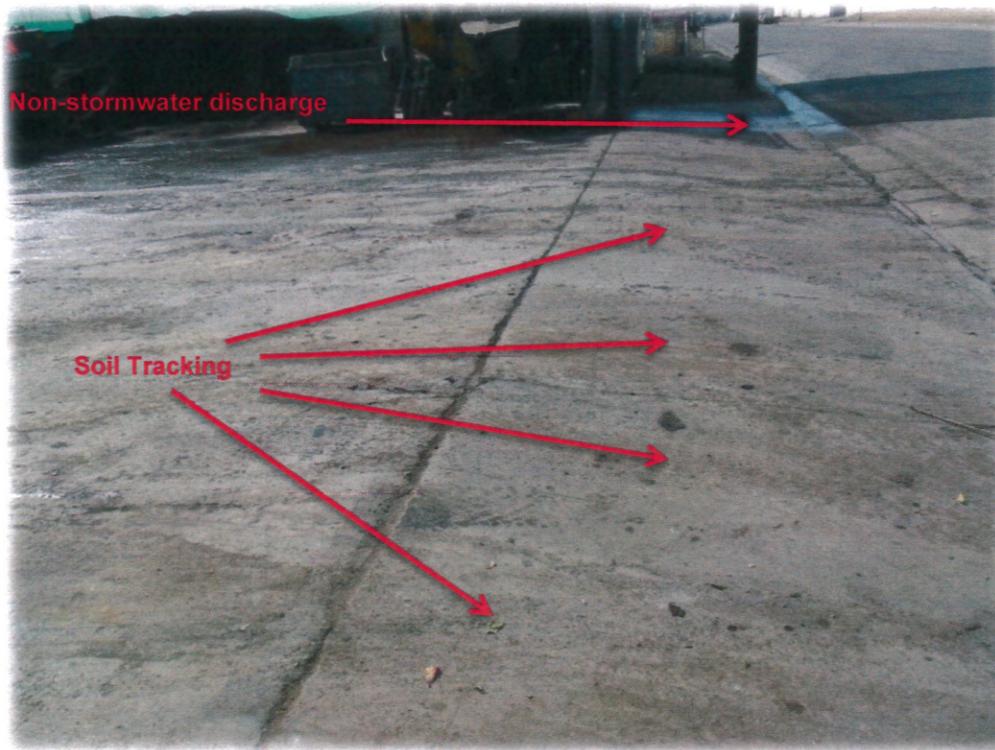
Photo 4 – Same position as photo number 3, showing non-stormwater discharge and soil tracking onto Pendleton Street.

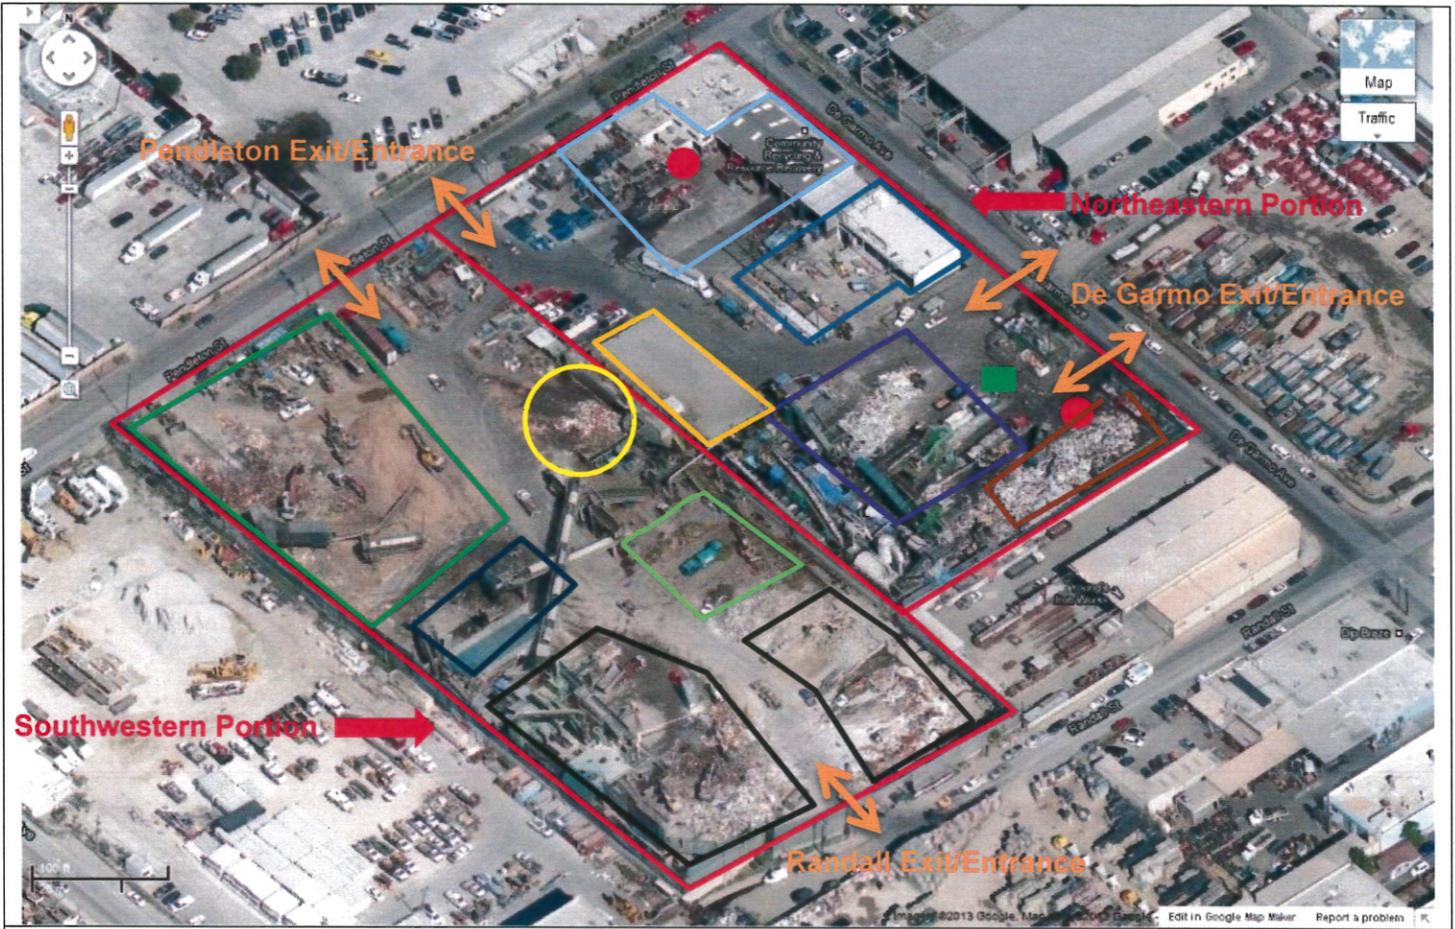
Attachment C

Figure 3 – Google image of the subject site used to demonstrate the subject site's layout.
