# CENTRAL VALLEY REGIONAL WATER QUALITY CONTROL BOARD

## INSPECTION REPORT

**ACL Complaint R5-2012-0515  
Attachment D  
19 May 2012 Inspection Report**

**INSPECTION DATE:** 19 May 2011  
**FACILITY:** Orestimba Creek Area Drain  
**LOCATION & COUNTY:** Area Drain Along JT Crow Road, Stanislaus County  
**INSPECTED BY:** Terry Bechtel  
**ACCOMPANIED BY:**

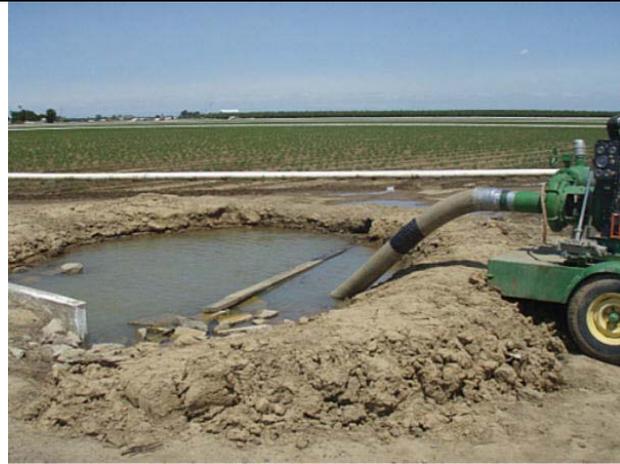
**Photo 1:** Irrigation supply water at JT Crow Road just east of Hwy 33. Turbidity – 42.7 NTU

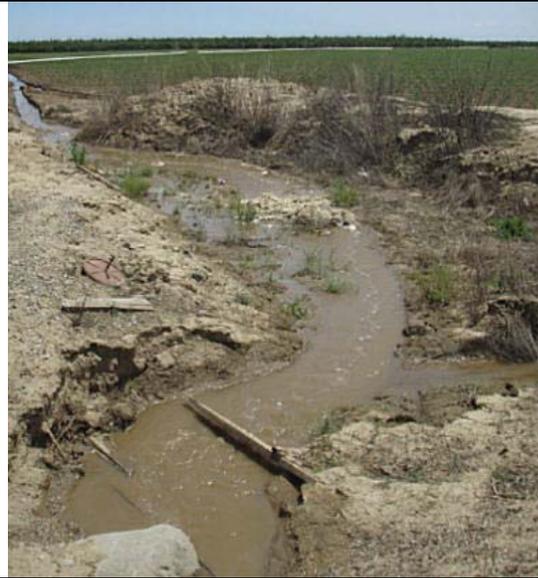
**Photo 2:** Field drainage water going into the area drain along JT Crow Road. Turbidity – 544 NTU

A tomato field tailwater was discharging sediments into an area drain that is a direct tributary to the San Joaquin River. The cropland described above contributed all or in part to the sediment load flowing into the San Joaquin River. The field discharge water turbidity of 544 NTU contributed to the increase the background water (supply water) turbidity from 42.7 NTU to the drain outfall of 671 NTUs in the Amaral Line – a 13x plus increase in turbidity. The Amaral Line is both a drain as well as irrigation supply water for down stream users.

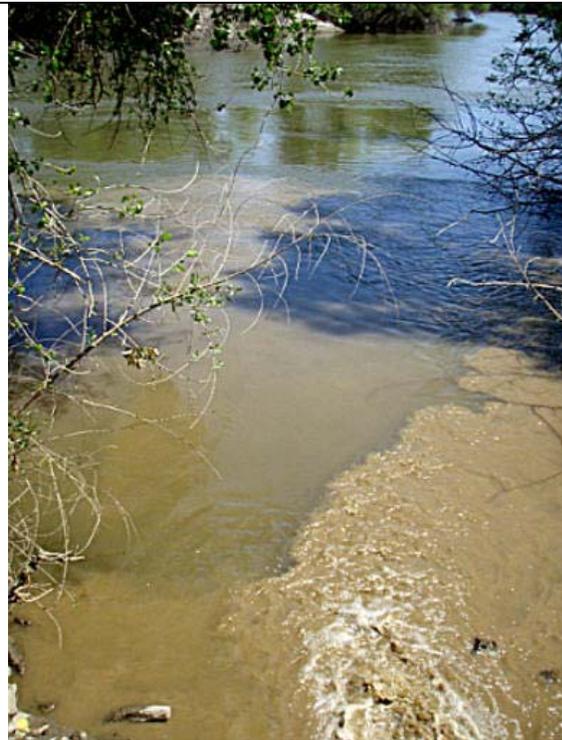
**Photo 3:** Flow into the San Joaquin River looking southeast.  
Up River Turbidity – 25.6 NTU  
Outfall Turbidity – 671 NTU  
Down River prox. 100 feet Turbidity – 52.1 NTU

The sediments in the outfall increased the river turbidity from 25.6 NTUs to 52.1 NTUs comparing the up-river to down-river samples. The Basin Plan in part states: “Waters shall be free of changes in turbidity that cause nuisance or adversely affect beneficial uses.” The Basin Plan also states in part “Where natural turbidity is between 5 and 50 NTUs, increases shall not exceed 20 percent.” The discharge from the tomato field exceeded the Basin Plan water quality objects for both the Amaral Line receiving water as well as the San Joaquin River.

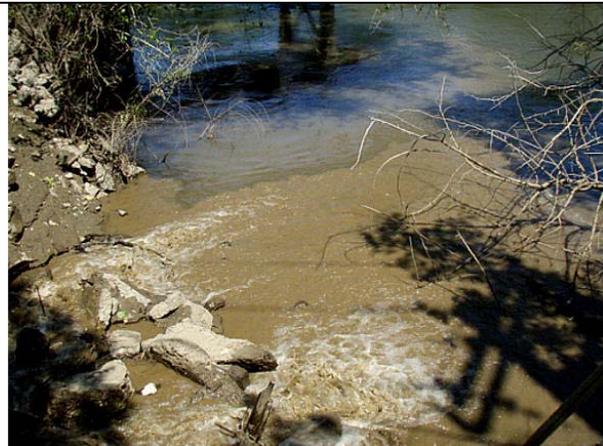
The water in the drain was flowing into the San Joaquin River. There was a significant plume of sediment flowing into the river. The flow in the drain at the river was estimated to be approximately 3 foot wide, by 3 foot deep (approximately 2 foot wide at the bottom), flowing approximately 1 foot per second, or approximately 643 cubic feet per minute (using 0.70 friction coefficient of the ditch). The distance from the field to the river is approximately 3.5 miles.

**Photo 4:** Flow into the San Joaquin River looking northeast.

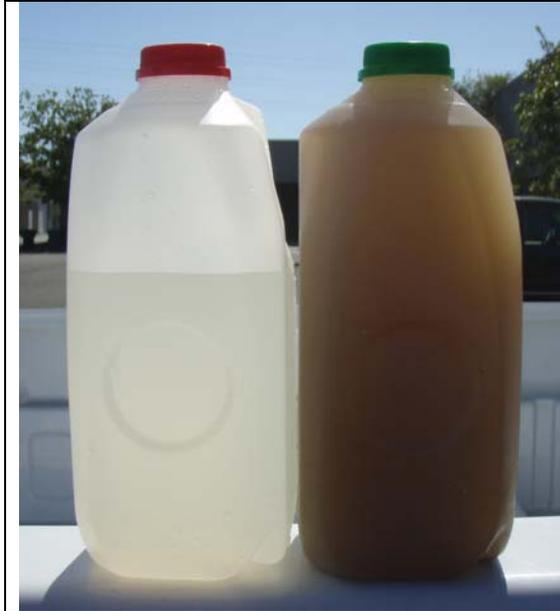
Irrigation supply water to the field (left). Field tailwater (right).

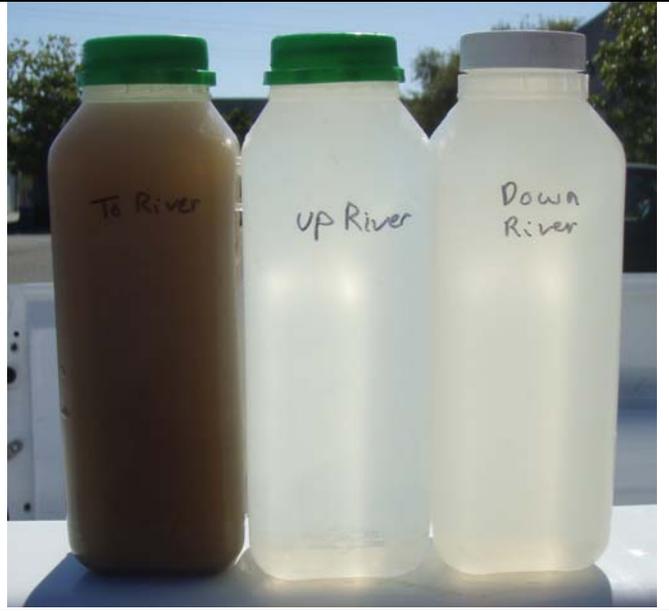
Left to right: Outfall to the river, upriver approximately 100 feet, and down river approximately 100 feet.
