NFA Letter for Agricultural Repair Shop USTs

NO FURTHER ACTION REQUIRED, FORMER UNDERGROUND STORAGE TANKS, FORMER SPRECKELS AGRICULTURAL REPAIR SHOP, 40600 COUNTY ROAD 18C, WOODLAND, YOLO COUNTY (LUSTIS NO. 570342)

SUBJECT: **NO FURTHER ACTION REQUIRED, FORMER SPRECKELS SUGAR PLANT
AGRICULTURAL REPAIR SHOP, 40600 COUNTY ROAD 18C, WOODLAND,
YOLO COUNTY (LUSTIS NO. 570342)**

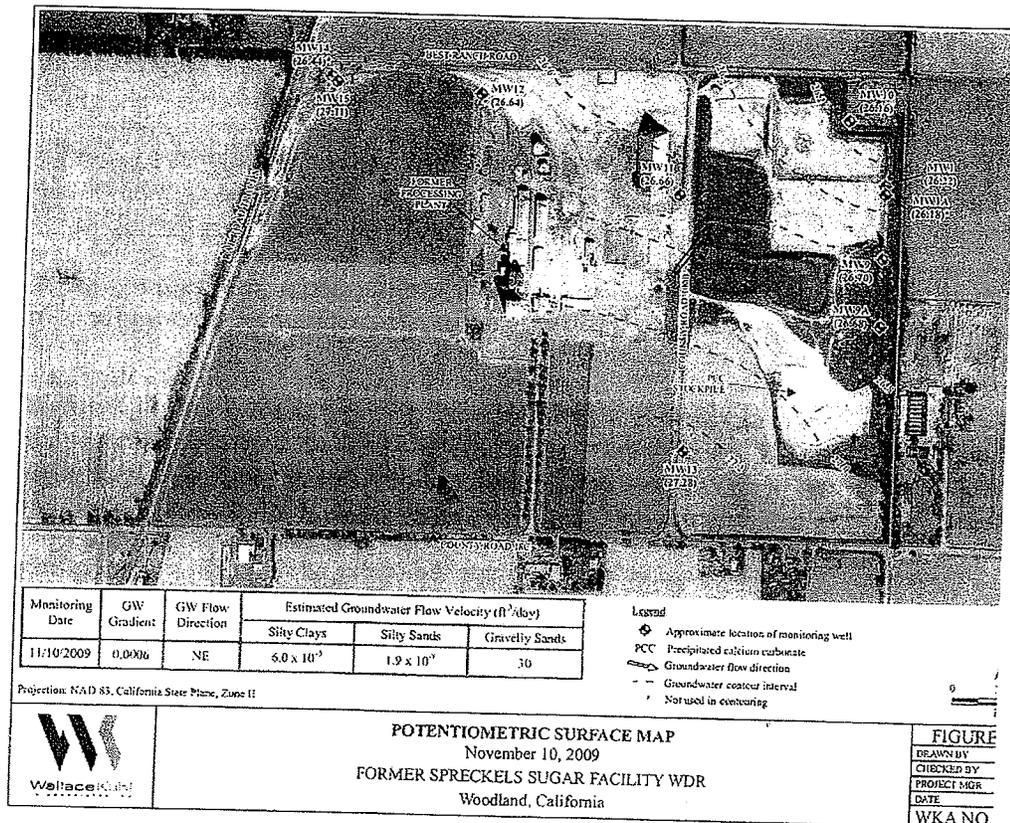
Well Locations - The following photo shows the locations of the monitoring wells from which samples were taken by Discharger.

Well 14 and 15 are those on the upper northwest corner of the property and are considered by the Water Board to be "reference" wells (i.e. those unaffected by the plant's operations) because they are upgradient from the direction of groundwater flow. The groundwater generally flows towards the east, northeast, or southeast (depending on when it was measured in the past) under the plant then under the calcium carbonate piles then under the horse ranch and the UC property to the north of the horse ranch. Wells 1, 1a, 9, 9a, and 10 are all situated on the northeast boundary of the former plant site and represent increased concentrations of contaminants in the groundwater that presumably could only have been added by plant activities.

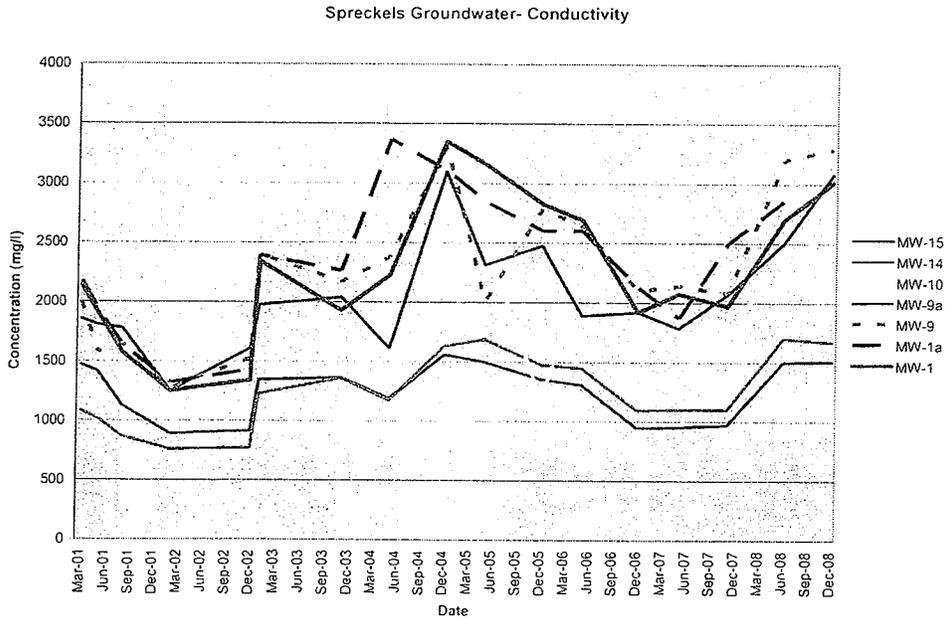
Electrical Conductance (or Conductivity) is a general measure of the amount of electrically conductive salts in the water. There is a federal drinking water standard of 1,600 micromhos/cm which is easily exceeded by the wells to the east. The charts show that reference wells (solid red and dark blue lines on all charts) are just at or below the federal standard clearly indicating the plant as the source of the increase in groundwater conductivity to above federal standards.

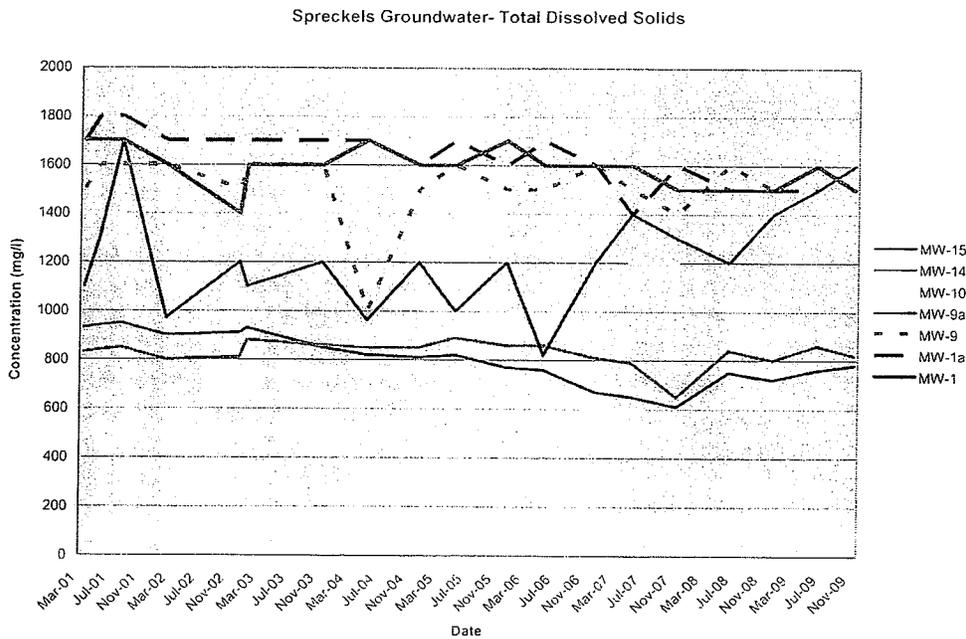
Total Dissolved Solids (or TDS) is another measure of how much total solids (organic and inorganic) are dissolved in the groundwater. There is a federal drinking water limit of 1,000 milligrams per liter (or mg/l = parts per million = ppm). Both reference wells are well below the standard while all eastern wells are well above the standard.

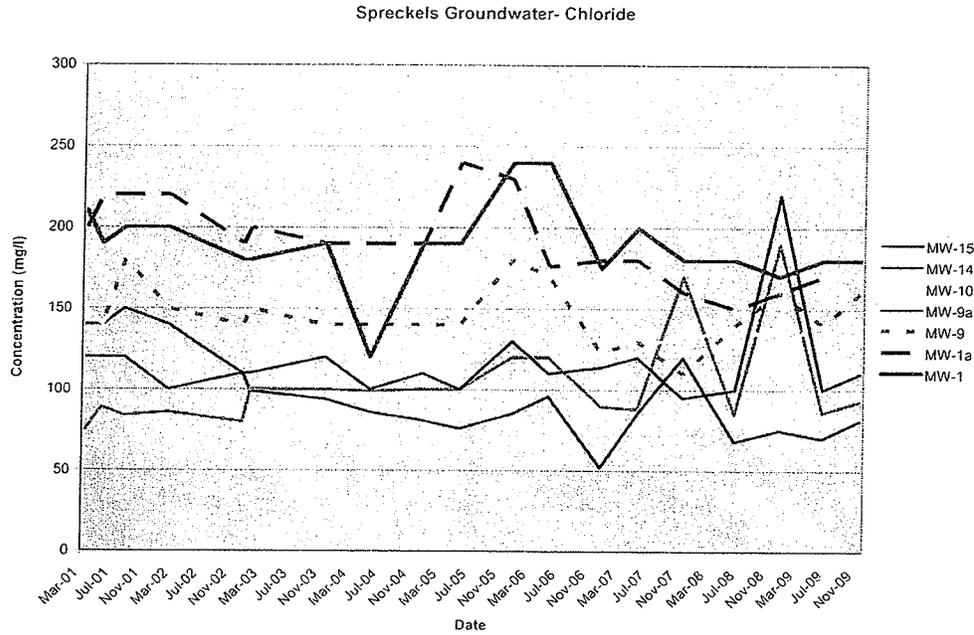
Chloride has a federal drinking water standard of 500 mg/l and both the reference wells and eastern wells are well below this limit. However, the eastern wells show a consistently higher concentration of chlorides than the reference wells indicating a substantial amount of chlorides are being added to the groundwater as a result of it passing through the plant underground.

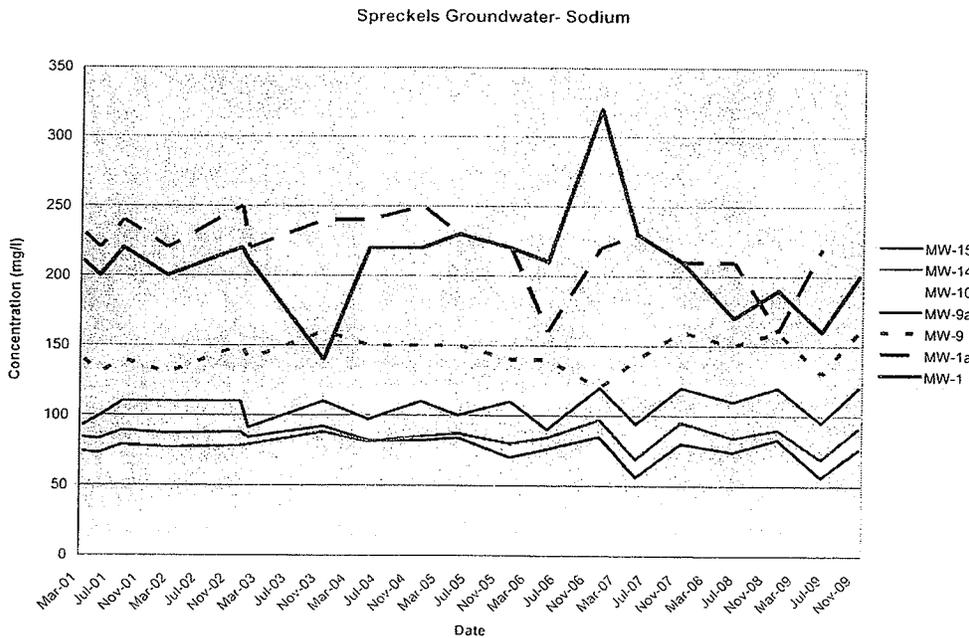
Sodium, hardness (calcium and magnesium carbonate), and alkalinity (bicarbonate and carbonate) do not have drinking water standards but all eastern wells are well in excess of the reference well.

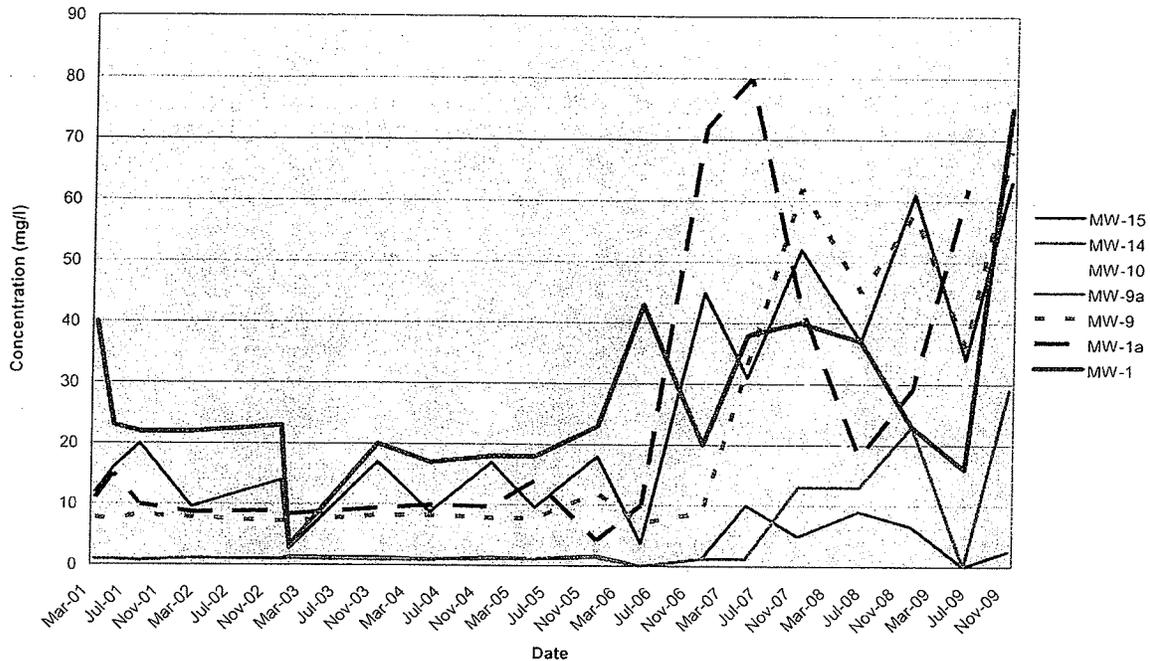
Spreckels Groundwater- Total Organic Carbon

Total Organic Carbon (TOC) also does not have a federal drinking water standard but there is again a clear pattern of TOC increasing on the easternmost test wells indicating that the plant added TOC to the groundwater.

TOC can include anything of including hydrocarbon materials including oils, diesel and gas known known to have leaked on the site. It could also possibly include PCB-laden transformer oil which was previously stored on the site with no record of its proper removal and remediation. Other sources of hydrocarbon contamination are solvents used on the site and disposed of in the waste ponds, sugar beet juice, and/or other sources of decomposing biomass.

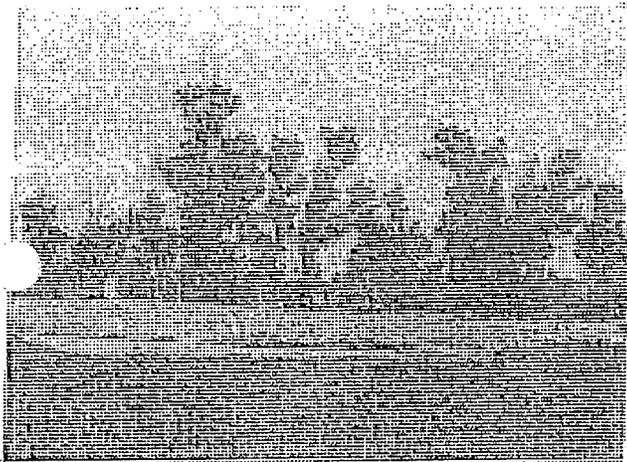
Photo taken 03-04-11 from CR 100B looking towards east.
Earth mover extracting lime from area bordering with
No visible emissions.

Photo taken 03-04-11 from CR 100B looking towards east.
