CENTRAL VALLEY REGIONAL WATER QUALITY CONTROL BOARD

INSPECTION REPORT

LOCATION & COUNTY: Henry Tosta Dairy
20662 San Jose Road, Tracy
San Joaquin County

INSPECTION DATE: 30 October 2012

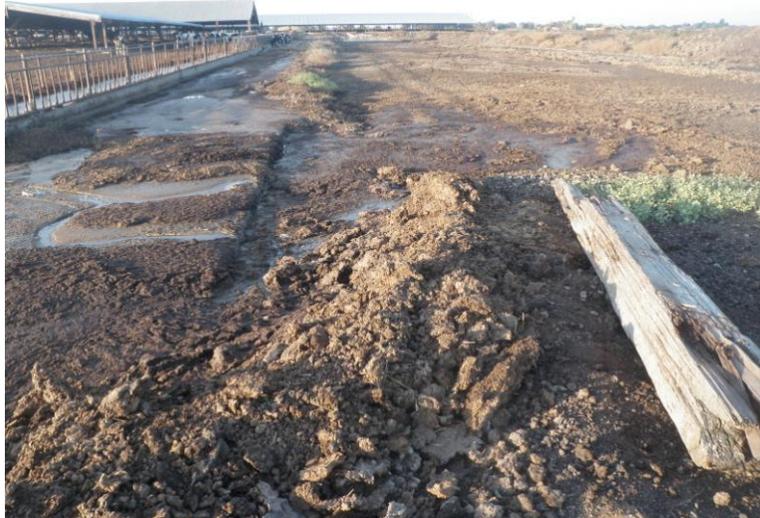
Photo 1: Settling Basin #1 has been lowered – approximately 0.5'-1.0' freeboard observed at Settling Basin #1. It appears to staff that as Settling Basin #1 is lowered the embankments at Settling Basin #2 over-top with wastewater.

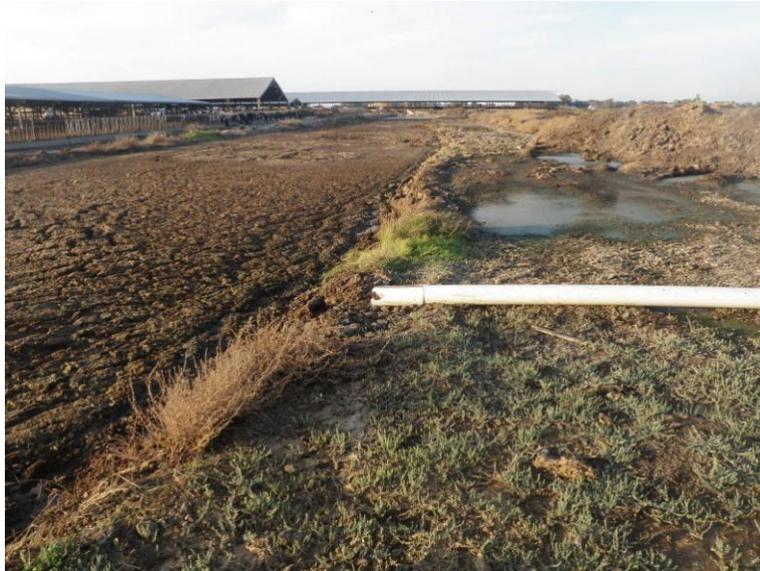
Photo 2: Settling Basin #1 has been lowered – approximately 0.5'-1.0' freeboard observed at Settling Basin #1. Puddles of wastewater remain on top of the lagoon embankments; evidence that wastewater had recently over-topped the embankments at Settling Basin #1.

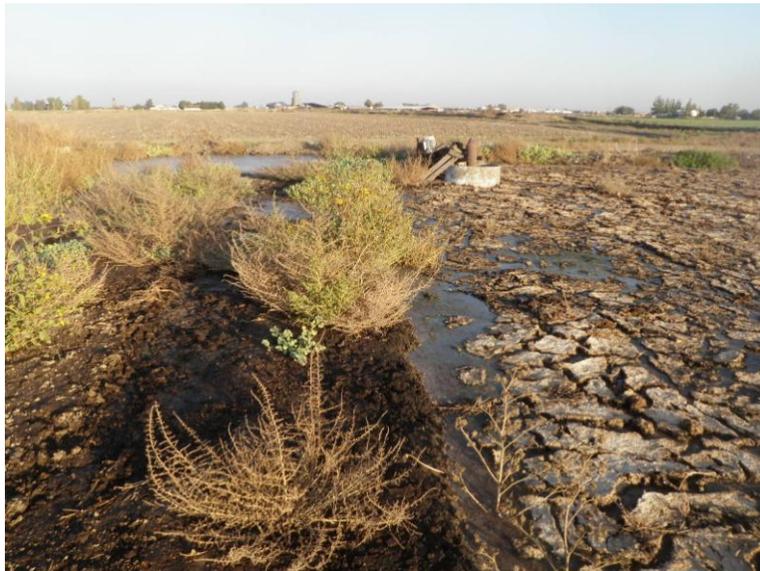
Photo 3: Looking east at the northeast corner of Settling Basin #2. Note the wet soil on the top of the lagoon embankment; evidence of recent over-topping of lagoon wastewater. Staff has observed freeboard diminish at Settling Basin #2 as freeboard increases at Settling Basin #1.

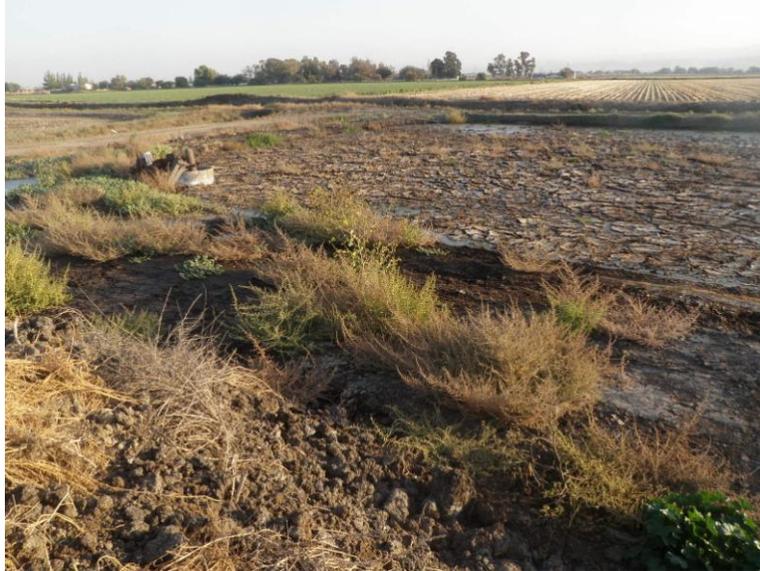
Photo 4: Looking southeast at the east end of Settling Basin #2. Significant amount of solid manure and wastewater are contained in the basin. Zero (0) freeboard was observed.

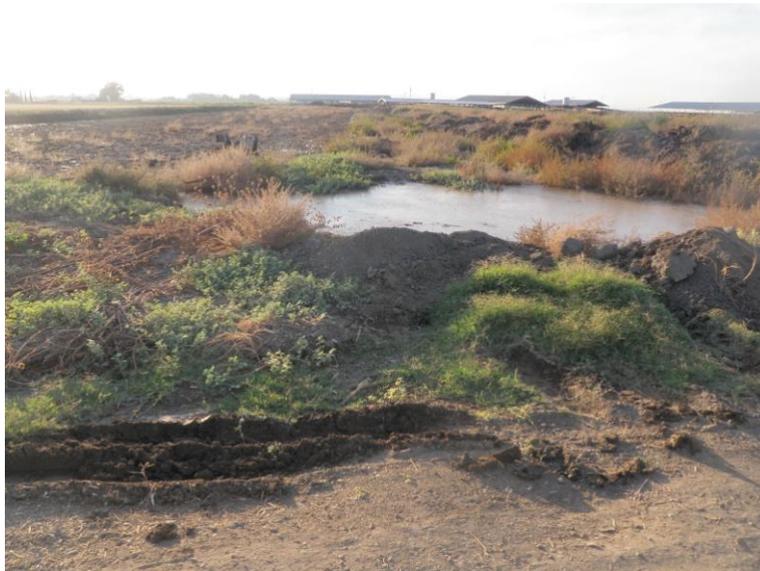
Photo 5: Looking west at Settling Basin #2. It appeared to staff that Settling Basin #2 has recently overflowed; the ponded water in the center of the photo is being contained with an impromptu berm; additionally wet soil was observed on the access road immediately east of the east end of Settling Basin #2.

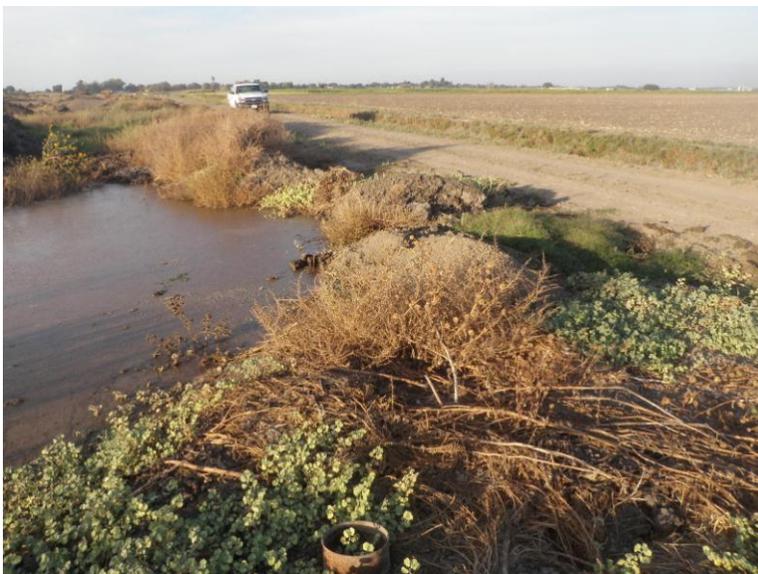
Photo 6: Looking north at Settling Basin #2. It appeared to staff that Settling Basin #2 has recently overflowed; the ponded water in the center-left of the photo is being contained with an impromptu berm. In addition, wet soil was observed on the access road immediately east of the east end of Settling Basin #2. See Photo 7 for a different perspective.

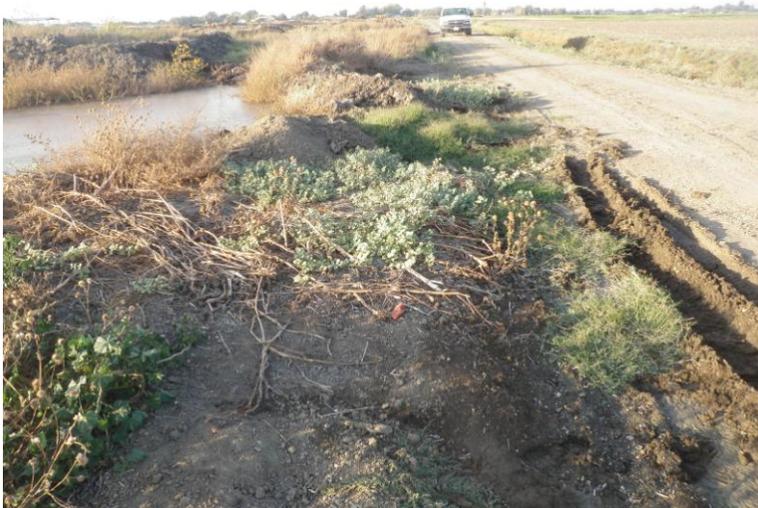
Photo 7: Looking north at Settling Basin #2. It appeared to staff that Settling Basin #2 has recently overflowed; the ponded water in the center-left of the photo is being contained with an impromptu berm. In addition, wet soil was observed on the access road immediately east of the east end of Settling Basin #2.

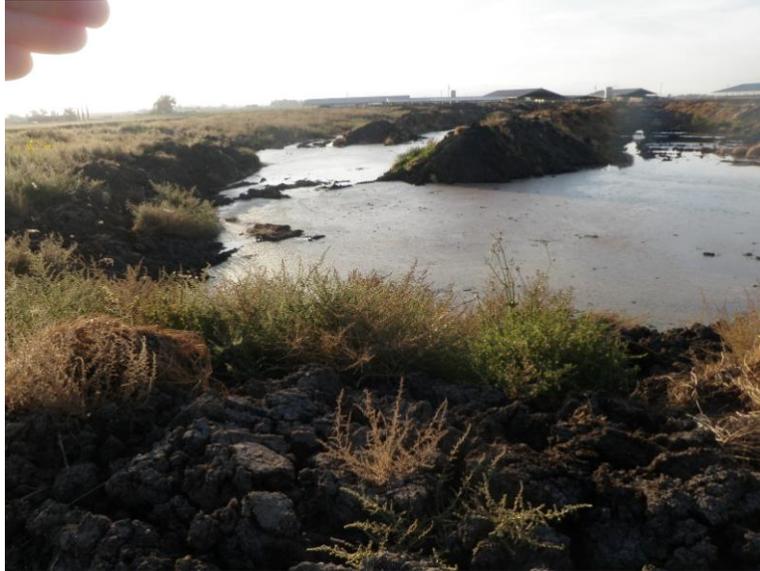
Photo 8: Wastewater Storage Lagoon #2 now contains wastewater. Staff could not determine the source of the wastewater as the conveyance channel from Settling Basin #2 to Wastewater Lagoon #1 is blocked with a dirt berm. Because of the weeds at Wastewater Lagoon #1 it's impossible for staff to determine if this lagoon is the source of the water observed inside Wastewater Lagoon #2 and #3.

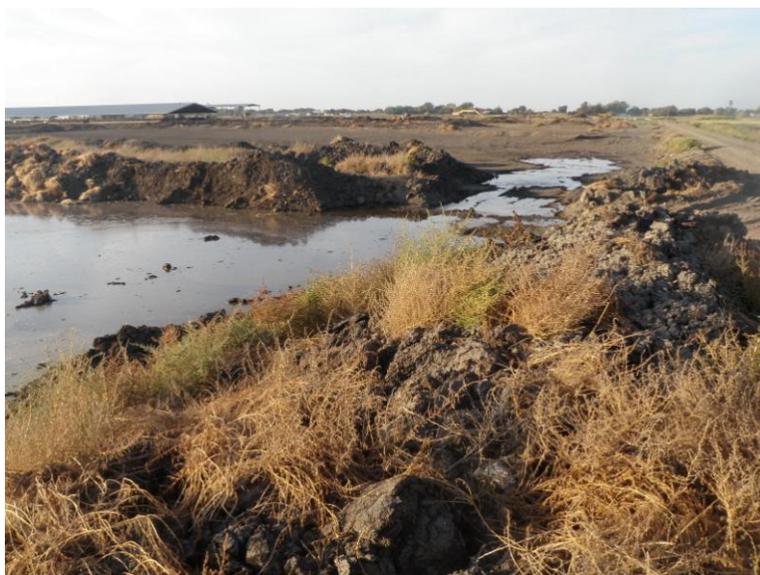
Photo 9: Wastewater spilling into Wastewater Lagoon #3. The source of the wastewater is not known; see Photo 8.

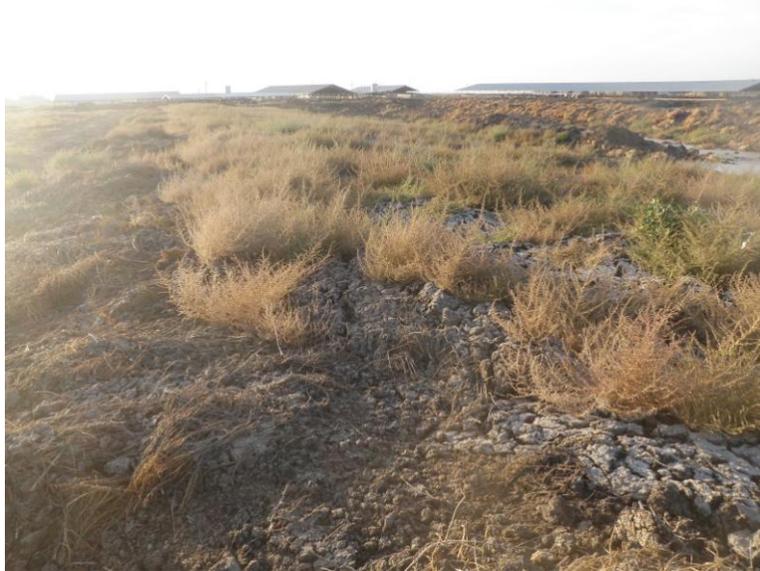
Photo 10: Wastewater Lagoon #1. A significant amount of weeds remains at lagoon. It's possible this lagoon is conveying wastewater to Wastewater Lagoon #2 and #3; but staff could not confirm this as the weeds make determining anything regarding Wastewater Lagoon #1 almost impossible.

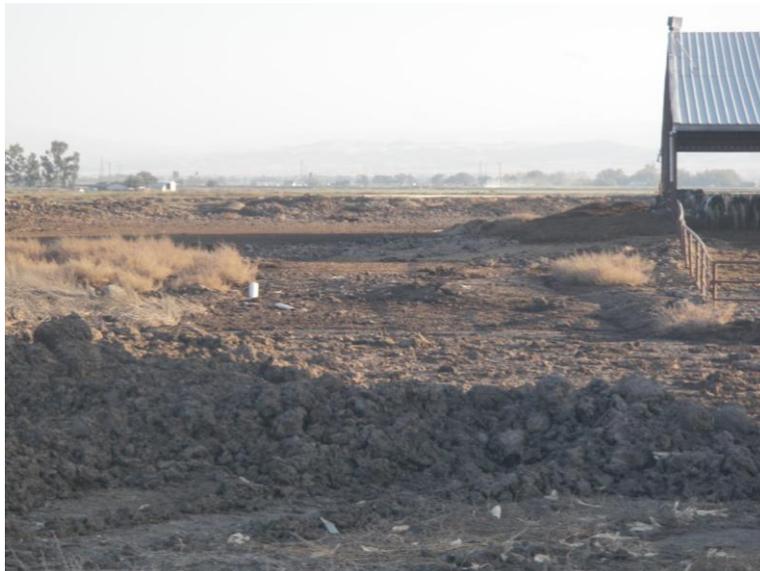
Photo 11: Looking south at the 3-4 acre area that contains solid manure, slurry manure, and wastewater. It appears waste that is being generated from the current herd (milking cows) is still being deposited in the 3-4 acre slurry area. Although a small portion of manure has been removed, a significant amount of solid manure, slurry manure, and wastewater remain in the 3-4 acre area.

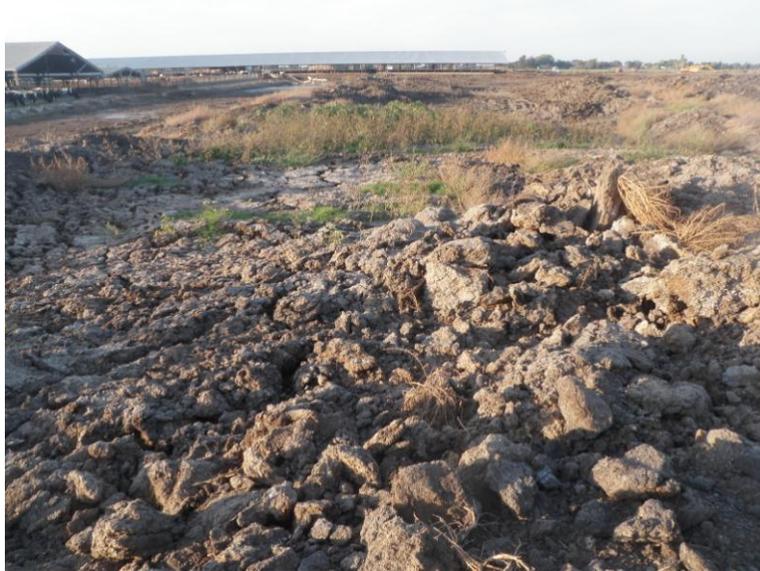
Photo 12: Looking north at the 3-4 acre area that contains solid manure, slurry manure, and wastewater. Significant amounts of solid manure, slurry manure, and wastewater are still contained in this area.

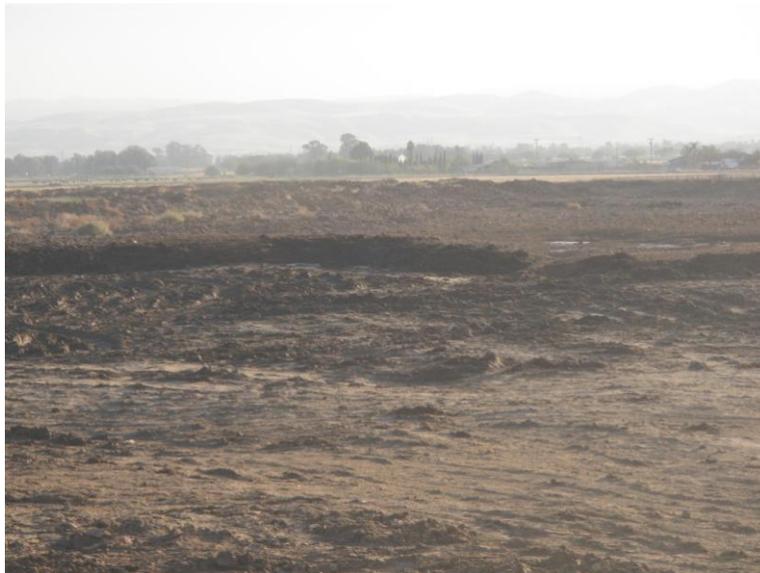
Photo 13: A small amount of manure has been removed from the 3-4 acre area. Note the wall of manure (2'-3' deep); significant solid manure, slurry manure, and wastewater remain in this area.
