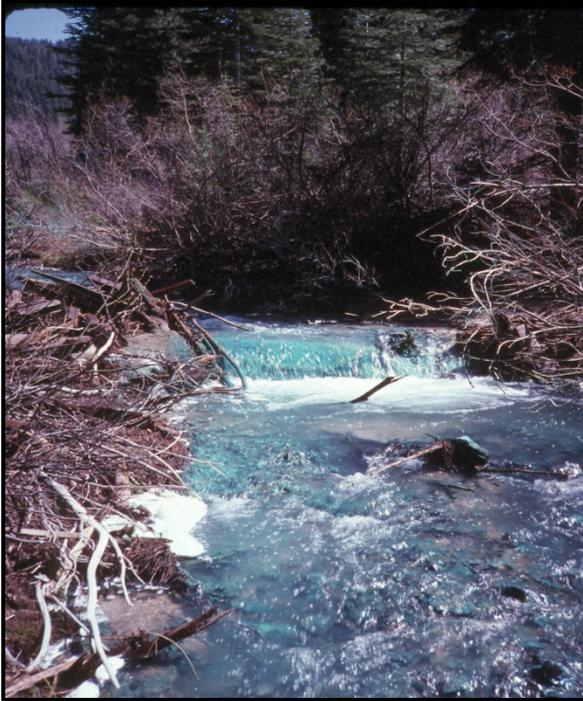
Photo 1. Dolly Creek below WM-3. Blue-green color of the water is from discharge of acid mine drainage water containing copper and other metals from the Walker Mine.

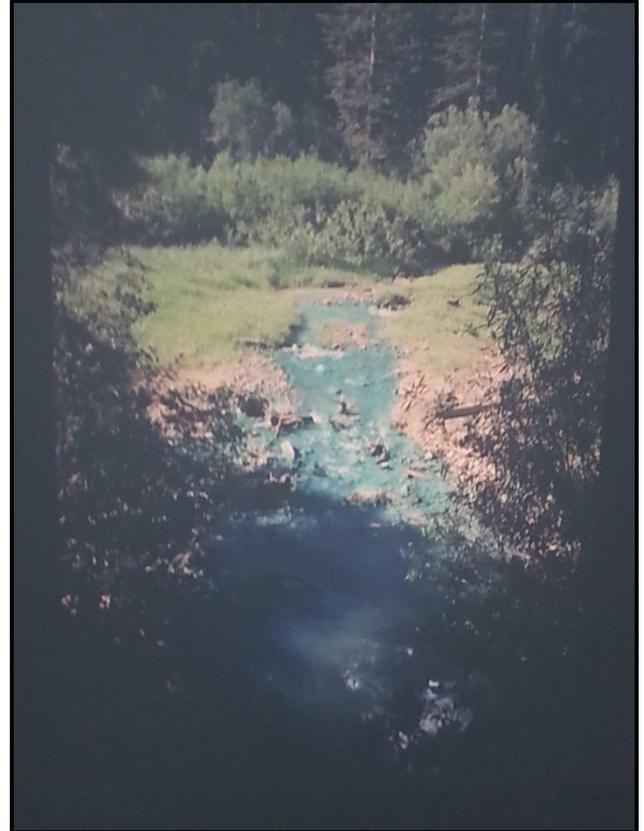
Photo 3. Dolly Creek below WM-4. Blue-green color of the water is from discharge of acid mine drainage water containing copper and other metals from the Walker Mine.

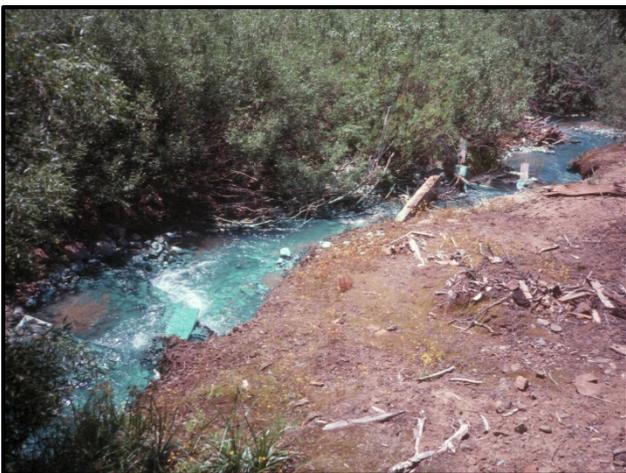
Photo 2. Dolly Creek below WM-3. Blue-green color of the water is from discharge of acid mine drainage water containing copper and other metals from the Walker Mine.

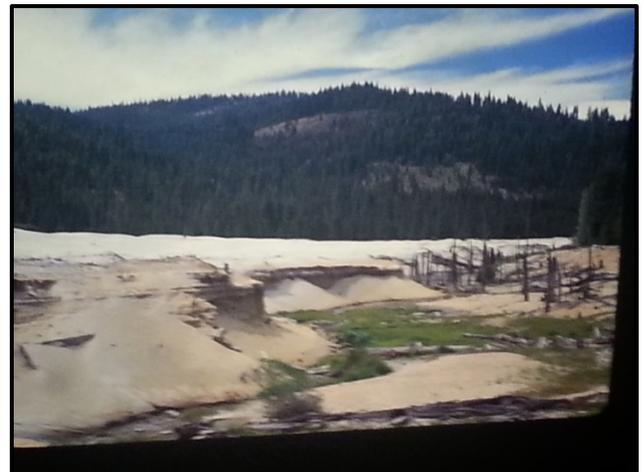
Photo 4. Walker Mine Tailings, Circa 1986. Showing conditions similar to photo taken by Paul L. Henchey in September 1951.
