**INSPECTION REPORT, ORIGINAL SIXTEEN TO ONE MINE, INC., SIXTEEN TO ONE MINE, SIERRA COUNTY**

**CALIFORNIA REGIONAL WATER QUALITY CONTROL BOARD  
CENTRAL VALLEY REGION  
INSPECTION REPORT**

*Facility:* Sixteen to One Mine  
506 Miners Street  
Alleghany, CA, Sierra County

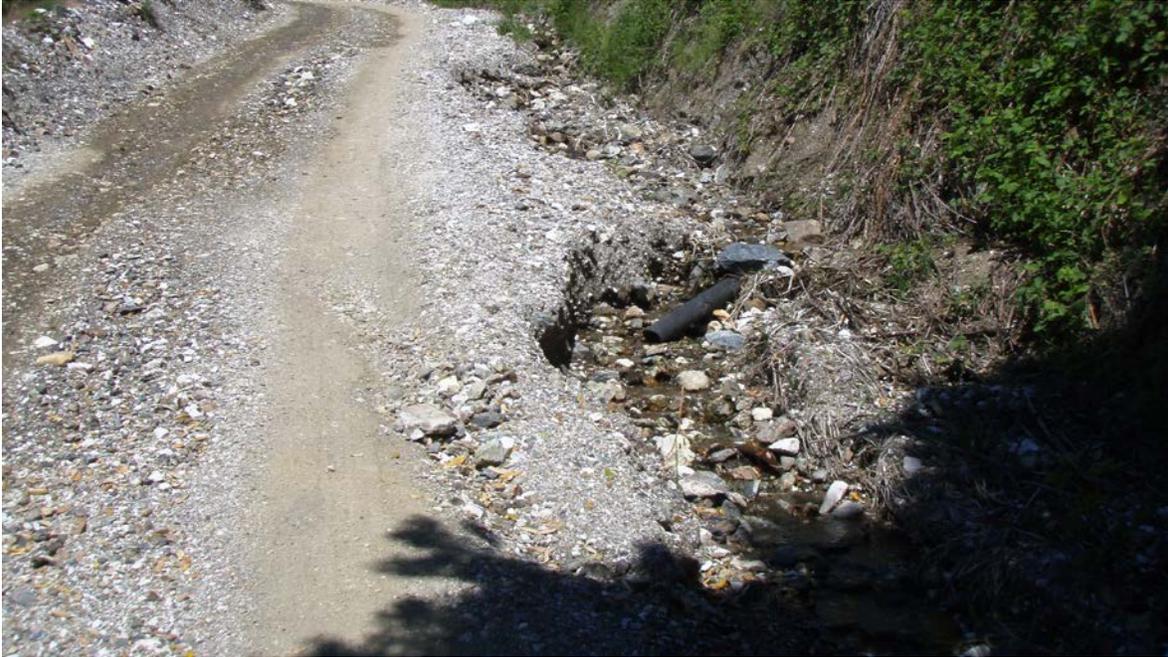
The group drove to the mill. Michael Miller said the mill operations had not changed since 1999. The mill is not used because no waste rock is produced. The general appearance of the mill building supported Michael Miller's statement. A spring near the ball mill was discharging into the road (**Figure 1**).

**Figure 1. Discharge from spring. SMJ.**

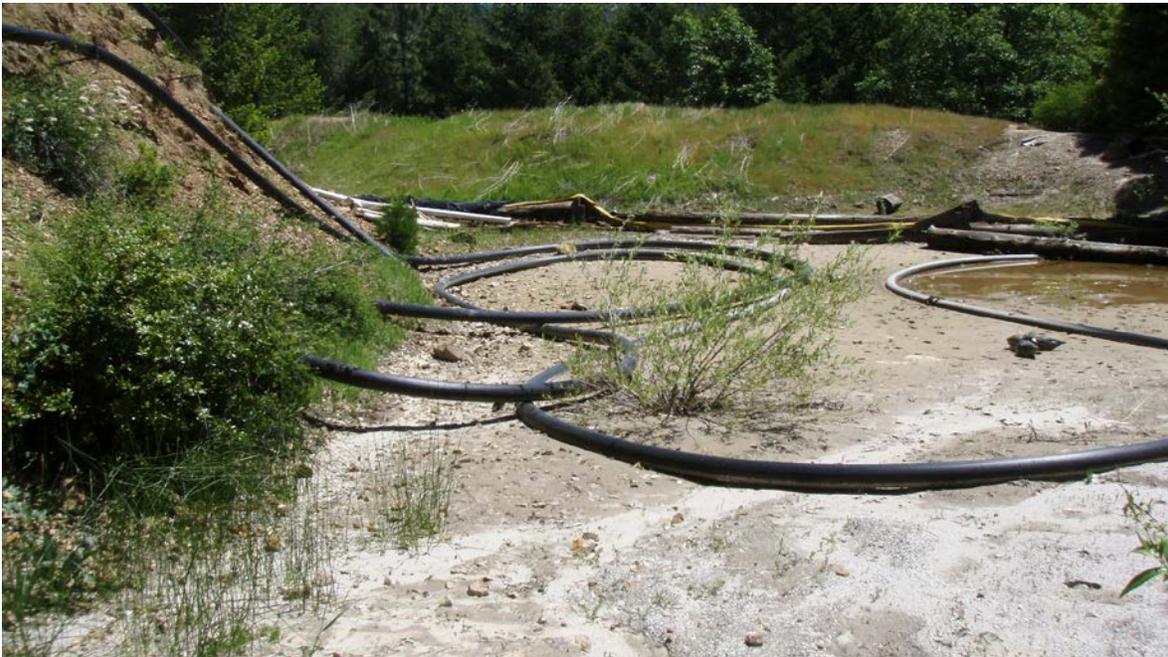
The group drove to and walked around the hydrocyclone and inactive settling ponds. Most of the ponds were dry (**Figure 2**). The hydrocyclone did not appear to have been used in several years.

**Figure 2. Inactive settling ponds. SMJ.**

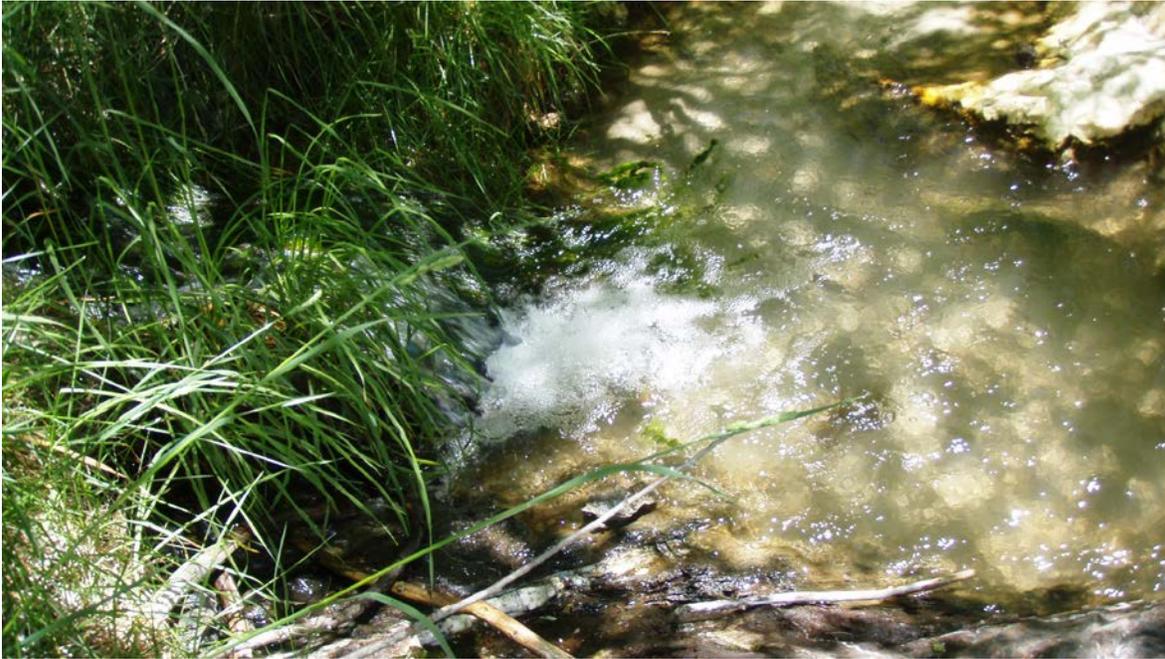
The group drove to the 800-level Tunnel (the main entrance to the mine) and lower shop, and then walked along a trail to the 21 Tunnel portal. Water was discharging from the portal to Kanaka Creek (**Figures 3 and 4**). Spencer Joplin and Jeff Huggins collected a sample from the 21 Tunnel Portal discharge at the location indicated in **Figure 5**. Details about the sampling and field analysis are found as Attachment B to this inspection report.

**Figure 3. Discharge from 21 Tunnel (far left) to Kanaka Creek (far right). SMJ.**

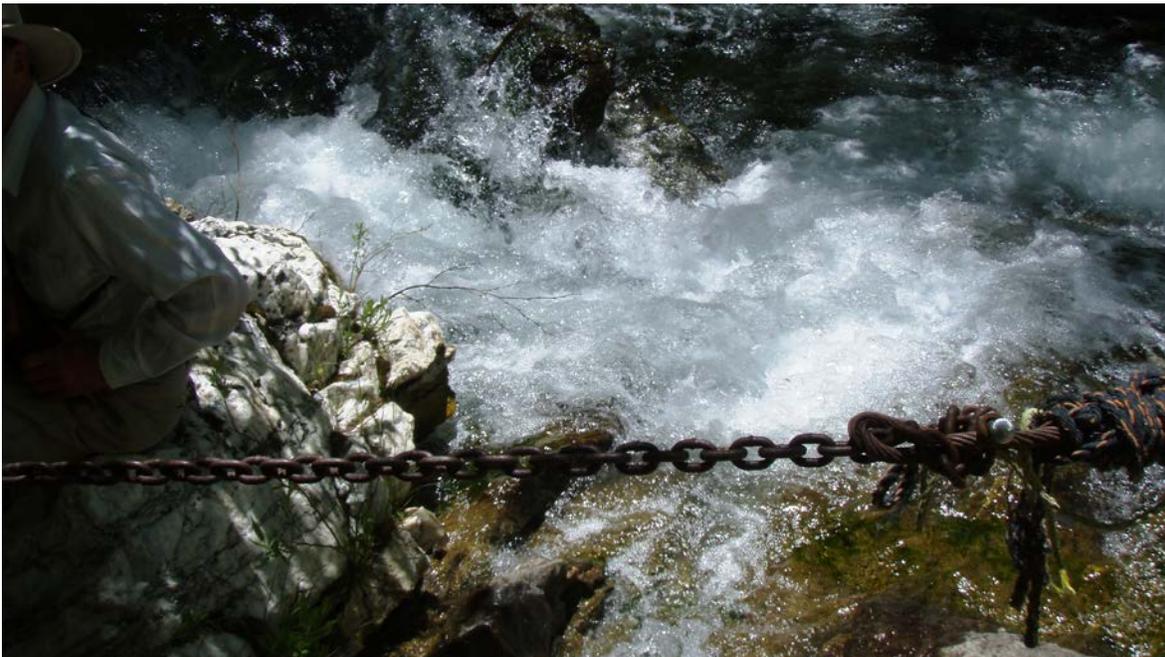
**Figure 4. Discharge from 21 Tunnel (far bottom) to Kanaka Creek (top). SMJ.**

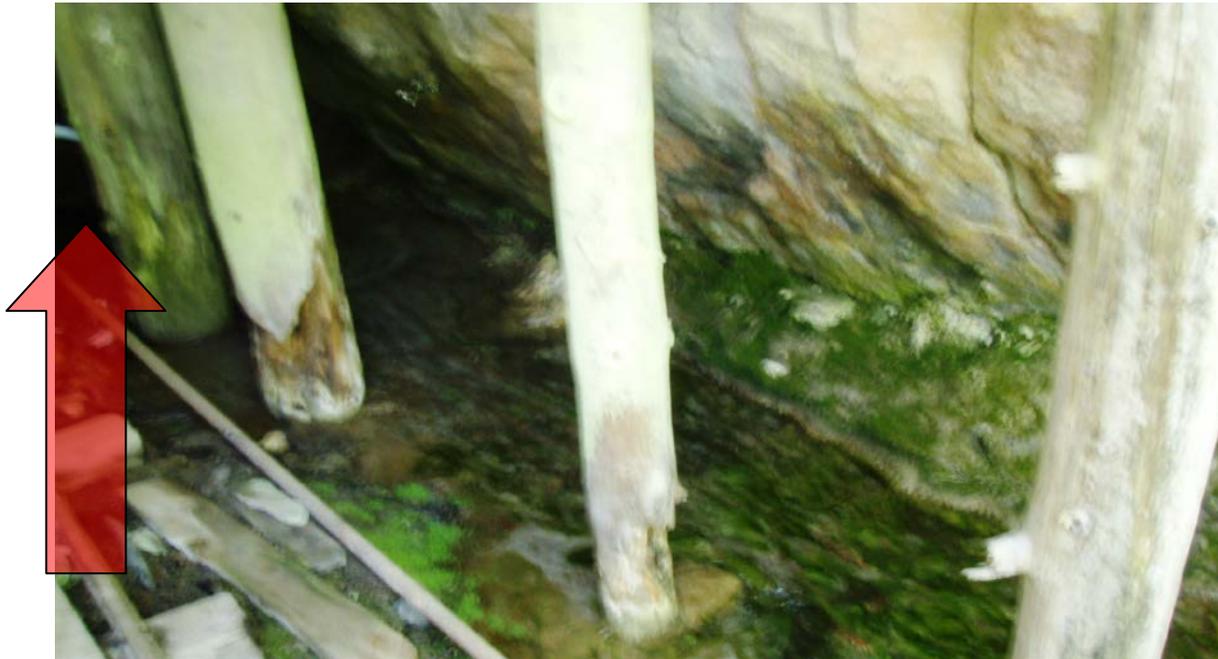
**Figure 5. 21 Tunnel. Arrow indicates location of sample collection. SMJ.**

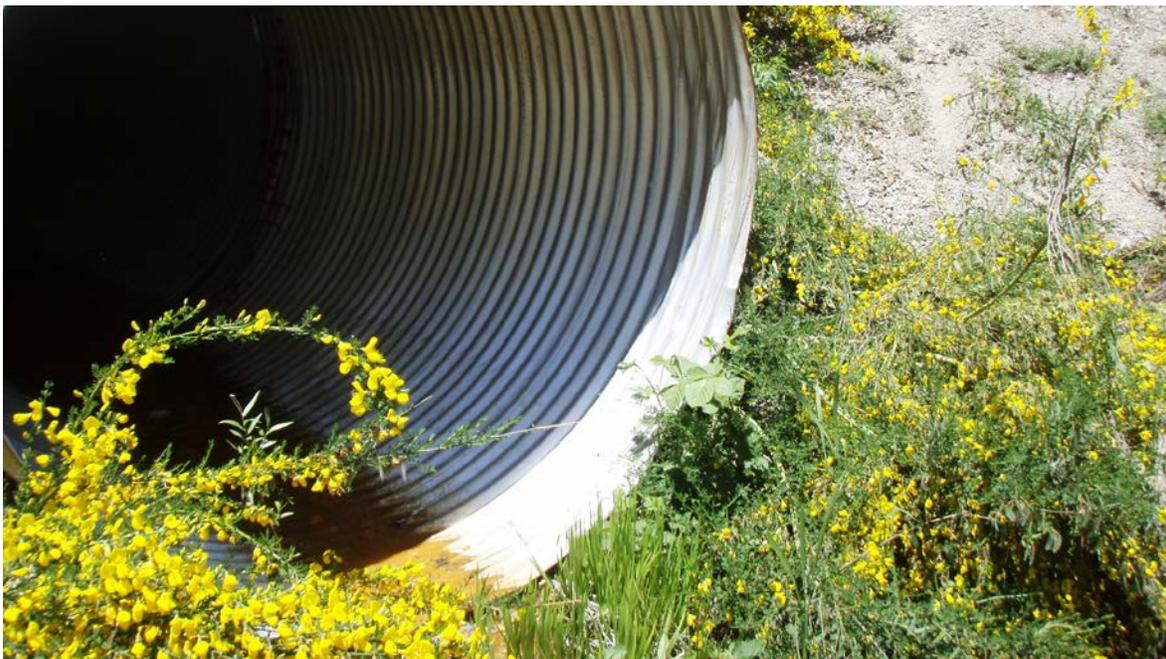
The inspection group drove to the entrance of the Happy Jack Extension Tunnel (**Figure 6**). Michael Miller said the tunnel was an abandoned mine that was discovered while Sierra County was drilling to assess the soil quality around an underground storage tank in a maintenance yard. Water was discharging from the Happy Jack Extension Tunnel to an unknown location, and a hay bale had been placed in the channel (**Figure 7**). Michael Miller said the underground storage tank cleanup fund would not reimburse OSTOMI because the cleanup would benefit OSTOMI.

**Figure 6. Happy Jack tunnel. SMJ.**

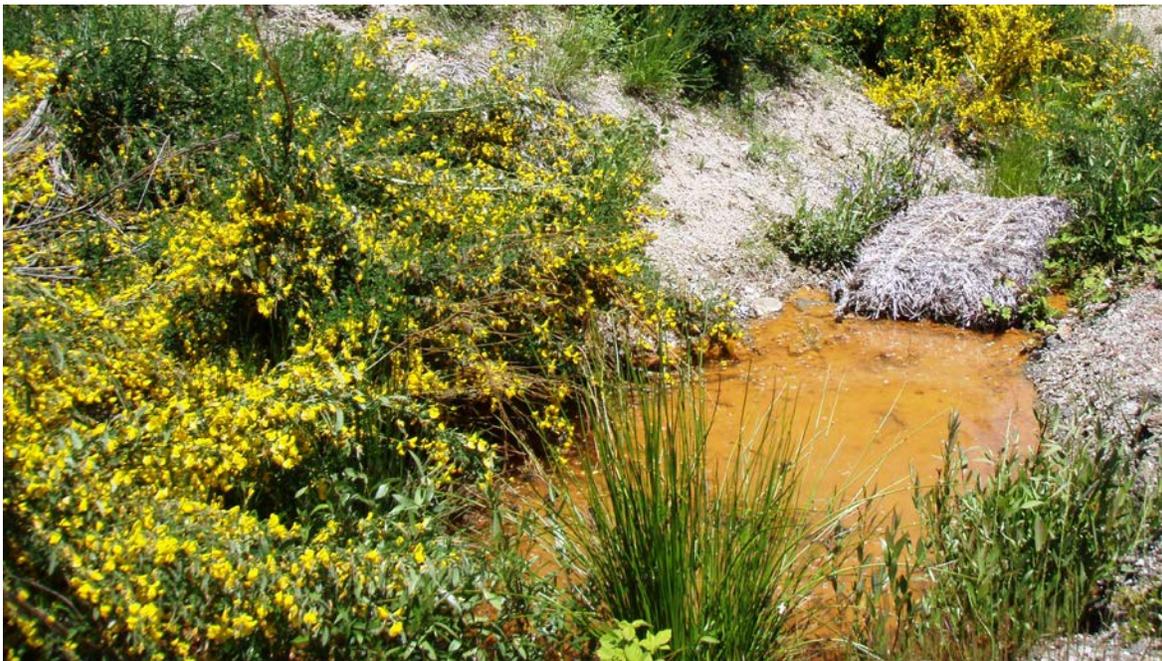
**Figure 7. Discharge from Happy Jack Tunnel (far bottom right). SMJ.**
