Up-Stream DO TMDL Project
Task: 5
Description of Flow and Water Quality Monitoring
Upgrades and Photo Documentation

February 2008

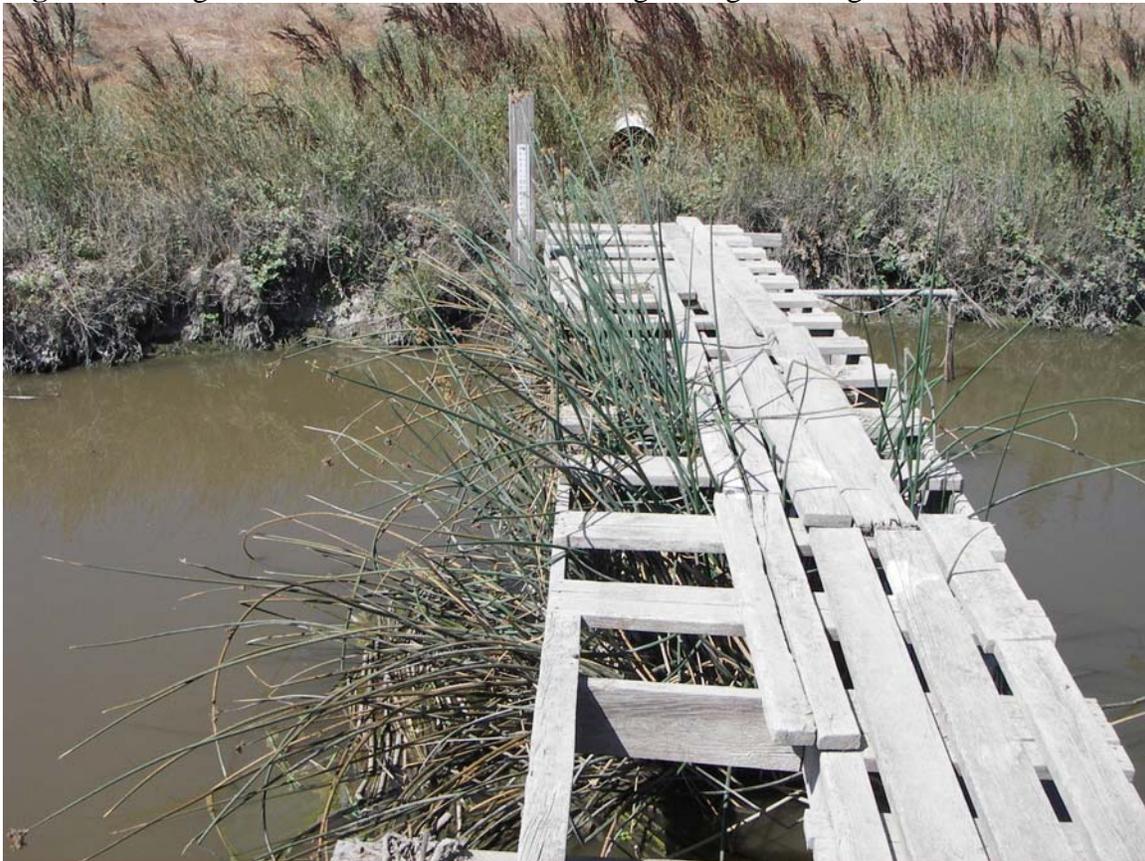
Figure 1: Bridge at Los Banos Creek before being damaged during storms of 2005/2006.

While all sites are currently operational, some sites have had problems that have had to be repaired. DO-20 Los Banos Creek was recently rehabilitated after being washed out during the storms of 2005/2006. A new bridge was constructed replacing the old wooden bridge. The SONTEK SL acoustic sensor was re-sited and new cable drawn. The EC sensor was replaced and a new pipe laid into the water for the bubbler sensor. At DO-38 Marshall Road Drain a leak in the T valve on bubbler line was found on 5/9/06. All flow data from the bubbler unit was low quality prior to this date. DO-65 Spanish-Grant Drain had sediment built up behind the weir resulting in low quality QA stage readings from 05/22/07 to 01/17/08. The sediment was cleared out on 01/17/08. DO-64 Moran Drain is currently operational with no significant problems. Sediment can build up behind the weir structure at these three sites and it occasionally needs to be cleared. The STARFLOW acoustic Doppler stage transducer is prone to clogging from the sediment and sometimes the unit becomes buried in the mud, especially at DO-38 Marshall Road Drain and DO-65 Spanish-Grant Drain. The monitoring systems for all three sites are powered by the same battery and solar panel which could cause a potential power issue. The steep bed slope at DO-36 Del Puerto Creek can result in low stage that is barely above bubbler at low flow events causing low quality flow values. The solar panel at this site has been stolen once. Frequent flow ratings are required due to a shifting channel bed. The bubbler line was found clogged with debris on 10/09/07 and cleared on 11/01/07. The clog resulted in low quality stage data from June 2006 until 11/01/07. DO-57 Ramona Lake at Levee was washed out during the 2005/2006 San Joaquin River flooding. Water flowed backwards through the culvert. The landowner dropped sandbags down the culvert to avert flooding his land and decommissioned the

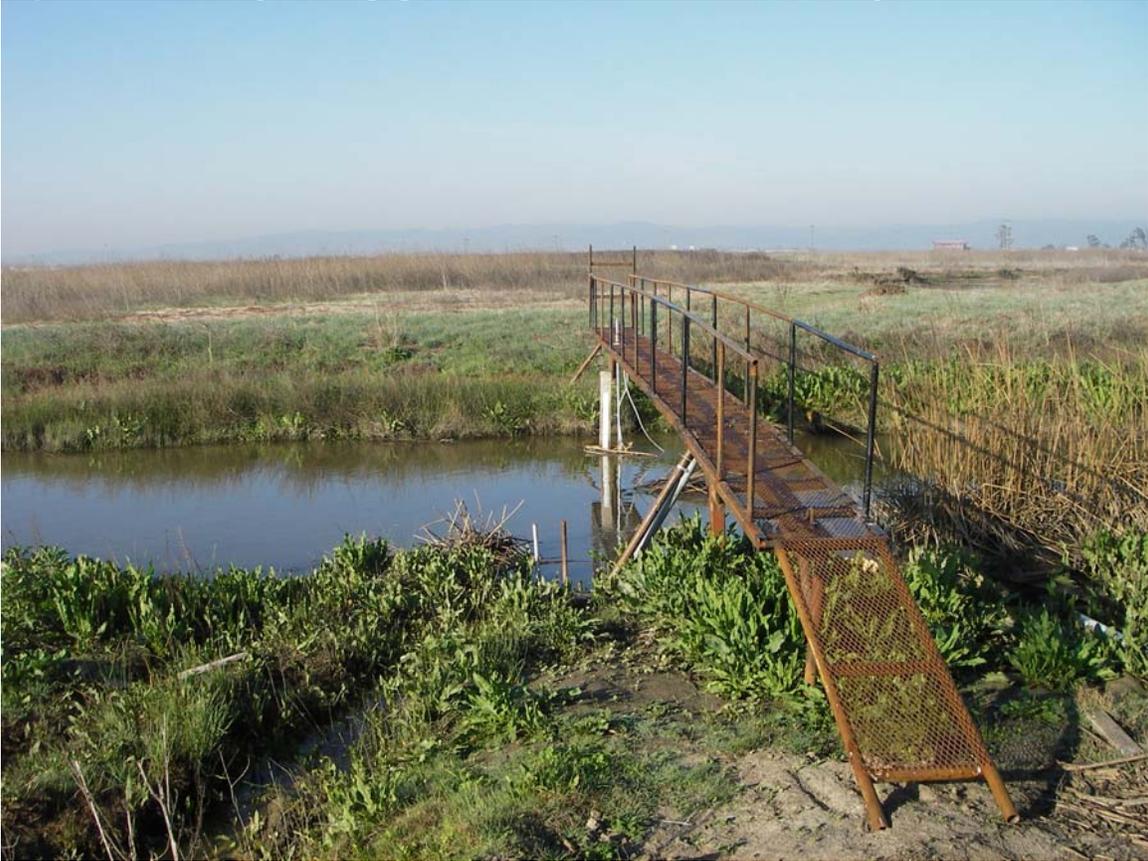
Site Description	20. Los Banos Creek Located within the Kesterson National Wildlife Refuge approximately ¼ mile south of Hwy 140.
Power	Solar Panel with 12-volt battery
Datalogger	Campbell Scientific datalogger
EC Sensor	Campbell Scientific temperature-compensated EC sensor
Flow Measurement	SONTEK SL acoustic Doppler sensor with built-in stage sensor
Depth	Design Analysis H350XL with H355 Smartgas system
Velocity	SONTEK SL
Telecommunications	GOES Telemetry installed but not operational.

Figure 2: New bridge and equipment installed at LBC after old bridge was washed out.

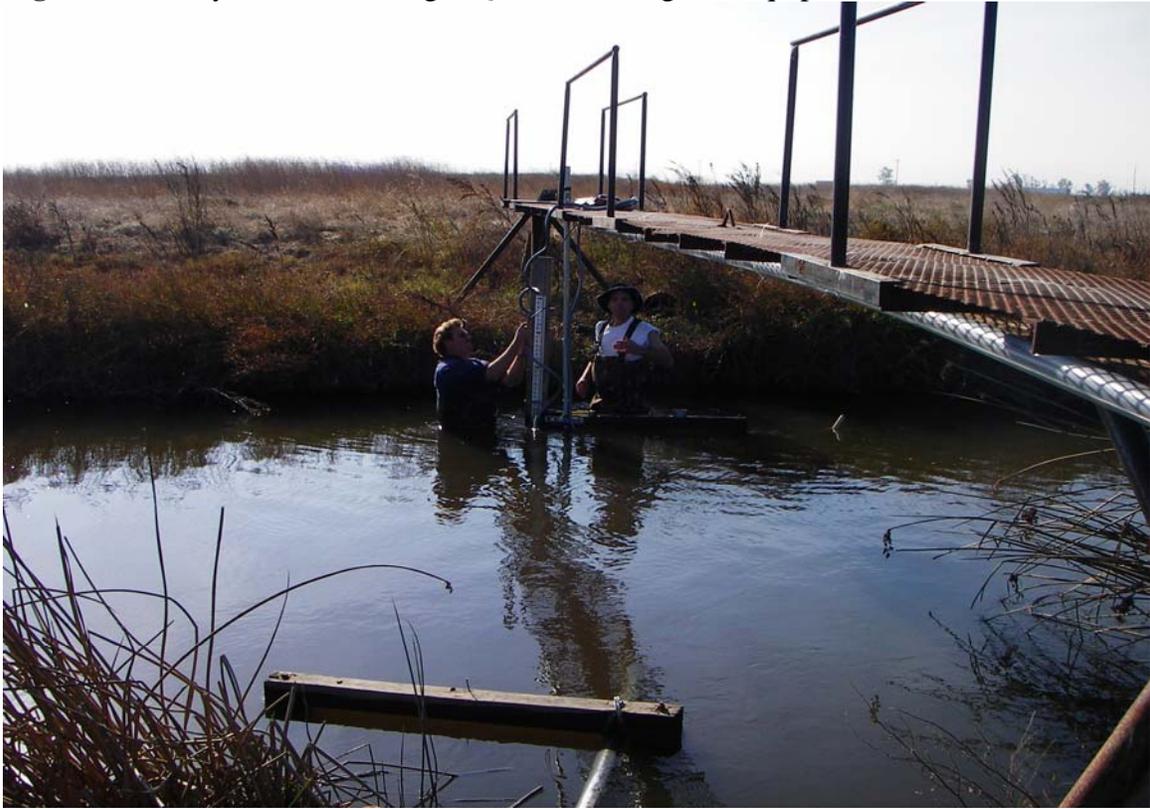
Figure 3: Jeremy Hanlon and Nigel Quinn installing new equipment at Los Banos Creek.

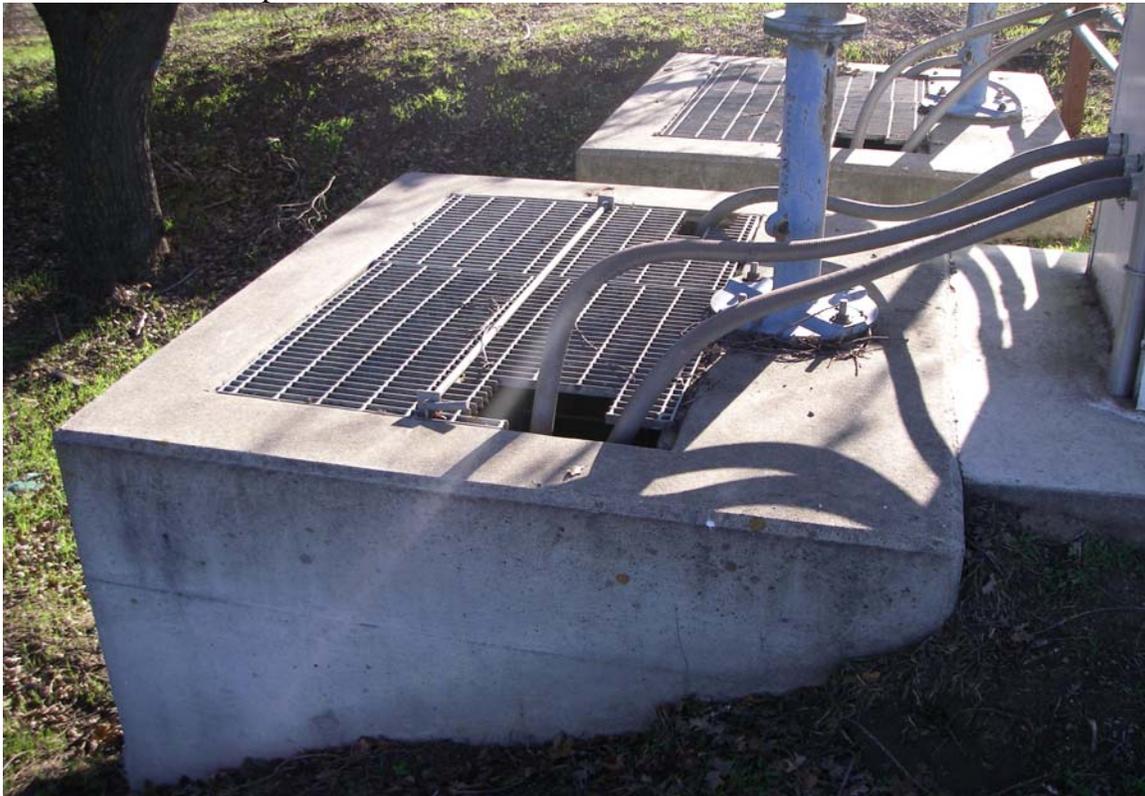
Site Description	38. Marshall Road Drain Located within Patterson Irrigation District at the east end of Marshall Road. Carries agricultural return flows from Marshall Road Reservoir.
Power	Solar Panel with 12-volt battery
Datalogger	Design Analysis datalogger
EC Sensor	YSI 600XL temperature compensated EC probe
Flow Measurement	Flow over a sharp crested weir using weir equation and stage to compute discharge (primary) Unidata STARFLOW integrated stage/velocity acoustic Doppler transducer (secondary)
Depth	Design Analysis H350XL with H355 Smartgas system (primary) Unidata STARFLOW stage (secondary)
Velocity	Unidata STARFLOW velocity
Telecommunications	GOES Telemetry installed but not operational.

Figure 4: Manhole at Marshall Road Drain. The manhole for Spanish Land Grant Drain is in the back of the picture.

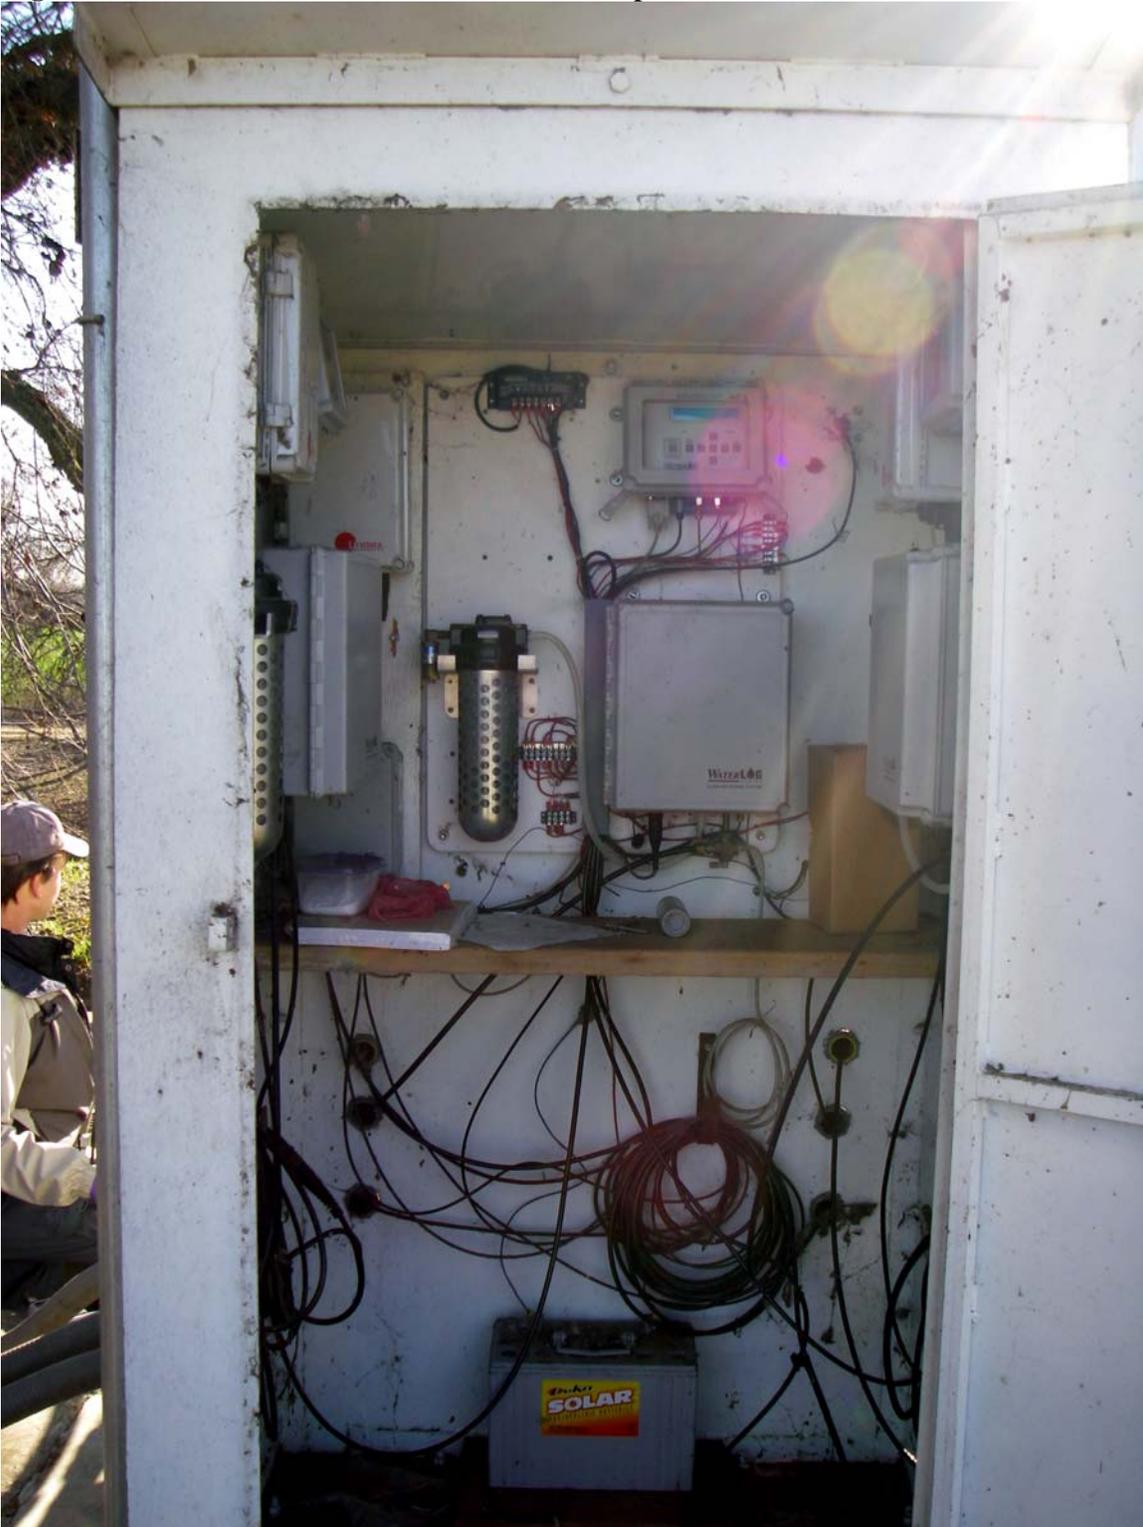
Figure 5: Flow station shed for Marshall Road, Spanish Land Grant, and Moran Drains.

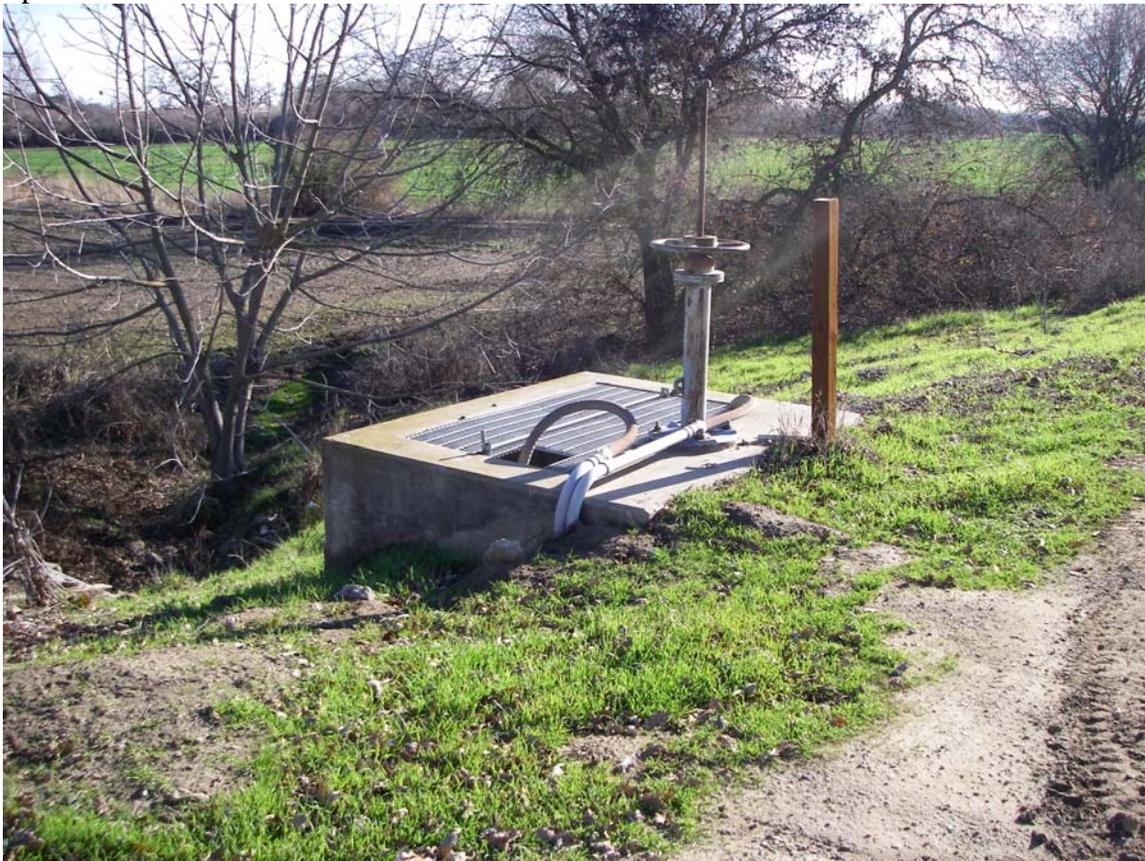
Site Description	64. Moran Drain Located within Patterson Irrigation District at the east end of Marshall Road. Carries agricultural return flows from adjacent fields.
Power	Solar Panel with 12-volt battery
Datalogger	Design Analysis datalogger
EC Sensor	YSI 600XL temperature compensated EC probe
Flow Measurement	Flow over a sharp crested weir using weir equation and stage to compute discharge (primary) Unidata STARFLOW integrated stage/velocity acoustic Doppler transducer (secondary)
Depth	Design Analysis H350XL with H355 Smartgas system (primary) Unidata STARFLOW stage (secondary)
Velocity	Unidata STARFLOW velocity.
Telecommunications	GOES Telemetry installed but not operational.

Figure 6: Manhole for Moran Drain. Manhole is about 50 ft south west of manhole for Spanish Land Grant Drain.

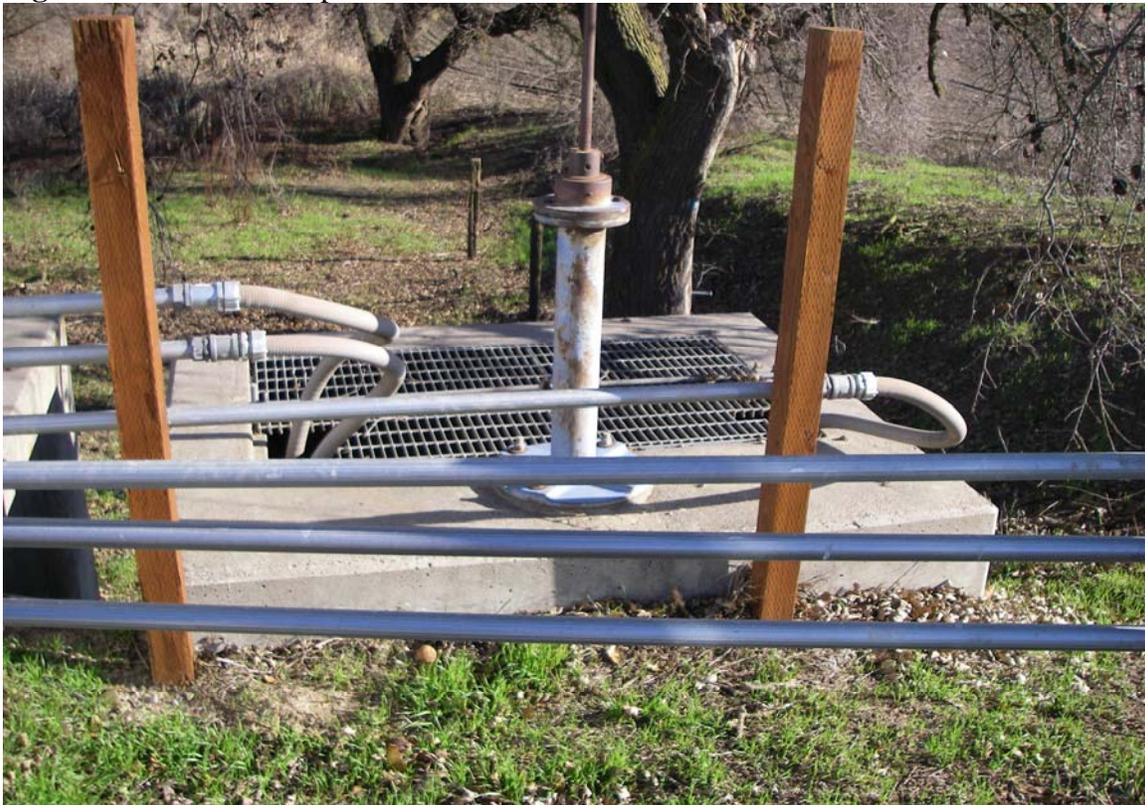
Site Description	65. Spanish Land Grant Drain Located within Patterson Irrigation District at the east end of Marshall Road. Carries agricultural return flows from Patterson Irrigation District.
Power	Solar Panel with 12-volt battery
Datalogger	Design Analysis datalogger
EC Sensor	YSI 600XL temperature compensated EC probe
Flow Measurement	Flow over a sharp crested weir using weir equation and stage to compute discharge (primary) Unidata STARFLOW integrated stage/velocity acoustic Doppler transducer (secondary)
Depth	Design Analysis H350XL with H355 Smartgas system (primary) Unidata STARFLOW stage (secondary)
Velocity	Unidata STARFLOW velocity.
Telecommunications	GOES Telemetry installed but not operational.

Figure 7: Manhole for Spanish Land Grant Drain.

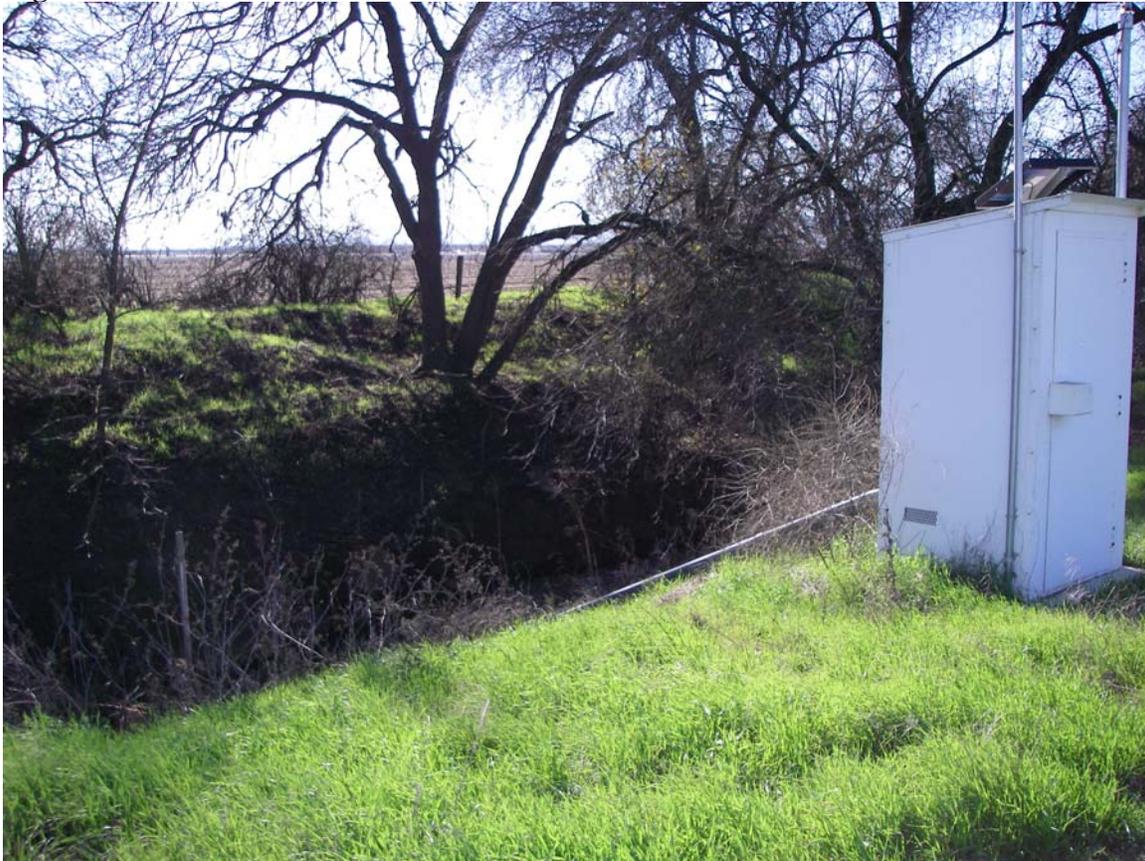
Site Description	36. Del Puerto Creek Ephemeral stream from the Coast Range that flows into the SJR through Patterson Irrigation District.
Power	Solar Panel with 12-volt battery
Datalogger	Design Analysis datalogger
EC Sensor	YSI 600XL temperature compensated EC probe
Flow Measurement	Stage-discharge relationship developed for a straight, narrowly incised and steep channel segment.
Depth	Design Analysis H350XL with H355 Smartgas system;
Velocity	n/a
Telecommunications	GOES Telemetry installed but not operational.

Figure 8: Flow station shed and stream channel for Del Puerto Creek.

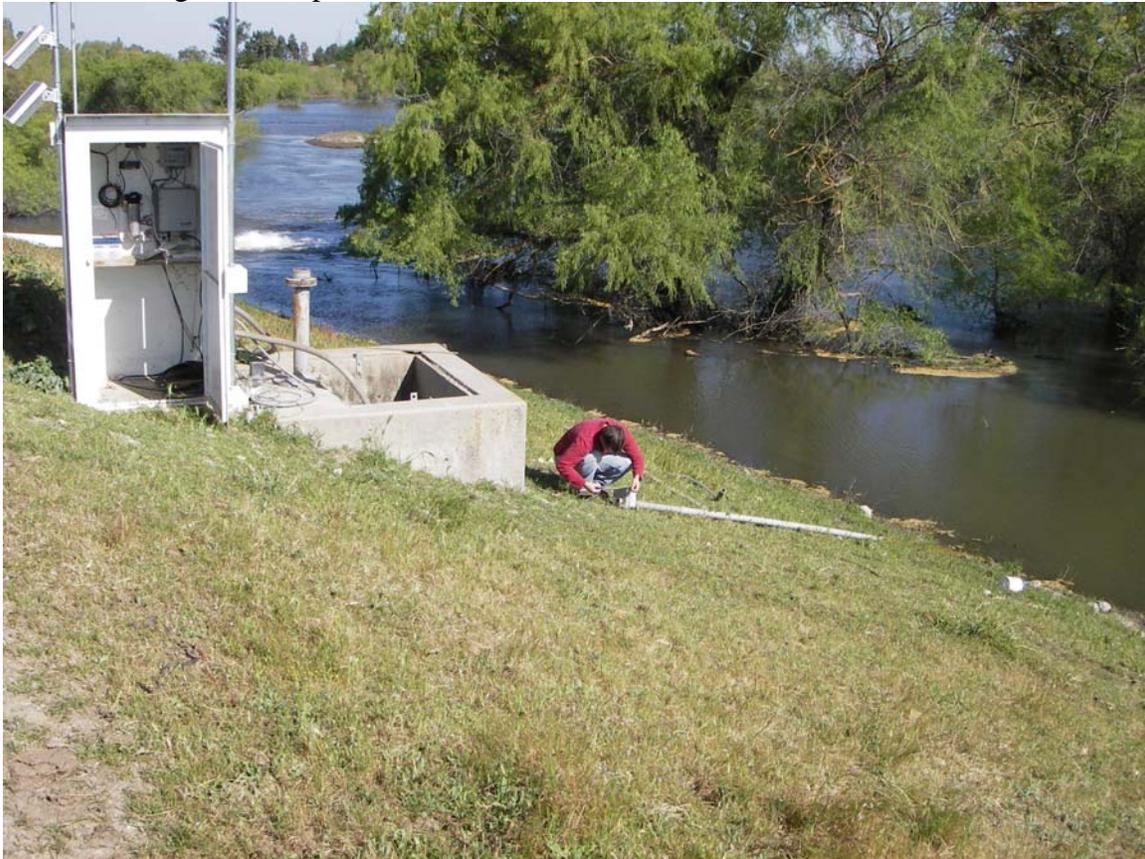
Figure 9: Kyle Kearney inspecting the damage to Ramona Lake Drain flow station. River flooding backed up into the culvert and decommissioned the station.

monitoring station. The EC sensor was redeployed and a new pipe laid for the bubbler sensor. The site is currently operational. The original culvert at DO-35 Westley Wasteway was undersized. The district replaced it with a larger diameter structure to accommodate more flow. A weir structure was installed at the same time. New pipe was laid for the EC probe and bubbler line just upstream of weir. Flow data was originally calculated with a STARFLOW acoustic Doppler which was prone to error from the small culvert and constant debris dumped upstream. The new weir provided high quality data from a bubbler system. DO-34 Ingram Creek has no significant problems. Heavy sediment load during summer months necessitated occasional removal of sediment behind weir structure. Sediment was last cleared out on 11/01/07. DO-31 New Jerusalem Drain was upgraded with a STARFLOW Doppler sensor which failed after six months of placement. Unit was replaced in mid-2006 with a MACE integrated stage/velocity acoustic Doppler sensor which has proved more reliable. The station is currently operational with no significant problems. DO-25 Miller Lake Outfall had a Design Analysis H355 Smartgas bubbler system installed in late 2007 and is currently operational with few significant problems. DO-22 Lateral 4 to SJR, DO-23 Lateral 5 to Tuolumne, DO-24 Lateral 6 to Stanislaus, DO-26 Highline Spill, DO-27 Lateral 2 to San Joaquin River, DO-28 Westport Drain, DO-29 Harding Drain, and DO-30 Lateral 6 & 7 at Levee are all operational with few significant problems. DO-33 Hospital Creek is operational with few significant problems.

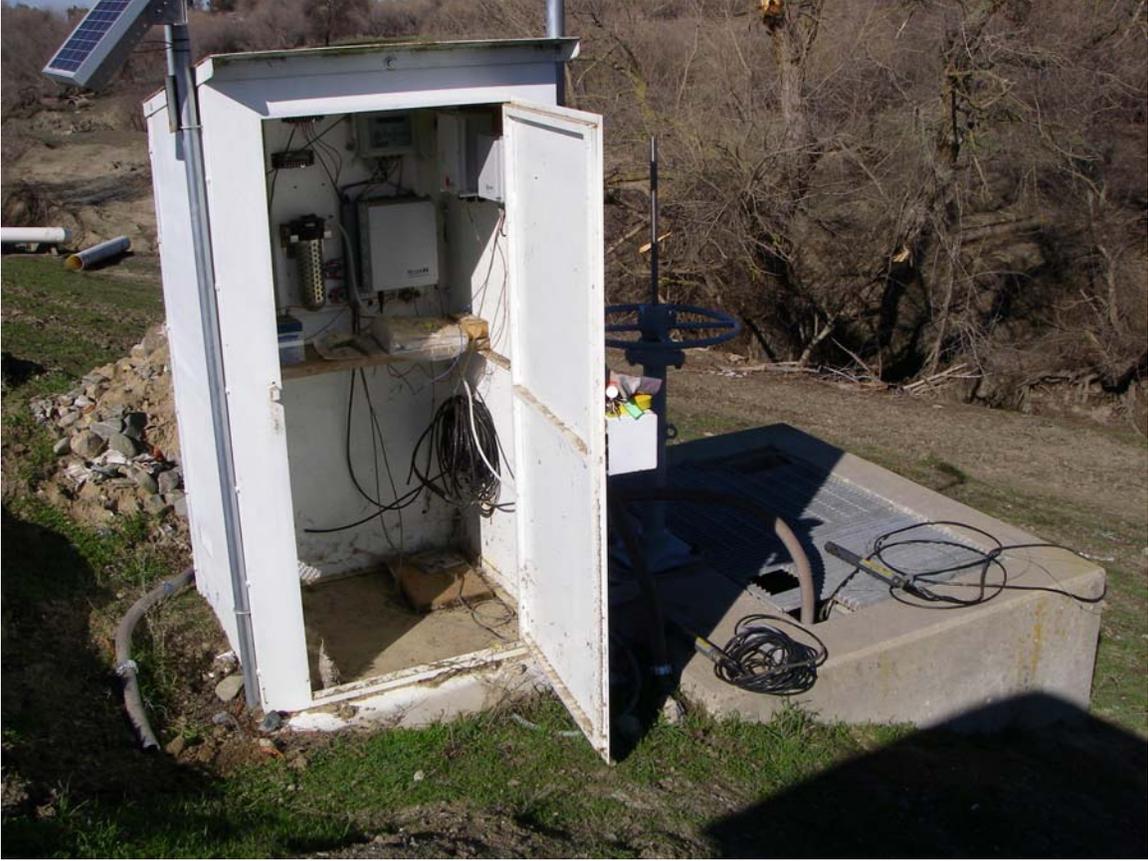
Figure 10: Ramona Lake Drain flow station shed and manhole after repairing the damage from San Joaquin River flooding during 2005/2006.

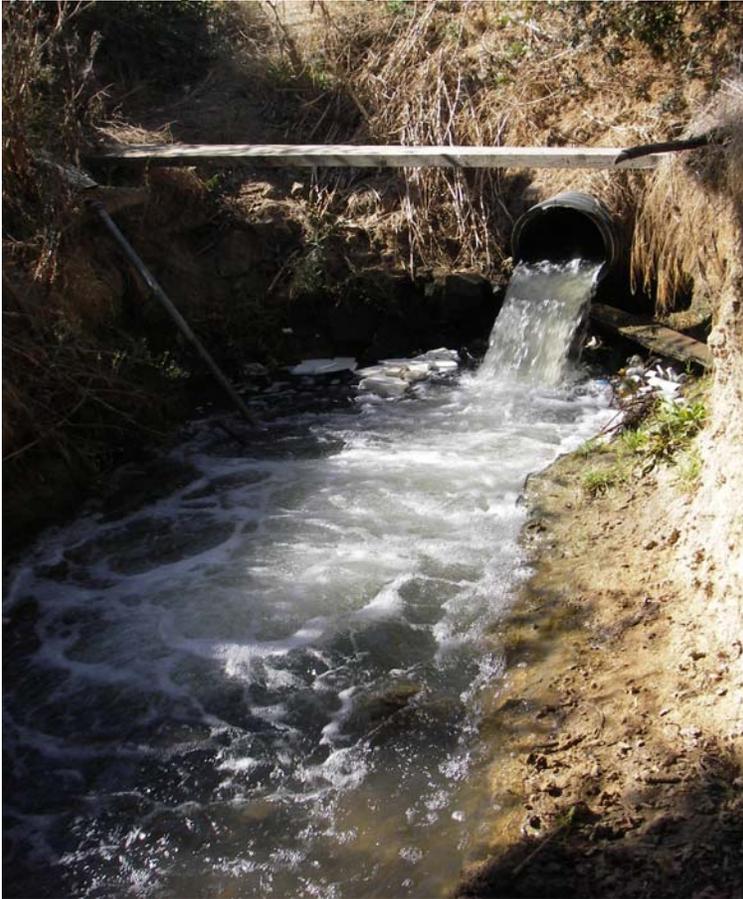
Figure 11: Old culvert at Westley Wasteway. Original culvert and acoustic Doppler system at site provided low quality data.

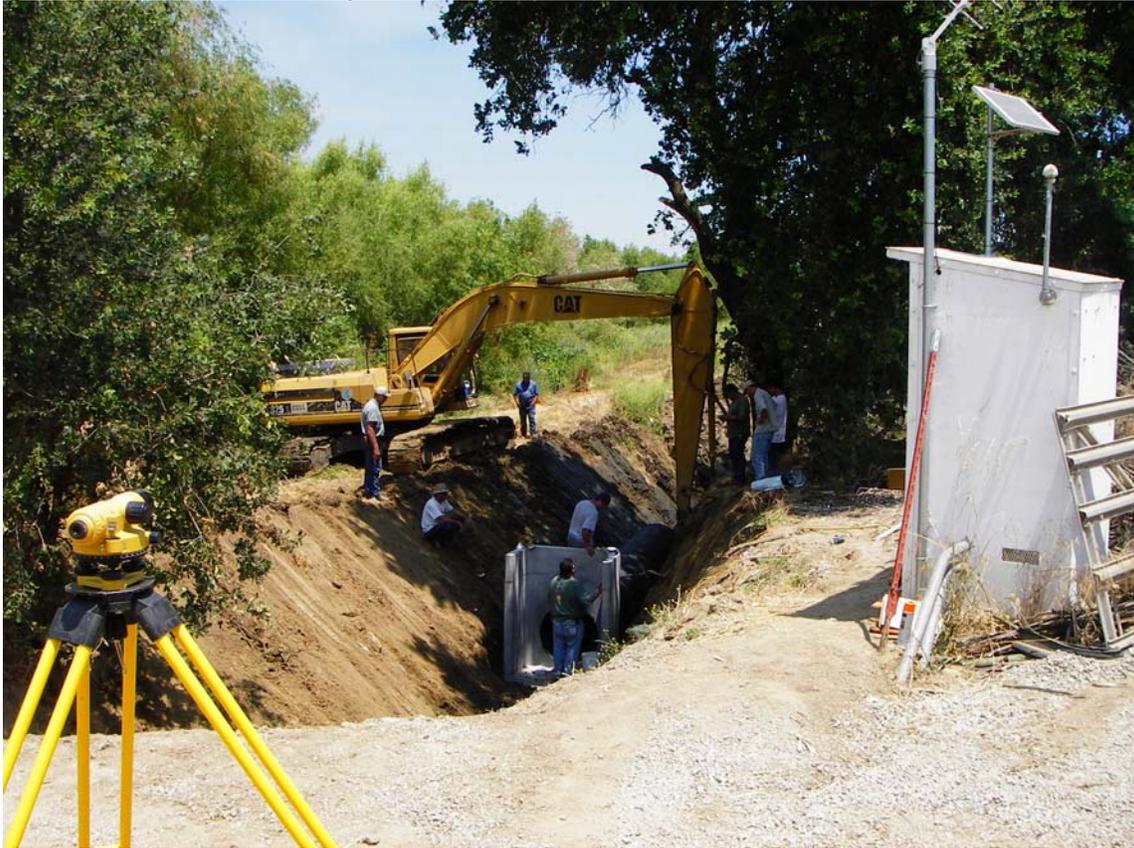
Figure 12: Irrigation district installing a new weir structure and culvert to provide higher quality flow data at Westley Wasteway.

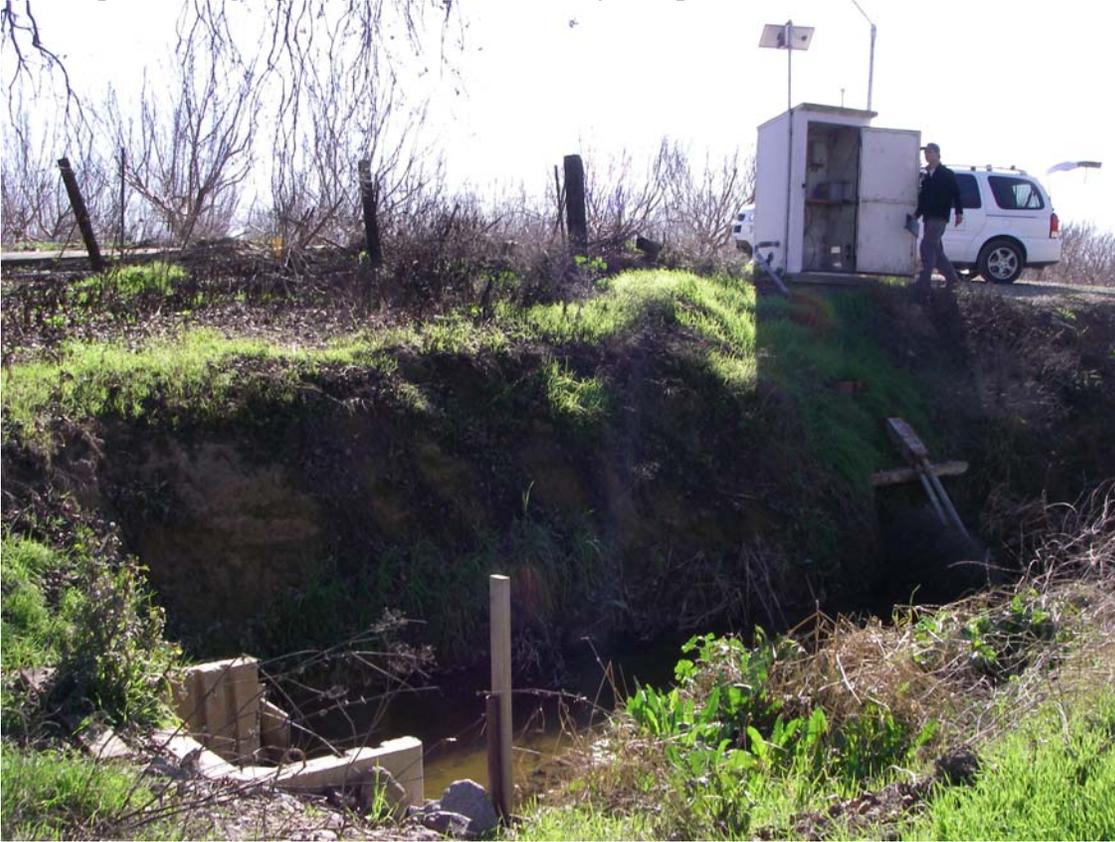
Site Description	35. Westley Wasteway Located along River Road within the West Stanislaus Irrigation District
Power	Solar Panel with 12-volt battery
Datalogger	Design Analysis datalogger
EC Sensor	YSI 600XL temperature compensated EC probe
Flow Measurement	Previously used a combination of STARFLOW acoustic Doppler transducer and bubbler stage. Current retrofit uses a regular contracted weir located approximately 30ft downstream. Flow measured using equation for contracted sharp crested weir.
Depth	Design Analysis H350XL with H355 Smartgas system (primary)
Velocity	n/a
Telecommunications	GOES Telemetry installed but not operational.

Figure 13: Current setup at Westley Wasteway. Weir structure and pond with bubbler system provide high quality flow data with very few problems.

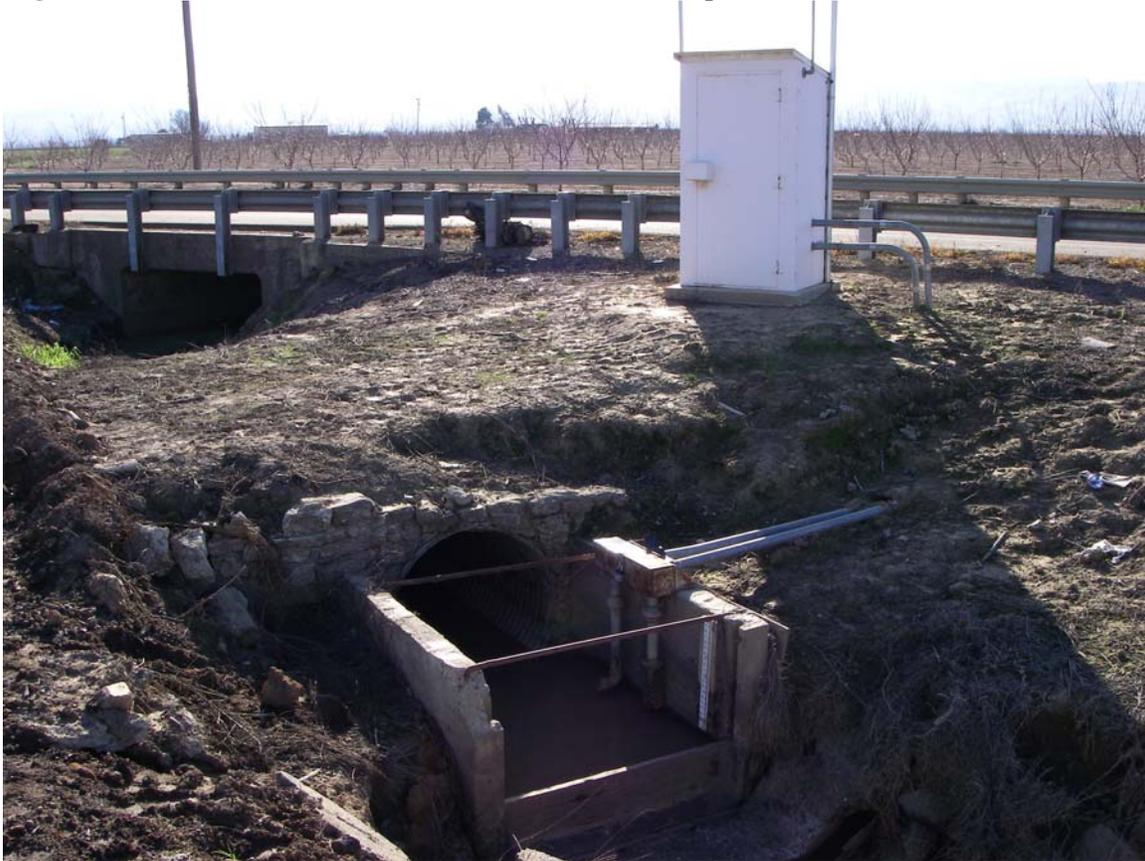
Site Description	33. Hospital Creek Located along River Road within the West Stanislaus Irrigation District. Hospital Creek is an ephemeral stream originating in the Coast Range.
Power	Solar Panel with 12-volt battery
Datalogger	Design Analysis Datalogger
EC Sensor	YSI 600XL temperature compensated EC probe
Flow Measurement	Flow over a sharp crested weir with minor contractions using weir equation and stage to compute discharge
Depth	Design Analysis H350XL with H355 Smartgas system
Velocity	n/a
Telecommunications	GOES Telemetry installed but not operational.

Figure 14: Flow station shed and weir structure at Hospital Creek.

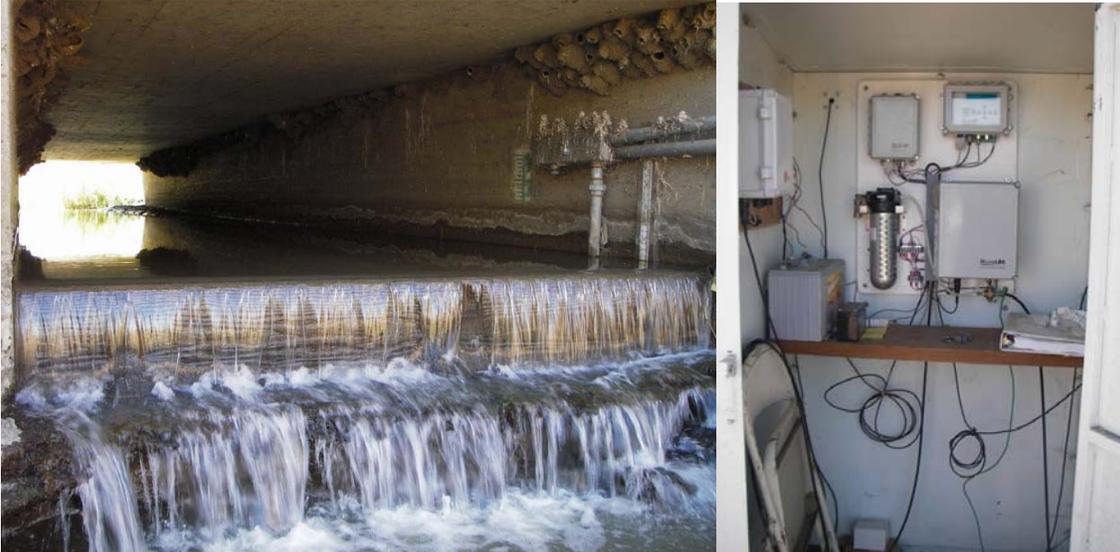
Site Description	34. Ingram Creek Located along River Road within the West Stanislaus Irrigation District. Ingram Creek is an ephemeral stream originating in the Coast Range.
Power	Solar Panel with 12-volt battery
Datalogger	Design Analysis datalogger
EC Sensor	YSI 600XL temperature compensated EC probe
Flow Measurement	Flow over a sharp crested weir using weir equation and stage to compute discharge
Depth	Design Analysis H350XL with H355 Smartgas system
Velocity	n/a
Telecommunications	GOES Telemetry installed but not operational.

Figure 15: Weir and flow station shed at Ingram Creek.

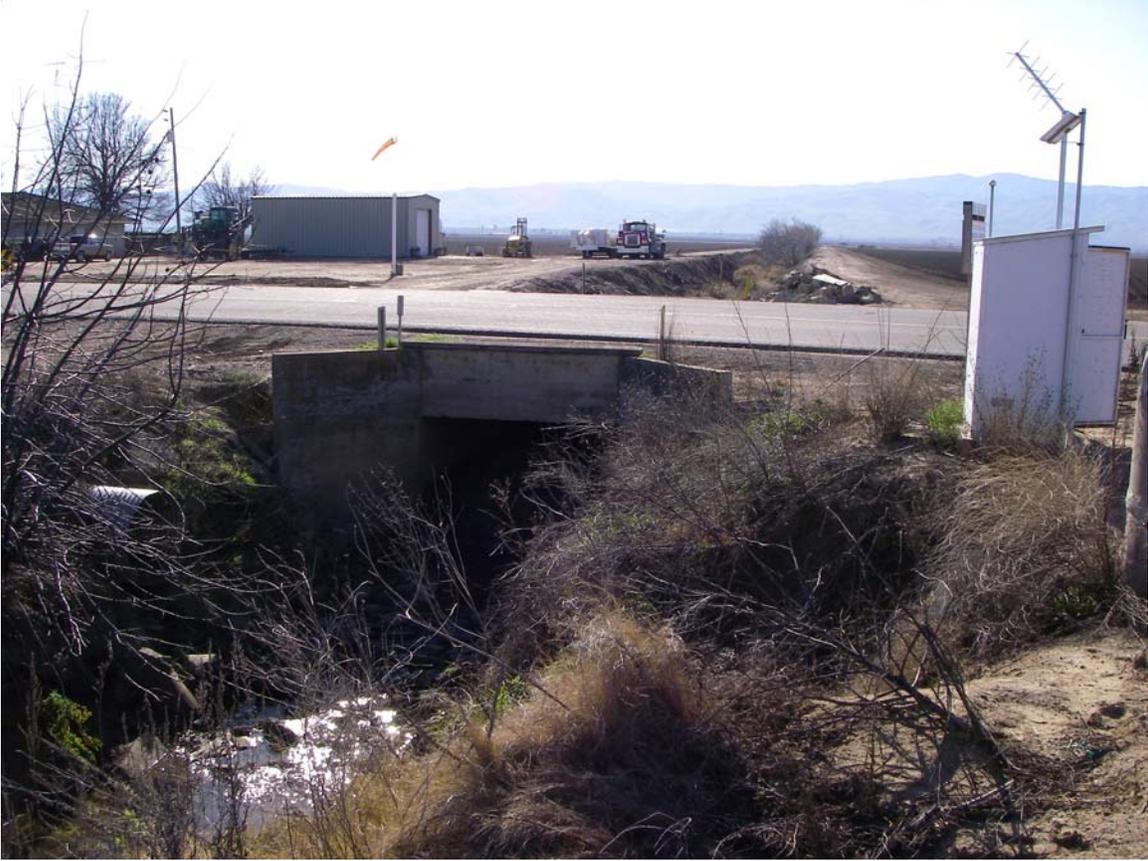
Figure 16: Weir is located under the bridge next to the flow station shed.

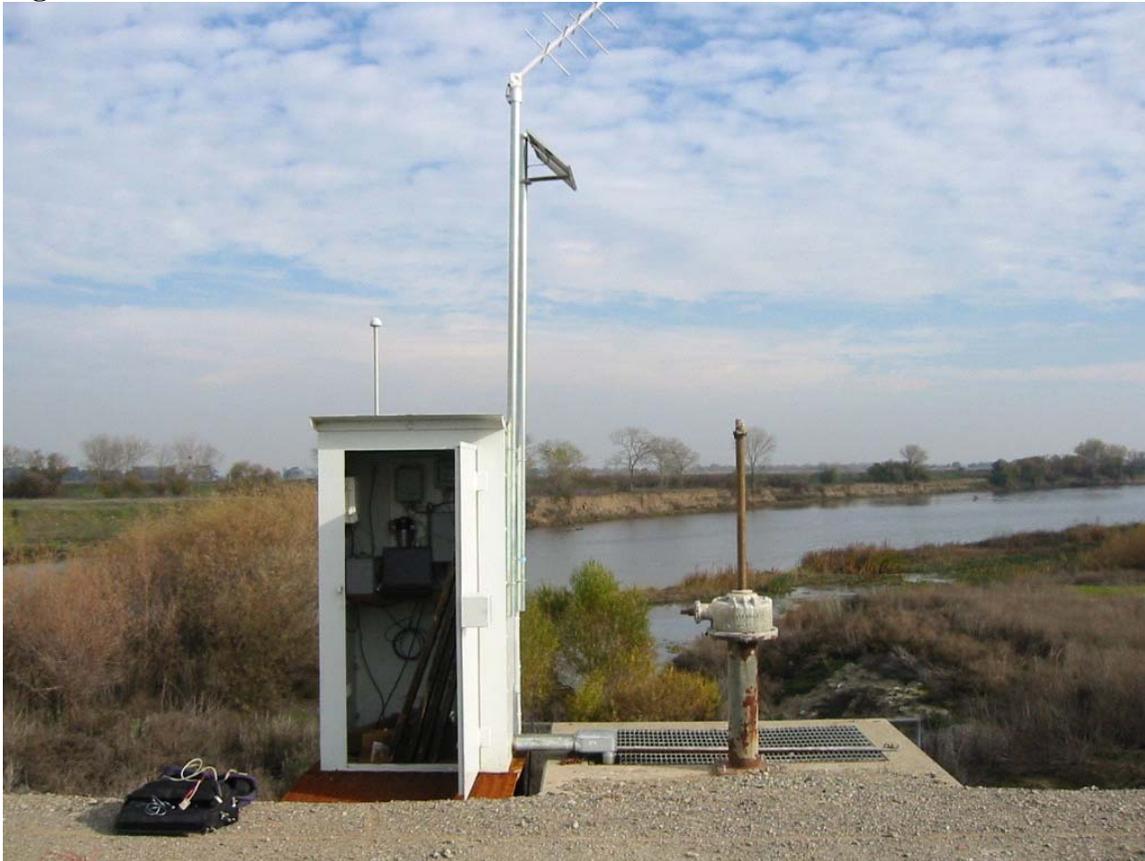
Site Description	31. New Jerusalem Drain Located ¼ mile north of the Banta Carbona Irrigation District fish facility
Power	Solar Panel with 12-volt battery
Datalogger	Design Analysis datalogger
EC Sensor	YSI 600XL temperature compensated EC probe
Flow Measurement	MACE integrated stage/doppler sensor providing direct discharge output (primary). Flow over a sharp crested weir using weir equation and stage to compute discharge (secondary)
Depth	Design Analysis H350XL with H355 Smartgas system (primary) MACE pressure sensor (secondary)
Velocity	MACE acoustic Doppler sensor
Telecommunications	GOES Telemetry installed but not operational.

Figure 17: Flow station shed and manhole at New Jerusalem Drain.

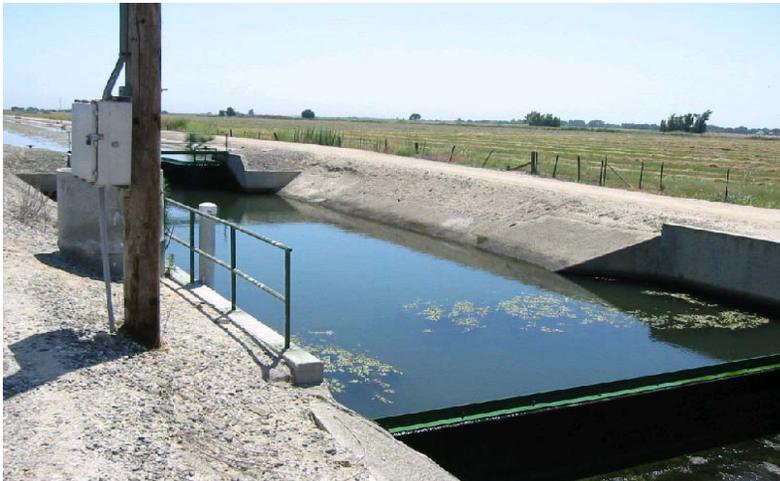
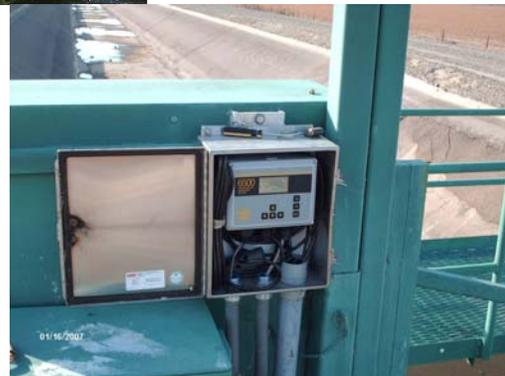
Site Description	22. MID Lateral 4 Modesto irrigation district operational outflow
Power	110 volt power
Datalogger	YSI 6500 Process Monitor which send data to a Sierra Systems SCADA RTU.
EC Sensor	YSI temperature compensated EC probe located ¼ mile upstream of the weir
pH Sensor	YSI pH probe located ¼ mile upstream of the weir
Flow Measurement	Flow over a sharp crested weir using weir equation and stage to compute discharge
Depth	Sierra Systems transducer reporting directly to RTU (primary) Stevens chart recorder (secondary) YSI 600XL internal pressure sensor (tertiary)
Velocity	n/a
Telecommunications	Sierra Systems RTU SCADA Telemetry

Figure 18: (top) Weir at MID Lateral 4. (bottom) Sierra Systems RTU SCADA system.

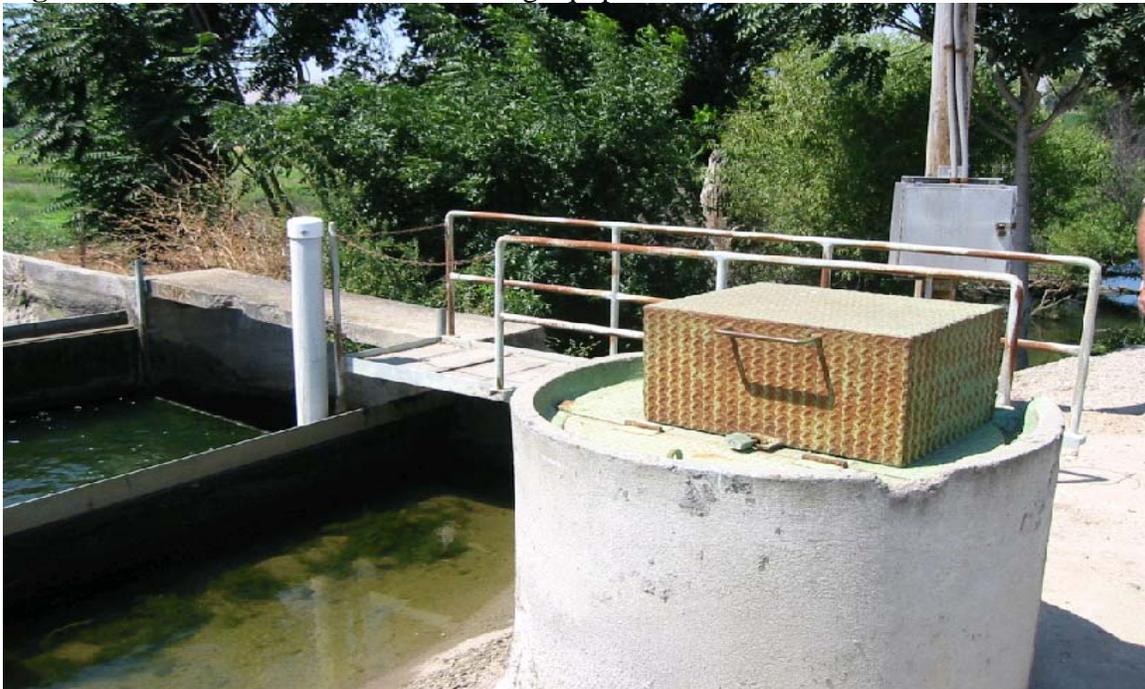
Site Description	23. MID Lateral 5 Modesto irrigation district operational outflow
Power	12 volt power supplied by battery and solar panel
Datalogger	Campbell Scientific CR-10 with digital to serial interface to process signal and make compatible with Sierra Systems SCADA RTU.
EC Sensor	YSI temperature compensated EC probe
pH Sensor	YSI pH probe
Flow Measurement	Flow over a sharp crested weir using weir equation and stage to compute discharge
Depth	Sierra Systems transducer reporting directly to RTU (primary) Stevens chart recorder (secondary) YSI 600XL internal pressure sensor (tertiary)
Velocity	n/a
Telecommunications	Sierra Systems RTU SCADA Telemetry

Figure 19: Weir structure and monitoring equipment at MID Lateral 5.

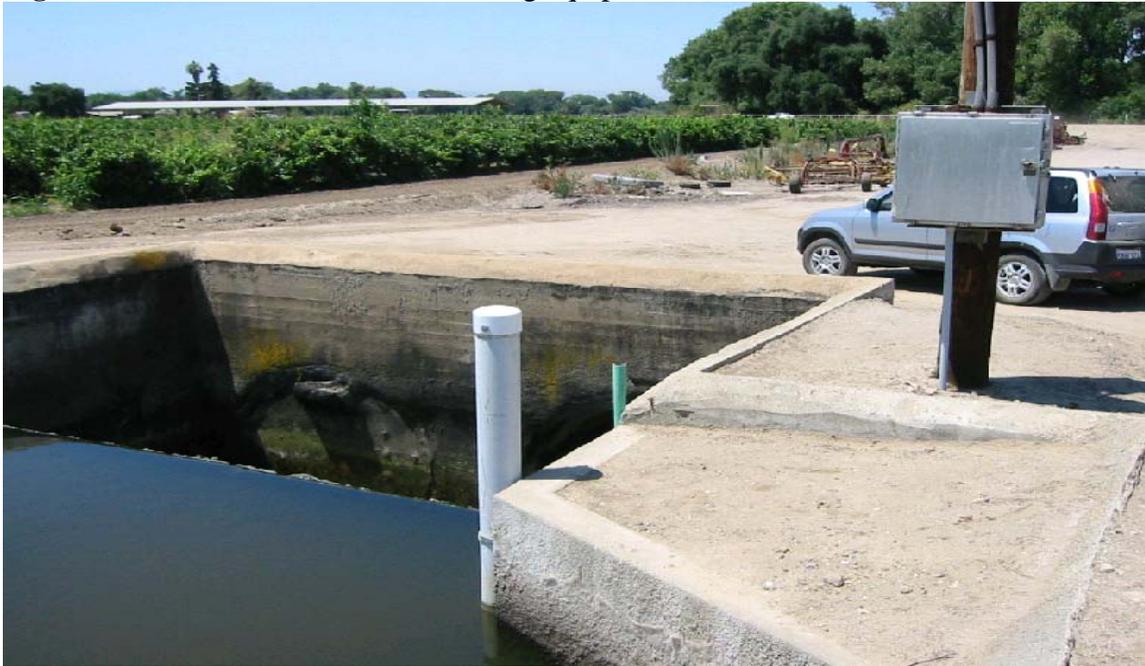
Site Description	24. MID Lateral 6 Modesto irrigation district operational outflow
Power	Solar Panel with 12-volt battery
Datalogger	Campbell Scientific CR-10 with digital to serial interface to process signal and make compatible with Sierra Systems SCADA RTU.
EC Sensor	YSI temperature compensated EC probe located upstream of the weir
pH Sensor	YSI pH probe located upstream of the weir
Flow Measurement	Flow over a sharp crested weir using weir equation and stage to compute discharge
Depth	Sierra Systems transducer reporting directly to RTU (primary) Stevens chart recorder (secondary) YSI 600XL internal pressure sensor (tertiary)
Velocity	n/a
Telecommunications	Sierra Systems RTU SCADA Telemetry

Figure 20: Weir structure and monitoring equipment at MID Lateral 6.
