Up-Stream DO TMDL Project
Task: 5
Description of Flow and Water Quality Monitoring
Upgrades and Photo Documentation

February 2008

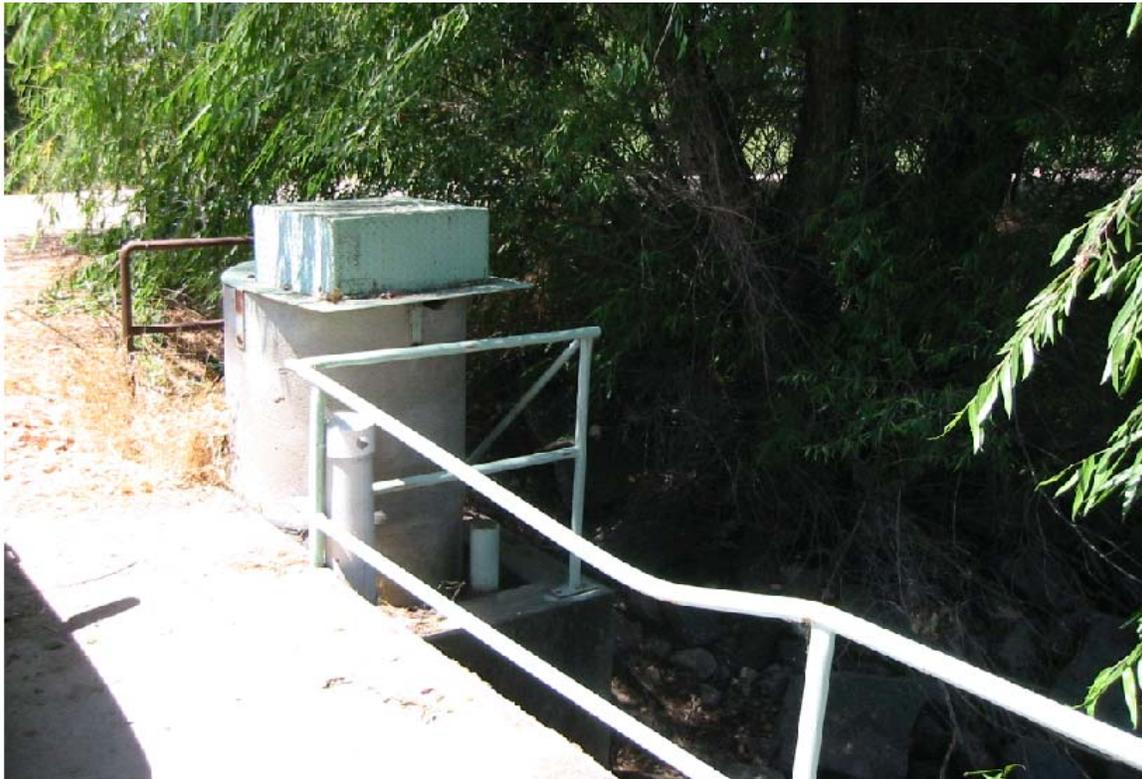
Site Description	25. MID Miller Lake Outfall Modesto irrigation district operational outflow. MID Main Drain canal empties into Miller Lake.
Power	110 volt power supplied to YSI and SCADA 12 volt power supplied by battery and solar panel to Design Analysis Smartgas system.
Datalogger	Design Analysis datalogger/YSI 6500 Process Monitor which send data to a Sierra Systems SCADA RTU
EC Sensor	YSI temperature compensated EC probe
Flow Measurement	Flow over a sharp crested weir using weir equation and stage to compute discharge
Depth	Design Analysis H350XL with H355 Smartgas system (primary) Stevens chart recorder (secondary)
Velocity	n/a
Telecommunications	Sierra Systems RTU SCADA Telemetry

Figure 21: Stevens chart recorder and YSI EC probe next to bridge over the weir structure at MID Miller Lake Outfall.

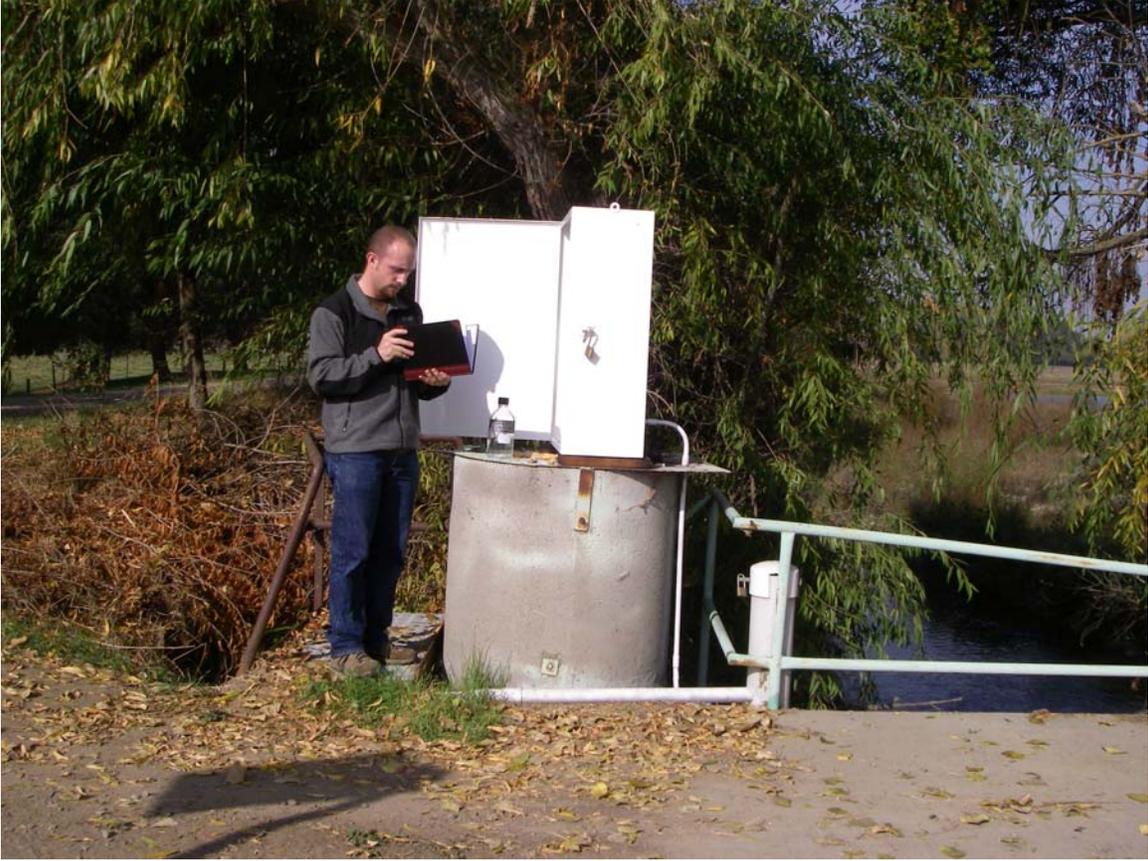
Figure 22: A Design Analysis Smartgas system was added to the Stevens chart recorder in late 2007, providing higher quality data.

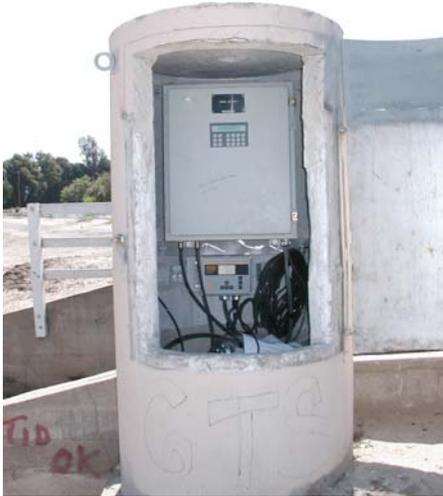
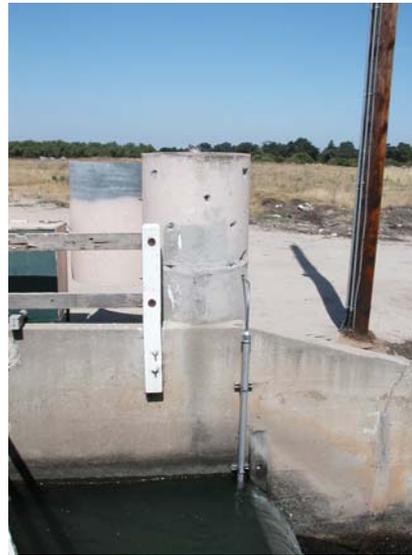
Site Description	26. TID Highline Canal Turlock Irrigation District operational spill/drainage site
Power	110 volt power
Datalogger	Sierra Controls RTU with SCADAPACK
EC Sensor	YSI 600XL temperature compensated EC probe
Flow Measurement	Flow over a long sharp crested weir using weir equation and stage to compute discharge
Depth	Sierra Controls float and shaft encoder
Velocity	n/a
Telecommunications	Sierra Controls SCADAPACK Telemetry

Figure 23: Sierra Controls SCADAPACK and weir structure at TID Highline Canal.

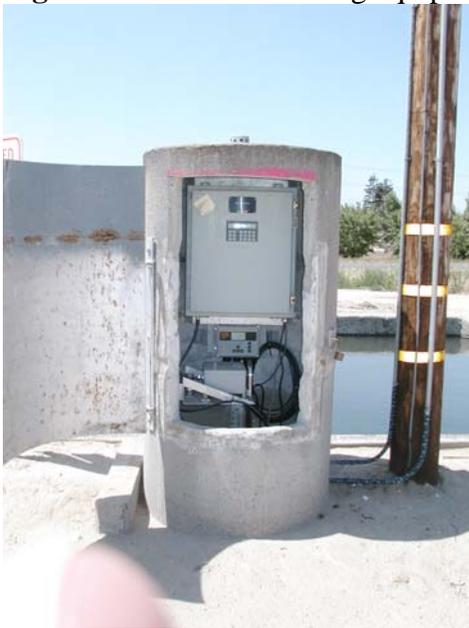
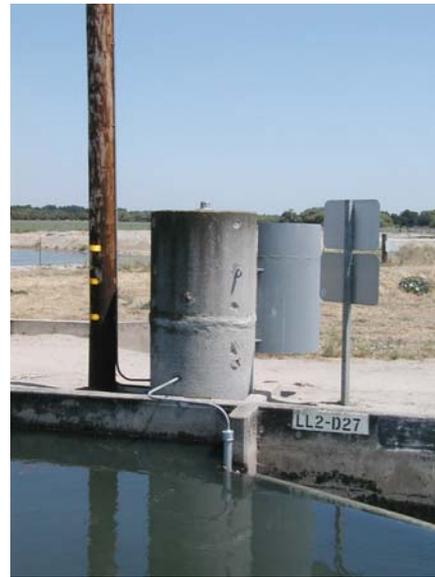
Site Description	27. TID Lateral 2 Turlock Irrigation District operational spill/drainage site
Power	110 volt power
Datalogger	Sierra Controls RTU with SCADAPACK
EC Sensor	YSI 600XL temperature compensated EC probe
Flow Measurement	Flow over a long sharp crested weir using weir equation and stage to compute discharge
Depth	Sierra Controls float and shaft encoder
Velocity	n/a
Telecommunications	Sierra Controls SCADAPACK Telemetry

Figure 24: Flow monitoring equipment and weir structure at TID Lateral 2.

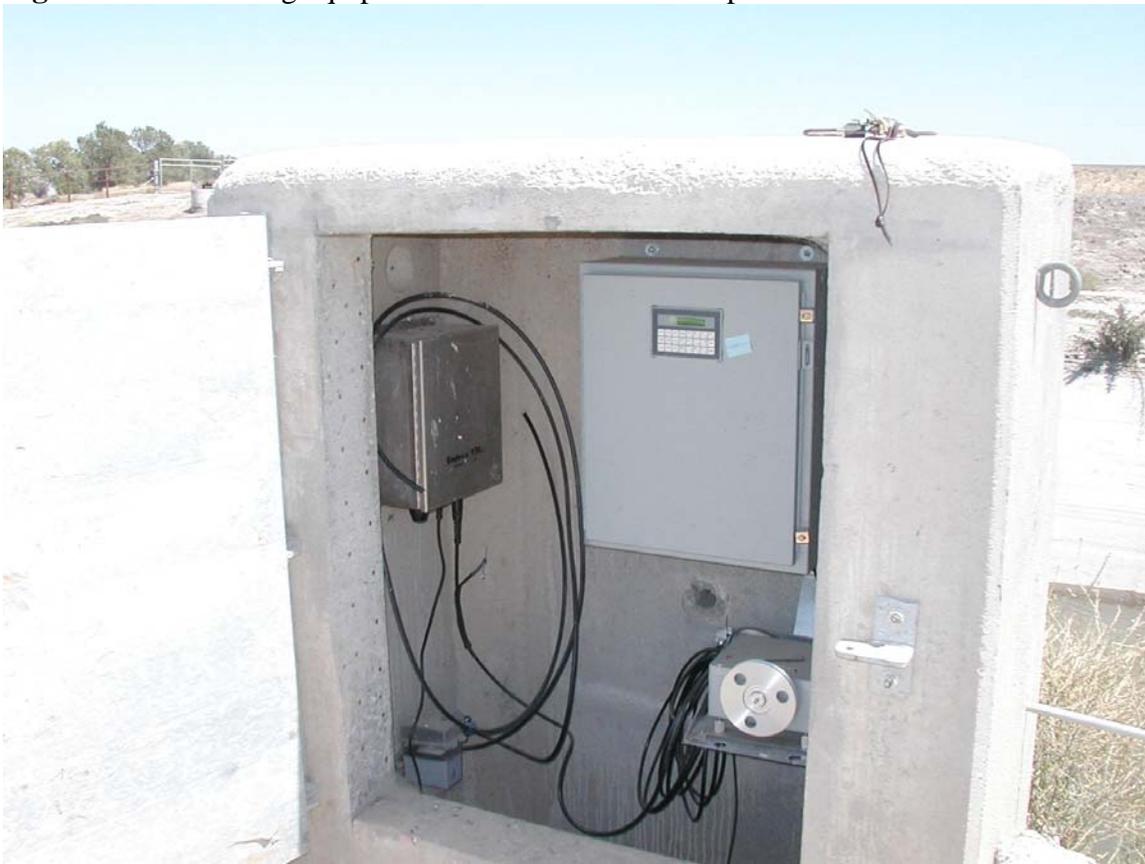
Site Description	28. TID Lateral 3 Westport Drain Turlock Irrigation District operational spill/drainage site
Power	110 volt power
Datalogger	Sierra Controls RTU with SCADAPACK
EC Sensor	YSI 600XL temperature compensated EC probe
Flow Measurement	Flow through a flume.
Depth	Sierra Controls float and shaft encoder (primary) YSI 600XL internal pressure sensor (secondary)
Velocity	n/a
Telecommunications	Sierra Controls SCADAPACK Telemetry

Figure 25: Monitoring equipment at TID Lateral 3 Westport Drain.

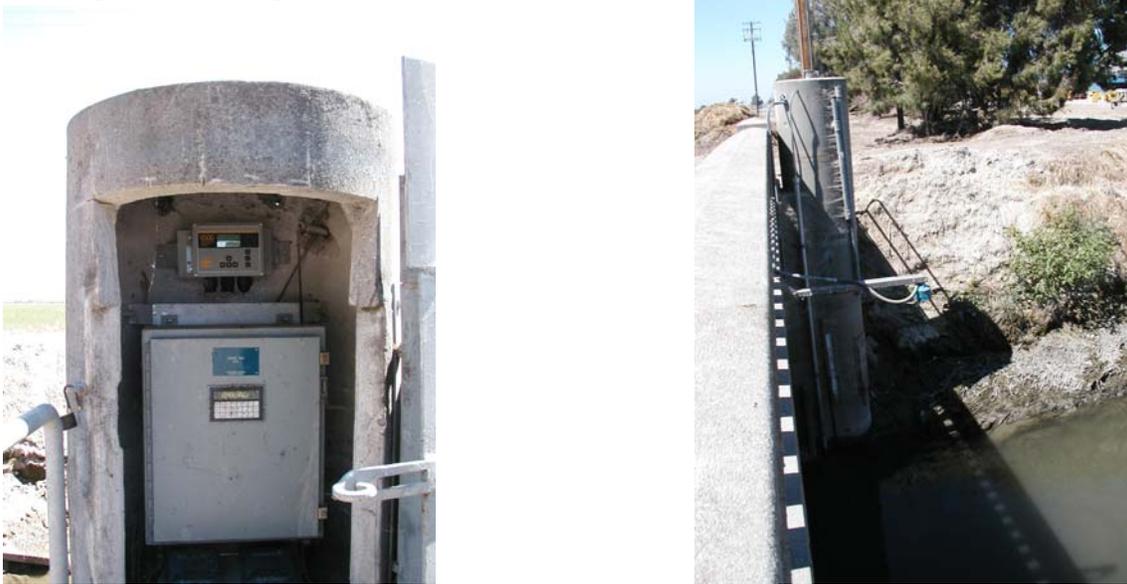
Site Description	29. TID Lateral 5 Harding Drain at Carpenter Rd. Turlock Irrigation District drainage site
Power	110 volt power
Datalogger	Sierra Controls RTU with SCADAPACK
EC Sensor	YSI 600XL temperature compensated EC probe
Flow Measurement	Flow over a long sharp crested weir using weir equation and stage to compute discharge
Depth	Sierra Controls float and shaft encoder
Velocity	n/a
Telecommunications	Sierra Controls SCADAPACK Telemetry

Figure 26: (right) Monitoring equipment and (left) weir structure at TID Lateral 5 Harding Drain at Carpenter Road.

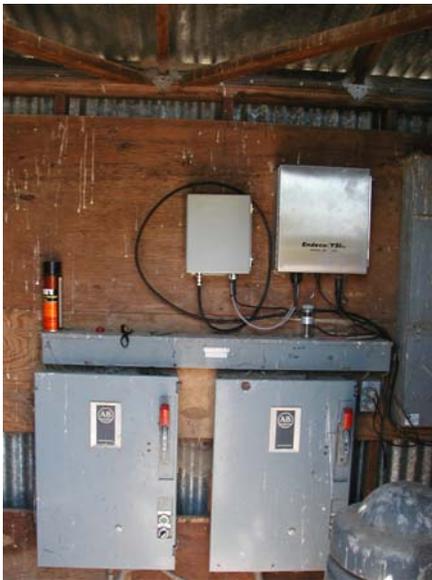
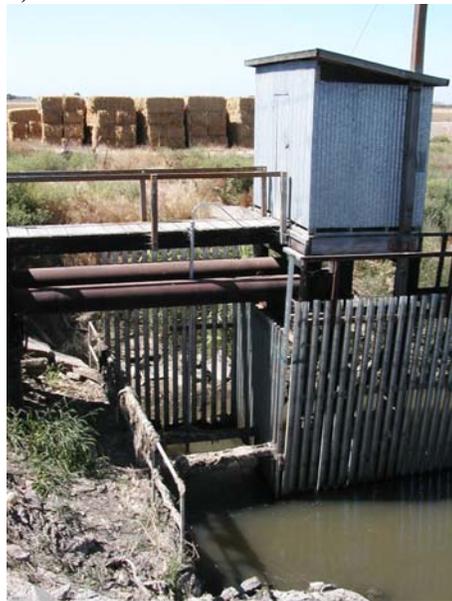
Site Description	30. TID Lateral 6 & 7 Turlock Irrigation District operational spill/drainage site
Power	110 volt power
Datalogger	Sierra Controls RTU with SCADAPACK
EC Sensor	YSI 600XL temperature compensated EC probe
Flow Measurement	No flow measurement at site. Combined flow of Lat 6 and Lat 7 are used to estimate flow
Depth	YSI 600XL internal pressure sensor
Velocity	n/a
Telecommunications	Sierra Controls SCADAPACK Telemetry

Figure 27: (left) Inside of monitoring shed and (right) culvert at TID Lateral 6 & 7.
