Appendix D: Causes of Degradation Technical Memorandum

Causes of Degradation

**San Bernardino County
Flood Control District**

**RBF Consulting
14725 Alton Parkway
Irvine, California 92618**

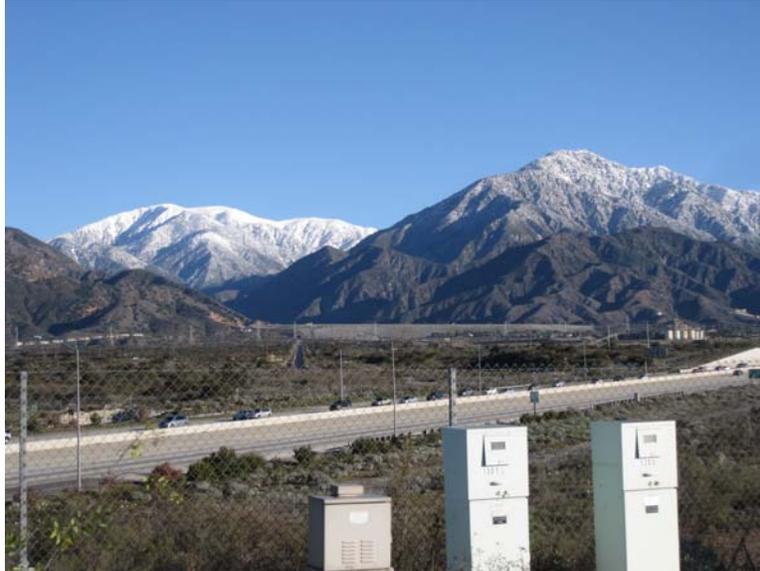
(San Antonio Dam can be seen at the base of the San Gabriel Mountains)

The channel varies between different conveyance types, from concrete-lined rectangular channels to natural channels with heavy vegetation. (See Figures 3 and 4). The natural stretches of the channel show signs of significant degradation, especially downstream of Central Avenue in the City of Chino (the most downstream section of the channel).

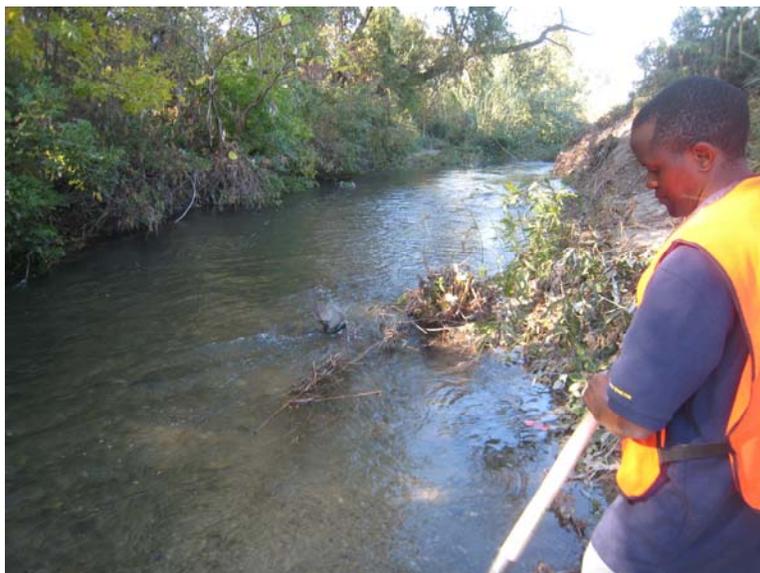
Figure 4: Natural Channel in Southern Portion of the San Antonio Watershed.

(Example of an incised reach of the channel just downstream of Central Avenue.)

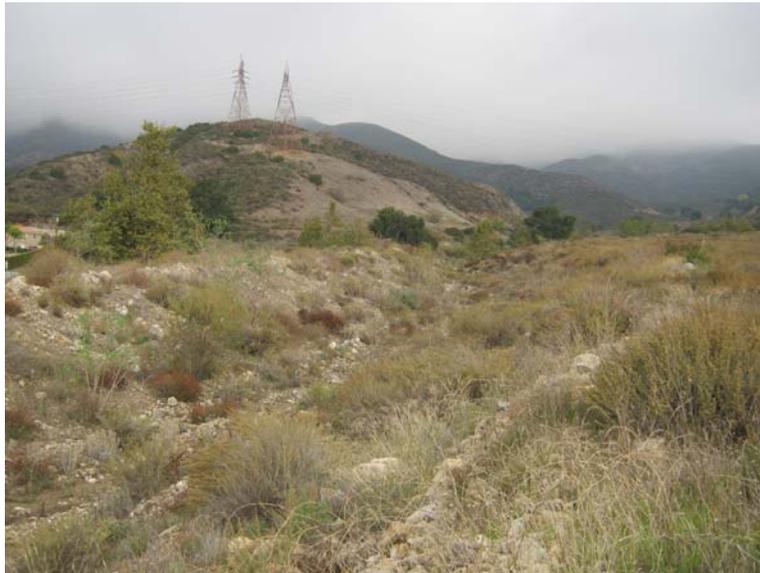
(Looking upstream along Demens Creek Channel at the San Bernardino National Forest.)

The Cucamonga Channel varies between different conveyance types, including concrete-lined trapezoidal channels to natural channels with heavy vegetation (see Figures 9 and 10). The majority of the watershed contains engineered channels, but the portion of the Cucamonga Channel between Prado Dam and Chino Corona Road in the City of Chino is a natural channel and has been significantly degraded.

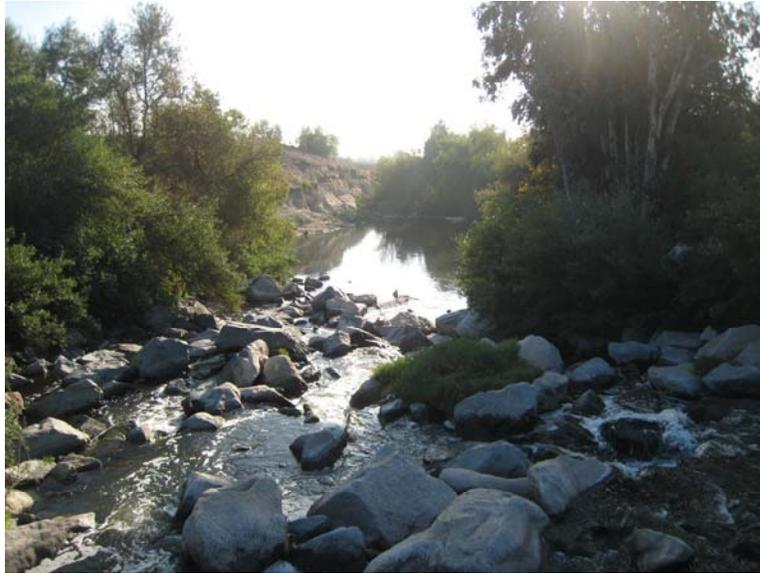
Figure 10: Natural Channel in Southern Portion of the Cucamonga Channel Watershed

(Looking downstream at the Cucamonga Channel from the Chino Corona Road crossing in Chino, CA.)

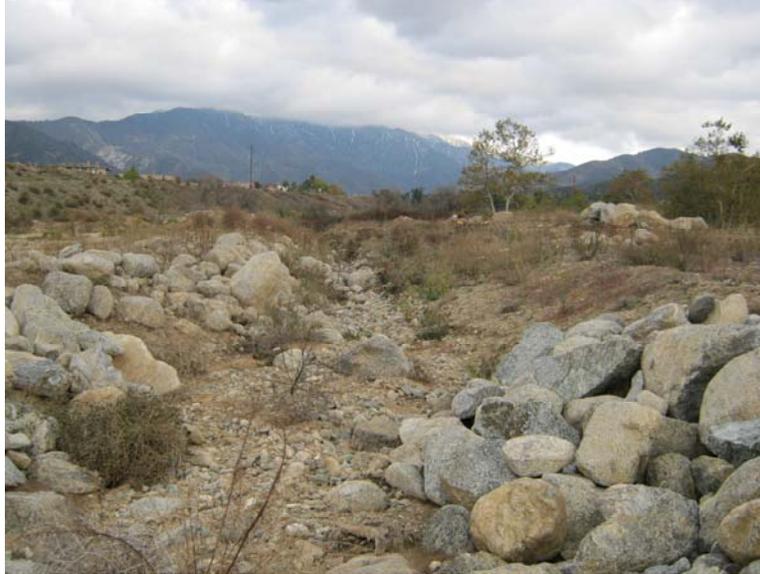
(Looking east along Wilson Creek at the upstream reaches of the Live Oak Watershed)

The channels are constructed of different conveyance types, from rip-rap lined trapezoidal channels to natural, earthen channels. (See Figures 15 and 16) A number of the channels have drop structures along the invert to prevent degradation.

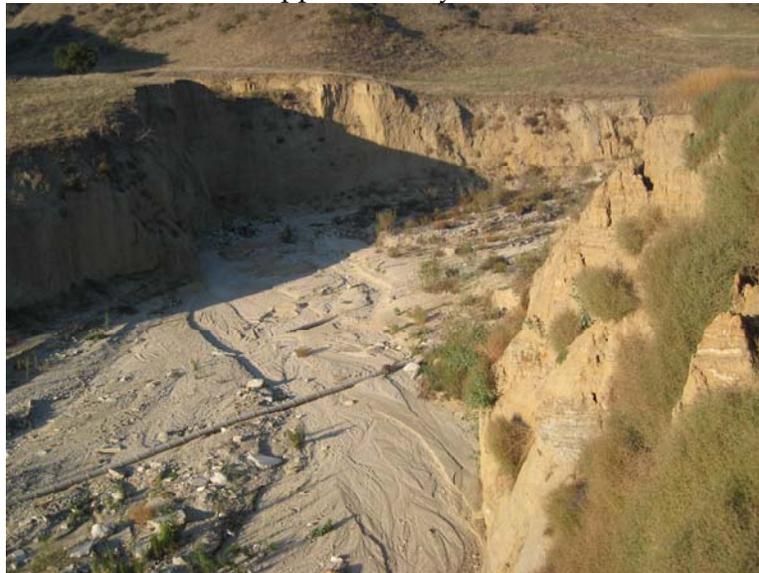
Figure 16: Live Oak Creek

(Looking upstream at Live Oak Creek, approximately 1.5 miles west of Interstate 10).

It is evident from the site visits that the soil is vulnerable to degradation, especially in the lower portions of the watershed where Live Oak Creek is located. Live Oak Creek is a natural channel that starts near Interstate-10 and flows west. It shows signs of significant erosion and degradation. In some areas, a +50 feet deep canyon has manifested. There is no reinforcement to protect the channel invert or banks. The channel will continue to erode in the future.

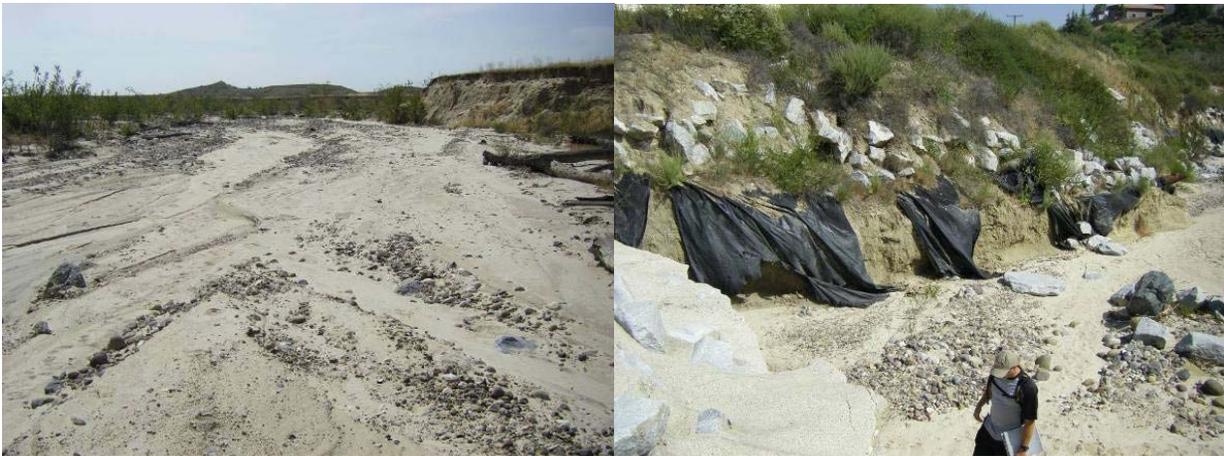
Figure 2. Alteration in channel morphology and stability, immediately upstream (left) and downstream (right) of a grade-control structure that blocks sediment passage. The two views are less than 10 m apart in the channel, with no intervening tributary.

With the base data assembled, characterization of both runoff and sediment yield (i.e., the top-most box of Figure 1) at the watershed scale is relatively straightforward processes. For runoff, we affirm the common approach of using the change in either developed land or imperviousness as the index of hydrologic change. However, the once-popular concept of a “critical threshold” of imperviousness, below which no channel changes occur, has been widely abandoned in the scientific literature and is not recognized here. Unfortunately, this also eliminates the seemingly promising framework that jurisdictions once used to discriminate whether or not a potential hydrologic change would likely be significant. Although understanding the magnitude of hydrologic change is still relevant to assessing hydromodification effects, a small value clearly does not provide any guarantees of non-impact, presumably because significant sediment delivery changes can still occur and produce dramatic channel changes. For example, Figure 2 illustrates changes in channel morphology and stability associated with an in-stream grade-control structure that blocks sediment passage. Although the change in sediment supply in this example is caused by a physical blockage rather than a change in land cover, the analogy to the relative importance of watershed-scale drivers is clear: channel instability can occur even with no change in hydrology at all.

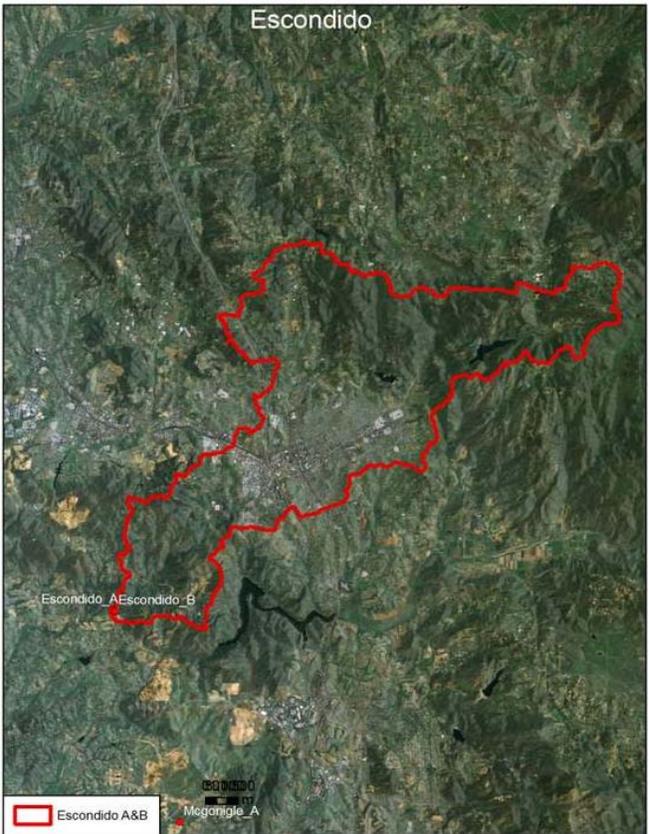
Figure 4. Processing the data layer.

To delineate a particular watershed, we use the National Watershed Boundary Dataset as our primary source (in California these are maintained and distributed by CalWater). CalWater offers a free vector dataset (shapefile) with basin and sub-basin delineations organized by the commonly used 8-digit HUCs from the USGS Hydrologic Unit Maps. After the watershed of interest has been extracted, we conduct a careful examination of its boundaries against a 10-m DEM hillshade. In cases where the boundaries seem inadequate, we turn to the DEM to improve the watershed delineation using ArcInfo Hydrology routines. After the area of analysis has been sufficiently well-defined, the analysis layers are 'clipped' to its boundaries and reprojected to a common coordinate system. An example, shown for the Escondido Creek watershed (San Diego County) on an orthophoto base, is given in Figure 4.

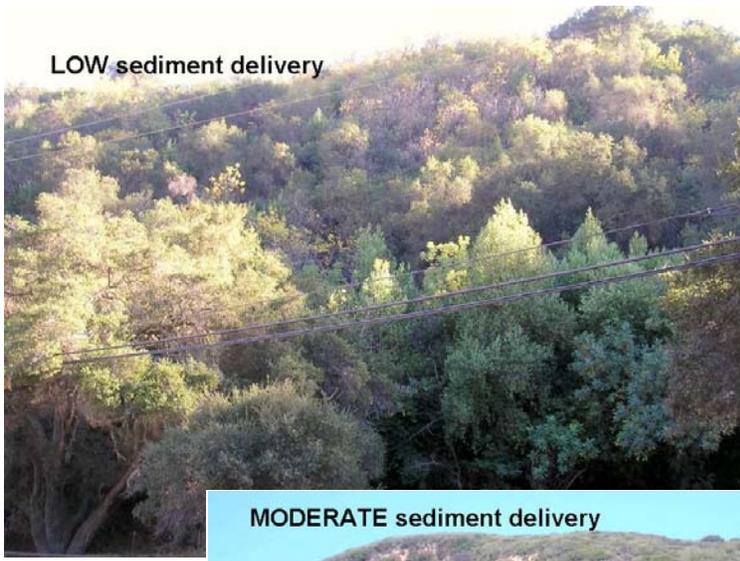
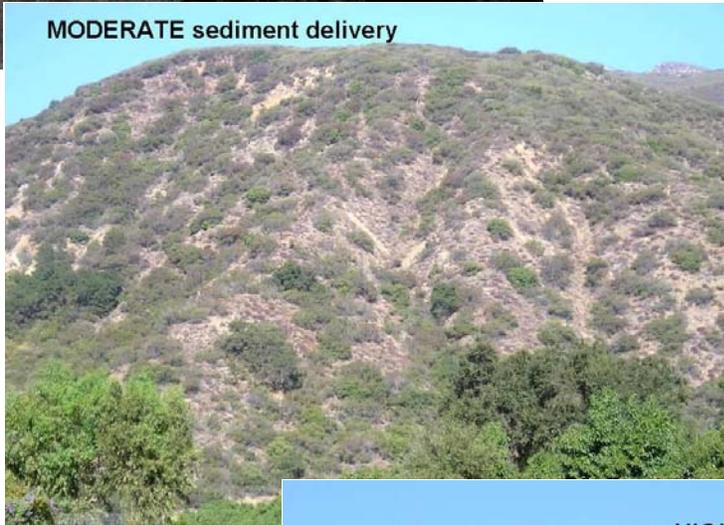
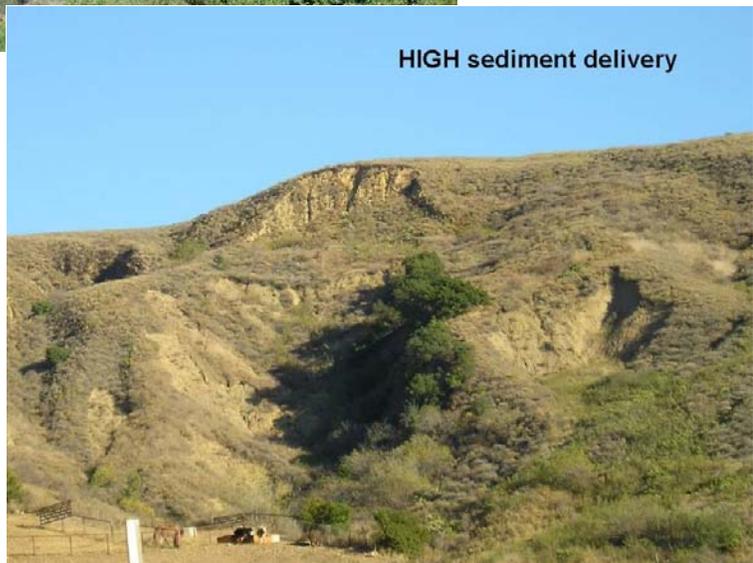
Figure 9. Examples of Low, Moderate, and High sediment production and delivery areas in the Santa Paula Creek watershed (Ventura County).

The final step is to assign each GLU type to a High, Medium or Low category based on its relative sediment production rate as observed in the field or inferred from literature information. Examples of areas from each category are provided on the next page (Figure 9). Currently, these assignments are based on field observations; although it might be anticipated that various combinations of the three factors will yield a particular outcome based on prior experience, we presently lack sufficiently widespread application to provide such a list *a priori* or to recommend its application in a new locality. Even with long-standing application, some level of field verification will always be appropriate.
