From: Chiu, Wayne@Waterboards
Sent: Monday, November 17, 2014 1:25 PM
To: Gustavo Maldonado
Cc: Larry Holley
Subject: WDID 937C369598 (Hilton Garden Inn): 14 November 2014 Inspection
Attachments: 2014-1114 Inspection Photos Hilton Garden Inn.pdf

From: Chiu, Wayne@Waterboards
Sent: Monday, November 17, 2014 12:57 PM
To: Gustavo Maldonado
Cc: Larry Holley; Arias, Christina@Waterboards; Becker, Eric@Waterboards
Subject: WDID 937C369598 (Hilton Garden Inn): 14 November 2014 Inspection

Attached are some photos taken during the inspection that show examples of areas that need to be addressed to demonstrate compliance with the CGP requirements for a Risk Level 1 site. Please send me the following information and documentation by **November 20, 2014**:

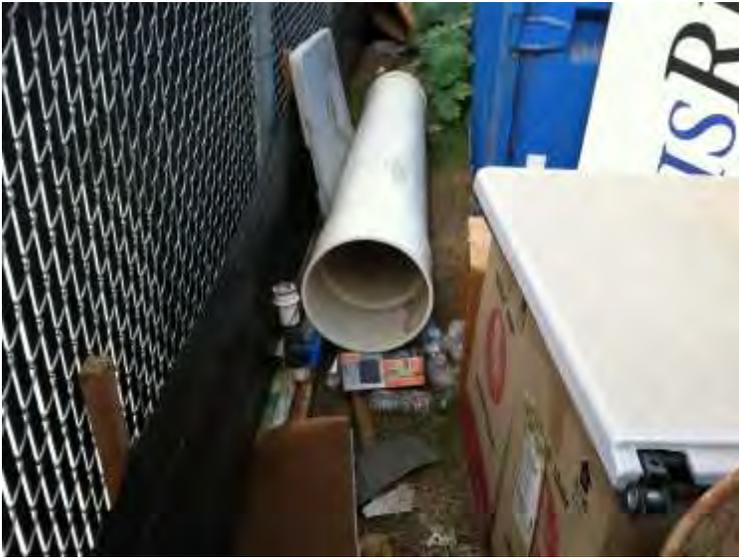
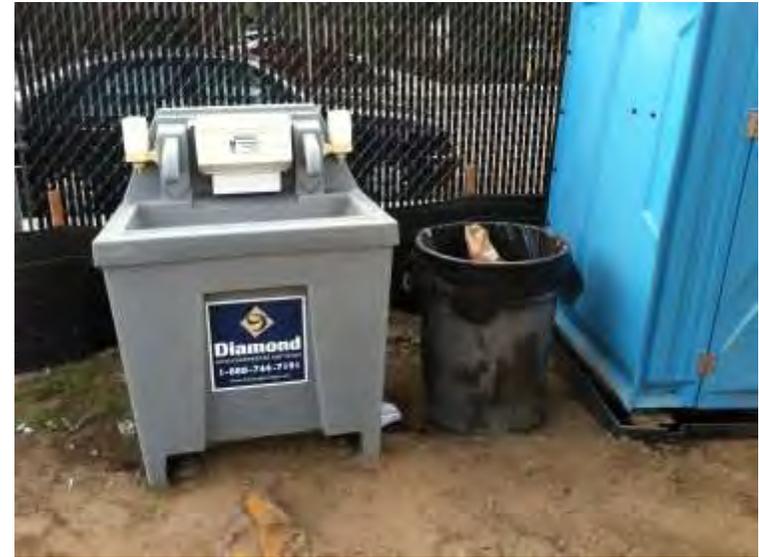
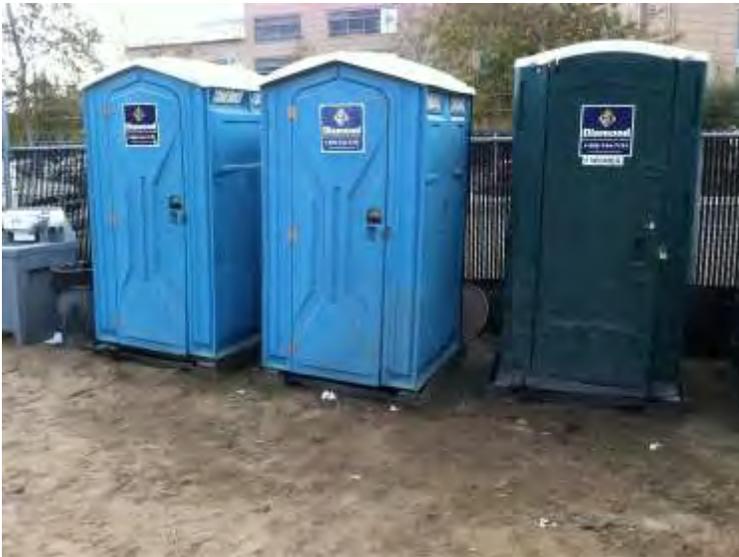
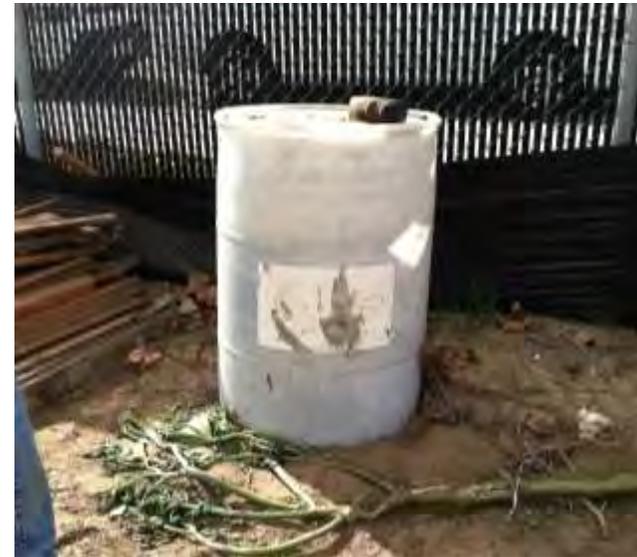
3. Good housekeeping BMPs are necessary for controlling pollutant sources and preventing pollutants from being exposed and potentially transported and discharged from the site during storm events. Photos 1 through 4 show examples of areas of the site where trash needs to be properly disposed and contained, trash containers need to have

covers available, sanitation facilities need to be properly maintained and inspected to prevent spills and leaks, and a waste oil container needs to be properly contained/protected and/or disposed. Please provide photos that demonstrate good housekeeping BMPs have been implemented to address the deficiencies identified.

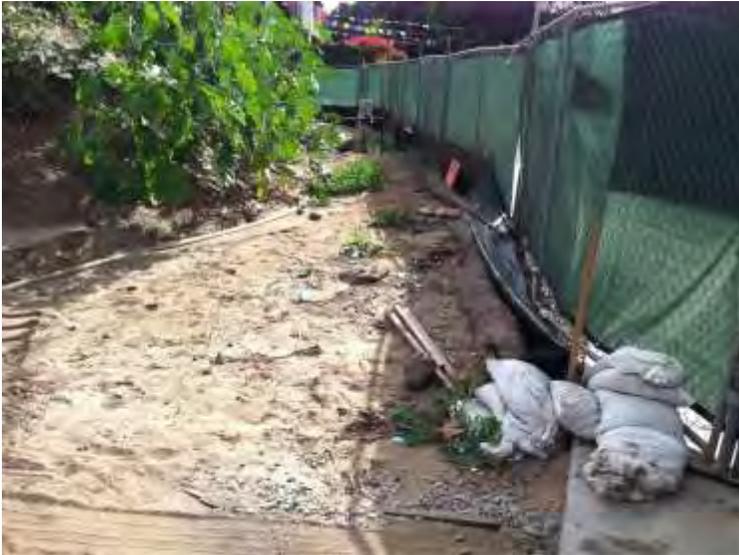
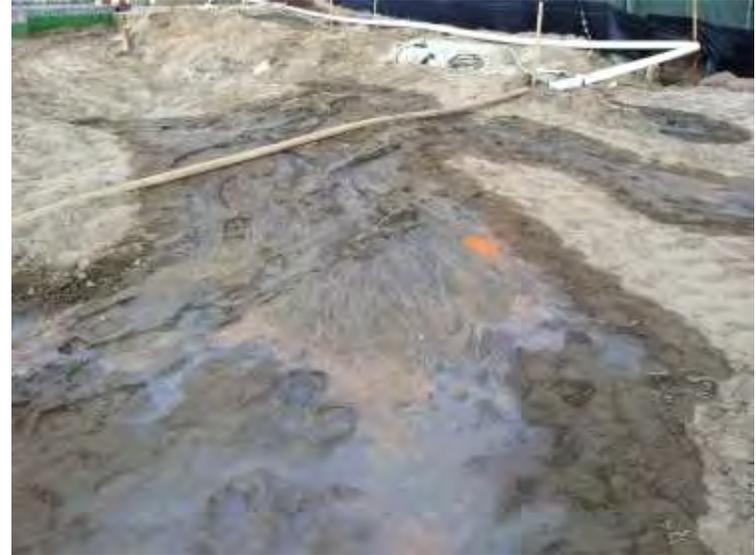
4. Non-storm water needs to be properly managed to prevent any non-storm water discharges and the transport of sediment and other pollutants of the site. Photos 5 and 6 show examples of locations we observed during the inspection where non-storm water discharges can be better managed to prevent non-storm water discharges from the site. Please provide photos or other documentation that demonstrate proper non-storm water management is being implemented to address the deficiencies identified.

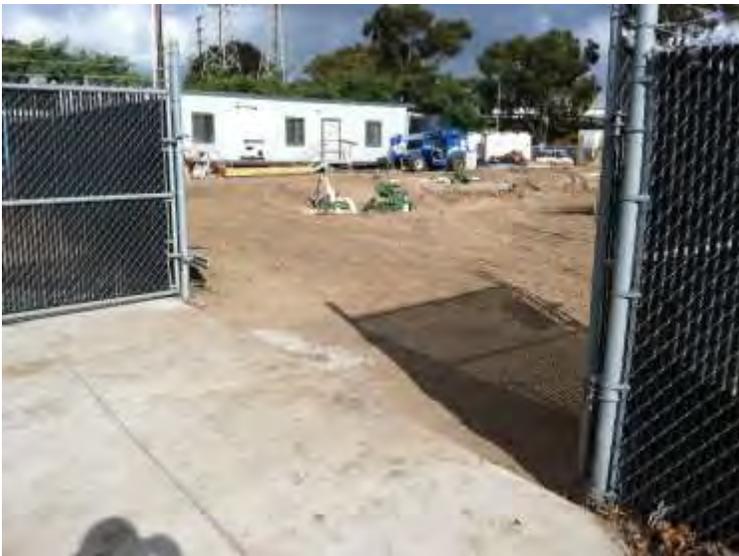
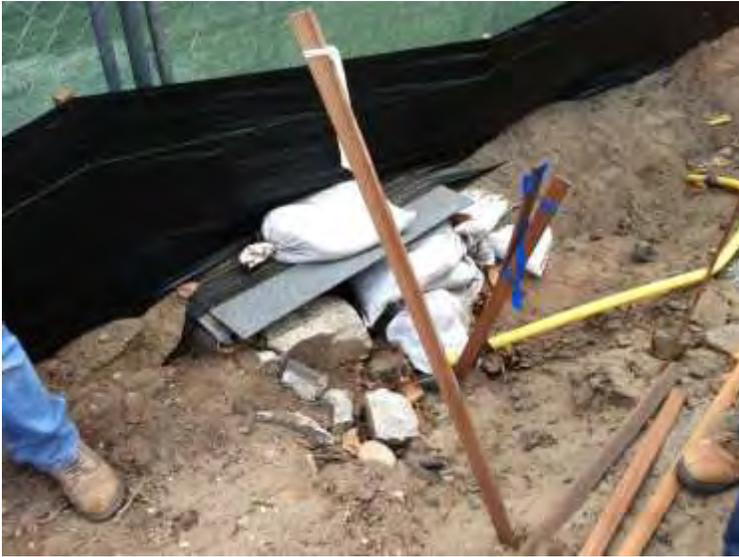
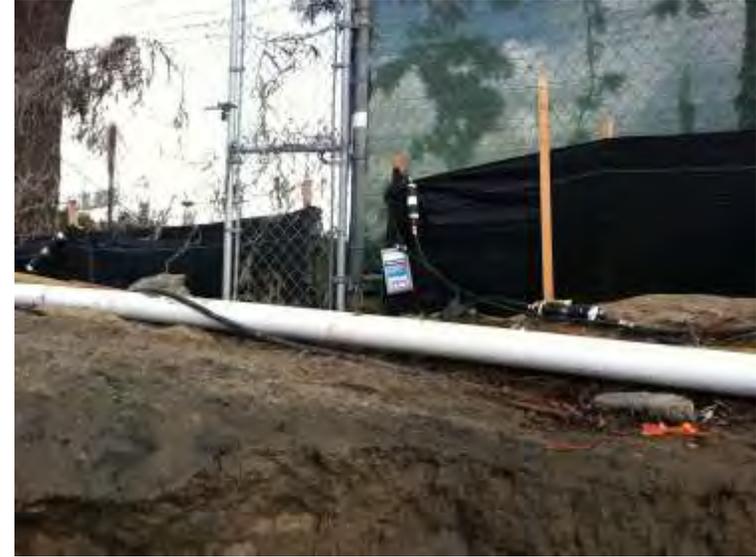
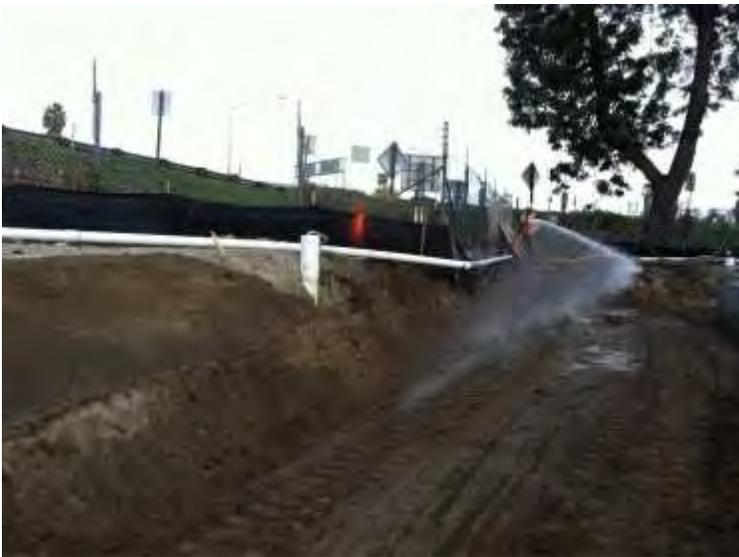
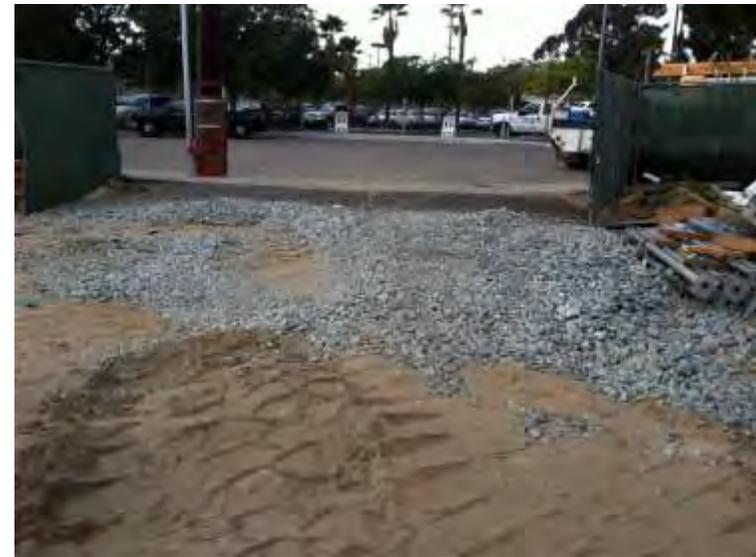
6. Sediment control BMPs are required to be implemented to reduce the potential for sediment to be transported within and potentially off site. Photos 7, and 9 through 12 show areas of the site where perimeter sediment controls have not been adequately implemented, installed, and/or maintained. Please provide photos or other documentation that demonstrate sediment control BMPs are being adequately implemented to address the deficiencies identified.

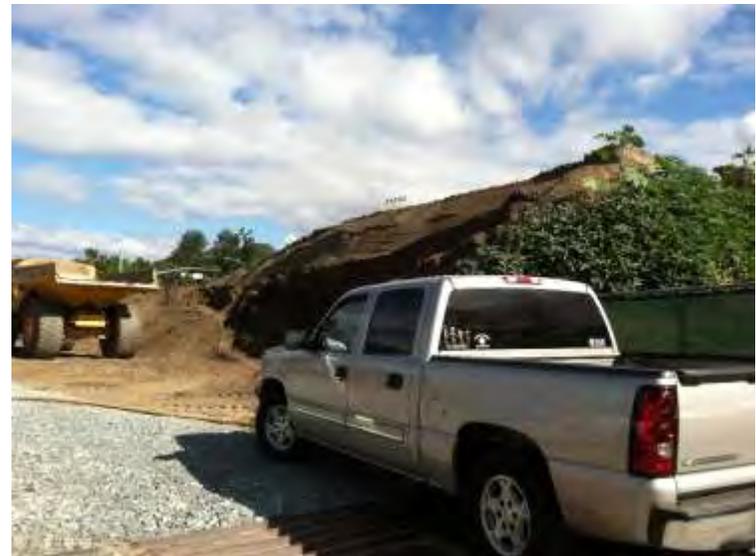
Photo 8

5. Erosion control BMPs that provide effective soil cover are required to be implemented to prevent the mobilization of sediment before it can be transported to other parts of the site and potentially off site. Erosion control BMPs must protect inactive disturbed soil areas from wind and surface runoff erosion. Photos 7 and 8 show areas of the site that should have had erosion control BMPs applied. Photo 6 also shows evidence of the lack of erosion controls already resulting in erosion and sediment transport. Please provide photos or other documentation that demonstrate erosion control BMPs are being implemented or available to be implemented to address the deficiencies identified.
