NOTICE OF VIOLATION
NO. R9-2008-0038

Subject Site: Del Mar North-Del Mar Housing at United States Marine Corps Base-
Camp Pendleton

RE: NOTICE OF VIOLATION NO. R9-2008-0038 &
REQUIRED TECHNICAL REPORT

FACILITY INSPECTION REPORT

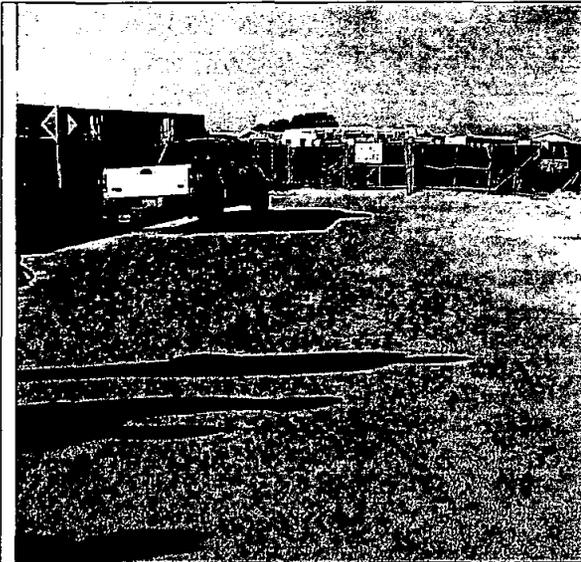
The immediate surrounding area of the construction site (slope along Oceanside Marine Centre) generally appeared free of sediment from the recent rains except for the site entrance at Nautilus Street (see photos 04, 05 and 06).

Photo 04: Looking north along Nautilus Street at site entrance. Observed sediment on asphalt from vehicle tracking and discharge from sediment basin. Site entrance lacks stabilized Entrance/Exit for tracking control. Construction materials are delivered at this entrance.

Observation: The site lacked adequate entrance/exit BMPs to eliminate sediment tracking unto the roadway.

The site lacked adequate entrance/exit BMPs to eliminate sediment tracking by vehicles.

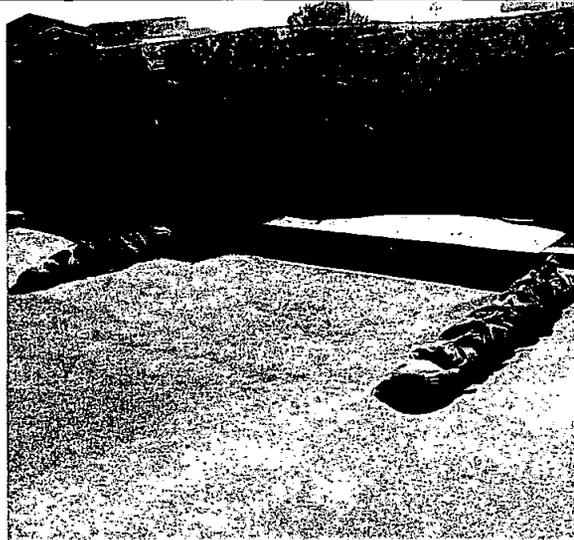
Site Area: Nautilus Street divides the Del Mar Housing construction project (Phase 1) from north to south. At the site entrance on Nautilus Street, I observed deposits of sediment residue at the storm drain inlets. The swept or brushed marks of sediment at the site entrance indicated there was some type of cleanup of sediment deposit. Fresh gravelbags were neatly placed along the curb leading to two storm drain inlets to abate storm water flows from the site. Silt fences were installed along the fenced perimeter to trap sediment discharge from the site. The installed BMPs (i.e. gravel bags and silt fences) at the site entrance appeared appropriate and well maintained to contain storm water discharges.

Photo 05: Storm drain inlet at site entrance along Nautilus Street. Chevrons were placed along curb to trap sediment. This inlet drains to Oceanside Harbor via 'south' outfall.

Observation: The storm drain inlets along Nautilus Street were not adequately stabilized to be protected against illicit discharge.

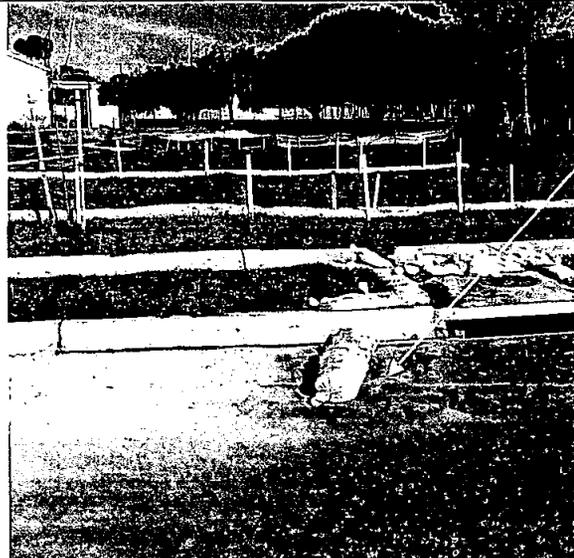
Photo 06: The other storm drain inlet at site entrance shows slight sediment buildup. This inlet discharges to the 'south' outfall into Oceanside Harbor.

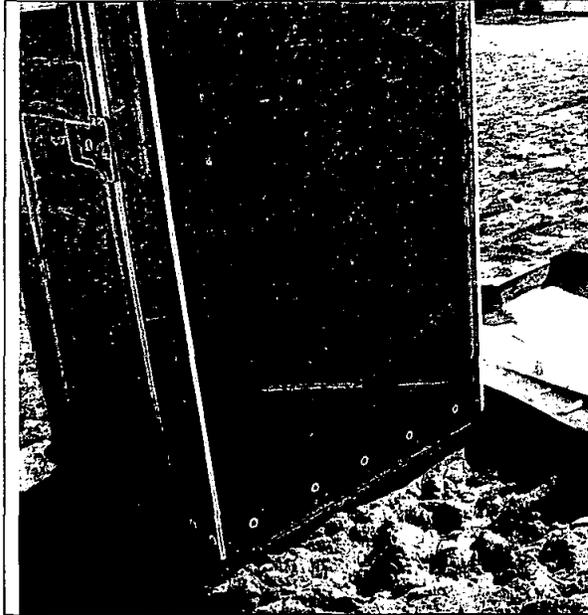
A porta john was improperly placed on the earthen surface without proper containment (see photo 10). Operator was advised of proper containment of waste storage and handling and proposed to correct the matter immediately.

Photo 10: Porta john improperly placed on earthen surface without containment.

Observation: The porta john located at the site entrance lacked secondary containment.

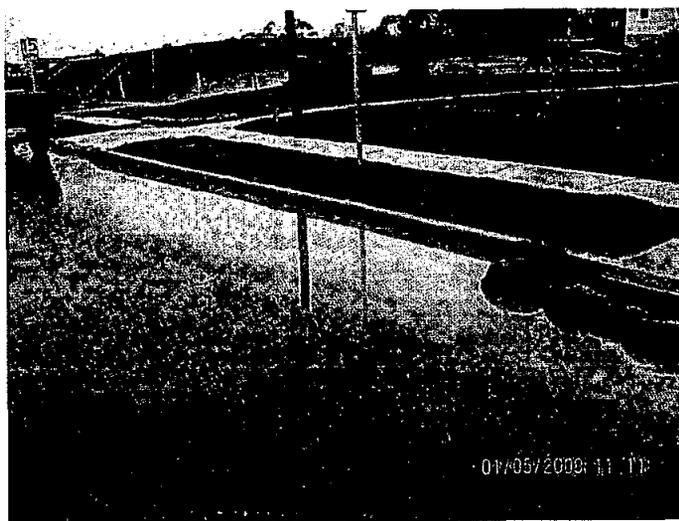
Storm drain inlet on Nautilus Street

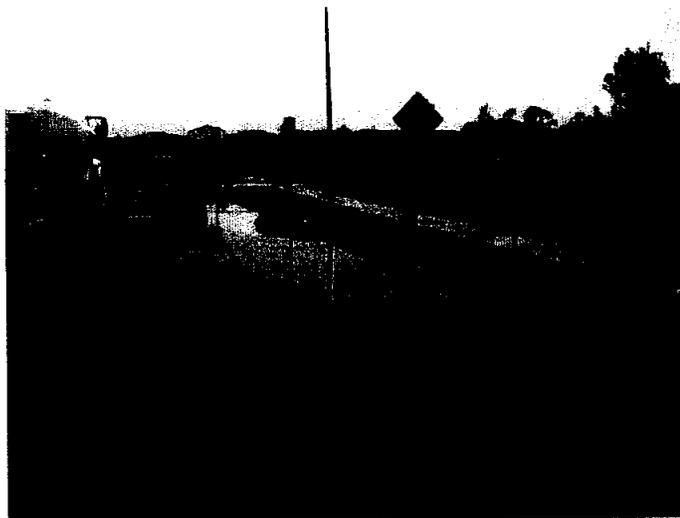
Storm drain inlet on Nautilus Street.

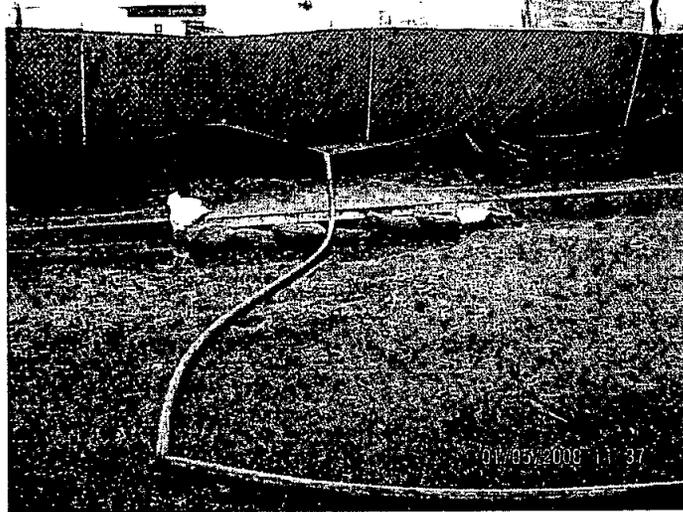
Storm drain inlet on Nautilus Street

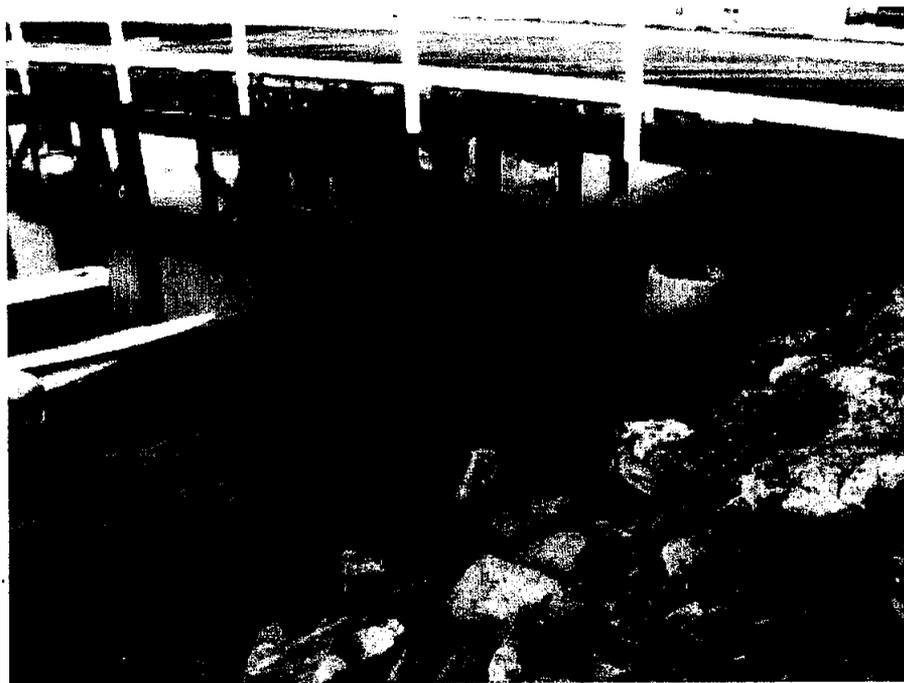
Sediment discharge at 'south' outfall into
Oceanside Harbor on 1/29/2008

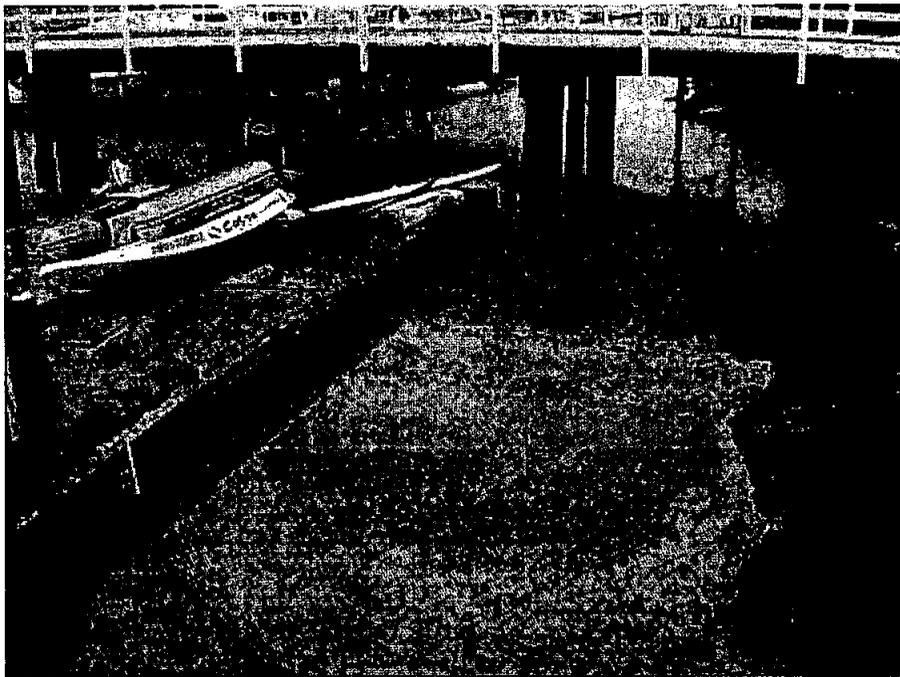
Sediment discharge at 'south' outfall into
Oceanside Harbor on 1/07/2008
