California Regional Water Quality Control Board, San Diego Region

Subject: Notice of Violation No. R9-2015-0031, City of San Diego Construction Management Program, Order Nos. R9-2013-0001 and R9-2007-0001, Municipal Storm Water Permits

NOTICE OF VIOLATION
No. R9-2015-0031

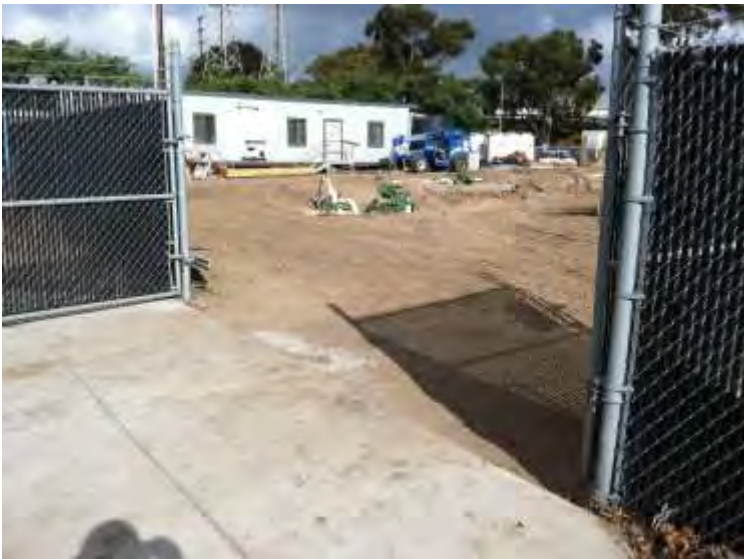
Photo 7

6. Sediment control BMPs are required to be implemented to reduce the potential for sediment to be transported within and potentially off site. Photos 7, and 9 through 12 show areas of the site where perimeter sediment controls have not been adequately implemented, installed, and/or maintained. Please provide photos or other

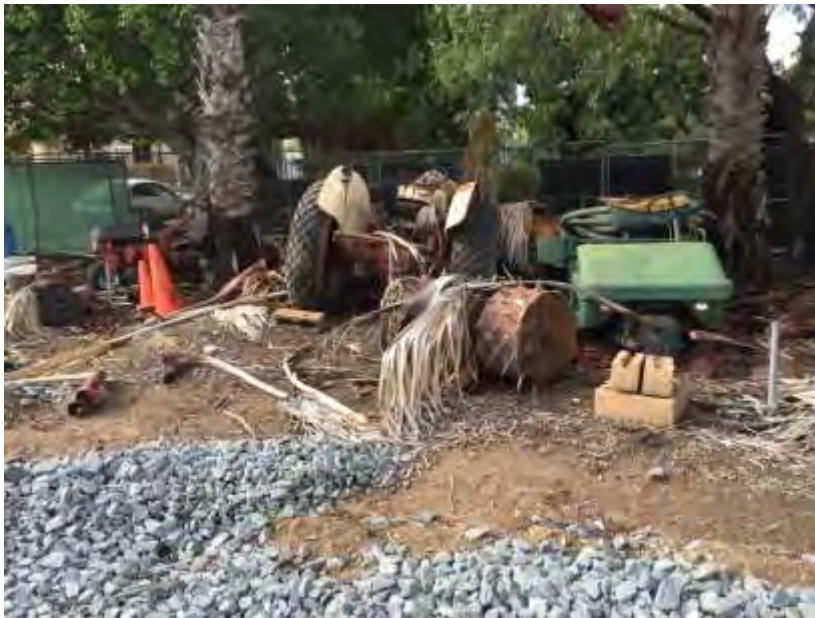
Photo 2 shows equipment and vehicles stored on site lacking appropriate BMPs to prevent oil, grease, or fuel to leak in to the ground, storm drains, or surface waters.

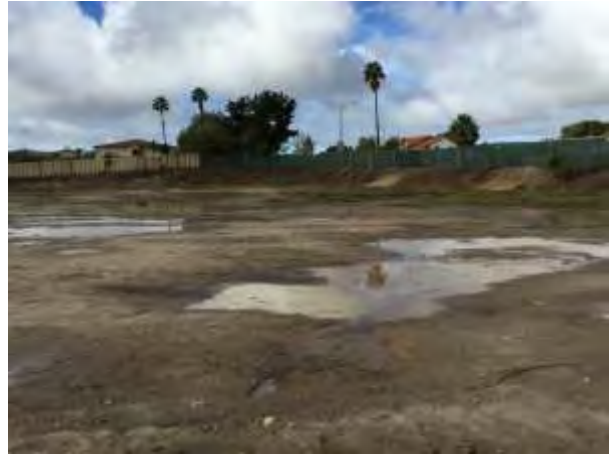
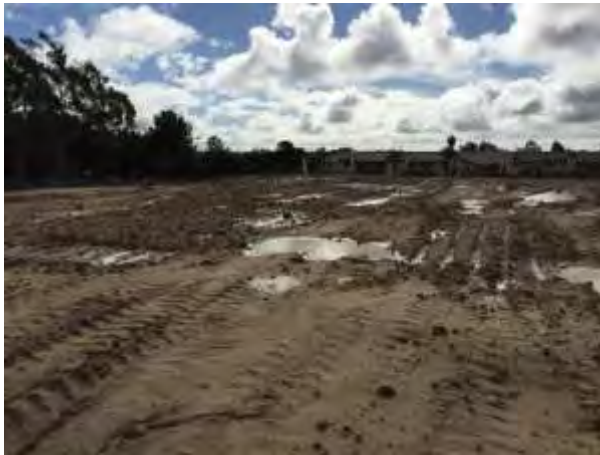
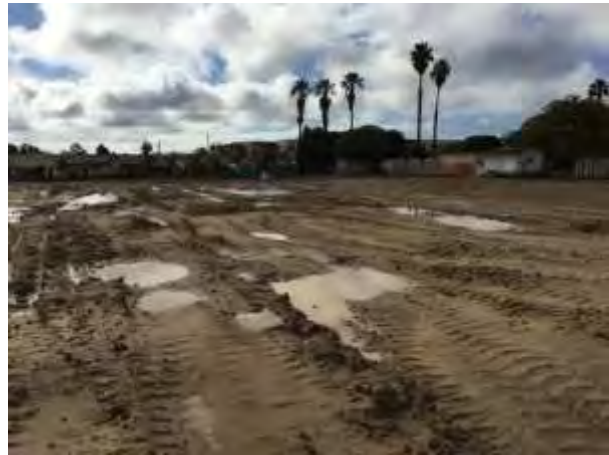
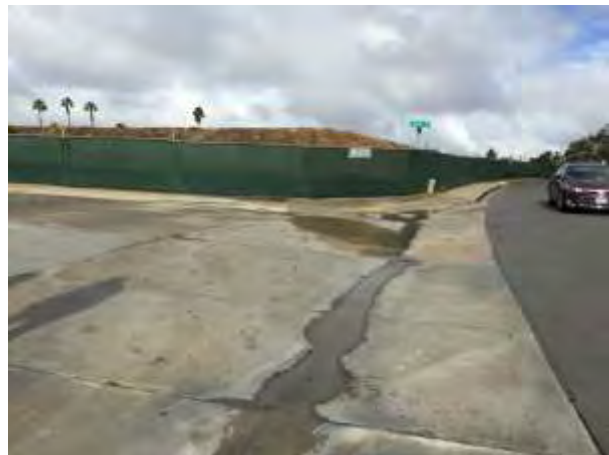
Photos 3 through 7 show lack of erosion controls for areas that are considered inactive, which is the entire site. Photo 3 shows the site looking toward the northeast corner. Photo 4 shows the site looking toward the northwest corner. Photo 5 shows the site looking toward the southeast corner. Photo 6 shows the site looking toward the southwest corner. Photo 7 is looking northwest toward the southeast corner of the site showing the slopes that lack any erosion controls.

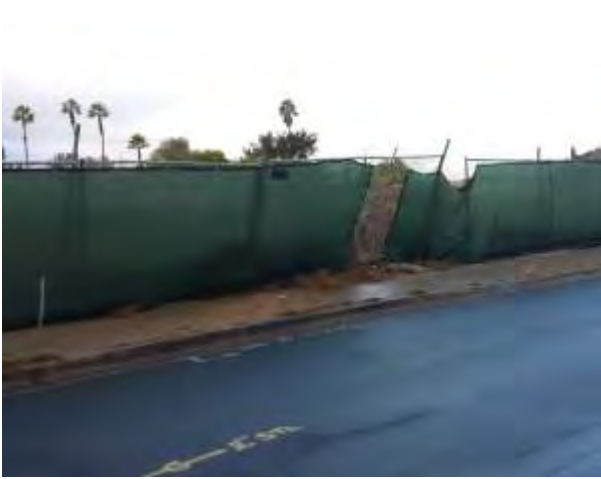
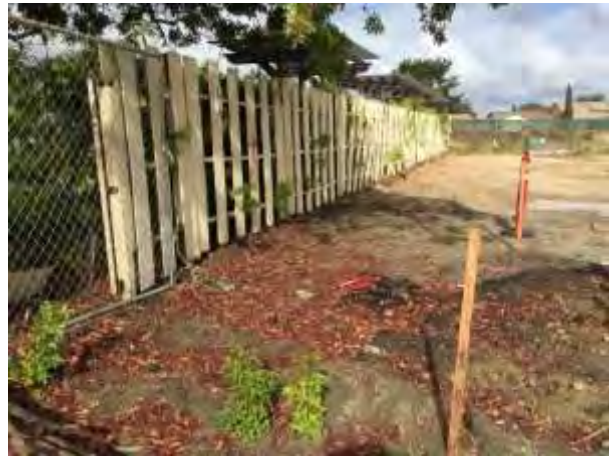
Photos 8 and 9 show two locations along the boundary of the site where there is an obvious lack of perimeter sediment and run-on/runoff controls. Photo 8 also shows evidence of sediment discharged from the site due to lack of erosion and perimeter sediment controls.

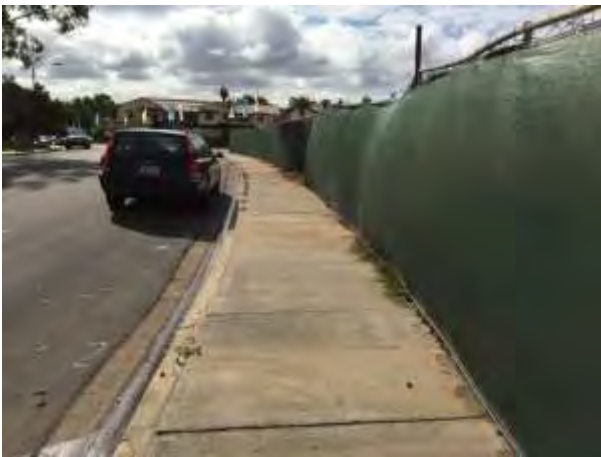
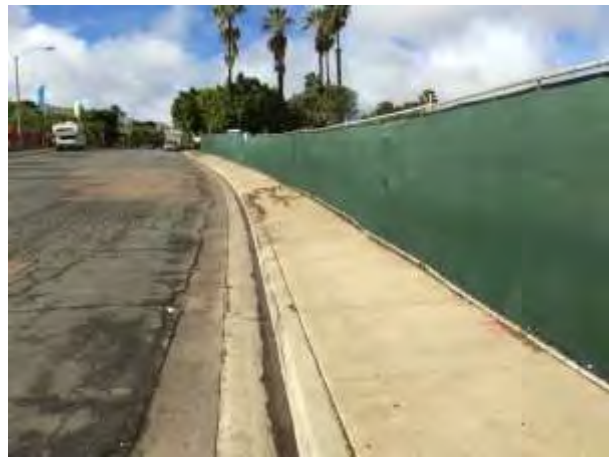
Photos 10 and 11 show evidence of sediment discharges from the site due to lack of erosion and perimeter sediment controls. Photo 10 is looking south along the eastern boundary of the site. Photo 11 is looking west along the southern boundary of the site.

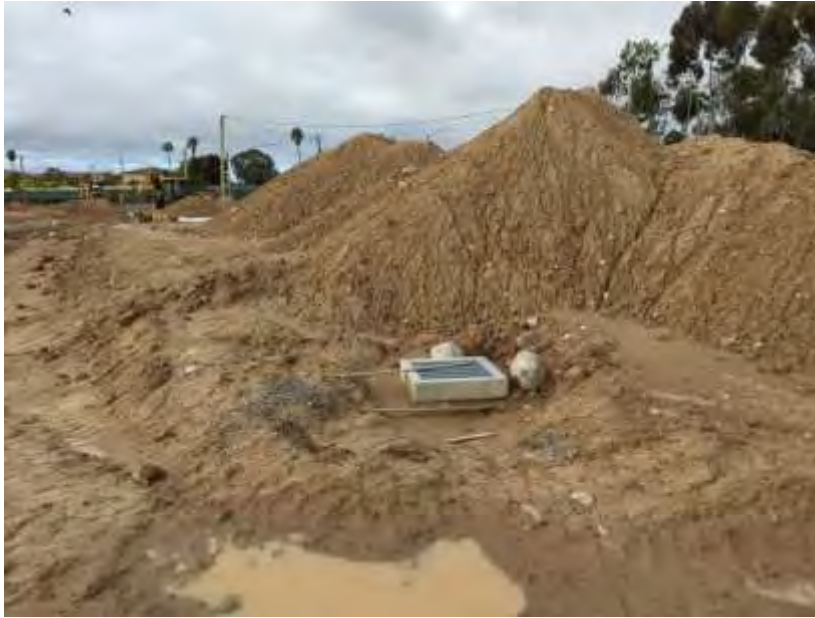
Photo 1 shows soil stockpile without adequate cover or containment next to a storm drain inlet. Evidence of erosion and sediment transport along that base of the stockpile.

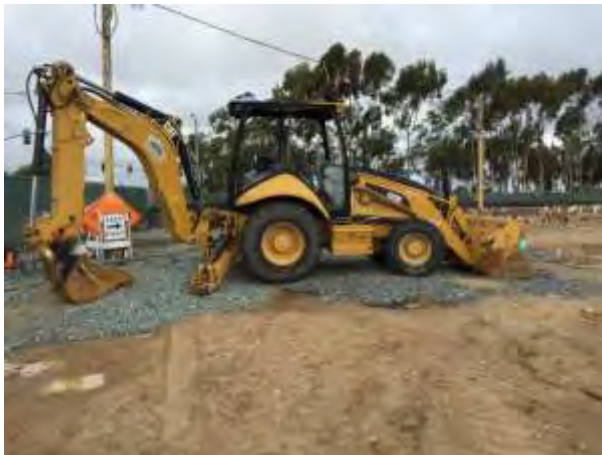
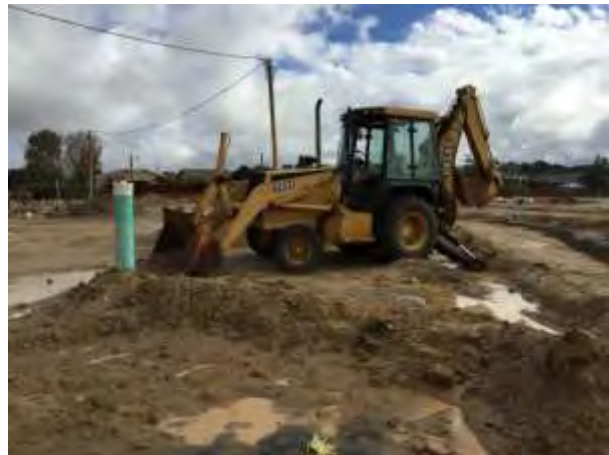
Photos 2 and 3 show construction equipment and vehicles without appropriate BMPs (e.g. drip pans) to prevent oil, grease, or fuel to leak in to the ground, storm drains, or surface waters.

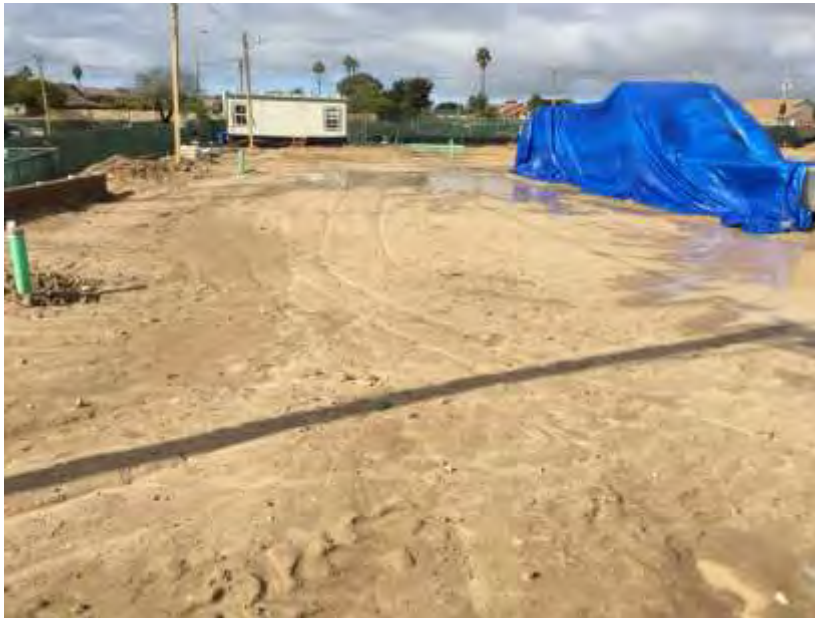
Photo 4 shows completed building pads without any erosion controls or runoff controls and evidence of erosion and sediment transport. .

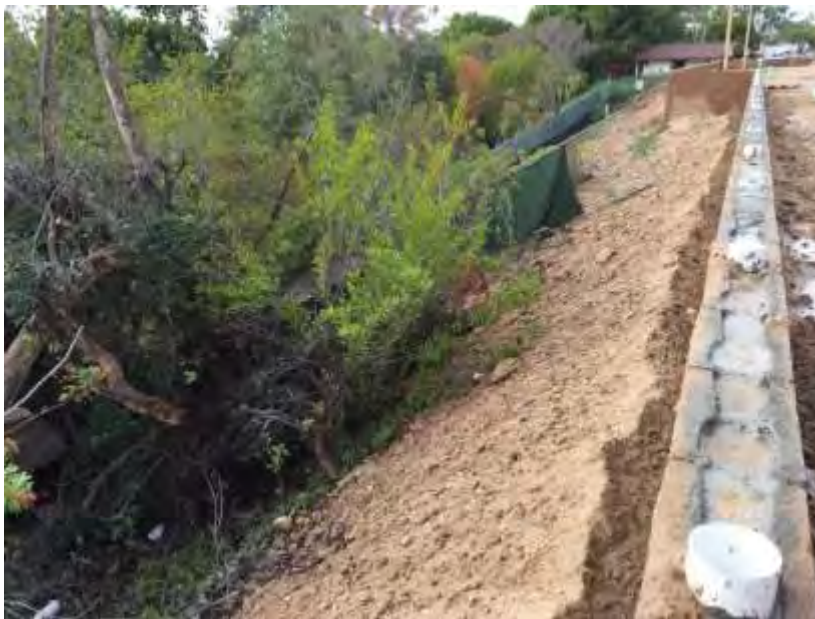
Photo 5 shows slope adjacent to completed building pad without any erosion controls.

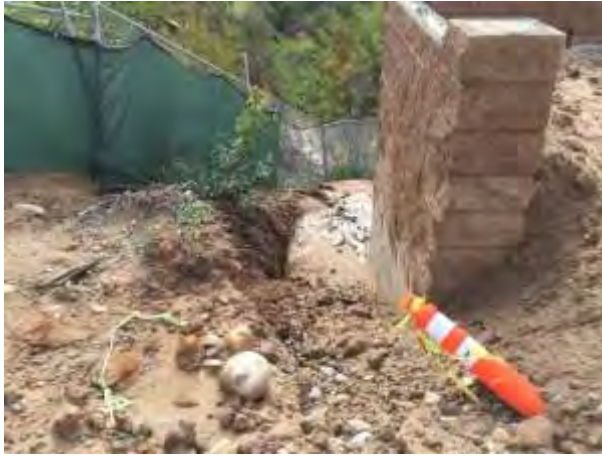
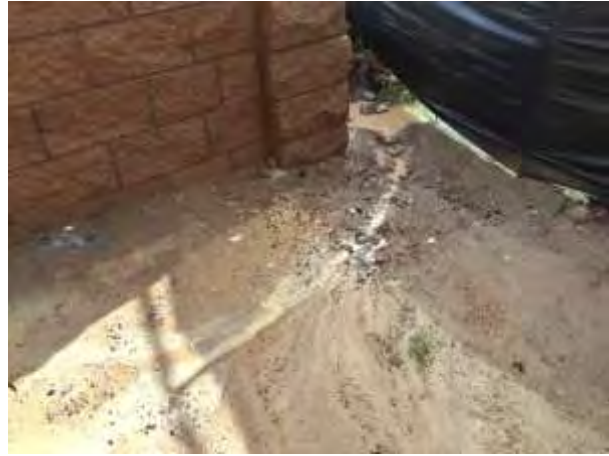
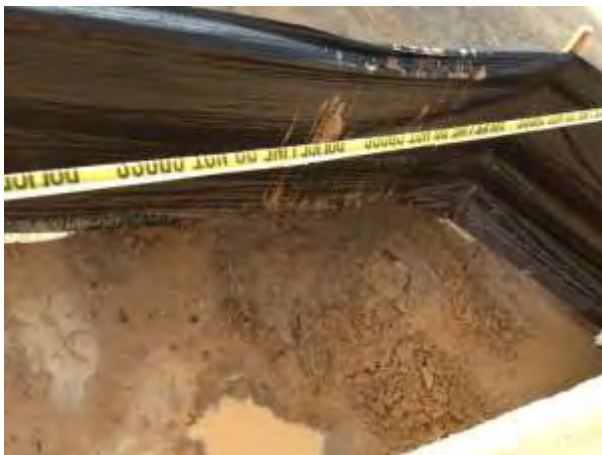
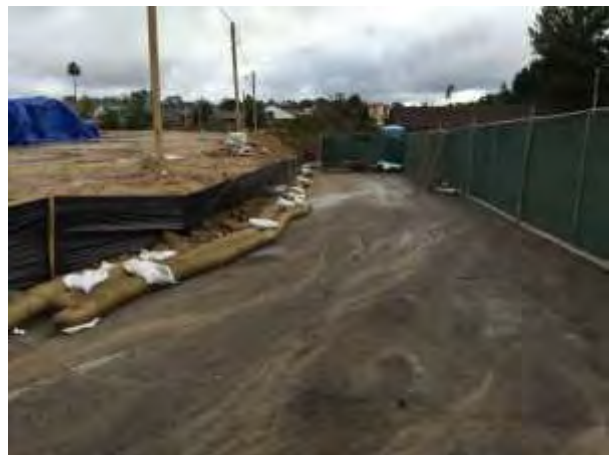
Photos 6 through 9 show inadequate implementation of perimeter sediment controls to prevent discharges of sediment from the site. Photo 6 shows evidence of erosion and sediment transport from completed building pads that contributed to an offsite discharge of sediment, with accumulation of sediment in a v-ditch outside of the site boundaries due to lack of perimeter controls at the base of the slope. Photos 7 and 8 shows evidence of erosion and sediment transport from the site that contributed to an offsite discharge of sediment and sediment-laden storm water due to inadequately installed perimeter controls. Photo 9 shows evidence of sediment transport through the site with lack of runoff controls and perimeter controls along the chain-link fence to prevent sediment discharges from the site.

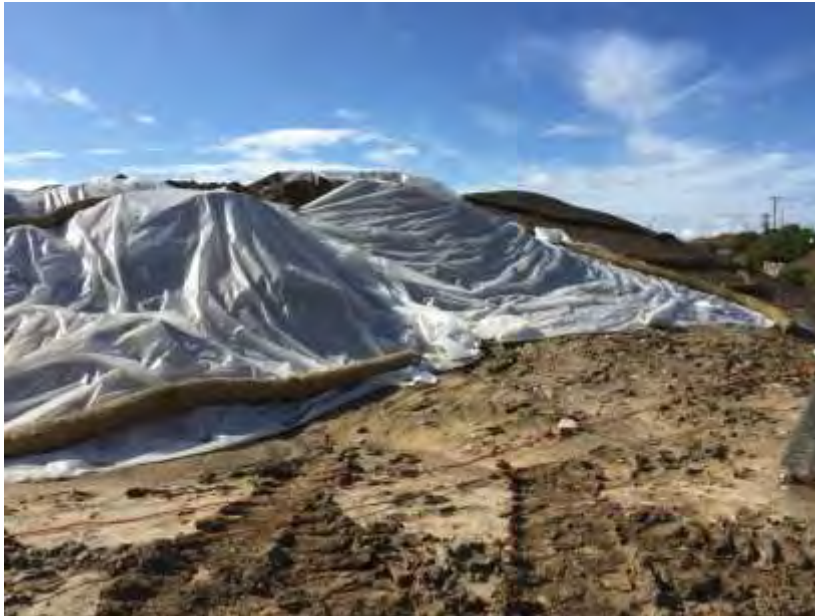
Photo 1 show soil stockpile without adequate cover or containment. Evidence of erosion and sediment transport along that base of the stockpile. Photo taken by San Diego Water Board inspector on December 4, 2014.

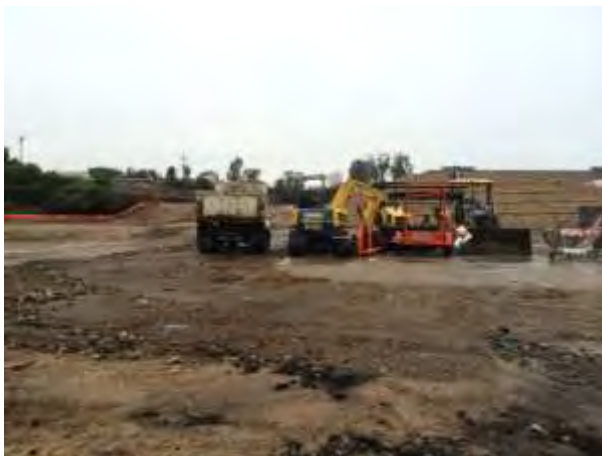
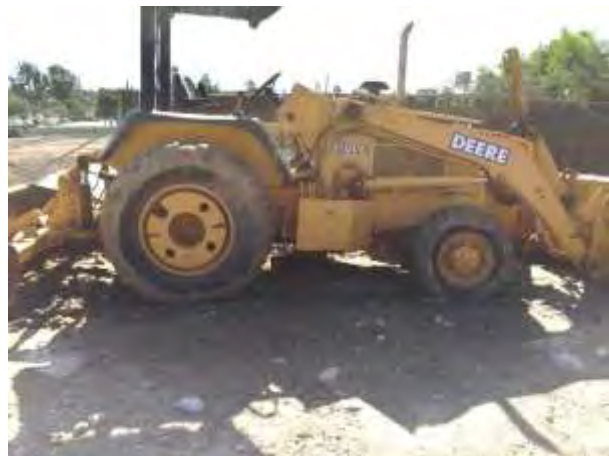
Photos 2 and 3 show construction equipment and vehicles without appropriate BMPs (e.g. drip pans) to prevent oil, grease, or fuel to leak in to the ground, storm drains, or surface waters. Photo 2 provided by concerned citizen, taken in the morning on December 3, 2014. The same vehicles were observed by the San Diego Water Board inspector on December 4, 2014, also without appropriate BMPs. Photo 3 taken by the San Diego Water Board inspector on December 4, 2014.

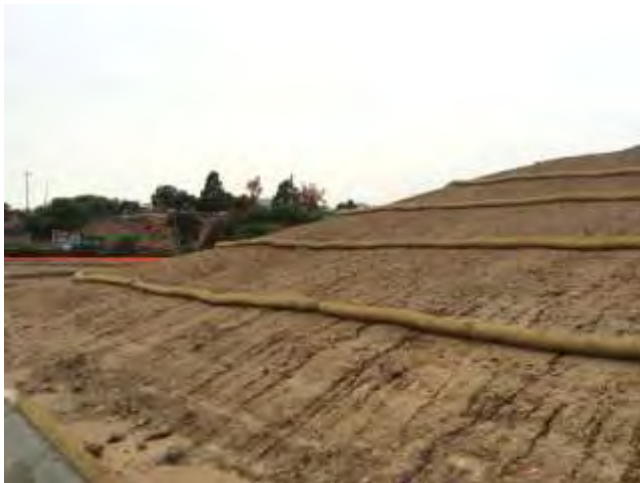
Photo 6 shows the evidence of erosion and sediment transported to the base of the slope. Photo 6 also shows the linear sediment controls were not properly installed, as the fiber rolls are not overlapped and properly trench into the slope. Photo 6 provided by concerned citizen, taken in the morning on December 3, 2014.

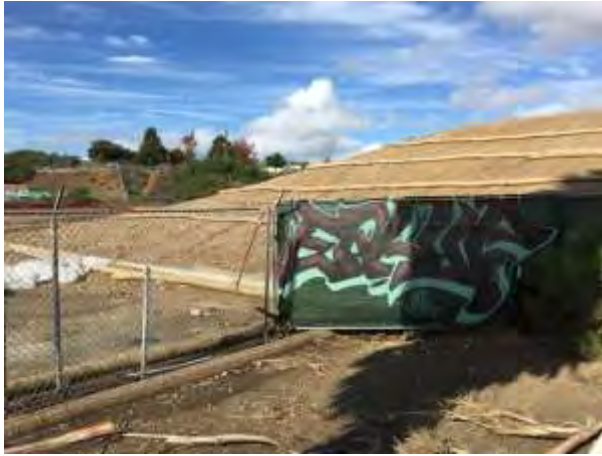
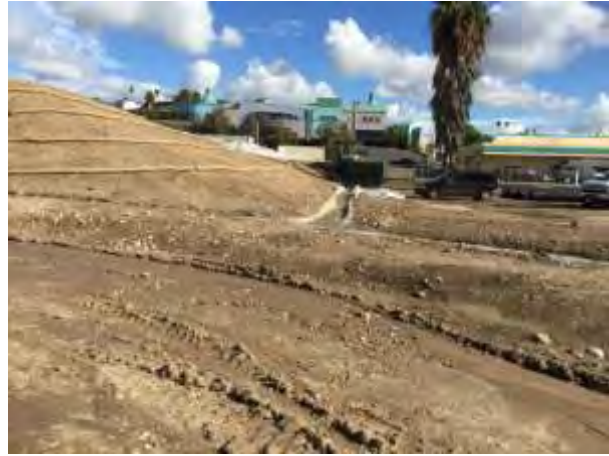
Photos 7 and 8 show evidence of erosion, in the form of rills on the slope. Photo 7 also shows evidence that erosion has resulted in sediment transport to v-ditch at base of the topographic feature, which drains to a post-construction BMP basin. Photos 6 and 7 taken by San Diego Water Board inspector on December 4, 2014.

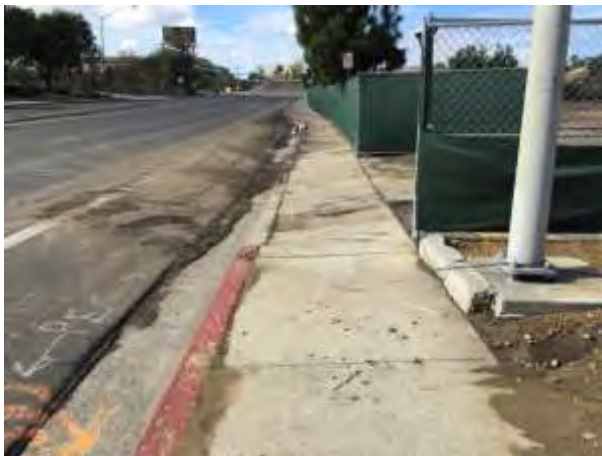
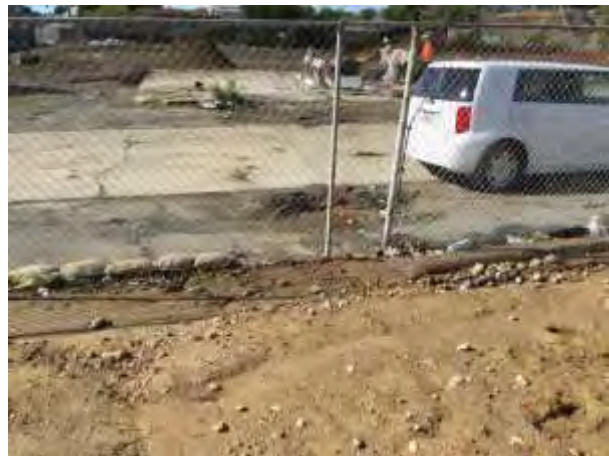
Photos 9 and 10 show factors that contributed to uncontrolled sediment discharges from the site. Photo 9 shows lack of perimeter sediment controls or tracking controls at an entrance/exit to the site. Significant offsite tracking of sediment can be seen in Photo 9. Photo 10 shows a missing section of the perimeter controls allowing offsite sediment to run-on to the site, which contributed to the sediment discharges from the site shown in Photo 9. Photos 9 and 10 taken by the San Diego Water Board inspector on December 4, 2014.

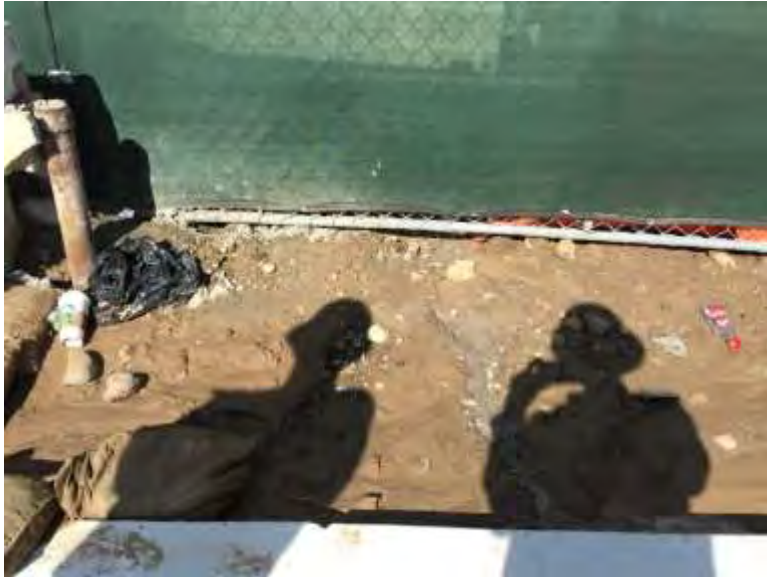
Photo 11 shows an additional location where perimeter sediment controls were not established, resulting in a discharge of sediment from the site. Photo 11 taken by the San Diego Water Board inspector on December 4, 2014.

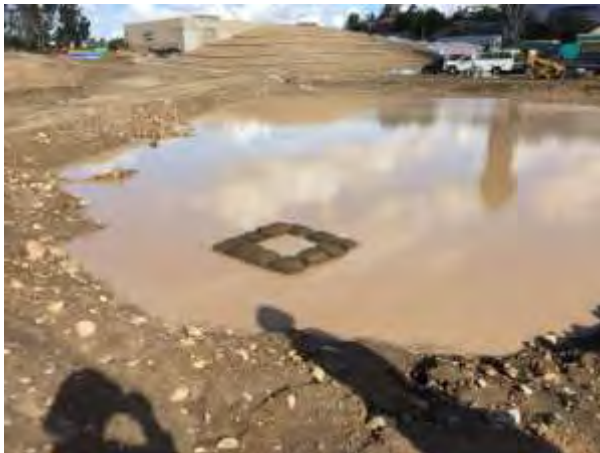
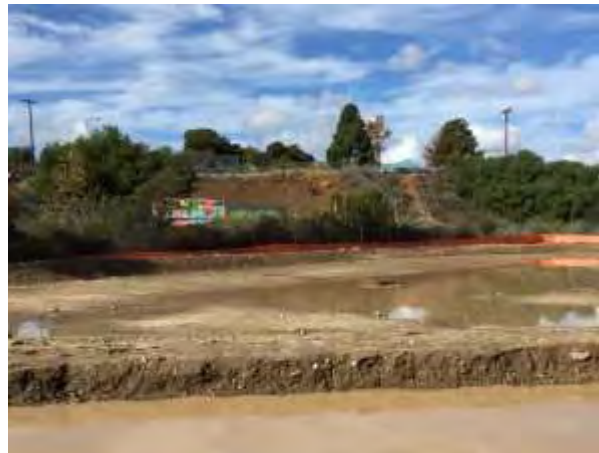
Photos 12 and 13 show the post-construction BMP basin that were inappropriately used and/or designed for the construction phase. Photo 12 shows the eastern basin, which collects runoff from the topograph feature seen in the background. Photo 13 shows the western basin. In both photos, the outlets (or storm drain inlets) can be seen surrounded by gravel bags. According to the superintendent, the outlets are covered with filter fabric. Photos 12 and 13 taken by the San Diego Water Board inspector on December 4, 2014.

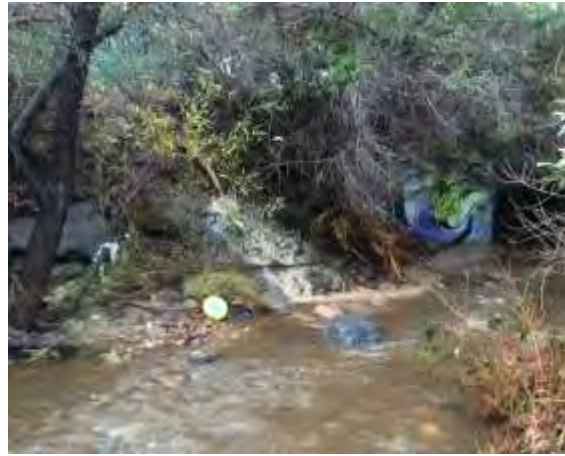
Photos 14 and 15 show the 6-inch pipe outfall connected to the post-construction BMP basins on the site discharging sediment-laden storm water directly to Chollas Creek. Photo 15 also shows a plume of sediment-laden storm water traveling downstream in Chollas Creek. Photos 14 and 15 provided by concerned citizen, taken in the morning on December 4, 2014.

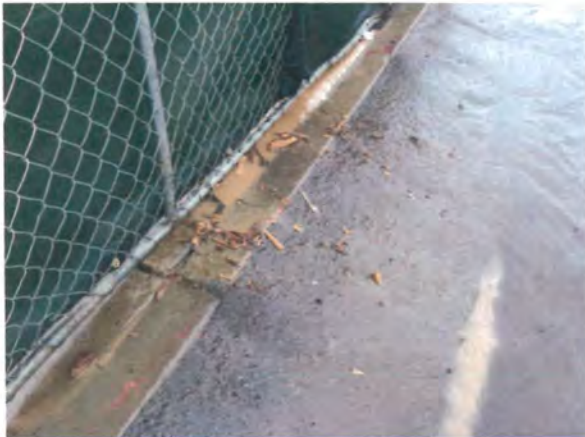
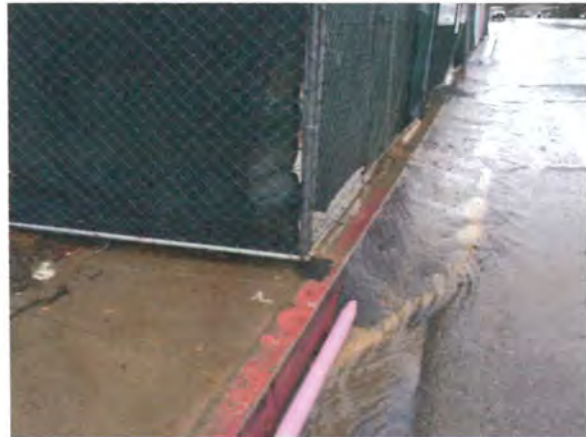
Photos 1 and 2 show discharges of sediment-laden storm water runoff from the site to the City of San Diego MS4 drainage system on Mission Gorge Road.

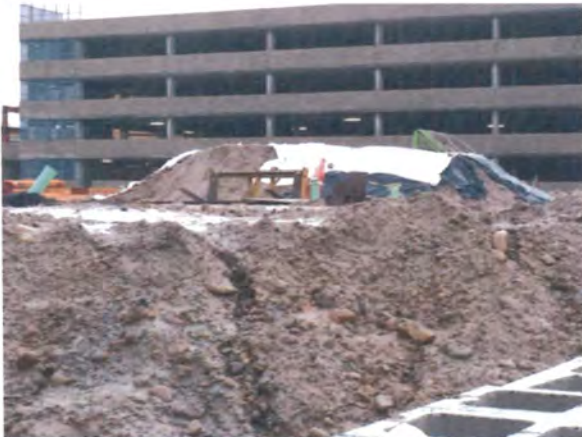
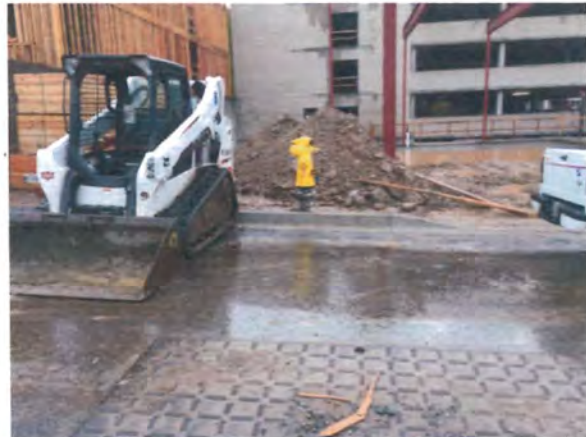
Photos 3 and 4 show soil stockpiles without adequate cover and containment during December 11 and 12, 2014 storm event. Evidence of erosion and sediment transport along that base of the stockpile.

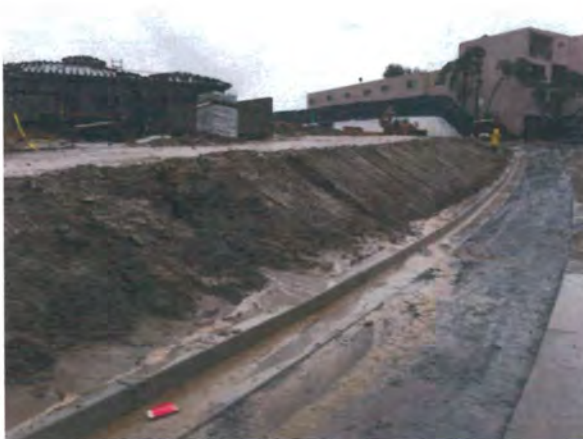
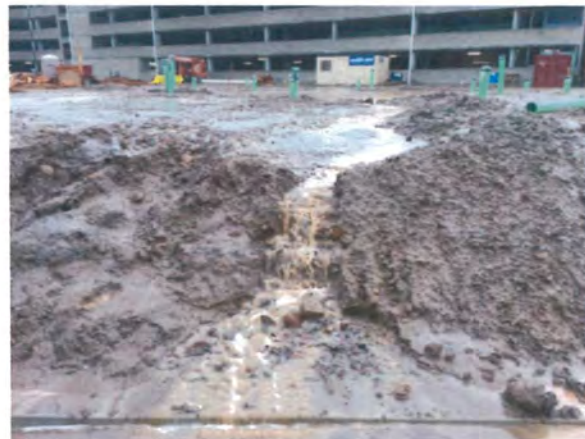
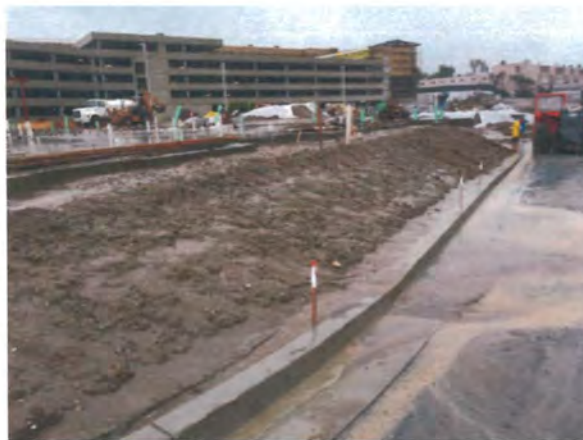
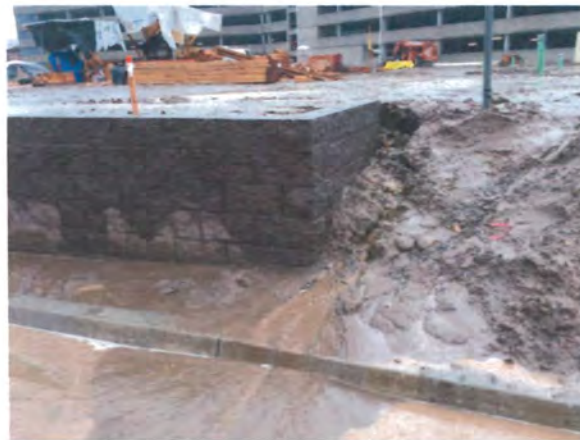
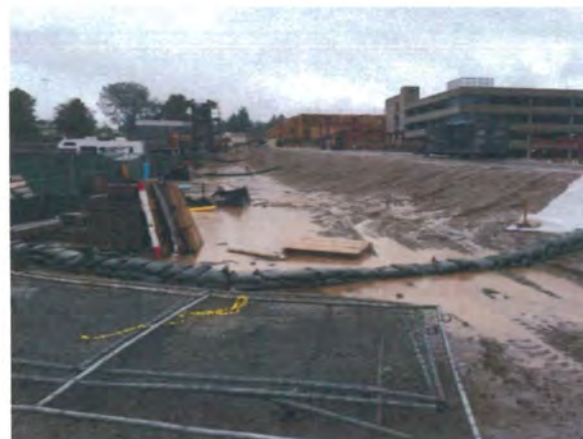
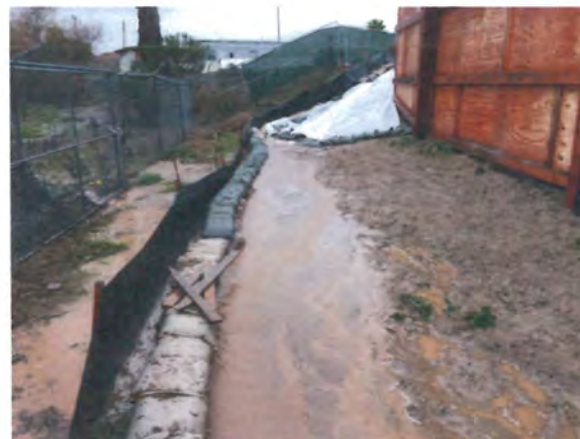
Photos 5 through 10 show several slopes and areas that have been inactive for at least 14 days lacking erosion control measures to prevent erosion. Photos also show lack of runoff controls within the site to limit the transport of sediment through the site.

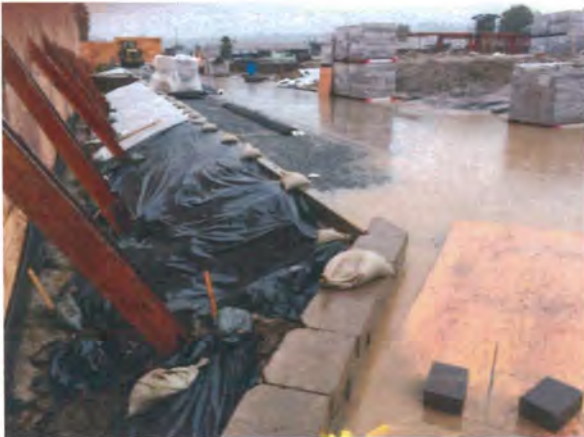
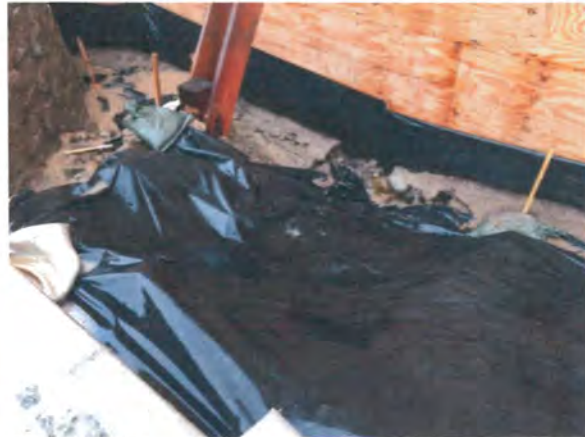
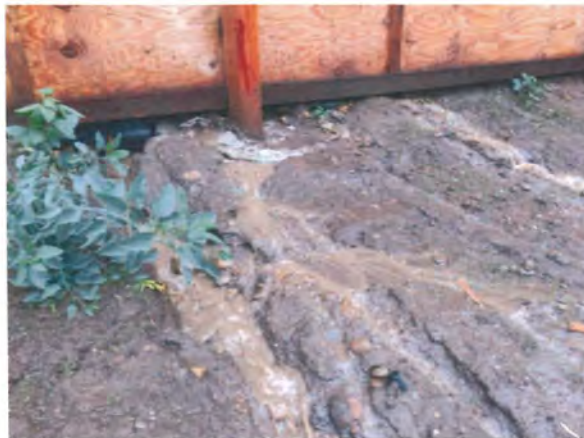
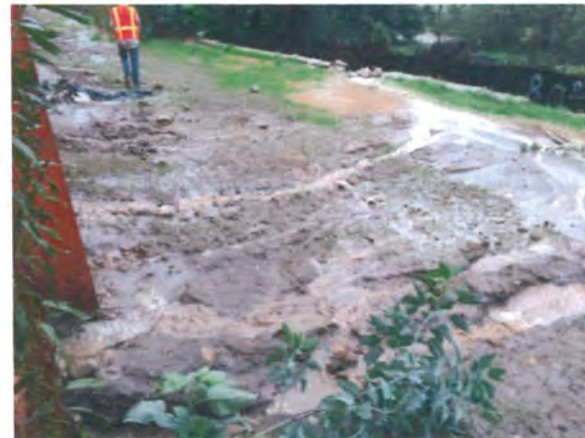
Photos 11 through 15 show pathway to unauthorized discharges of sediment and sediment-laden storm water runoff from the site to the San Diego River. Photo 11 shows area where runoff in Photos 5 through 8 collect. Photo 12 shows where runoff from Photo 11 flow down slope. Photo 13 shows where flow from Photo 12 emerges. Photo 14 shows where flow from Photo 13 and Photos 9 and 10 converge and discharge from location in perimeter controls (i.e. gravel bags) that appears to have been moved to allow flow off site. Photo 15 shows sediment-laden storm water runoff flowing off site to the San Diego River due to inadequate implementation of erosion controls, runoff controls within the site, and perimeter sediment controls.
