California Regional Water Quality Control Board San Diego Region

NOTICE OF HEARING AND ISSUANCE OF COMPLAINT NO. R9-2008-0057 FOR ADMINISTRATIVE CIVIL LIABILITY AGAINST SANTA MARGARITA WATER DISTRICT FOR VIOLATION OF ORDER NOS. 2006-0003-DWQ AND R9-2007-0005

This report provides a summary of factual and analytical evidence that form the basis for findings to support an administrative assessment of civil liability in the amount of \$133,190 against the Santa Margarita Water District (Discharger) for violations of State Board Order No. 2006-0003-DWQ, *Statewide General Waste Discharge Requirements* (hereafter the "State Board Order"), and Regional Board Order No. R9-2007-0005, *Waste Discharge Requirements for Sewage Collection Systems San Diego Region* (hereafter the "Regional Board Order"), as alleged in Complaint No. R9-2008-0057.

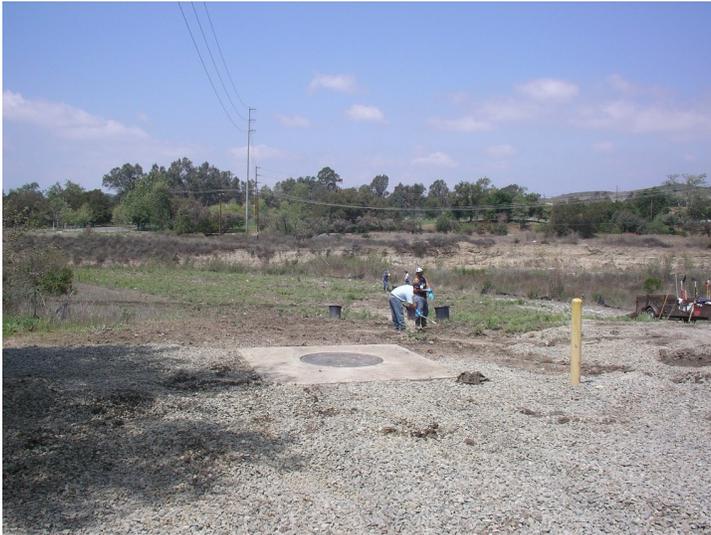
Figure 1 – Area between Lift Station and San Juan Creek

- Ortega Lift Station has two force mains: the main one (16 inches) and a backup (10 inches). The flange on the 16-inch force main broke, causing the sanitary sewer overflow (SSO). The force main had been repaired and there was a crew working on cleaning up the debris (Photo 1).

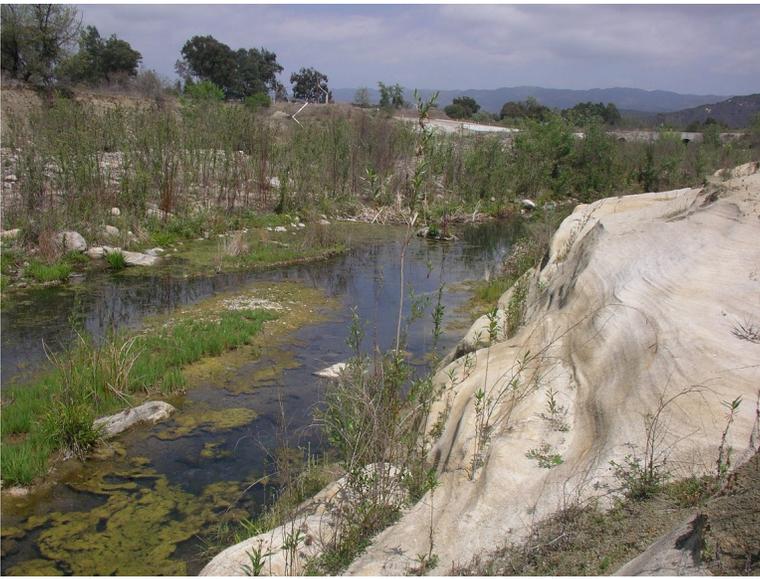
Figure 13 - Approximately 400 feet upstream from spill

- There was no surface flow observed 800 feet upstream of the SSO (Pictures 13).
 - There was a small flow in San Juan Creek downstream of the SSO, between the SSO and Antonio Parkway (Pictures 14-17).

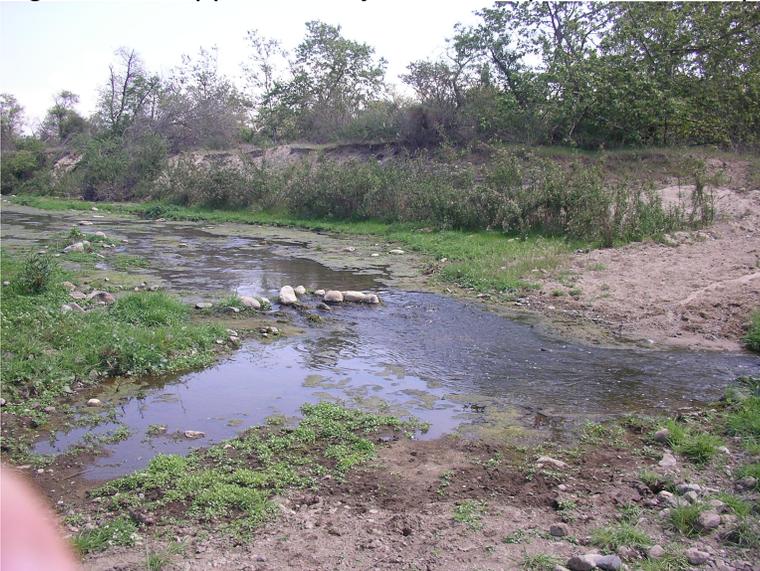
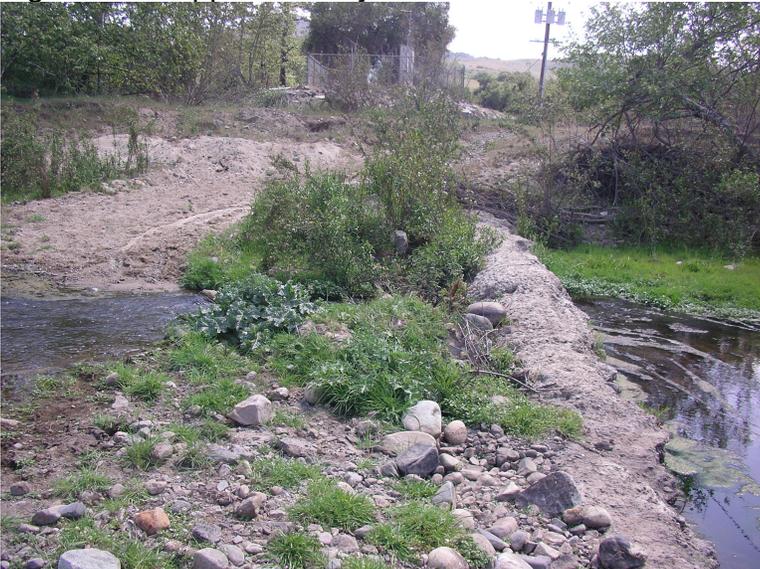
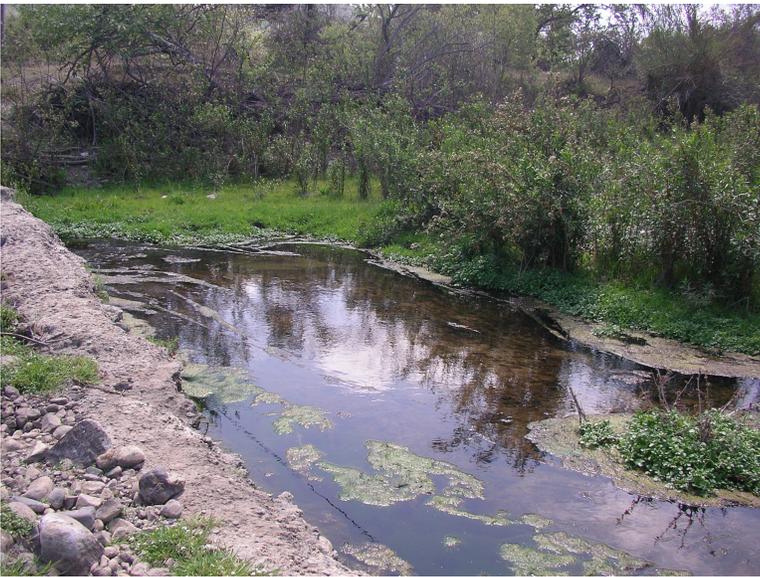
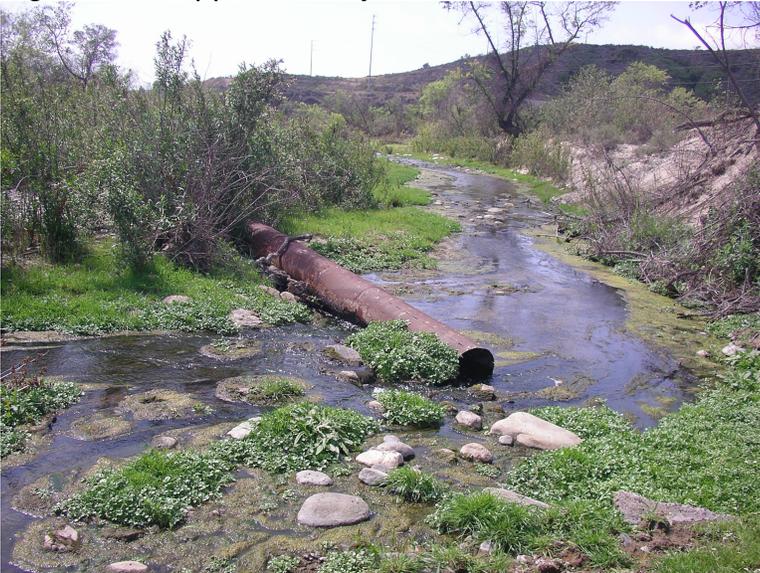
Figure 14 – Approximately 1.5 miles downstream from spill

Figure 15 - Approximately 1.5 miles downstream from spill

Figure 16 - Approximately 2 miles downstream from spill

Figure 17 - Approximately 2 miles downstream from spill

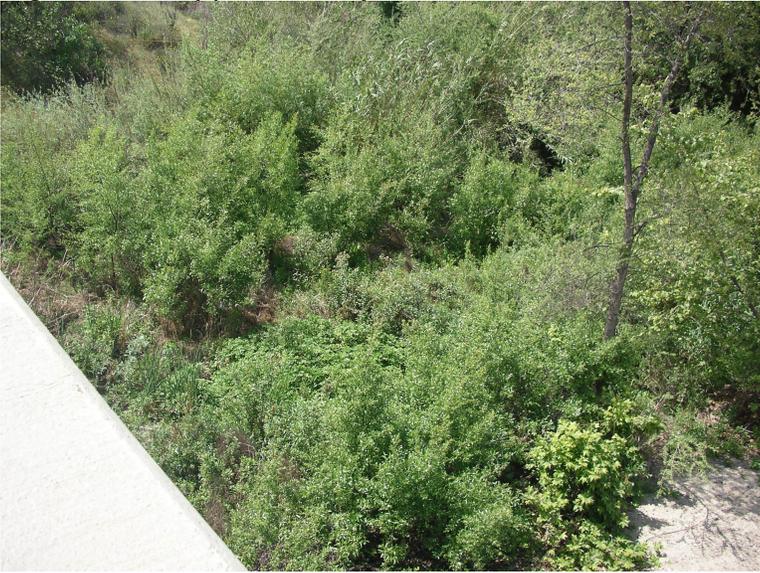
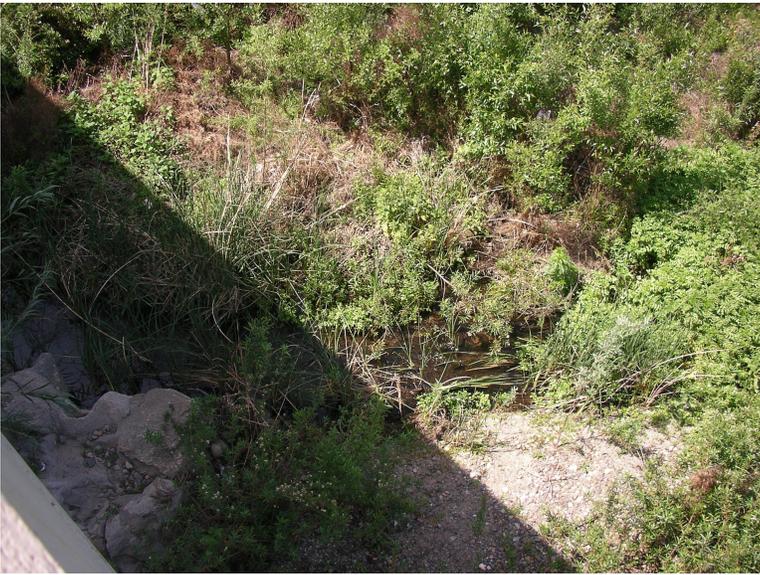
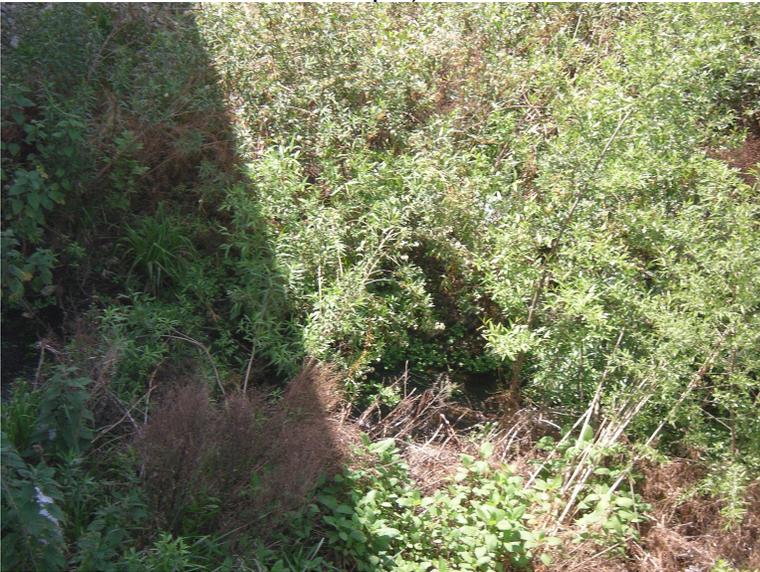
- Flow and heavy vegetation was observed from Ortega Highway underpass (Pictures 18-20).
 - Flow and light algae growth was observed from Camino Capistrano (Pictures 21).

Figure 18 – Upstream side of San Juan Creek from Ortega Highway overpass (approximately 3.5 miles downstream of spill)

Figure 19 - Upstream side of San Juan Creek from Ortega Highway overpass (approximately 3.5 miles downstream of spill)

Figure 20 - Upstream side of San Juan Creek from Ortega Highway overpass (approximately 3.5 miles downstream of spill)

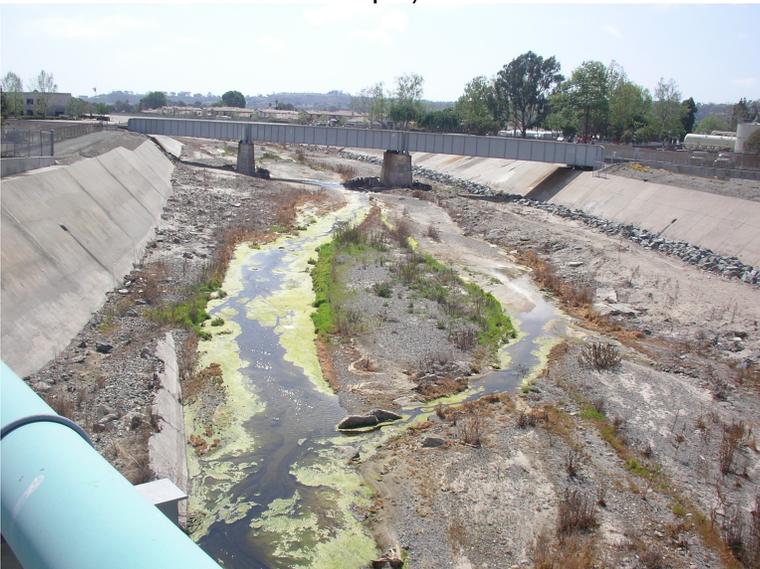
Figure 21 - Upstream side of San Juan Creek from Camino Capistrano overpass (approximately 6 miles downstream of spill)

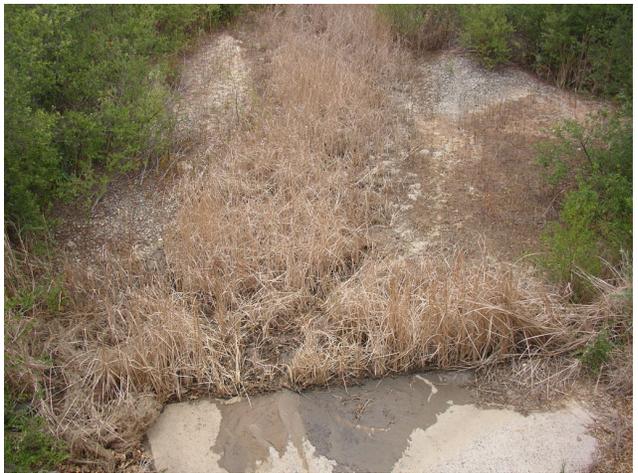
Fig 8

impact. Visible white sand spots were observed in the stream bed that are suspected arroyo toad burial holes (Fig 8). If so, these burial holes could have been inundated and arroyo toad could have been suffocated during the spill.

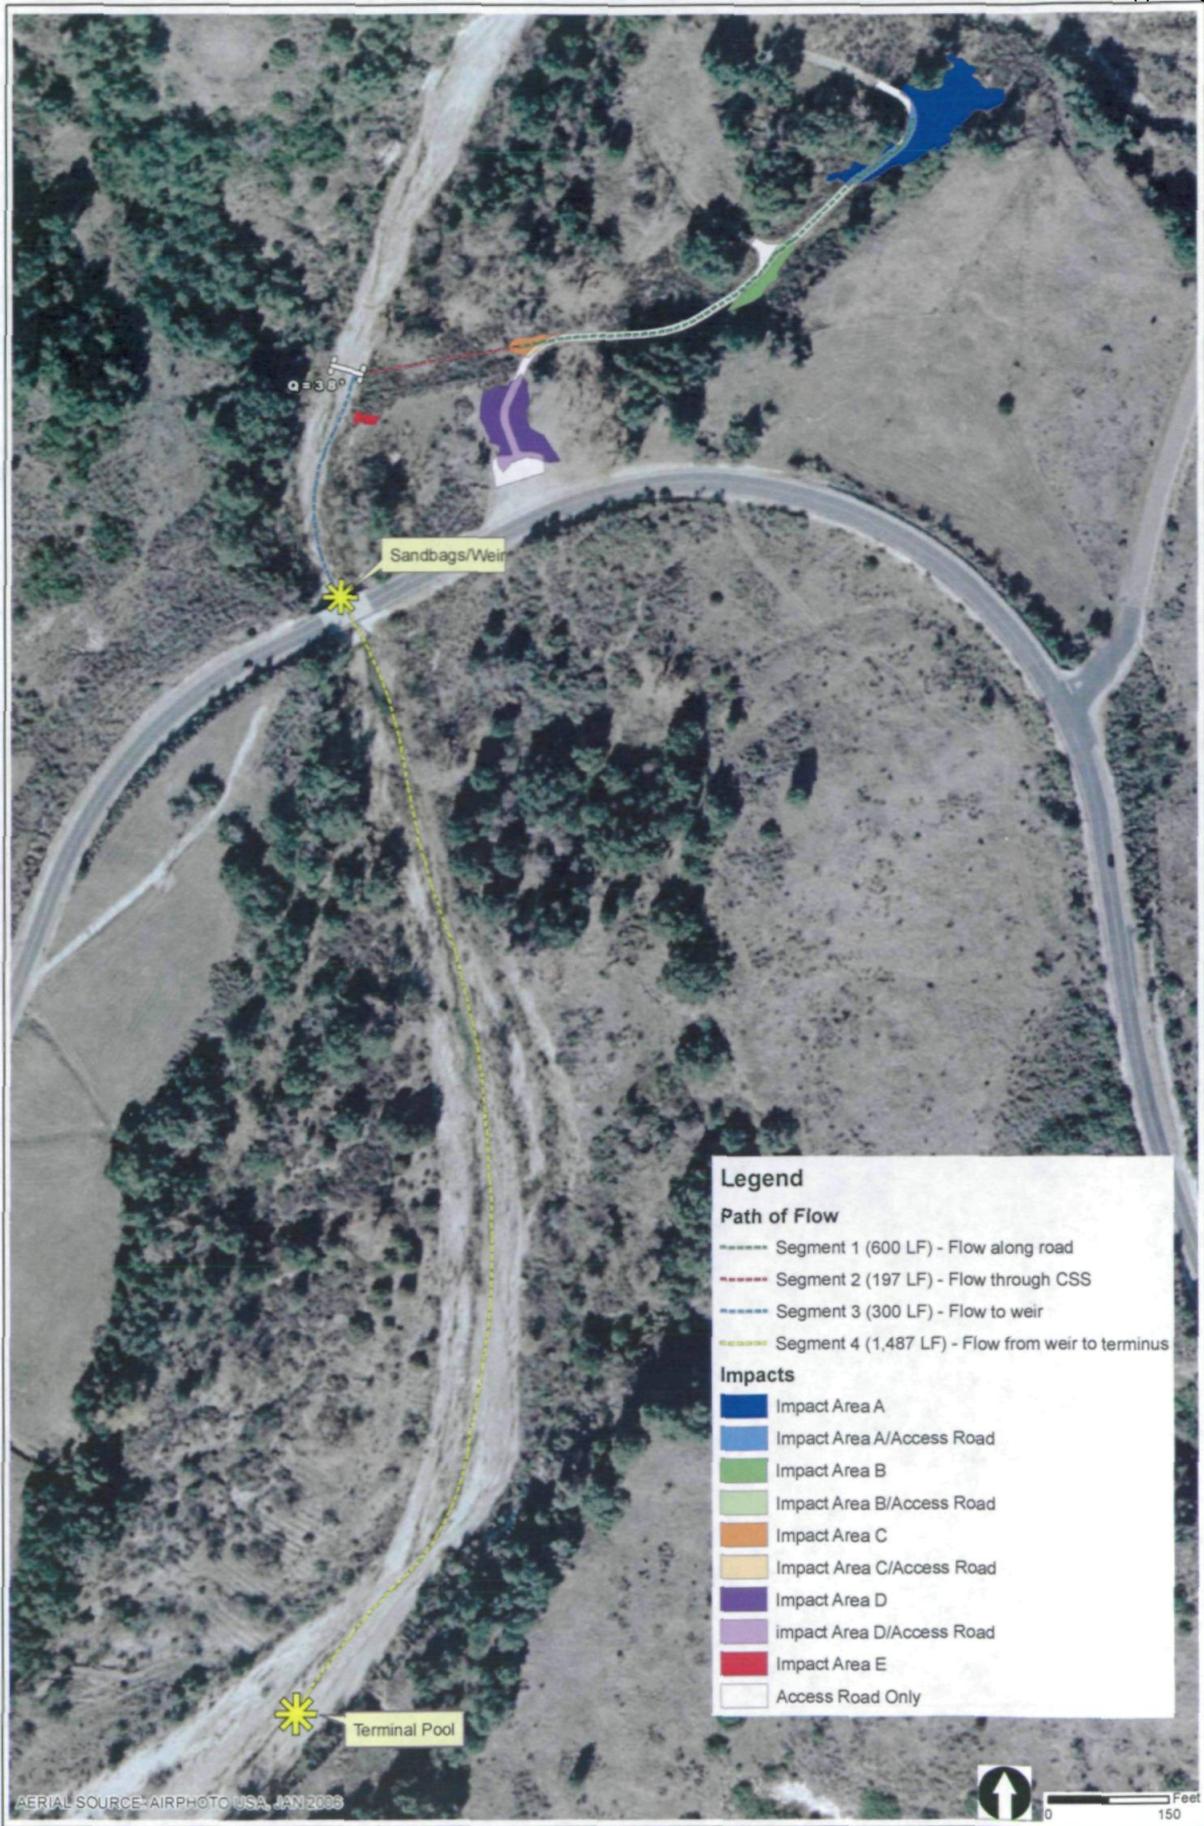
FIGURE 3

Santa Margarita Water District Sewer Break Assessment
Impacts at the Site of Broken Sewer Line on Rancho Mission Viejo Near Cristianitos Creek

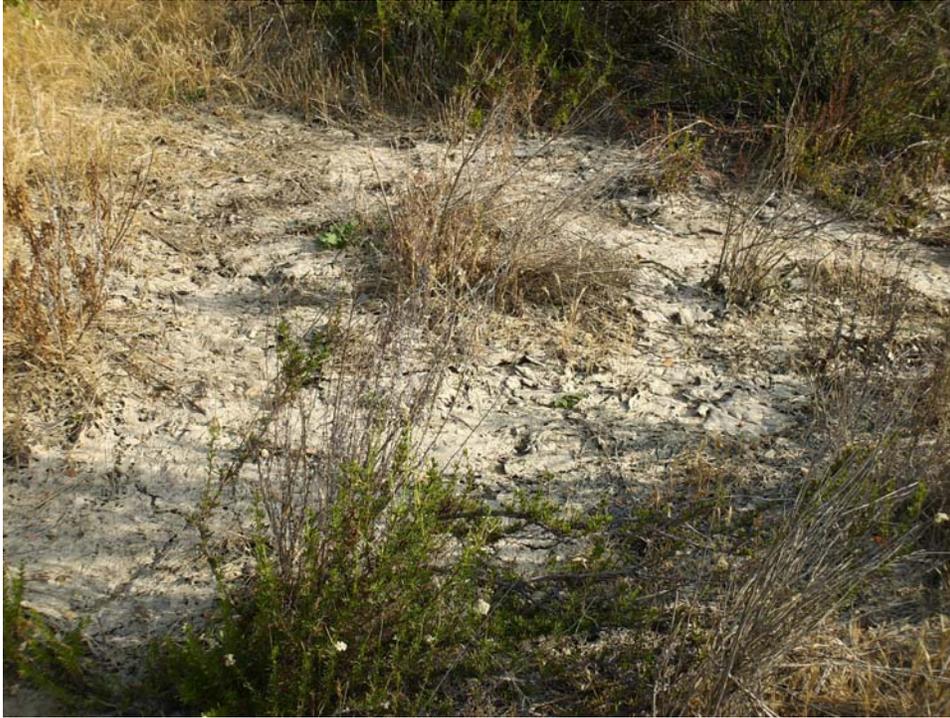
Flattened
vegetation
and mud
where water
flowed
through the
coastal sage
scrub area
close to the
source of the
break

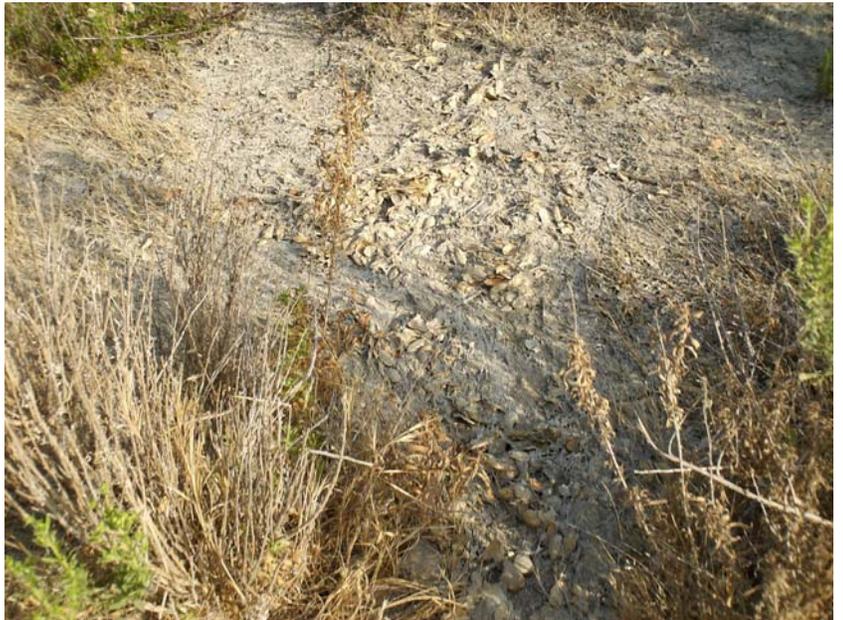
Gravel in the creek near the V-notch weir.

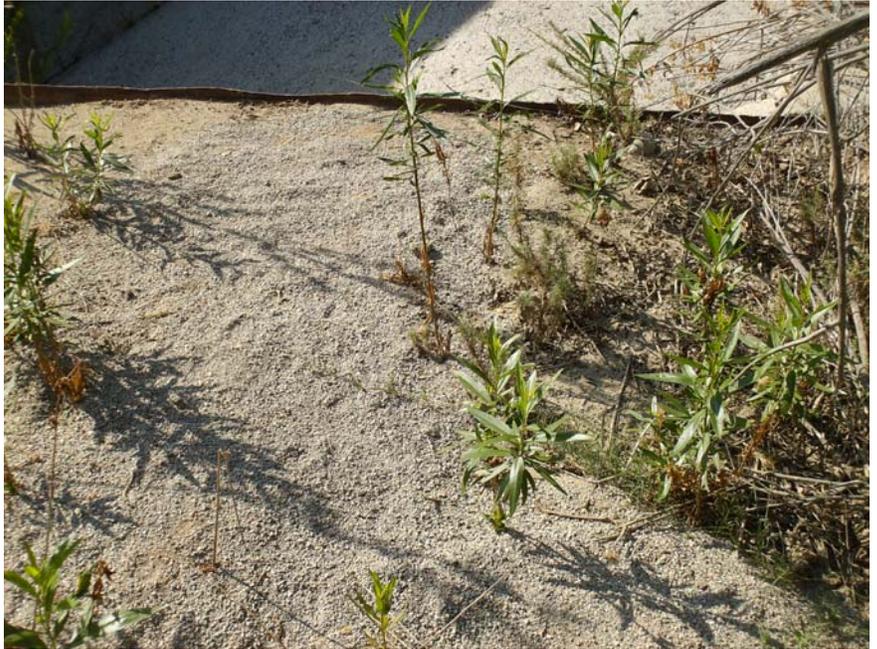
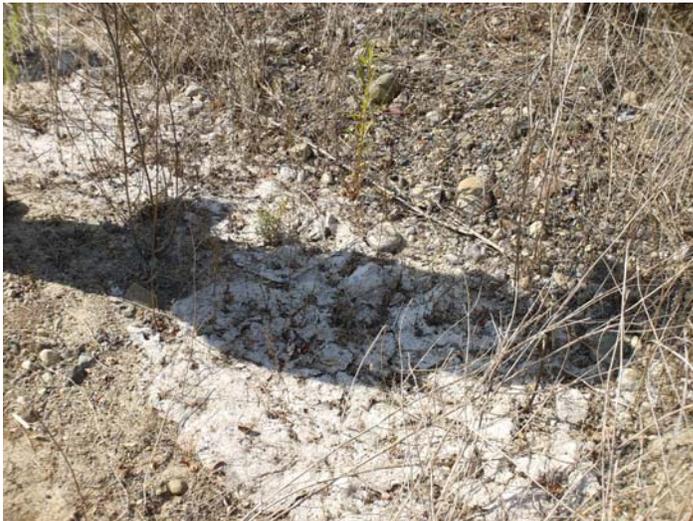
Residue that was found near the terminus of the flow

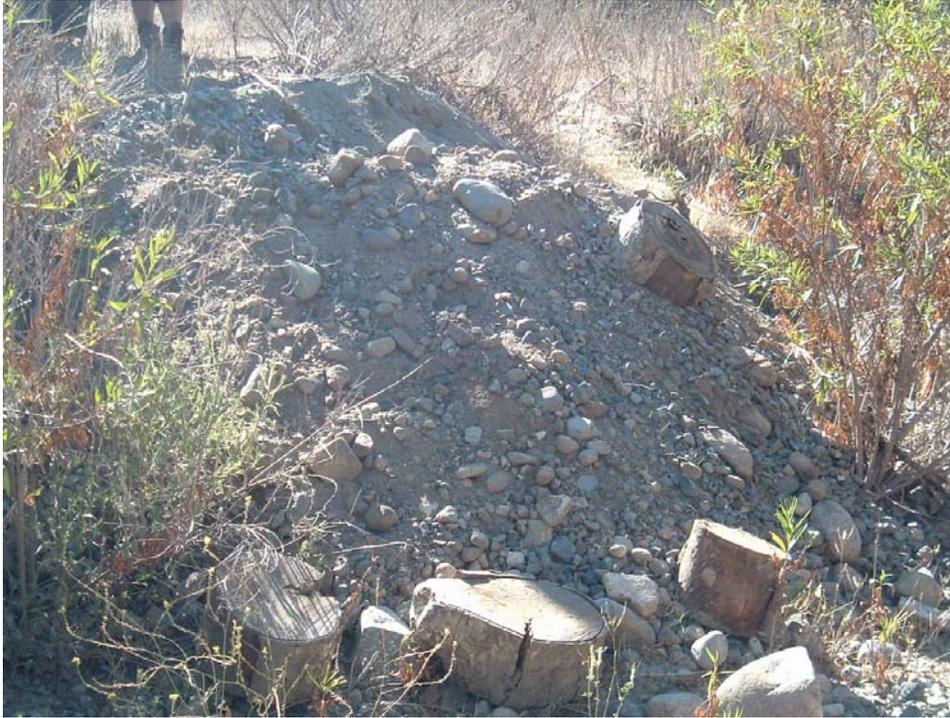
Debris
desposited
on bank of
Cristianitos
Creek
