CLEANUP AND ABATEMENT ORDER NO. R2-2013-1029

**CRISTINA FAMILY LLC
FOR THE PROPERTY LOCATED WITHIN HENRY COE STATE PARK
APPROXIMATELY 10 MILES EAST OF MORGAN HILL
SANTA CLARA COUNTY**

Inspection Report

Subject: Fill and Grading of Non-Perennial Tributary to East Fork of Coyote Creek, Santa Clara County

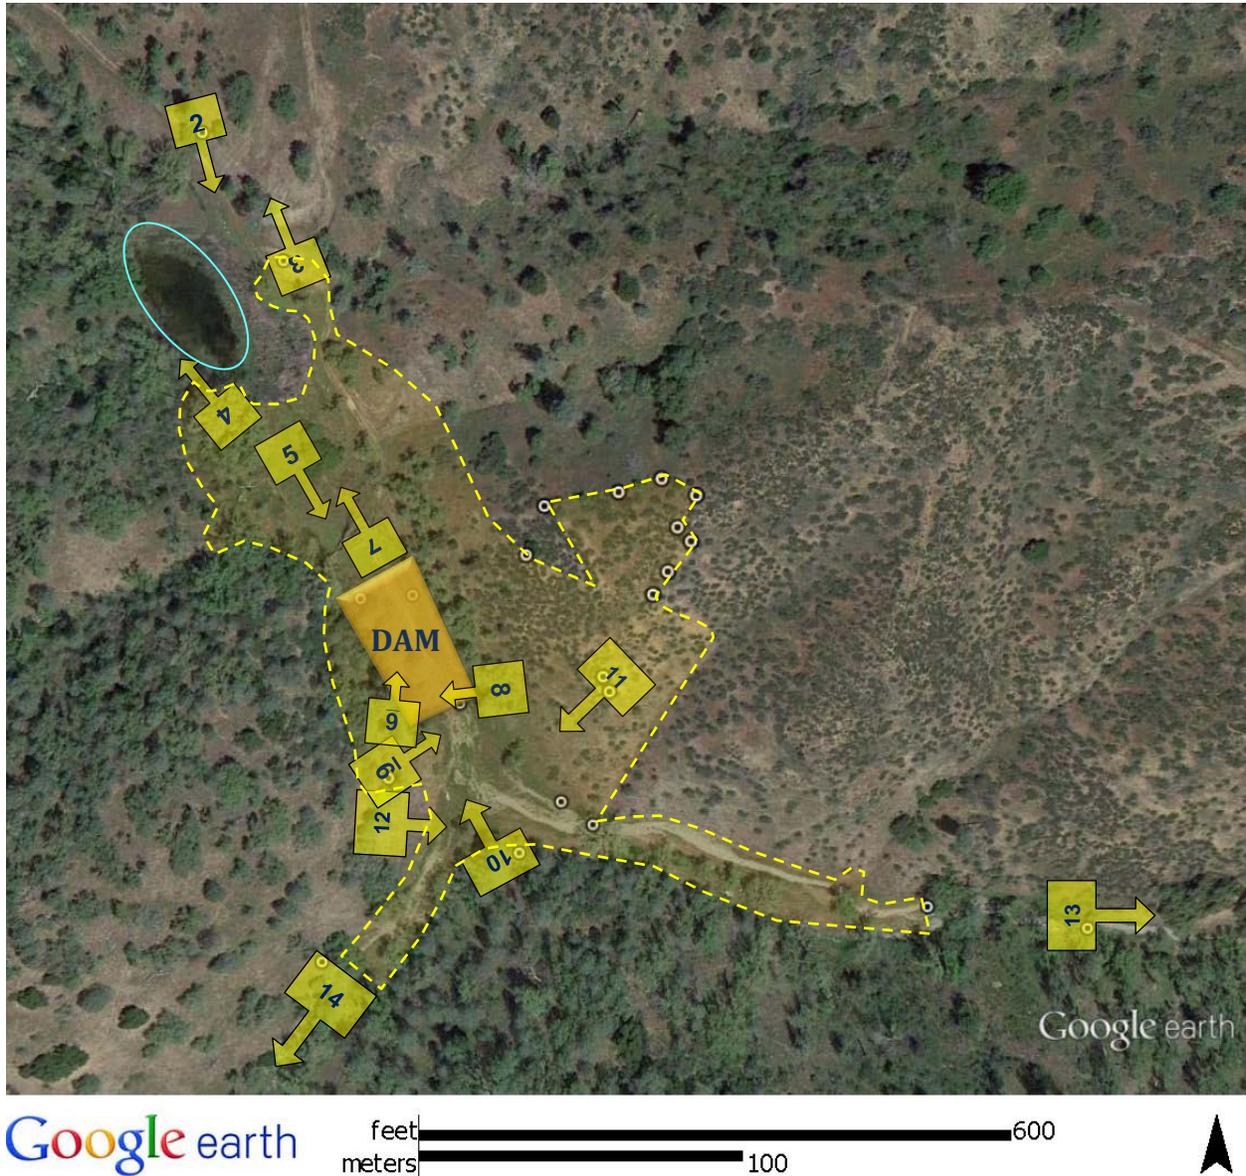
Photograph 1 – Aerial view from May 5, 2012, of the Site from Google Earth. Additions to the photograph include the location of stock pond (circled with the solid line at the top left of image), the dam, approximate extent of the grading (outlined in dashed line), the confluence at box number 10, and approximate directions and locations where photographs (photograph numbers in boxes) were taken.

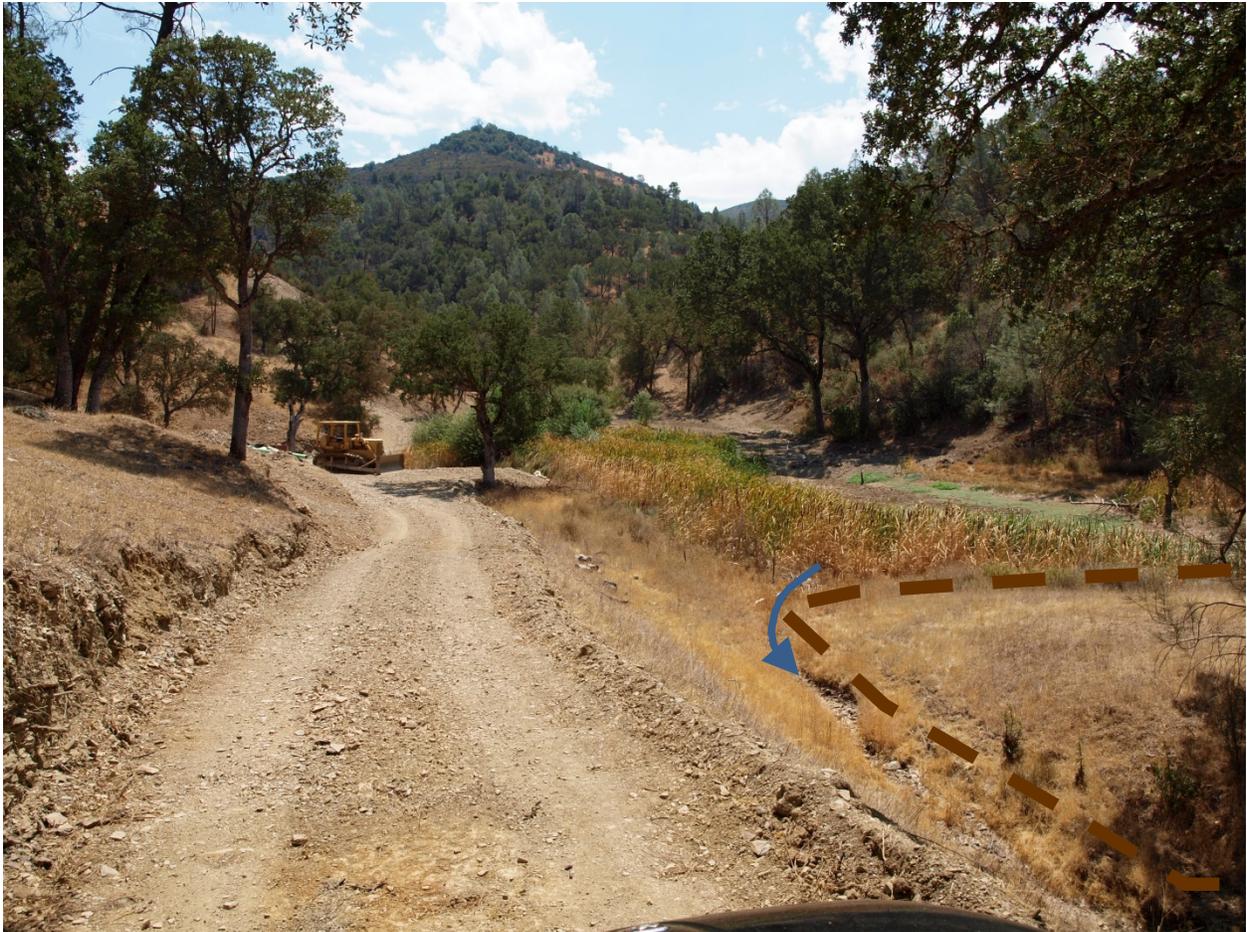
Richard Cristina stated during a telephone call with me on August 15, 2013, that the intent of the earthmoving was to create a dam to store water and make a reservoir for livestock watering and recreation. He stated that he wanted to build a new reservoir instead of "repairing" an existing stock pond previously constructed at the Site (Photograph 2). The stock pond is located

approximately 250 feet downstream of the newly constructed dam, and while not successfully functioning as a reservoir, it is supporting a wetland in an otherwise dry environment (Photograph 2).

- a Caterpillar D6C bulldozer parked next to the creek channel and wetland (Photograph 2),
- Seven 55-gallon drums used to store diesel fuel (Photograph 3). The drums were sitting on plywood adjacent to the wetland on a ledge cut into the road side. The drums were exposed with no secondary containment, and three of the seven drums were full of diesel fuel.

Photograph 2 – Bulldozer parked next to the wetland just off the access road that runs along the unnamed, non-perennial tributary to the East Fork of Coyote Creek. The photograph was taken looking upstream to the south. To the right of the road is an earthen impoundment (dashed line) for a stock pond. The impoundment was not retaining surface water, but appeared to be supporting wetland vegetation including cattails. An erosional channel is forming along the east side of the impoundment allowing water to flow past this diversion (see arrow).

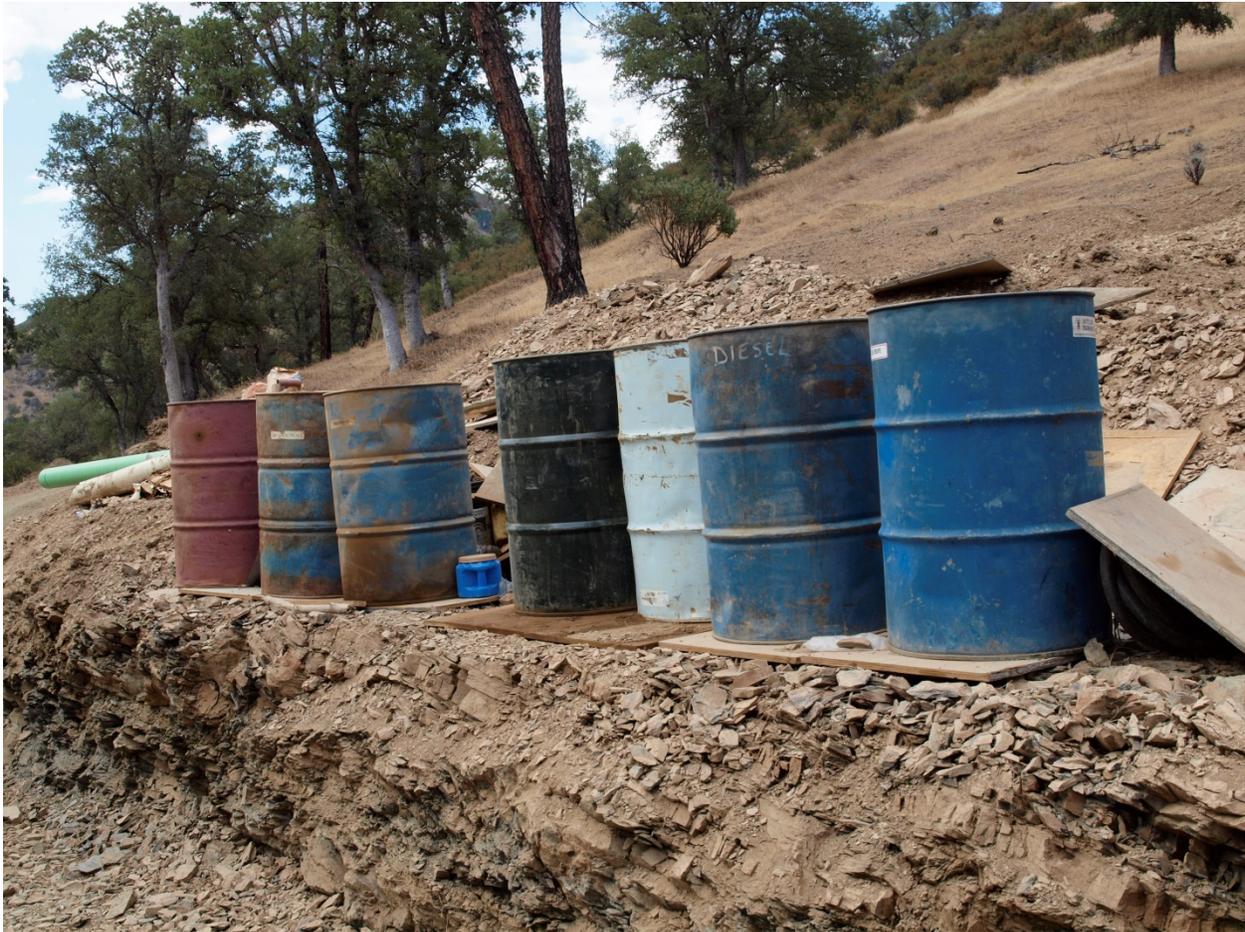
Photograph 3 – Exposed 55-gallon drums sitting on a road-cut ledge, adjacent to where the bulldozer is parked. Three of the seven drums were full of diesel fuel. There was no secondary containment for the drums.

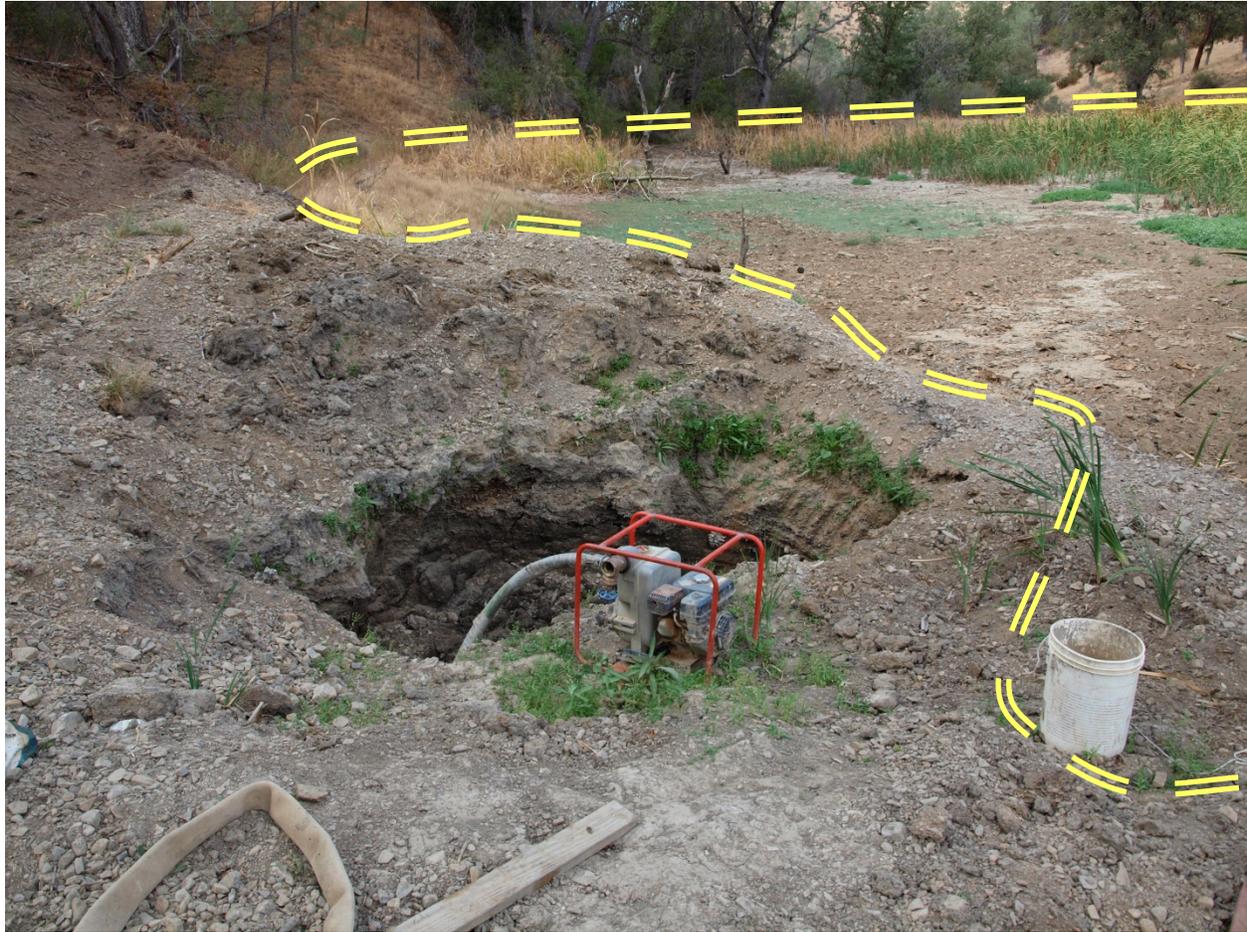
There was an excavation near the upstream margin of the wetland that was roughly 8 feet in diameter and approximately 8 feet deep (Photograph 4). A water pump, commonly referred to as a “trash pump,” and a hose were next to the excavation, with the hose extending from the excavation up to the location of the newly constructed dam. There was standing water in the excavation and a bullfrog.

Photographs 4 – Excavation near the perimeter of a wetland (delineated by the dashed line). The excavation was roughly circular, about eight feet in diameter, and approximately eight feet deep. A “trash” pump is sitting next to it, and the hose at the bottom of the photograph leads back upstream to the dam Site. Photograph was taken looking downstream to the northwest.

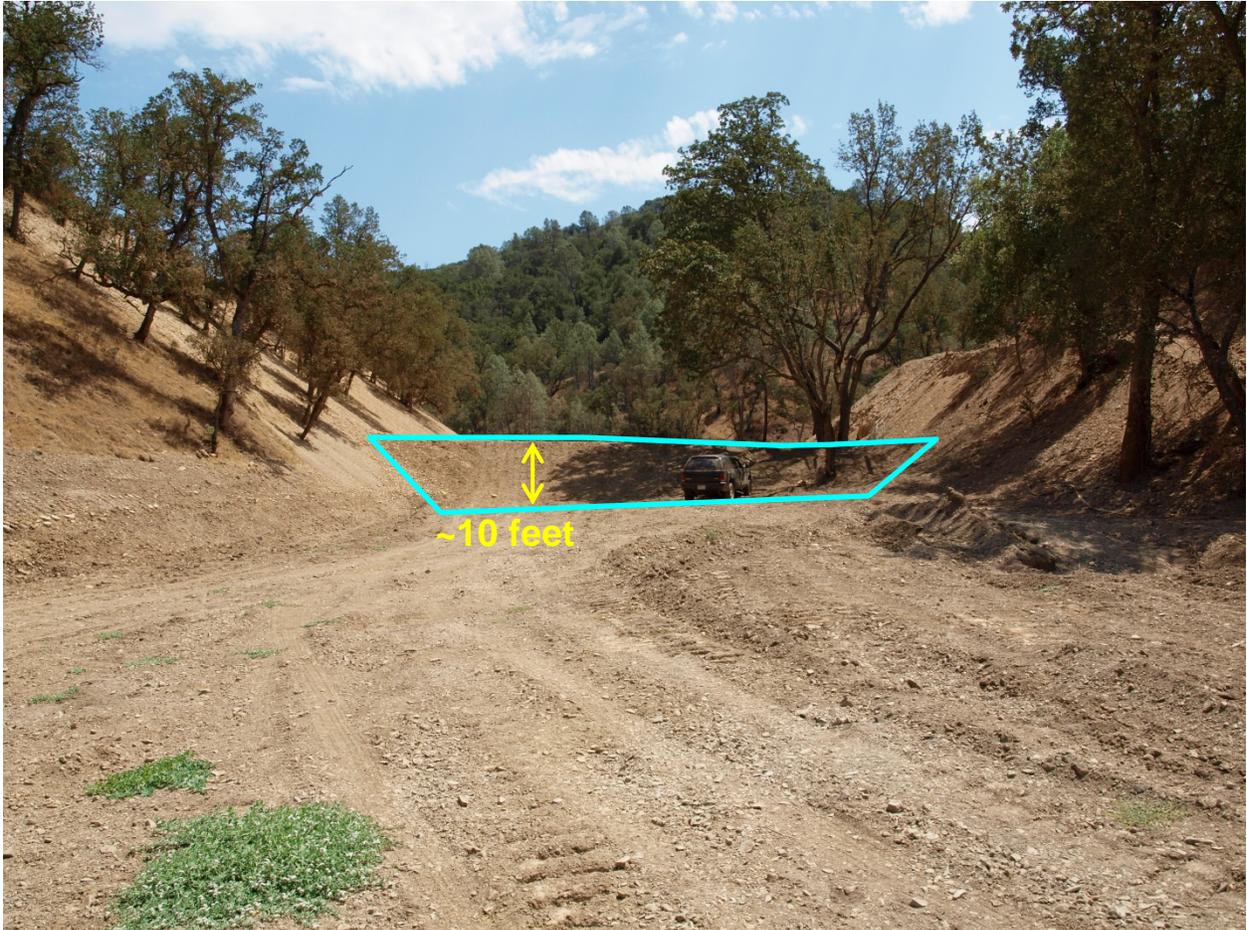
As I drove further onto the Site, I observed the newly constructed dam. It is located approximately 250 feet upstream of the stock pond wetland. The dam completely obstructs the stream channel and is about 80 feet wide (Photograph 5). The dam was constructed like a small mesa, with a flat top that extends along the stream channel for about 120 feet (Photograph 6), and short steep front and back faces which are approximately 10 feet high. In total, the dam was made up of about 3,556 cubic yards of rock and soil in the streambed.

Photograph 5 – Dam constructed across the unnamed stream, completely obstructing the stream channel. It is located approximately 250 feet upstream of the stock pond impoundment, and it is approximately 80 feet wide. Photograph was taken looking upstream to the south at approximately the center of the unnamed stream channel, which has been obscured by grading activities.

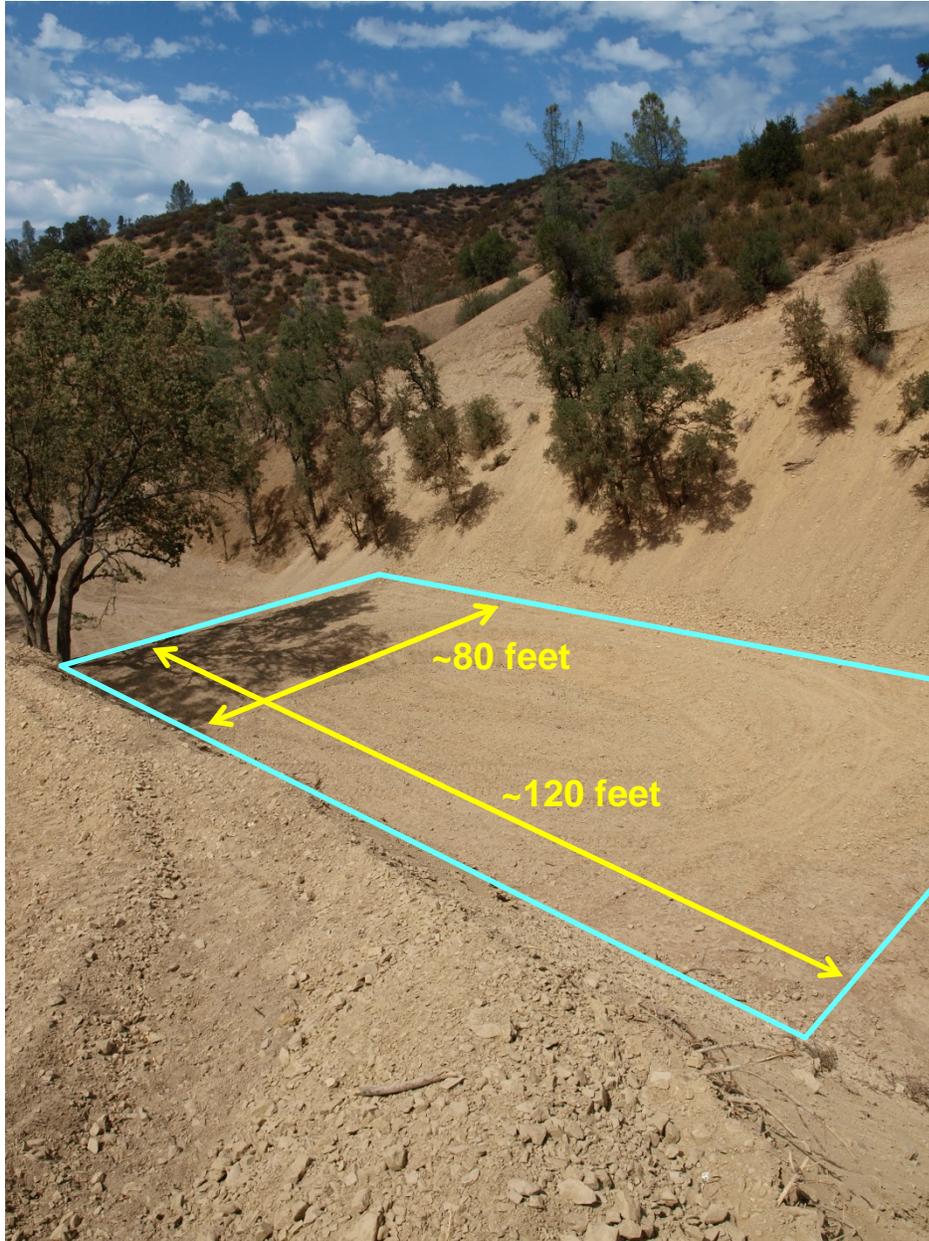
Photograph 6 – Dam constructed across the unnamed stream (approximately 80 feet). The top of the dam extends for about 120 feet along the channel. Photograph was taken from the west bank looking across the dam (downstream) to the north.

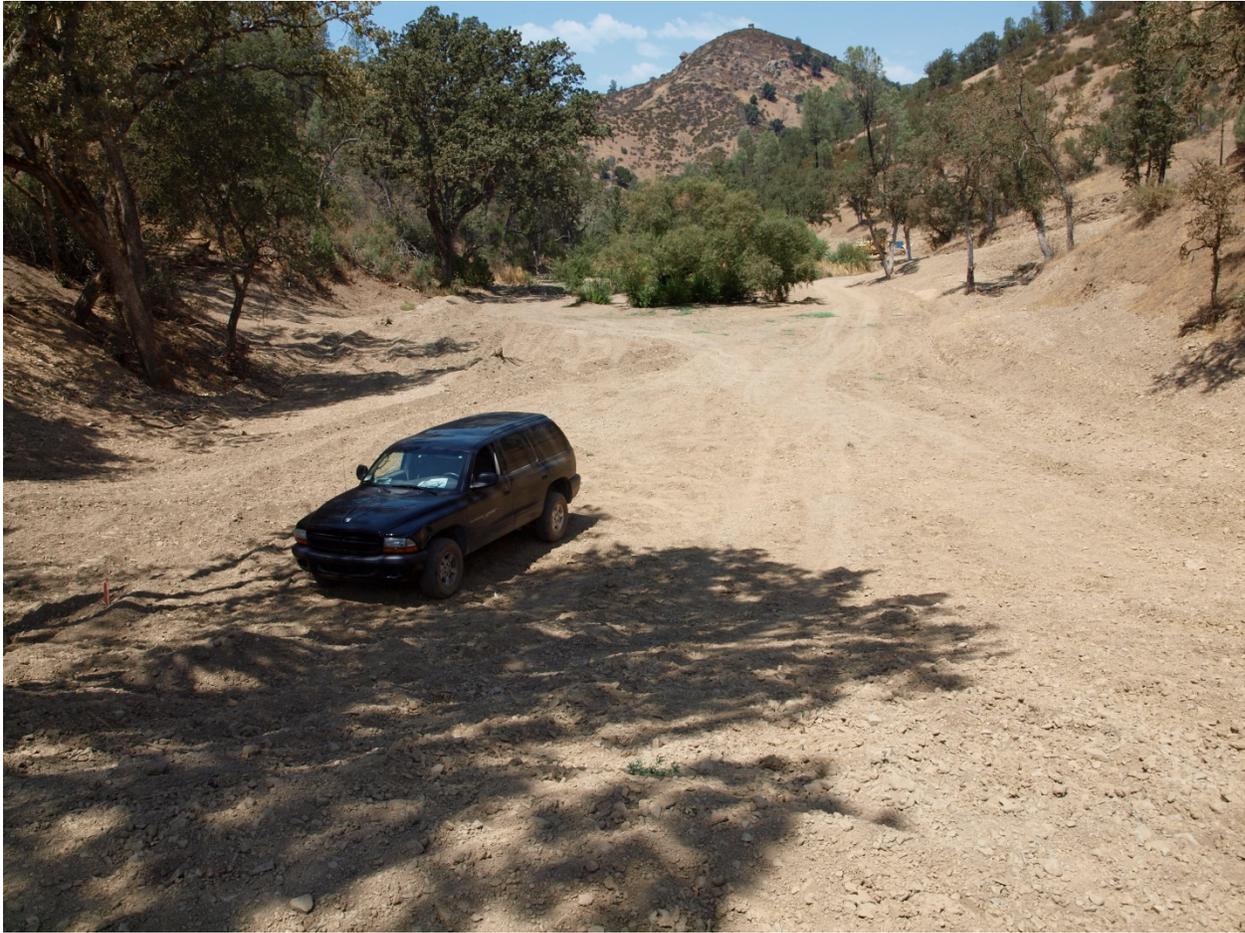
I observed a significant amount of grading around the new dam, presumably done to generate the material to construct the dam. The entire streambed between the wetland and the dam has been graded (Photograph 7), the hillsides above both banks of the channel were also graded (Photographs 8, 9 and 10), and the streambeds of two tributaries upstream of the dam were graded (Photographs 11 and 12). The ground surface where grading activities have occurred has dislodged soil and rock, and much of it is now loose and unconsolidated.

Photograph 7 – Streambed between the stock pond and the dam has been graded. Photograph was taken from the top of the dam looking downstream, to the north.

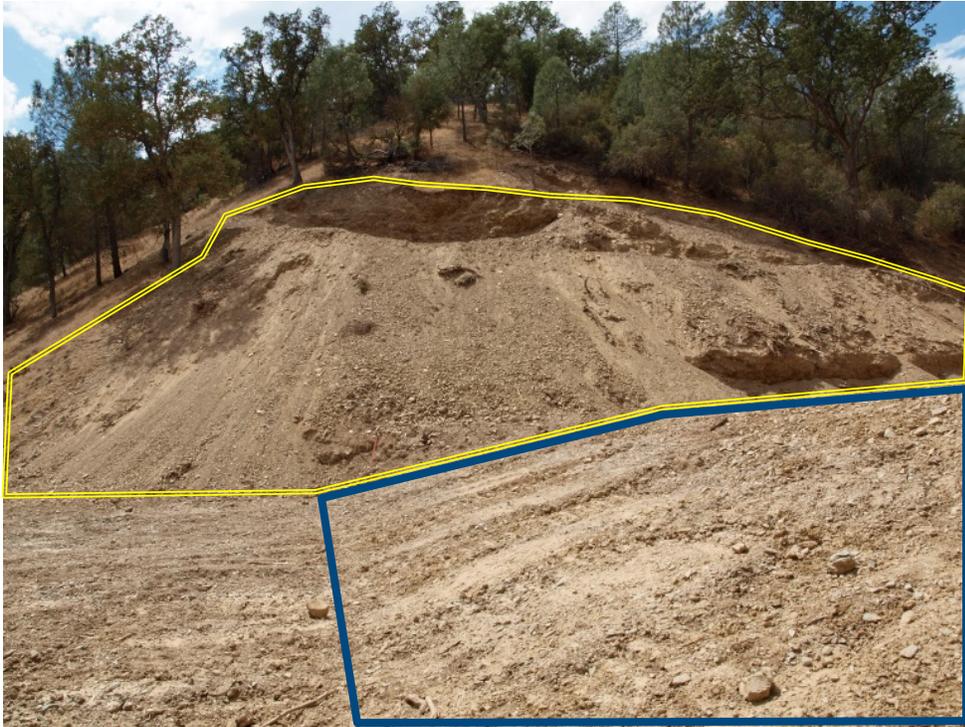
Photograph 8 – Graded hill side, outlined in double lines, on west bank overlooking dam. Photograph was taken looking at west bank from east bank (at streambed) across upstream face of the dam. Dam is outlined in the solid line.

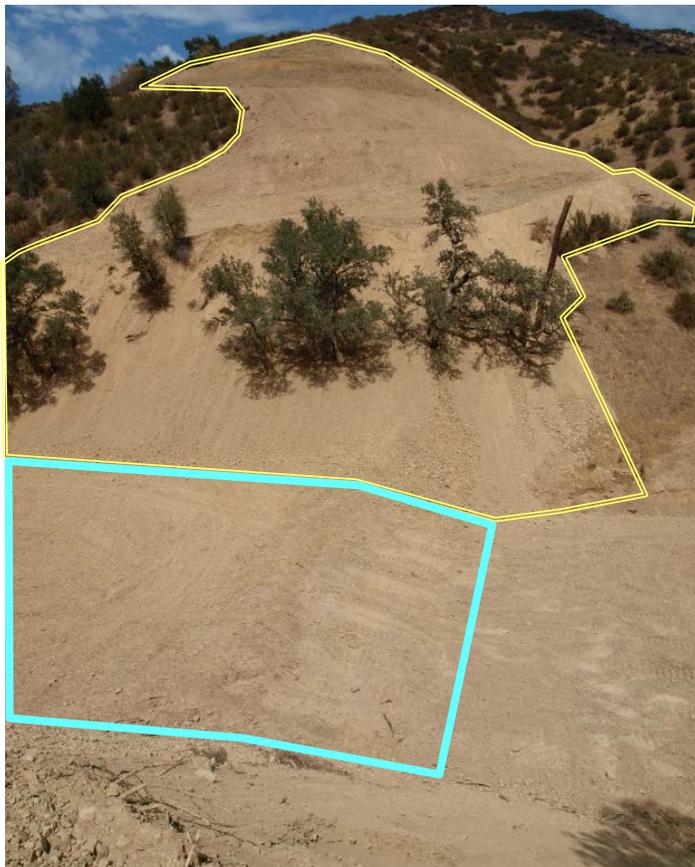
Photograph 9 – Graded hill side, outlined in double lines, on east bank above dam. Photograph was taken looking from hillside on west bank to the east. Dam is outlined in solid line.

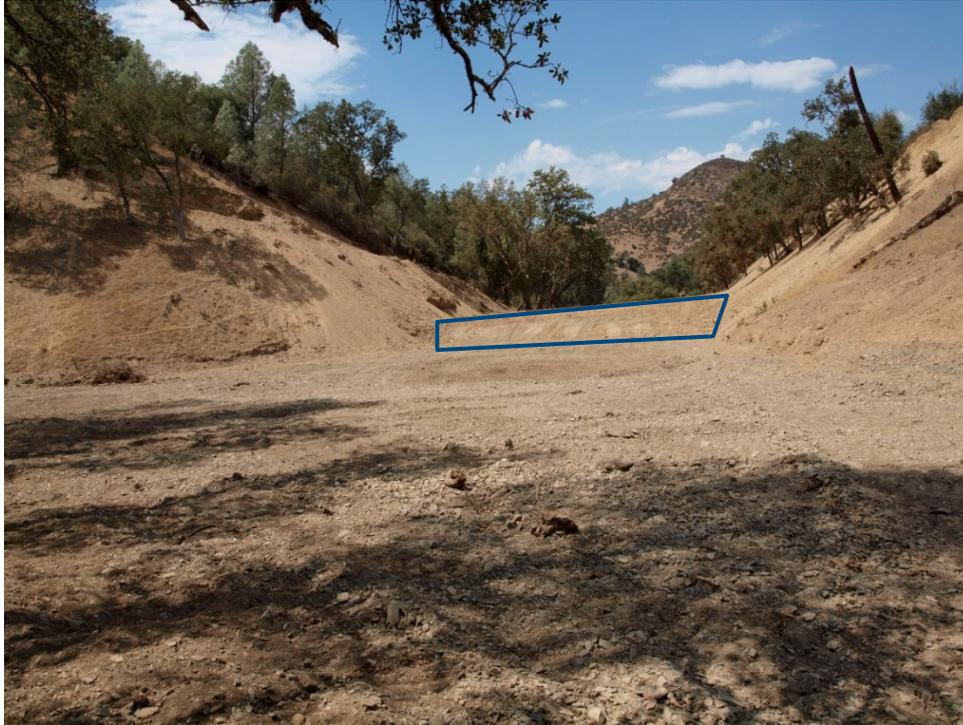
Photograph 10 – Dam, outlined in solid line, and graded hill sides and stream channel. Photograph was taken looking downstream to the north at dam from the center of the upstream edge of the confluence of the two unnamed tributaries above the dam.

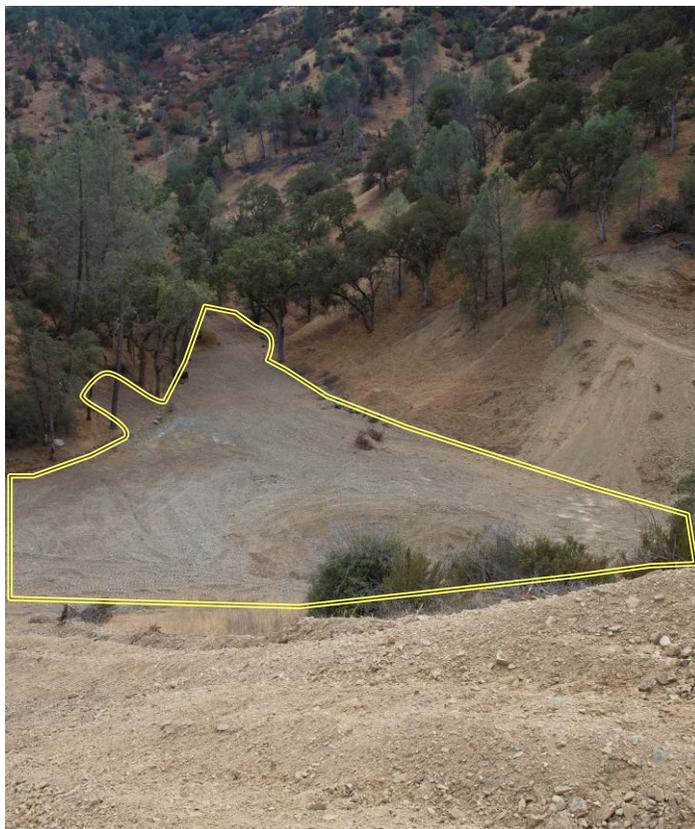
Photograph 11 – Graded stream channel, outlined in double lines, at confluence of the two unnamed tributaries above dam. Photograph was taken looking upstream to the southwest at the south fork tributary from hilltop on the east bank above the dam.

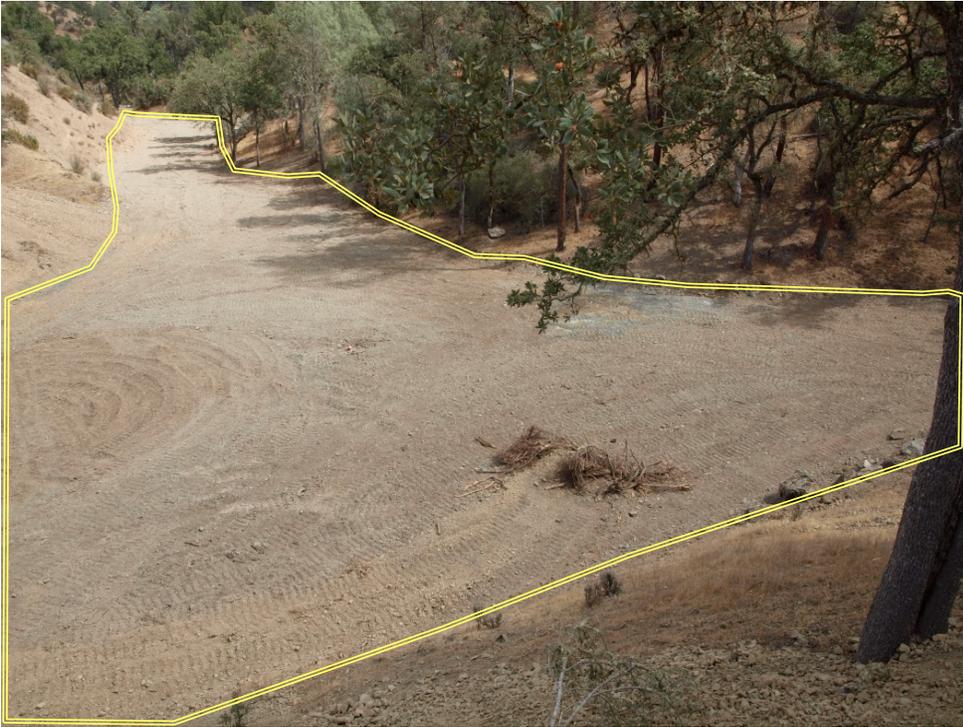
Photograph 12 – Graded stream channel, outlined in double lines, at confluence of the two unnamed tributaries above dam. Photograph was taken looking upstream to the east at the east fork tributary from the hillside on the west bank above the dam.

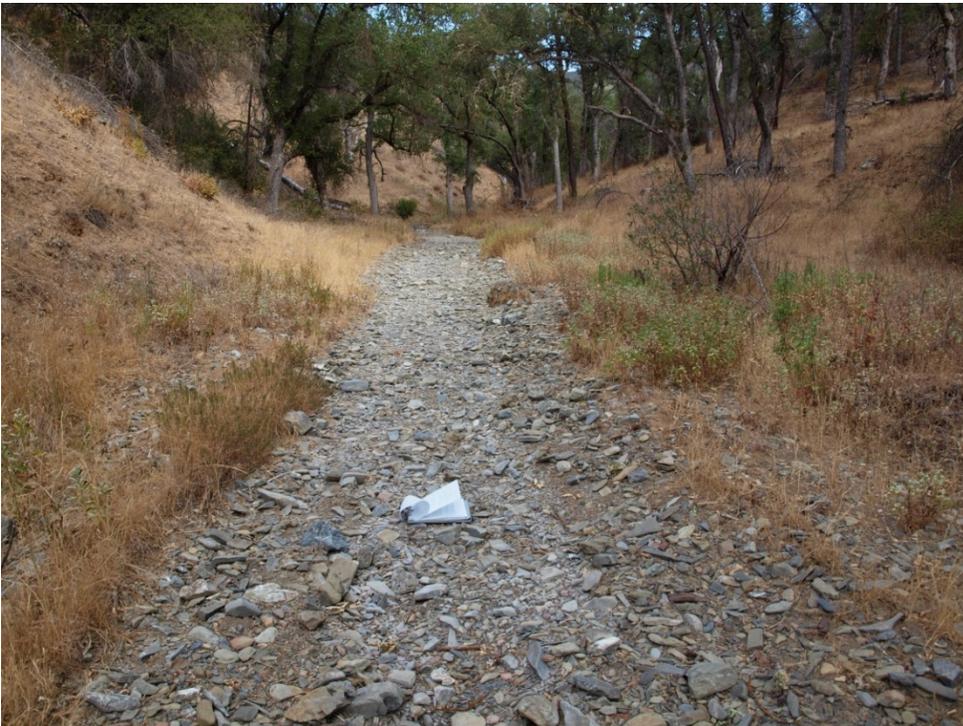
I checked the stream channels outside of the grading activities for a comparison to native conditions (i.e., how the stream channels would look if the Site had not been graded). Photographs 13 and 14 show the condition of two tributaries (also unnamed) upstream of the new dam.

Photograph 13 – Undisturbed stream channel above the dam Site on the east fork tributary. Photograph was taken looking to the east (upstream) from the center of the channel.

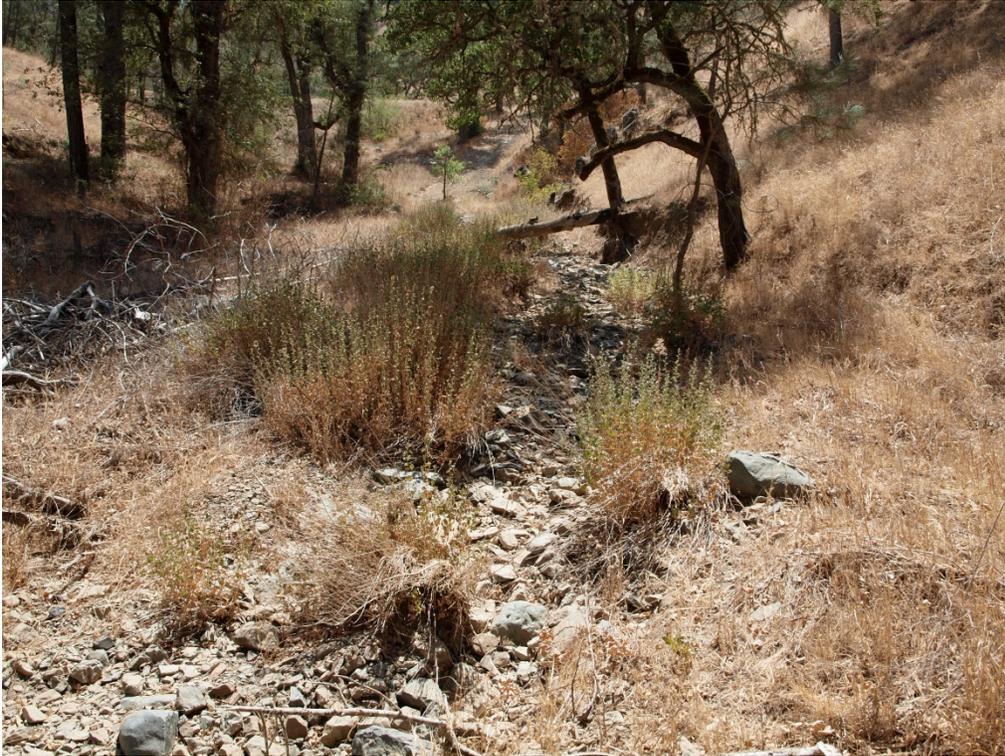
Photograph 14 – Undisturbed stream channel above the dam Site on the south fork tributary. Photograph was taken looking to the southwest (upstream) from the center of the channel.

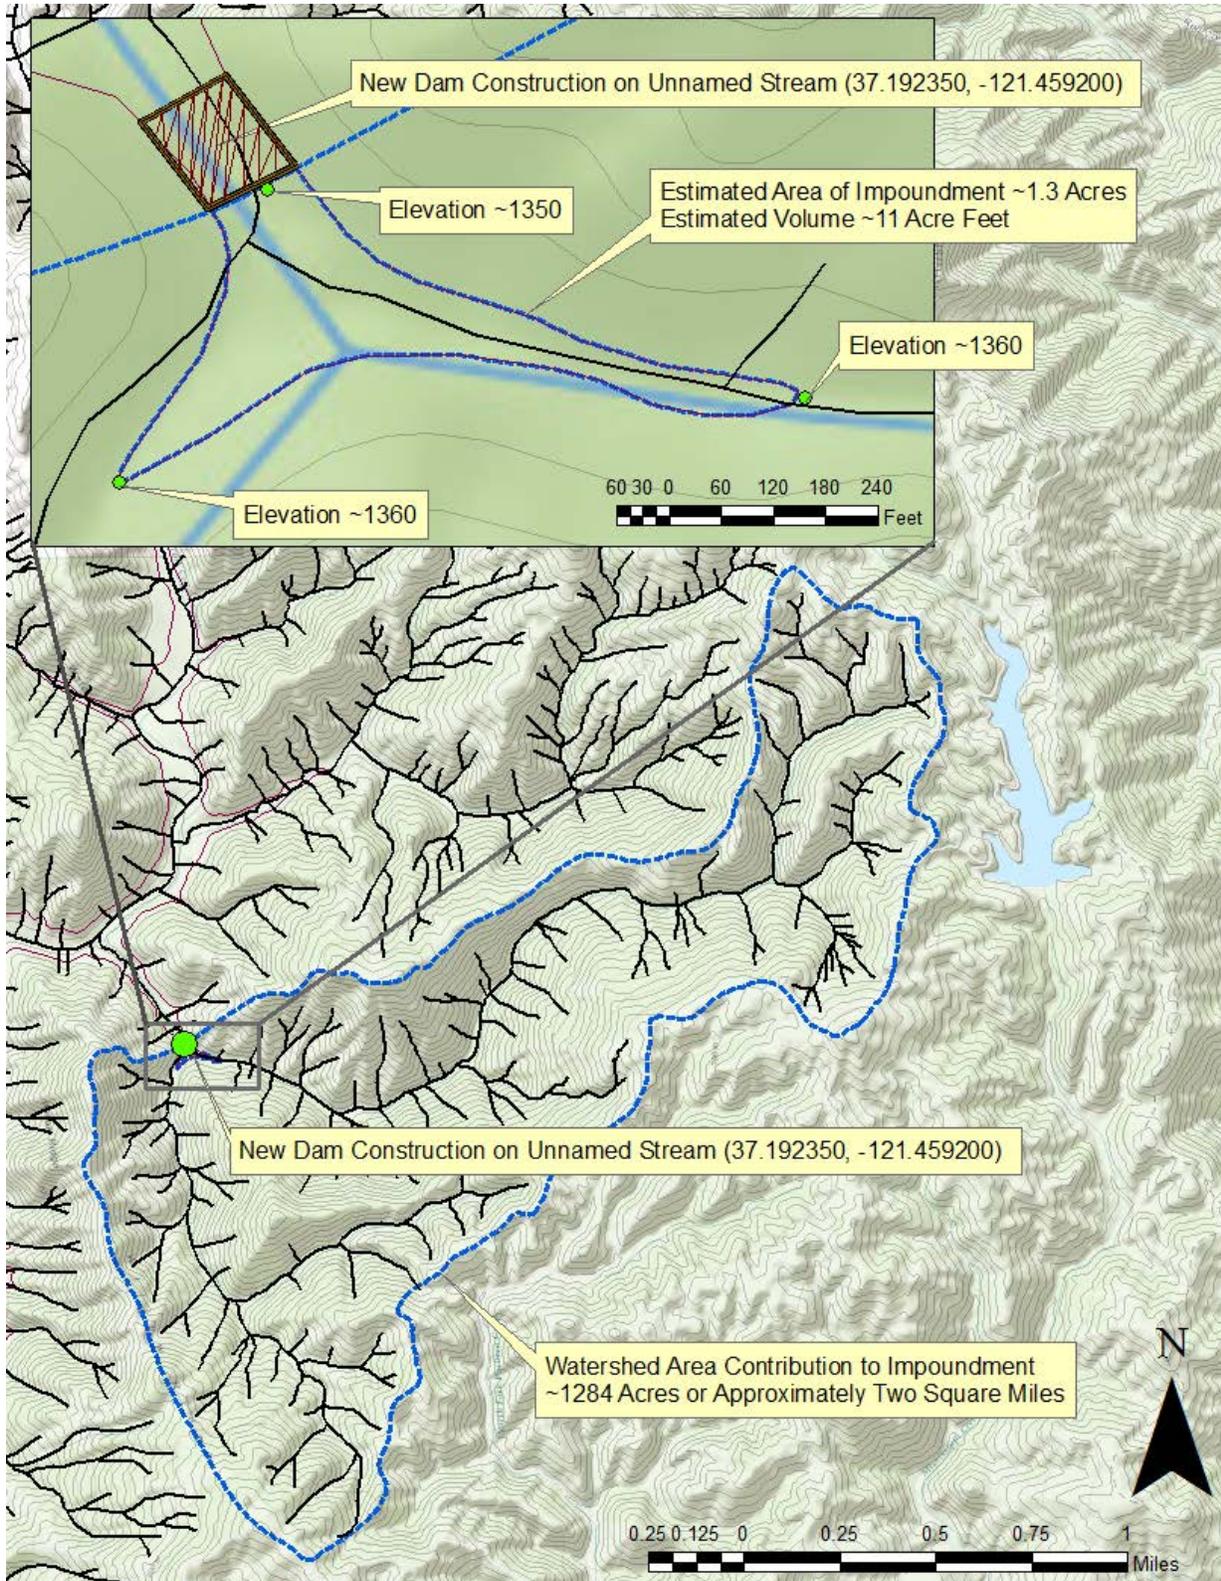
Figure 1: Estimated watershed with runoff that will contribute to storage behind the newly constructed dam. Inset is the estimated storage capacity of the impoundment at full stage.
