San Francisco Bay Beaches Pathogens TMDL

Project Definition

**SAN FRANCISCO BAY
REGIONAL WATER QUALITY CONTROL BOARD**

September 2013

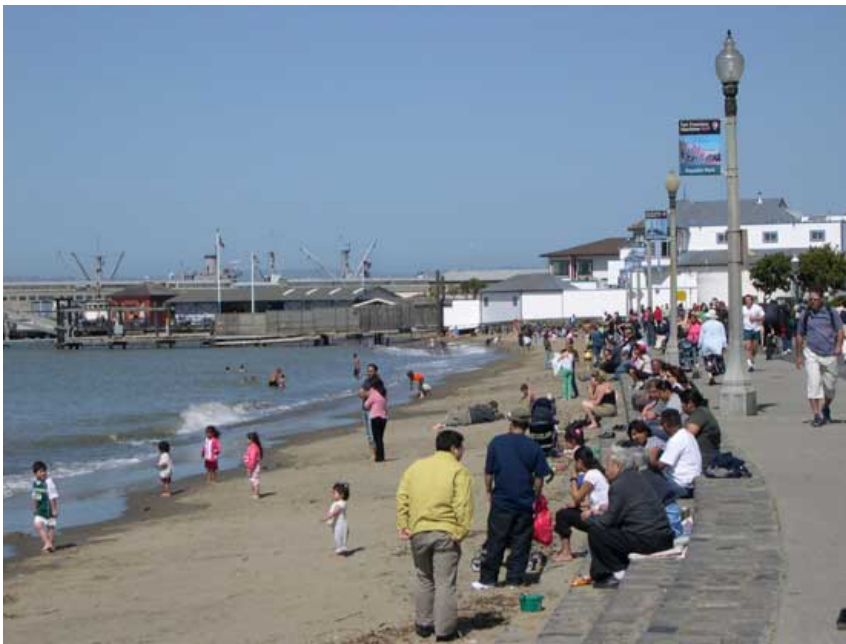
Aquatic Park Beach is located within the San Francisco Maritime National Historic Park. The beach lies within a horseshoe-shaped cove bounded by Hyde Street Pier on the east and the fishing pier on the west (Figure 2). Other features within this National Park include historic ships, such as the Balclutha on Hyde Street Pier and the Bathhouse building, which was built by the Works Progress Administration in the 1930s. After being used by troops in WWII, the Bathhouse building became home to the San Francisco Maritime Museum and the country's first Senior Center. The museum was operated by the San Francisco Maritime Association until it was transferred to the National Park Service in 1978 (National Park Service 2013).

Urban stormwater: Due to San Francisco’s combined sewer system and the topography of the surrounding area, only a small catchment discharges to Aquatic Park Beach. The outfall for this catchment is at the western end of the beach (Figure 2). Stormwater runoff from the Maritime Museum building and grounds, including the green roof over the building, also discharges to Aquatic Park Beach. Stormwater runoff from the remainder of the catchment flows to the SFPUC’s combined sewer system. The nearest combined sewer overflow discharge points are:

- At the western end of Gas House Cove (Figure 2). According to SFPUC personnel, there is rarely a discharge at this point (Chastain 2013b).
- At Baker Street, over one mile west of Aquatic Park Beach, a deep-water pipe discharges CSOs 290 feet off-shore.
- Near Pier 39, approximately one-half mile east of Aquatic Park Beach (Figure 2).

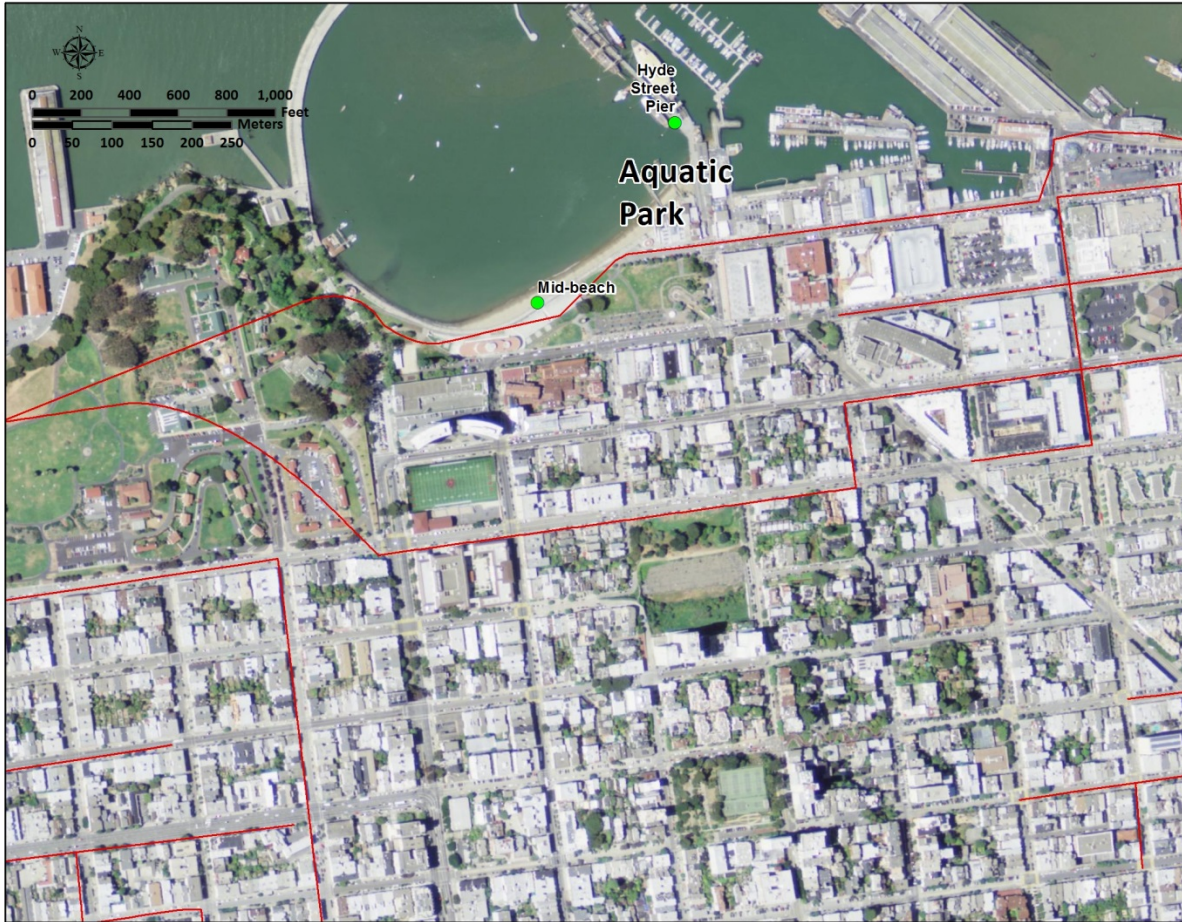
Figure 2. Aquatic Park Beach, San Francisco

SFPUC does additional sampling following combined sewage discharges (CSD), when designated water contact recreation areas that could be affected by a CSD are monitored daily until monitoring confirms that FIB levels are below water contact recreation standards. Signs are posted when monitoring shows an exceedance of standards and a website is updated to show when a CSD or a FIB exceedance occurs. As a precautionary measure, Aquatic Park is posted whenever there are widespread CSDs from SFPUC’s northshore outfalls (Figure 2) (Chastain 2013a).

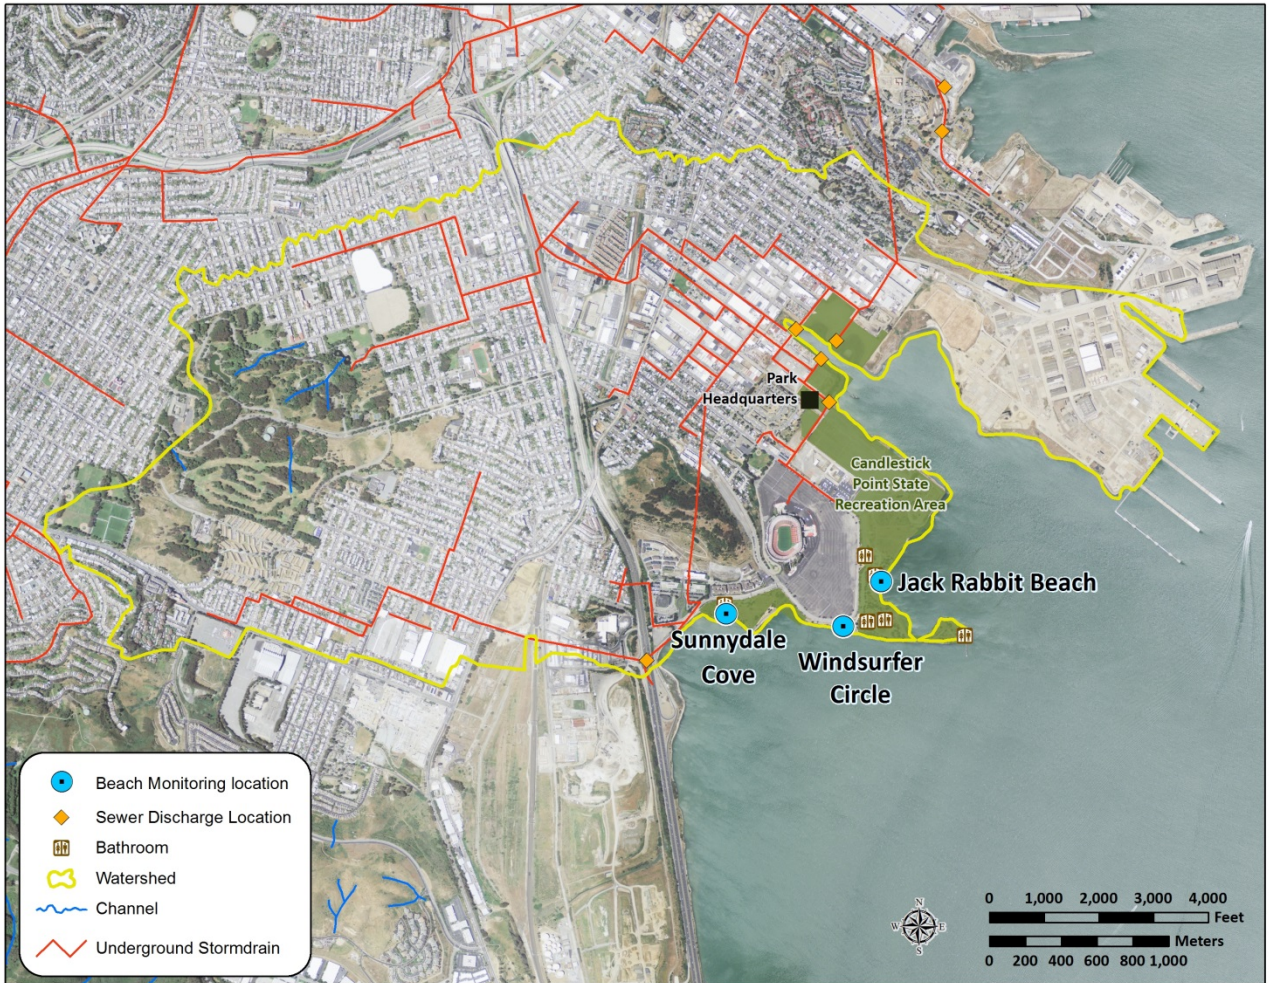
Figure 3. Candlestick Beaches

Urban Stormwater: A large portion of the urban area abutting Candlestick Point includes Visitacion Valley, a 720-acre area served by SFPUC's 100+ year-old Sunnydale combined sewer. Historically, this system frequently discharged untreated combined wastewater during storm events, but construction of the Sunnydale Transport/Storage (T/S) Structure and Pump Station at Harney Way near Candlestick Park in 1991 has greatly reduced the number of such discharges. When this system does overflow, the discharge is first routed through the T/S structure, which allows solids to settle and removes floating debris. The Sunnydale T/S structure has four outfalls in the vicinity of Candlestick Point, as shown in Figure 3.

In addition, Candlestick State Park contains seven restroom facilities (Figure 3). All the restrooms were built when the park was created in the mid-1970s and are plumbed to the SFPUC combined sewer system. Park personnel describe the restroom facilities as follows (Moises 2013):

Candlestick Point State Recreation Area is located at the southeastern tip of San Francisco, adjacent to Candlestick Stadium (Figure 3). The State purchased the land in 1973 and soon after turned it into a state recreation area, making Candlestick Point Park the first urban State recreation area in California. The park contains two fishing piers and three beaches: Jackrabbit Beach, Windsurfer Circle, and Sunnydale Cove. Windsurfer Circle in particular is a popular area for windsurfing because of strong winds.

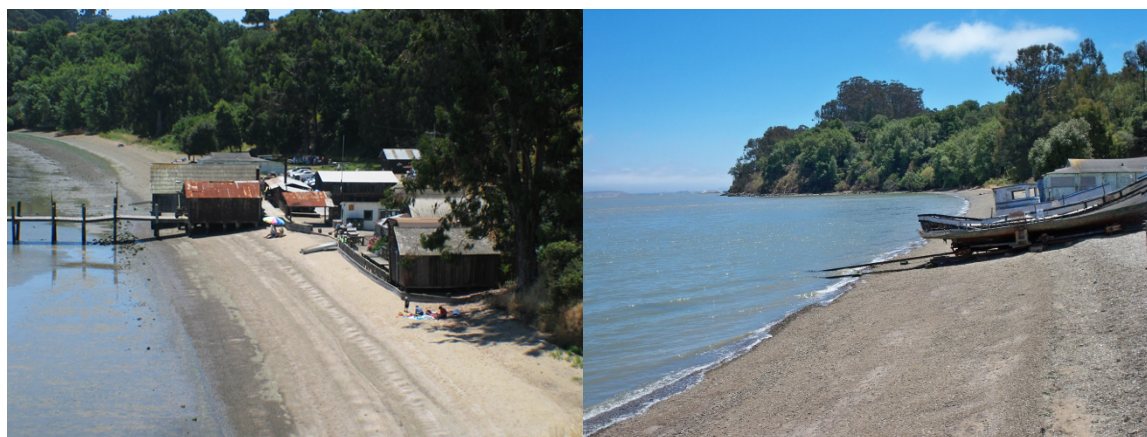
China Camp Beach is located within China Camp State Park, on the southwest shore of San Pablo Bay (Figure 4). A Chinese shrimp-fishing village thrived on this site in the 1880s, populated by nearly 500 people from Canton, China. In its heyday, there were three general stores, a marine supply store and a barber shop. A museum at China Camp Beach tells the story of these fisher-people.

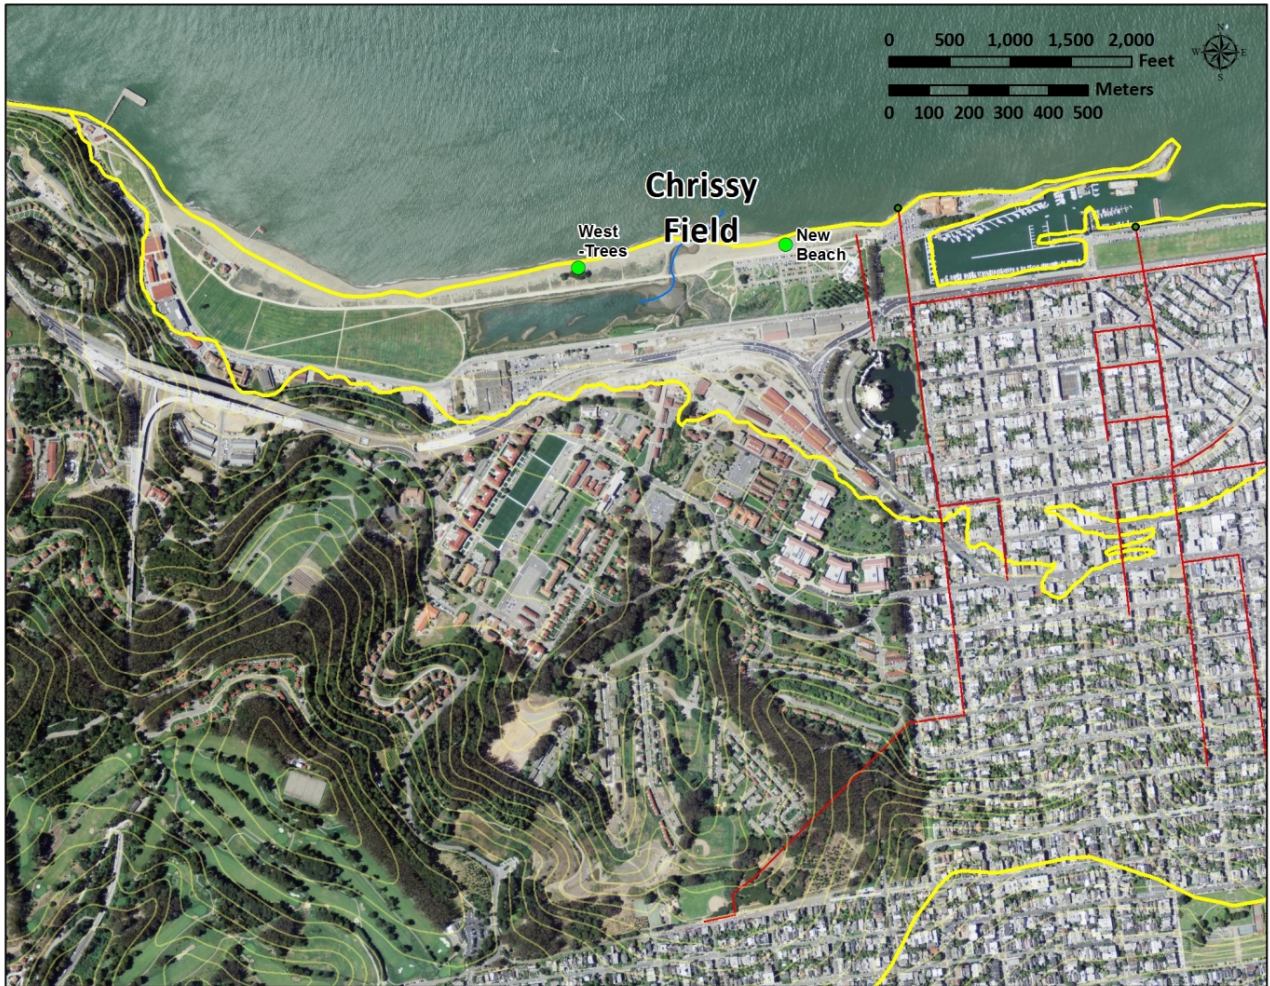
Figure 5. Crissy Field Beach and Sample Locations

Crissy Field Beach (Crissy Beach) is located within the Golden Gate National Recreation Area and within the Presidio (Figure 5). Boardsailing is a common water activity. General swimming and wading occur, but are limited by cold water temperatures and strong tidal currents. This two-mile beach includes two locations from which samples are collected to measure bacteria water quality. Sample results have shown that contact recreation uses of waters at Crissy Beach are impaired by pathogens, particularly the data from the eastern sample location.

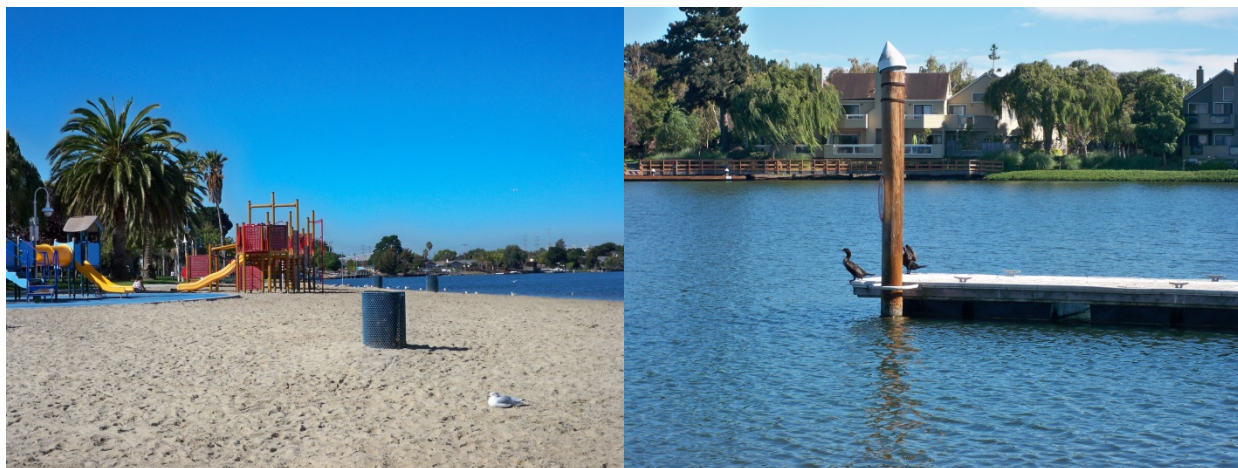
Two beaches are located on the Lagoon (Figure 6). Lakeshore Park, located at 1500 Marina Court, has beach access to the Lagoon as well as picnic areas, a playground, basketball courts, and a baseball diamond. Parkside Aquatic Park, with a sandy beach for swimming, is located at the end of Seal Street. This park offers kayaks, sailboats and stand up paddle surfboards for rent, as well as a boat ramp.

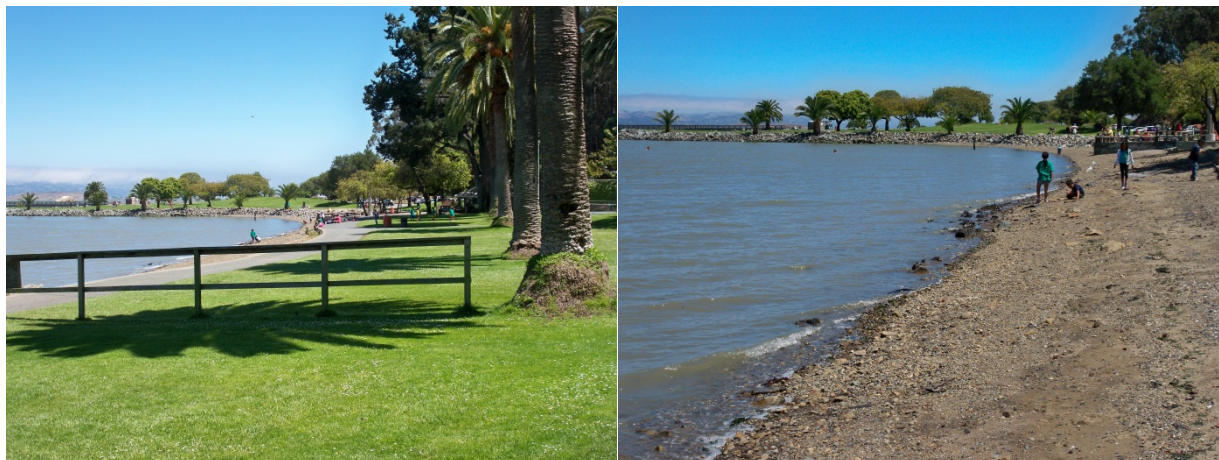
McNears Beach is located on San Pablo Bay within the 55-acre McNears Beach Park, a popular park operated by Marin County Parks (Figure 7). The one-mile long beach is used for swimming, wading, and fishing, and by kayaks and canoes. The surrounding park offers adult and toddler swimming pools, tennis courts, grassy play areas, and a fishing pier, as well as shower/changing rooms and restrooms. Dogs are not permitted in McNears Beach Park.
