**1997 JRP Historical Consulting Services Report: Peyton Marsh Drainage System**

## **Inventory and Evaluation:**

**Peyton Marsh Drainage System,  
Contra Costa County, California**

**June 1997**

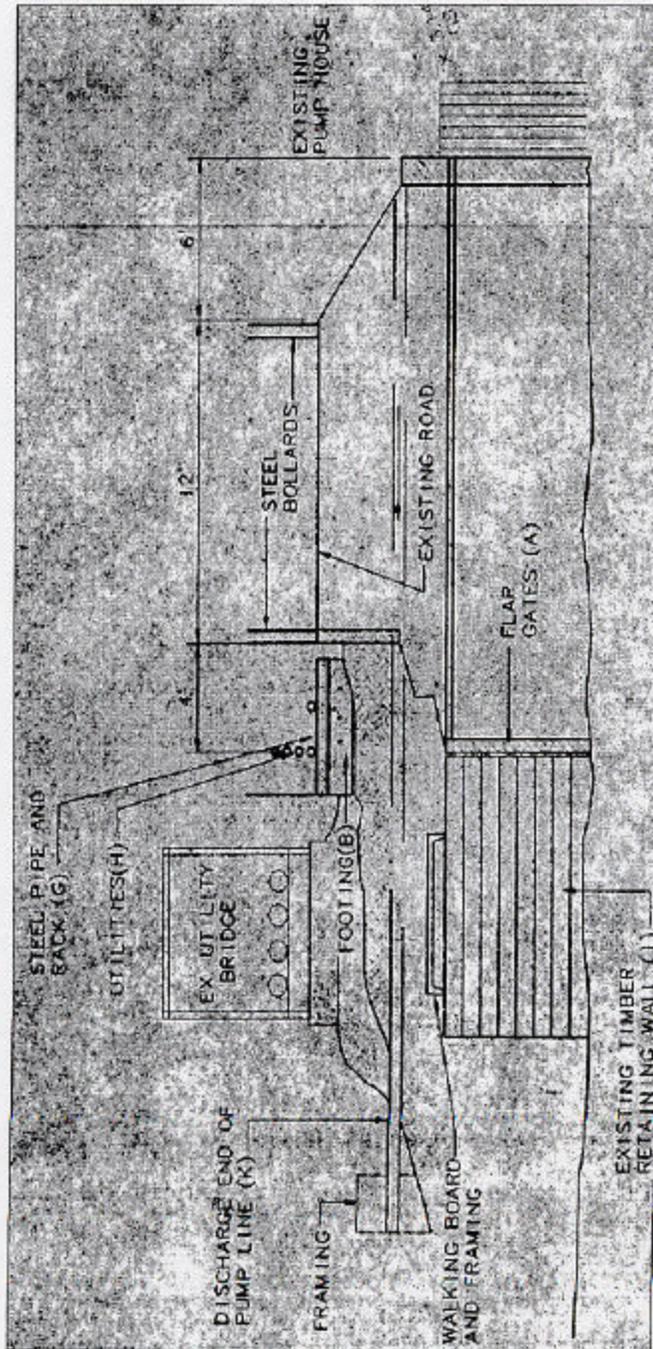
**Figure 4: Peyton Marsh Tide Gate Structure**

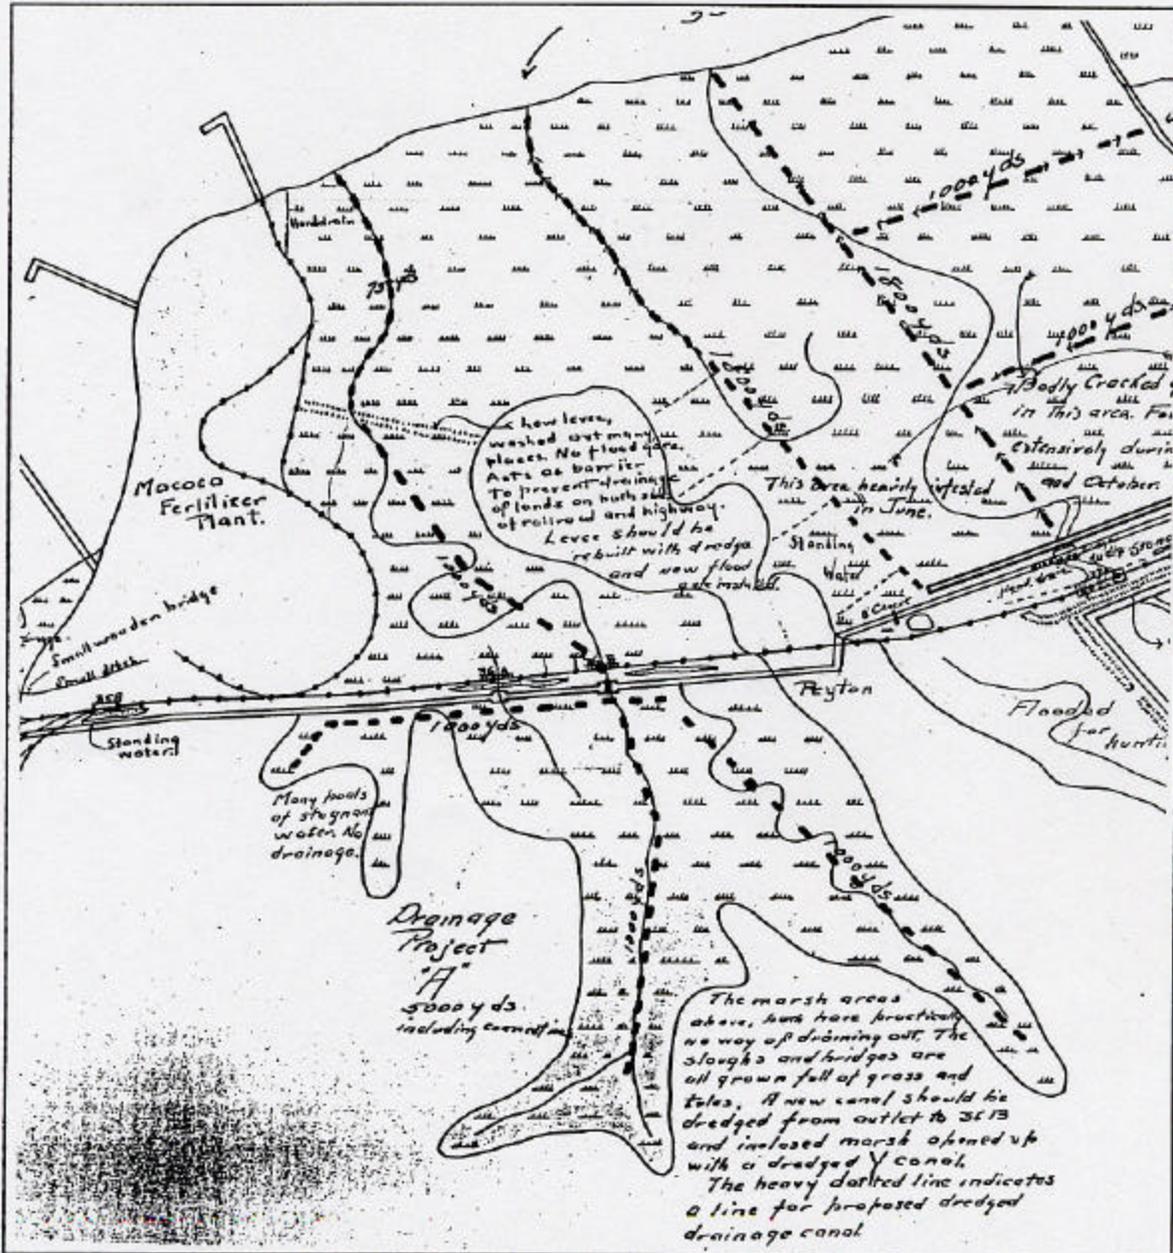
Figure 6: Detail of Stover's drainage plan for Peyton Marsh, 1927.

Stover's recommendation for drainage of Peyton Marsh included three key elements: the rebuilding of the old levee; installation of a network of drainage channels; and installation of a tide gate structure at the western end of the rebuilt levee (Figure 6). The new higher levee would be about 1,500 feet long and follow the alignment of the older dike. Stover's designs called for dredging an 18 foot-wide, 4.5 foot deep, 1,000 yard long channel from the gates southeastward to the culvert under the railroad. South of the railroad, the channel would be dredged to branch into the three reaches of the marsh. Finally, one-way flap-type tide gates installed at in the new levee would allow water in the marsh to flow through the drains and out to the bay at low tide and close at high tide to prevent re-flooding of the area. Stover specified that the tide gates in the levee across Peyton Slough would consist of two Model 100 California Corrugated Culvert Company (Calco) 60-inch diameter automatic drainage gates. The gates came attached to 35 feet of corrugated metal culvert. A concrete and timber box structure set into the levee framed the gate-culvert elements, which Stover estimated could carry 500 cfs of drainage water at low tide.<sup>23</sup>

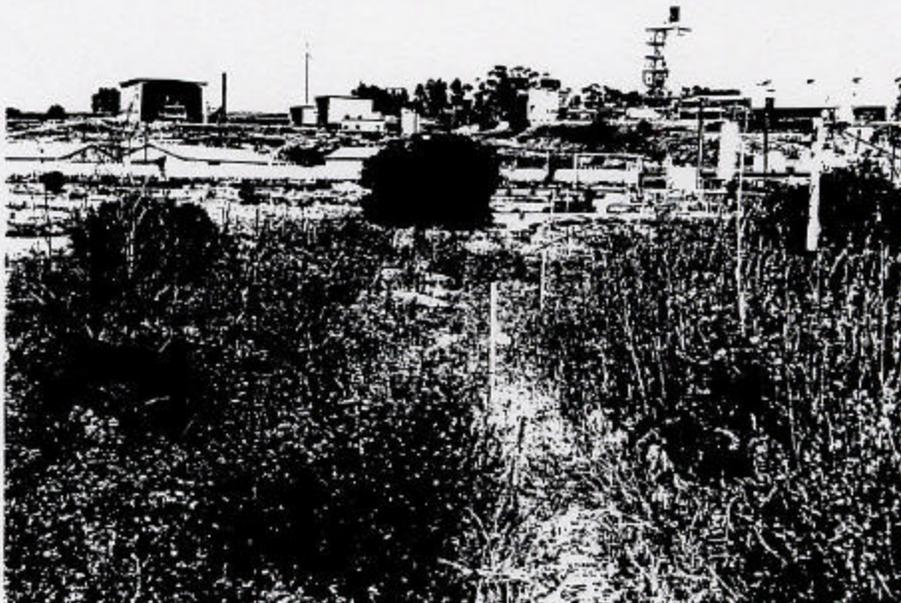
**Photograph 1.** Deteriorated East Levee, location indicated by white stakes. Rhône-Poulenc Basic Chemicals, Inc. facility in background, camera facing west.

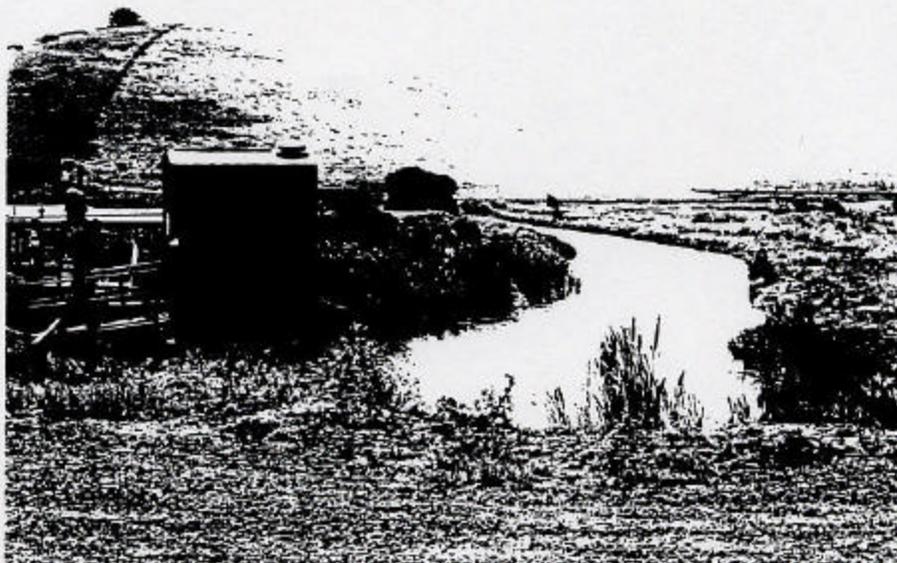
**Photograph 2.** Main Peyton Marsh drainage channel, camera facing east. Pump house near tide gate intake appears to left and Peyton Hill in background.

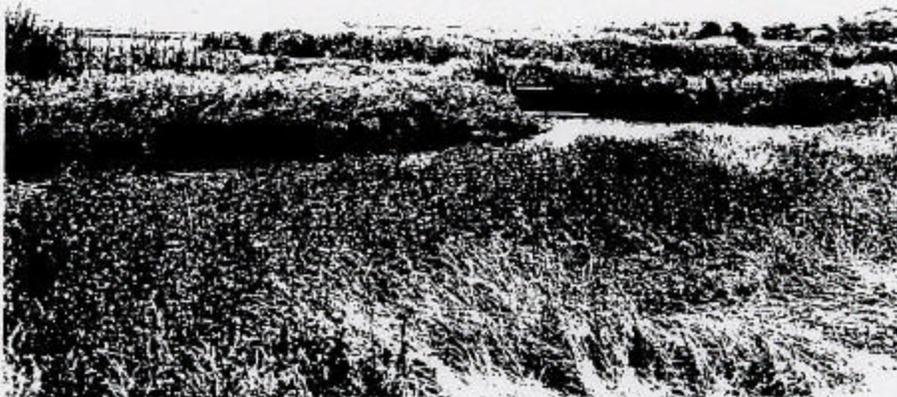
**Photograph 3.** Drainage channels in Peyton Marsh near meeting point of the three reaches. Camera facing southeast.

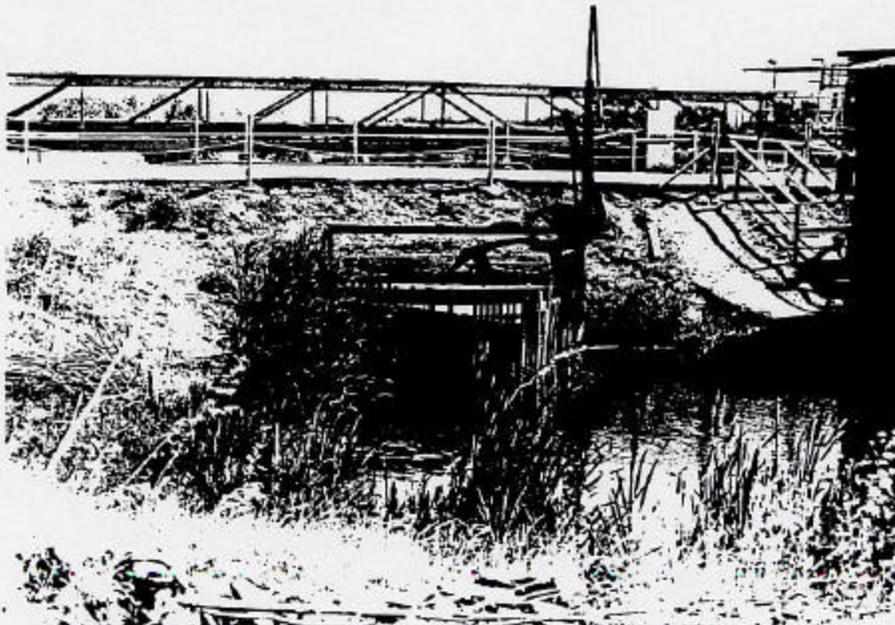
**Photograph 4.** Intake (south side) of tide gate structure showing trash rack, or grizzly, at water level and utility bridge on the north side. Camera facing north.

Recent work on the Peyton Marsh drainage system includes dredging the slough from the gates to the bay in 1988 and installation of a new timber grizzly, or trash grate at the south side of the gate structure. The pump discharge pipe rusted through, so the district has also recently placed a 10" diameter plastic pipe inside the old metal pipe to stop water losses between the pump and the discharge point. Furthermore, the easternmost tide gate failed in 1995 and the district replaced it with a similar 60" flap gate bearing the "HYDRO" manufacturers mark.<sup>41</sup>

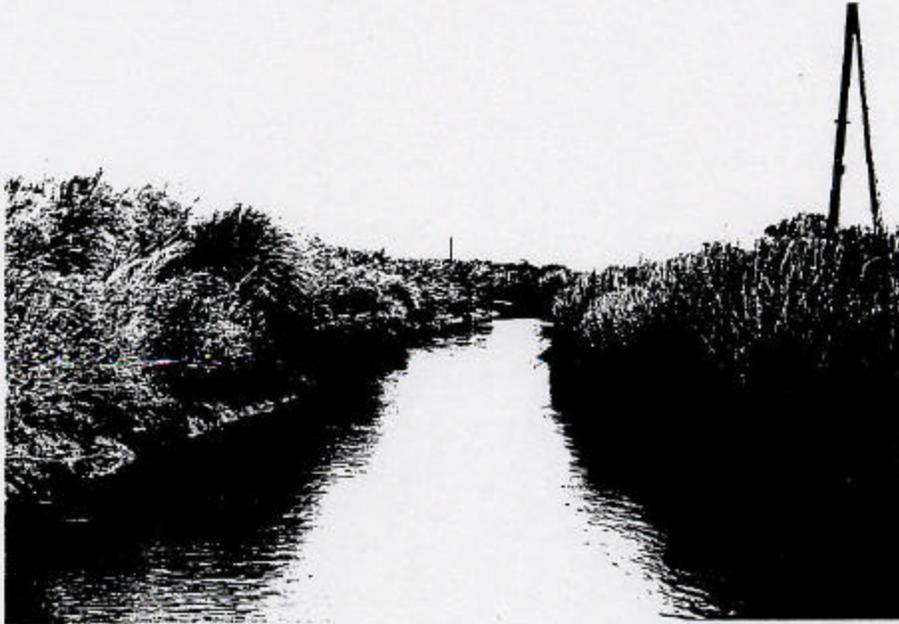
Photograph 5. Peyton Slough. Taken from tide gate structure, camera facing north.

gates.<sup>29</sup> The abatement district was especially diligent in cleaning and dredging Peyton Slough from the gates to the bay. In his 1929/1930 fiscal report, Stover explained that "there is a continual depositing of silt in this channel through the summer months, and it is necessary to remove this in order to allow the gate to flow down to the bottom." Ten years later Superintendent Campbell noted that Peyton Slough, "from the tide gate to deep water has had to be de-silted with floating dredge every two years." As early as 1935 Stover suggested moving the Peyton gates closer to the bay to eliminate the need for dredging the slough every spring, however, the district never followed up on this proposal. Stover's successor, Ernest Campbell, noted that dredging Peyton Slough continued to be the regular practice for this area during the 1940s, even though he also supported the idea of moving the gates closer to the bay to eliminate the need for this work.<sup>30</sup>

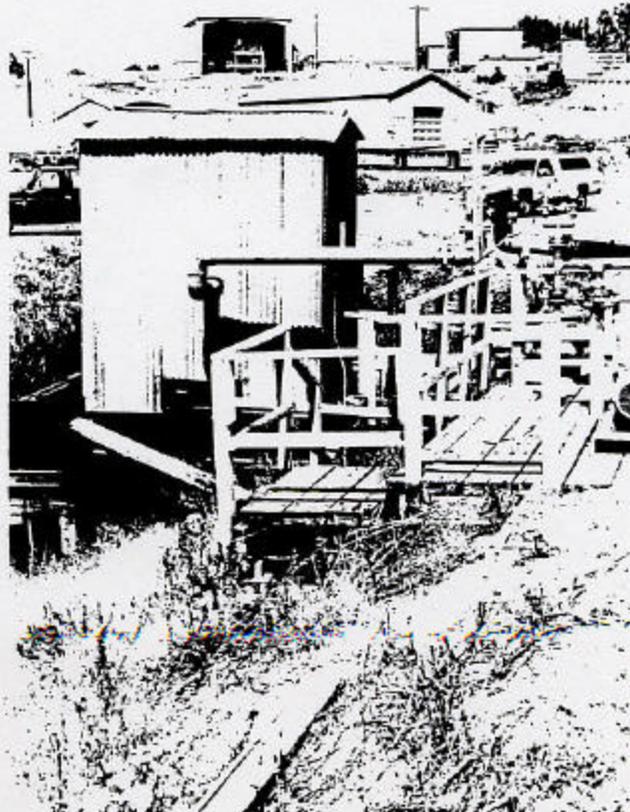
**Photograph 8.** Pumphouse,  
south side of tide gate structure.  
Camera facing west.

The materials, or physical elements used in the drainage system have been altered as well. The box culvert, and possibly the flap gates, were completely rebuilt and replaced in 1940. The district also added a pumphouse and pumping equipment, including a discharge pipe that runs through the levee, to handle the increased discharges into the marsh. This addition changed the design of the outlet and altered the function of the gates, as well as introducing new materials to the gate superstructure. Later, the pump discharge was further altered by the installation of a plastic pipe inside the existing metal pipe. It is possible that neither of the flap gates is of original design. Certainly, the easternmost tide gate, which failed in 1995, has been replaced with another flap gate of the same dimensions, but of different manufacture. Without integrity of materials, the workmanship, or physical evidence of the skill involved in constructing this resource has also been compromised.

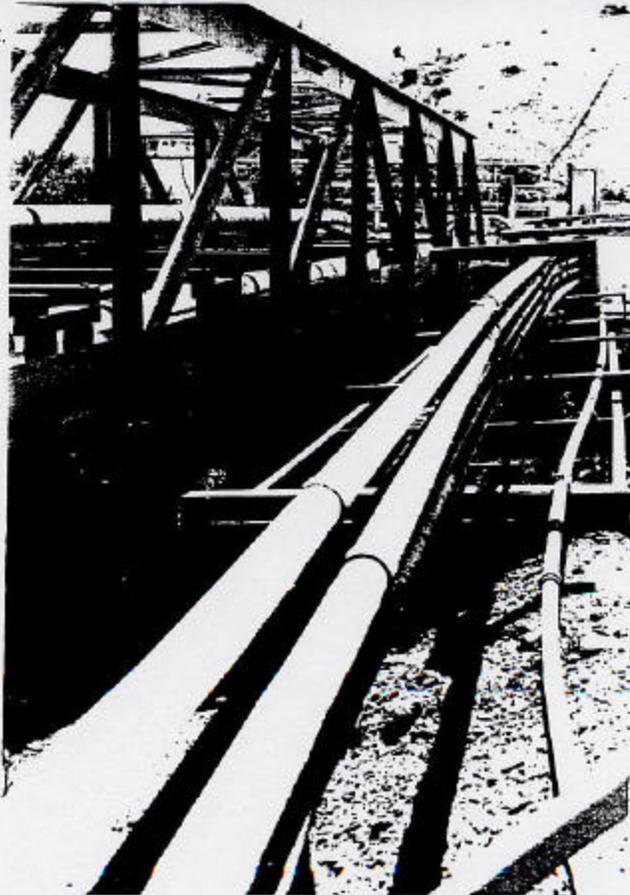
**Photograph 10.** Detail of utility bridge and pipelines on north side of tide gate structure. Camera facing east.

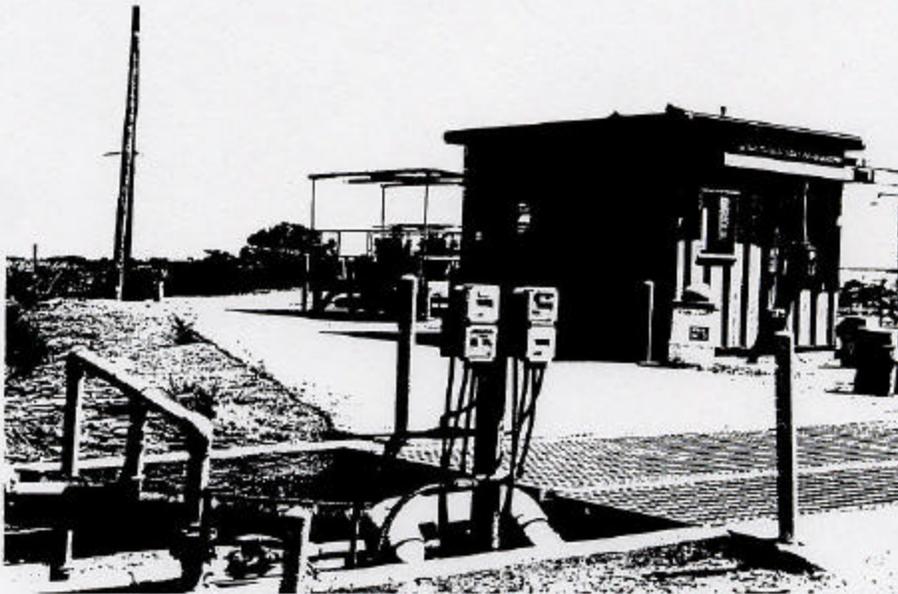
**Photograph 11.** Rhône-Poulenc Basic Chemicals, Inc. waste water treatment facility, east side of tide gate structure. Camera facing north.

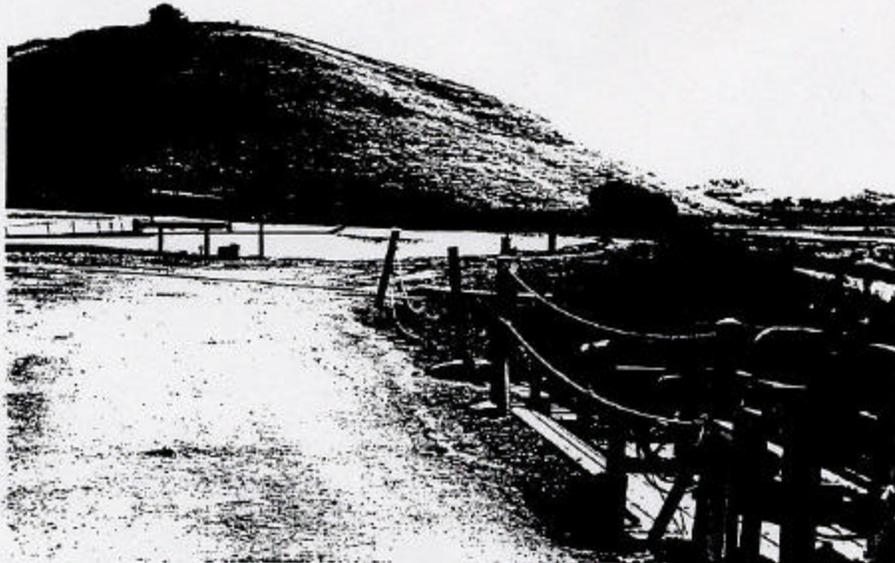
**Photograph 13.** Rhône-Poulenc Basic Chemicals, Inc. waste water treatment containment pond. Taken from center of roadway over tide gate structure, camera facing east.
