**UPPER NEWPORT BAY ECOSYSTEM RESTORATION PROJECT
POST-RESTORATION MONITORING PROGRAM**

VEGETATION MONITORING

**ANNUAL REPORT
YEAR 5 – 2015**

**UPPER NEWPORT BAY ECOLOGICAL RESERVE
ORANGE COUNTY, CALIFORNIA**

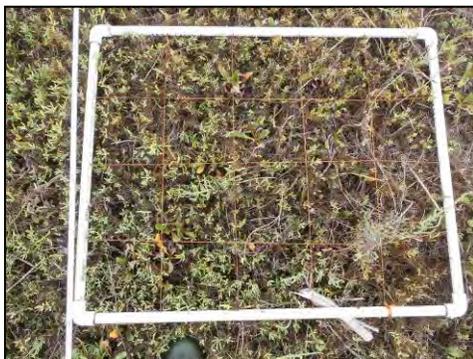
Gridded quadrat for determining percent cover.

Each plot was analyzed using a rectangular quadrat 0.5 square meters in area. The quadrat was gridded with twine to form 20 squares. At each selected plot point, the lower left corner of the quadrat was placed at the measuring tape marker (e.g., the 100-foot mark), to the right of the tape. The percent cover of each species present within the quadrat (plot) was estimated in the following way. Each of the 20 squares was examined. If a plant species covered more than half of a given square, it was considered to be 'present' in the square and to represent 5% cover within the quadrat. If it covered less than half of the square, it was not counted. Each of the 20 squares was inspected for presence/absence of the species, and the resulting coverages totaled in 5% increments for a maximum of 100%. If a species was present in only one of the twenty squares, and in less than half of it, it was marked down as 'trace', meaning

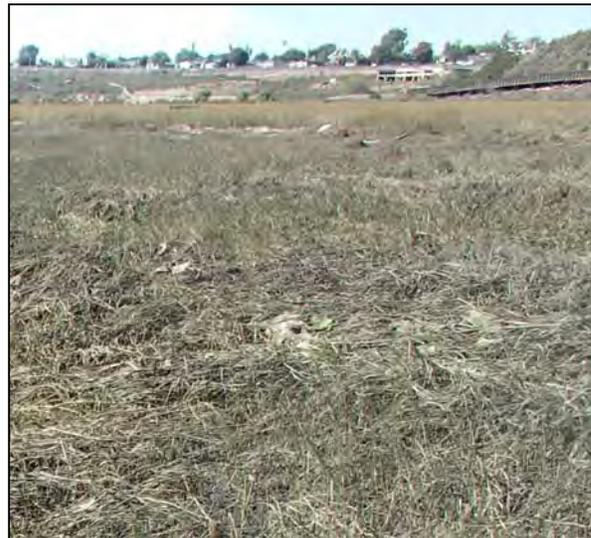
Cordgrass northeast of New Least Tern Island.

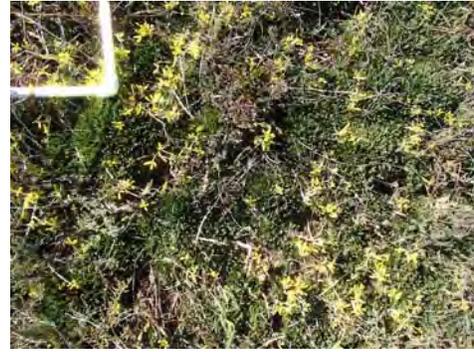
Expanding colonies of the invasive non-native Algerian sea lavender (*Limonium ramosissimum*) were noted in several locations in the salt marsh on the eastern side of the main channel, generally on elevated and disturbed areas in the middle and high marsh. No quantitative assessment was made of its extent, but it appeared to have expanded since the last observations made by the monitoring biologist in 2012. In San Francisco Bay and Carpinteria Marsh this species has been shown to rapidly displace native marsh species (Archbald 2011). Archbald reports that this species prefers disturbed areas of high marsh habitat, including areas disturbed to facilitate restoration. A colony of several hundred plants has become established on the upper edge of the salt marsh that has developed on the Shellmaker Island Mudflat created by the restoration. CDFW made a few pesticide applications to treat Algerian sea lavender in 2015 and plans to do additional treatment in 2016. The extent of this plant at UNB is still limited enough that an eradication effort could be implemented at UNB. It would require a comprehensive mapping of infested areas, repeated treatment, and long term monitoring.

Non-native *Limonium ramosissimum* in the marsh.

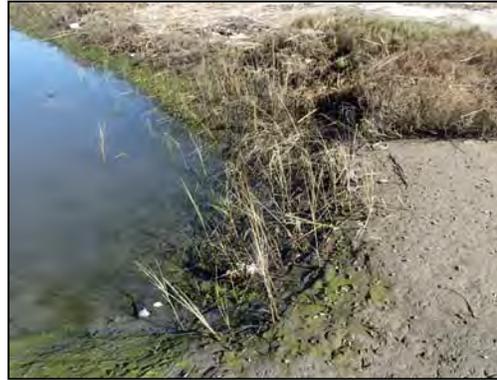
The 2015 assessment of the cordgrass transplanted in November 2009 on the shoreline of New Least Tern Island found little change from conditions in Year 3 (2013). The only persisting planted patches were on the west slope of the island, where the sandy shoreline has eroded to expose a mud base more suitable for cordgrass growth than the other shorelines of the island. Field measurements of the cordgrass patch dimensions estimated a total area of approximately 36 square meters, growing at elevations between +2.5 and 3.5 feet MLLW. Similar to much of the cordgrass in UNB, the transplanted cordgrass was sparse. As noted in 2013, none of the transplanted cordgrass on the south shore remained. It is unlikely that cordgrass will ever establish on this windward shoreline due to the intense wind wave exposure, and the sandy nature of the substrate. The limited areas of sandy substrate elsewhere in UNB also do not support cordgrass. It should continue to persist on the west side of the island, where substrate and wave exposure are most suitable, though there is limited additional area for expansion in this area.

Cordgrass six years post- transplant on the west shore of New Tern Island.

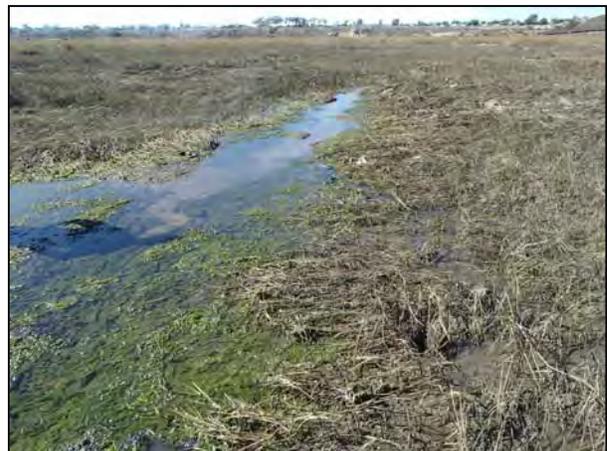
The low marsh was dominated by cordgrass and pickleweed (*Sarcocornia pacifica*), with average percent covers of 47% and 12%, respectively (Table 2). *Jaumea* (*Jaumea carnosa*) and saltwort (*Batis maritima*) were present in lower percentages. A total of seven native species was recorded in the low marsh. Table 3 shows that cordgrass occurred in 78% of the low marsh plots, with pickleweed and saltwort present in 45% and 40% of low marsh plots, respectively. The other four native species were present in lower frequencies in the low marsh plots. The total percent vegetative cover in the low marsh, including overlap of multiple species, was 85.3%.

Dead and thinned cordgrass NE of New Least Tern Island.

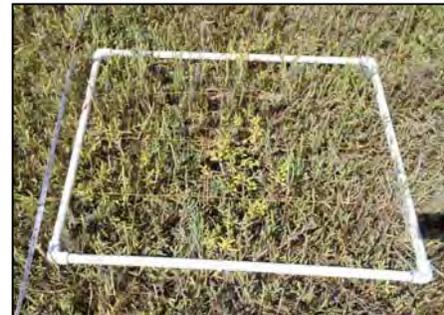
As was noted in 2012 (Year 2), much of the middle marsh in UNB was notably short in stature and sparse, due to both the dominance of low growing species such as jaumea and saltwort, and to the highly reduced growth habit of the pickleweed. In many places the pickleweed ranged in height from 20 to 40 centimeters and individual plants had simple structure, with very little branching. Although taller, more dense areas of pickleweed are present in UNB, similar to that found in other salt marshes regionally, the most common growth morphology of pickleweed along the transects was short and sparse. In particular, large expanses of middle marsh on Middle Island and Upper Island have this appearance. This condition is not a result of the Restoration Project, but more likely related to localized soil conditions that dictate species composition and plant growth, or poor drainage that increases the inundation duration. This low growing mix of salt marsh plants provides little canopy for nesting by state endangered Belding's Savannah sparrows (*Passerculus sandwichensis beldingi*), which relies on salt marsh habitat for nesting. The most recent Belding's Savannah sparrow breeding survey reported the majority of nesting activity occurring instead in the more limited high marsh of Upper Newport Bay, between New Least Tern Island and Jamboree Road (Zemba et al. 2015).

Middle marsh on T8, showing low stature.

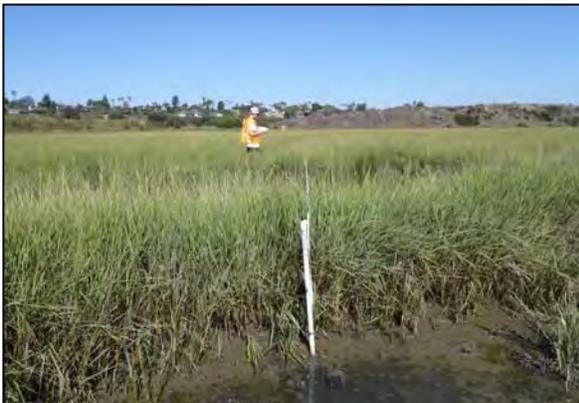
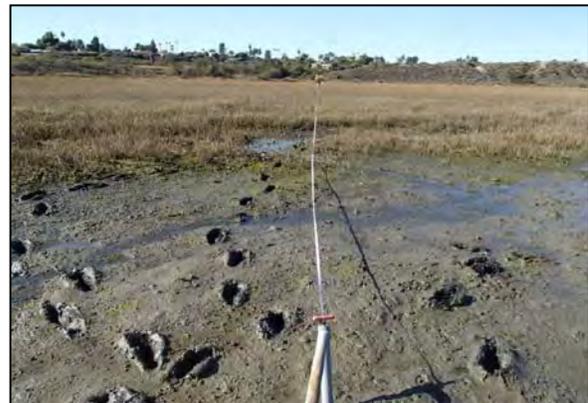
A comparison of low marsh habitat at the start of Transect 6 in September 2012 (left) and in November 2015 (right).

From Year 2 to Year 5, the low marsh dropped in total vegetative cover from 126% to 85%, with overlap of species. In Year 2, cordgrass occurred in 98% of the plots, with an average cover of 75%. In Year 5, cordgrass occurred in only 78% of the plots, with an average cover of 47%. Photos 11 and 12 in Appendix C exemplify changes seen in the low marsh. Photo 12 shows robust cordgrass and pickleweed in 2012, while Photo 11 shows the same marsh dominated by jaumea, with sparse cordgrass and pickleweed remaining.

The loss or thinning of cordgrass is likely related to extended periods of inundation resulting from elevated sea level during the strong El Nino conditions in 2015. Data collected by NOAA tide gauges and NASA satellites have shown that average water levels on the west coast of California for October 2015 were 0.15 – 0.23 meter (6 to 9 inches) above normal (Ocean Protection Council 2015). The cordgrass may be experiencing continued excess inundation as large winter storms have hit the region during the 2015-2016 winter, which were expected to add an additional 0.3 to 0.6 meter of sea level excess. This loss of cordgrass within the salt marsh habitat was not as evident in the habitat mapping effort because the cordgrass is still largely present and visible in the July 2015 aerial imagery. Closer inspection during the transect monitoring revealed its less functional condition, with large areas of dead plant material laid down and the remaining growing plants sparsely distributed and short in stature. It should be noted though that there were areas where the cordgrass was robust even on the lower edges of the mudflat.
