Contract 01-230-55-0  
Refugio State Beach  
Final Report  
Submitted by California State Parks, Channel Coast District

# Refugio State Beach Clean Beaches Project Map

## Refugio State Beach

### Septic System Improvements & Passive Treatment for Park Runoff

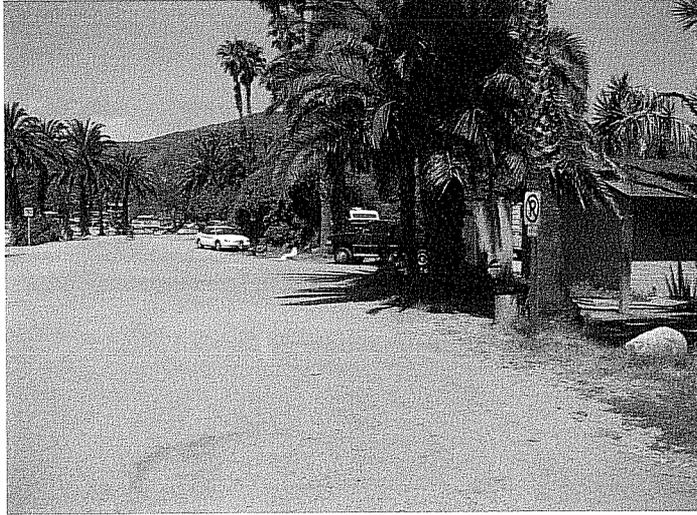
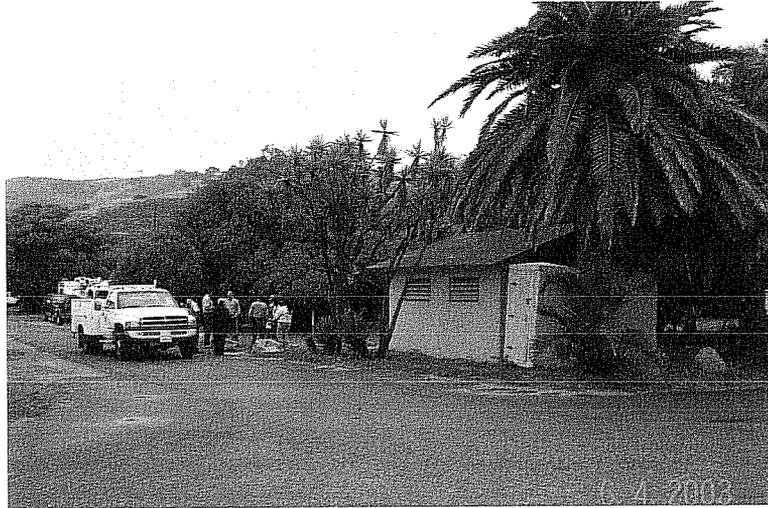
**Original Location Restroom #5**

- Demolition of Comfort Station #5, aged redwood septic tank and outdoor shower
- Re-location of facility inland
- Replacement with Combo building including toilet, indoor hot water showers, outdoor “beach” shower, septic tank, bio-filters and sandtrap

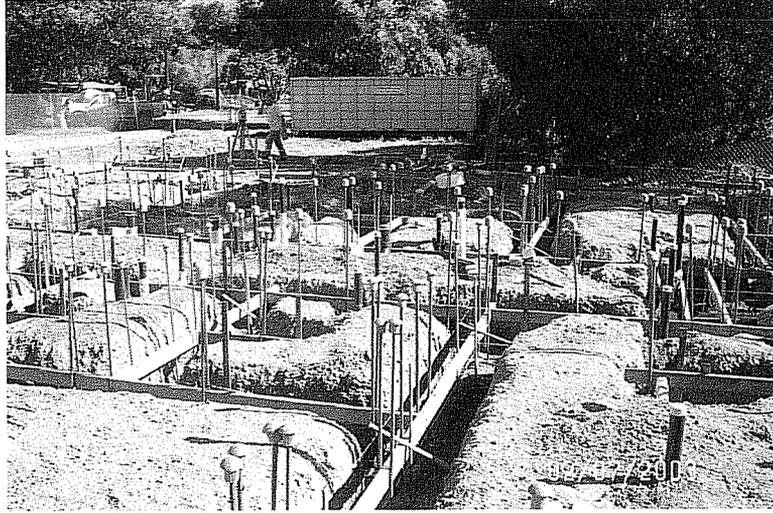
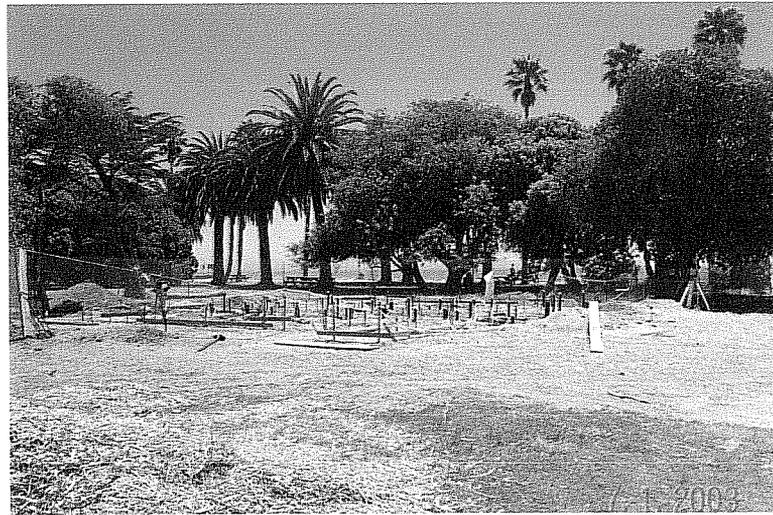
**Footings Set-up Combo #5**

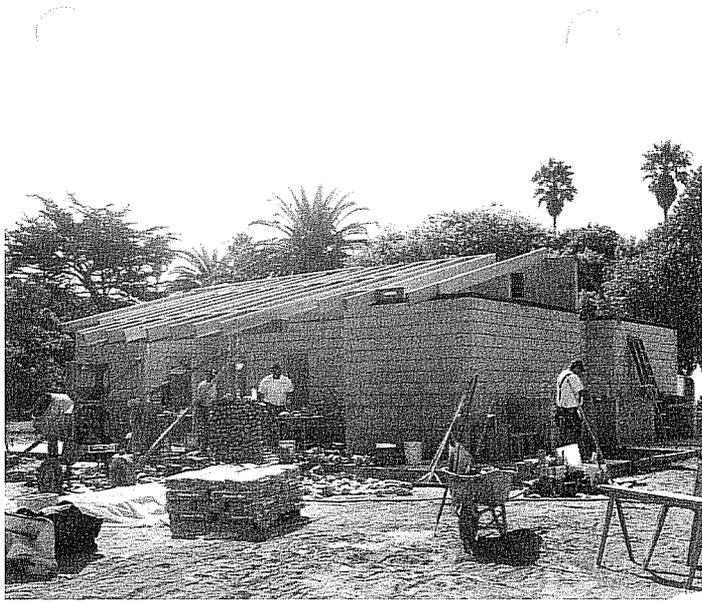
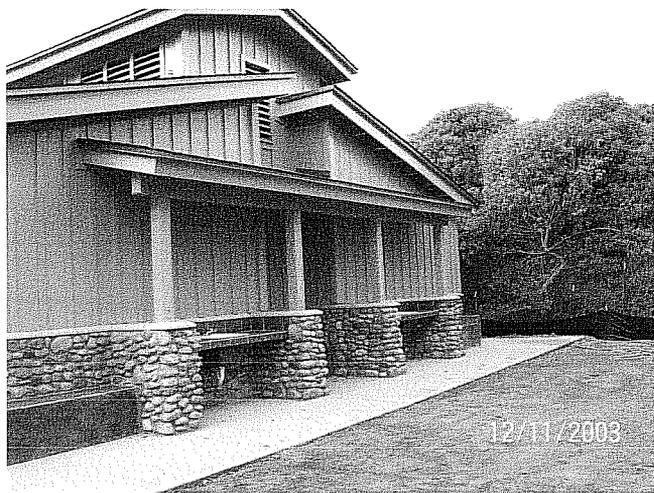
**Block Wall and Roof Framing #5  
Completed Building**

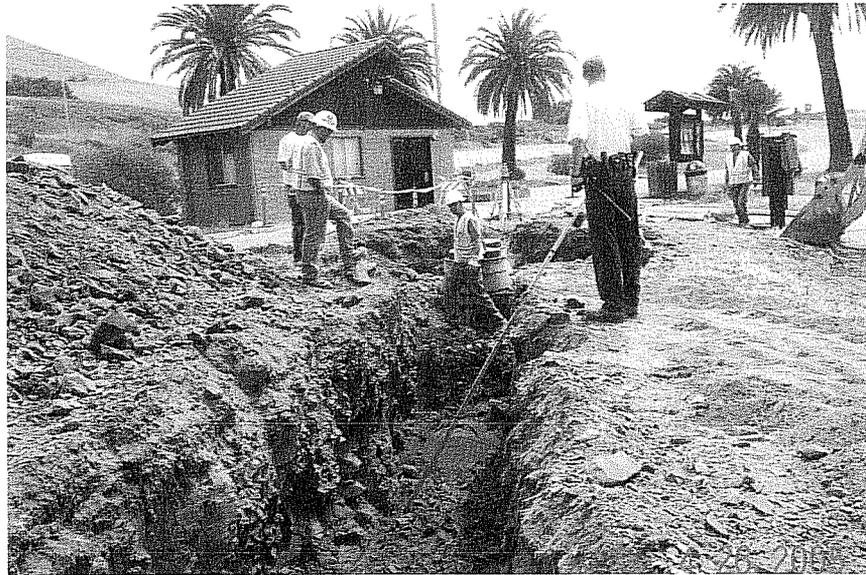
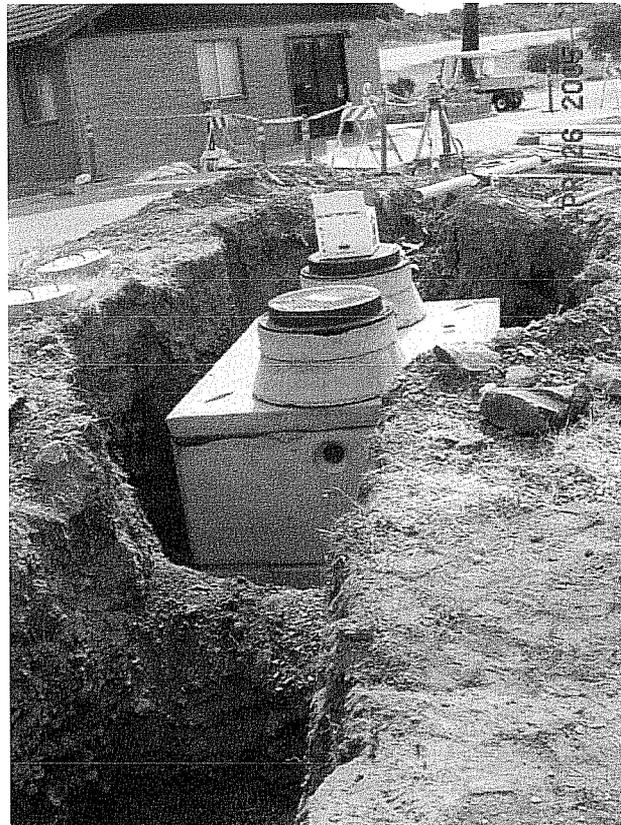
**Trenching at Kiosk for Septic Tank and Leachfield**

- Demolition of holding tank
- Installation of septic tank and leachfield

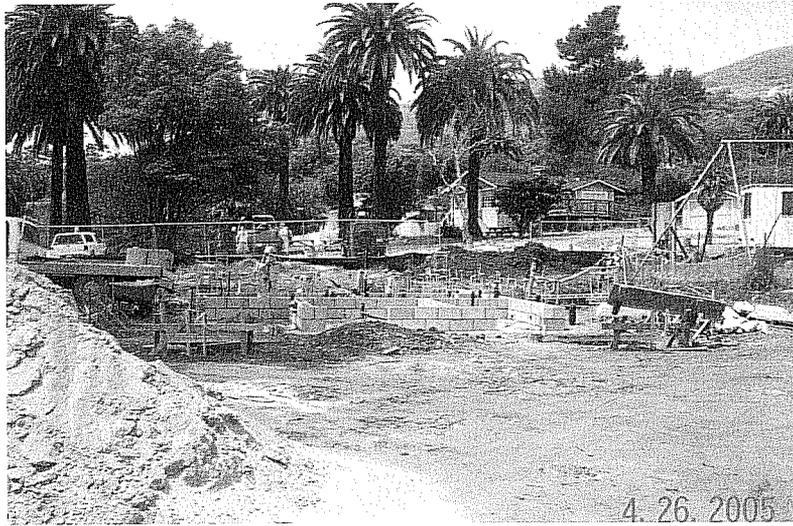
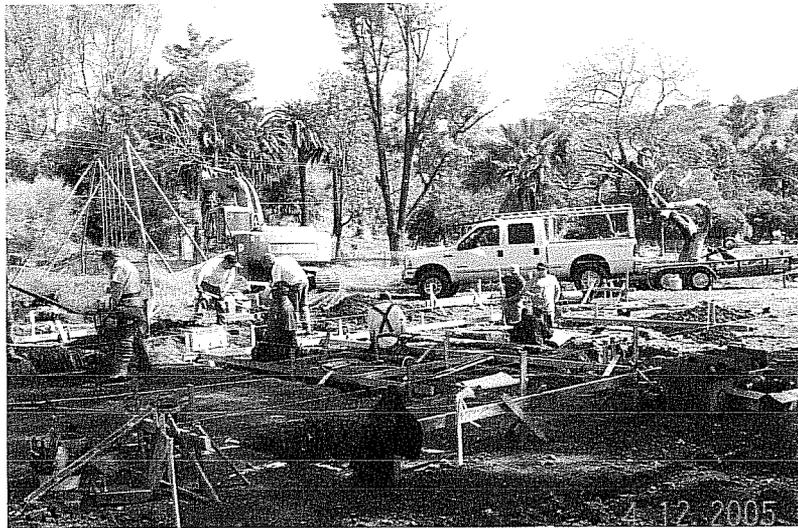
**Site of Restroom #1 – Day Use**

- Demolition of Comfort Station #1, aged redwood septic tank and outdoor shower
- Facility footprint downsized and septic tank moved inland of facility
- Replacement of comfort station with new building including toilets, outdoor “beach” shower, septic tank, bio-filters and sand-trap

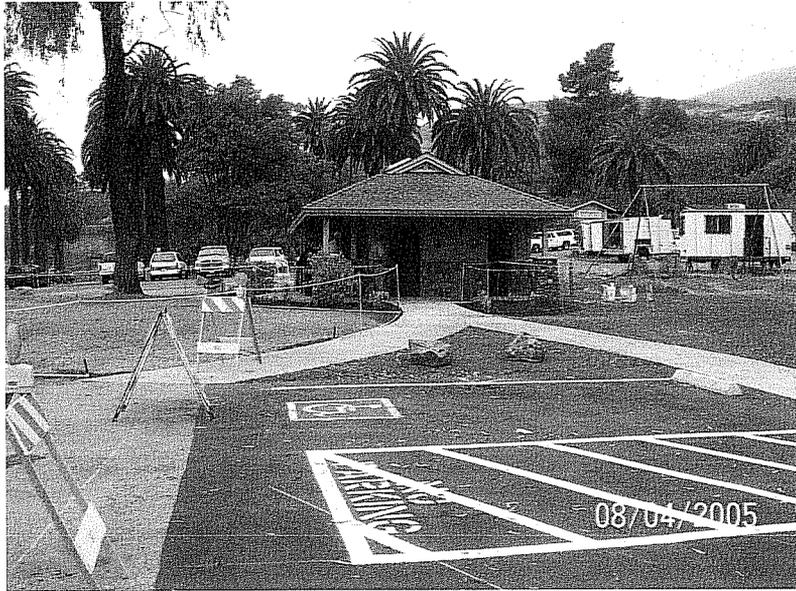
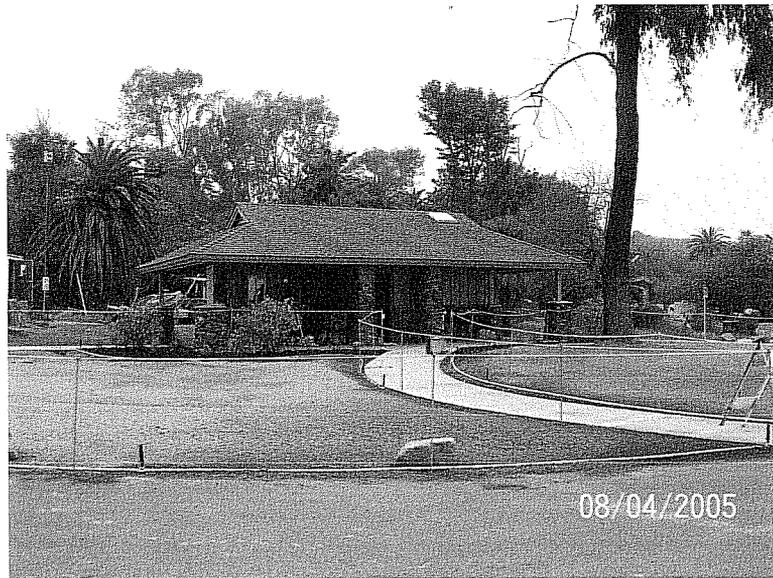
**Completed Restroom #1**

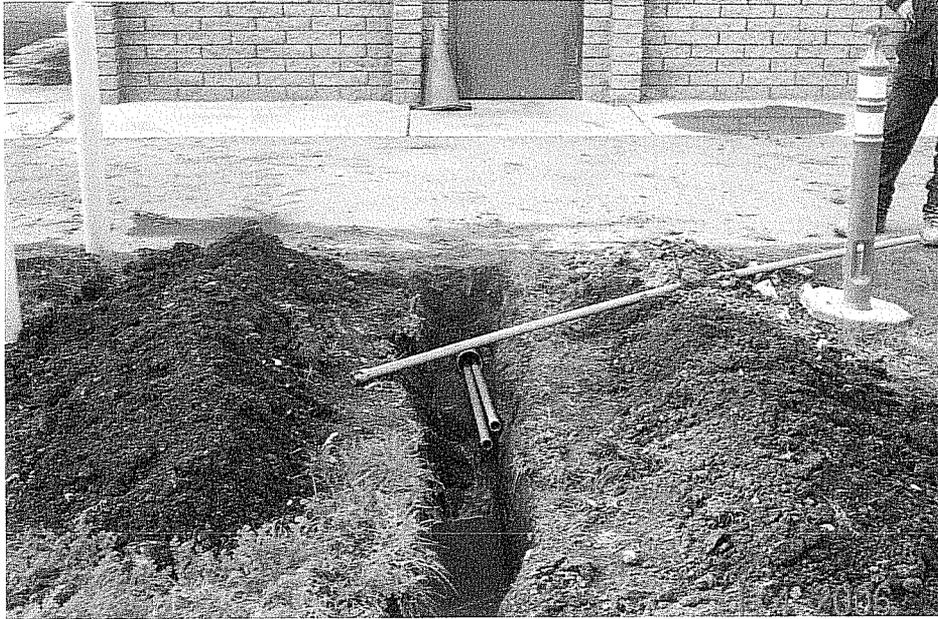
**Trenching for Bio-Tube Alarms**

- Replaced cracked and thinning covers
- Installed missing T valves
- Installed bio-filters in remaining 5 tanks to process effluent prior to discharge into the leach lines

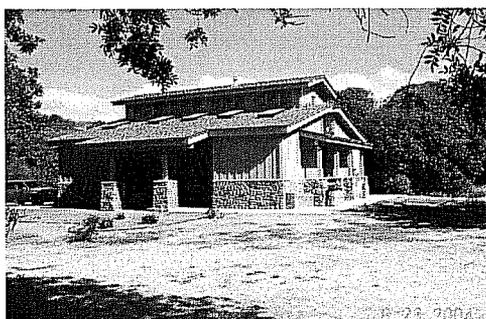
In November the first of two restroom replacement projects was completed. This facility was removed from its near shore location and set back nearly 200 feet into the campground proper. This facility provides 5 toilets and 5 showers and an outside shower with sand trap for use by campers and beach going visitors. Construction on the balance of the project is expected to begin in early 2005.

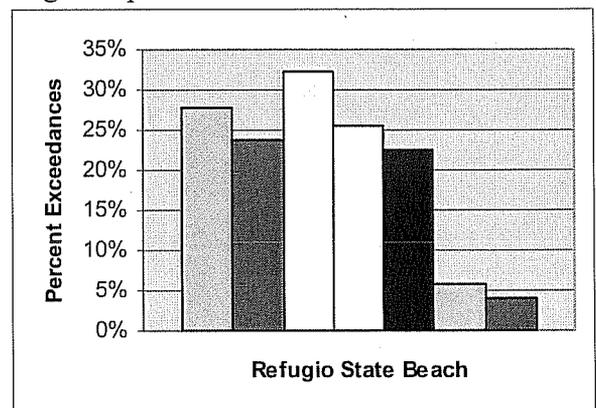
The graph depicts percentage of exceedances for Refugio State Beach. It is too early to be conclusive yet there appears to be a reduction in beach closures that coincide with completed work.
