SWAMP Annual Workplan for Central Coast

2007-08

Central Coast Ambient Monitoring Program Workplan for 2008

January 2008

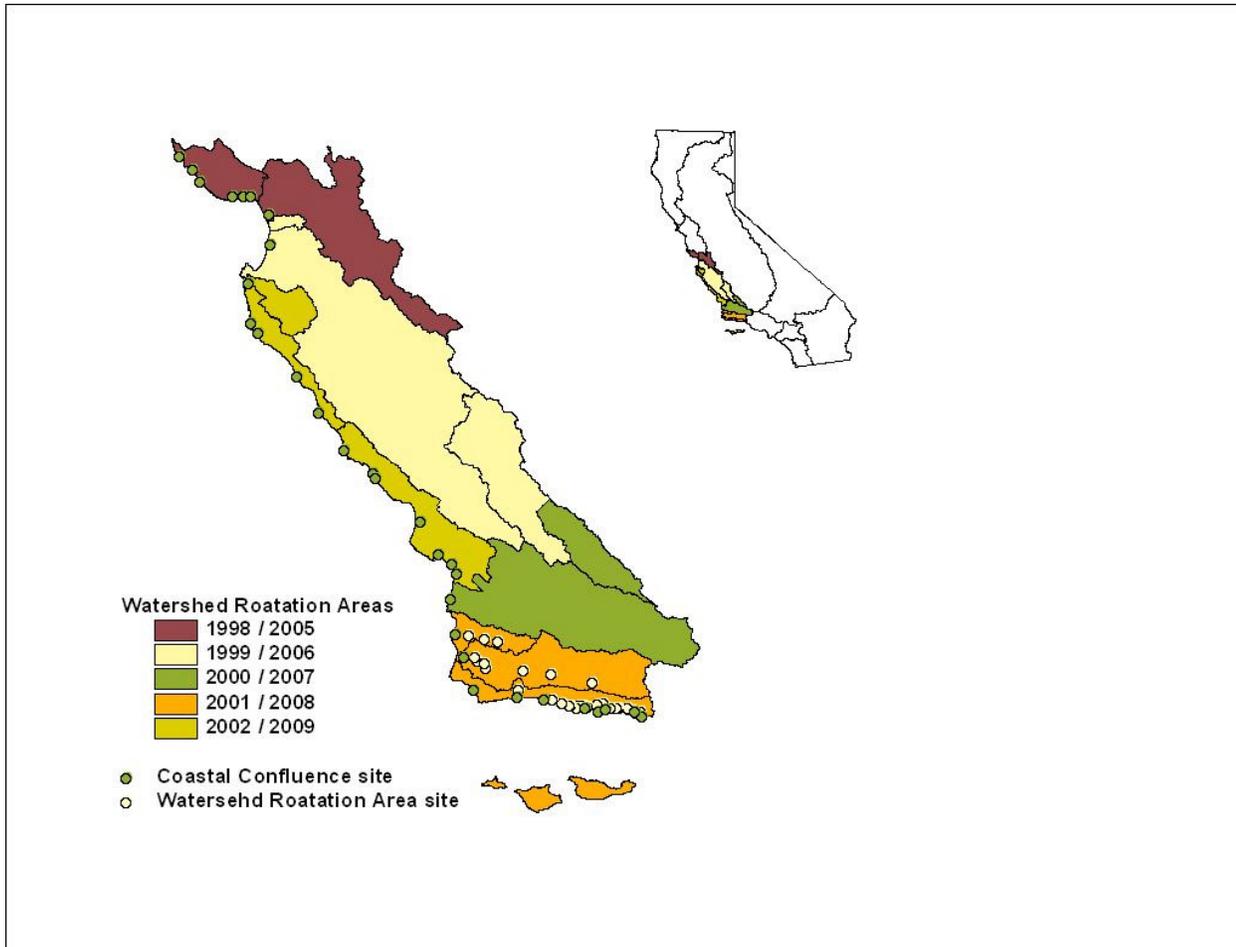
Figure 1. Region 3 watershed rotation areas and coastal confluence sites planned for CCAMP monitoring in 2008.

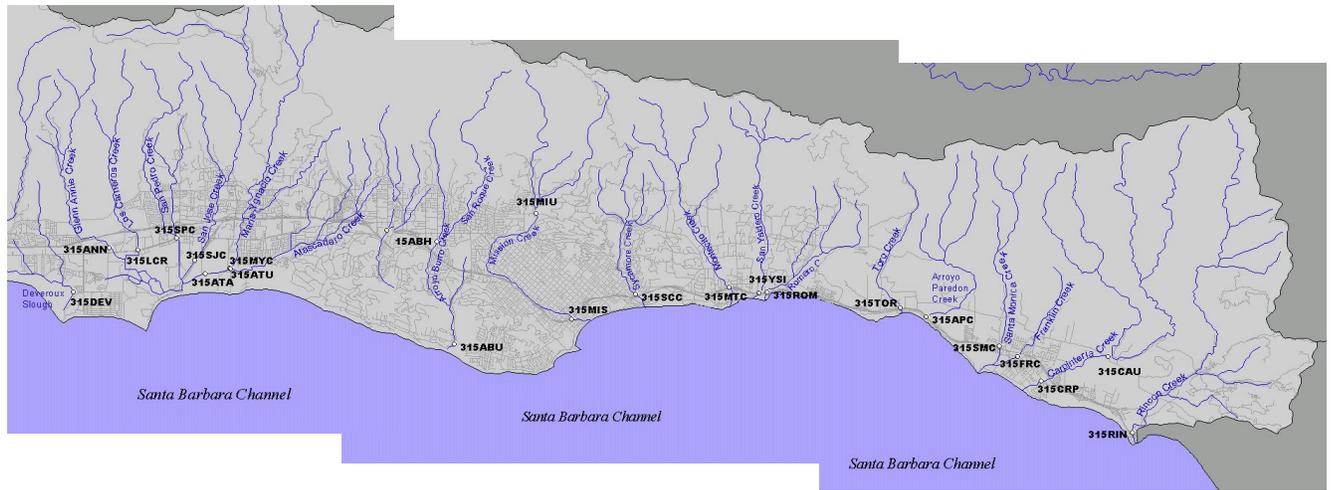
Figure 4. CCAMP monitoring sites located in the Santa Barbara watershed rotation area

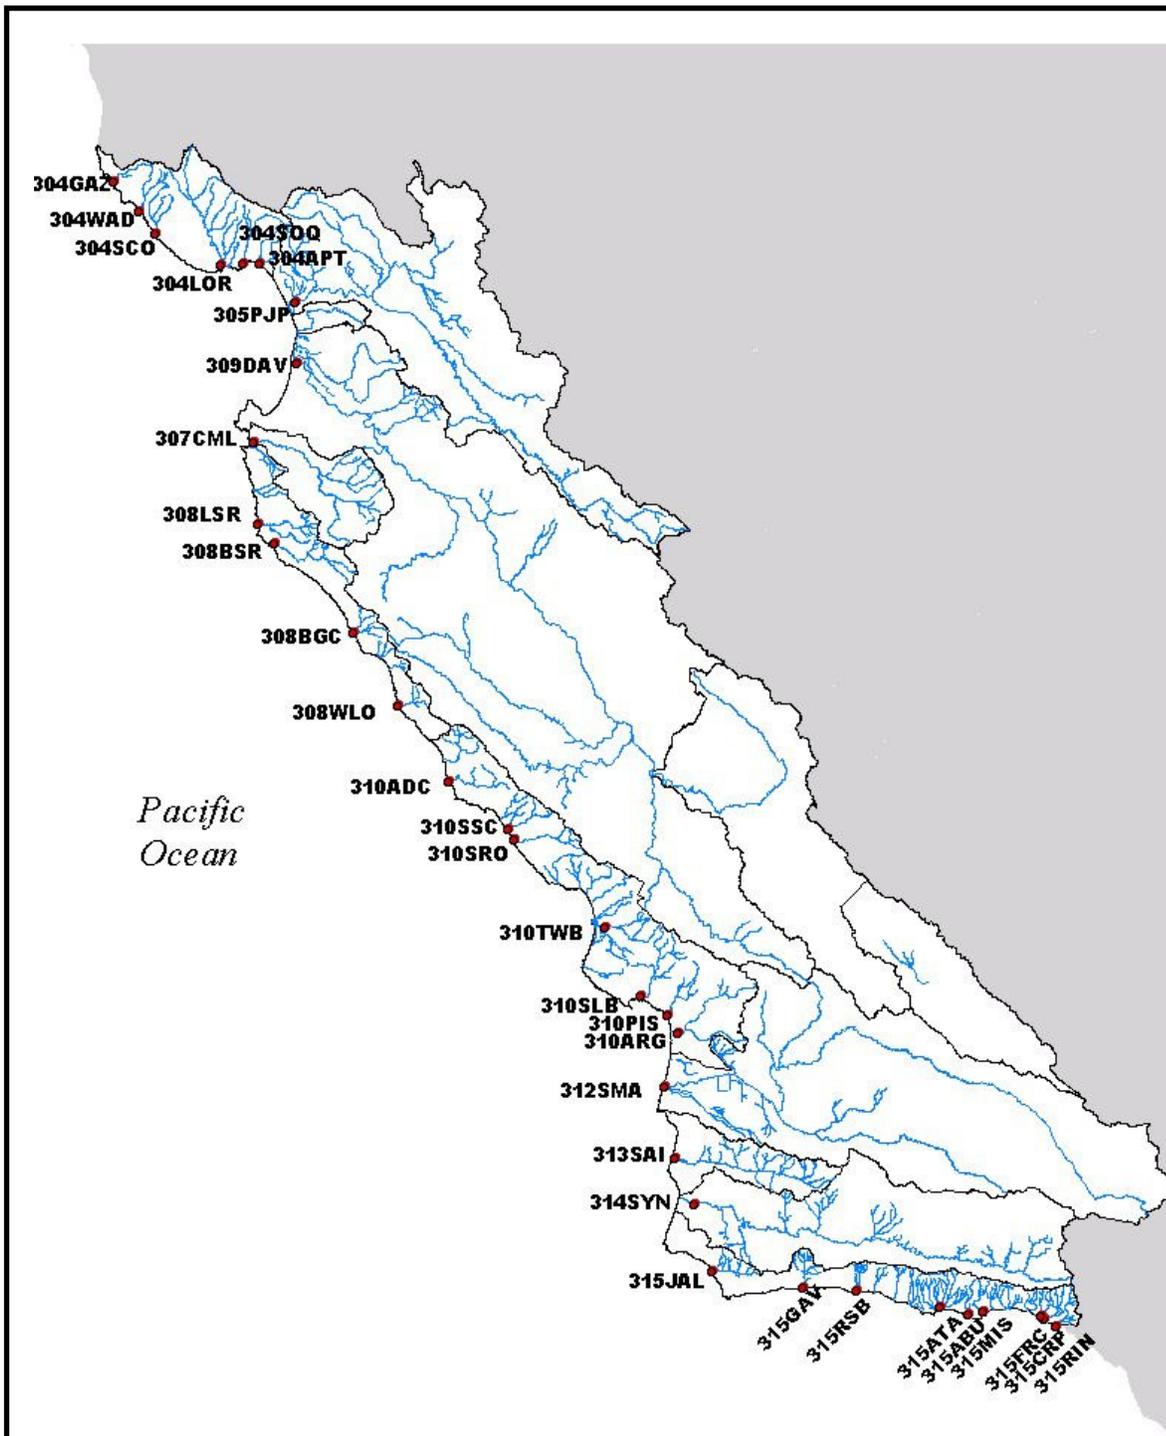
Figure 5. Coastal confluence site locations in the Region
