The History of Mass Movement Processes in the Redwood Creek
Basin, Humboldt County, California

A Thesis in

Geology

Steven M. Colman

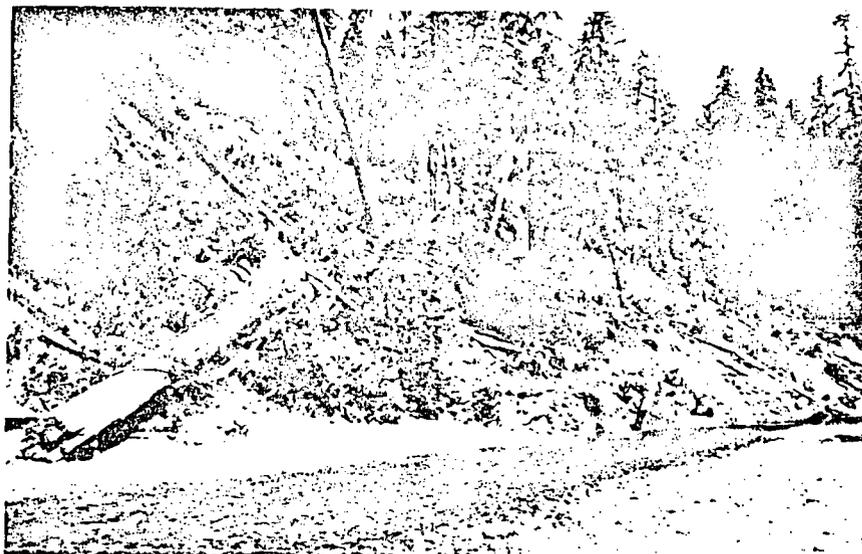
Figure 4. A slump adjacent to the channel of Redwood Creek. Note the clearly defined crown scarp, protruding toe, and upslope tilt of the trees. The scar is about 150 feet high. Landslide number 102.

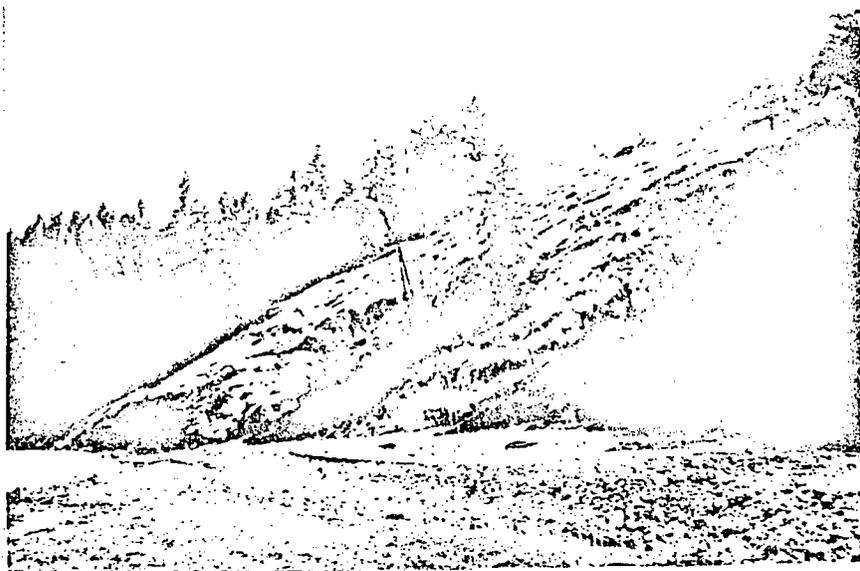
Figure 5. A very active earthflow adjacent to Redwood Creek. Note the straight to slightly convex upward slope profile with no prominent crown scarp or bulbous toe. Also note the hummocky, but largely unbroken surface, and the undercutting of the far side of the toe. This earthflow is just upstream from the mouth of Minor Creek and is about 550 feet wide at the toe. Landslide number 161.

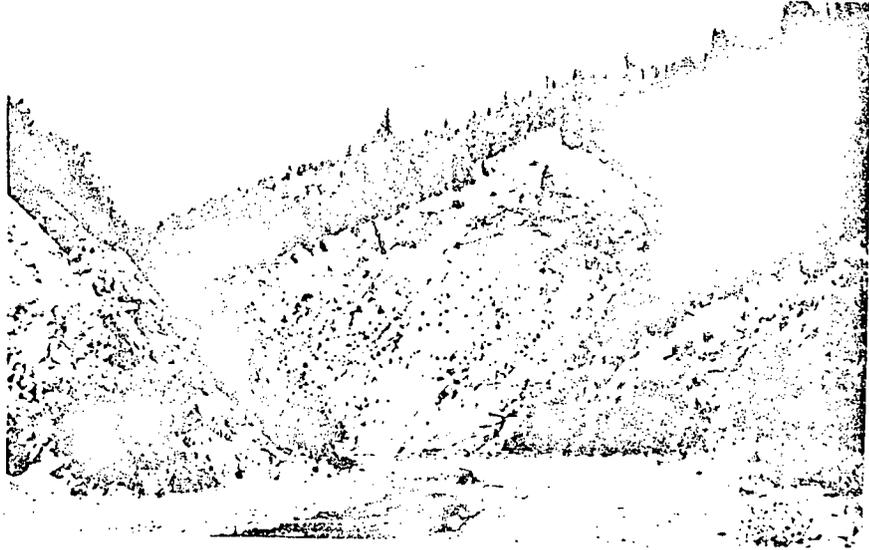
Figure 9. A slide adjacent to the channel of Redwood Creek. Note the position of the slide on the outside of a stream bend, undercutting of the toe, straight failure surface, and the beginning of revegetation. The slide is about 850 feet high. Landslide number 254.

several individual slide blocks. Slides grade into avalanches, which involve the rapid movement of one or more intensely disrupted slide blocks. Slides are identified by unvegetated or partly vegetated scars, by failure surfaces or zones nearly parallel to the hillslope, and by less pronounced crown scarps or bulbous toes than those associated with slumps. Individual episodes of movement take place in a relatively short time (seconds to minutes). Some of the larger slides appear to have had multiple episodes of movement separated by hours or even years. Although slides have apparently occurred in this area for a long time, a large increase in the number of slides on the lower slopes adjacent to the stream channels has taken place in the last 25 years. Reasons for this large increase are discussed in the "Recent History of Mass Movement" section. Examples of slides are illustrated in Figures 8 and 9.

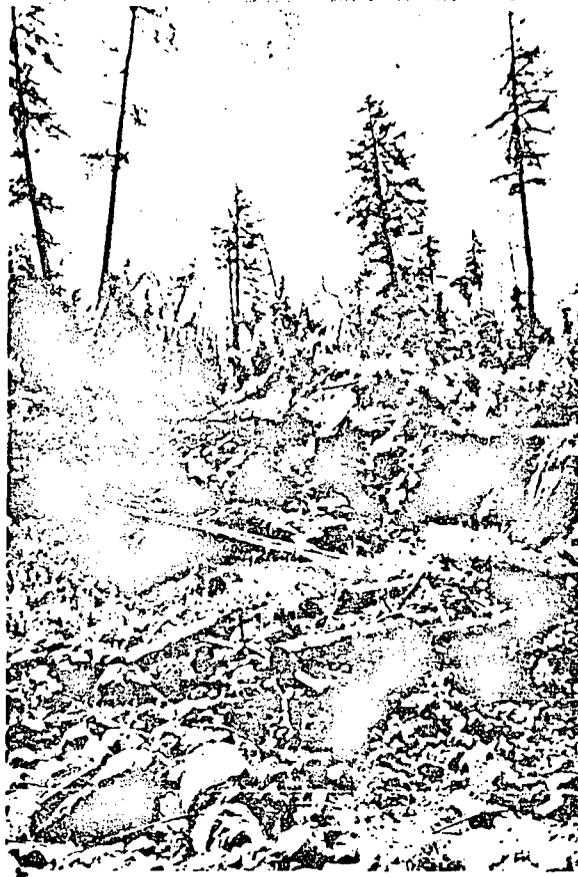
Figure 10. A pile of debris deposited at the edge of the channel of Redwood Creek. Note the avalanche track behind the debris pile and the unsorted nature of the debris in the pile. The avalanche track is about 70 feet wide at its base. Landslide number 347.

and debris flows are indicated by levees, lobate forms, and other flow structures in debris deposited in the track. Debris avalanches, flows, and torrents are difficult to distinguish from one another on small scale aerial photographs, but avalanches appear to be the most common of these forms in the Redwood Creek basin. There often appears to be a gradation between these forms of mass movement. Debris avalanches, flows, and torrents are commonly caused by steeply deeply incised gullies or streams. Consequently, rapidly eroding cutover land, gullied skid trails, and road fill around culvert crossings are particularly vulnerable to debris avalanches. Illustrations of debris avalanches are contained in Figures 10 and 11.

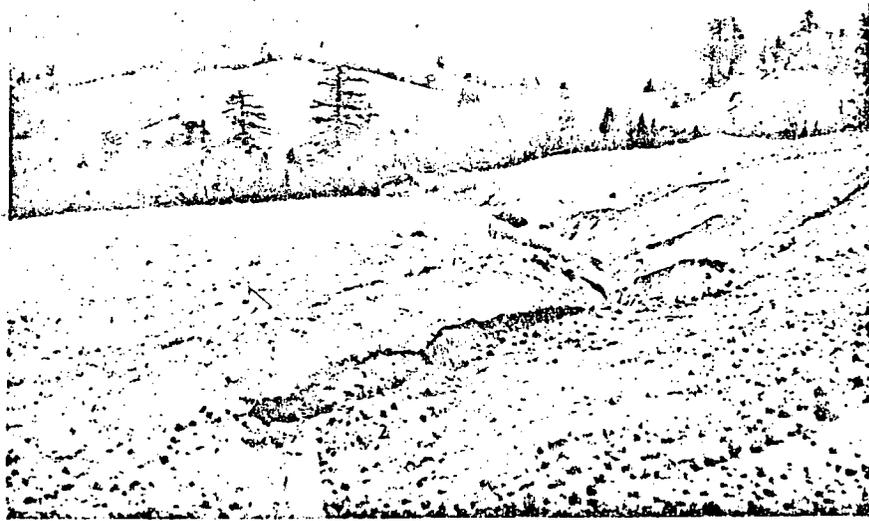
Figure 20. Road drainage from Highway 299 has been concentrated at this point and has cut a deep gully.

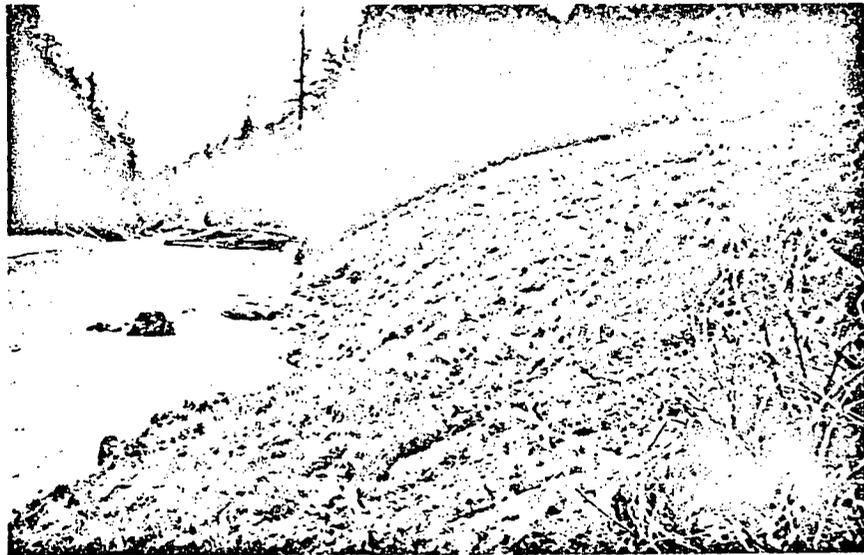
Figure 22. The log jam at the south boundary of Redwood National Park. Aggradation behind the jam during the 1972 flood (off the picture on the left) shifted the thalweg up against the active earthflow at right. The jam itself has sharply deflected the stream against the left bank.
