Big
Cleanup

By Willis Evans Fisheries Management Supervisor

It All Started on the Noyo River in 1957. Today . . .

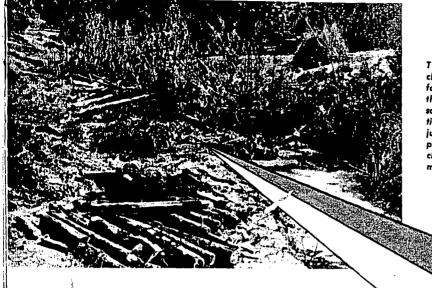
The contrast. A cleared area in the foreground points up the difference in the solidly jammed section of Olds Creek just upstream. DFG photos with this article by Gerald Holman.
