*Erosion and Sediment Transport in Pacific Rim
Steeplands. I.A.H.S. Publ. No. 132 (Christchurch, 1981)*

Erosion control techniques used in Redwood National Park,
Northern California, 1978-1979.

William E. Weaver and Mary Ann Madej, Redwood National Park,
P O Box 55, Arcata, California 95521, U.S.A.

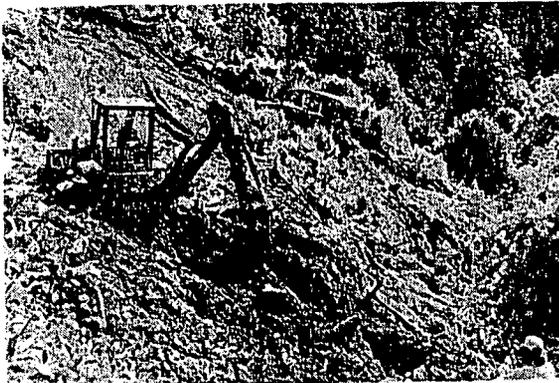
FIGURE 3

FIGURE 3. A hydraulic backhoe and crawler tractor work together in clearing a stream channel. The tractor in the background winches out large organic debris. The backhoe (foreground) follows, excavating road fill and grading stream banks to a stable slope. Note person in channel for scale.

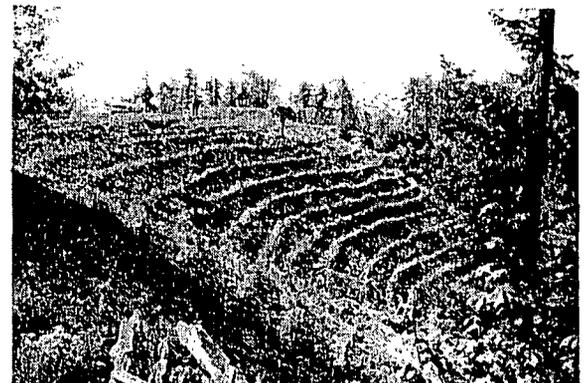
FIGURE 6a and 6b. Before and after sequence showing the removal of an oversteepened fill slope from a log landing. Willow wattles, planted on hillslope contours after heavy equipment work, are beginning to sprout (6b).

Heavy earth moving equipment was used extensively to remove logging roads and stabilize log landings. Typically, the rock-surfaced road bench was first decompacted using chisel teeth mounted on a crawler tractor. Several passes of the tractor successfully disaggregated the upper 0.5 m of material and increased the infiltration rate of the previously impermeable surface. Then a drag-line or excavator, scooped loose, oversteepened fill material and organic debris from the outside edge of the road or landing and placed it on a stable bench. To "outslope" a road, a crawler tractor then graded this material against the cutbank at a 3° to 12° gradient (Fig. 5), obliterating the inboard ditch and directing surface runoff across the former road alignment. Figure 6 shows the results of heavy equipment work on an unstable log landing.

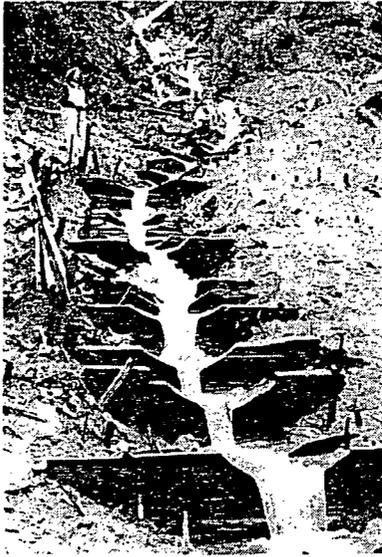
FIGURE 7. Redwood slab check dams were installed in a newly excavated stream channel to prevent downcutting of the stream bed and to help stabilise stream banks. They convey winter flows through broad, high-flow spillways. Each dam is ponding water, and sediment will settle out in the basin up to the height of the spillway. Note the close spacing of check dams, and the rock energy dissipation below the spillways. Stem cuttings of willow are planted on both banks to accelerate revegetation.

To prevent erosion by flowing water at the outlets of structures, wood boards, coarse rock, and anchored logging slash were used to dissipate the energy of cascading water (Fig. 7). Energy dissipators are an integral part of the design and cost of structures (waterbars, checkdams, flumes, etc.).

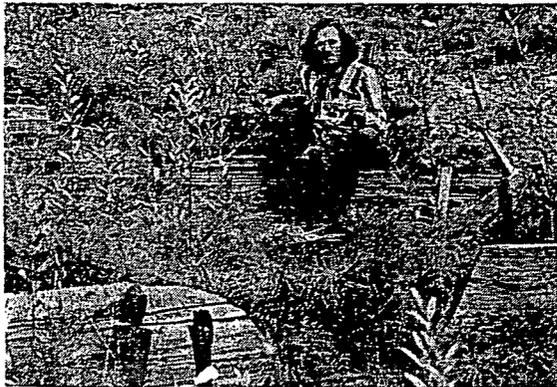
FIGURE 8. After one season the catch basins upstream of each check dam are filled with sediment. Sprouting willow stem cuttings and other plants are beginning to stabilise channel banks and bed.

Bank erosion and channel downcutting in gully systems and recently excavated stream channels are a substantial source of sediment in rehabilitated clearcut areas. Both check dams and rock armor were used to protect highly erodible channel banks and beds. In 1978-1979, check dams were confined to streams with less than 0.2 cms mean annual peak winter discharge. Most structures were constructed from redwood slabs which were split or milled at each work site. Installed in a sequence such that the sediment basin behind one dam abuts the base of the next upstream, check dams can effectively prevent further channel downcutting, help stabilize adjacent stream banks and provide a fertile substrate for vegetation (Fig. 7). Once erosion is retarded, vegetation becomes reestablished to provide root support and surface protection when the check dams begin to deteriorate after their minimum expected lifetime of 10 years (Fig. 8). Periodic maintenance inspections following winter storms prevents premature failure of check dams.
