**Patrick Higgins**  
Consulting Fisheries Biologist  
791 Eighth Street, Suite N  
Arcata, CA 95521  
(707) 822-9428

Subject: Adding Sediment Impairment of the Mainstem Klamath River to the Clean Water Act Section 303 (d) - List of Water Quality Limited Segments, June 2004

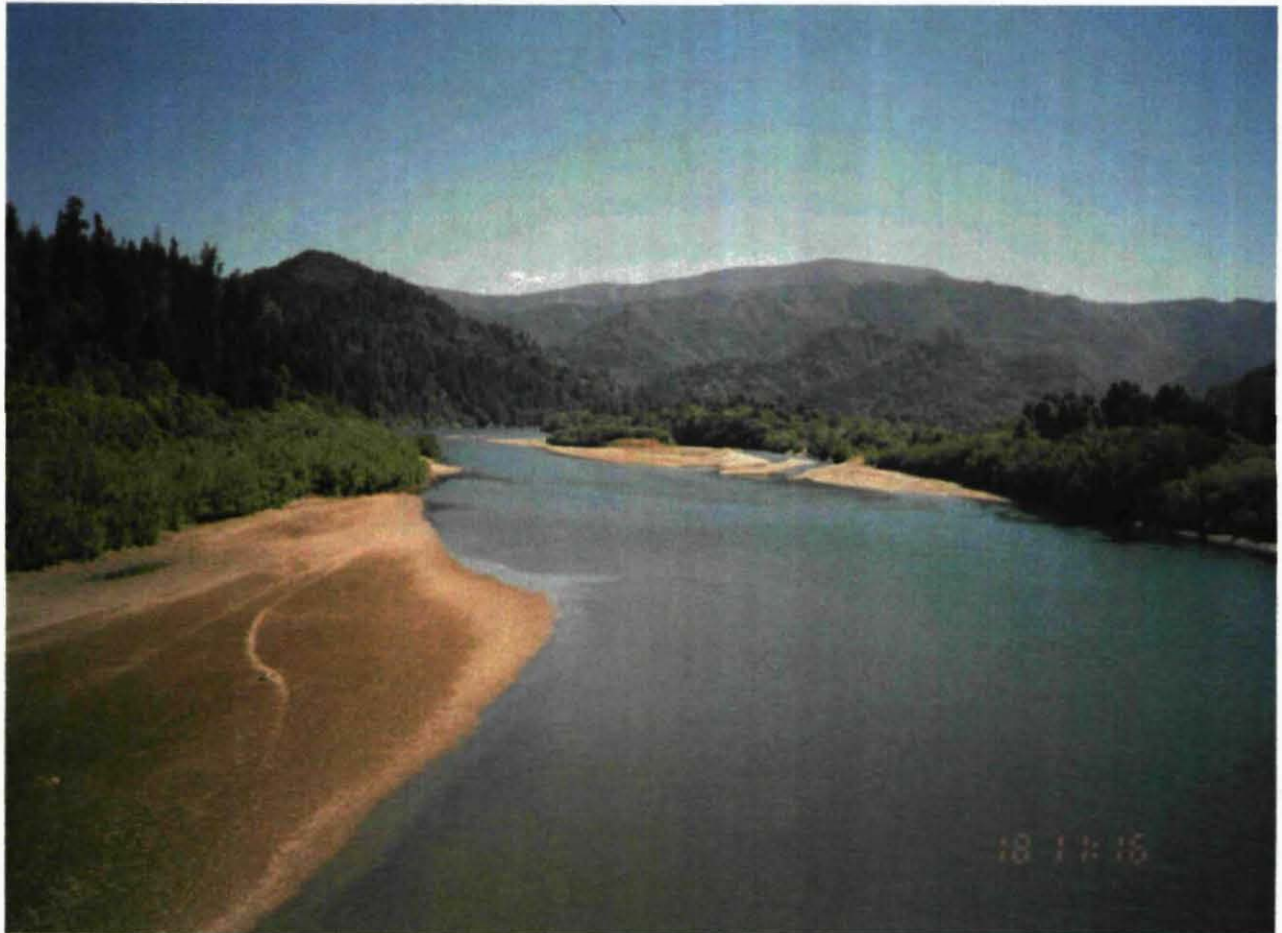
Figure 1. Lower Klamath above Highway 101 with sediment deposits in the margins.

Voight and Gale (1998) noted that 17 of 23 tributaries to the lower Klamath River remained underground, indicating lack of recovery and continuing contributions of sediment. Figure 1 shows the lower Klamath River in 1998, looking upstream from the Highway 101 bridge. Sediment deposits in the margins indicate sediment impairment.

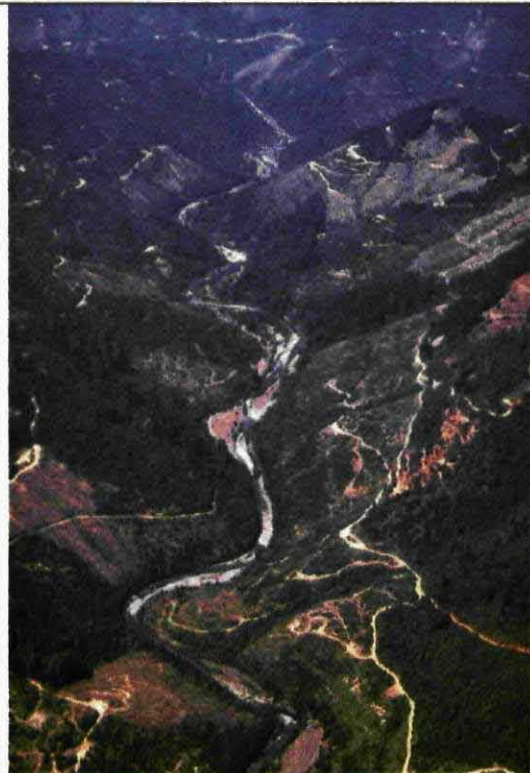
Figure 2. Lower Blue Creek and timber harvest.

Figure 2. Watershed conditions and land use management in lower Blue Creek contribute to sediment yields. High road densities contribute chronic fine sediment to Blue Creek and other Lower Klamath tributaries. Road failures during storm events may also lead to larger yields, which aggrade stream beds to the point where surface flows are sometimes lost. In this photograph, Blue Creek remains on the surface, but the lower creek is widened by sediment. The U.S. Fish and Wildlife Service (1988) is concerned about deteriorating spawning gravel quality in reaches downstream of these activities.

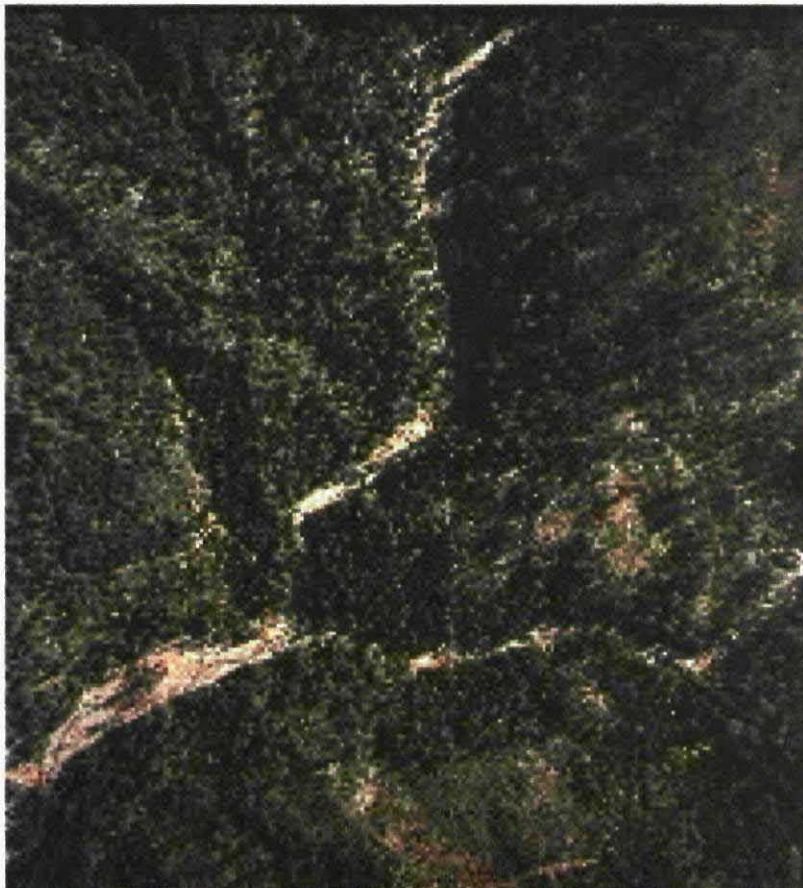
Figure 3. This aerial photo shows tracks of debris torrents in Walker Creek, which buried the stream channel and extended all the way to the mainstem Klamath River.

Contributions of sediment to the mainstem Klamath River between the Salmon River and Beaver Creek, including the Scott River and its tributaries, were documented by de la Fuente and Elder (1998). They noted that the January 1, 1997 storm caused hundreds of landslides in the Klamath National Forest and 446 miles of scouring in tributary channels (Figure 3).

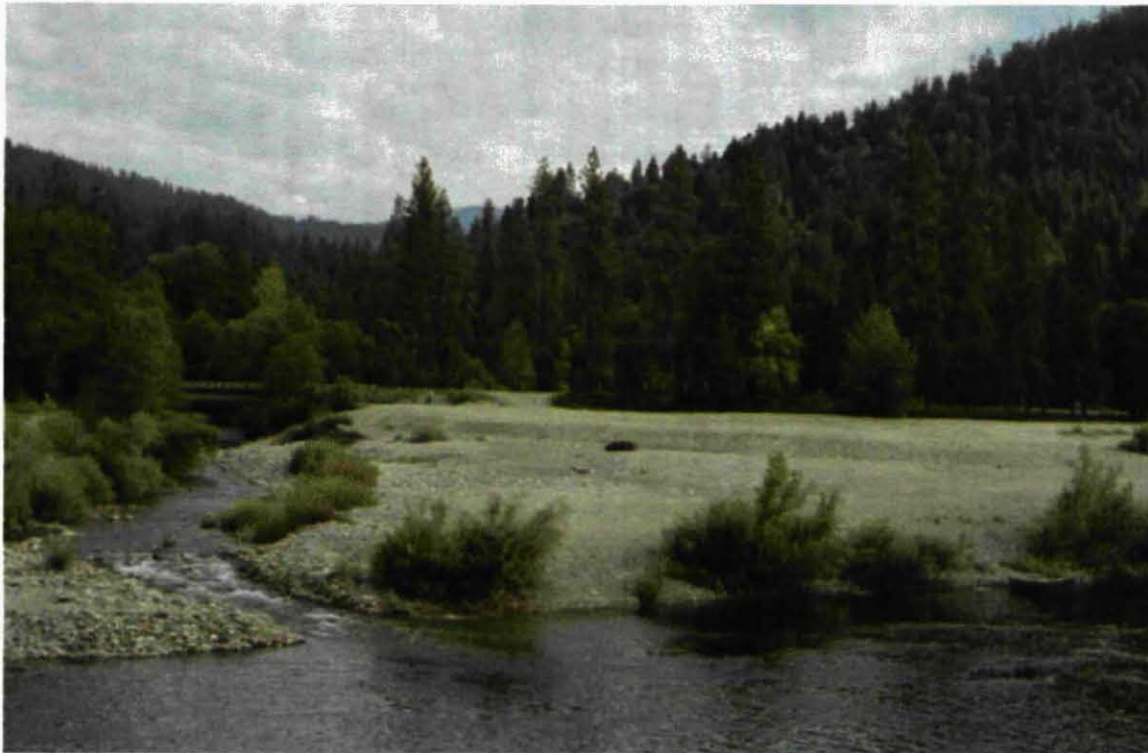
Figure 4. Mouth of Elk Creek. The delta extending to the edge of the photo at right was aggraded more than ten feet after the January 1997 storm.

The quantification of sediment inputs to the mainstem Klamath River were beyond the scope of the study by de la Fuente and Elder (1998), but very large deltas at the mouths of tributaries left clear evidence (Figure 4). Roads, recent clear-cuts and areas burned in the 1987 fires had the greatest number of landslides. De La Fuente found that a

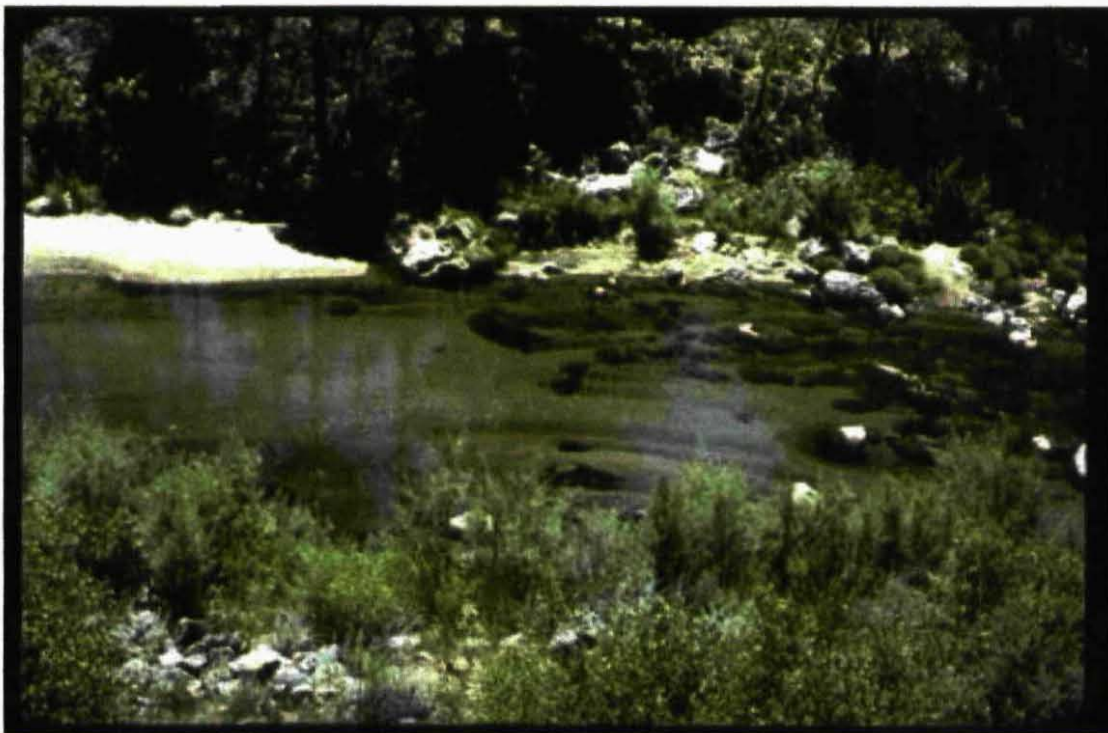
Figure 5. The mainstem Scott River stream bed below Jones Beach has a high amount of decomposed granite sand, contributed from upland. This sand also makes its way into the Klamath River.

The de la Fuente and Elder (1998) noted major sediment contributions from the Scott River and its tributaries during the January 1997 storm. Longer term studies (Sommerstrom et al., 1991) show that huge amounts of decomposed granite sands are in the Scott River (Figure 5) as a result of land use activities. The National Academy of Sciences (2003) report on the Klamath River and Endangered fishes also recognized Scott River impairment: "Highly erodible decomposed granite has led to a serious loss in volume and number of pools in tributaries and associated degradation of spawning and rearing habitat. Logging over the past 50 years has taken place on a mix of USFS land and land held by a few large private timber companies. Historical logging practices have been poor, particularly on private land, and have left a legacy of degraded hillslope and stream conditions." The Scott sends a constant supply of sand to the mainstem Klamath, contributing to its sediment impairment.
