# THE FLOOD OF 1997 KLAMATH NATIONAL FOREST

## PHASE I FINAL REPORT: NOVEMBER 24, 1998

### BY: JUAN DE LA FUENTE AND DON ELDER

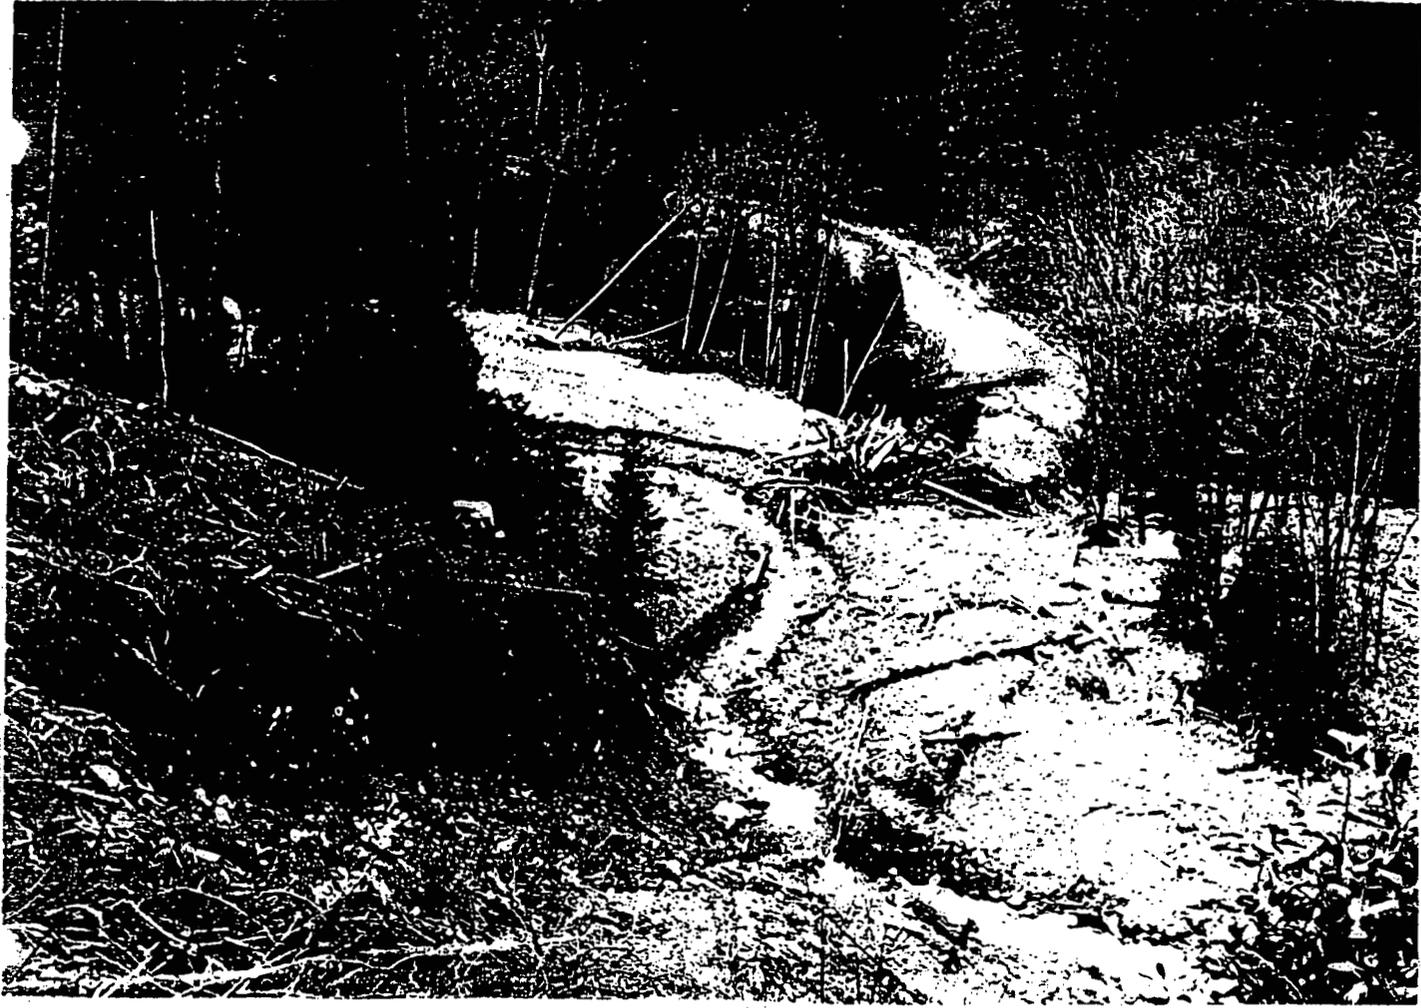
**Photo #97-27-6A:** Walker Creek road crossing taken out by debris flow. View from the head of a small slump activated by stream undercutting. Road formerly passed along the base of the slump. (J.d.l.F: 4-25-97).

**Road Stream Crossing Failures-** Road crossings at streams accounted for 42-51% of the ERFO sites, highlighting the sensitivity of this part of the landscape (Photo #8 & 97-27-6A). Most of these involved blockage of culverts and overtopping and partial or complete failure of fills. About **66%** (Figure 5) of the **debris mobilized** at culvert crossing sites was delivered to streams while the remainder either remained in the road prism, or was deposited on hillslopes below. From **2-7%** **generated debris flows**. From 22-29% of stream crossing failures resulted in **drainage diversions** which caused gullies and fill failures downslope. This compares to 35% reported by Ledwith and others (1998). Further, **water diverted to the site** by the road contributed to failure in **16-24%** of the stream crossing failures. **Debris flows** originating upstream from the failed road stream crossing accounted for 23% of the road stream crossing failures. A larger pipe would probably not have

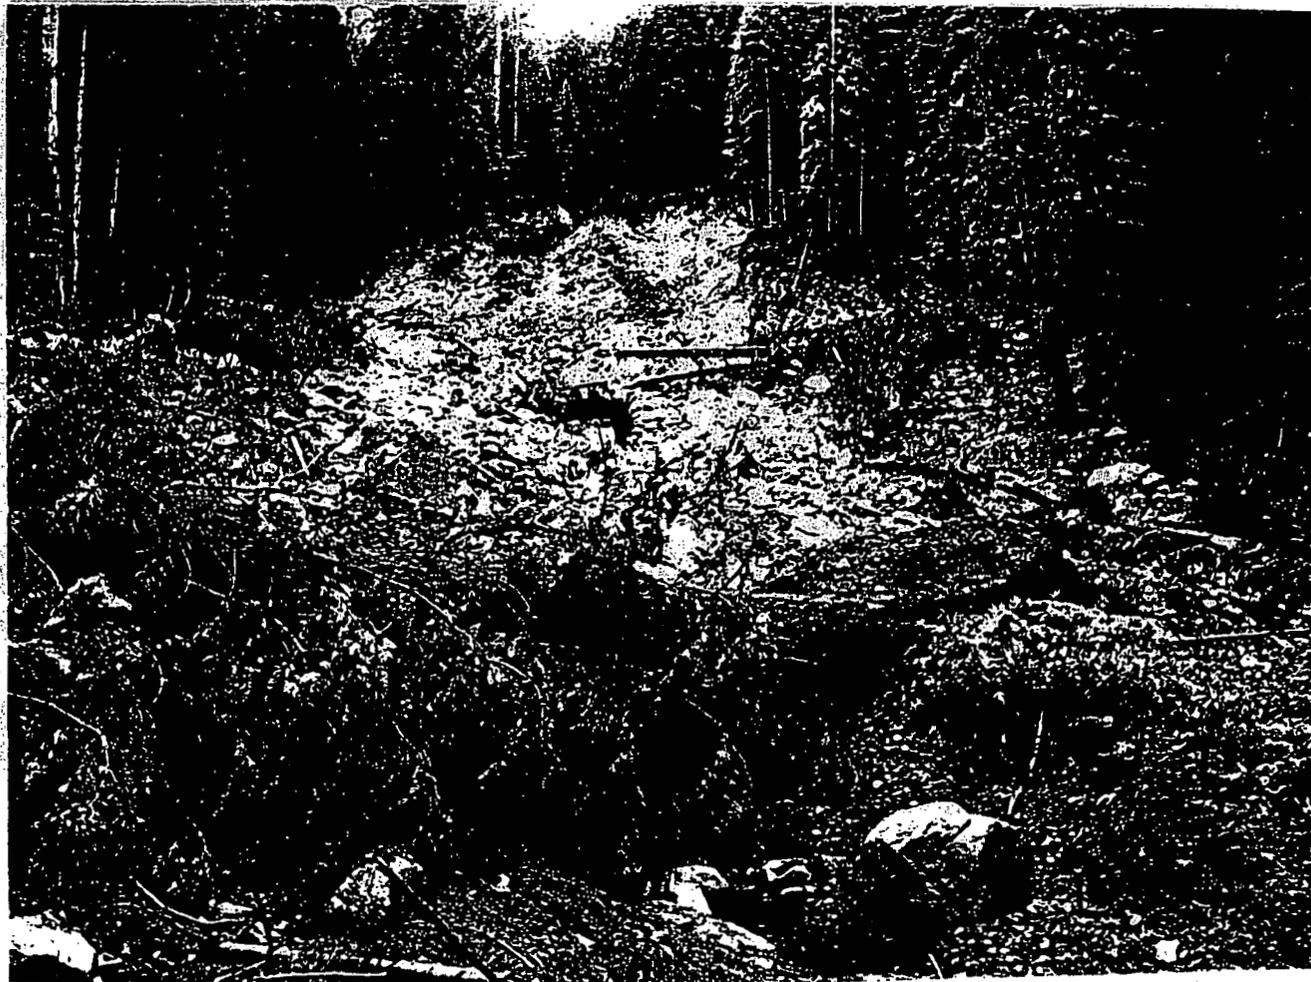
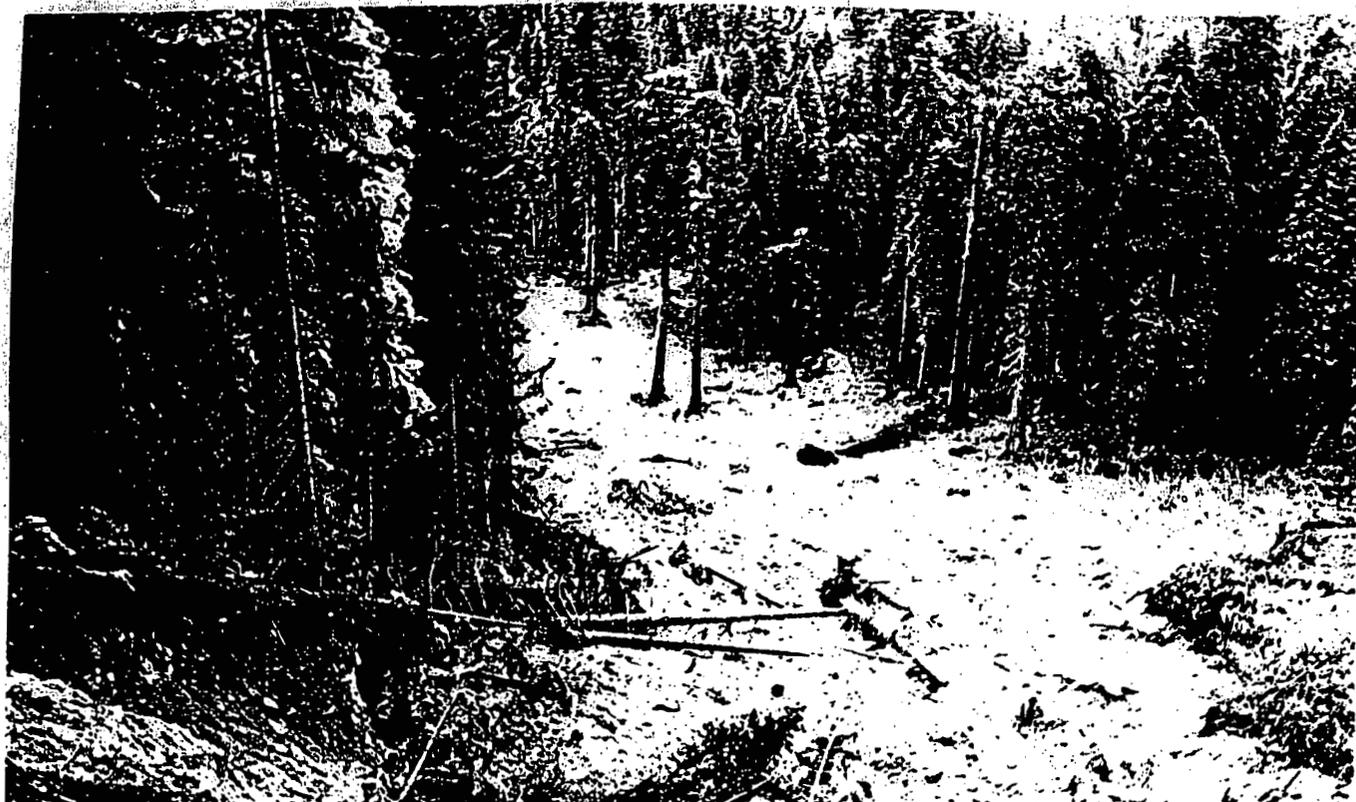
**Photos #1a & 1b: Debris Slide-** Large debris slide (about 250 feet wide, 1000 feet long) occurred in the Marble Mountain Wilderness in Granite Creek, a tributary to Elk Creek, Happy Camp Ranger District. It is on the timbered wall of a U-shaped glaciated valley which had not been affected by the fires in 1987. The ensuing debris flow caused severe channel alteration for several miles downstream, and also formed log jams. Photo 1a is viewing upslope, and 1b downslope. Photo summer of 1997 by J.d.I.F.

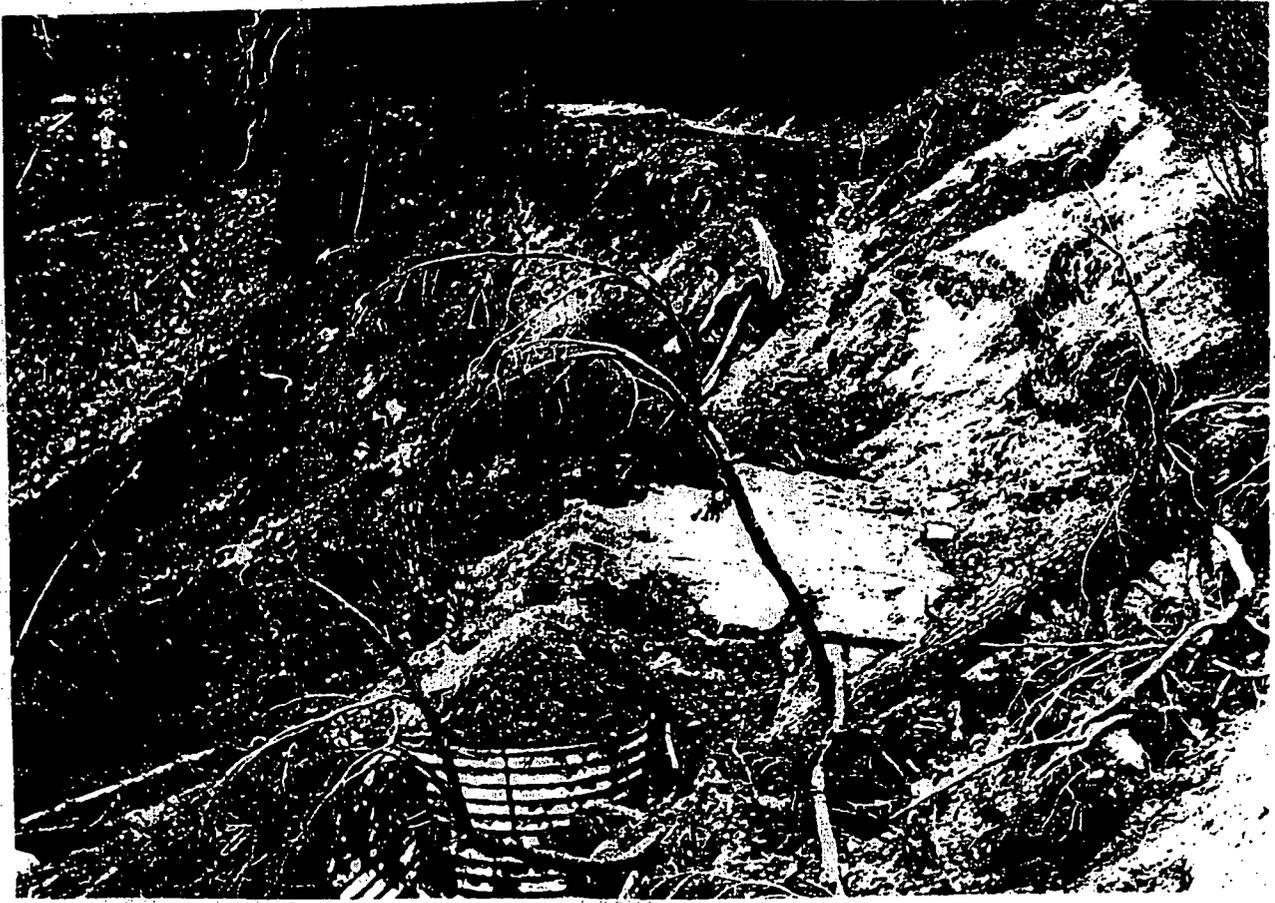
**Photo #6: Landslide-** This slump/earthflow closed road 46N64 in the Walker Creek watershed, Happy Camp Ranger District. A cellular retaining wall (note corrugated metal) had been installed at this site several years before the 1997 flood. The entire area consists of the toe of a large old landslide deposit. Photo by J.d.l.F., February, 1997.

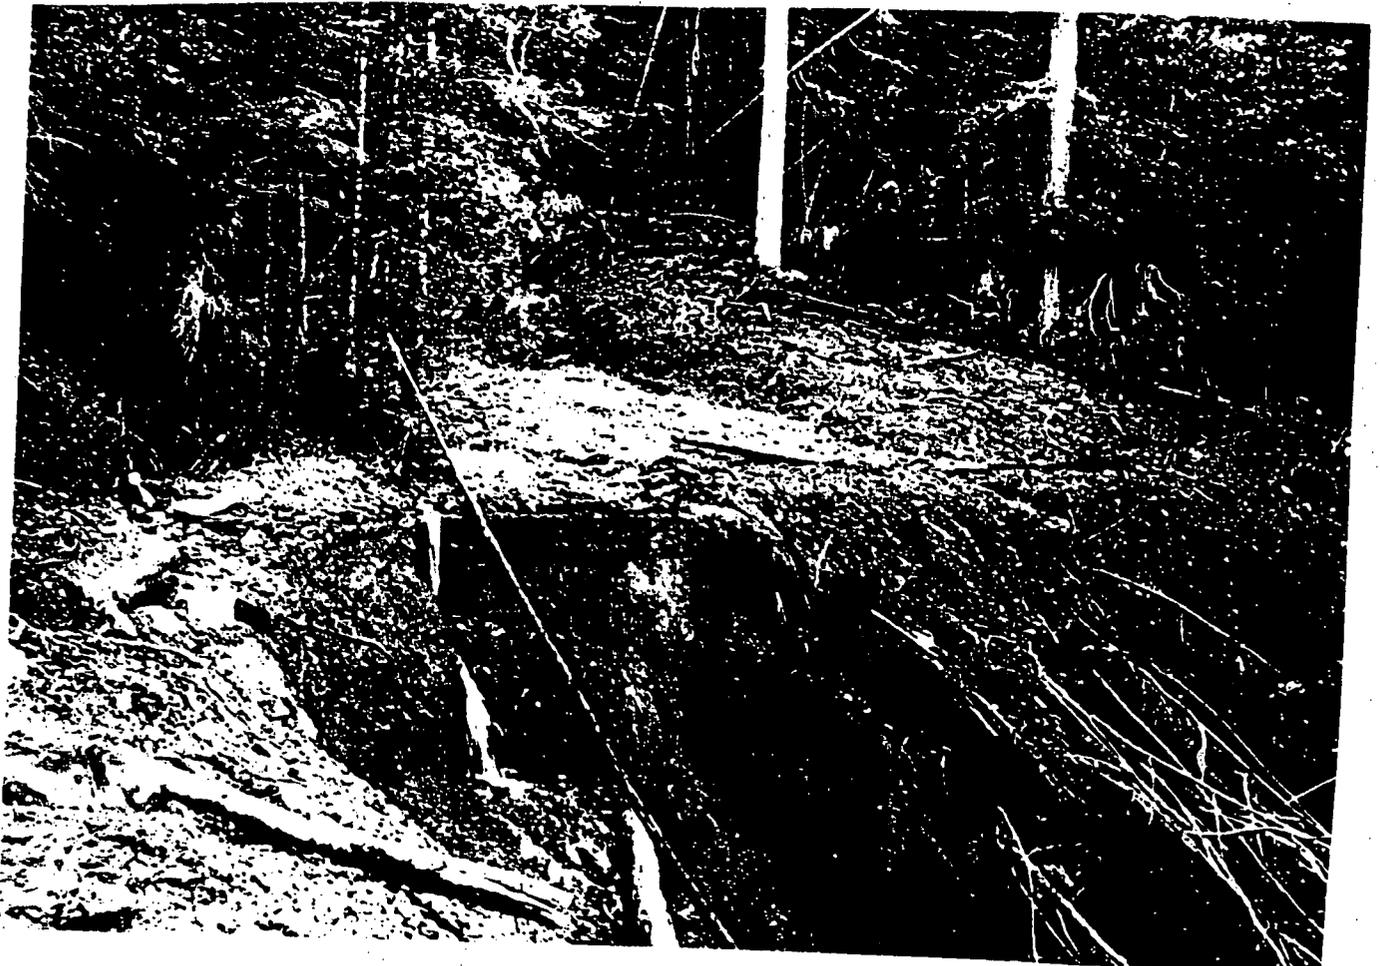
**Photo #8: Stream Crossing Failure-** This road stream crossing is on Road 15N75 in the Elk Creek Watershed (Doolittle tributary), Happy Camp Ranger District. Failure of the fill was caused by a debris flow which originated by a small fill failure on the same road where it crossed the head of the debris flow channel. Photo summer of 1997 by J.d.I.F.

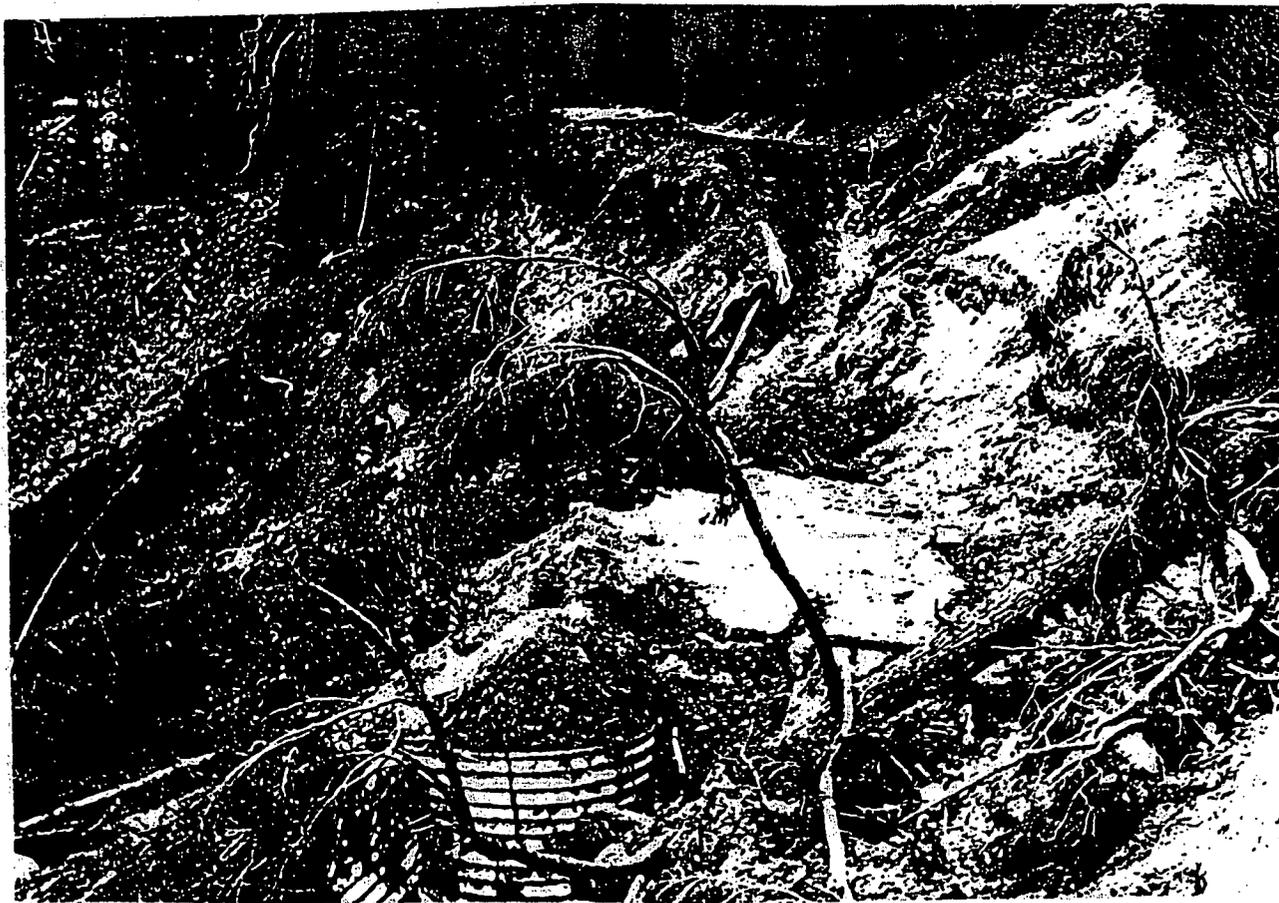
**Photo #6: Landslide-** This slump/earthflow closed road 46N64 in the Walker Creek watershed, Happy Camp Ranger District. A cellular retaining wall (note corrugated metal) had been installed at this site several years before the 1997 flood. The entire area consists of the toe of a large old landslide deposit. Photo by J.d.I.F., February, 1997.

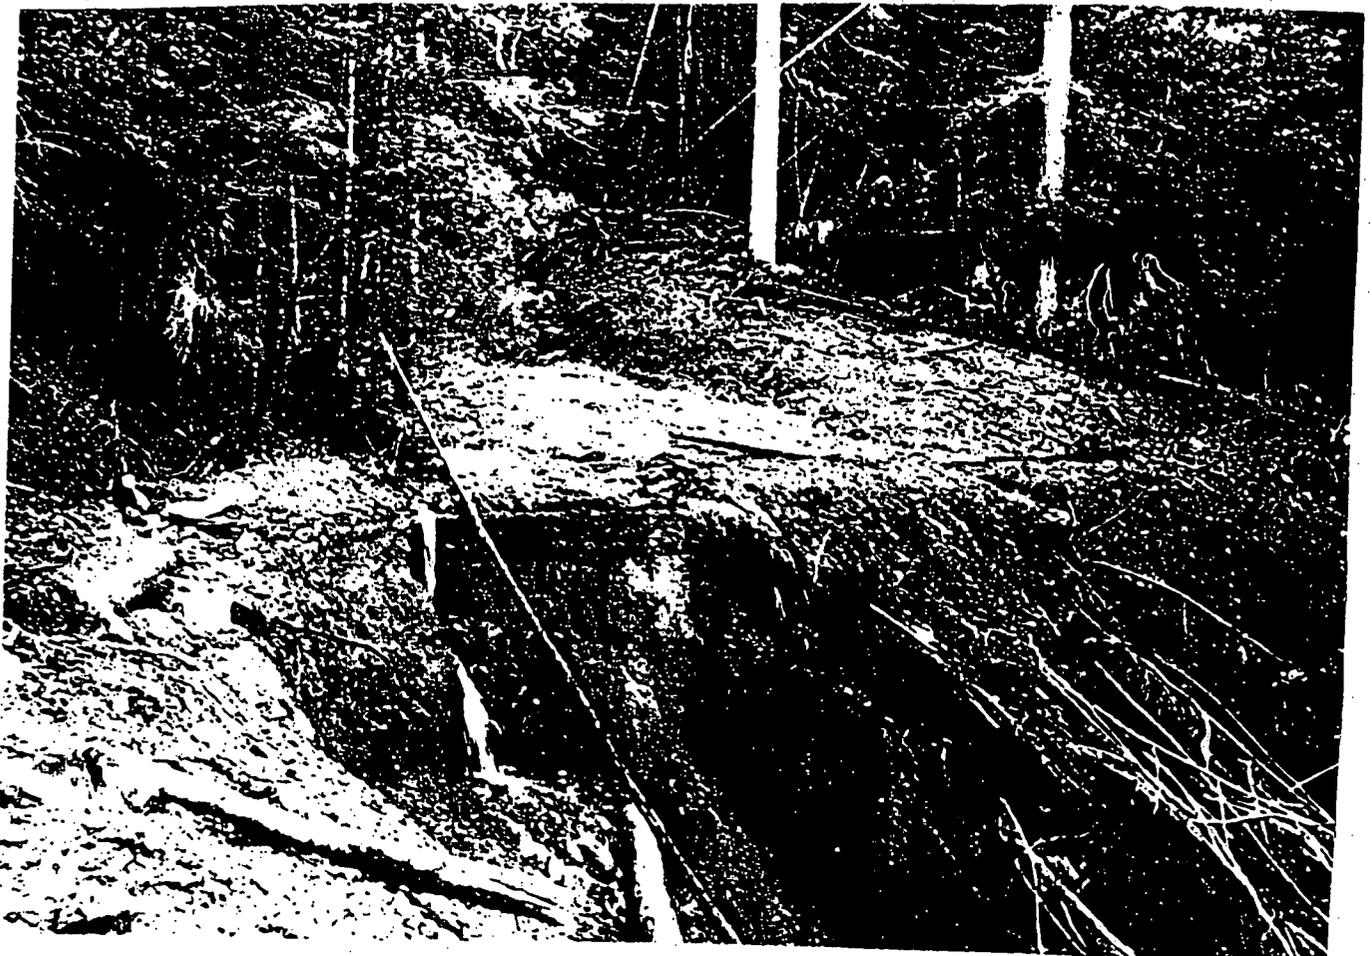
**Photo #8: Stream Crossing Failure-** This road stream crossing is on Road 15N75 in the Elk Creek Watershed (Doolittle tributary), Happy Camp Ranger District. Failure of the fill was caused by a debris flow which originated by a small fill failure on the same road where it crossed the head of the debris flow channel. Photo summer of 1997 by J.d.I.F.

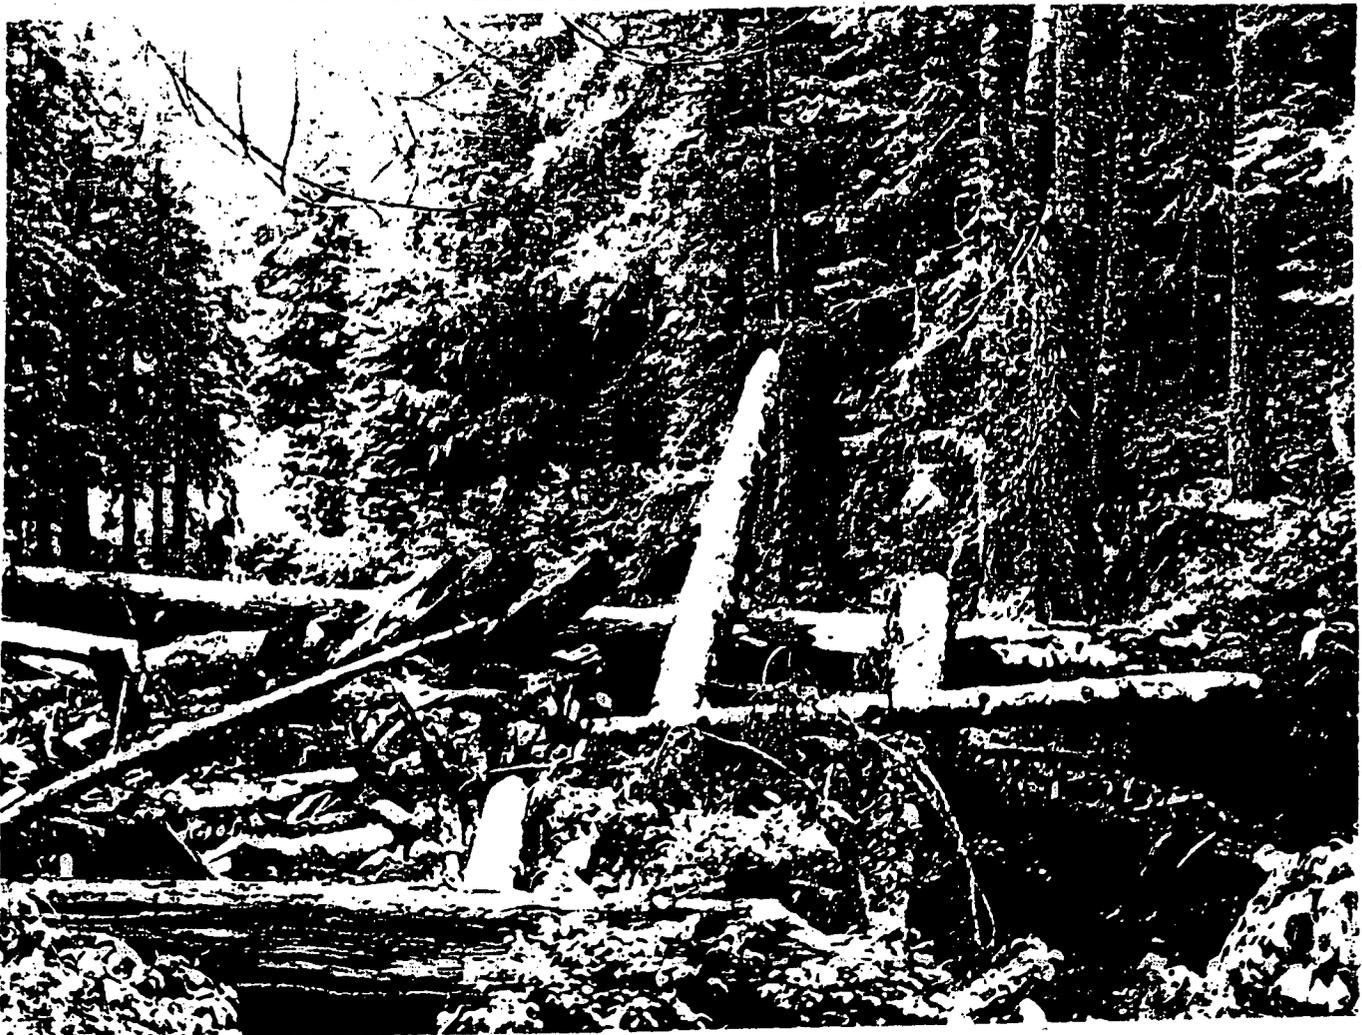
Photo 97-82 #19- Granite Creek (Tributary to Elk Creek) Happy Camp Ranger District. Photo by J.d.l.F. 6-30-97. A large debris slide on the valley wall initiated a debris flow which deposited this log jam in Granite Creek.
