Russian River Watershed Protection Committee 2009 Photo Project

Report: June 21, 2010

Photographic Report on 2009 Water Quality Conditions in Lower Russian River: Response to proposed 45% cut in summer flows.

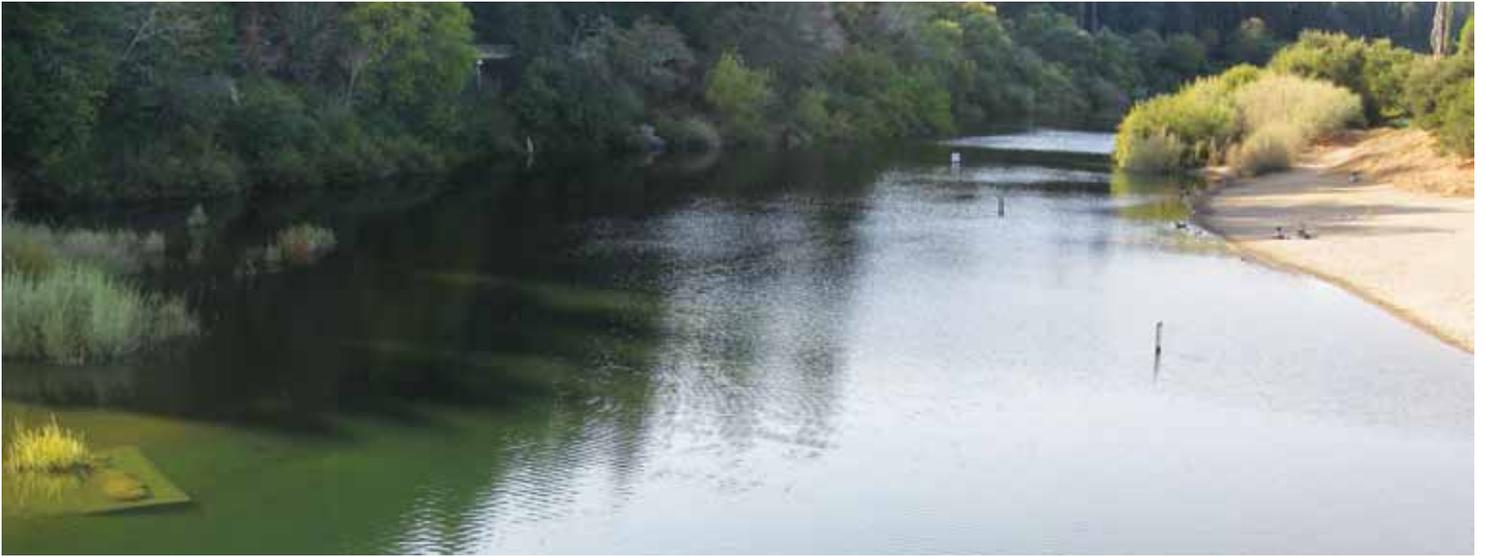
Photo 0145 was taken from the Monte Rio Bridge in the afternoon on Oct. 5, 2009 around 4 pm. looking west. Notice signs on mid-right of photo, far into the water. On far left notice accentuated plant on cement structure and plants submerged behind it. The water here was much higher than I had seen all summer at this location.

Hacienda flow: 92 cfs (not yet verified by USGS)

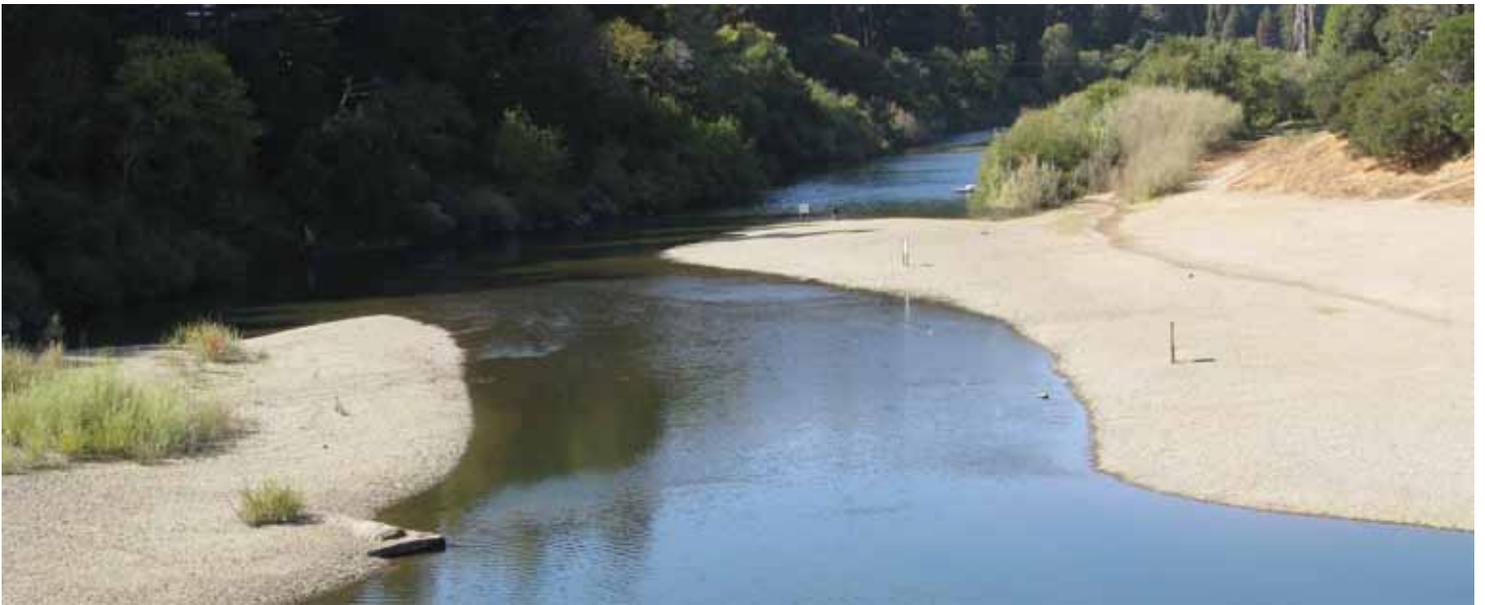
Photo 0228 was taken one day later (Oct. 6, 2009) of the same scene (magnification a bit different however.) In this picture you can see flat rectangular cement structure with plant behind it and beach all exposed behind.

On the right you can see the sand bar jutting way out with signs that had been far into the water on Oct. 5th, now far back on the sand. The line in the sand behind the signs is where the water had been the day before. Also, you can see sand bar jutting way out beyond bushes in upper right of photo. Although you can't see it in this picture, that beach is covered in algae where the water had been.

Hacienda flow: 102 cfs (not verified by USGS)

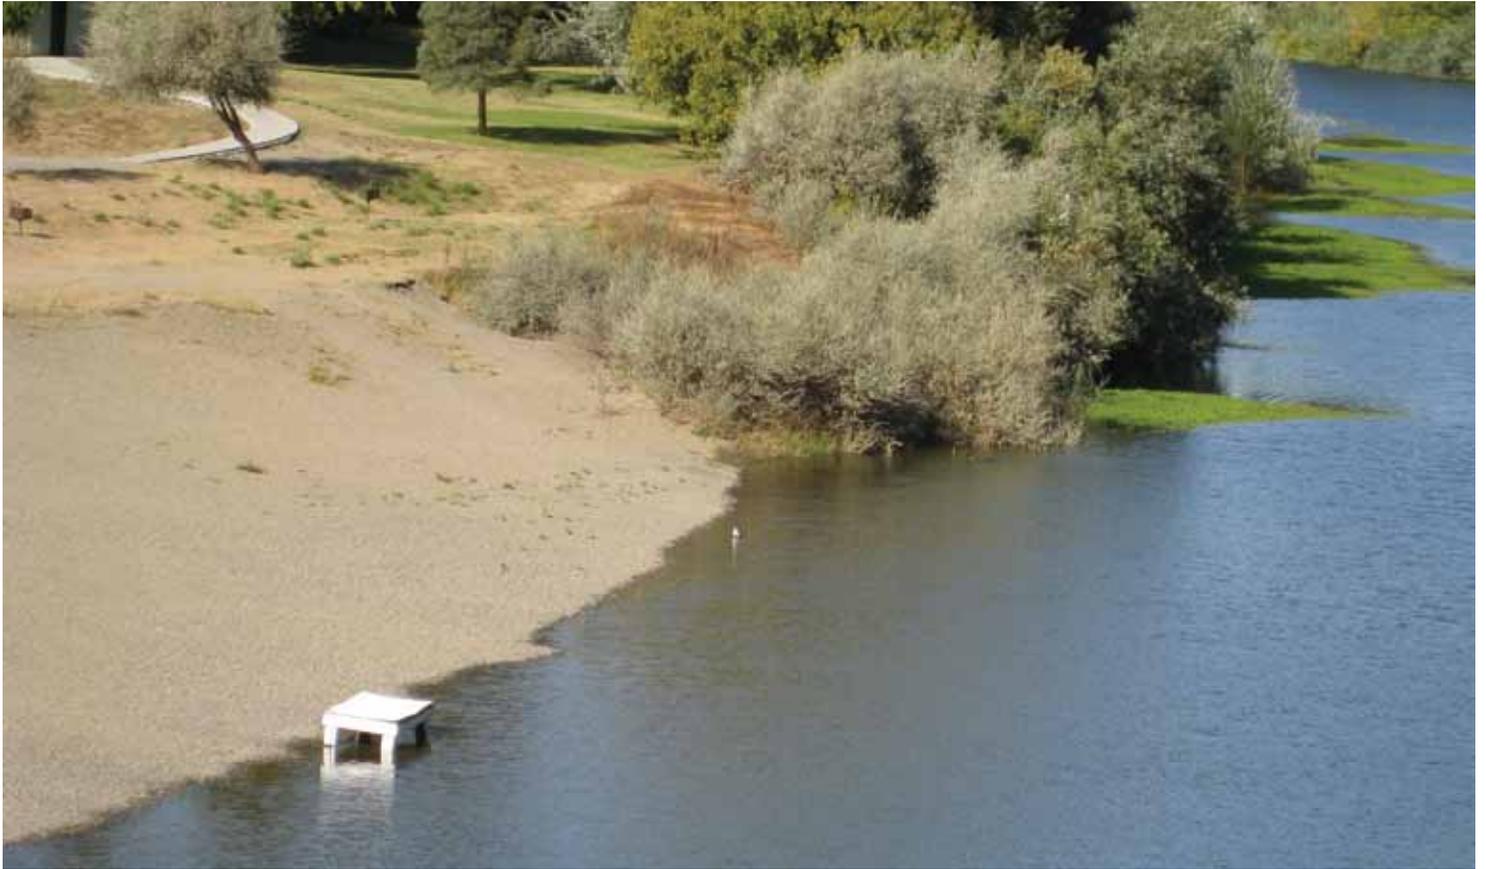
Photo 0165: This picture was taken about 4 pm on Oct. 5th. The water line is right behind white wood platform. Bushes along the bank and Ludwigia go far out beyond water line.

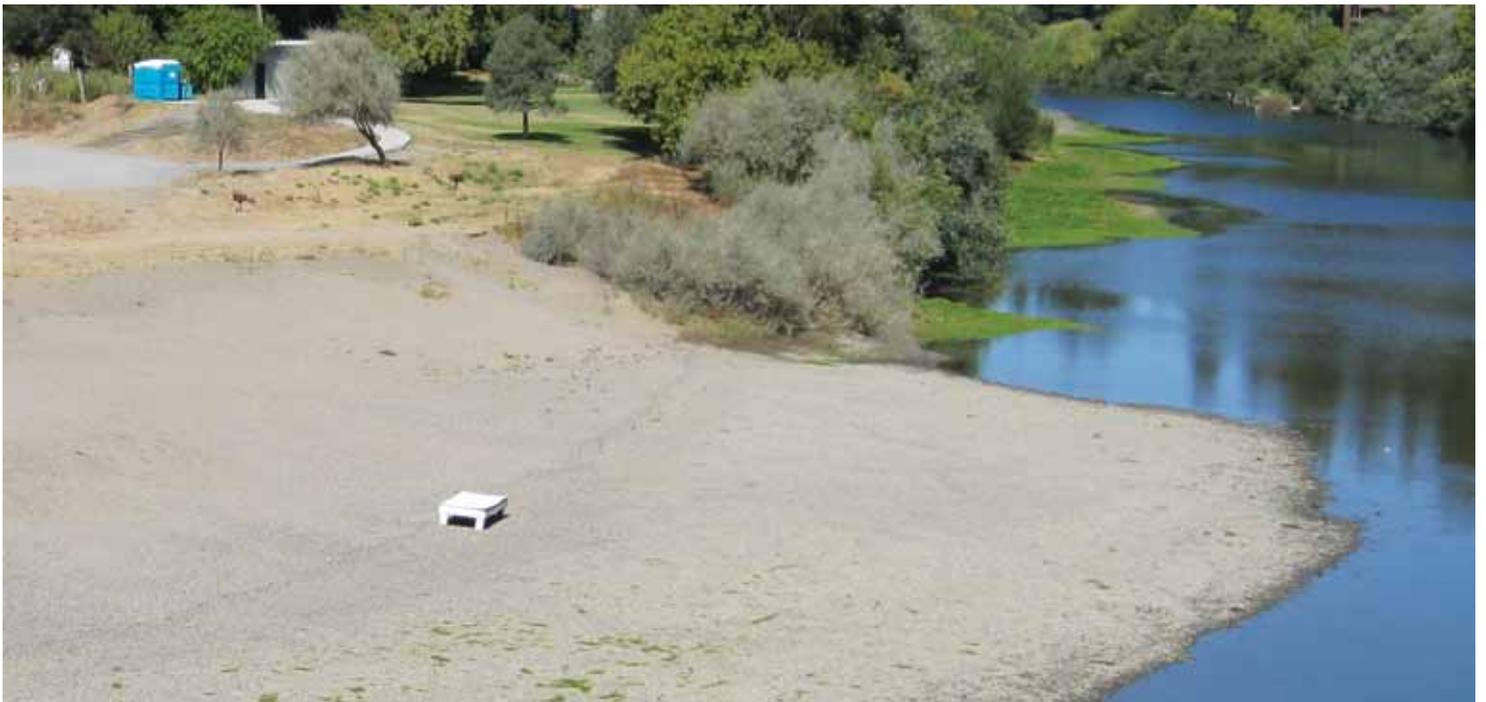
Photo 0239: This was taken around 2:30 pm on Oct. 6th after breaching of the mouth. You can see white platform far back on sand and sand bar juts out beyond Ludwigia.

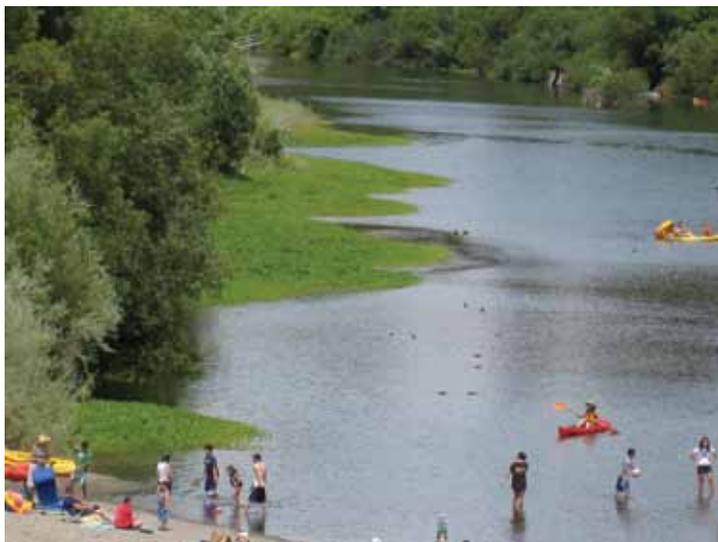
Photo 5845: This is another comparison of the same beach scene looking east. This picture was taken earlier in the season on July 11, 2009. Water levels are more than October 6th but less than October 5th when the mouth was closed. The mouth was open when this picture was taken.

Hacienda Flow: 112 cfs

Temperature: (Johnson's Beach) 23 Celsius

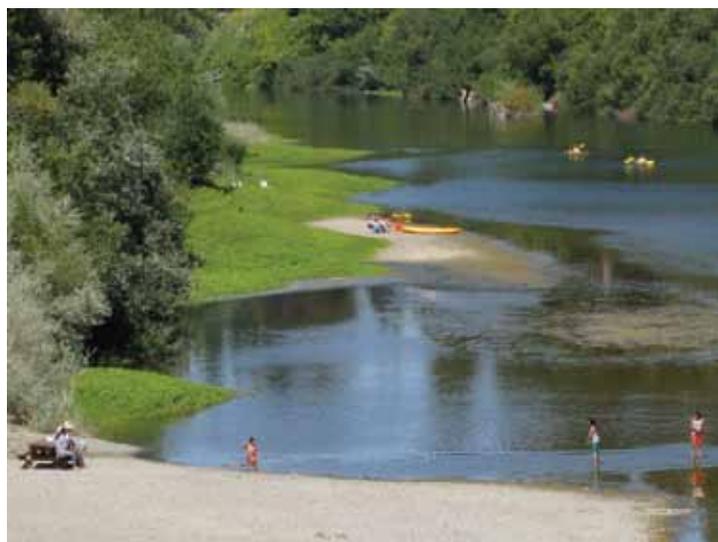
Photo 7924: This picture contrasts with 5845 in that you can see that the river level is much lower (mouth open in both pictures). This was the most visible bridge location where we can see the impact of flow levels on the river. It was taken on Aug. 15, 2009

Hacienda Flow: 50 cfs

Temperature: (Johnson's Beach) 25 Celsius

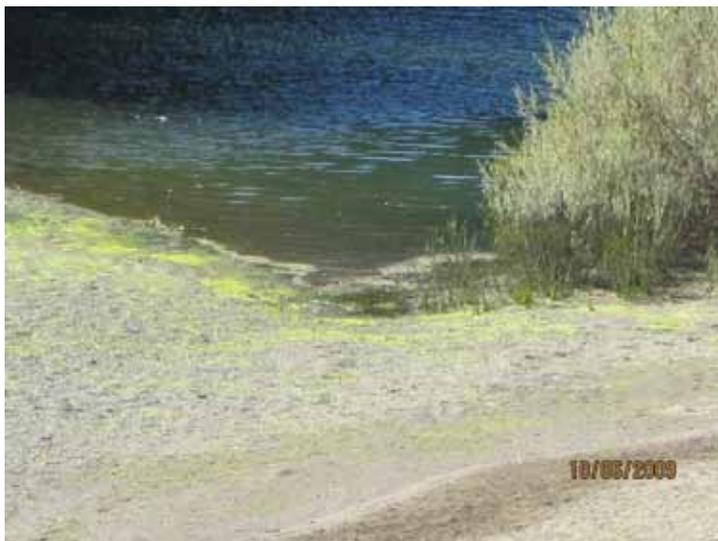
Photo 0329: This is essentially a blow up of photo 0228 on page 3 (upper right of photo) and taken Oct. 6, 2009 at Monte Rio Beach looking west. It shows prevalent algae in water and on beach AFTER opening of the mouth of the river. You can also see water line from prior day in bottom right corner.

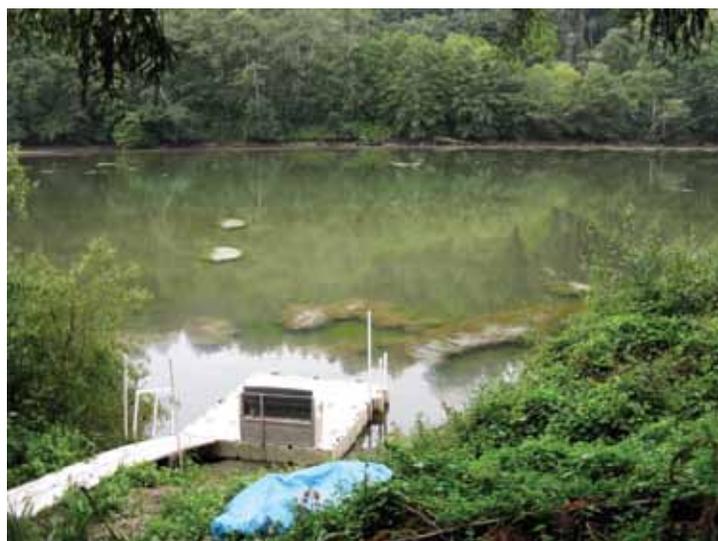
Photo 0387: taken by Bill Clark behind his Duncans Mills vacation home on July 31, 2009 in the morning.

Hacienda flow: 76 cfs

Monte Rio Pathogen exceedence

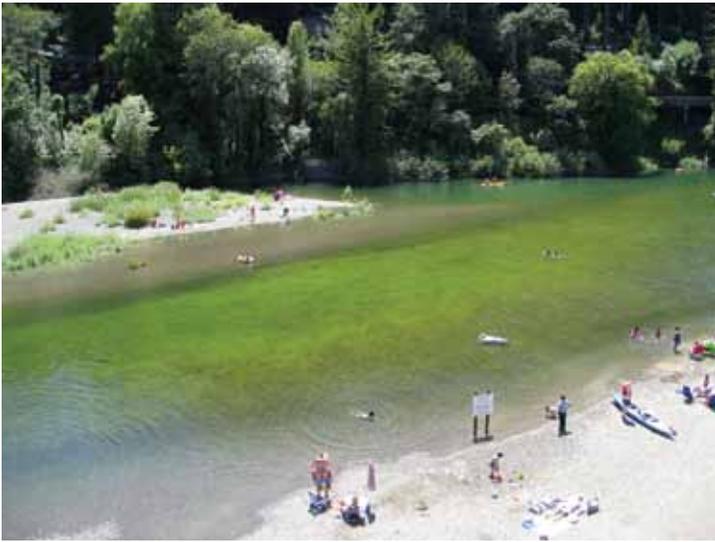
Photo 4752: This photo was taken from the Monte Rio Bridge looking west on June 22, 2009. The whole water column seems to be subject to a large algal bloom. In subsequent visits, it was not nearly so iridescent green.

Hacienda flow: 157 cfs

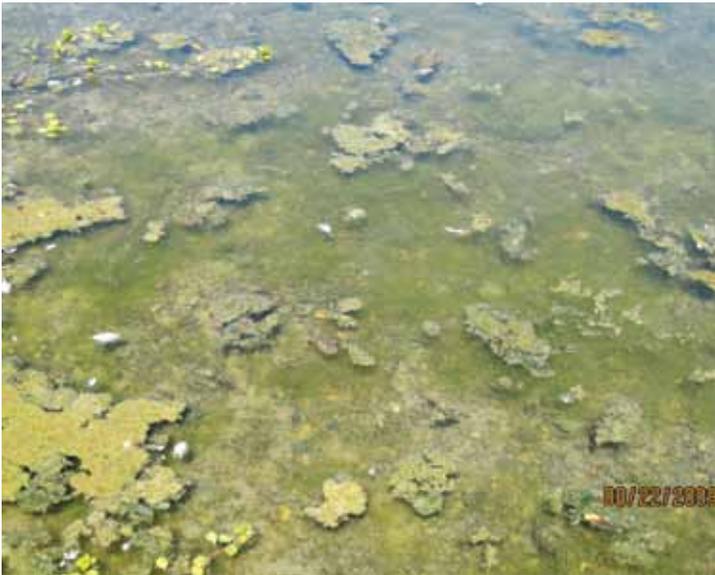
Photo 0326: This picture was taken on Aug. 22nd from the Monte Rio Bridge looking east towards the Kid's Beach. As I looked down into the water in the middle of the bridge, the floating algae could be seen going by.

Hacienda flow: 64 cfs

Temperature: (Johnson's Beach) 23.63 Celsius

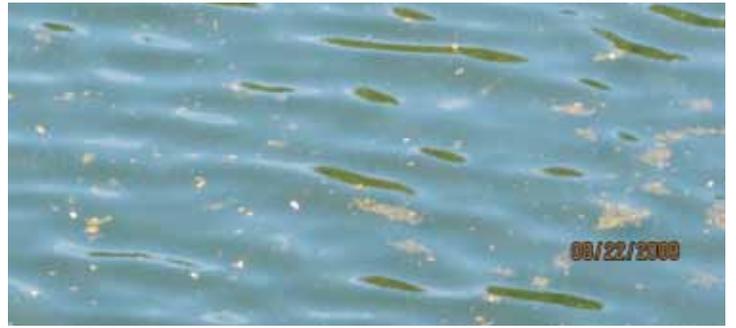
Photo 0407: This was taken at the Monte Rio Kid's Beach while down at the beach, also on Aug. 22nd. I believe that this is a different kind of algae than what was seen in the prior picture.

Hacienda flow: 64 cfs

Temperature: (Johnson's Beach) 23.64 Celsius

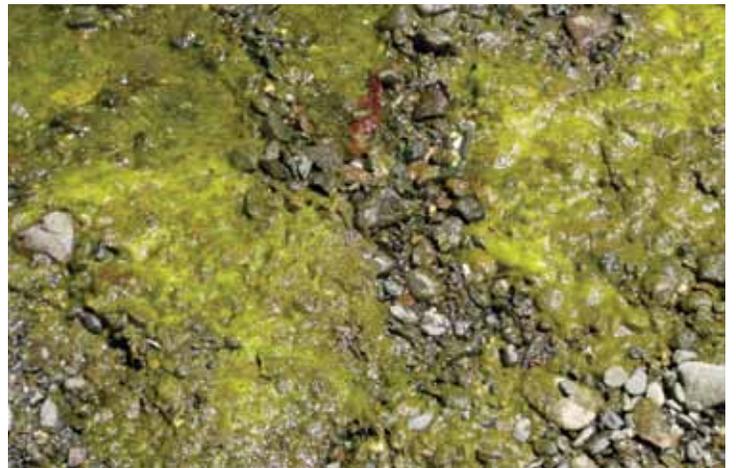
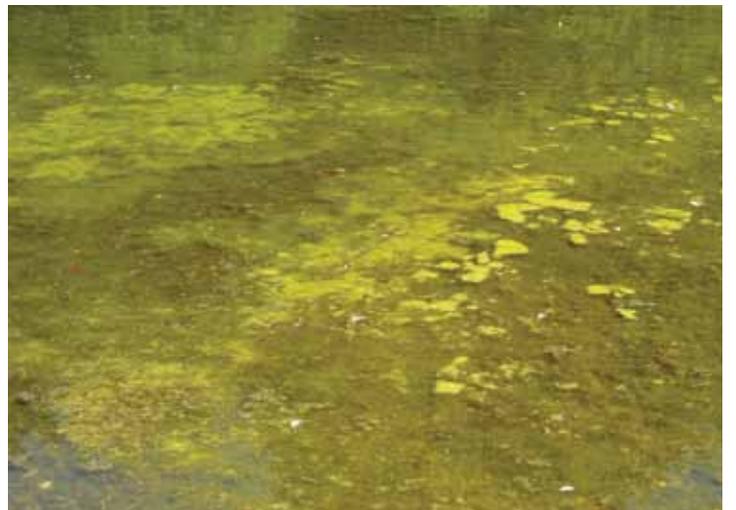
Photos 6814 and 7239: These photos were both taken at the Kid's Beach (from the beach) in Monte Rio. 6814 was taken on Aug. 2, 2009 and 7239 was taken on Aug. 8th. They were both from the same area.

Hacienda flow: 71 cfs and 64 cfs

Temperature: (Johnson's Beach) 23.35 Celsius

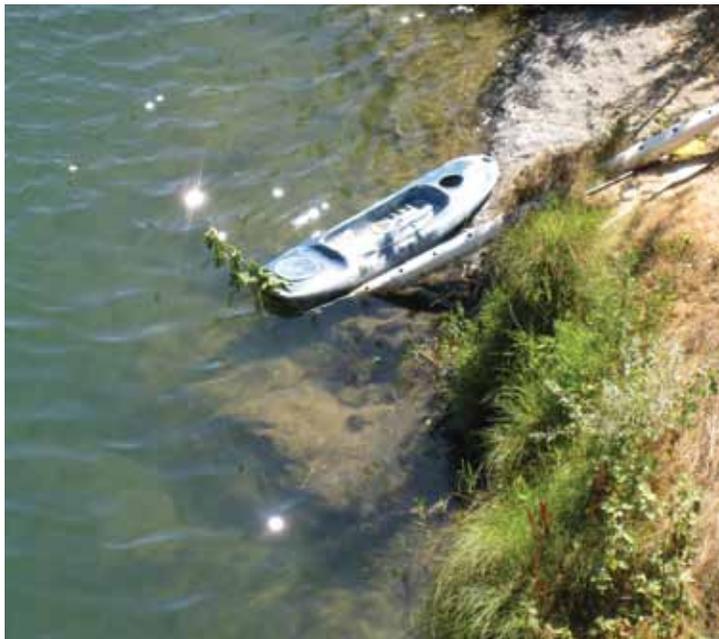
Photo 6980: This picture was taken from Hacienda Bridge on Aug. 2, 2009 Looking west (downstream), the hill on the right is where the pipe is located and the algae is right down below.

Hacienda flow: 71 cfs

Temperature: 22 C

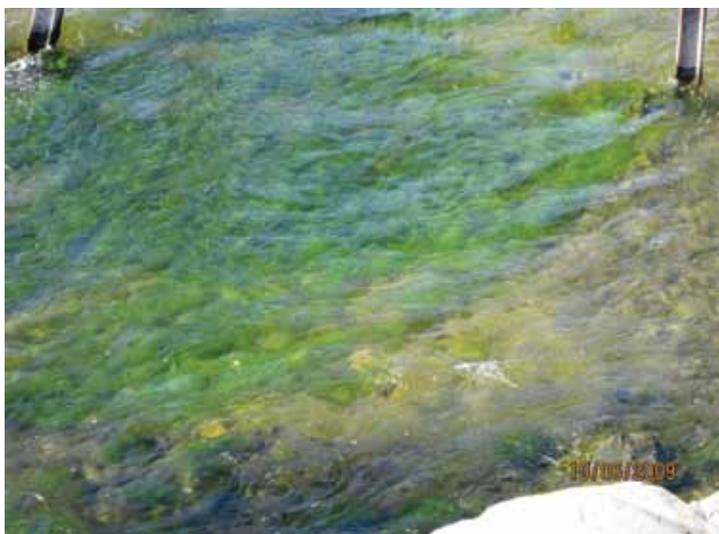
Photo 0369: This was taken at the footings of the Vacation Beach Dam (from the road) soon after it was taken down. The picture was taken on Oct. 6, 2009. The algae are very bright green as you can see, but we don't know what it is. Regional Board staff verified that it is not blue-green algae.

Hacienda flow: 102 cfs

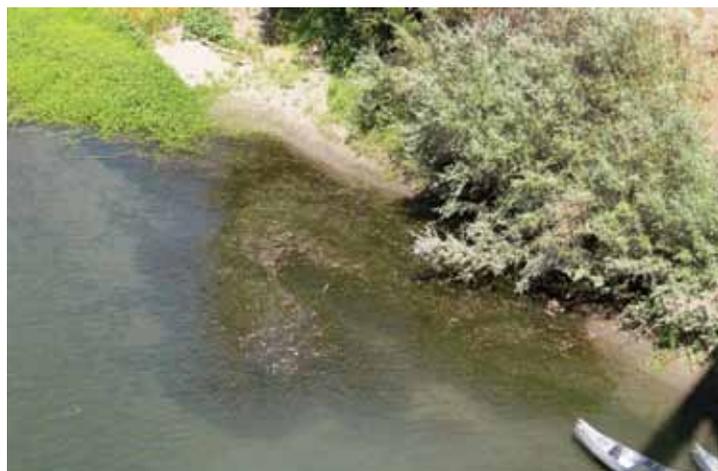
Photo 8100: This picture was taken from the Hacienda Bridge on the North side and looking over to the right. There is a huge outcropping of Ludwigia on this bend and immediately downstream is the large mat of attached algae. This picture was taken on Aug. 16, 2009.

Hacienda flow: 51 cfs

Temperature: 23 C

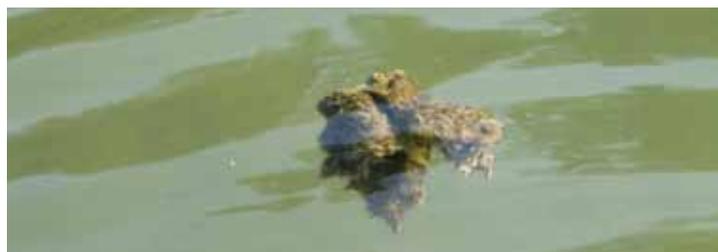
Johnson's Beach algae photographed by Shula Zuckerman on September 27, 2009. The picture speaks for itself.

Hacienda flow: 69 cfs

Temperature: 21 C

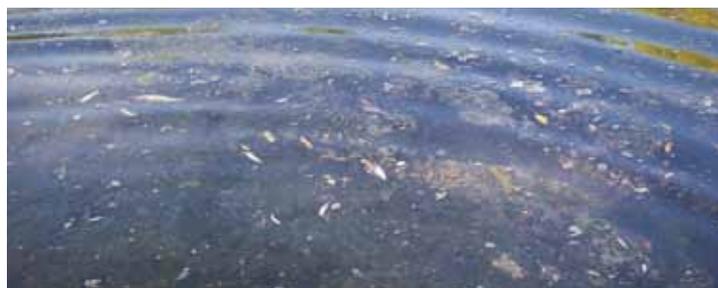
Photo 3542: Picture of floating and submerged algae taken by Laurie Ross in the Steelhead Beach area on August 18, 2009

Hacienda flow: 51 cfs

Temperature: 23 C

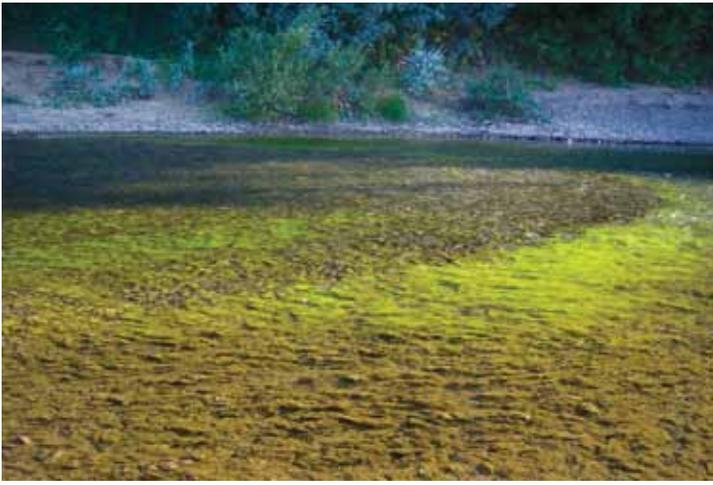
Photo 3552: Steelhead Beach algae taken by Laurie Ross on August 16, 2009

Hacienda flow: 51 cfs

Temperature: 23 C

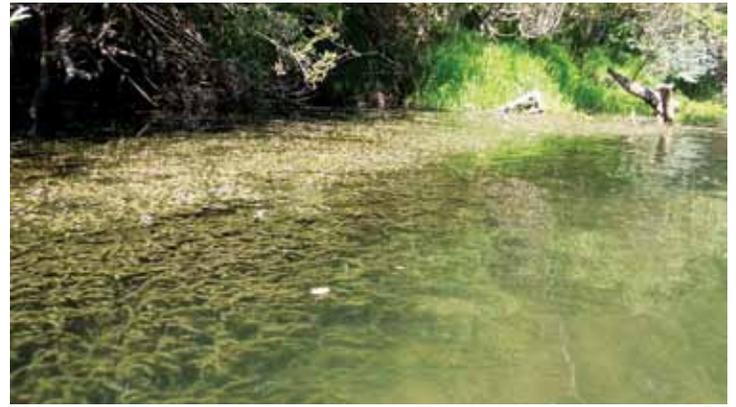
Photo 3311: taken by Laurie Ross in the Steelhead Beach area. This picture shows both Ludwigia and the attached floating and attached tubular algal plant under the water's surface. July 20, 2009 at west Steelhead Beach area, I found the same kind of growth at Hacienda looking south from the bridge on the right bank. **Photo 6327** was taken July 19, 2009.

Hacienda flow: 69 cfs

Temperature: 23 C

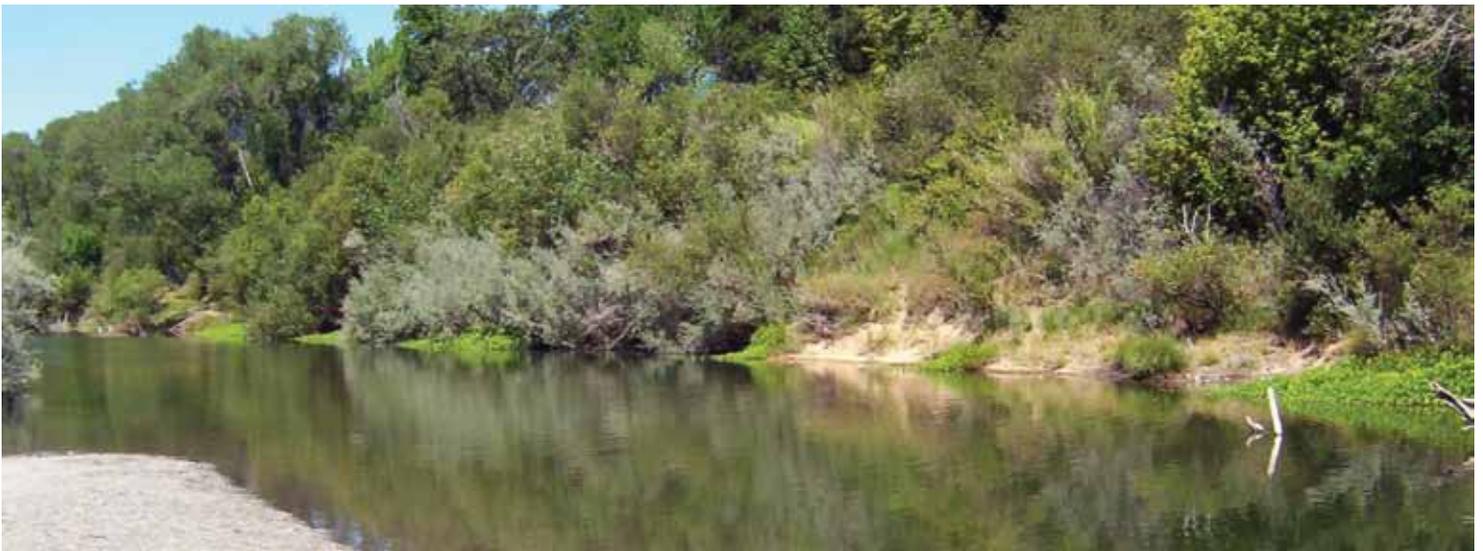
Steelhead Beach: Photo 7-31c looking downstream on July 31, 2009. You can see seven outcroppings in this picture along the bank. Hacienda flow on that date was 76 cfs. Picture taken by Tom Meldau and Shane McColgin.

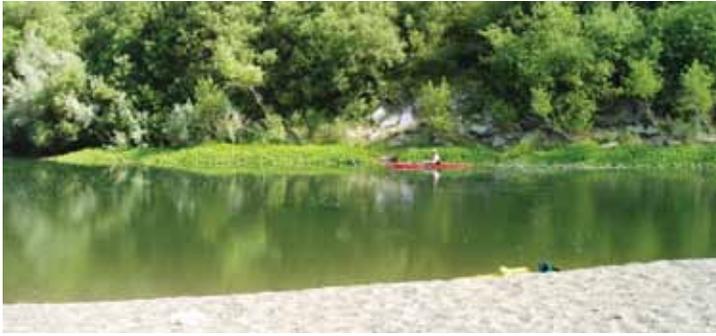
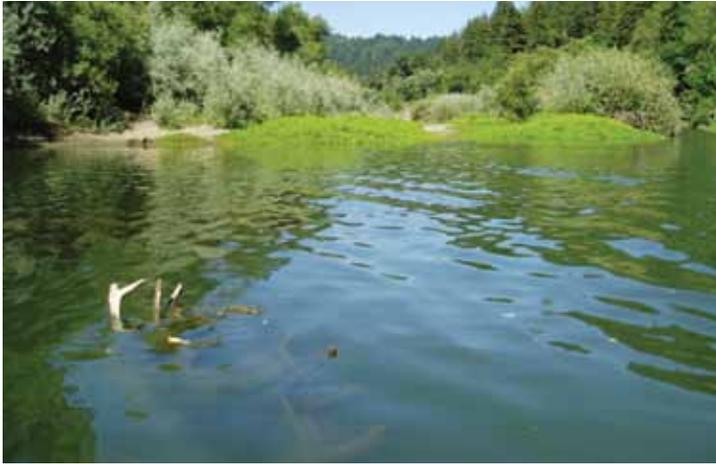
Photos 0024 and 0026 were taken west of the main Sunset Beach on July 25, 2009

Hacienda flow: 71 cfs

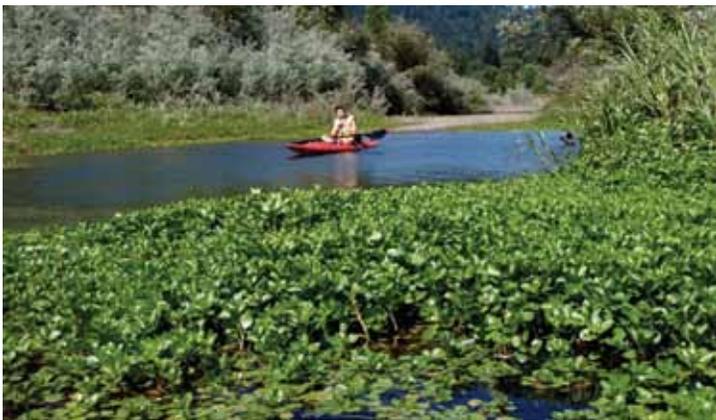
Photo 0098 was taken on July 4, 2009 in about the same location

Hacienda flow: 128 cfs

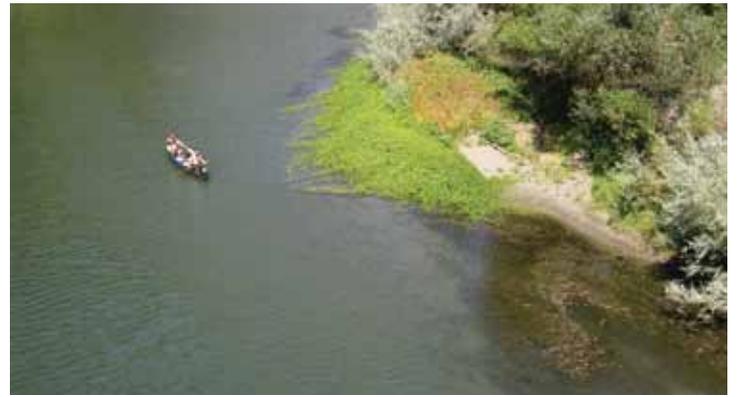
Photo 8091 was taken on August 16, 2009 (**Hacienda flow:** 51 cfs) and shows a large outcropping just north of the Hacienda Bridge looking down to the right.

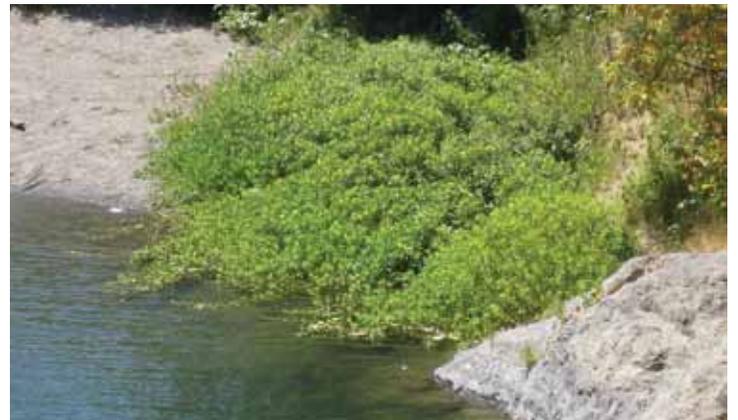
Photo 8384 was taken looking south on the Hacienda Bridge towards the right bank on August 22, 2009.

Hacienda flow: 64 cfs

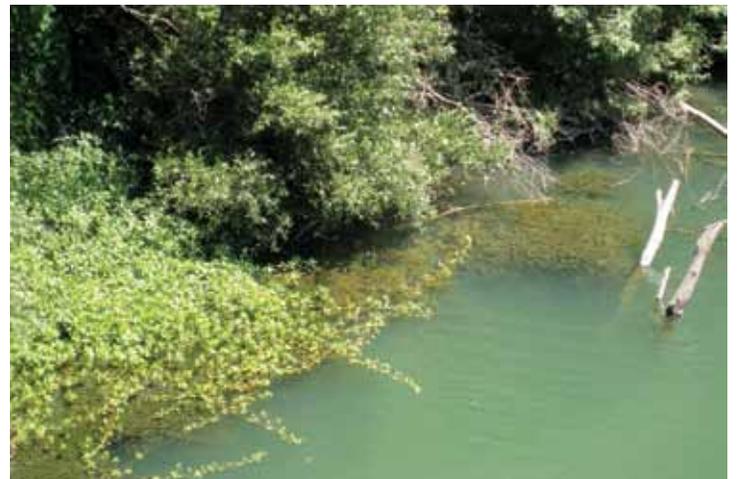
Photo 6684: Hacienda Bridge looking downstream at the left bank. Picture taken July 26, 2009 This is an outcropping of Ludwigia right next to outcropping of submerged attached algae.

Hacienda flow: 74 cfs.

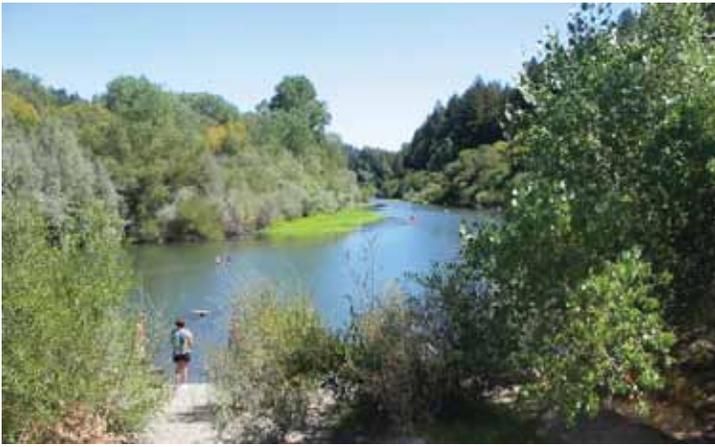
Oddfellow's Bridge:

Photo 3002 taken by Kim Pistey, I believe at the Oddfellow's Bridge. (I was unable to contact her to verify.) The picture was taken in late August.

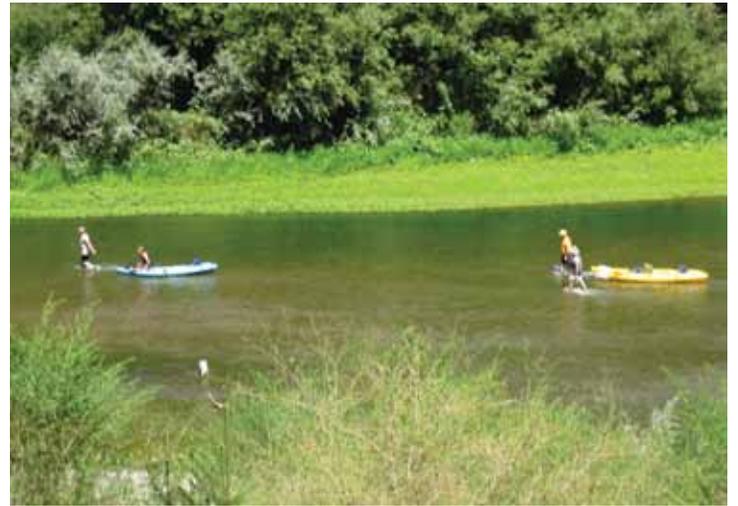
North bank between Russian River County Sanitation District and Monte Rio Beach:

Photo 3200: taken by CCWI volunteer. Not sure of date, but I had noticed area and it had been pretty consistently the same all summer.

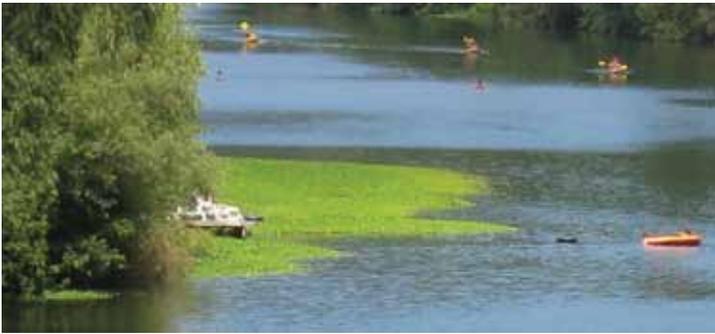
Old Guerneville Bridge: (looking east):

Photo 6246: taken July 18, 2009.

Hacienda Flow: 81 cfs.

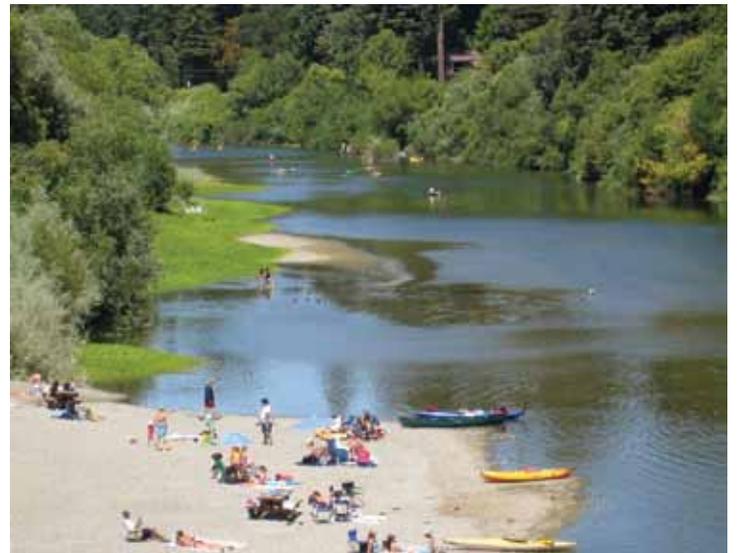
Monte Rio Kid's Beach:

Photo 6591 taken July 25, 2009.

Hacienda Flow: 71 cfs

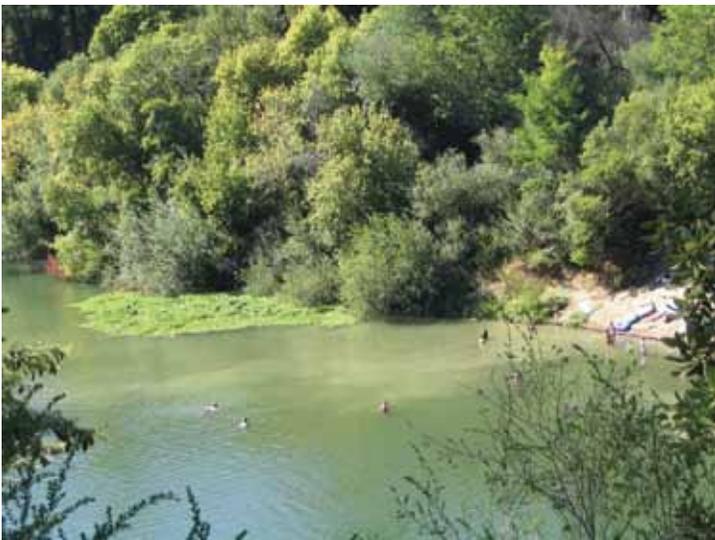
Dubrava Beach:

Photo (#8) taken September 5, 2009 by Shula Zuckerman.
