*North Coast Watershed Assessment Program*

**Gualala River  
Watershed  
Assessment Report**

March, 2003

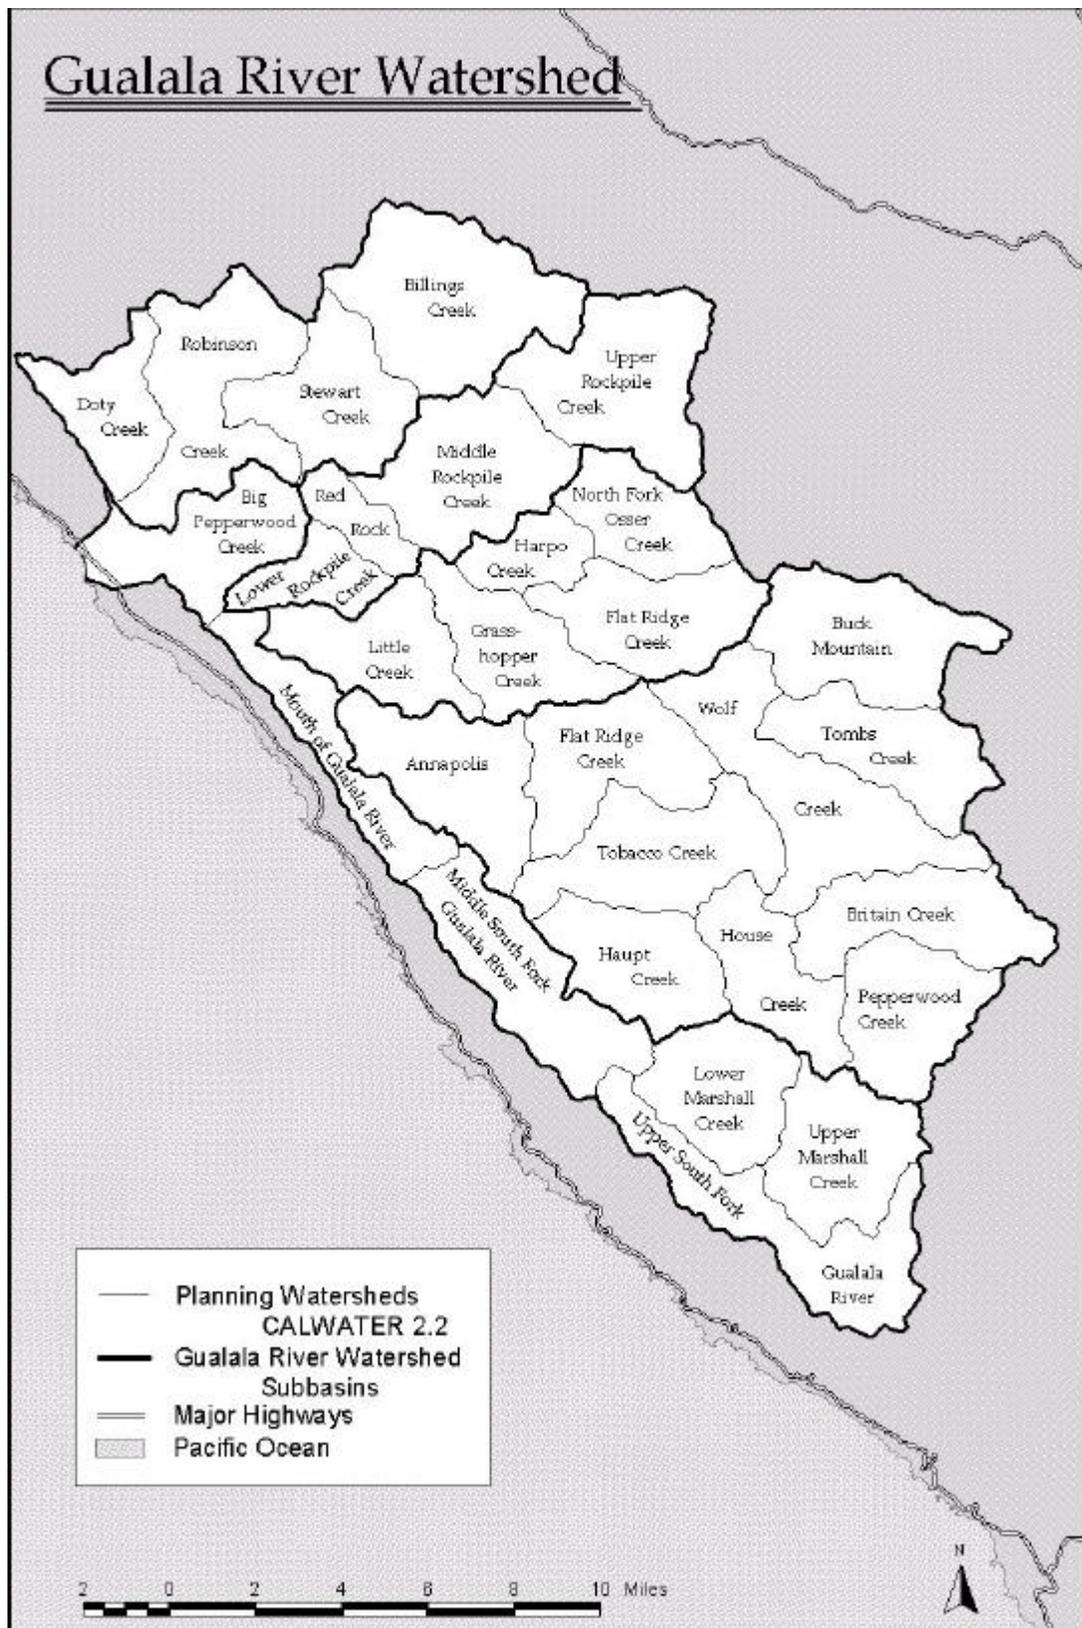
**Figure ES-2**  
The Gualala River Watershed with NCWAP subbasins and Calwater 2.2a Planning Watersheds.

NCWAP's Gualala Team sub-divided the Gualala River Watershed into five subbasins for assessment purposes: North Fork, Rockpile, Buckeye, Wheatfield Fork, and the Gualala Mainstem/South Fork (Figure ES-2). Each subbasin has somewhat unique attributes that are generally common to the several CalWater 2.2a Planning Watersheds (PWS) contained within each subbasin. These PWS are approximately 3,000-10,000 acres and are used as planning and evaluation units for projects such as Timber Harvesting Plans submitted to CDF. These common subbasin attributes pertain to its geology, vegetation, climate, land use, streams, fisheries, towns and communities, access corridors, etc. The reader will encounter the term "blue line streams," which refers to those streams identified on standard U.S. Geologic Survey (USGS) topographic maps as solid blue lines.

Subbasins and their planning watersheds are used as the basis of the format of the assessment report. They also are used as the basis for display of the Ecological Management Decision Support system GIS images, geologic and landslide maps, landslide potential maps, potential restoration sites maps, and tabular data.

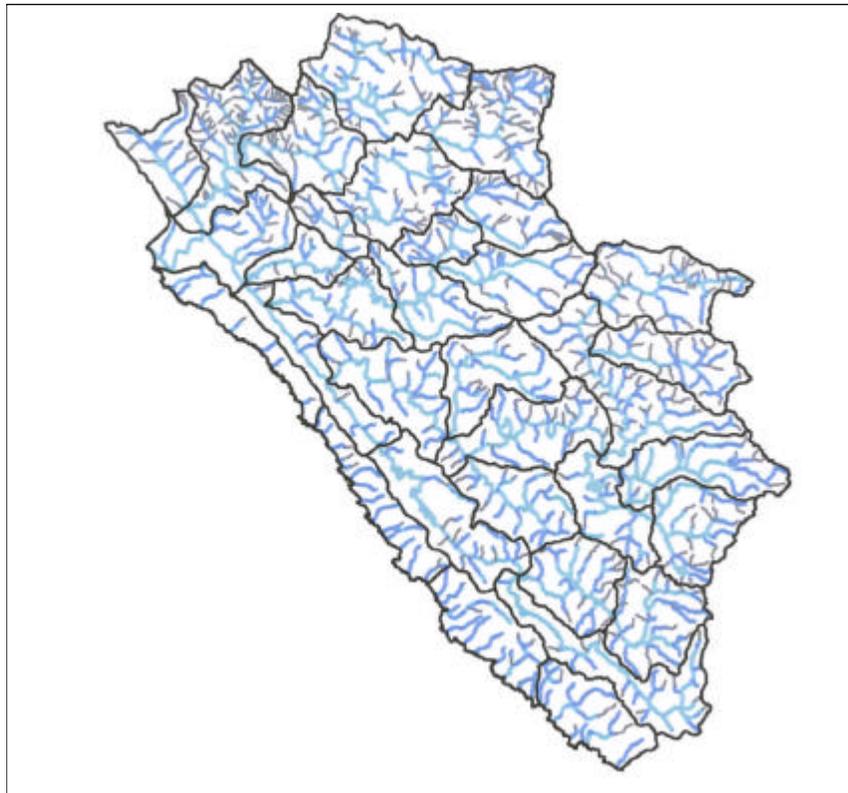
**Figure 3-2**

Distribution of Channel Gradients in the Gualala River Watershed

*Gualala River watershed showing channel type as response (light blue), transport (violet) or source (gray). Response reaches are approximately 459 km (39 percent) of the total 1188 km USGS 1:24,000 blue line streams. Transport reaches are approximately 439 km (37 percent) of the USGS channels. Source reaches are the remaining 290 km (24 percent). Response reaches are those with a blue line channel gradient of less than 4 percent. Transport reaches have gradients of between 4 and 20 percent. Source reaches have gradient above 20 percent. Channel gradients are calculated from USGS 10 meter grid DEMs. Green grid is USGS topographic 7.5-minute boundaries. Black dashed lines are CalWater2.2 planning watershed boundaries.*

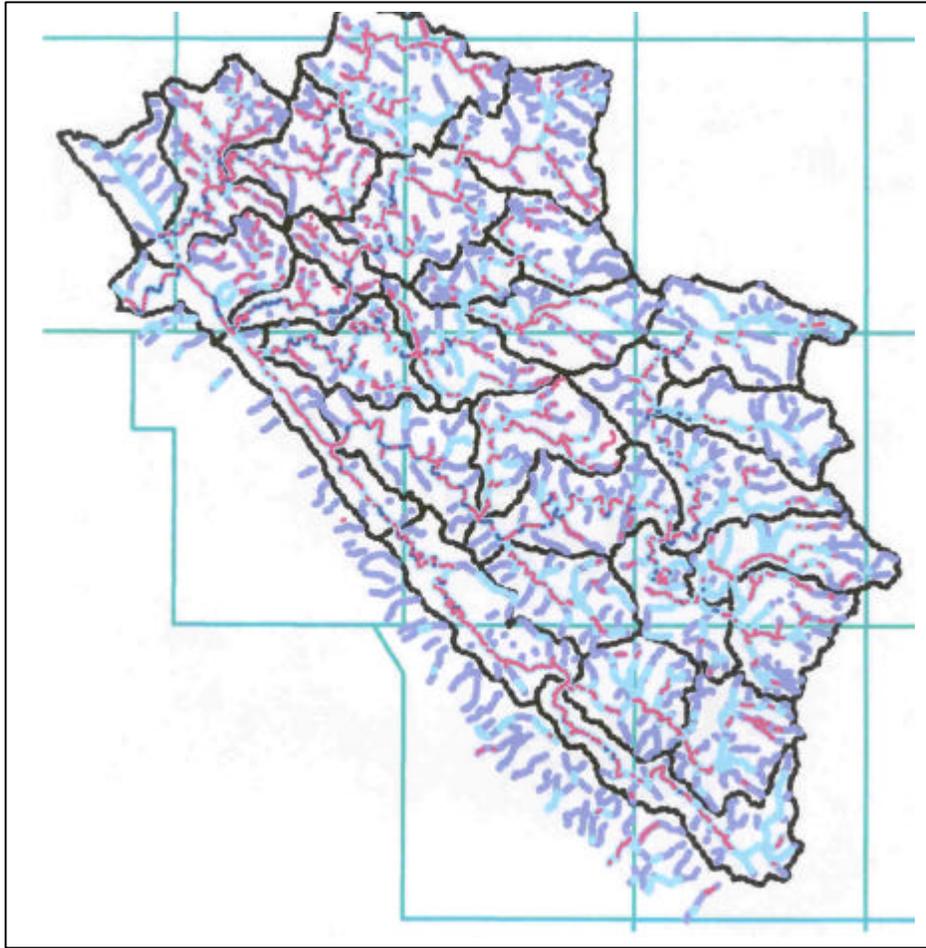
**Figure 3-3**  
Distribution of the Excess Sediment in the Gualala River Watershed in 2000, Mainly in Low-Gradient Reaches

*Mapped channel characteristics for 1999 and 2000 that suggest excess deposition or sediment delivery are shown in red, and other mapped channel sediment deposits in blue. Light blue lines are response reaches, slope less than 4 percent, and violet lines are transport reaches, slopes between 4 and 20 percent. Green grid is USGS topographic 7.5-minute boundaries. Black dashed lines are CalWater2.2 planning watershed boundaries.*

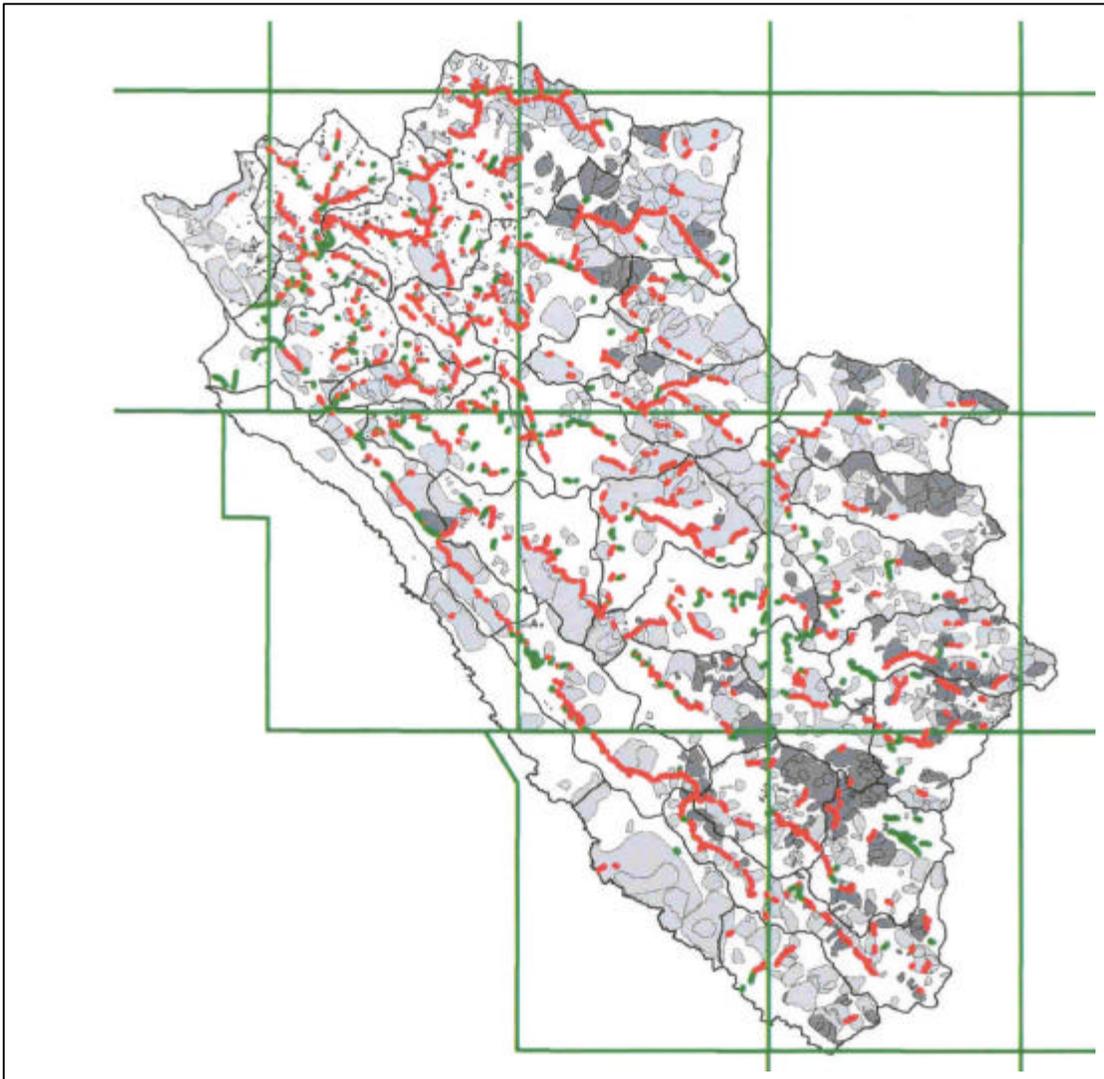
**Figure 3-4**  
Distribution of Landslides in the Gualala River Watershed

*Those reaches shown in red represent the 70 percent of 1,355 mapped reaches with sediment deposition and erosion stream characteristics within 50 meters of an active or dormant deep seated landslide. Other mapped stream reaches are shown in green. Light gray polygons are dormant and dark gray are historically active deep-seated landslides. Green grid is USGS topographic 7.5-minute boundaries.*

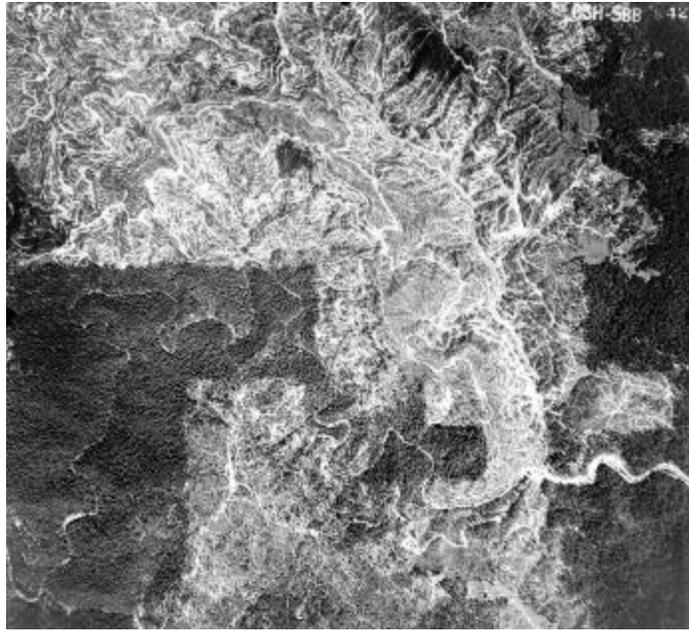
**Figure 3-5**  
1961 Aerial photo, Post World War II Pre-Forest Practice Rules Logging in the Buckeye Subbasin  
(Franchini Creek and a new Streamside Road are in upper right)

and overtopping by dirt fill. Across steep terrain, skid trails cut deep into the sideslopes, creating a terraced effect. By 1964, tractor harvesting had continued at an active pace to comprise a majority, and in some areas, most of the timbered areas in the west and central reaches of the watershed Figures 3-5.

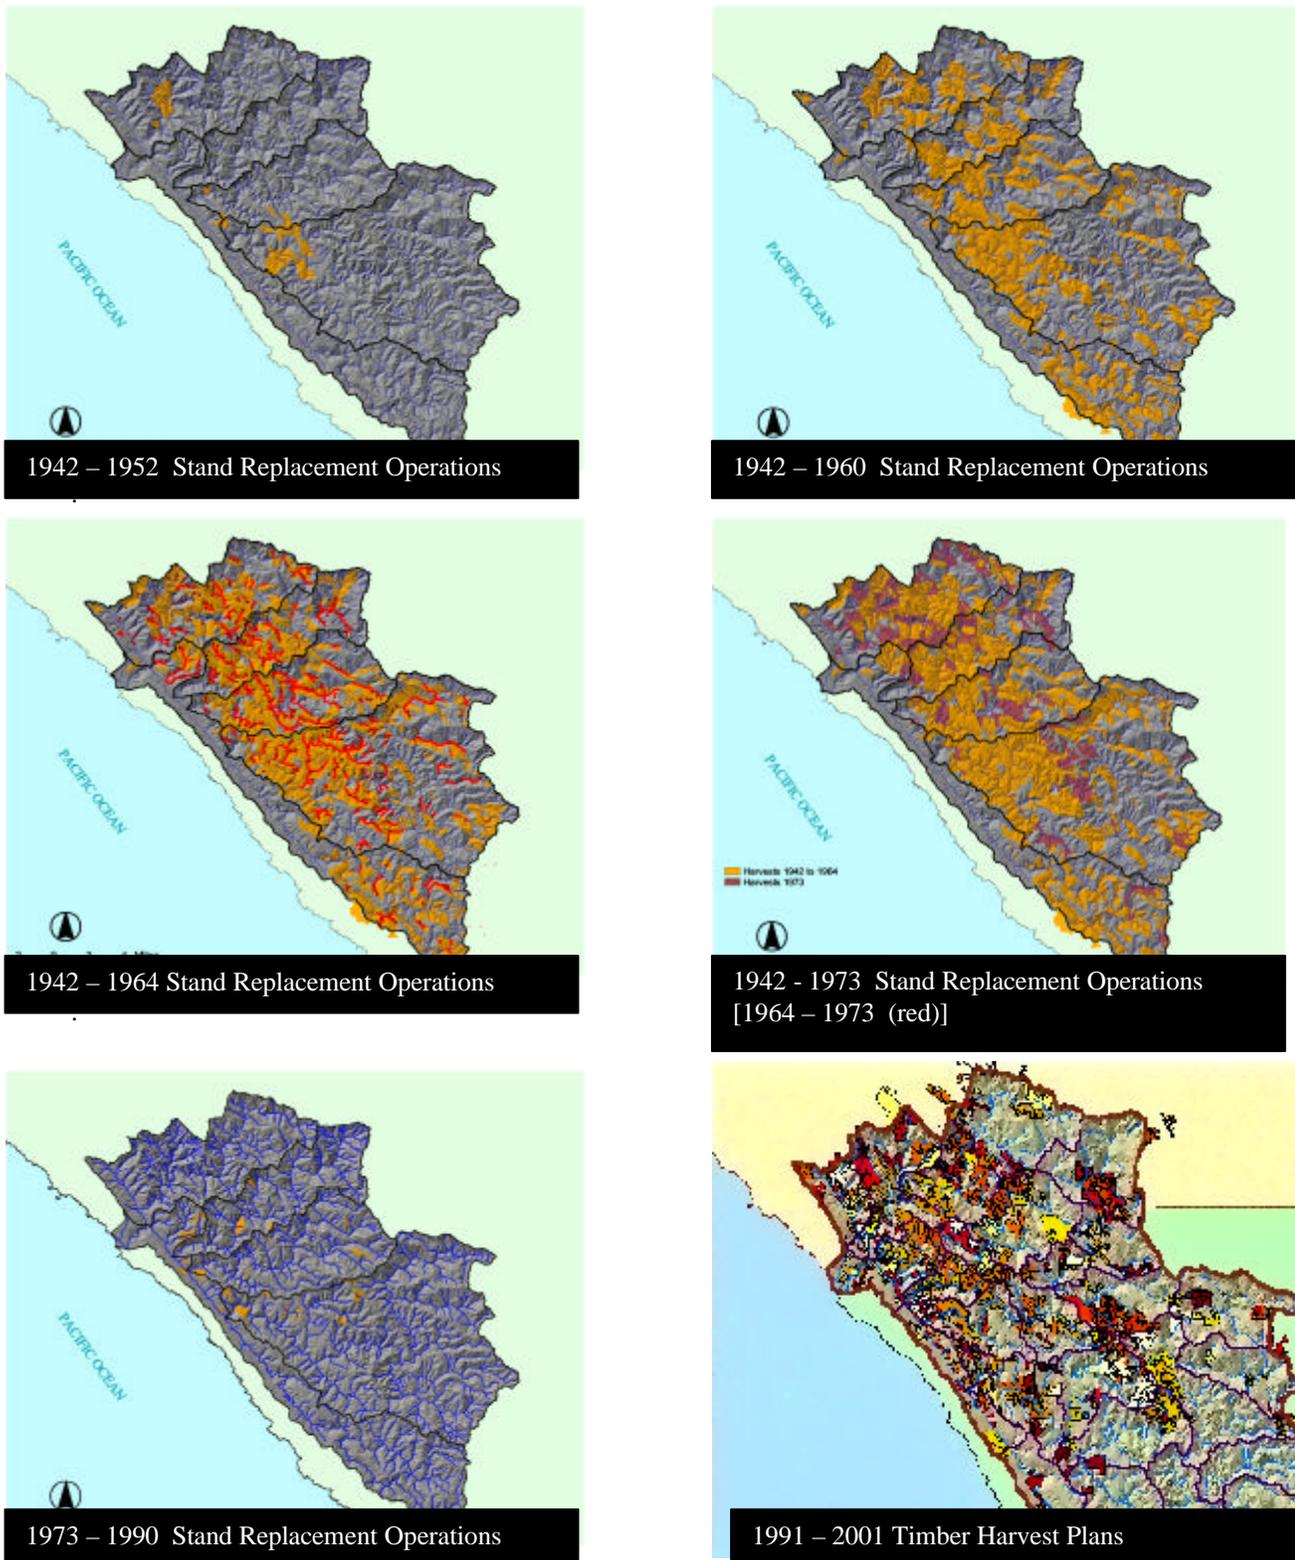
**Figure 3-6**  
Cumulative Stand Replacement Operations 1942 – 1973, and Post 1973 Operations and THPs

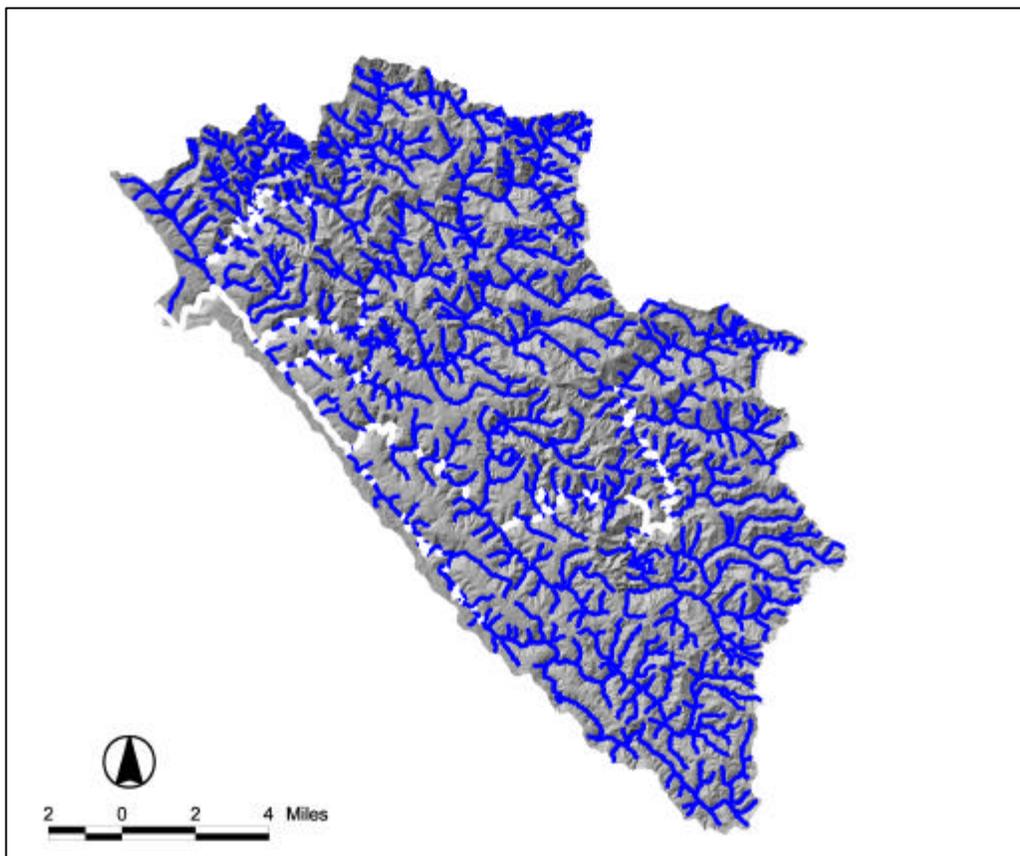
**Figure 3-7**  
1942 Bank-to-Bank Stream Exposure (white) in Generally Undisturbed Old Growth Watershed Conditions  
*Turn of the century logging was limited to the South Fork valley watershed, and the lower to middle reaches of the North Fork. Dark blue represents partial to entire canopy cover over blue line streams.*

Canopy cover was complete in most tributaries in 1942 indicating advanced regeneration from the original old growth logging along the South Fork and lower to mid reaches of the North Fork. The remainder of this subbasin in 1942 consisted of undisturbed old growth conifer timberland in the central reaches, and natural grassland oak woodlands in upland areas. Most stream reaches at this time had nearly full canopy cover. The larger order, downstream stream reaches were naturally aggraded and wide and thereby exposed (Figure 3-7).

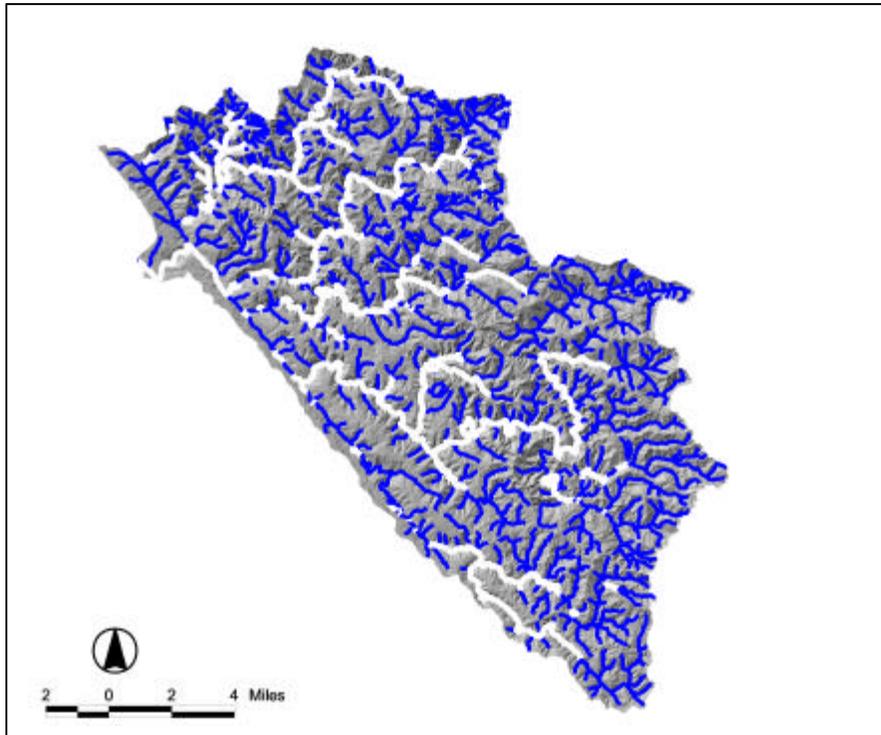
**Figure 3-8**

1968 Bank-to-Bank Stream Exposure (white)  
*Pre-1973 tractor harvesting was mostly complete. Partial to entire stream cover is shown in dark blue.*

Large-scale block clearance timber harvest projects in the mid-20th-century entirely eliminated overstory shade canopy over most salmonid spawning ground by 1968 (Figure 3-8).

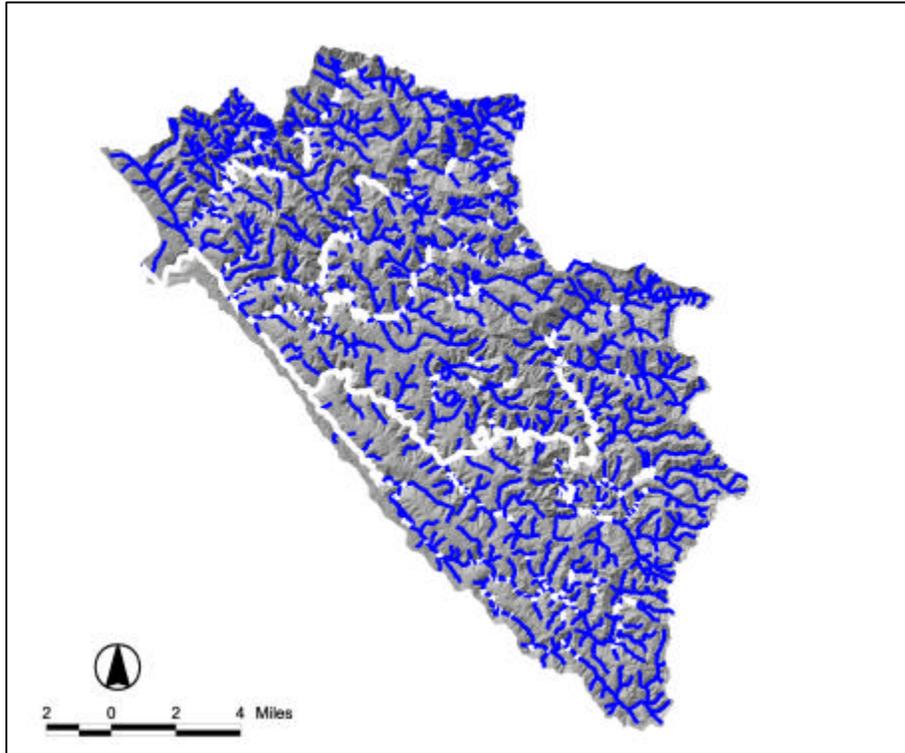
**Figure 3-9**  
1999/2000 Bank-to-Bank Stream Exposure (White), Reflecting Vegetational Ingrowth Since 1968

The end of the tractor logging era and infrequent timber harvesting until the late 1980s allowed canopy cover in-growth in most areas. These improvements in canopy coverage are evident in comparing the 1968 map to the 1999 map, with the amount of exposed stream length reduced from a range of 40-70 percent to approximately 25 percent averaged throughout the watershed (Figure 3-9). Streamside canopy now consists primarily of 40-year-old pole- to mid-sized conifers and mixed conifer/hardwood stands in the middle to upper subbasin reaches.

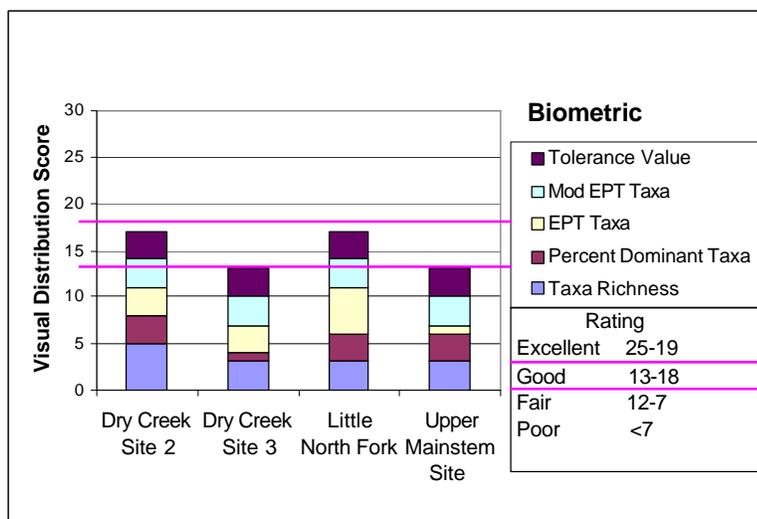
**Figure 3-10**  
North Fork Gualala Macroinvertebrate Data, 2001

Gualala Redwoods, Inc. provided benthic macroinvertebrate data from three replicate samples collected at four sites: two sites in Dry Creek, and one site each in the Little North Fork and mainstem Gualala. The biological metrics from these sites were averaged, then compared to modified biotic condition categories. The Shannon Diversity metric was unavailable and not included in the score, thus biotic condition categories were decreased by five points to arrive at the “Visual Distribution Score”: excellent (25-19), good (18-13), fair (12-7), and poor (<7) (pers comm. A. Rehn). The sites sampled on Dry Creek, Little North Fork and the mainstem Gualala indicated a “good biotic condition” (Figure 3-10).
