Coastal Watershed Planning Assessment Program

**Big River
Basin
Assessment**

November 2006

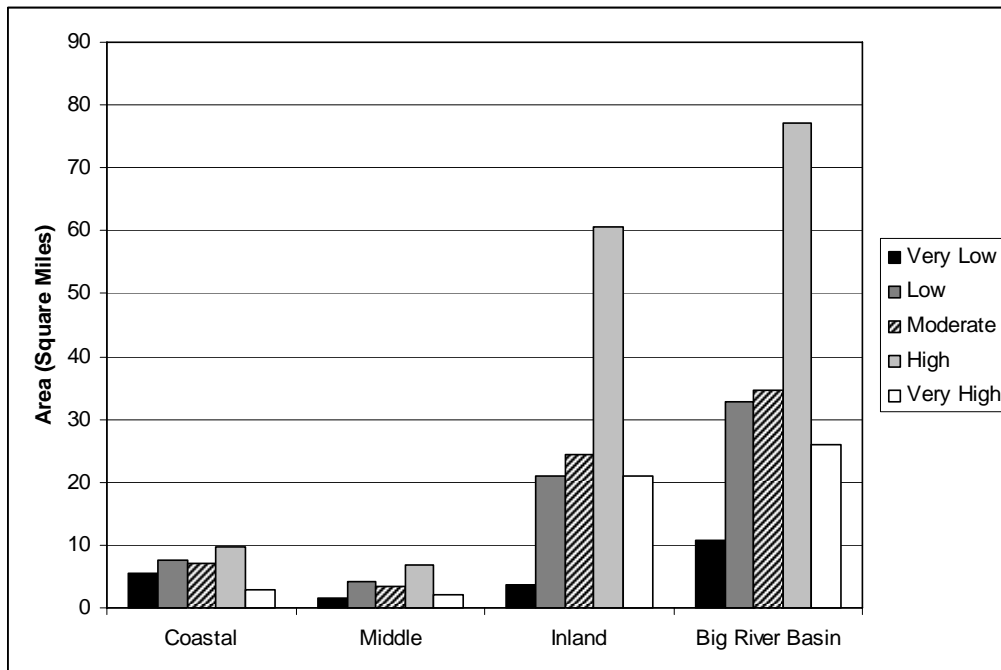
Figure 21. Area of each subbasin assigned to landslide potential categories (CGS 2005).

CGS completed a landslide potential map of the basin in 2005. Over 50% of the basin is in the high and very high landslide potential classes (Figure 20). The Coastal Subbasin has are higher percentage area in the very low and low landslide potential categories, while the Inland Subbasin has a higher percentage area in the higher landslide potential categories (Figure 21).

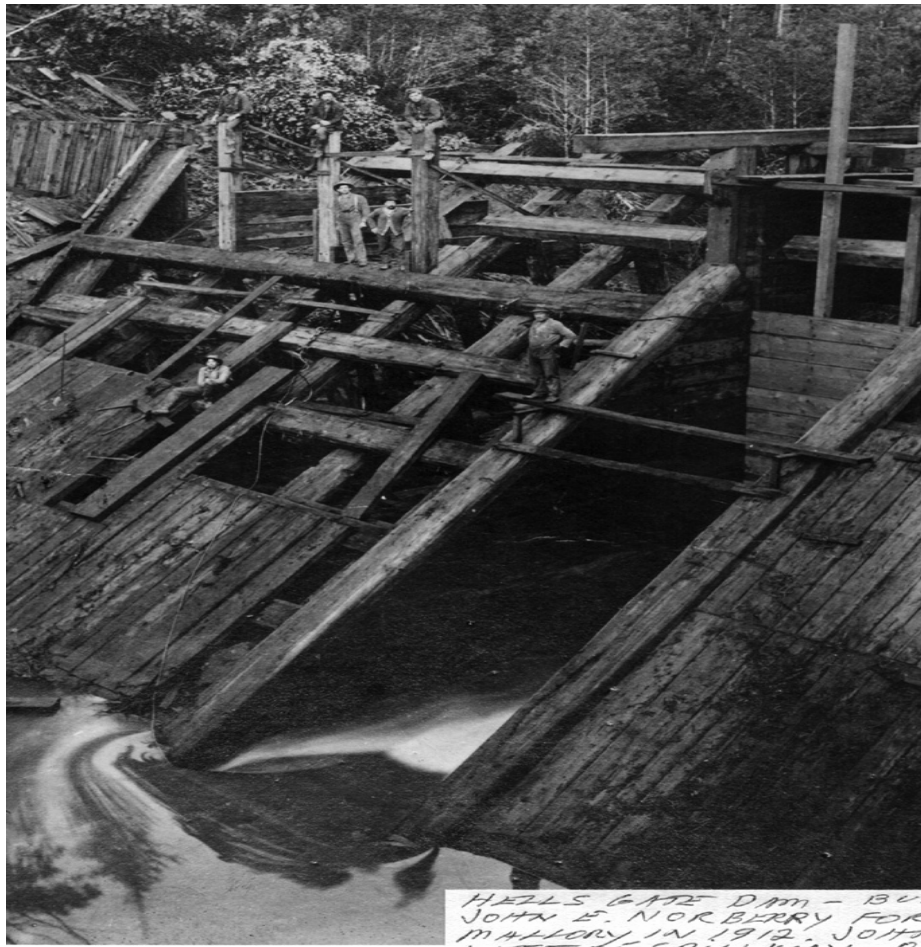
Figure 30. Hells Gate Splash Dam on the South Fork (1912).

Logging operations in the basin proceeded generally from the lower reaches in the early years, into the Little North Fork and Two Log Creek watersheds by the 1870s, then gradually into the headwaters over a period of 40-80 years. Logging in the South Fork began about 1888 (Jackson 1991). The early years of logging had one common theme, drag the log downhill to river, corduroy road, or track. The entire log was on the ground, thus it is called ground lead logging. Animals, primarily oxen, were used for yarding of logs until 1914 (Jackson 1991). The logs were usually dragged downhill and dumped into the river. Big River had 27 splash dams (Figure 30) that were then used to float logs downstream to the mill at the town of Mendocino.

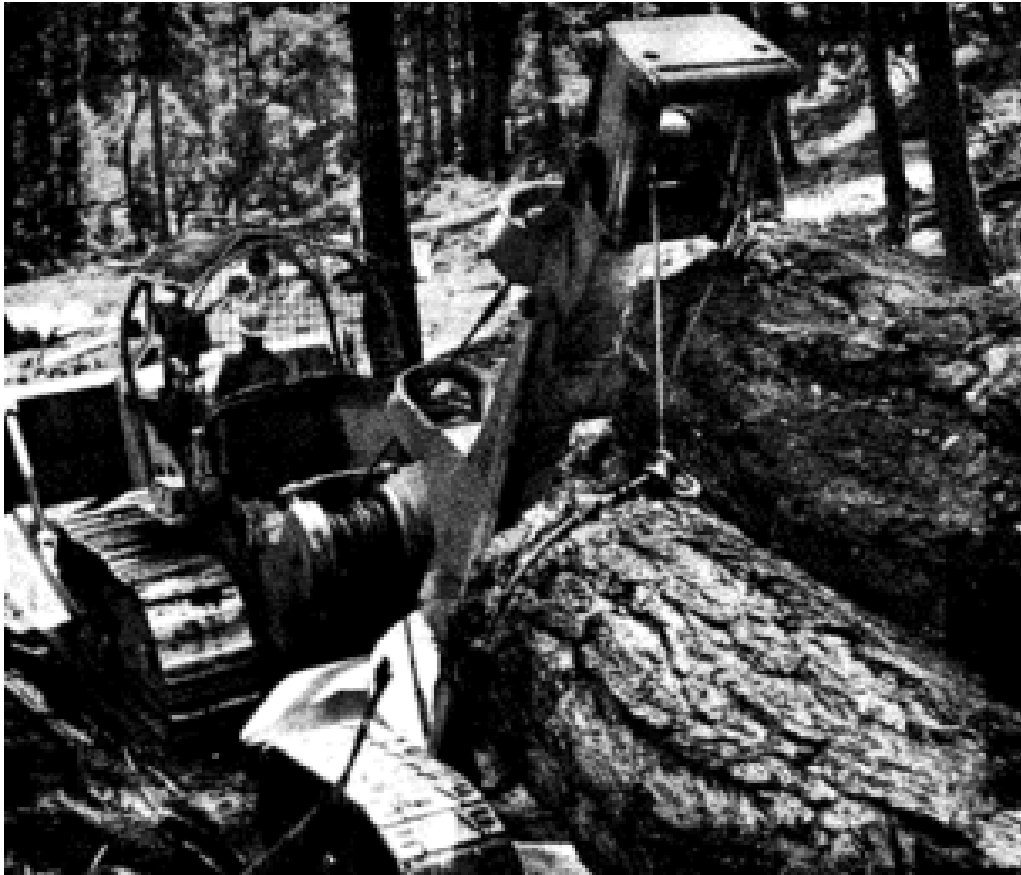
Figure 31. Tractor arch operations.

The logs were then winched up into the arch and the leading end hoisted clear of the ground. Due to the size of the tractor-arch combination there was a significant reduction in the maneuverability of the machine, resulting in an increase in the size of skid trails and landings. Each skid trail also needed a “turn around” for the tractor before it could connect to a turn of logs. These large, significant skid trails resulted in large cut banks, significant fills at low points and the increase in soil displacement. This combination of equipment, the manner of its use, and the disturbance almost certainly resulted in significant erosion and delivery of sediment to streams. Development of the integral arch eliminated the tractor arch operations, as the arch was now a part of the tractor and eliminated the need for a second piece of equipment.

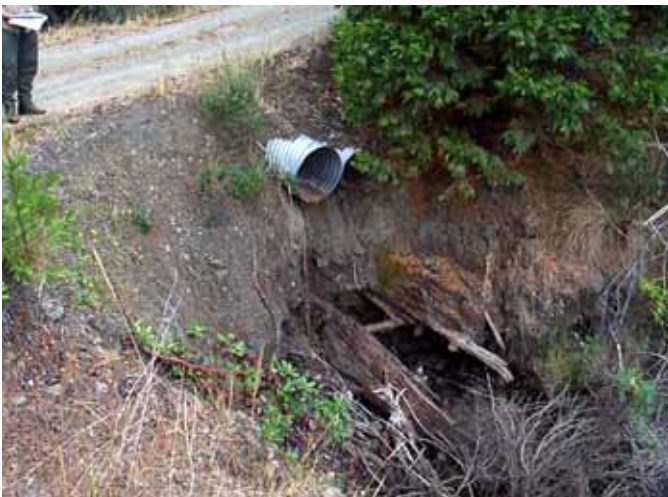
Figure 36. Watercourse crossing at high risk of failing.

Some of the techniques being used currently for abandonment of roads include the removal of watercourse crossings and re-contouring of the road prism (Figure 36, Figure 37 and Figure 39). Additionally, the number of roadside turnouts and large landings used for large old growth logging are being reclaimed (Figure 38).

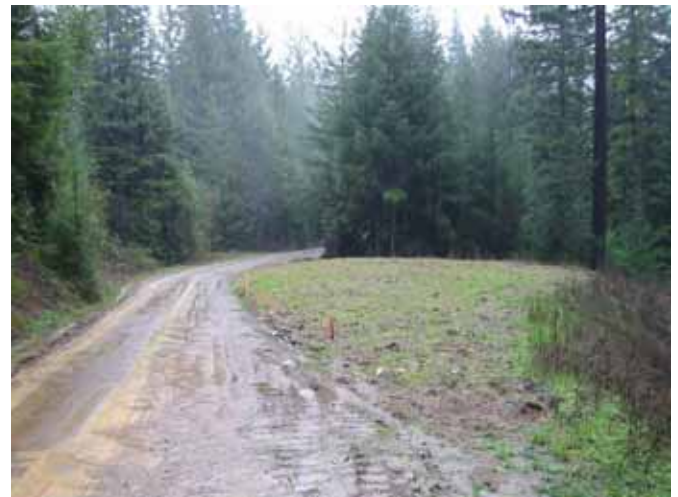
Figure 38. Reclaimed landing on mainline road.

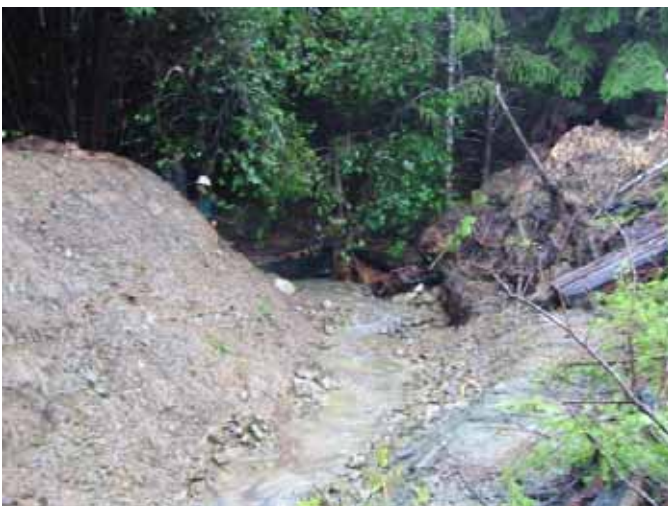
Figure 37. Legacy watercourse crossing removal.

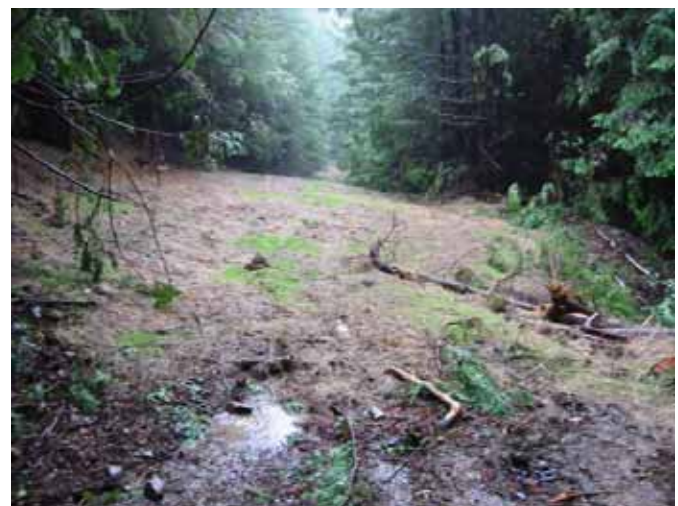
Figure 39. Abandoned road re-contoured to natural slope.

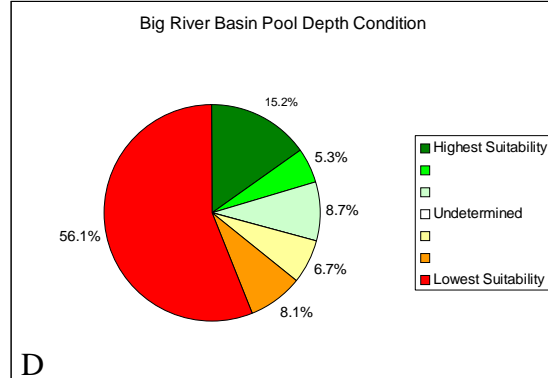
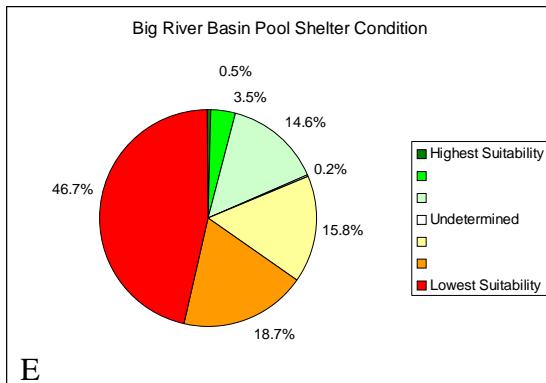
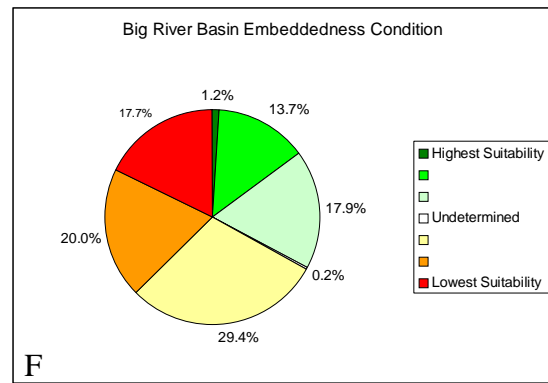
Figure 51. EMDS Reach Condition model results for the Big River Basin by percent surveyed stream miles.

A. Overall reach condition. B. Canopy density. C. Pool quality. D. Pool depth. E. Pool shelter. F. Cobble embeddedness.
