***FISHERY RESOURCES CONDITIONS
OF THE CORTE MADERA CREEK WATERSHED,
MARIN COUNTY, CALIFORNIA***

**Alice A. Rich, Ph.D.
A. A. Rich and Associates
150 Woodside Drive
San Anselmo, California 94960**

**Friends of Corte Madera Creek Watershed
P.O. Box 415
Larkspur, California 94977**

November 10, 2000

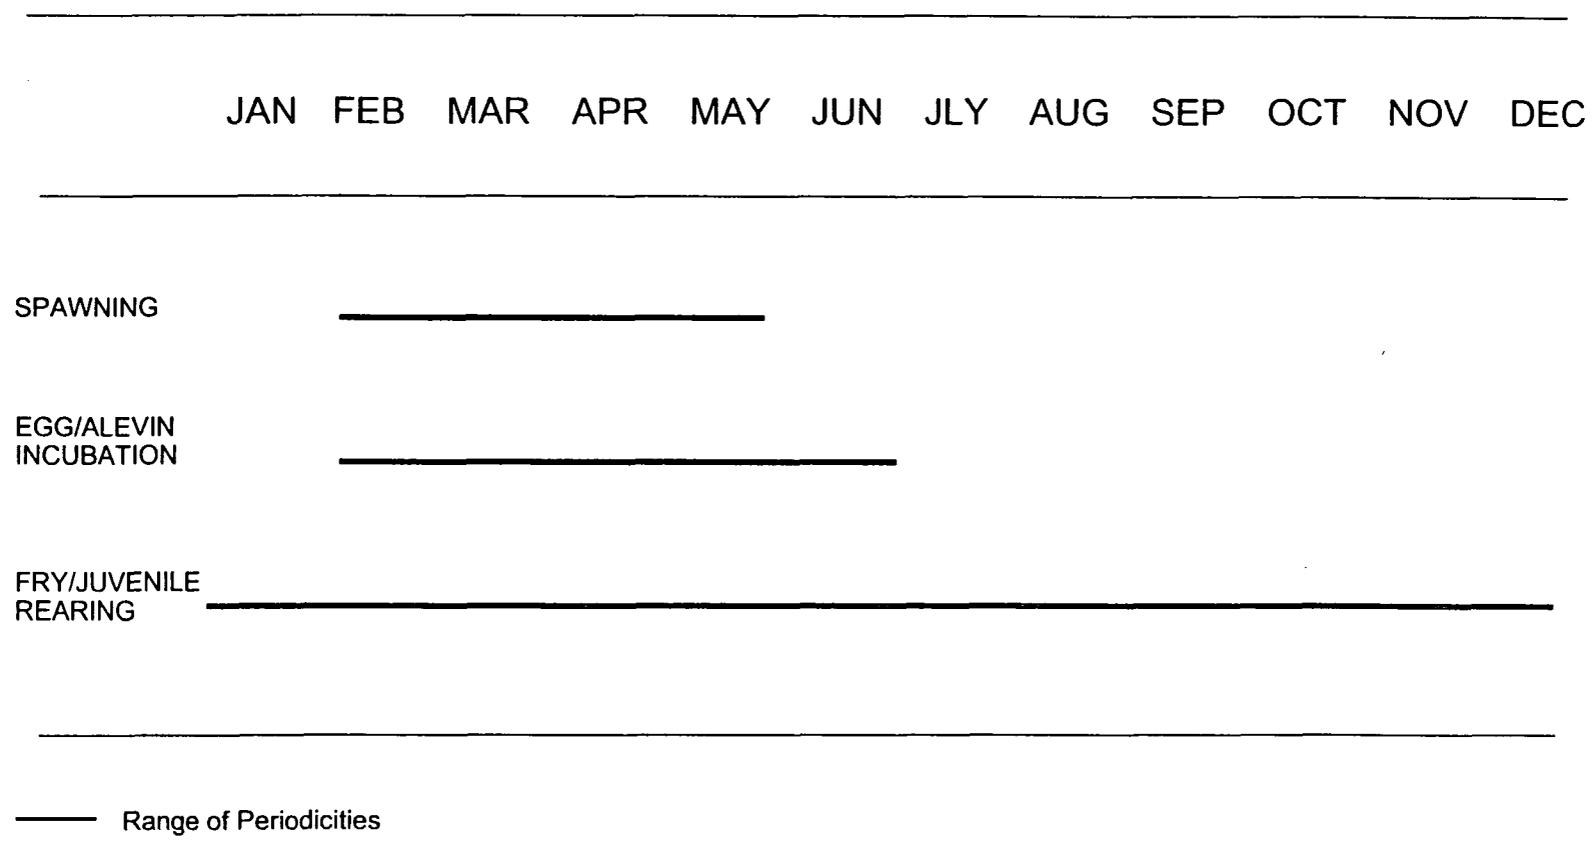
FIGURE 3. RAINBOW TROUT LIFE STAGE PERIODICITIES IN THE CORTE MADERA CREEK WATERSHED

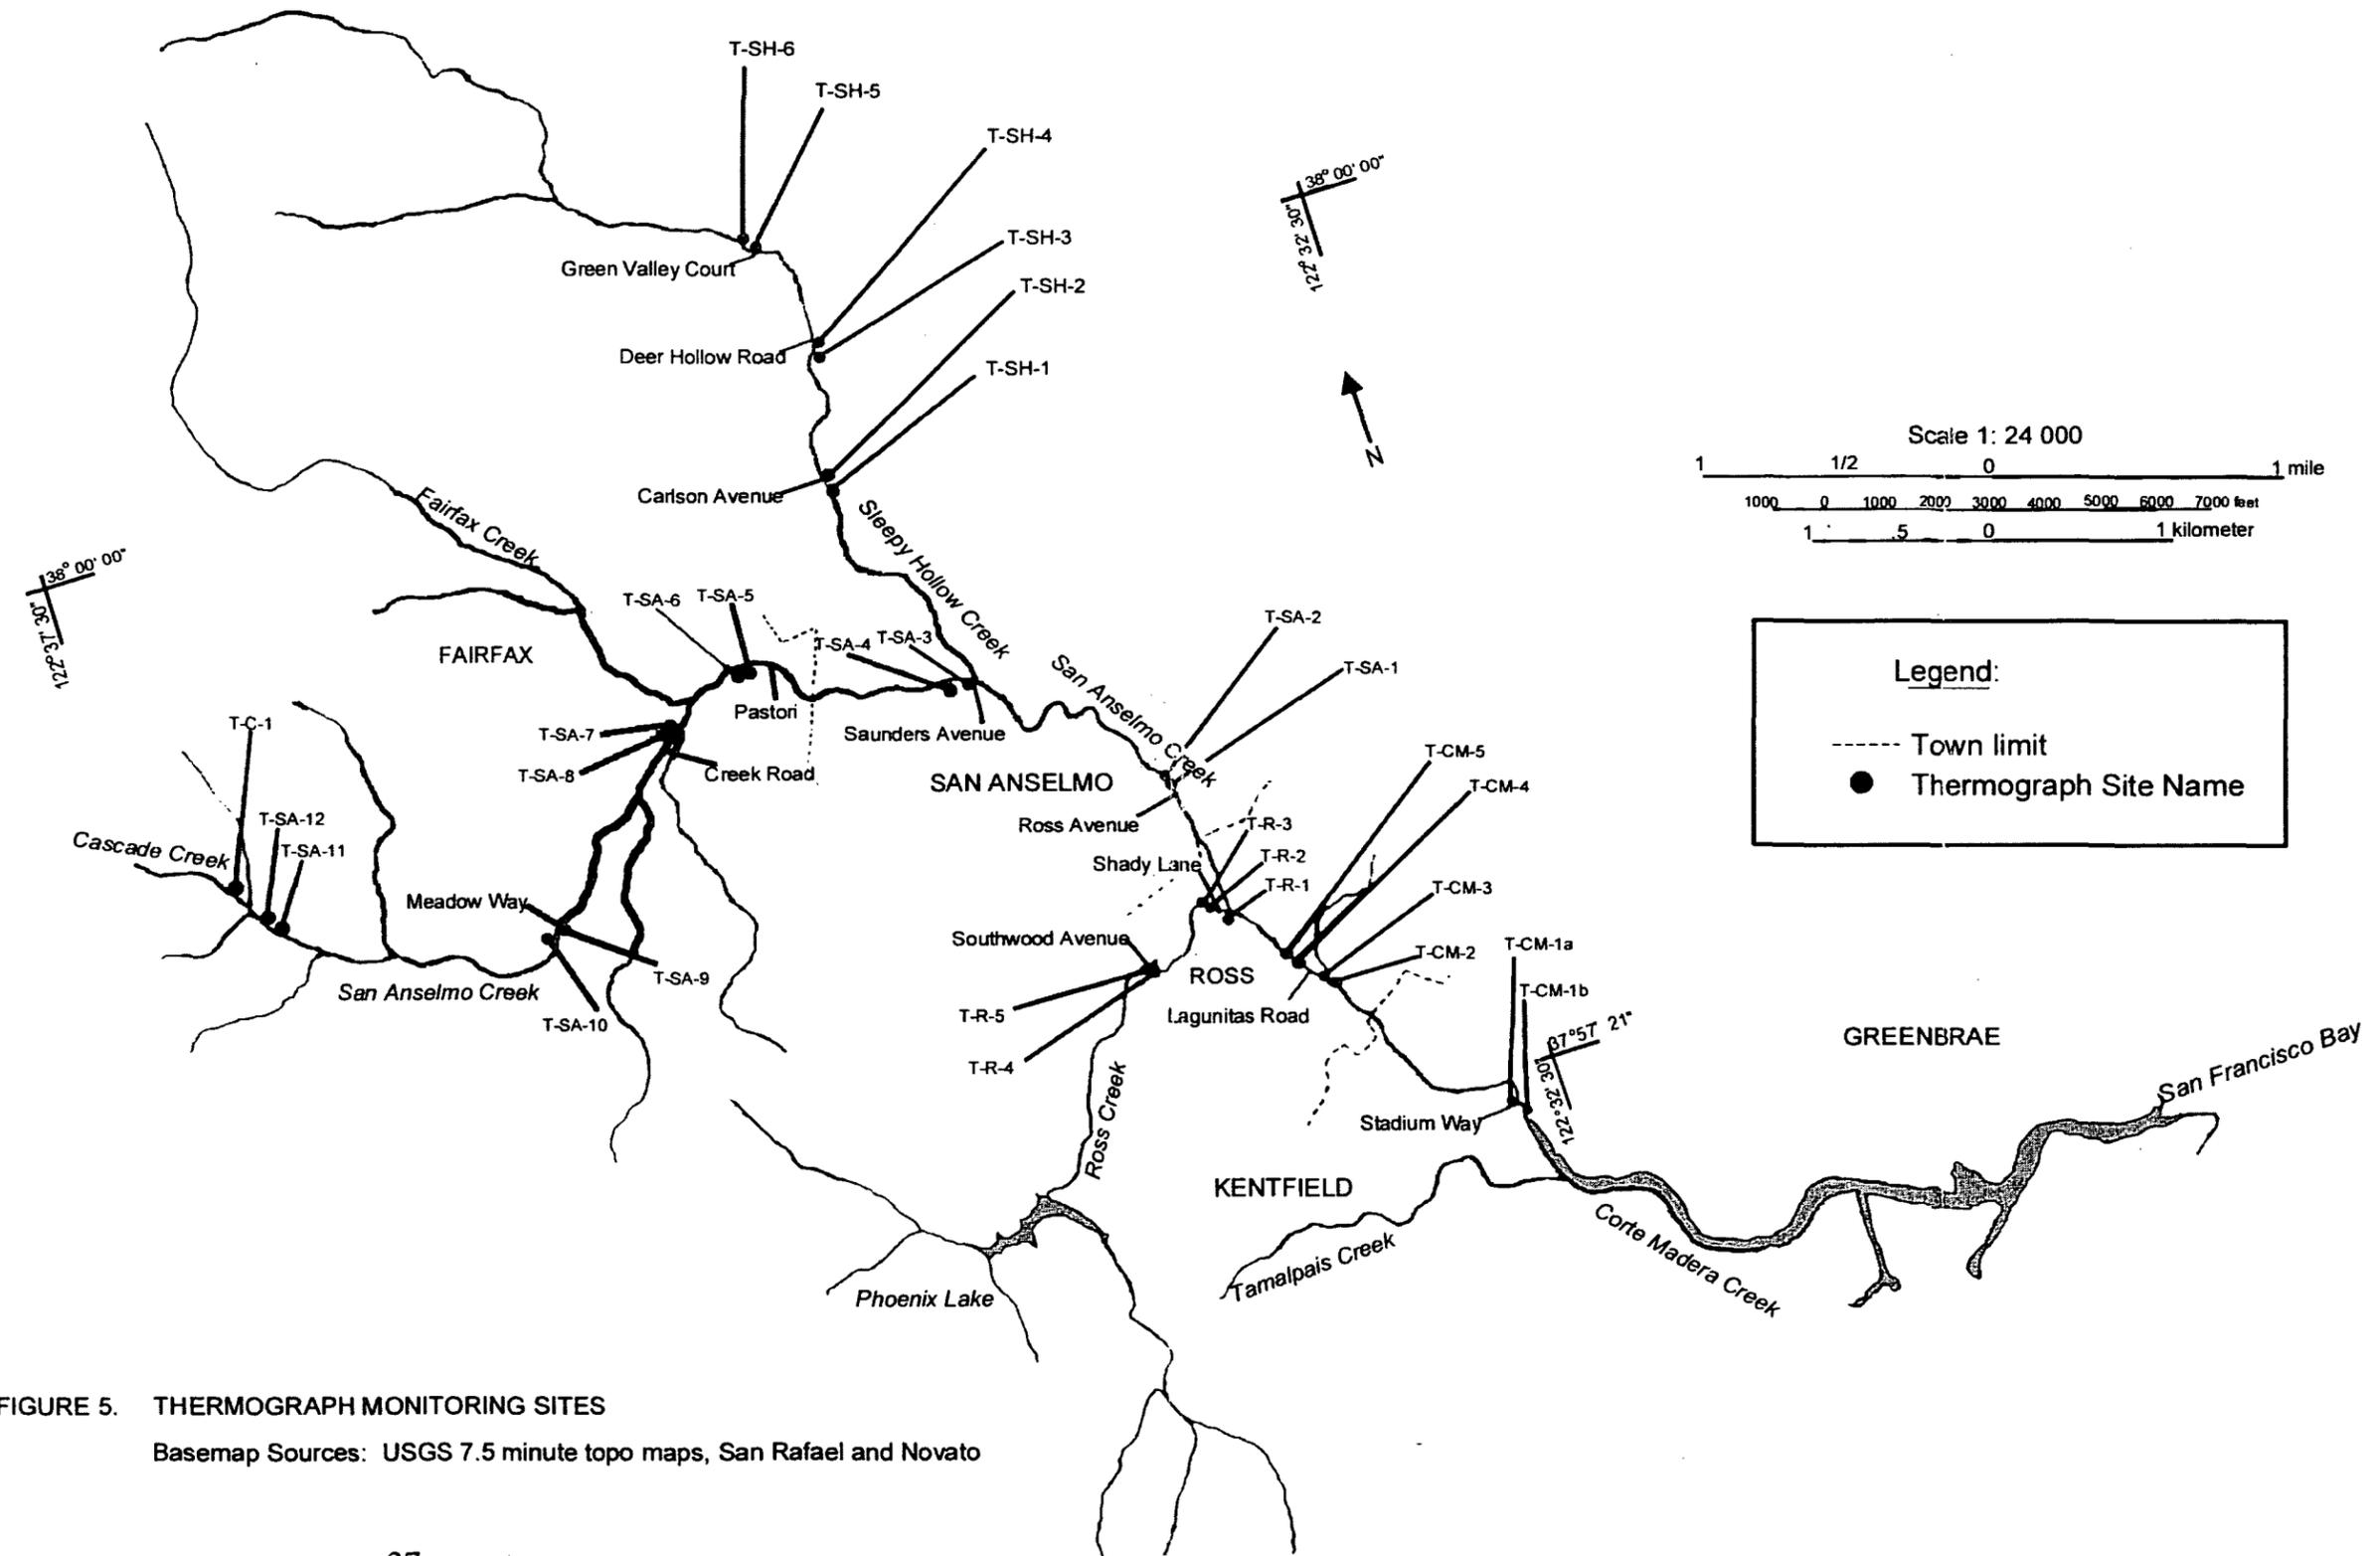
FIGURE 5. THERMOGRAPH MONITORING SITES
 Basemap Sources: USGS 7.5 minute topo maps, San Rafael and Novato

A total of 32 thermographs ("Tidbits" and "Hobos", Onset Computer, Massachusetts) were installed in representative areas of each stream reach in Corte Madera, San Anselmo, Cascade, Sleepy Hollow, and Ross creeks, beginning in April and extending to the end of September for the sites where water was still flowing; at some of the sites, thermographs were removed earlier because the site dried up (Figure 5; Appendix C, Tables 1-6). Each thermograph was cabled to a concrete landscaping block; each block was cabled to a tree. *AAR's* fisheries biologists and volunteers trained by Dr. Alice Rich (Appendix B) maintained the thermographs during their installation. At the time of their initial installation, the location of each thermograph was photographed and the latitude and longitude recorded, using a Garmin GPS 48 Personal Navigator. Prior to installation, each thermograph was calibrated to record water temperature every 10 minutes, 24 hours a day. The number of thermographs installed in each of the creeks were as follows: (1) Corte Madera Creek - 8; (2) San Anselmo Creek - 12; (3) Cascade Creek - 1; (4) Sleepy Hollow Creek - 6; and, (5) Ross Creek - 5 (Figure 5).

To monitor the water and habitat conditions of each site during the time when the thermographs were installed, photographs were taken (one facing upstream and one facing downstream) at each site on a weekly basis. Each thermograph was checked weekly to determine whether or not the thermograph was working (from the blinking light on each thermograph); (1) immersed in water; and, (2) residing in the original habitat in which it was placed. When any of the conditions did not apply, Dr. Rich was contacted and she assessed whether or not to either move or replace the thermograph. Some of the thermographs were removed early, as many of the stream reaches dried up (Tables C-1 through C-6, Appendix C). To preclude the possibility of losing data sheets, two sets of data sheets and two sets of photographs were stored at all times in the following

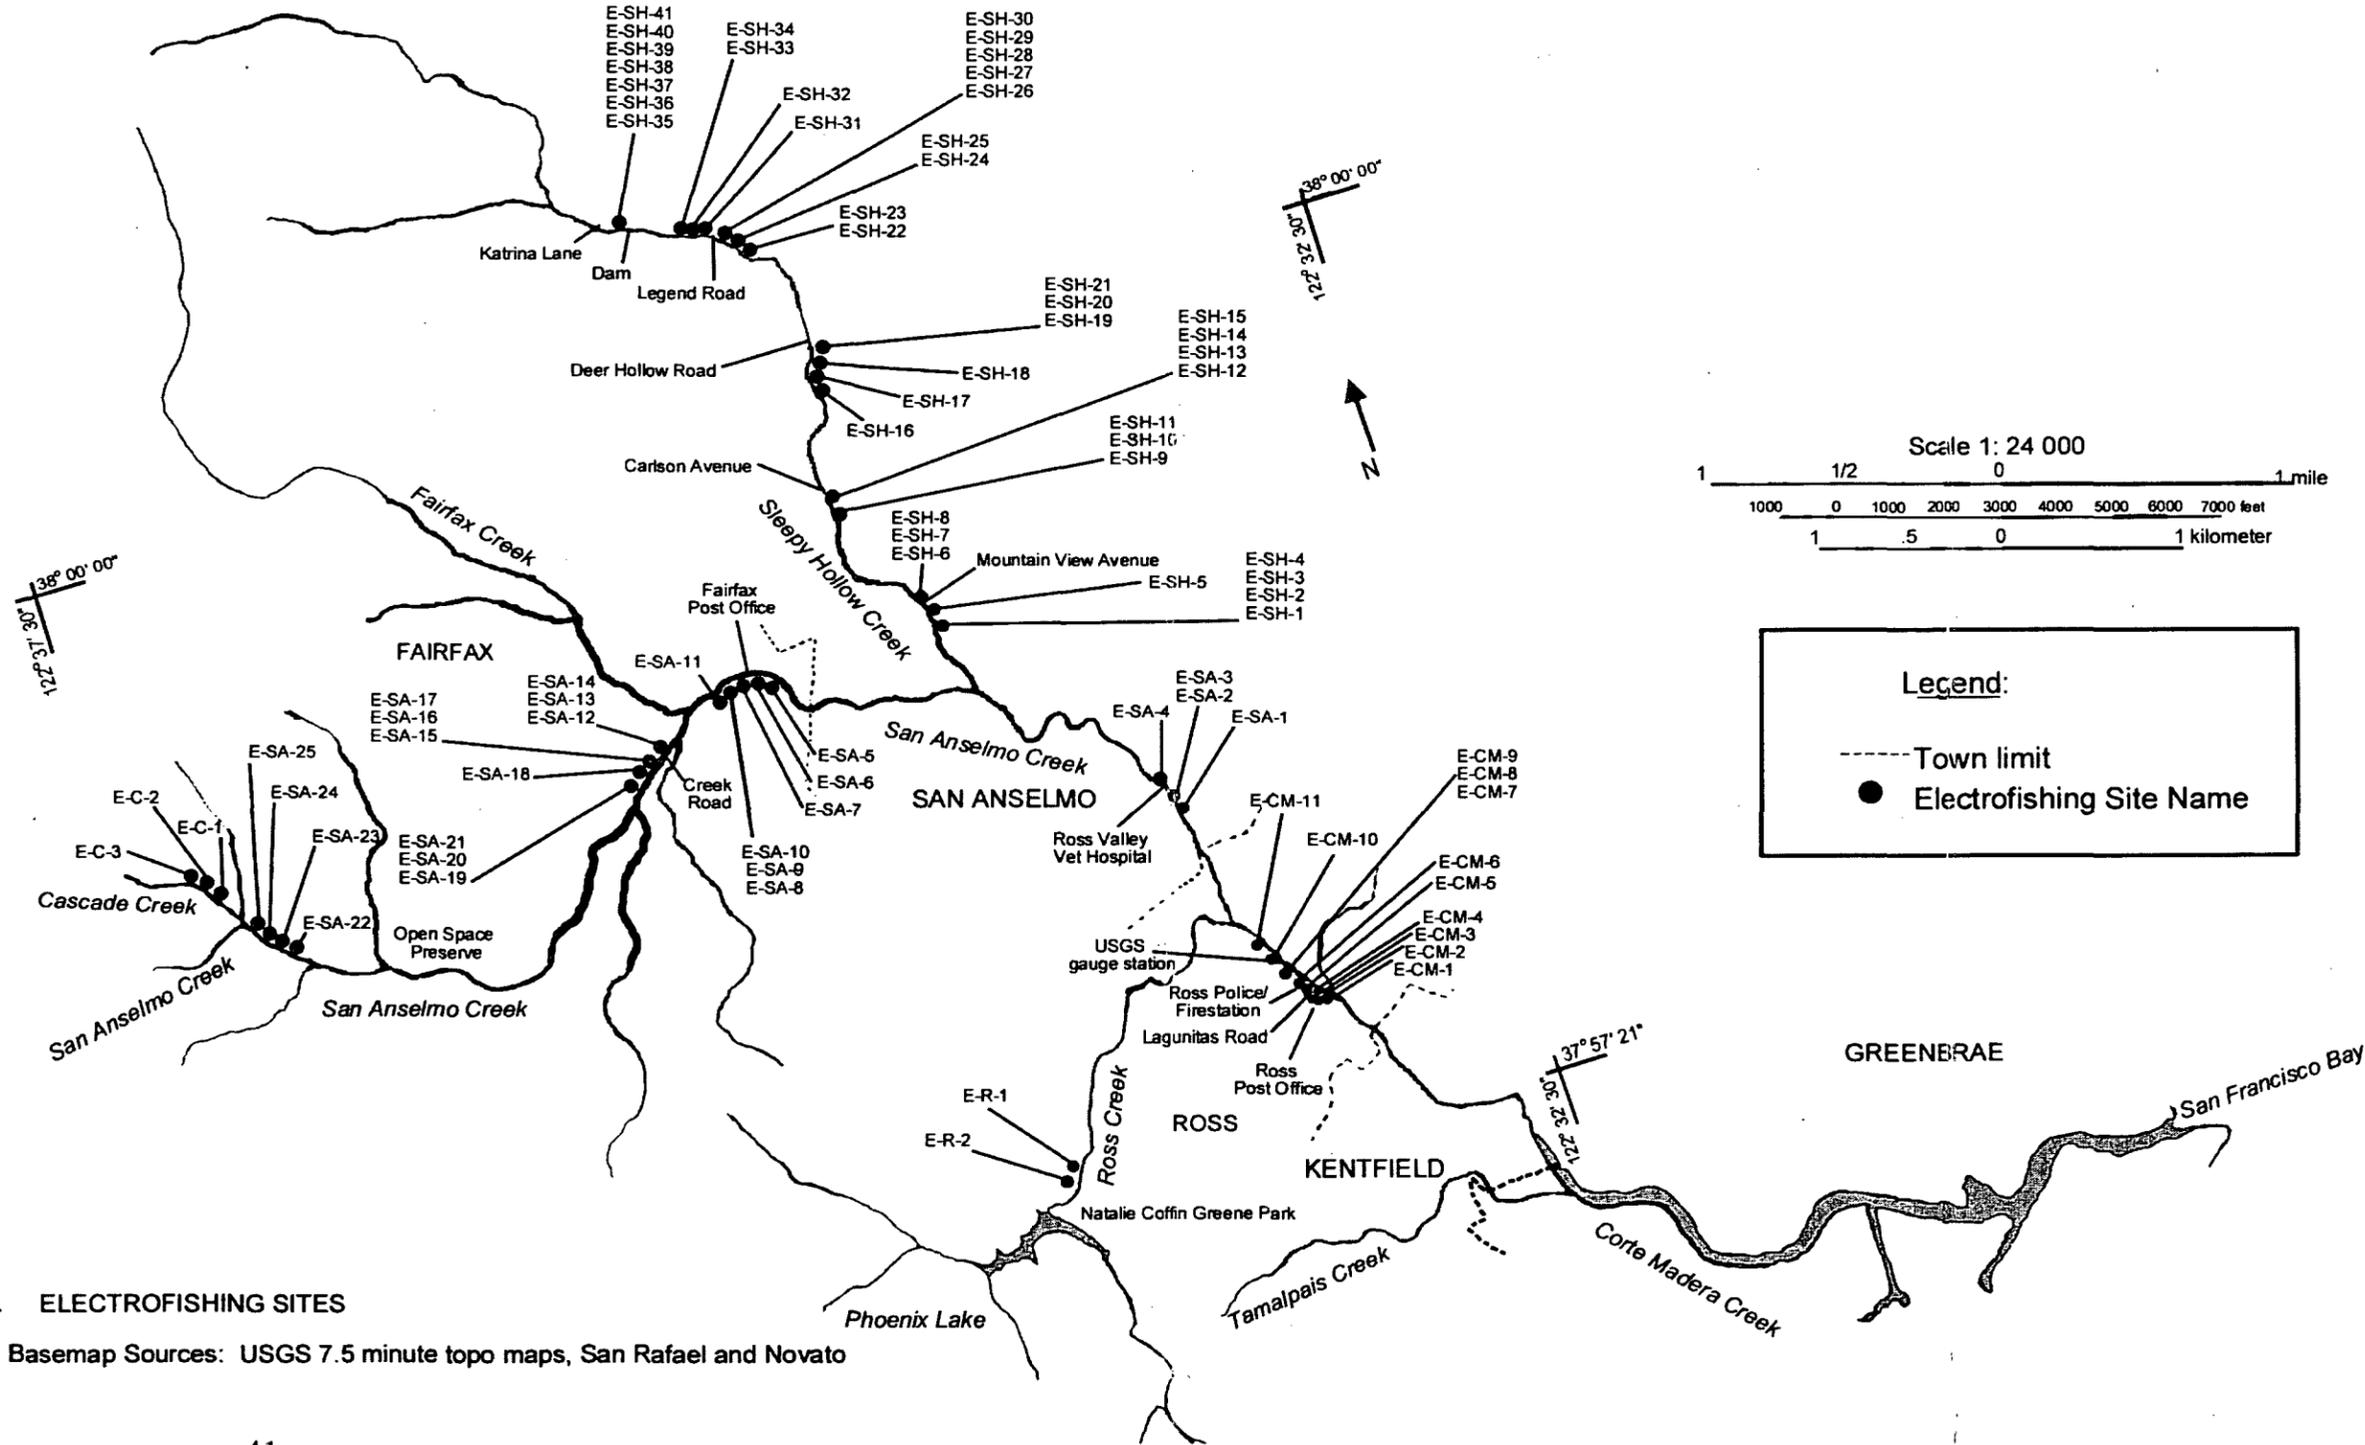
FIGURE 6. ELECTROFISHING SITES
 Basemap Sources: USGS 7.5 minute topo maps, San Rafael and Novato

To accurately sample the number and species of fishes in the creeks, it was necessary to electrofish **representative samples** of each habitat type observed in the creek. Ideally, to provide a statistically-sound study, one needs, first, to identify the number of **habitat types**, and then sample (randomly) about 30% of each habitat type. As there were budgetary constraints on this project, such a methodology was not practical. However, at least one representative of each habitat type was chosen for fish sampling for each creek and, except for Ross Creek, from 10-100% of each habitat type was sampled. Based on the results of the habitat surveys, the total number of sampling sites was as follows: (1) Corte Madera Creek - 11 sites out of 26 habitats recorded (42%); (2) San Anselmo Creek - 41 sites out of 183 habitats recorded (22%), (3) Cascade Creek - 3 sites out of 32 habitats recorded (9%); (4) Sleepy Hollow Creek - 25 sites out of 216 habitats (12%); and, (5) Ross Creek - 2 sites (Ross Creek was not habitat typed) (Figure 6).

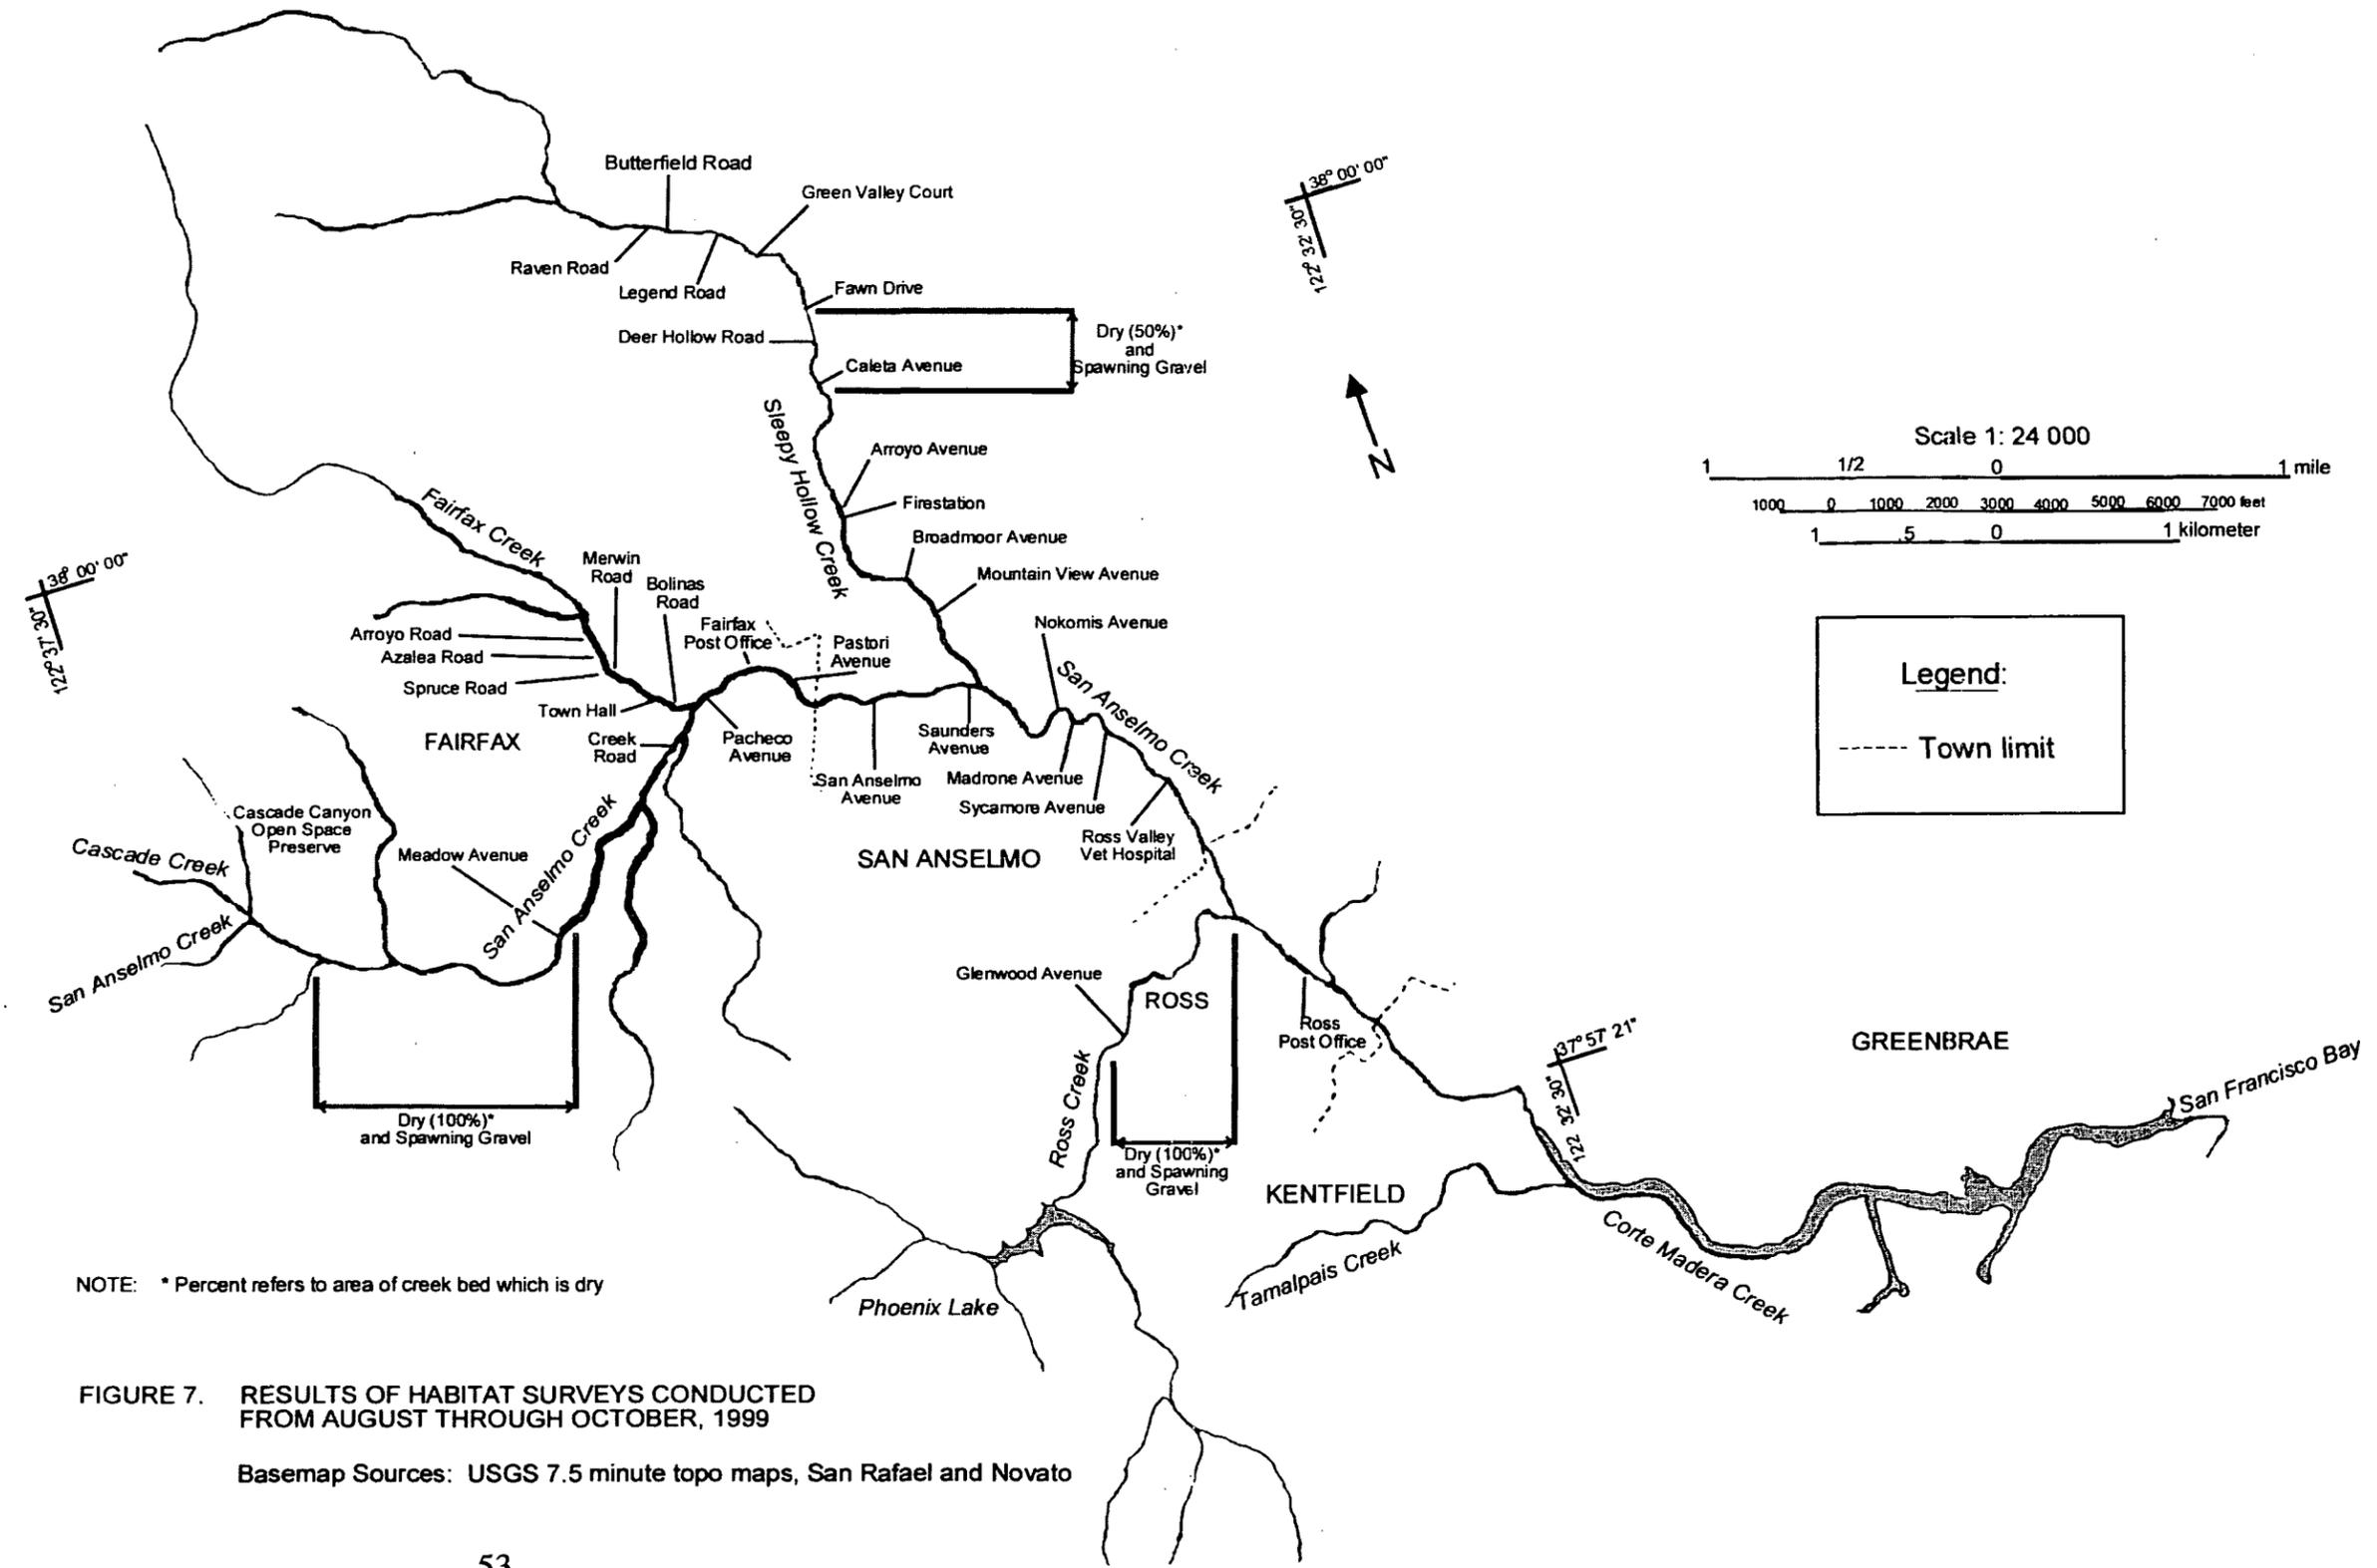
NOTE: * Percent refers to area of creek bed which is dry

FIGURE 7. RESULTS OF HABITAT SURVEYS CONDUCTED FROM AUGUST THROUGH OCTOBER, 1999

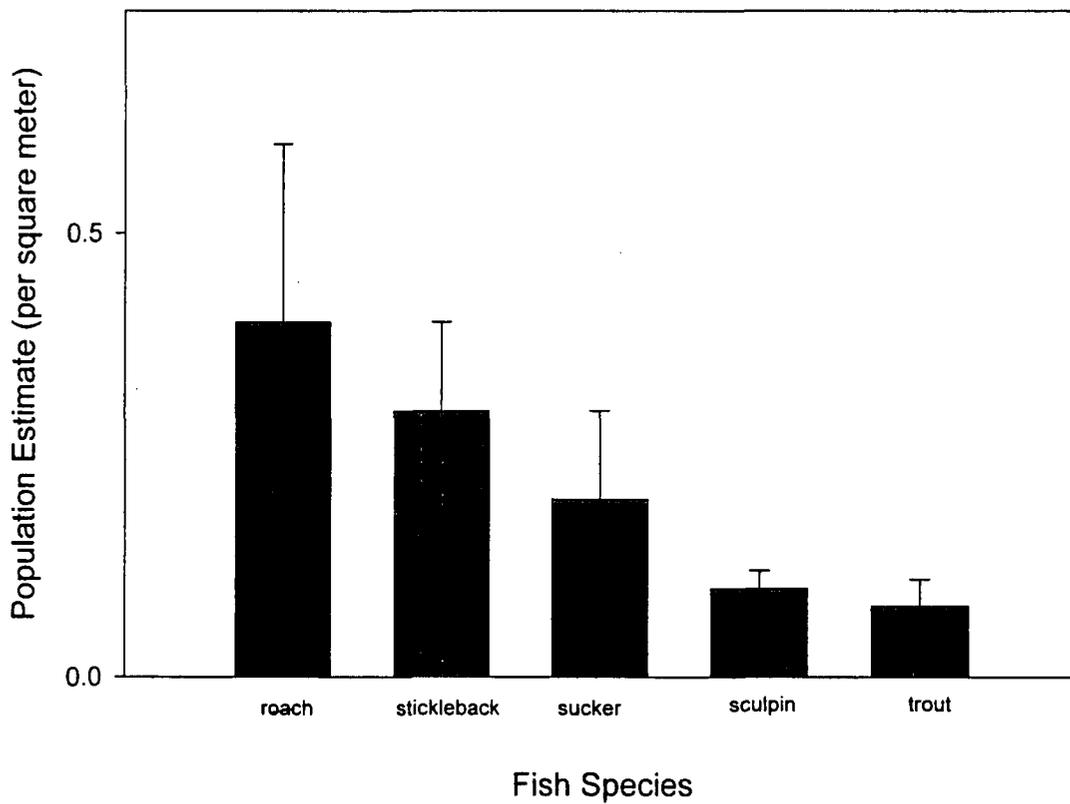
Figure 8. Relative Numbers of Each Fish Species Within Corte Madera Creek (mean +/- s.e.m.)

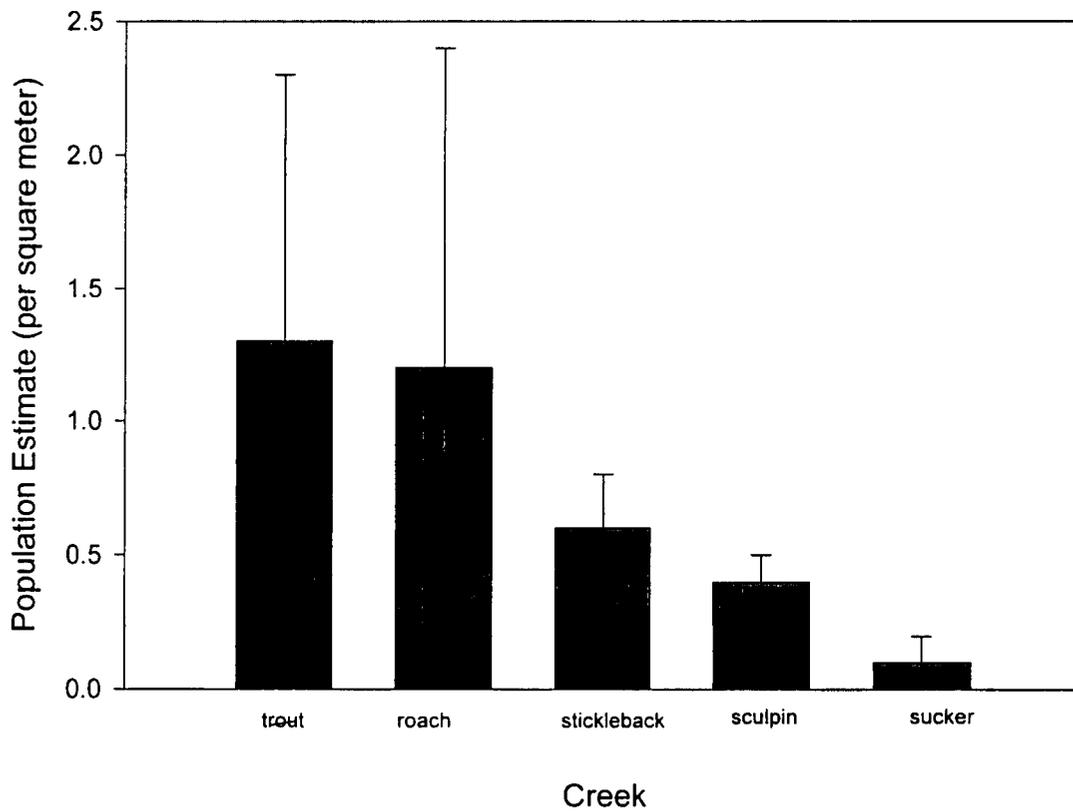
Figure 9. Relative Numbers of Each Fish Species Within San Anselmo Creek
(mean +/- s.e.m.)

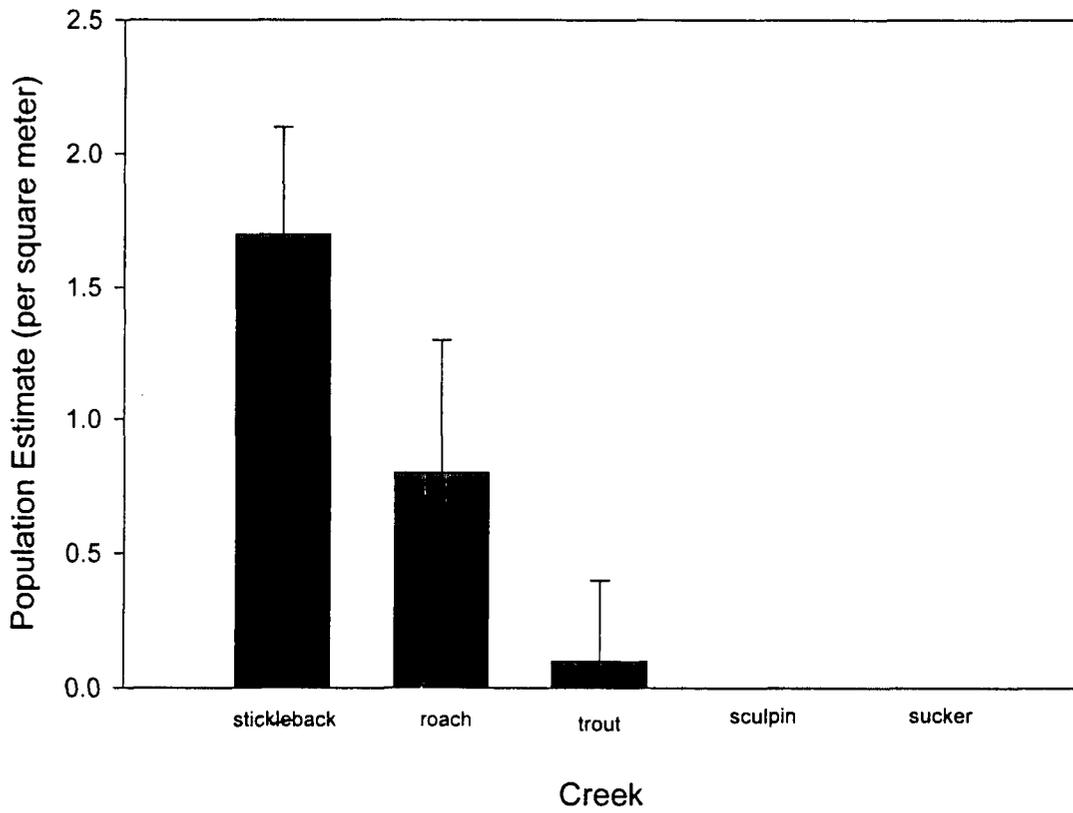
FIGURE 10. RELATIVE NUMBERS OF EACH FISH SPECIES WITHIN SLEEPY HOLLOW CREEK (mean +/- s.e.m.)

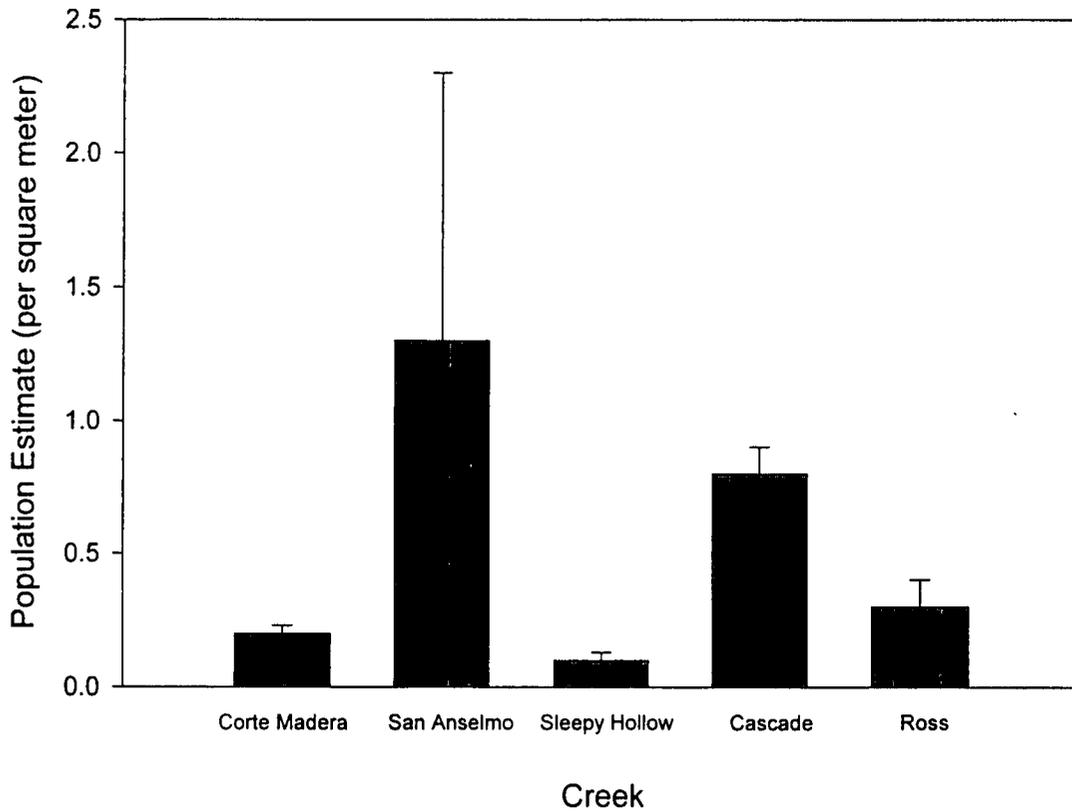
FIGURE 11. RAINBOW/STEELHEAD TROUT POPULATIONS WITHIN THE CORTE MADERA CREEK WATERSHED (mean +/- s.e.m.)

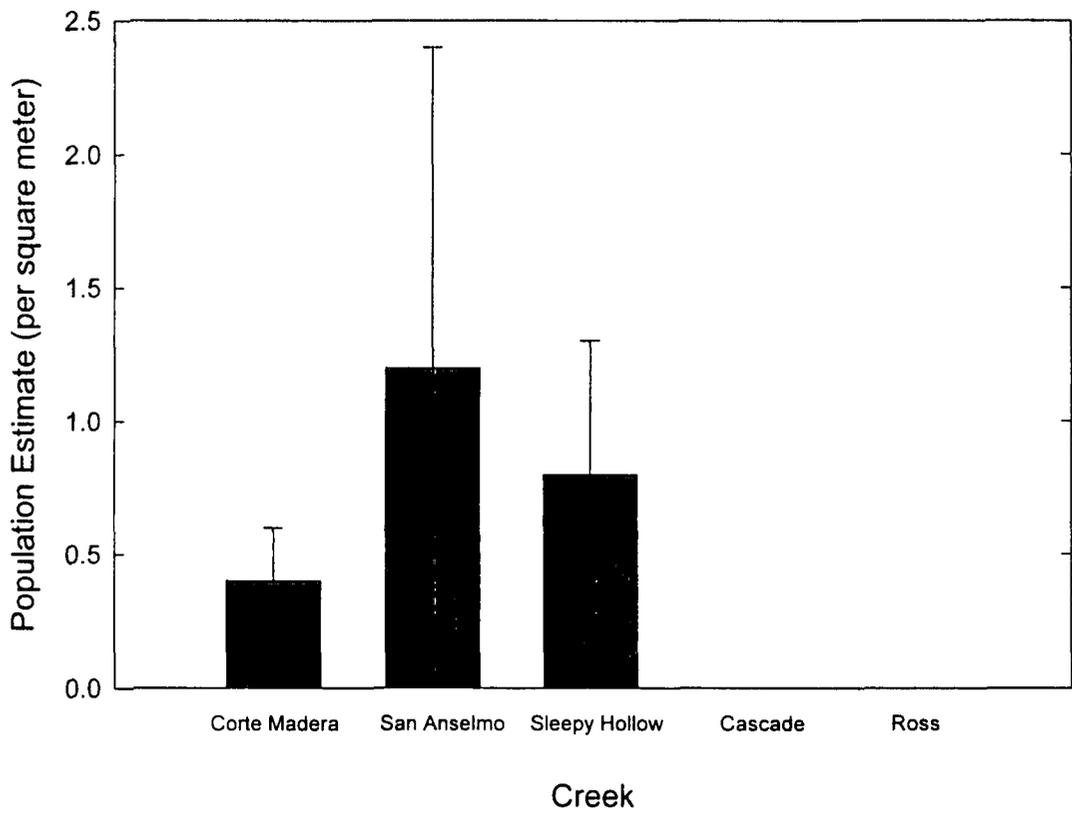
FIGURE 12. CALIFORNIA ROACH POPULATIONS WITHIN THE CORTE MADERA CREEK WATERSHED (mean +/- s.e.m.)

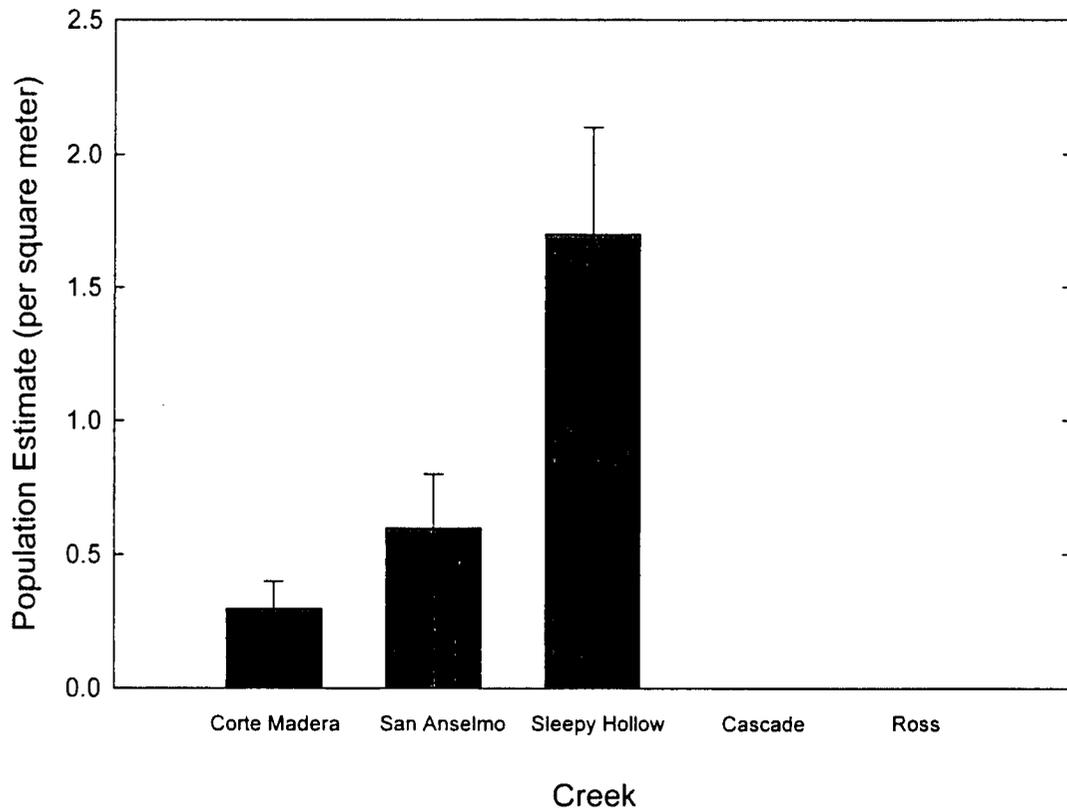
FIGURE 13. THREESPINE STICKLEBACK POPULATIONS WITHIN THE CORTE MADERA CREEK WATERSHED (mean +/- s.e.m.)

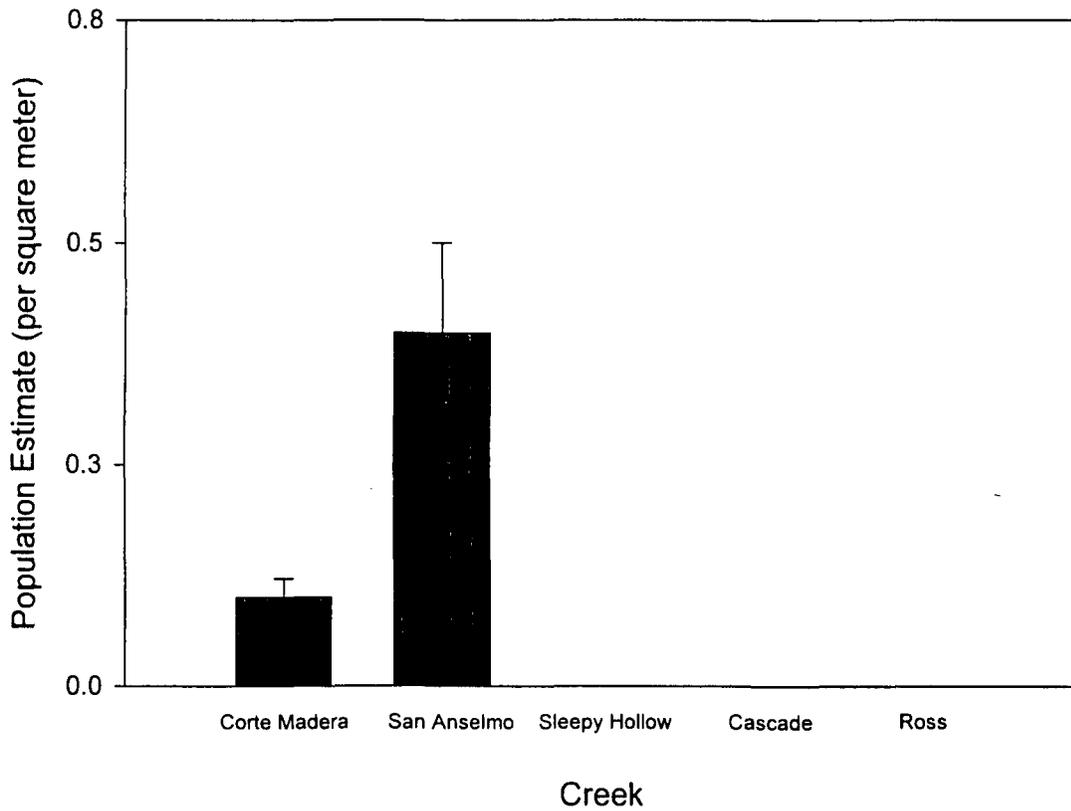
FIGURE 14. SCULPIN POPULATIONS WITHIN THE CORTE MADERA CREEK WATERSHED (mean +/- s.e.m.)

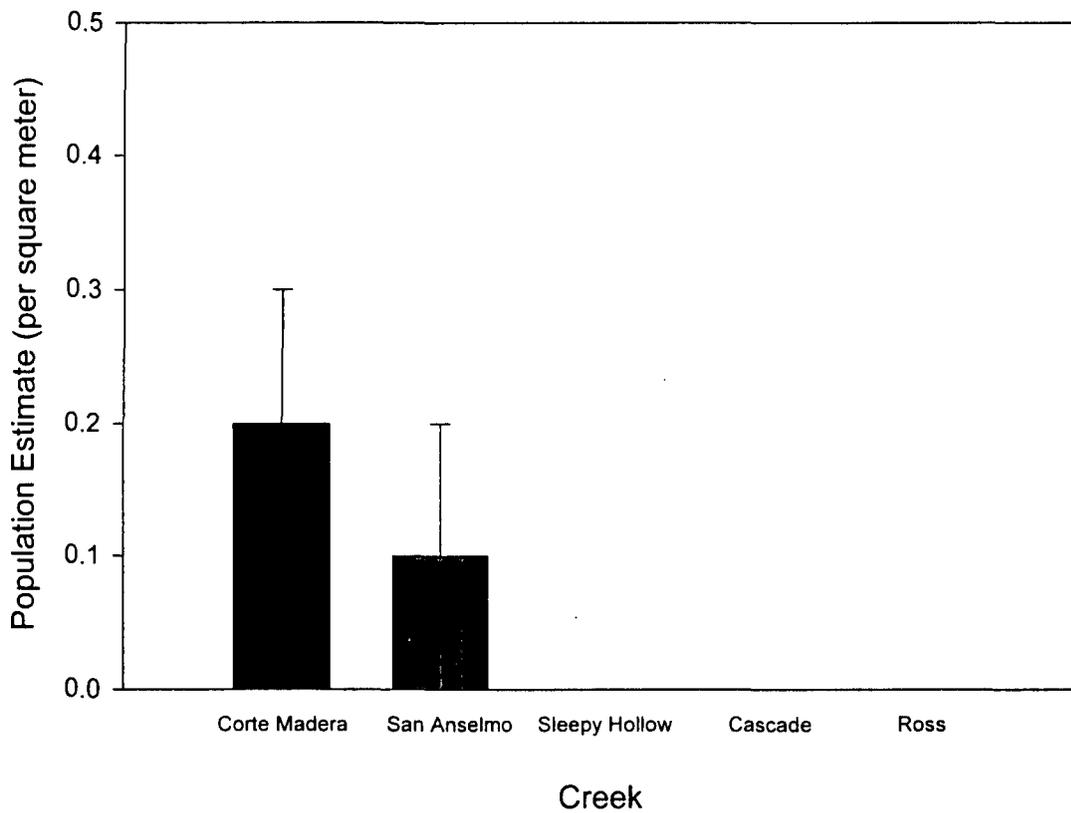
FIGURE 15. SACRAMENTO SUCKER POPULATIONS IN THE CORTE MADERA CREEK WATERSHED (mean +/- s.e.m.)

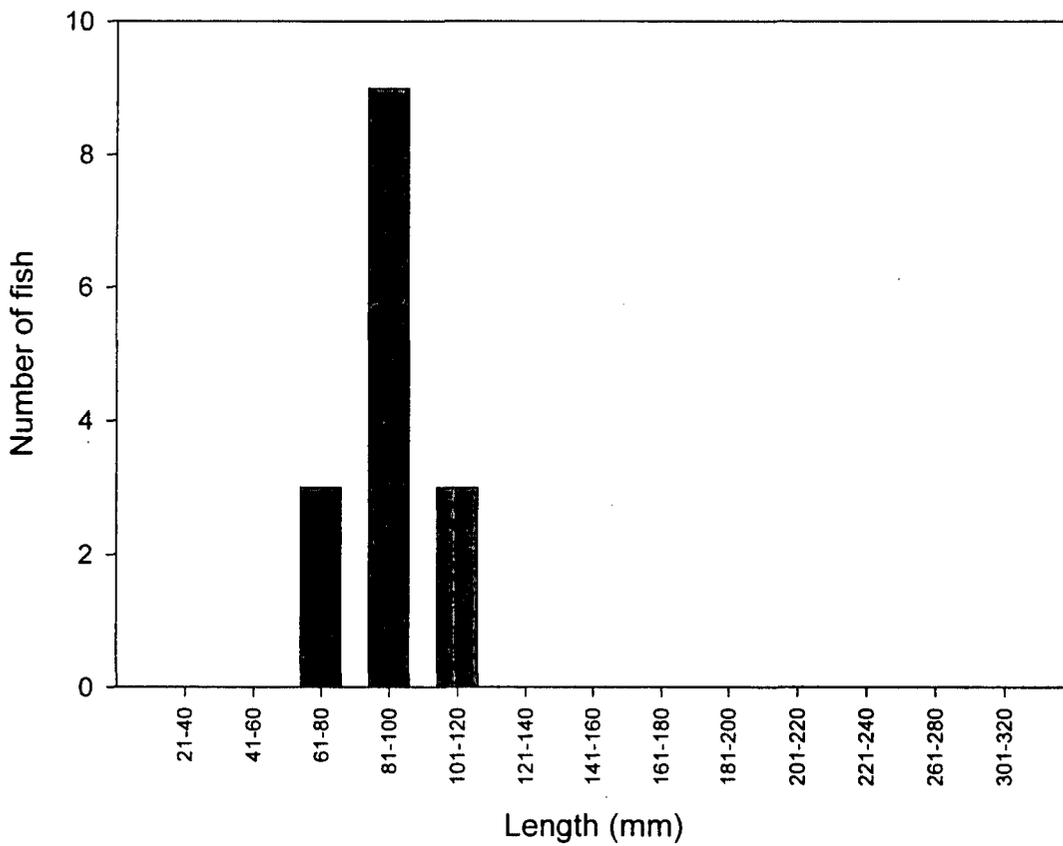
FIGURE 16. RAINBOW/STEELHEAD TROUT LENGTH-FREQUENCY DISTRIBUTION IN CORTE MADERA CREEK.

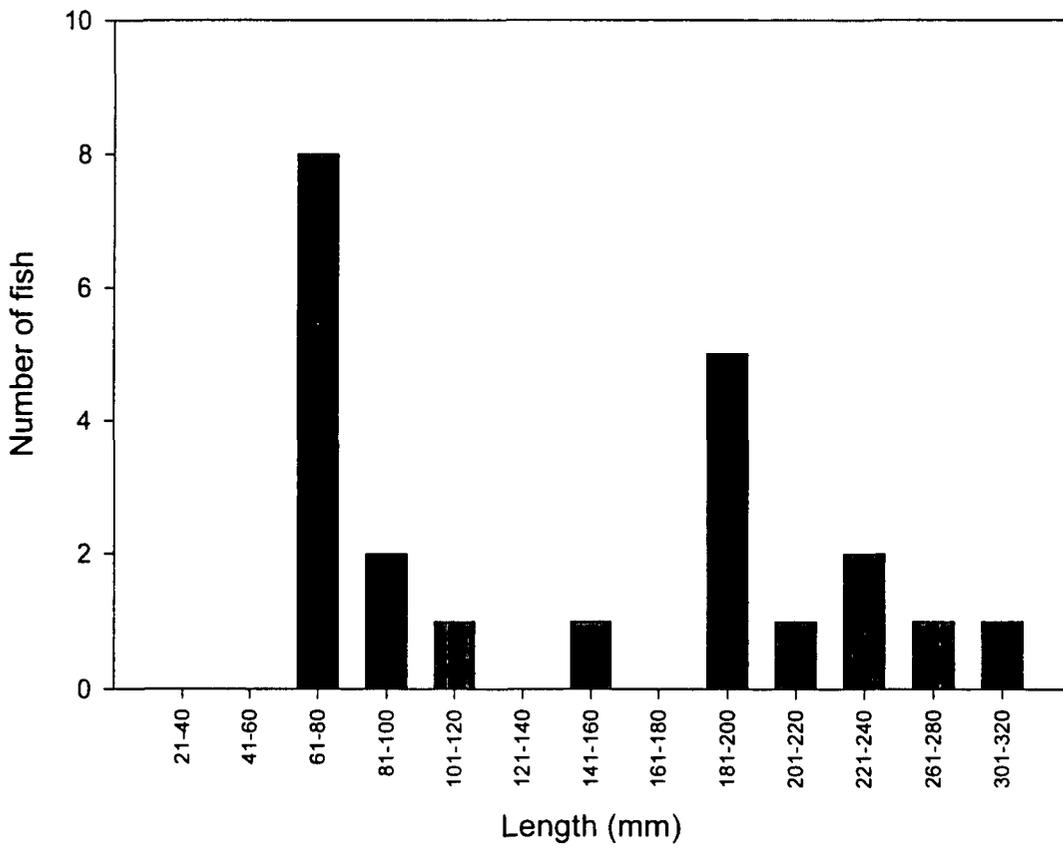
FIGURE 19. RAINBOW/STEELHEAD TROUT LENGTH-FREQUENCY DISTRIBUTION IN SLEEPY HOLLOW CREEK.

Based on the length data (Figures 17-21 and Appendix E, Tables E-10 to E-14), the stickleback collected were young-of-the-year fish, the roach and suckers, from one to four years old, and the sculpin from one to five years old.
