***FISHERY RESOURCES CONDITIONS
OF THE CORTE MADERA CREEK WATERSHED,
MARIN COUNTY, CALIFORNIA***

**Alice A. Rich, Ph.D.
A. A. Rich and Associates
150 Woodside Drive
San Anselmo, California 94960**

**Friends of Corte Madera Creek Watershed
P.O. Box 415
Larkspur, California 94977**

November 10, 2000

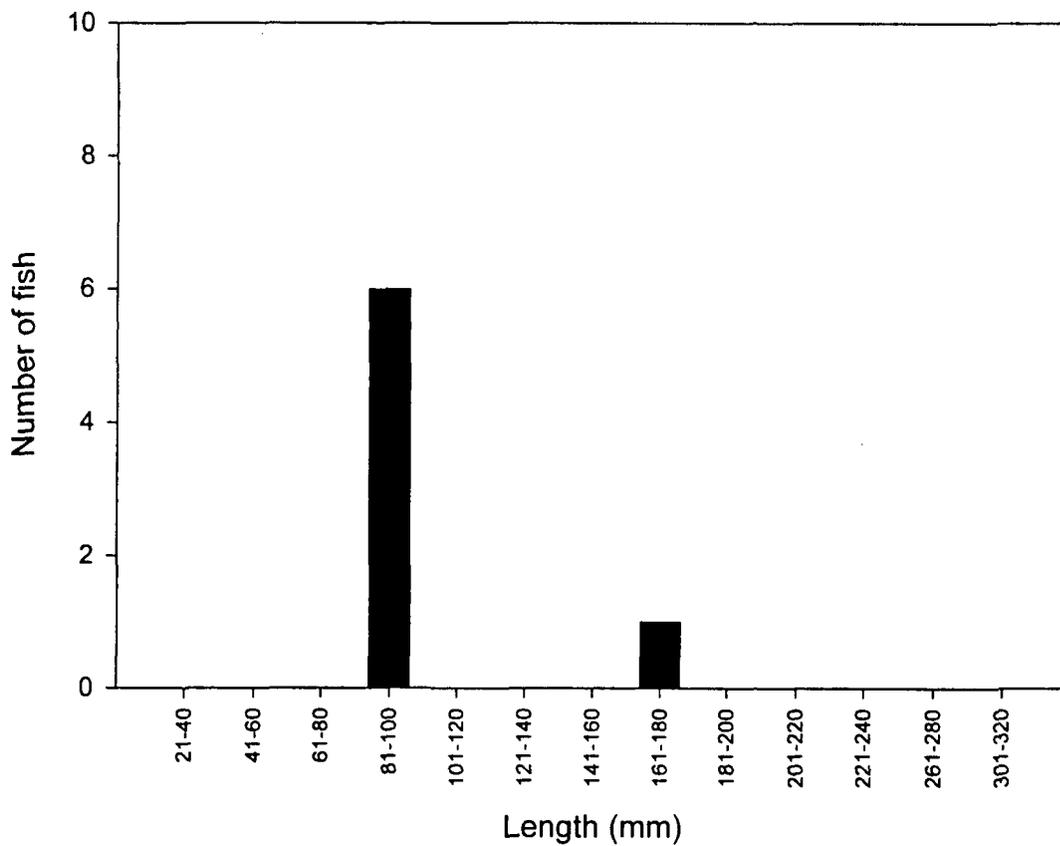
FIGURE 20 RAINBOW/STEELHEAD TROUT LENGTH-FREQUENCY DISTRIBUTION IN ROSS CREEK.

Based on the length data (Figures 17-21 and Appendix E, Tables E-10 to E-14), the stickleback collected were young-of-the-year fish, the roach and suckers, from one to four years old, and the sculpin from one to five years old.

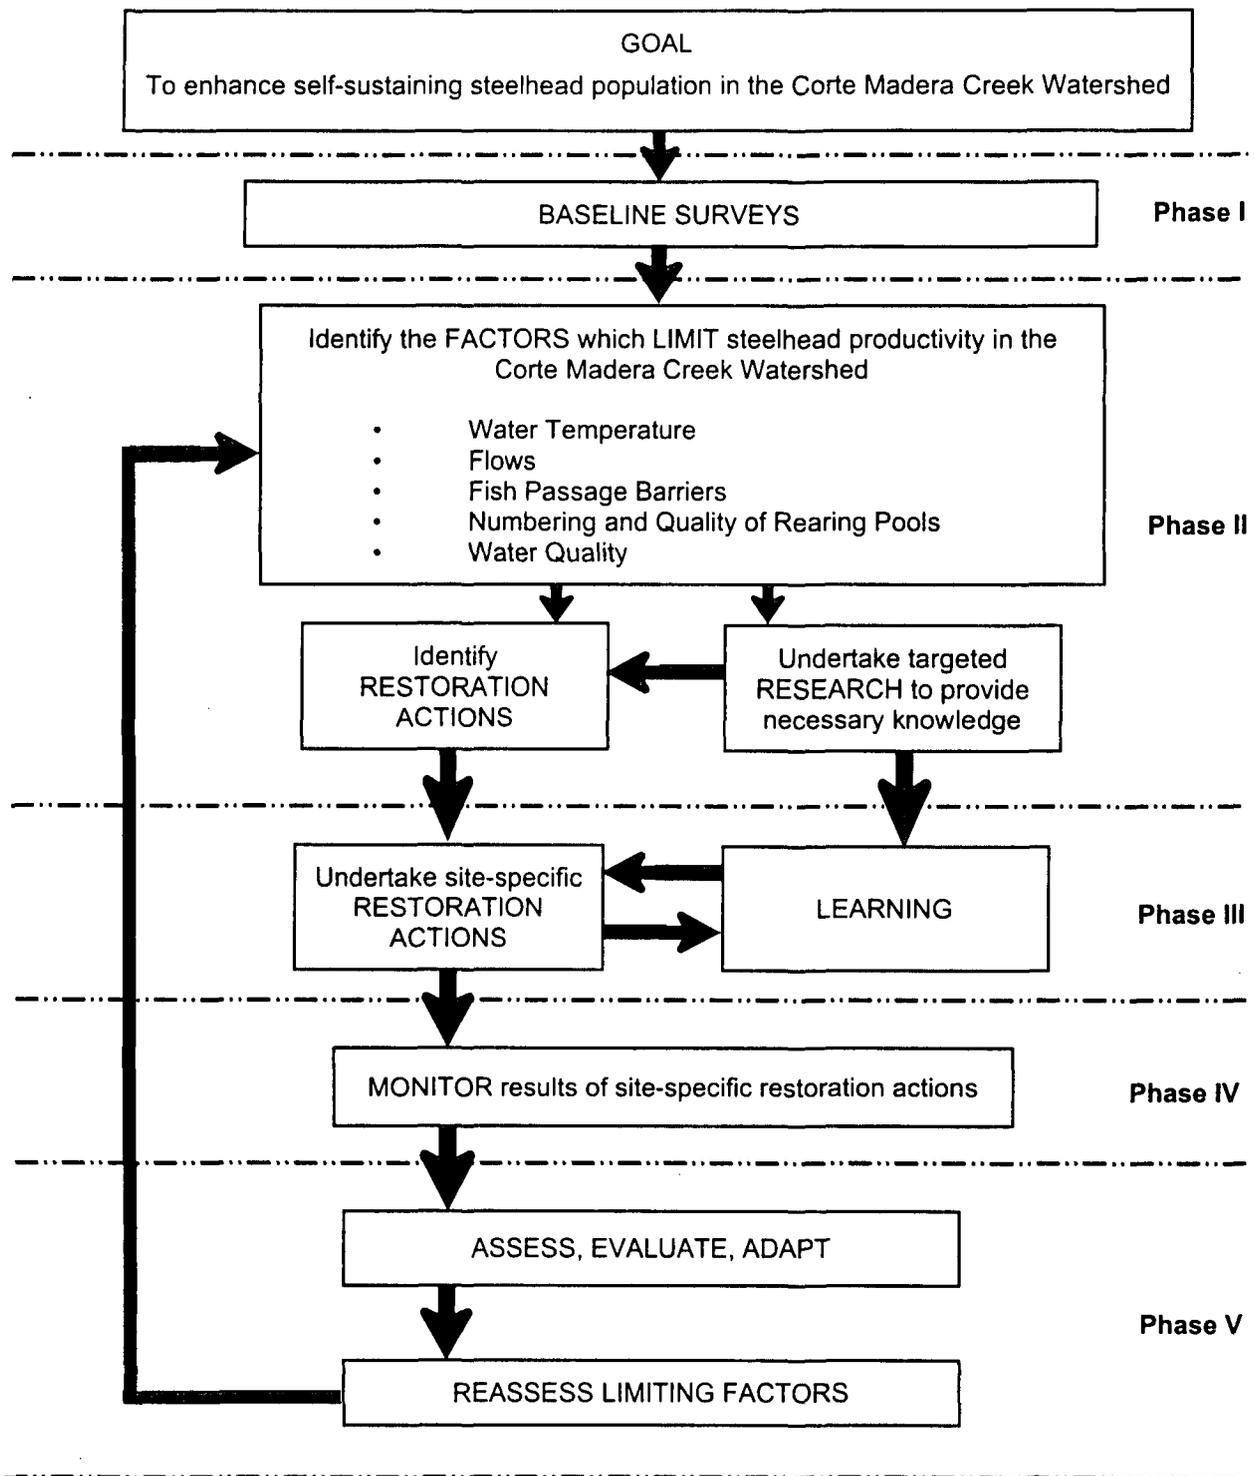
FIGURE 21. CONCEPTUAL PLAN TO RESTORE CONDITIONS IN THE CORTE MADERA CREEK WATERSHED

A steelhead Restoration Plan should have the following elements (Figure 21):

- (1) Identification of Objectives;
- (2) Determination of existing water quality and habitat conditions and factors limiting steelhead/rainbow trout;
- (3) Identification of what restoration measures are possible, from both an economic and practical standpoint;
- (4) Implementation of restoration actions;
- (5) A Monitor Program to assess the relative success of the restoration actions; and,
- (6) If warranted, re-evaluation of restoration actions, and adaptation.

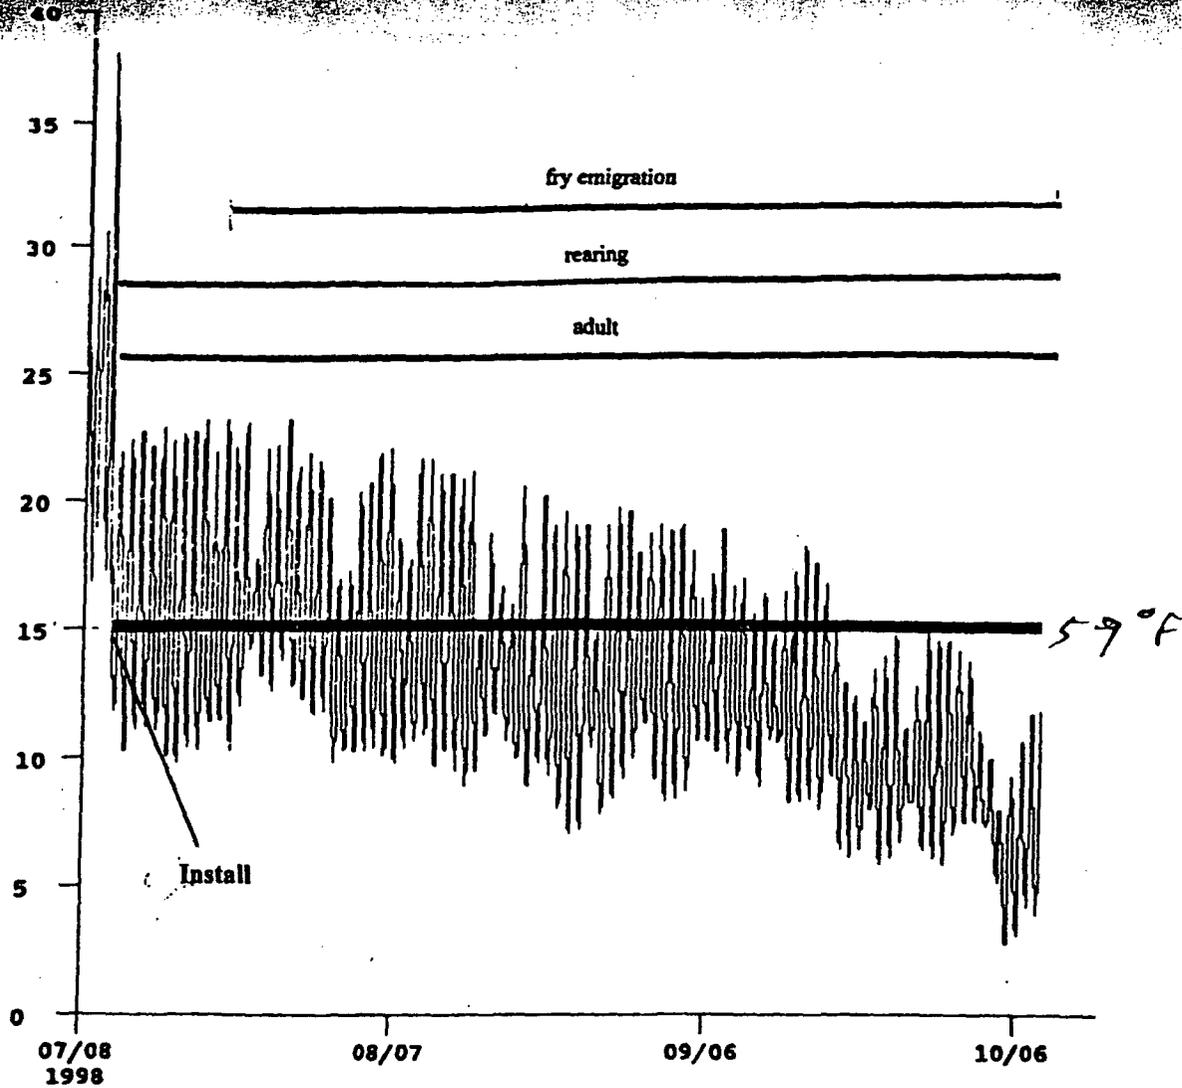
RELATIONSHIP BETWEEN MAXIMUM OPTIMAL WATER TEMPERATURES FOR SOME LIFE STAGES OF CUTTHROAT TROUT AND WATER TEMPERATURES IN LOWER DRY VALLEY CREEK FROM JULY 7-OCTOBER 8, 1998

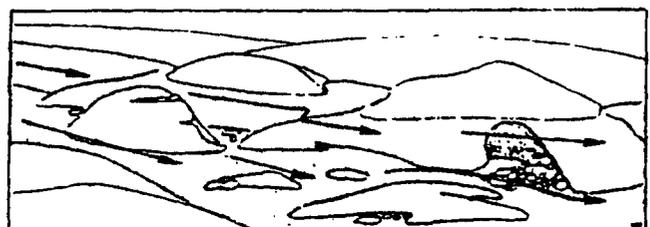
Figure 12. Lateral scour pool associated with bedrock.

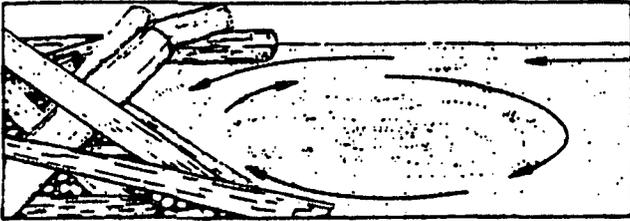
Figure 13. Dammed pool associated with large debris.

(Fig. 13) consisted of water impounded upstream from a complete or nearly complete channel blockage. Typical causes of dammed pools were debris jams, rock landslides, or beaver dams. Depending upon the size of the blockage, dammed pools could be very large. Water velocity in this pool type was characteristically low and substrates tended toward smaller gravels and sand.

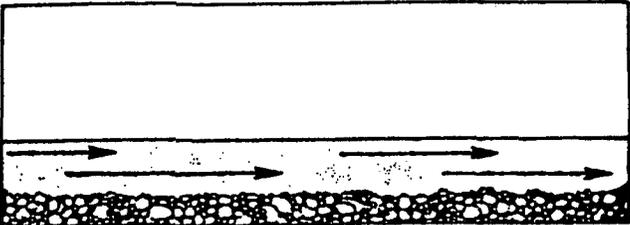
Figure 14. Glide.

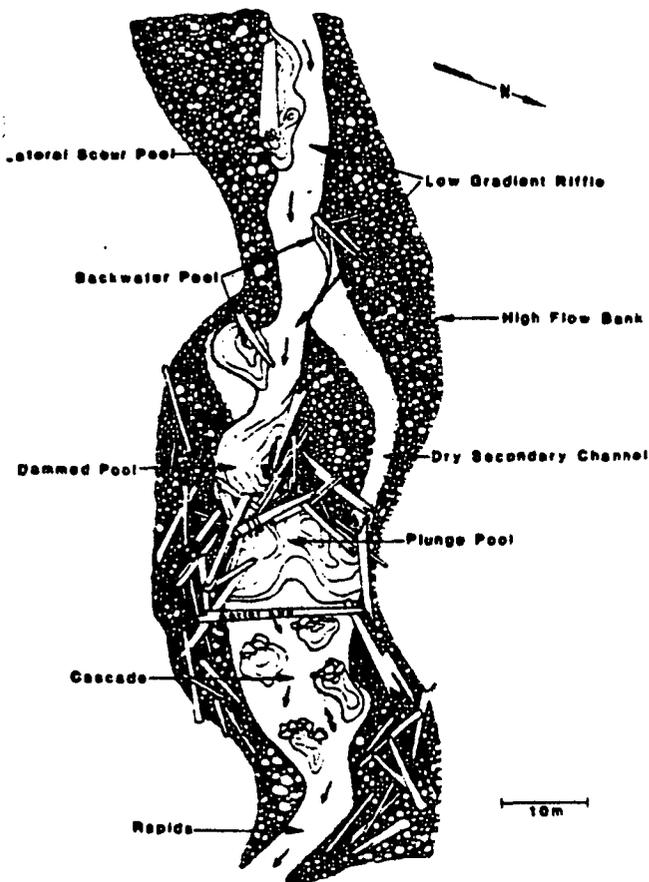
Figure 15. An example of a stream channel map showing locations of various habitat types.

Each stream reach was surveyed on foot and the location of different habitat types, as well as significant flow controlling structures, was drawn to scale on a map (Fig. 15). Contour lines based on depth measurements were drawn within pools to enable volume estimation. Wetted surface areas were determined by counting squares on gridded paper that was superimposed on the maps. Axial length was figured as the distance along the thalweg or greatest linear dimension of a habitat unit parallel to the direction of flow. Reach summaries were constructed by summing the lengths, areas, and volumes of each habitat type and expressing each group as a percentage of the total. The amount of cover in each habitat was rated on a relative abundance scale of 0-3, where a score of zero indicated that the particular kind of cover was essentially absent and a score of three indicated a very abundant condition. Substrate was noted as predominant type, i.e., the physical and/or biological type most prevalent within a habitat unit.

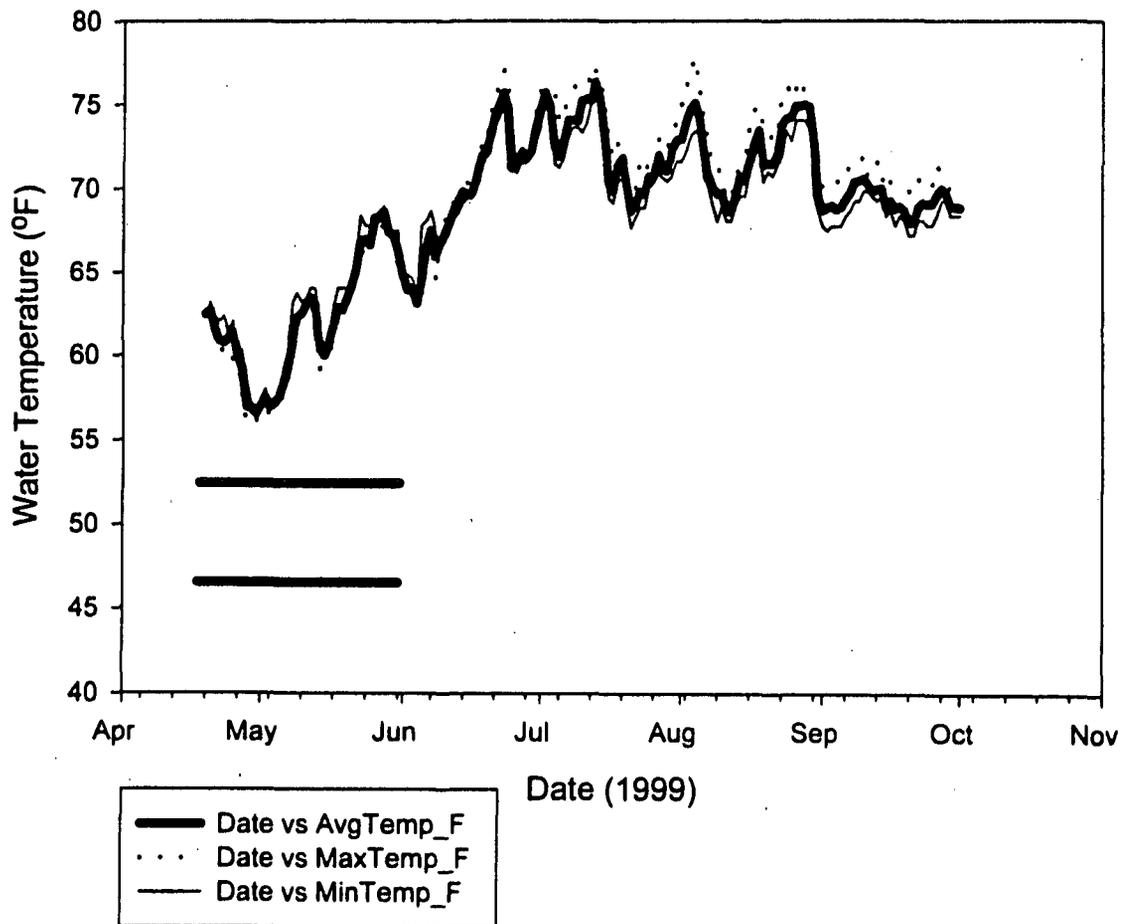
Site T-CM-1a (Cement channel/USACE)

FIGURE C-1. STEELHEAD TROUT-IMMIGRATION THROUGH FRY EMERGENCE. Daily mean, minimum and maximum water temperatures at Thermograph Site T-CM-1a. Horizontal bold lines represent lower (bottom) and upper (top) optimal water temperatures.

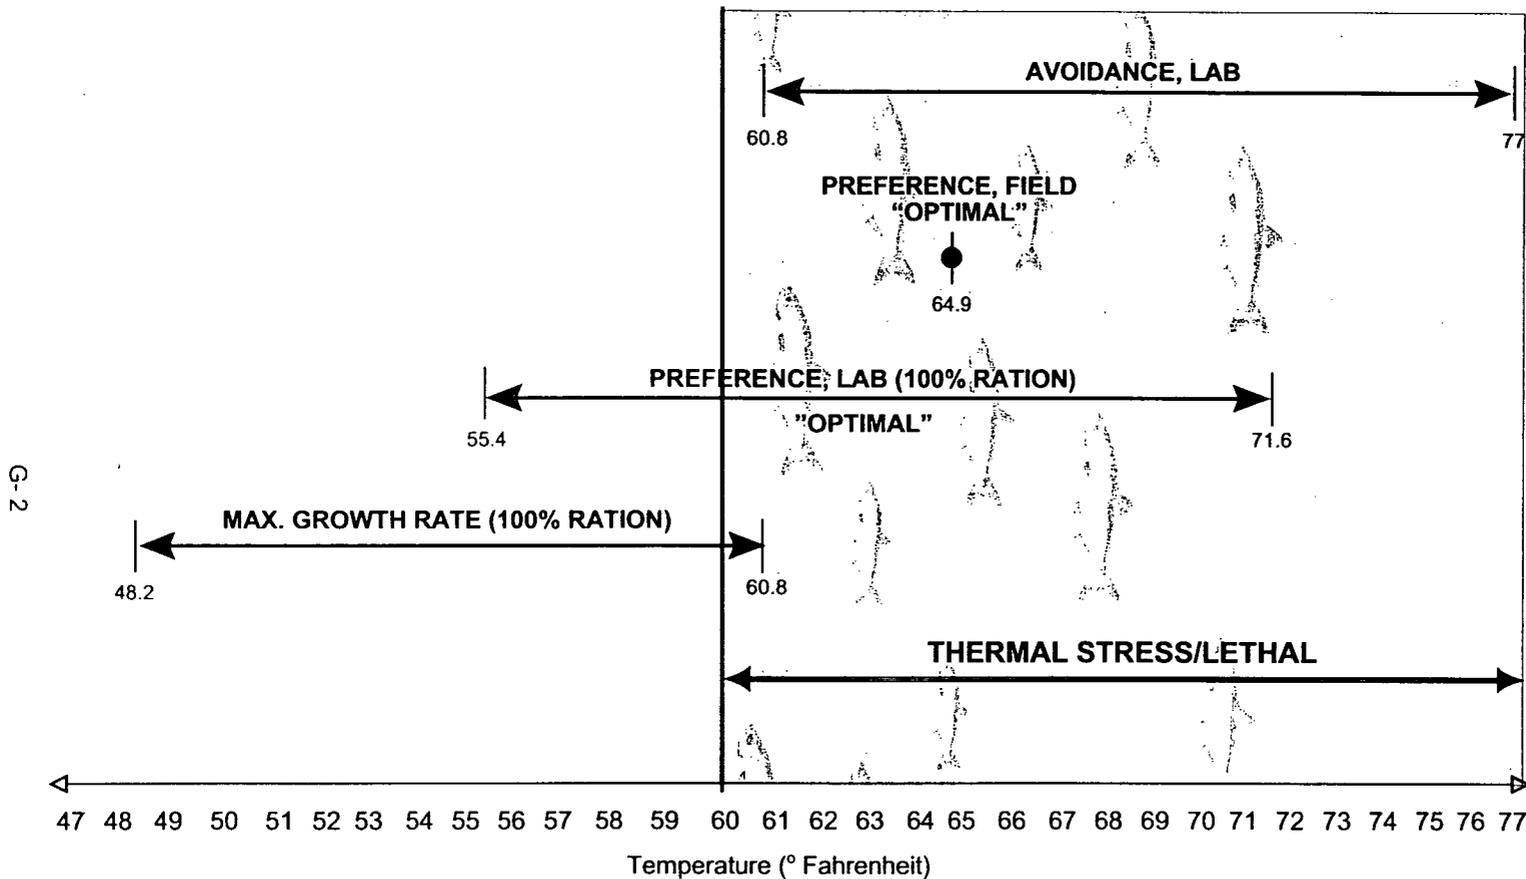
FIGURE G-2. SUMMARY OF THE RESULTS OF THE PHYSIOLOGICAL AND BEHAVIORAL RESPONSES OF RAINBOW TROUT TO WATER TEMPERATURE.

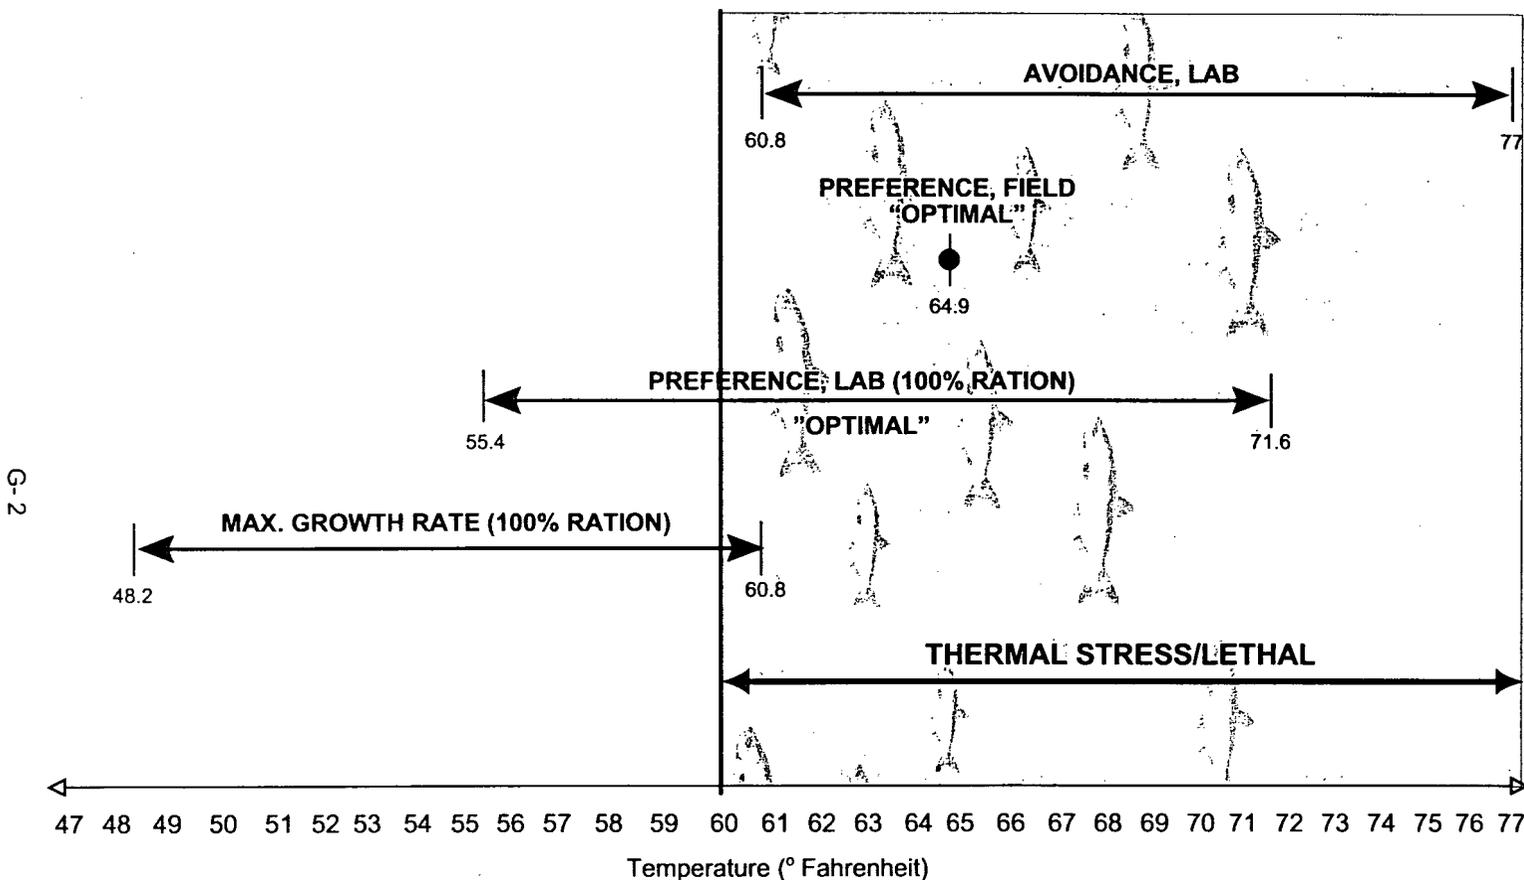
FIGURE G-2. SUMMARY OF THE RESULTS OF THE PHYSIOLOGICAL AND BEHAVIORAL RESPONSES OF RAINBOW TROUT TO WATER TEMPERATURE.
