**SUBJECT:** Recommended Update for Region's 303(d) List of Impaired Surface Waters

#### **TULA WEST DRAIN (DRAIN)**

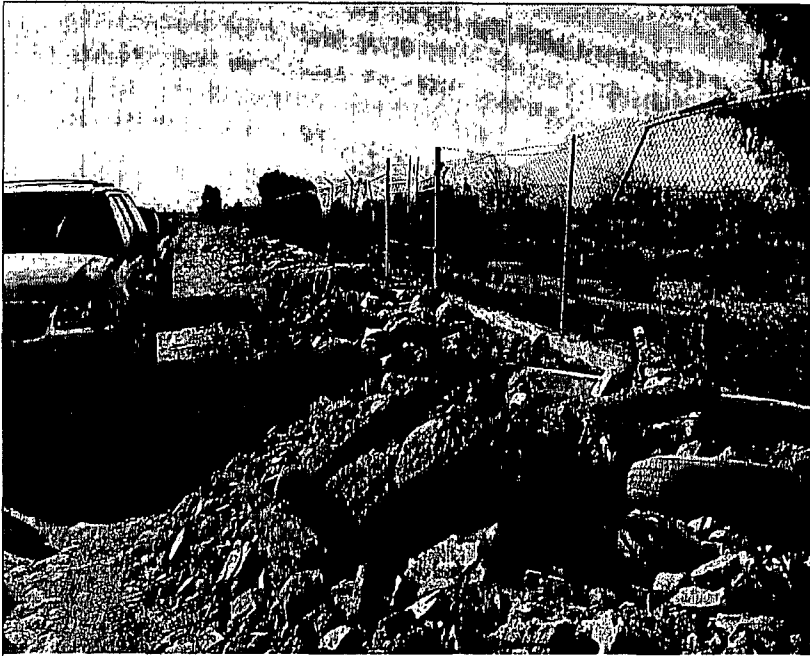
**PHOTO NO. 3**

The slopes and banks of the Drain are still overwhelmed with huge stockpiles of municipal waste, tires, and dredging spoils previously removed from the Drain (Photo No. 3). Also, the drain bank adjacent to the residential area is used as a local trash dumping spot.

A request for local authorities to implement punitive measures to reduce the problem associated with the disposal of solid wastes and potential hazardous materials along the drain's banks and in the closed dumpsites is strongly recommended. This problem should be elevated for discussion and potential solutions to the Binational Technical Committee.

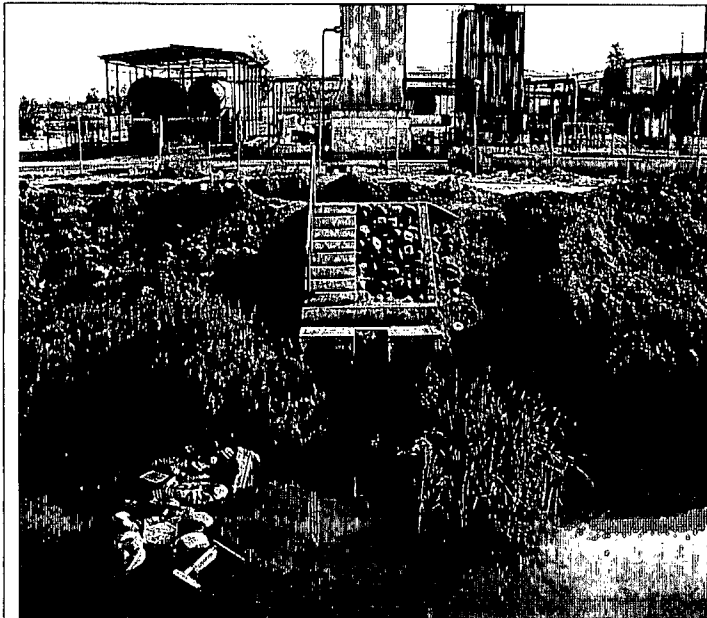
PHOTO NO. 6

No discharges from these locations into the drain were observed. Staff from CNA reported that the facility filled bankruptcy and, at least for the current fiscal year, is officially closed. In addition, Staff from CNA also reported that their wastewater discharge permit expired during the month of October 2000 (Photos No. 6).

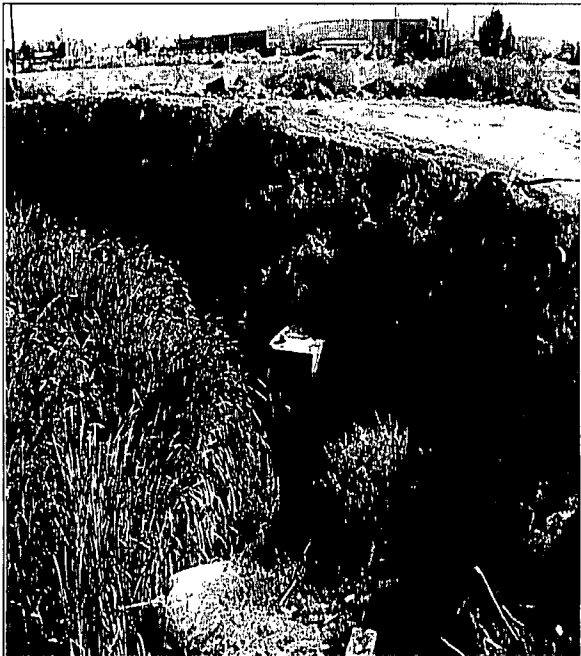
**PHOTO NO. 9**

No discharge was observed from these industrial park outlets (Photos No. 9 and 10).

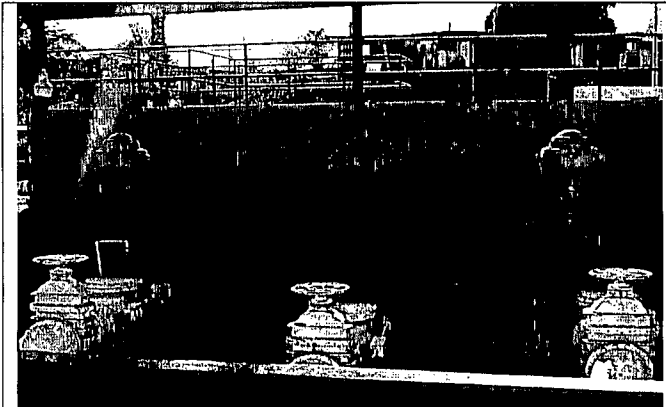
**PHOTO NO. 13**

Pump station No. 2 look clean and well maintained, however the facility was inoperable during the observation tour and reportedly it would take CESPM a minimum of two weeks to fully operate this facility (Photo No. 13).

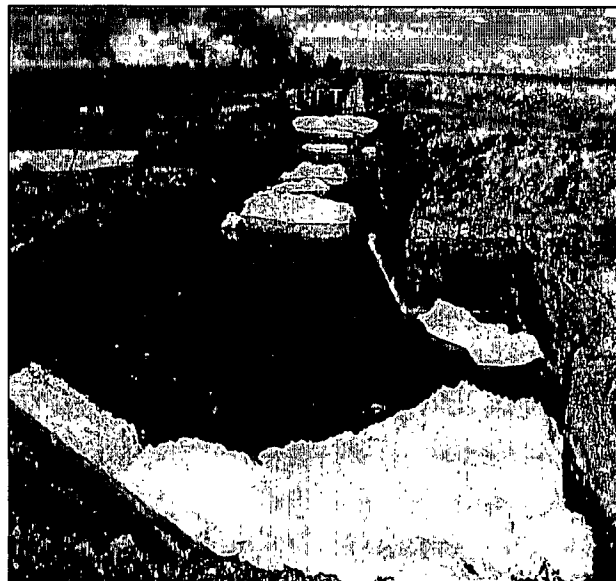
PHOTO NO. 21

The watercolor of the primary treatment lagoons varies from dark to a grayish color. Watercolor in the secondary treatment lagoons varies in color from brown greenish to olive green. The lagoons are well maintained and with the exception of one of the primary anaerobic lagoons all others lagoons are in service and fully operational. The effluent from the lagoons is foamy. The wastewater color is olive green (Photos No. 20 and No. 21).

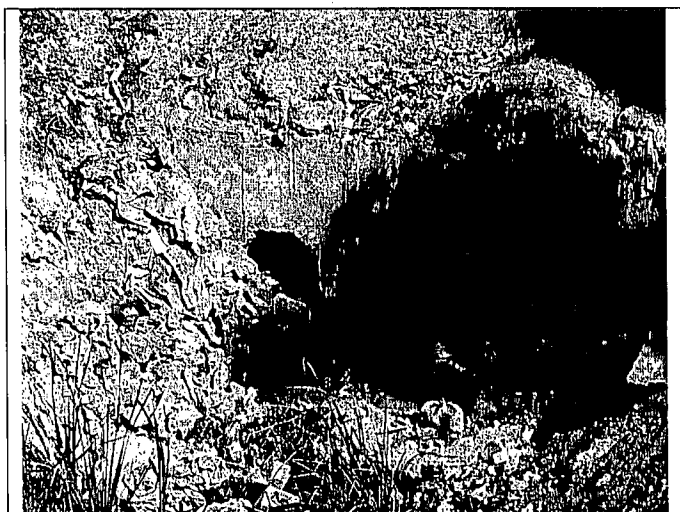
PHOTO NO. 22

A trickle of water flow was being discharged into the drain. The drain is covered with piles of domestic waste (Photo No. 22).

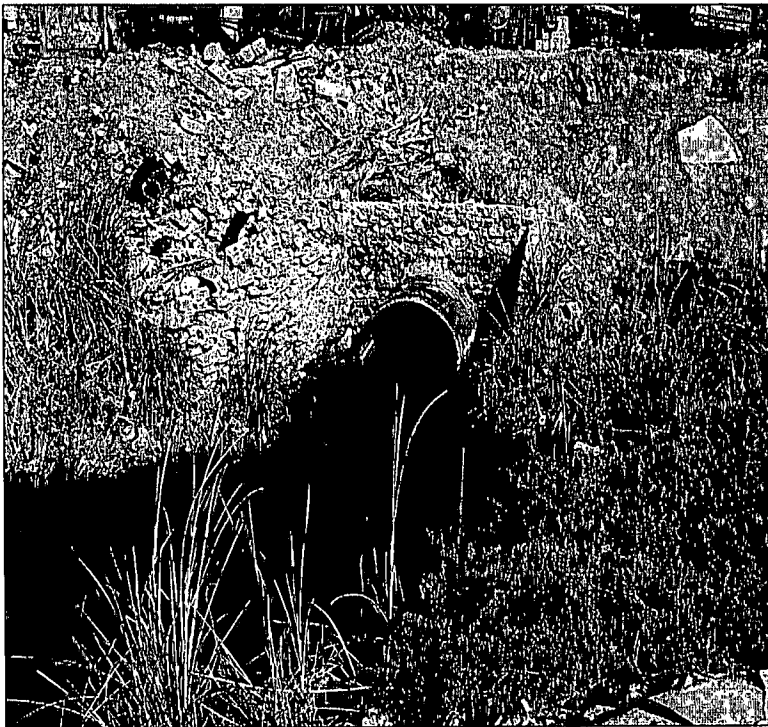
**PHOTO NO. 24**

An estimated flow of 80 l/sec of raw sewage was being discharged from the 48-inch principal collector into the Mexicali drain. The watercolor here was dark green (Photo No. 24).

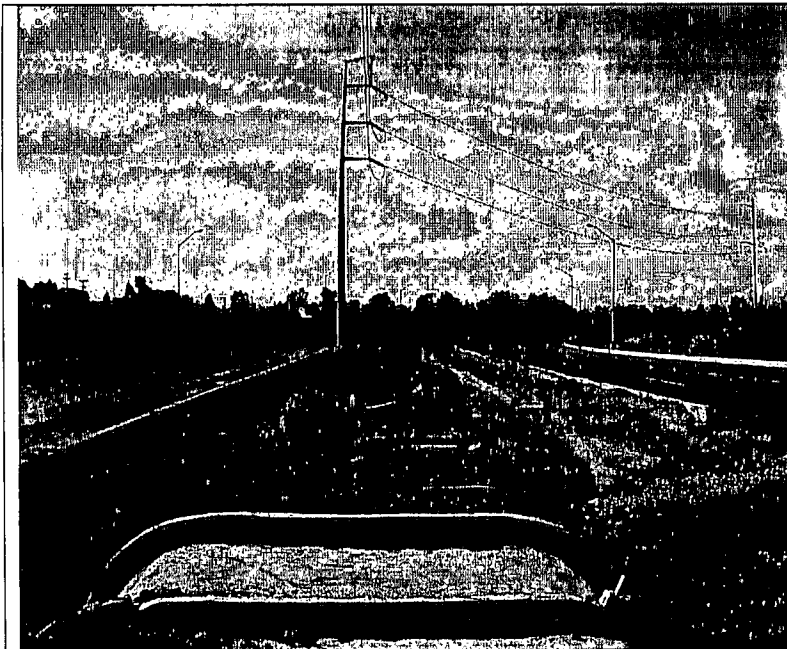
**PHOTO NO. 26**

All of the discharges to Drain 134 are no longer visible as a result of the encasement of the New River and the Drain (Photo No. 26).

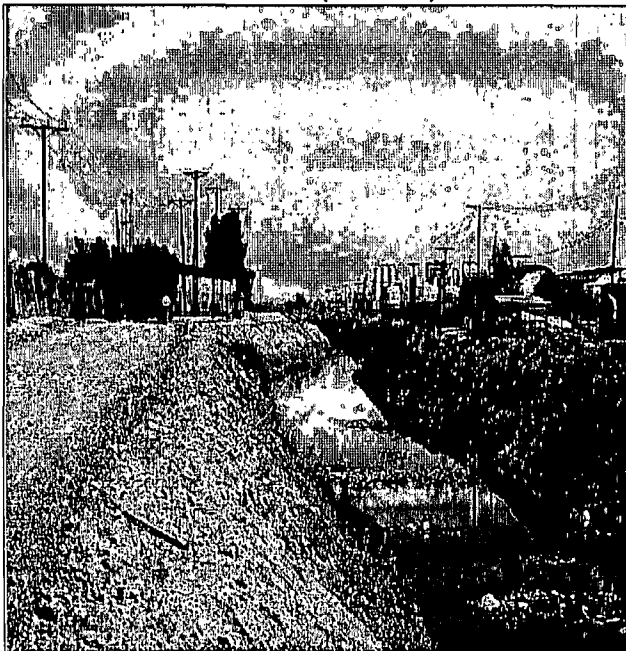
Photo No. 1 - Tula Drain

The Drain's watercolor varies from a dark green color in the vicinity of the San Luis Hwy to a milky pale color in the northern part of the Drain. A mild acid odor is prevalent along the entire length of the Drain in this industrial/residential area. The vegetation and the piles of municipal wastes have been removed from the Drain's channel. However, abundant waste was already observed in the Drain's channel; also, the dredging spoils removed from the drain were deposited along the Drain's banks. (Photo Nos. 1, and 2).

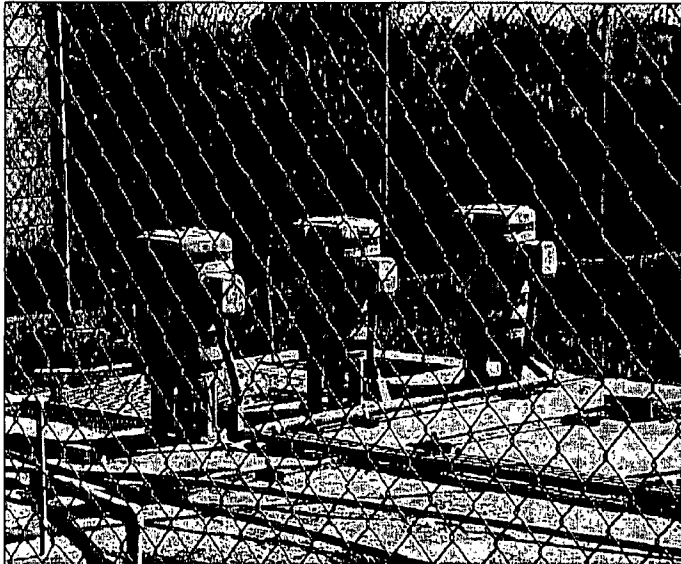
**Photo No. 7 – Gonzales-Ortega**

The Gonzales-Ortega pump station was reported to be in good condition but partially operational during this tour observation. The wastewater influent to this plant is lifted into the Gonzales-Ortega lagoons for treatment.

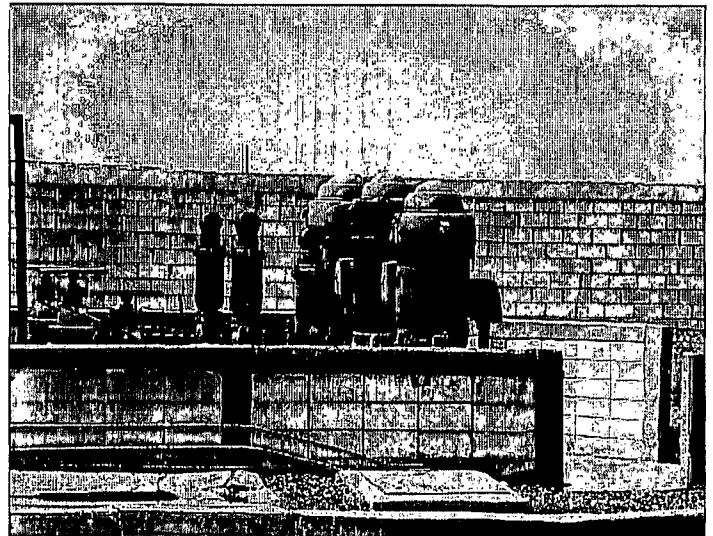
**Photo No. 8 – Pump station No. 3**

Pump station No. 3 was reported to be in good condition and observed to be fully operational. The wastewater influent to this plant is lifted into the Zaragoza lagoons. The facilities look clean and well maintained.

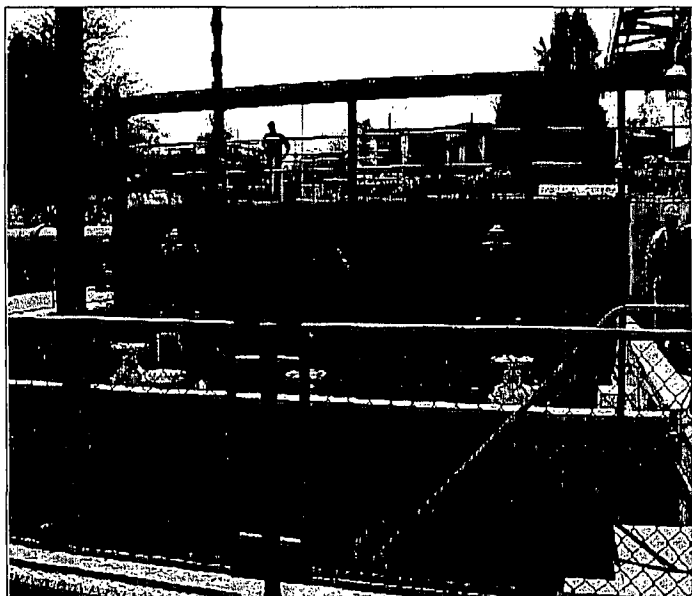
**Photo No. 9 – Pump Station No. 2**

during this observation tour. Staff from CESPМ reported that the Cardenas Collector collapsed and is in the process of being repaired. CESPМ also reported that it will take at least ten more days to fully repair the collapsed collector (Photo No. 9 and 10).

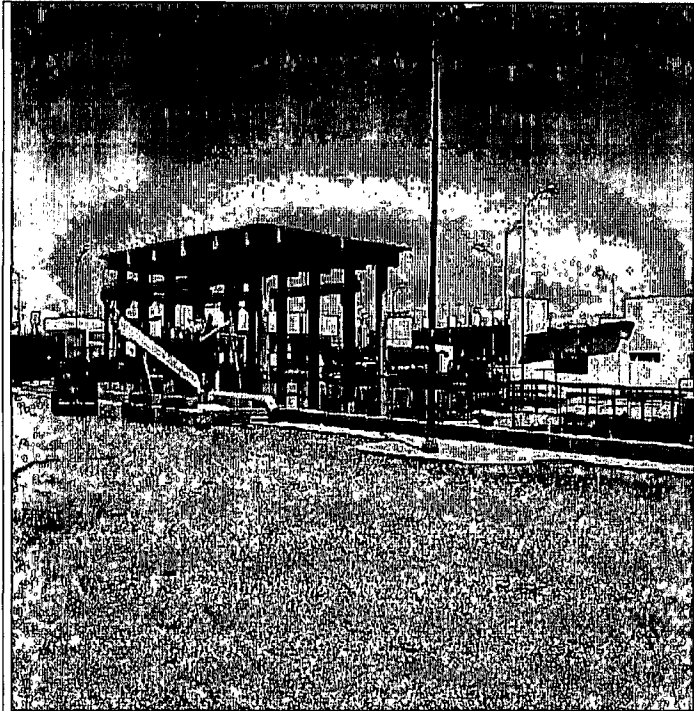
**Photo No. 11 – Pump Station No. 4**  
Pump station No. 4 has been completed.

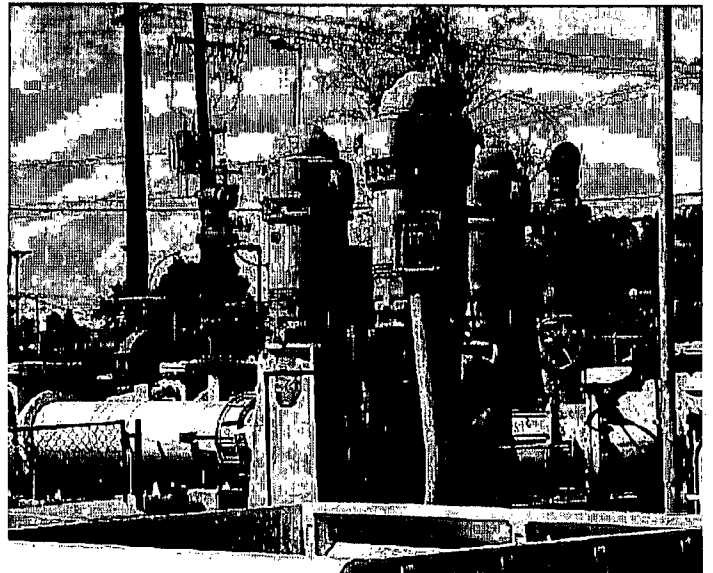
**Photo No. 12 – Pump Station No. 1**  
Pump station No. 1 looks clean and well maintained. This pump station was reported to be in good condition but partially operational during this tour observation.

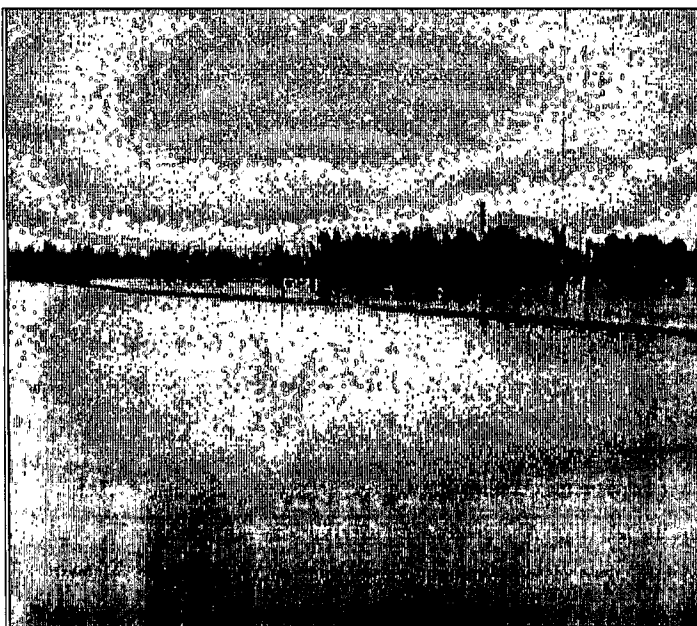
**Photo No. 17– Zaragosa Lagoons**

The watercolor of the Zaragosa primary treatment lagoons varies from grayish to a greenish color. Watercolor in the Zaragosa secondary treatment lagoons varies in color from brown greenish to olive green. The lagoons are well maintained and with the exception of one of the primary anaerobic lagoons all others lagoons are in service and fully operational. The effluent from the lagoons is foamy. The effluent wastewater color is olive green. A septic haulers was observed releasing wastes into the head-works of this wastewater treatment plant (Photos No. 17, 18, 19, and 20).

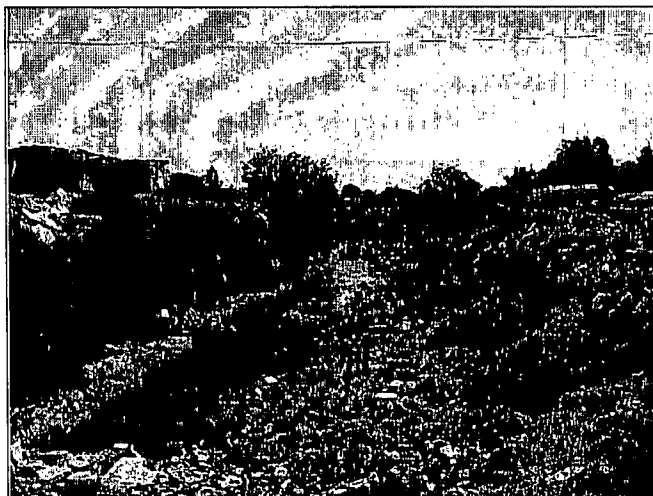
**Photo No. 21 – Mexicali Drain**

Fresh trash was observed in the closed dumpsite along the Mexicali Drain just east of the San Felipe Highway.

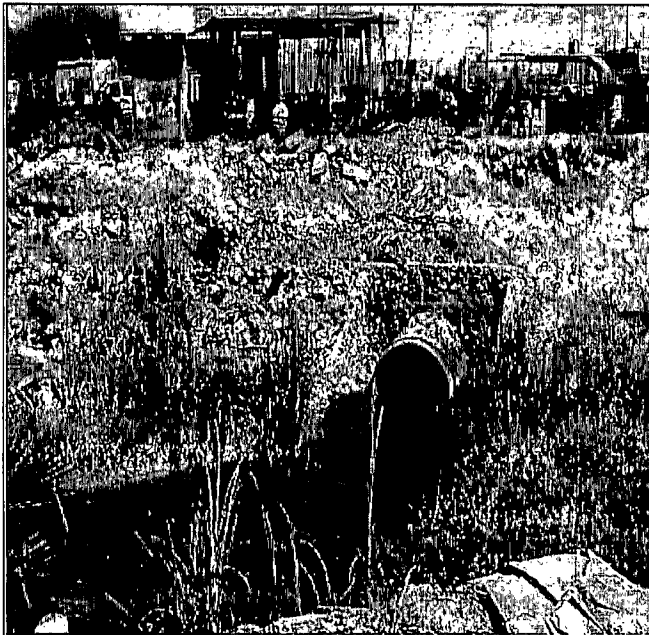
**Photo No. 23- Principal Collector**

An estimated flow of 80 l/sec of raw sewage was being discharged from the 48-inch principal collector into the Mexicali drain. The watercolor here was black.

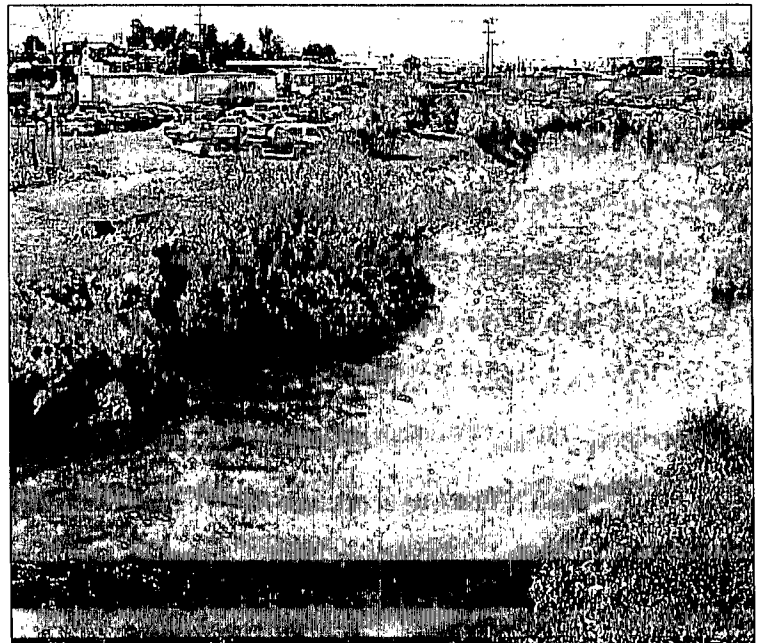
**Photo No. 26- bank Interceptor line**

No flow discharged was observed from the left bank collector, under the Reforma Bridge, into the New River .

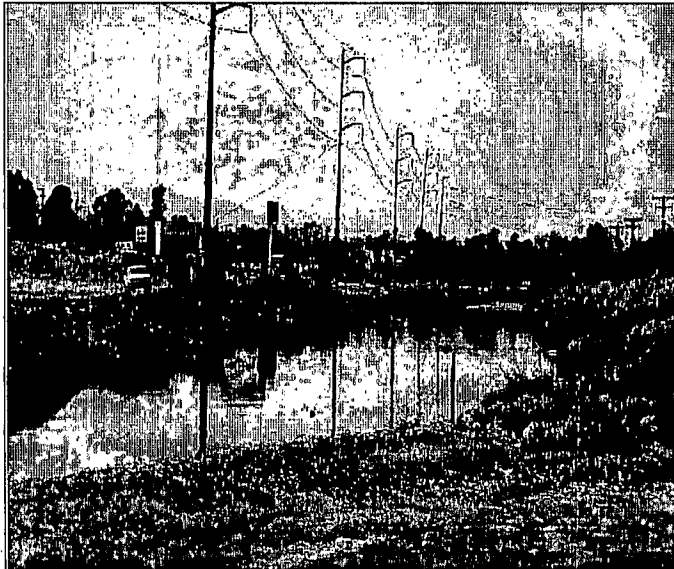
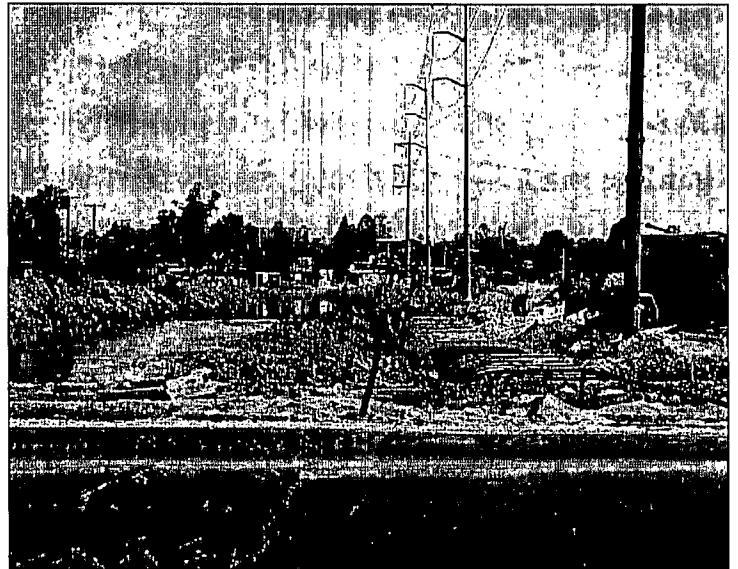
Encasement of the New River continues south towards the boulevard Lazaro Cardenas (Photos No. 27 and 28).

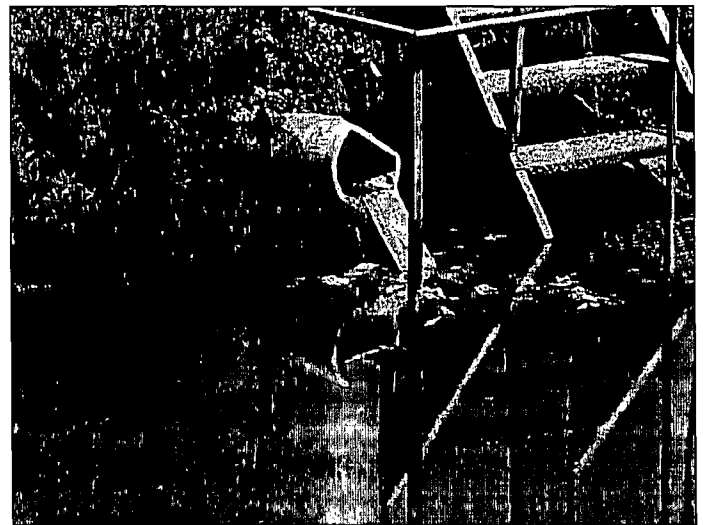
**Photo No. 9 - Cerro Prieto Laundry**

An estimated wastewater flow of 1 l/sec was being discharged from this location into a drain. The watercolor here was clear. Toilet paper and small towels were observed in the discharge (Photo Nos. 8 & 9).

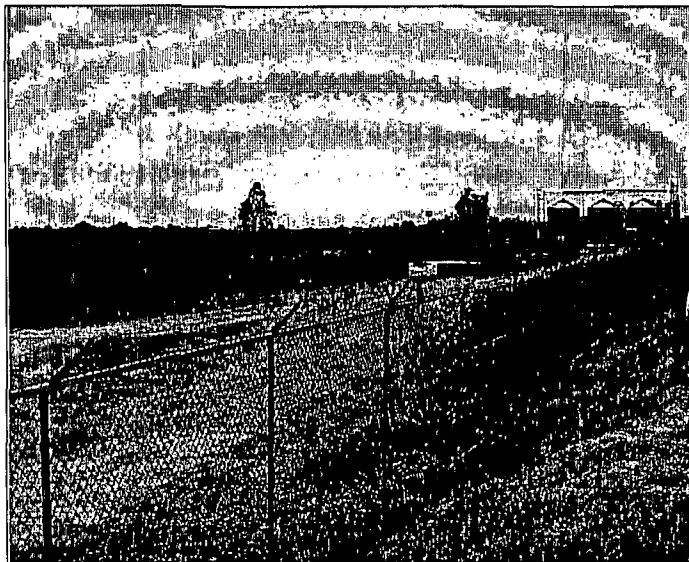
**Photo No. 14 – Maseca Treatment Lagoons**

An observation of the Maseca's wastewater treatment facilities was conducted during this tour. No discharge into the drains was observed from this facility during this observation tour. It is assumed that the wastewater flow from the production facilities is retained in the drying bed area located within the Maseca's premises. It was also assumed that the runoff water and washout wastewater from the storage/distribution facilities is disposed into a drain, which was covered with vegetation. Additional treatment facilities (ponds) were observed south of the plant. These wastewater treatment facilities appeared to be idle during the time of this observation (Photo Nos. 14 & 15).

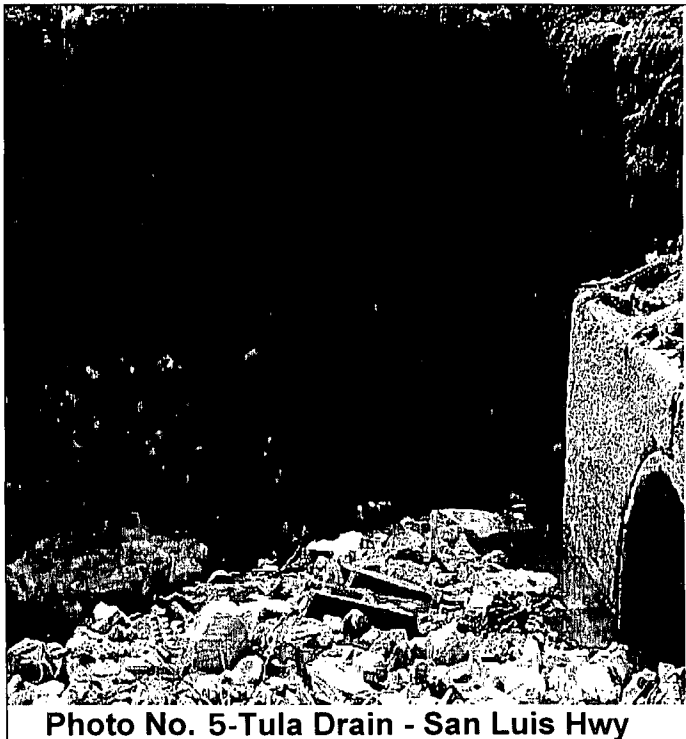
**Photo No. 5-Tula Drain - San Luis Hwy**

Two PVC pipes running parallel to the San Luis Highway one on each bank of the Drain upstream of the San Luis Highway culvert discharge an estimated 2 liter per-second (l/sec) of clear foamy wastewater into the Drain. The pipe located on the left side was covered with mud during this tour (Photos No. 5 and No. 6).

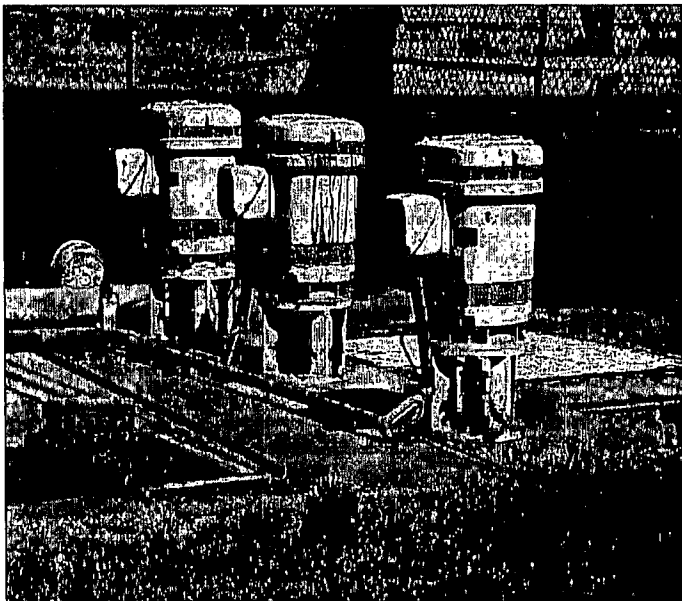
**Photo No. 9 – Gonzales-Ortega**

The Gonzales-Ortega pump station was reported to be in good condition and fully operational during this tour observation. The wastewater influent to this plant is lifted into the Gonzales-Ortega lagoons for treatment.

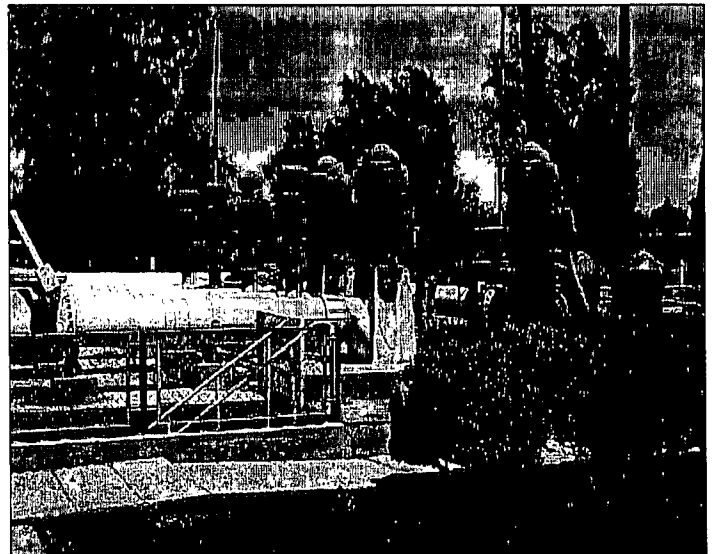
**Photo No. 10 – Pump station No. 1**

Pump station No. 1 was reported to be in good condition but partially operational, two of the pumps were off for maintenance. The wastewater influent to this plant is lifted into the Zaragoza lagoons for treatment. The facilities look clean and well maintained.

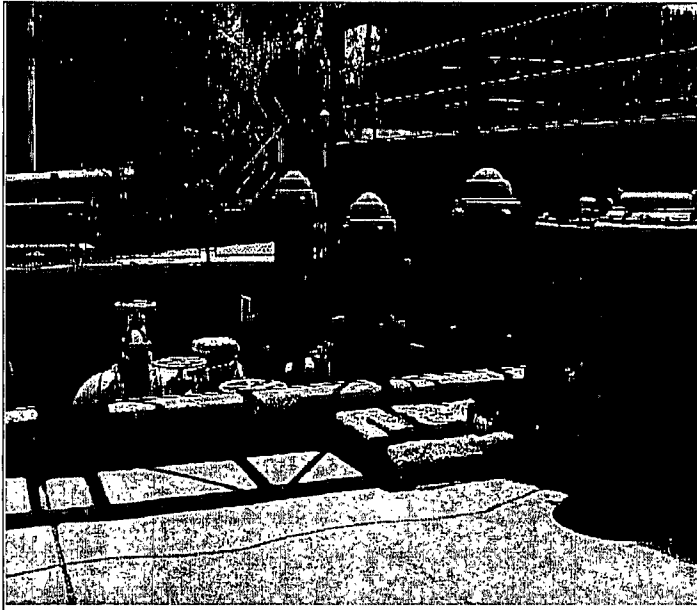
**Photo No. 11 – Pump Station No. 2**

Pump station No. 2 look clean and well maintained. The facility was reported to be in good condition and observed to be fully operational. However, the inflow to this facility was estimated to be about 20 l/sec, it is suspected that the majority of the inflow to this facility continues to be bypassed to the New River. Staff from CESPM reported that the Cardenas Collector, under repair last month was completed; however CESPM also stated that another collector was under repair this month. CESPM reported that they do not know how long it will take them to repair the newly collapsed collector (Photo No. 11)

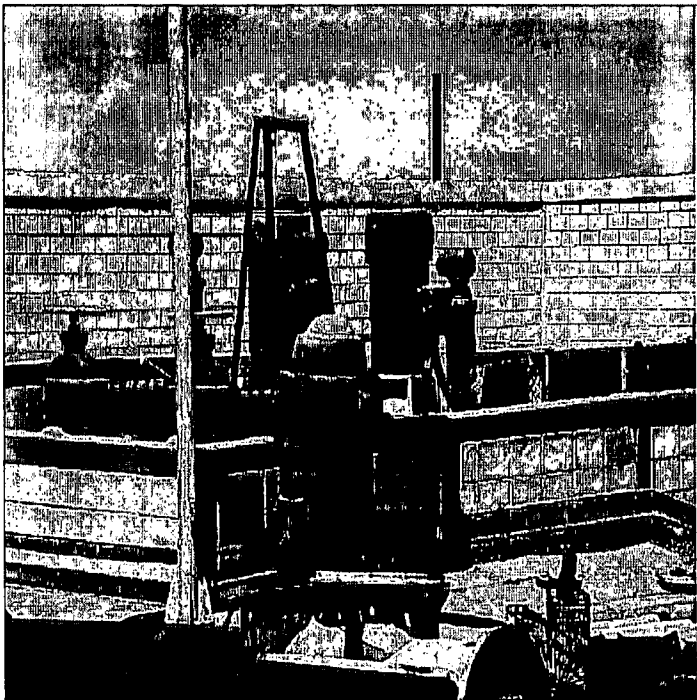
**Photo No. 12 – Pump Station No. 3**

Pump station No. 3 looks clean and well maintained. This pump station was reported to be in good condition but partially operational during this tour observation. One of the pumps was off for maintenance.

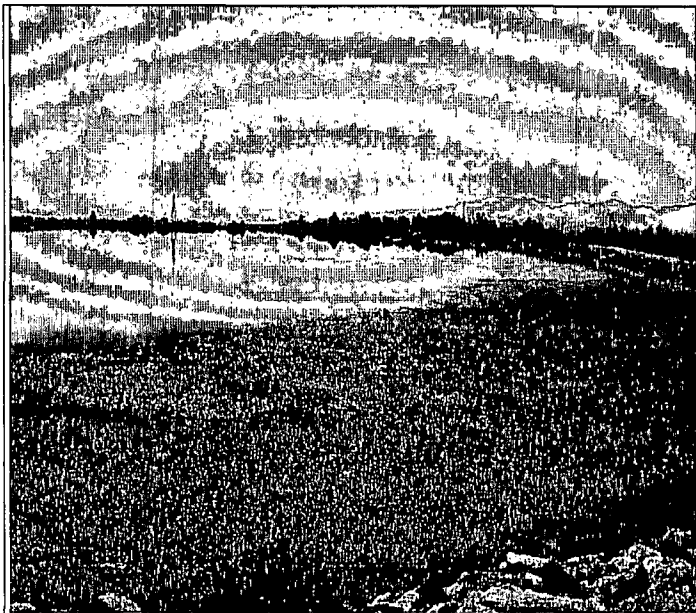
**Photo No. 19– Zaragosa Lagoons**

The watercolor of the Zaragosa primary treatment lagoons varies from grayish to a brownish color. Watercolor in the Zaragosa secondary treatment lagoons varies in color from brownish to olive green. The lagoons are well maintained and with the exception of one of the primary anaerobic lagoons, which has been out of service for the last seven months, all others lagoons are in service and fully operational. The effluent from the lagoons is foamy and the wastewater color is olive green. A mild septic odor can be detected at the effluent channel of this facility. A stronger more persistent odor is detected at the influent head-works of this wastewater treatment plant. Two septic haulers were observed releasing wastes into the head-works of this wastewater treatment plant. We were told that automatic online flowmeters and chemical analyzers devices would be installed at the inlet and outlet discharge channels of the plant (Photos No. 17 - 22).

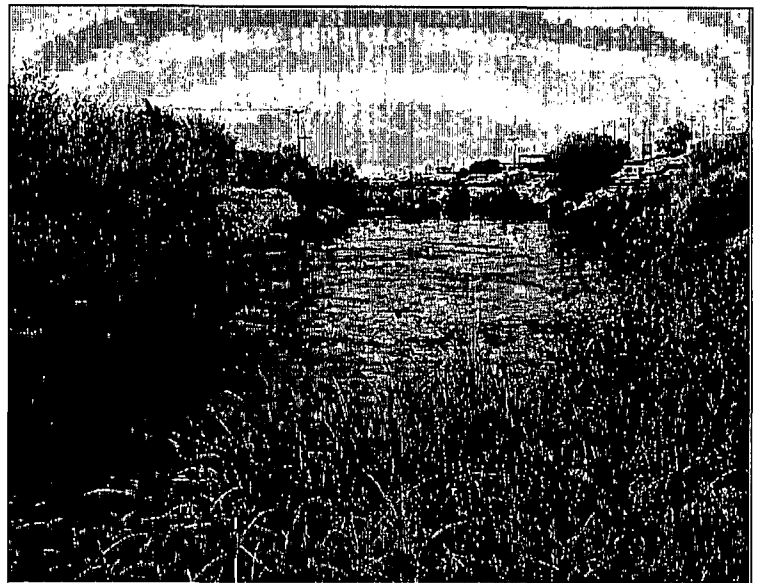
**Photo No. 28- bank Interceptor line**

No flow discharged was observed from the left bank collector, under the Reforma Bridge, into the New River.

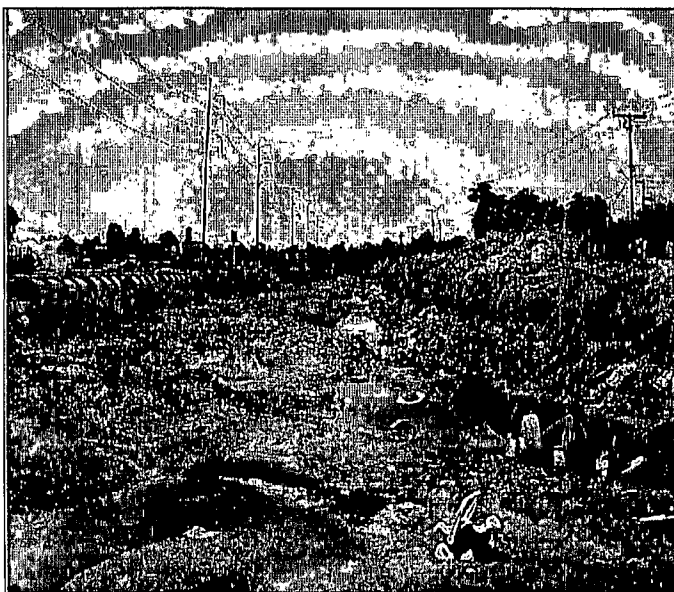
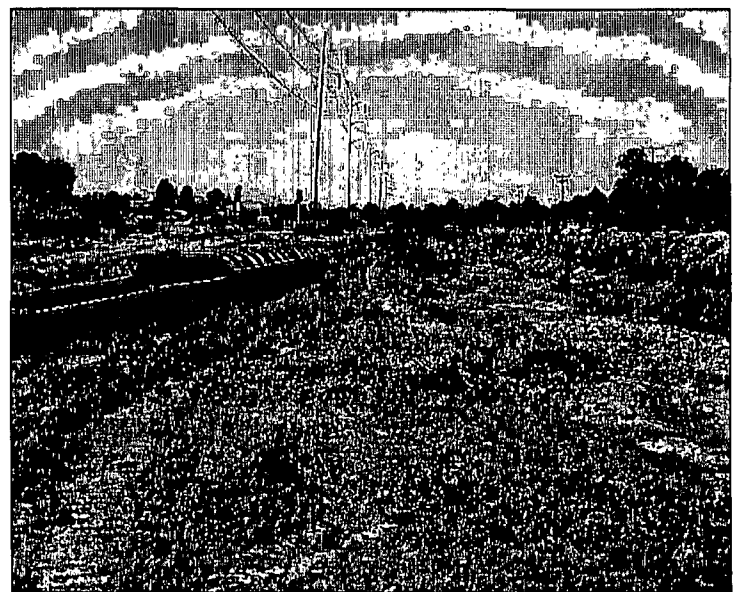
Encasement of the New River continues south towards the boulevard Lazaro Cardenas (Photos No. 29 and 30).

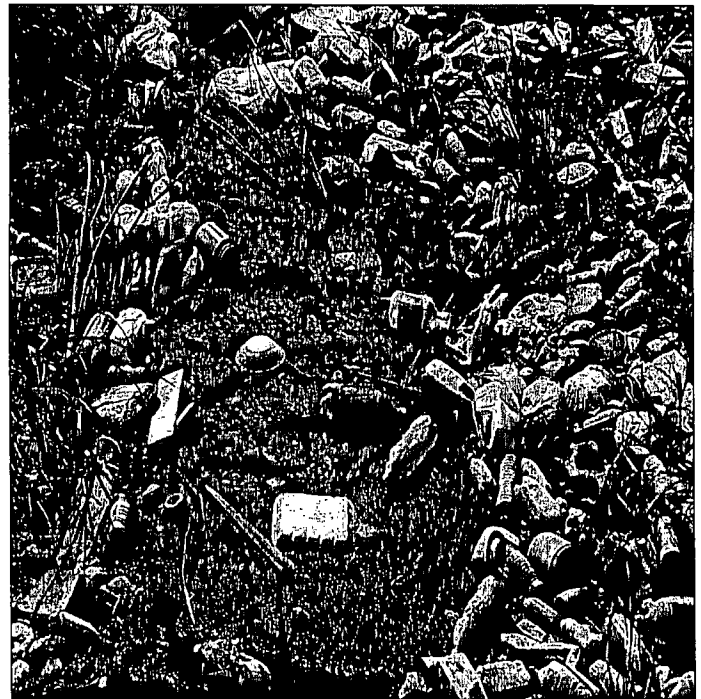
**Photo No. 2 - Tula Drain**

The drain's watercolor changes from a dark green color in the vicinity of the San Luis Hwy to a blackish-oily color in the vicinity of the Hydrogenadora Nacional to a milky pale – grayish color in the northern part of the drain. A scum of what appears to be motor oil was observed by the San Luis Highway culvert. The milky pale – grayish color in the northern portion of the drain is suspected to be some kind of vegetal grease. A mild acrid-septic odor is prevalent along the entire length of the drain in this industrial/residential area. The drain's channel commences to be

overwhelmed with vegetation and municipal waste (a car was observed in the channel's drain). Also, the slopes and banks of the drain are overwhelmed with huge stockpiles of municipal waste, tires, and dredging spoils previously removed from the drain. A new discharge was observed in the left side of the drain by the Hydrogenadora Nacional's northwestern corner lot. According to CESP, this discharge may be linked to the bypasses occurring due to the installation of a new sewer line. (Photo Nos. 1 – 4 ).

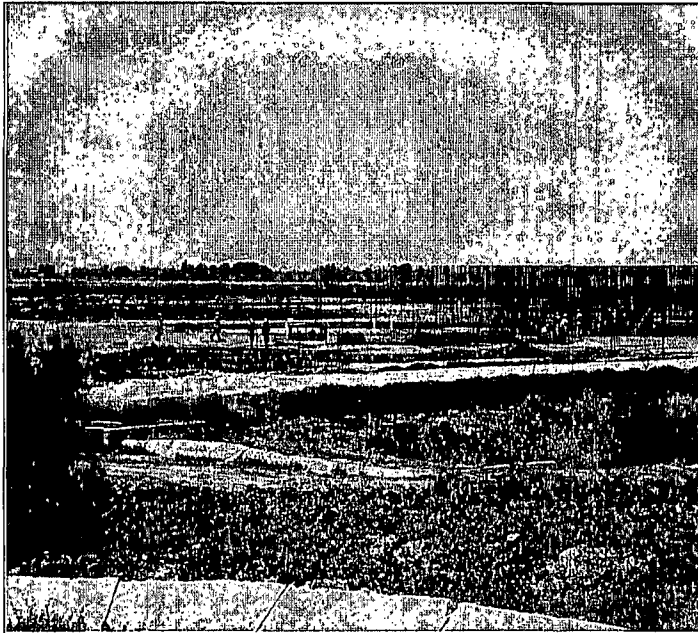
**Photo No. 19– Power Plant WWTP**

and fully operational. The effluent from the lagoons is foamy and the wastewater color is olive green. A mild septic odor can be detected at the effluent channel of this facility. A stronger more persistent odor is detected at the influent head-works of this wastewater treatment plant. Scum and some algae were observed in one of the lagoons. Septic tanks continue to discharge in the lagoons. In addition, the construction of the new power plant's wastewater facilities continues west of the Zaragosa facility (Photos No. 17 - 22).

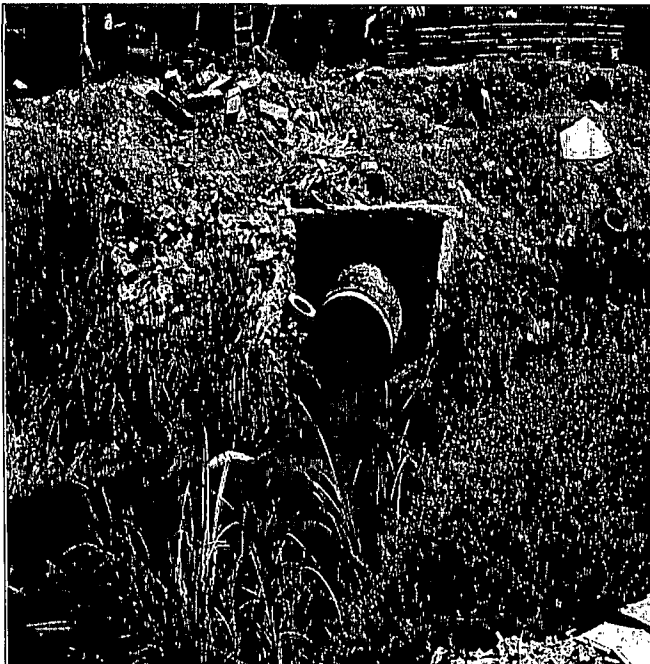
**Photo No. 25- Principal Collector**

An estimated flow of 110 l/sec of raw sewage was being discharged from the 48-inch principal collector into the Mexicali drain. The watercolor here was olive green.

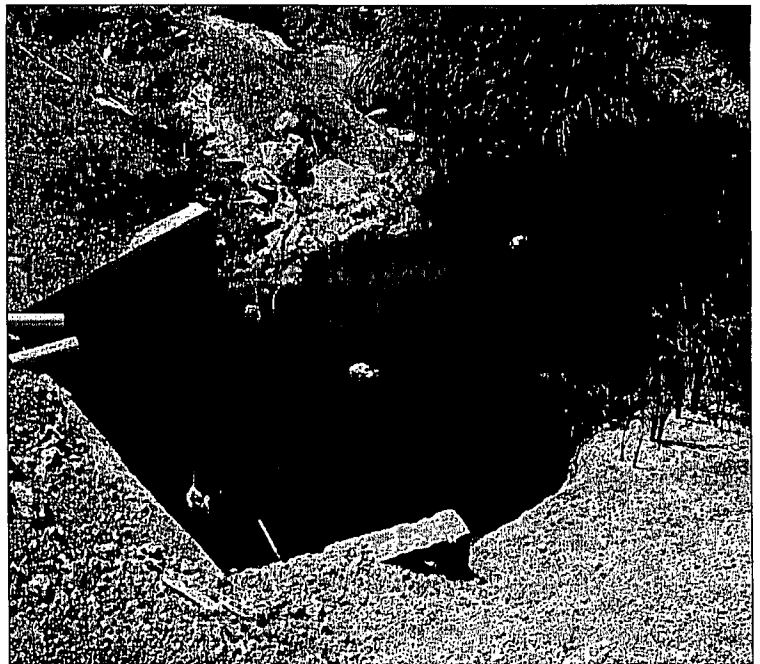
**Photo No. 26 -Nutrimex bypass**

An estimated flow of 120 l/sec of raw sewage was being discharged from the Nutrimex Collector into the Mexicali Drain.

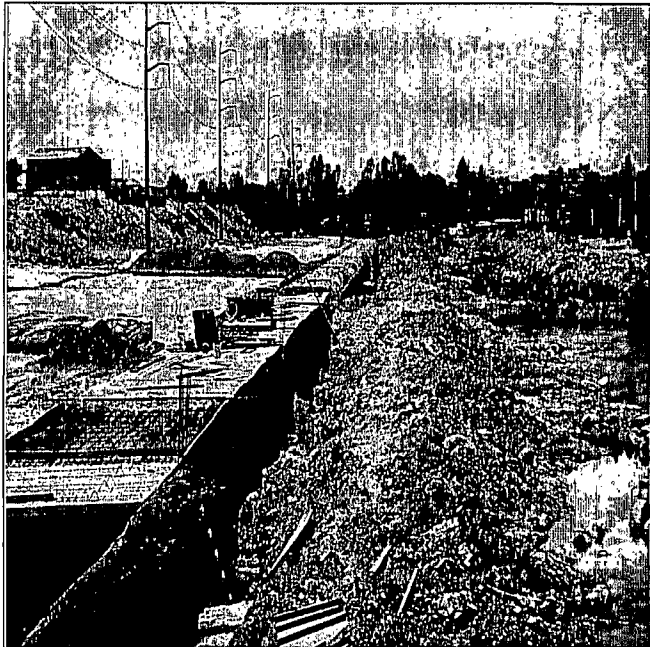
**Photo No. 27 - Drain 134**

All of the discharges to Drain 134 are no longer visible as a result of the encasement of the New River and the Drain.

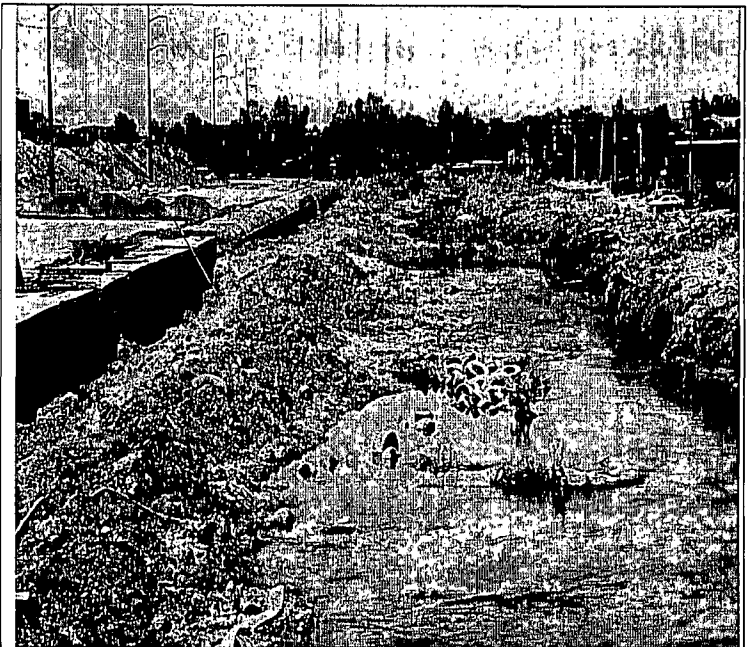
**Photo No. 28 – New River Encasement**

Encasement of the New River continues south towards the Boulevard Lazaro Cardenas.

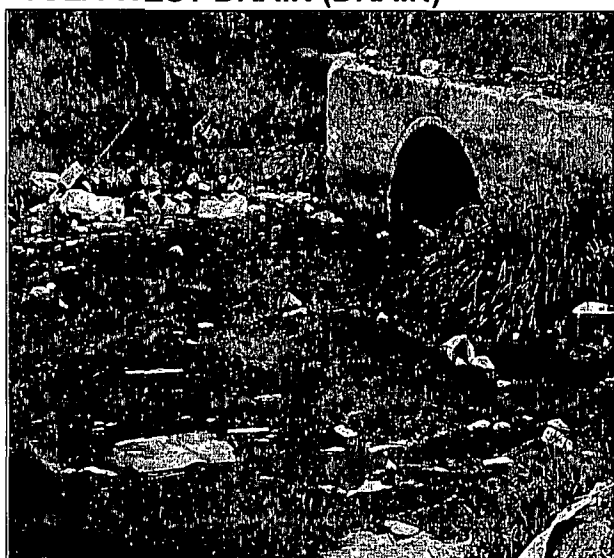
**PHOTO NO. 1-TULA DRAIN**

The Drain's watercolor changes from a dark green color in the vicinity of the San Luis Hwy culvert to a dark green oily color in the vicinity of the Hydrogenadora Nacional facility to a milky pale combined with a blackish color in the northern part of the Drain. A scum of what appears to be motor oil was still observed upstream of the San Luis Hwy culvert. The milky color in the northern portion of the drain is suspected to be some kind of vegetal grease, which is being discharged according to CESPM from the BIMBO facility. The dark green oily colored water can be associated with a discharge of an oily substance in the drain. The dark green colored water is suspected to be domestic sewage. A mild acrid odor is prevalent along the entire length of the Drain in this industrial/residential area. Once again the Drain's channel is overwhelmed with vegetation and piles of municipal waste. A car was still observed in the Drain. Also, the slopes and banks of the Drain continue to be overwhelmed with huge stockpiles of municipal waste, tires, and dredging spoils previously removed from the Drain (Photo Nos 1 and 2).

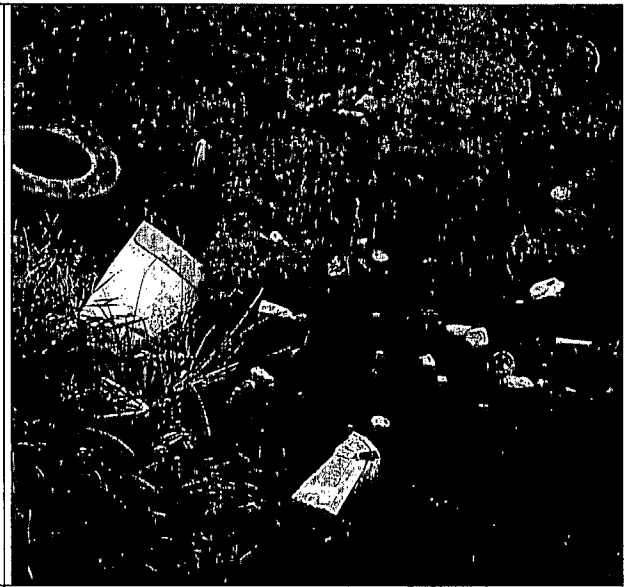
**PHOTO NO. 4-TULA DRAIN**

Two PVC pipes (one on each bank of the drain upstream of the San Luis Hwy culvert) continue discharging an estimated 2 liter per-second (l/sec) of clear foamy wastewater into the drain. The pipe located on the left side is partially covered with sediments since the last observation tour (Photos No. 3 and No. 4). No other discharges from Quipac or the Hydrogenadora Nacional facilities into the drain were observed. Staff from CNA has continually reported that these facilities are closed. In addition, Staff from CNA also reported that the Hydrogenadora Nacional's wastewater discharge permit expired during the month of October 2000. We do not know if Quipac is still allowed to discharge into the drain.

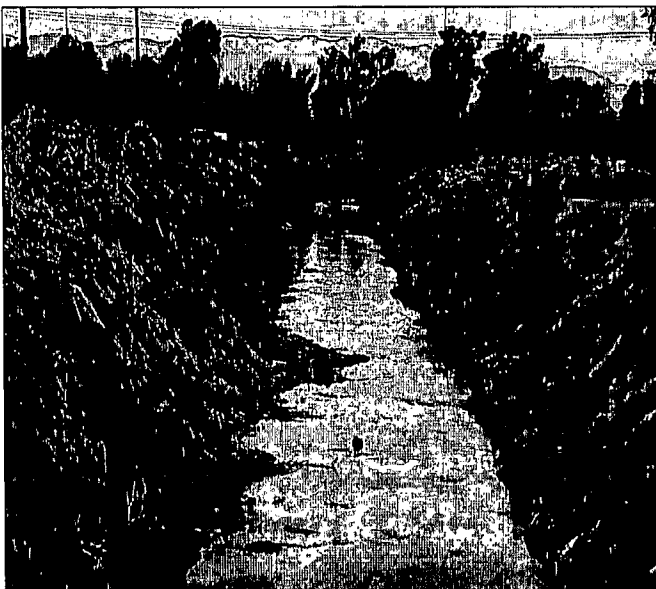
**PHOTO NO. 5-SOUTH OF TULA DRAIN**

A foamy discharge from the Cucapa Industrial Park (Vigia 2) into the drain was estimated in 15 l/sec. The vegetation in the drain was recently removed. No other discharge was observed from this industrial park outlets (Photos No. 5 and 6).

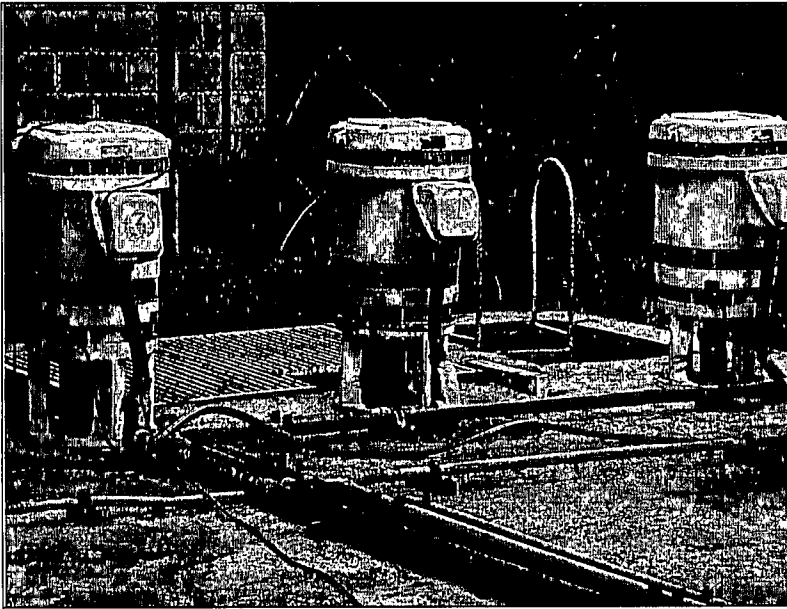
**PHOTO NO. 7-GONZALEZ - ORTEGA PUMP S.**

The Gonzales-Ortega Pump station is in apparent good condition and fully operational (Photo No. 7). The wastewater flow into this facility is, according to CESPM, "normal". However, I do suspect that this pumping station is currently used only to lift domestic wastewater generated in the surrounding areas to the pumping station to the Gonzales-Ortega lagoons. The rest of the wastewater is diverted in to, possibly, the Mexicali drain.

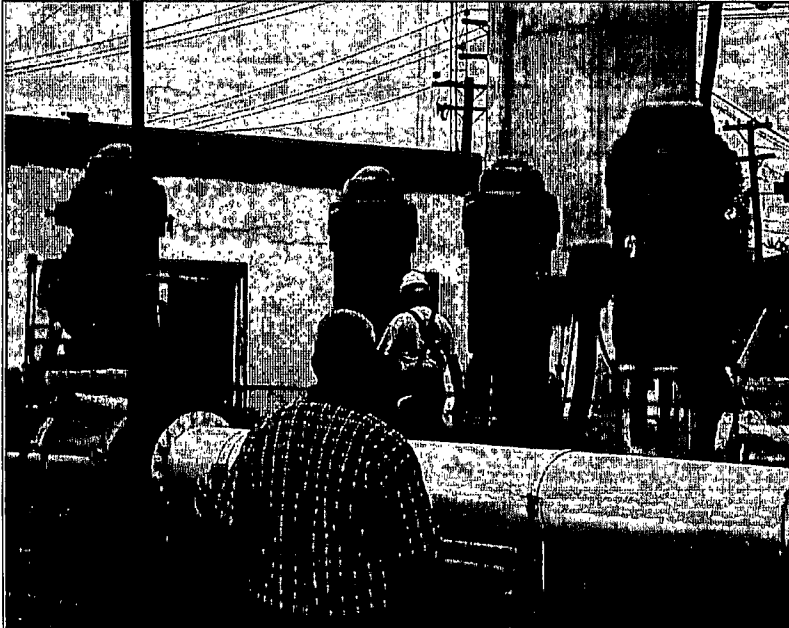
**PHOTO NO. 8-PUMP STATION NO. 1**

Pump station No. 1 is in apparent good condition but partially operational, one of the pumps is being repaired (Photo No. 8). The facility appears clean and well maintained.
