**SUBJECT:** Recommended Update for Region's 303(d) List of Impaired Surface Waters

#### **TULA WEST DRAIN (DRAIN)**

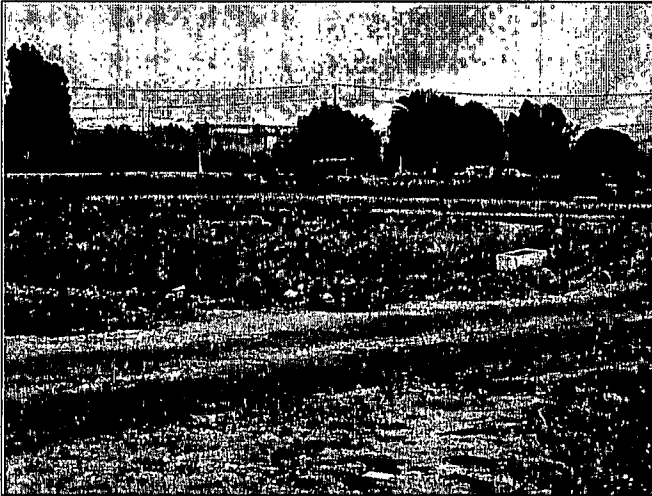
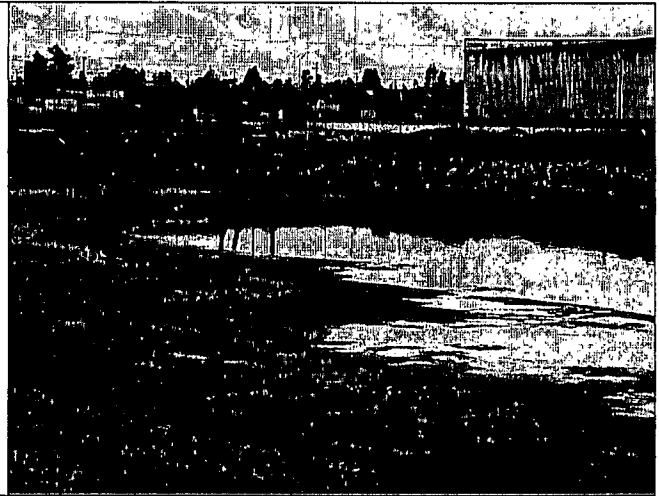
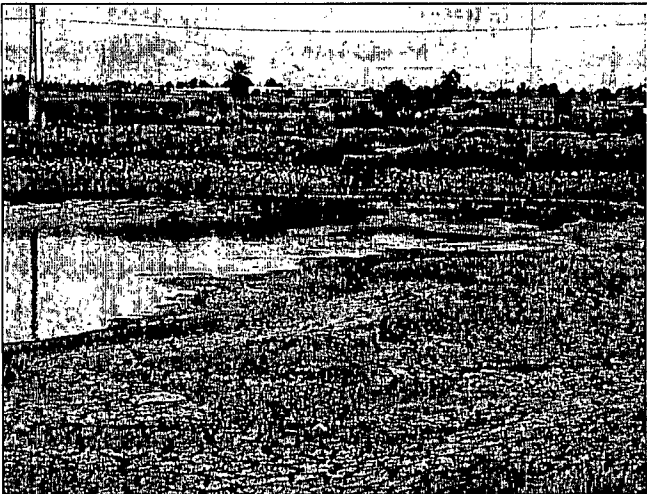
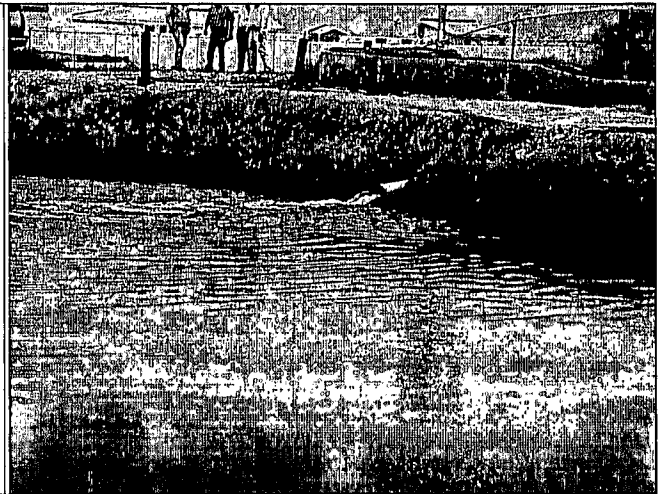
The flow into the Gonzales-Ortega lagoons is minimal. Four of the lagoons are dry. These lagoons should be dredged because of sludge and grit build-up. However, all of the eight lagoons are still operational; it is unknown why only four of the lagoons are currently used. Based on this tour observation, my suspicion regarding the majority of the flow being diverted to another location is stronger. The lagoon's watercolor varies from dark green to a grayish color. The effluent from the lagoons is minimal and possesses a greenish/gray color (Photos No. 14 - 19).

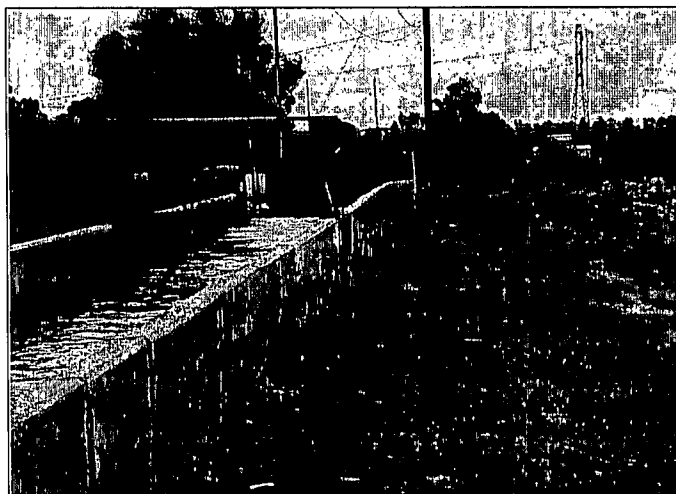
**PHOTO NO. 20-ZARAGOZA INFLUENT**

The watercolor of the primary lagoons varies from dark to a grayish color. Watercolor in the secondary treatment lagoons varies in color from brown greenish to olive green. The lagoons are well maintained and with the exception of one of the anaerobic lagoons all of the lagoons are in service. The effluent from the lagoons is foamy and has an olive green color. A flow meter was installed at the influent of the plant. The construction of the new power plant's wastewater treatment plant continues. Truck haulers continue to discharge at the headwork influent facilities (Photos No. 20 and No. 25).

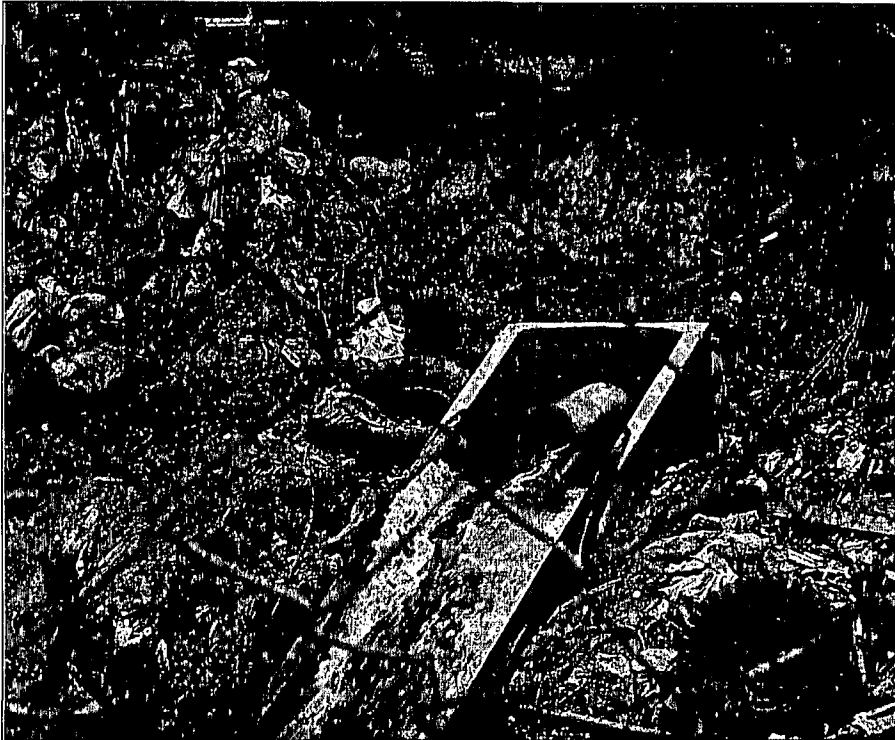
**PHOTO NO. 26 - PLANT NO. 5**

**PLANT NO. 5:** An estimated flow of 15 l/sec of raw sewage was being discharged from the Plant No. 5 into the New River (Photos No. 26).

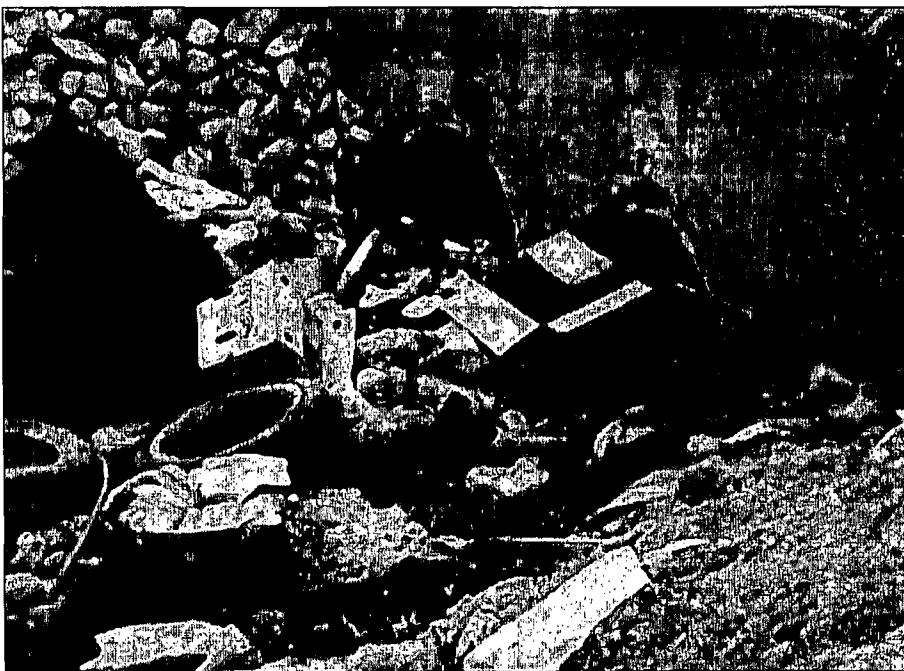
**PHOTO NO. 27- KEN/MEX PLANT**

A trickle of water flow was being discharged into the drain. The drain is still covered with piles of domestic waste (Photo No. 27).

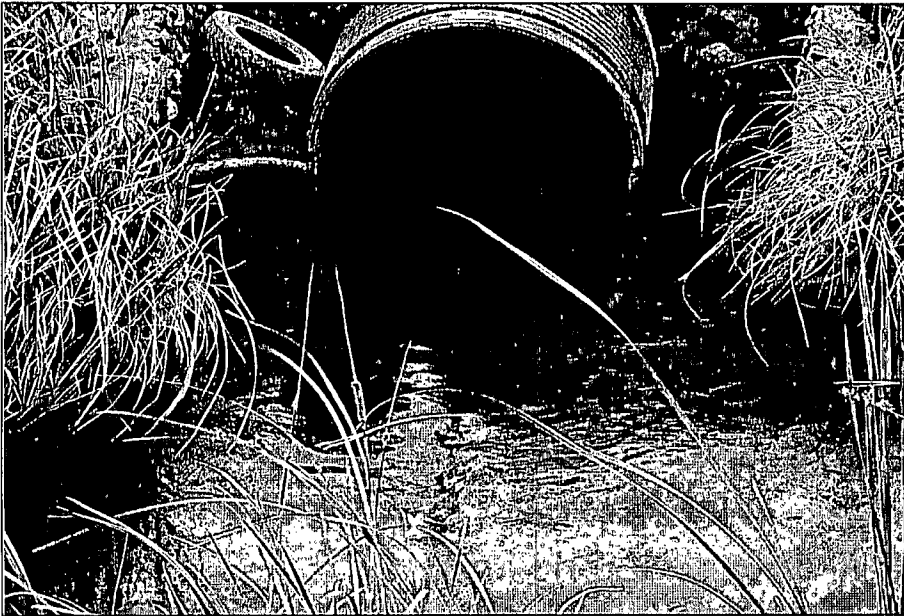
**PHOTO NO. 28 - PRINCIPAL COLLECTOR**

**48-INCH PIPE, PRINCIPAL COLLECTOR:** An estimated flow of 120 l/sec of raw sewage was being discharged from the 48-inch principal collector into the Mexicali drain. The watercolor here was olive green; a mild septic odor was also detected in this location suggesting that the effluent is mostly from domestic sources (Photo No. 28).

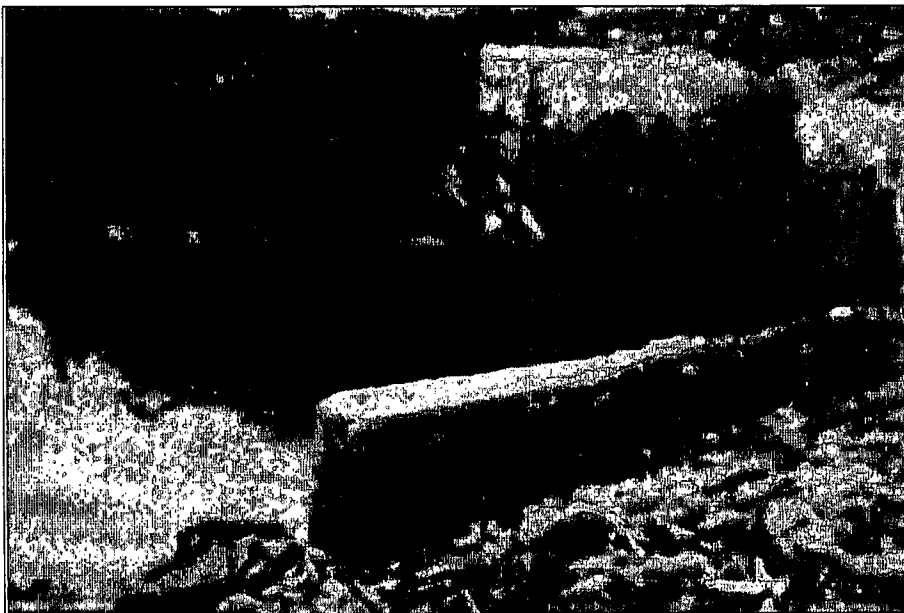
**PHOTO NO. 29-NUTRIMEX COLLECTOR**

**NUTRIMEX COLLECTOR:** An estimated flow of 150 l/sec of raw sewage was being discharged from the Nutrimex Collector into the Mexicali Drain. The watercolor in the drain was dark green; a mild septic odor was also detected in this location suggesting that this effluent is mostly from domestic sources (Photo No. 29).

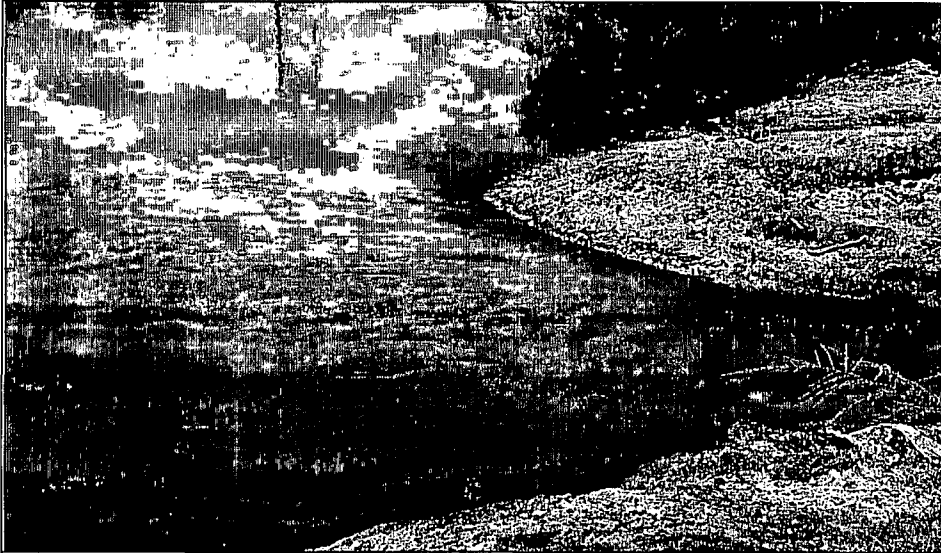
**PHOTO NO. 30 – PUMP NO. 26**

**PUMP NO. 26:** An estimated flow of 50 l/sec of raw sewage was being discharged from the pump No. 26 station into the New River. The watercolor here was brownish and a mild septic odor was detected in this location (Photos No. 30).

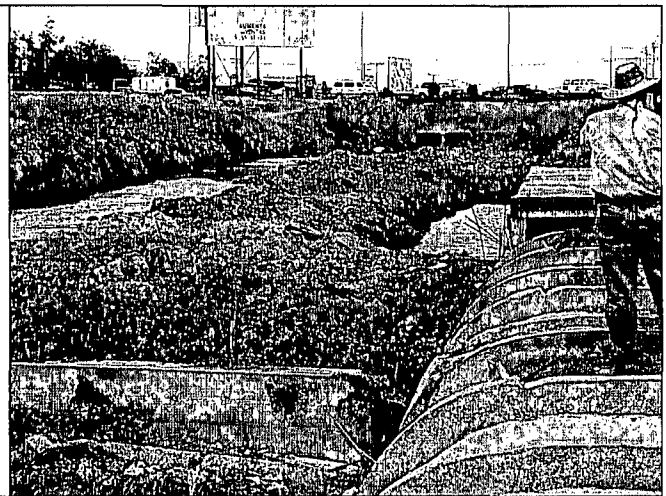
**PHOTO NO. 32-NEW RIVER  
ENCASEMENT**

All of the discharges to Drain 134 are no longer visible as a result of the encasement of the New River and the Drain (Photo No. 31 and 32). Encasement of the New River continues toward Lake Xochimilco. Eventually, most of the discharges to the New River in between the international boundary and Lake Xochimilco will no longer be visible because of the encasement. No other discharges were observed into the New River during this observation Tour.

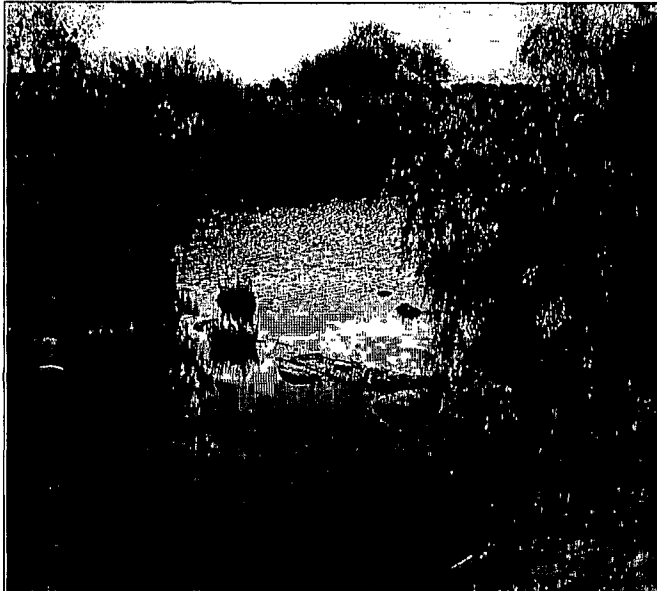
**PHOTO NO. 33-ALAMO RIVER WEIR**

The Alamo River Weir was observed during this Observation Tour. An estimated flow of 40 l/sec was being discharged into the United States (Photo No. 33).

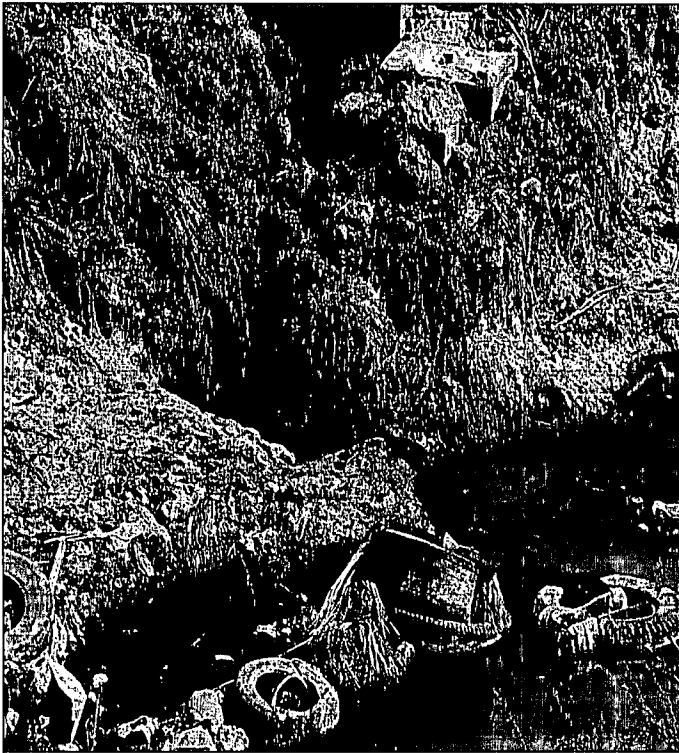
PHOTO NO. 3 - TULA DRAIN

As previously observed, the drain's watercolor changes from a dark green color in the vicinity of the San Luis Hwy culvert to a blackish-oily color in the vicinity of the Hydrogenadora Nacional facility and to a milky pale – grayish color in the northern part of the drain. It's suspected that an illegal dumping/discharging of an oily substance occurred or is occurring around the Hydrogenadora Nacional location. The milky pale – grayish color in the northern portion of the drain is suspected to be some kind of vegetal grease. The drain's channel looks cleaner. However, the slopes and banks continue to be overwhelmed with municipal waste, tires, and dredging spoils previously removed from the Drain. In addition to the usual discharges from the PVC pipes located by the San Luis Hwy, a trickle of wastewater was observed from the Parque Industrial La Vigia discharge outlet into the drain. No others discharges from Quipac, the Hydrogenadora Nacional, or the Vidriera Mexicali (Vitro-Mex) facilities were observed during this tour (Photos No. 1 - 4).

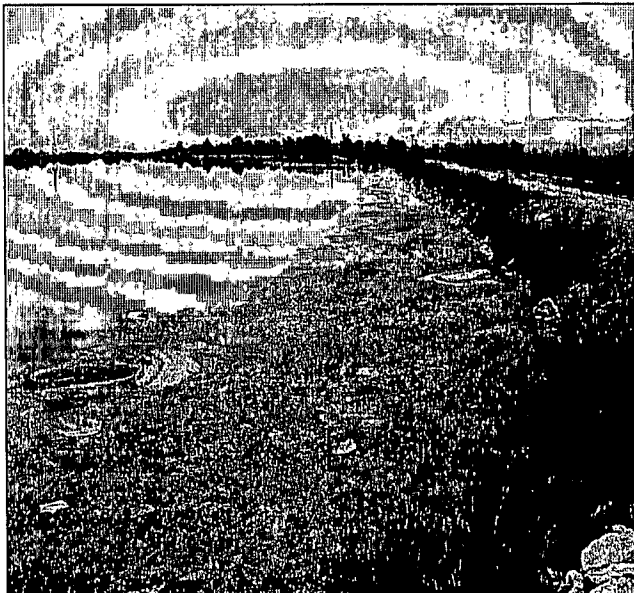
PHOTO NO. 15 - ZARAGOZA INFLUENT

The watercolor of the primary lagoons varies from brownish to a grayish color. Watercolor in the secondary treatment lagoons varies in color from brown greenish to olive green. Algae were observed in one of the lagoons. The lagoons are well maintained and with the exception of one of the anaerobic lagoons all the lagoons are in service. The effluent from the lagoons is somewhat foamy and has a strong green color. The construction of the new power wastewater treatment plant continues. (Photos No. 15 and No. 20).

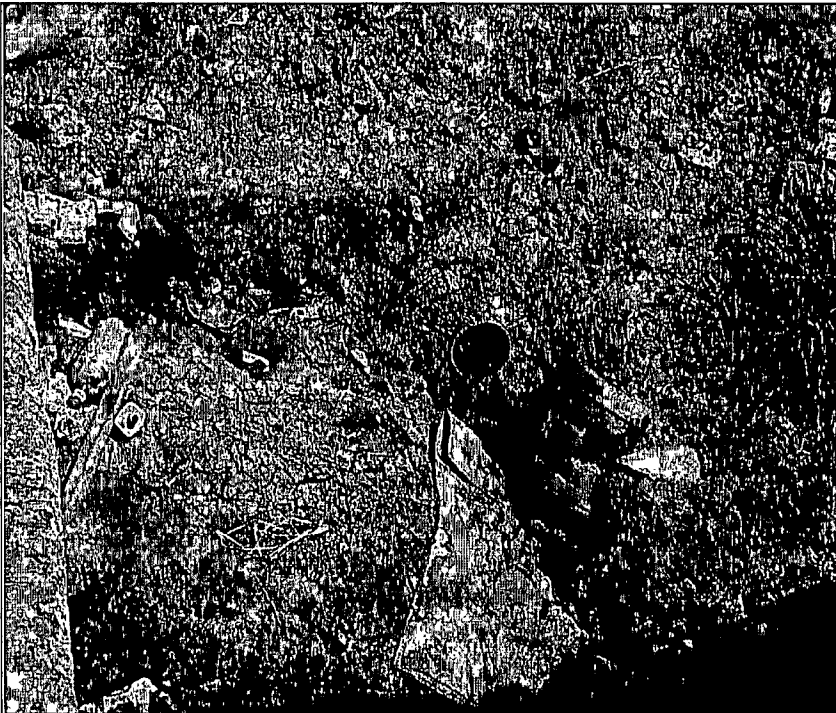
PHOTO NO. 21 - TULA DRAIN BY SAN LUIS HWY

**TULA DRAIN BY SAN LUIS HWY:** Two PVC pipes located north of the San Luis Highway culvert one on each side of the drain's banks continue discharging an estimated 2 l/sec of clear foamy wastewater into the Tula drain the pipe located on the left side of the drain has been partially covered with soil sediments but the discharge to the drain still continues (Photos No. 21).

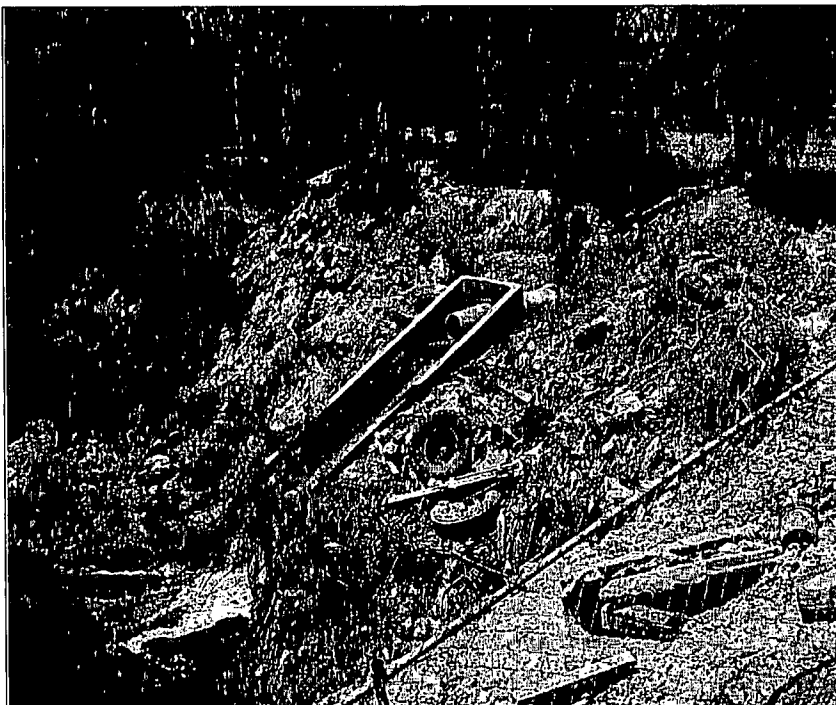
PHOTO NO. 22 - PLANT NO. 5

**PLANT NO. 5:** An estimated flow of 15 l/sec of raw sewage was being discharged from the Plant No. 5 into the New River (Photo No. 22).

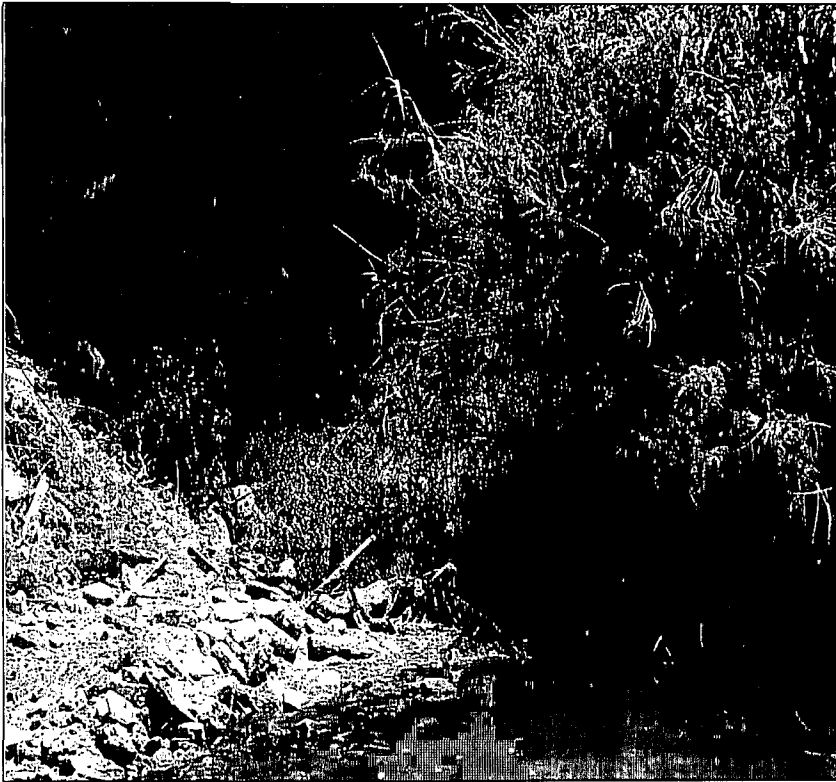
PHOTO NO. 23 – CASTELLAN DRAIN

**CASTELLAN DRAIN:** An estimated flow of 5 l/sec of raw sewage was being discharged from the Castellán drain into the New River (Photo No. 23).

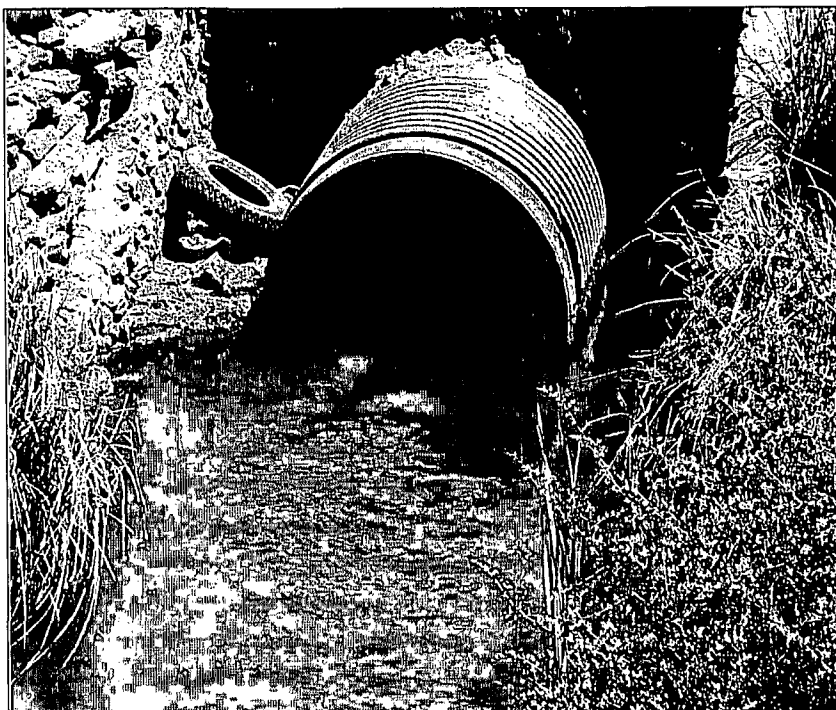
**PHOTO NO. 24- PRINCIPAL COLLECTOR**

**48-INCH PIPE, PRINCIPAL COLLECTOR:** An estimated flow of 120 l/sec of raw sewage was being discharged from the 48-inch principal collector into the Mexicali drain. The watercolor here was olive green; a mild septic odor was also detected in this location suggesting that the effluent is mostly from domestic sources (Photos No. 24).

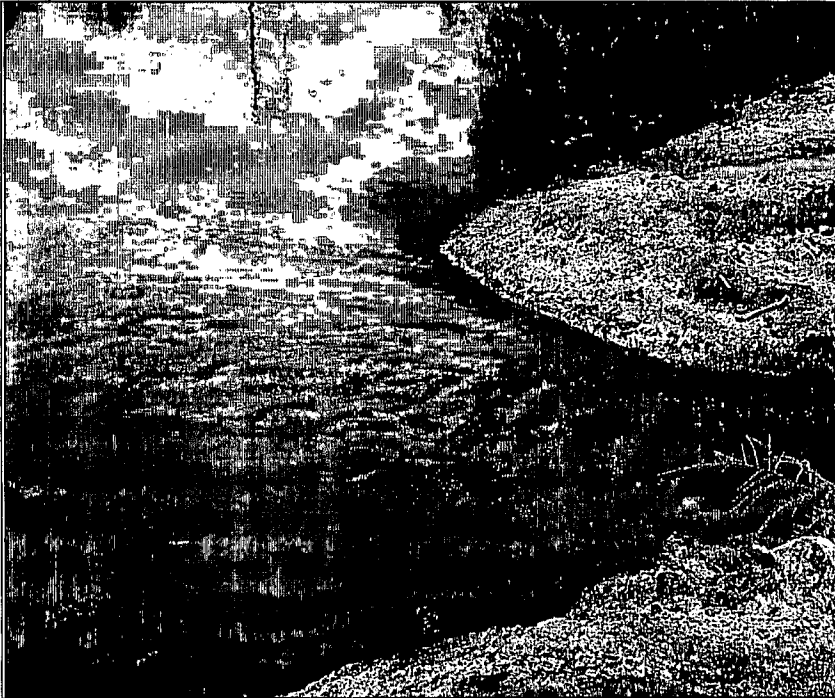
**PHOTO NO. 25- PUMP NO. 26**

**PUMP NO. 26:** An estimated flow of 50 l/sec of raw sewage was being discharged from the pump No. 26 station into the New River. The watercolor here was brownish and a mild septic odor was detected in this location (Photos No. 25).

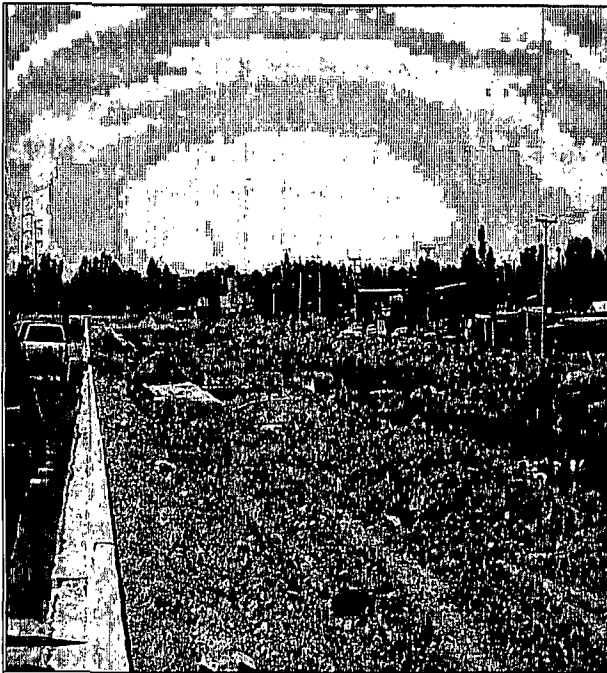
**PHOTO NO. 27 - ENCASEMENT**

All of the discharges to Drain 134 are no longer visible as a result of the encasement of the New River. The Encasement of the New River continues toward Lake Xochimilco. Eventually, most of the discharges to the New River in between the international boundary and Lake Xochimilco will no longer be visible because of the encasement. (Photo No. 27 and 28).

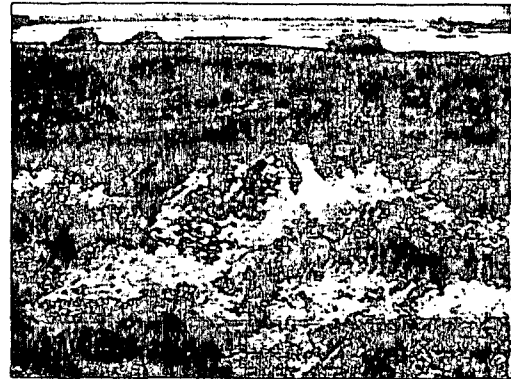
Figure 2: Outfall from Sukarne

west of the evaporation ponds. During the tour, there was approximately 1' freeboard in the ponds, hence it is probable that a rainstorm may result in an acute surface discharge of facility wastewater, which could impact the drain, New River, and the water supply canal. Moreover, apparently, there is an outfall from the ponds into the drain (Figure 2). During the tour, however, I did not observe any discharge from the outfall into the drain or from the facility into the canal.

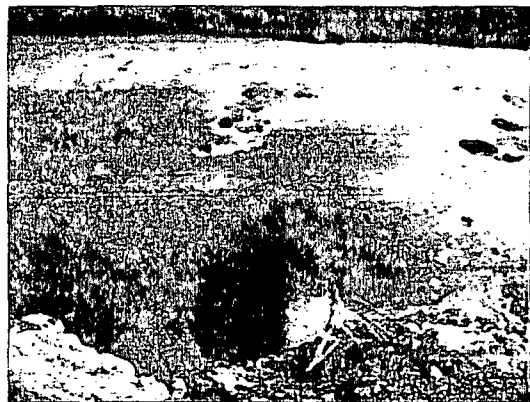
Figure 5: Slaughterhouse discharge

During the tour, a large volume of bright red wastewater, assumed to be mostly blood, was being discharged into a drain located east of the facility, Figure 5. The drain is tributary to the New River. Due to the water level within the drain the discharge pipe could not be seen and is presumed to be beneath a water supply canal located between the drain and the facility. Should the facility experience a discharge pipe failure it is possible that the water within the canal would be contaminated with facility wastewater. Additionally, the water within the supply canal may be contaminated with facility wastewater during a

rainstorm. The wastes in the drain were off-gassing nauseous odors. Also, trash (e.g., tires, plastic containers, and wood debris) was present in the drain.

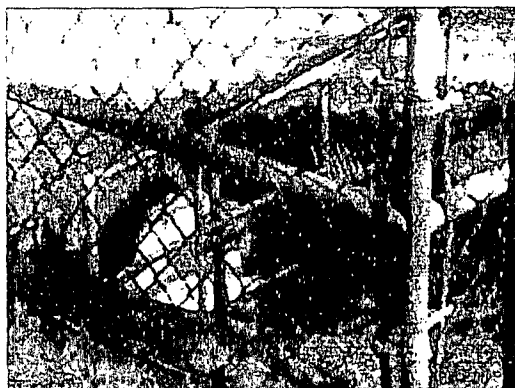
Figure 10: Paper mill discharge

The facility was discharging approximately 1 mgd of a grayish orange liquid with a large quantity of gray, fibrous suspended material. The facility has on-site wastewater treatment lagoons located southwest of the facility, and they serve as settling basins. An eight-foot chain link fence that is topped with several strands of barbed wire restricts access to the discharge point located northeast of the facility, Figure 10. Several no smoking signs are attached to the fence. The discharge within the fenced area has a grayish orange color with a large quantity of foam. Downstream from the discharge point, a fine gray fibrous material coated the banks of the drain up to 3.5' above the existing water level, which likely results from lagoon flushing activities by the facility, Figure 11.

1. Within the New River Watershed in Mexicali, there are several industrial facilities that routinely discharge their untreated and inadequately treated wastewater directly into New River tributaries. Based on previous tours and the subject tour, the quantity and characteristics of the industrial discharges varies, but the discharges are nevertheless adversely impacting New River water quality.
2. The occurrence of a rainstorm in the region may result in the discharge of a large volume of industrial wastewater from various types of facilities into the New River and could potentially impact water supply canals.
3. Pretreatment and regulatory enforcement programs are necessary to deal with the discharges of wastes from these industrial facilities.

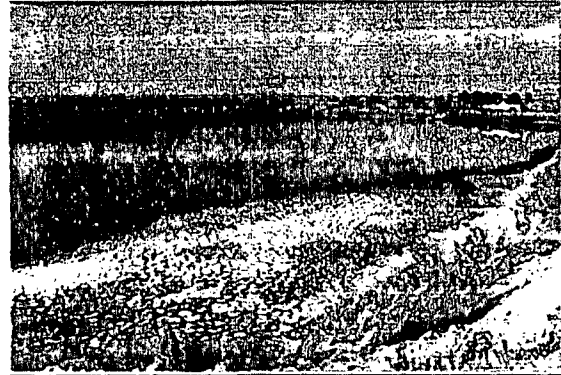
Photo 3: Gonzalez-Ortega Primary Lagoon

The Gonzalez Ortega pumping station appeared to be fully functional with no problems noted. The treatment lagoons were producing gray/green effluent, and according to AI, appear to be operating at only 10-15% of normal, although we were unable to locate any significant bypassing of raw sewage in the vicinity. One of the primary lagoons is in dire need of dredge-out (Photo 3).

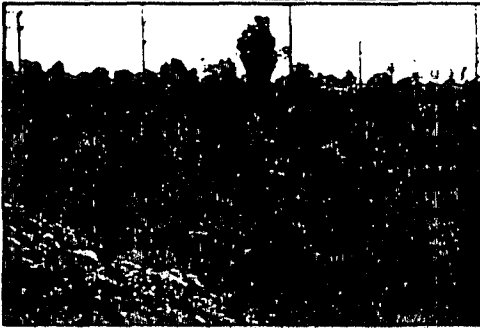
Figure 7: Old Dump upstream of Kenmex

**Old Dump and Mexicali Drain:** The old dump along the Mexicali Drain upstream of the Kenmex outfall is on fire. Smoke is emanating from the dump at several locations, indicating subsurface burning, and flames (approximately 3' high) were observed at one location (see Figure 7). Illegal disposal of trash at this location continues, as evidenced by the large quantities of trash observed all along the banks of the Mexicali Drain. There are also numerous outhouses along the Drain. During the tour, there was no discharge from Kenmex facility. However, a large pile of Styrofoam is present on the right hand bank (facing downstream), just in front of the Kenmex outfall (see Figure 8).

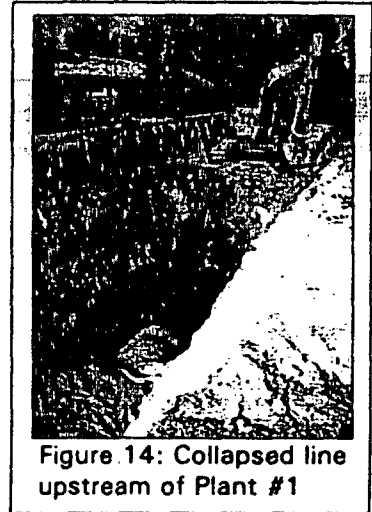
Figure 14: Collapsed line upstream of Plant #1

All six pumps at this station are operational. However, CESPM is only pumping 3 hours per shift because sections of the South Collector system (e.g., South Collector near "Calle Nuevo Leon" and South Collector near "Calle 10"), including a section approximately 1000 feet upstream of the plant, on the eastern end of the Military Headquarters are collapsed (see Figure 14). Consequently, CESPM is bypassing most of the normal wastewater flow from the plant into the New River. The typical flow at this plant is about 10-15 mgd. CESPM is replacing the collapsed and delapidated surrounding pipe sections with 54-inch "PVC" pipe. The new flow meters for the plant are useless as their readings continue to be unreliable.

2. Pipes continue to collapse periodically. Although the approved Mexicali I and Mexicali II projects address about 20 miles of sewage collectors, the actual state of all main collectors (sewer pipes 8 inches in diameter or greater) is not fully known. It is imperative that a comprehensive pipe survey (i.e., a TV-survey of the pipes' interior) of the collection system be conducted to better prioritize pipe replacement/rehabilitation and maintenance.

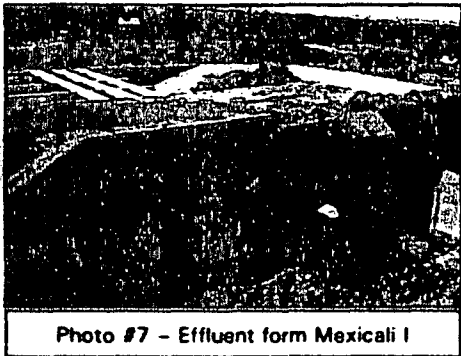
Photo #7 - Effluent form Mexicali I

Primary lagoons #2 and #3 were at full capacity; their watercolor was black. There was a strong septic odor that was emanating from the lagoons. This facility continues to be overloaded. Primary lagoon #1 is still out of service to allow for the installation of a new distribution system. Similarly, most of the secondary lagoons were at full capacity. In general, their watercolor was light green. Red algal growth was observed on the surface of secondary lagoon #5. The effluent from this facility was pea green in color (photo #7).

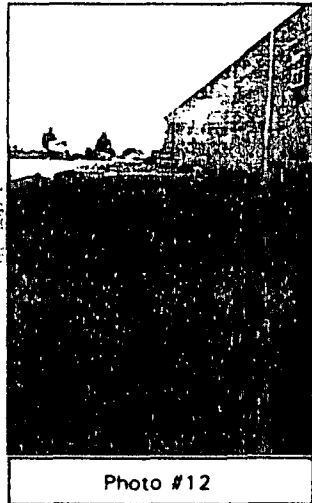
Photo #12

- Rehabilitation work was observed on a collapsed segment of the South Collector near "Calle Nuevo Leon", 1000 meters will be rehabilitated by installing a liner. This work should be completed by the end of January 2000. (photo #12)

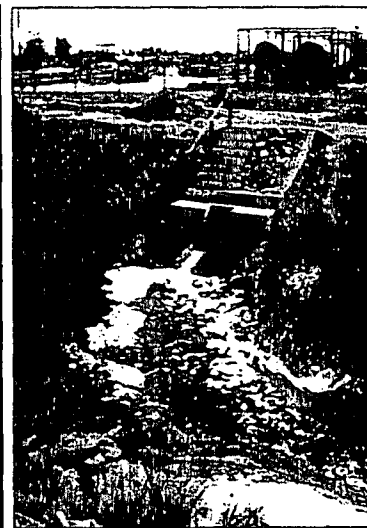
Figure 2

- Approximately 30 gallons per minute (gpm) of putrid milky green wastewater from the Hidrogenadora Nacional plant. The discharge created a greasy scum on the surface of the receiving drain [Figure 2].
- Approximately 10 cfs of dark wastewater was flowing from the terminus of the Tula West concrete encasement about one mile upstream, of the Hidrogenadora plant. Although sewage solids were not readily observed, the wastewater had the appearance and odor of raw sewage.

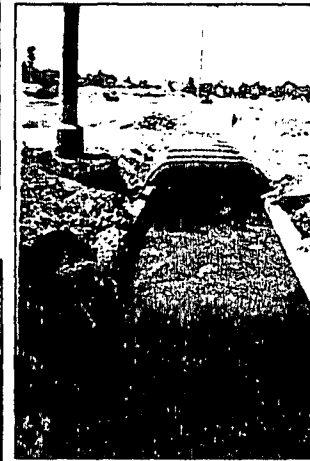
The encasement of the New River has now been completed from Av. Anahuac to Av. Reforma. Figure 12 shows the beginning of the encasement at Av. Anahuac. With parallel highway construction in the floodplain, the New River is now practically invisible. The highway construction extends over about half the length of the encasement. A high groundwater table and considerable dumping of demolition rubble and trash will complicate completion of the highway to the south.

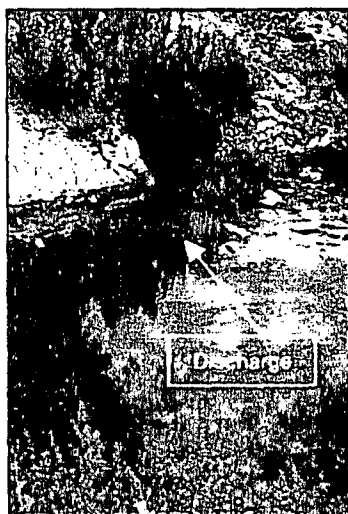
Photo #1 - Discharge from Establo las Delicias

Establo Las Delicias is a dairy that appeared to have at least 500 dairy cattle present. Milking is reportedly done by hand. About 5 gallons per minute (gpm) of turbid brown wastewater was emanating from the facility to an adjacent drain, which is part of the Mexicali Drain system. The discharge is apparently comprised

of washdown from the pens and the milking area. CNA has reportedly taken enforcement action against the discharger, which is now awaiting direction from a Mexican federal court.

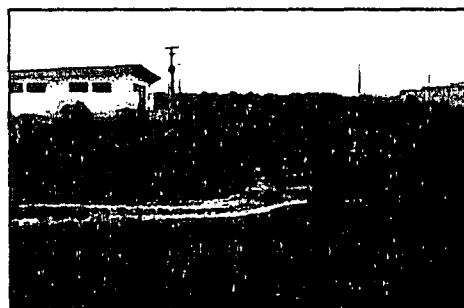
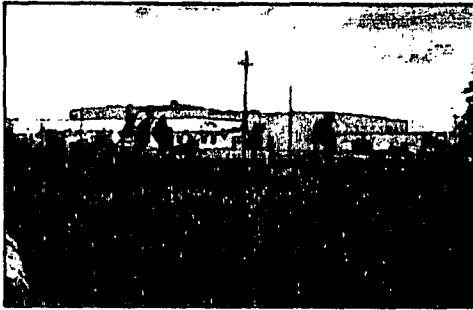
Photo #6 - Discharge from Serv. Textiles de B.C.

This facility is an industrial laundry located in an obscure area far removed from the city of Mexicali. Visual access to the plant and its discharge was via permission from the Cerro Prieto geothermal operation (CFE - Federal Electricity Commission). The plant is completely independent of the geothermal operation, but is located adjacent to it. The facility reportedly accepts dirty linen primarily from hospitals in the United States, but also from an array of other sources. On the grounds of the facility several truck trailers were noted with "Hospital Textile Systems, Inc." imprinted on them. Many sealed containers, presumably containing the dirty laundry, were visible. About 20 gpm of milky wastewater was being discharged from the facility to a receiving drain ultimately tributary to New River. The operation has reportedly been the target of enforcement by Mexican regulatory agencies. The facility has been ordered by Mexican authorities to post a bond to ensure that the wastewater is satisfactorily characterized and treated prior to discharge. The actions of the Mexican regulatory agencies have reportedly been challenged in court. This facility has reportedly been in operation for at least five years.

The discharge from Services Textiles de B.C. S.A. is considered to be the most serious finding from these initial observations. Because of the connections with hospitals in the United States, it is recommended that U.S. EPA investigate why laundry from the United States is being taken to a relatively remote location in Mexico.

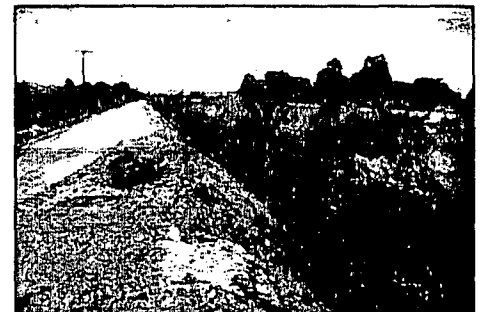
Photo #12 - Bachoco Discharge

This extensive hog and chicken farm has space for many thousands of chicken/hogs. About 3 gpm of overflow wastewater was being discharged into a receiving drain that caused the slow flowing drain to assume a turbid purple/red appearance. Reportedly, no meat processing occurs here so the source of the discharge must solely be washdown from the animal enclosures. However, the color of the wastewater certainly suggested slaughterhouse waste.

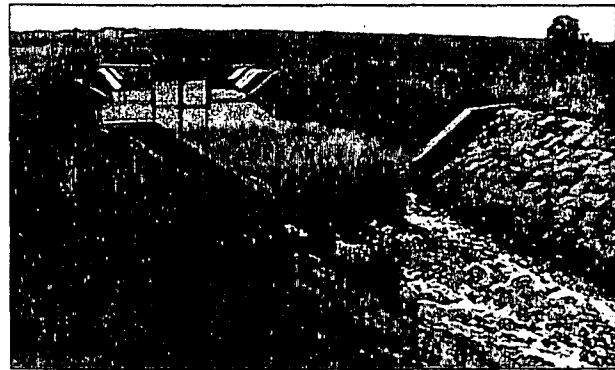
*Figure 6: Mexicali I Outfall*

The three primary lagoons at the Mexicali I Wastewater Treatment Facility ranged from gray to black in color and had 2, to 5 feet of freeboard. Of the facultative lagoons connected in series on the north side (lagoons F1 through F4), two lagoons (F3 and F4), were not in operation. Lagoons F3 and F4 were almost completely drained. The water in lagoons F1 through F4 was gray in color. Lagoon F2 was being divided into two cells to increase retention time, as shown in Figure 5. The six facultative lagoons connected in series on the south side (lagoons F5 through F10) were all in operation, and ranged from milky whitish-green to pale green in color. The final effluent from the treatment plant was pale-green in color, as shown in Figure 6.
