# Geologic Setting of the Sacramento-San Joaquin Delta

J. David Rogers, Ph.D., P.E., P.G., C.E.G., C.HG.

Berkeley NSF RESIN Project Meeting

January 26, 2011

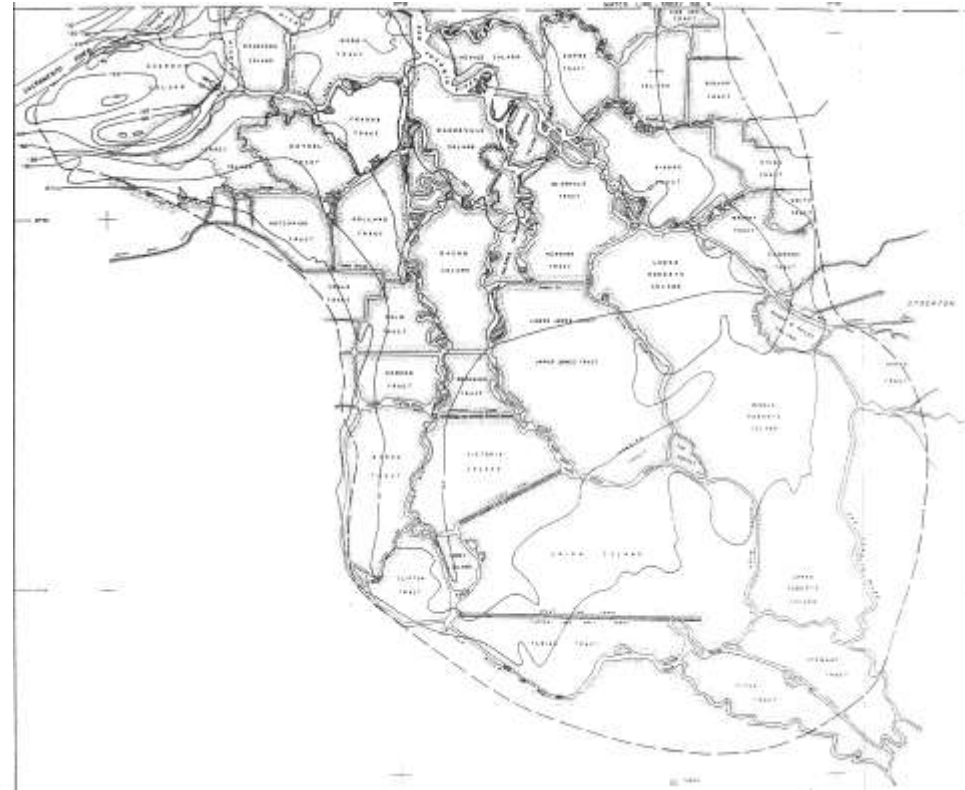
# Isopleths of peat thickness

By the early 1960s the Corps of Engineers had begun tabulating data on the peaty soils, noting their variation in thickness and mineral constituency, because they exerted such profound influence on long-term performance

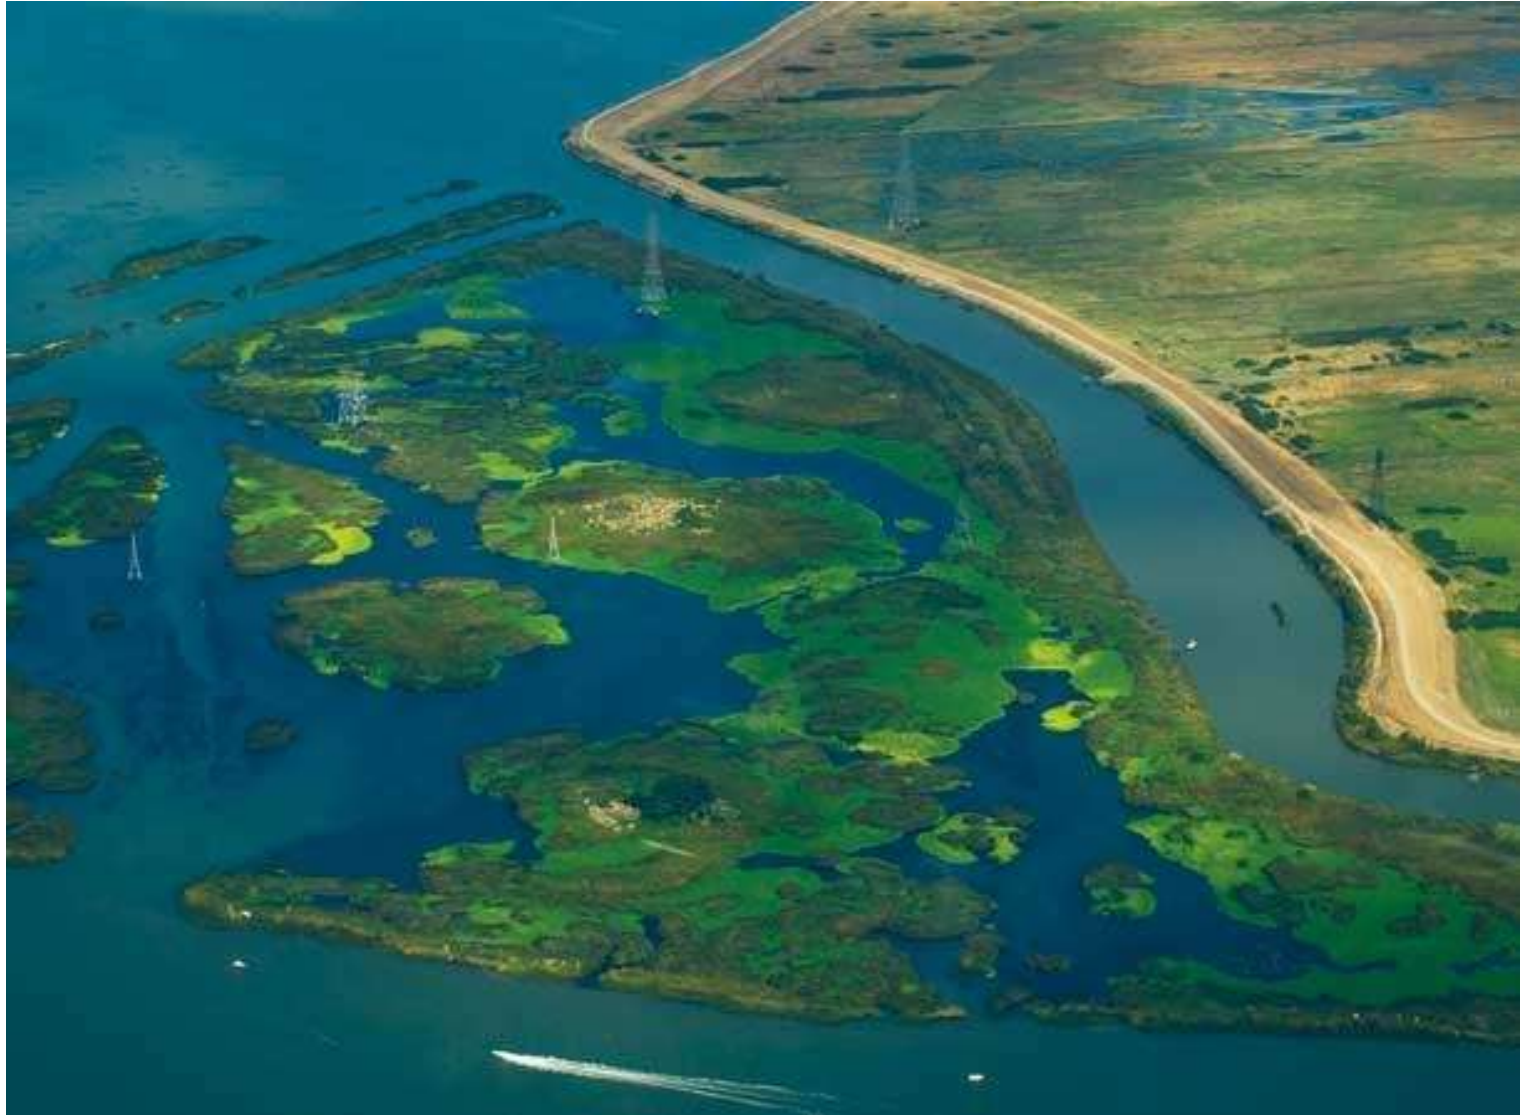
# Some materials settle more than others

The only constant in the delta is the inconsistency of its foundation conditions – you cannot use rulers anywhere in this environment

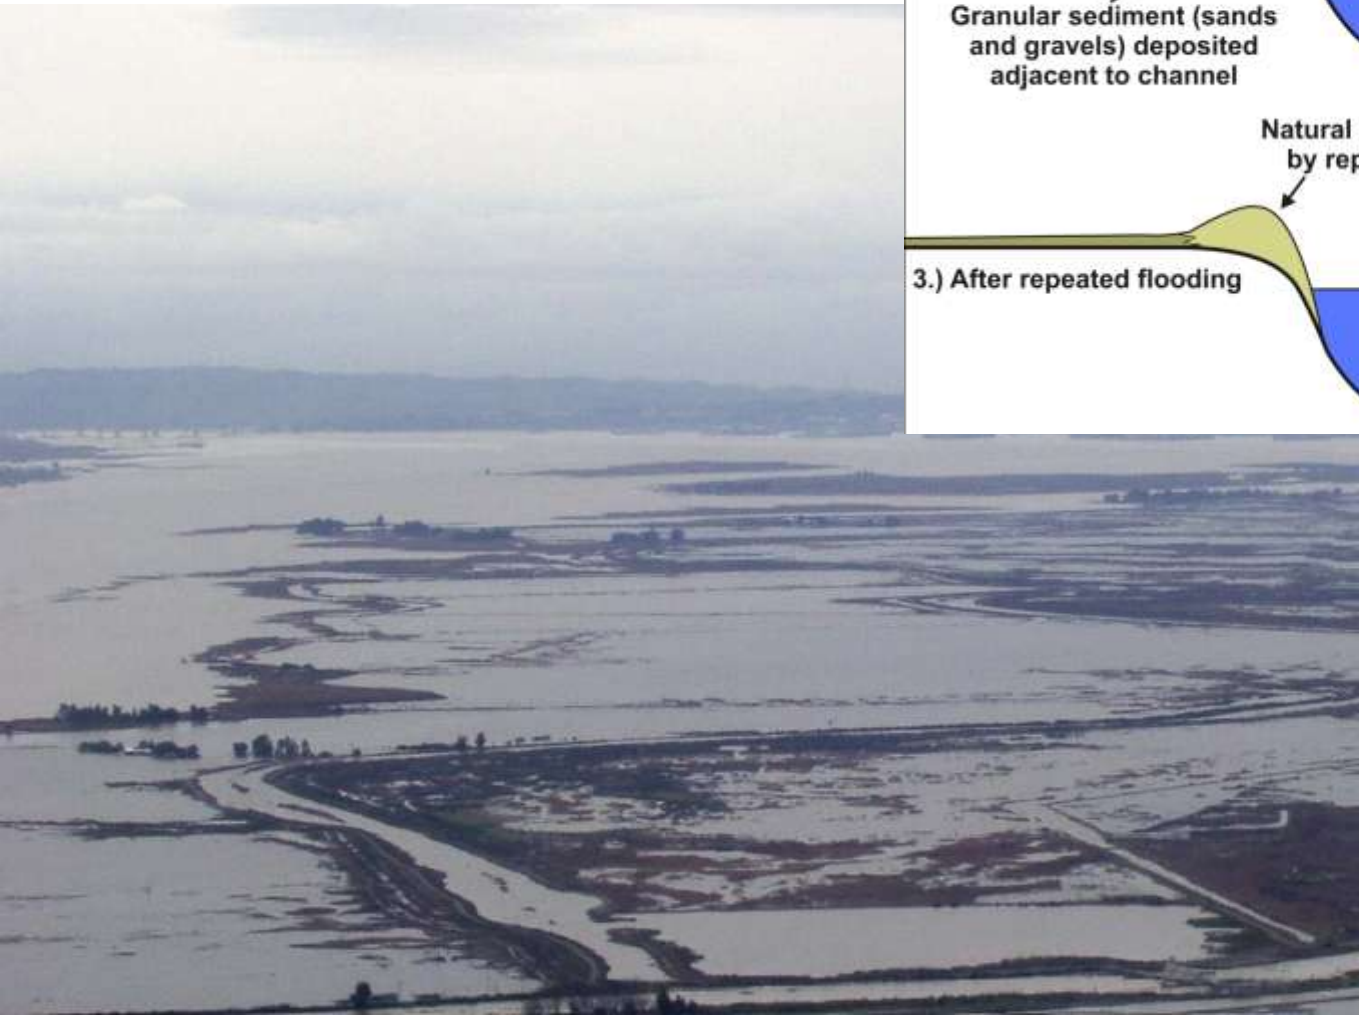
# Overbank silts and natural levees

90% of all sediment deposited on the continents is overbank silts

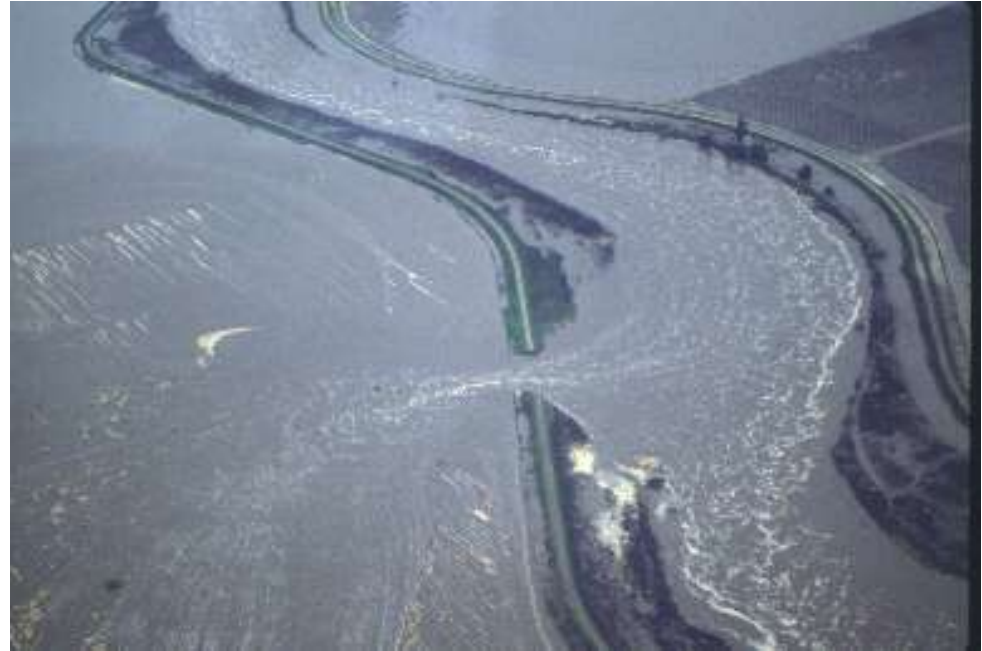
# Sediments are orthotropic

Sediments are laid down with a preferential “depositional grain,” which causes them to have differing physical properties in three planes mutually perpendicular to one another

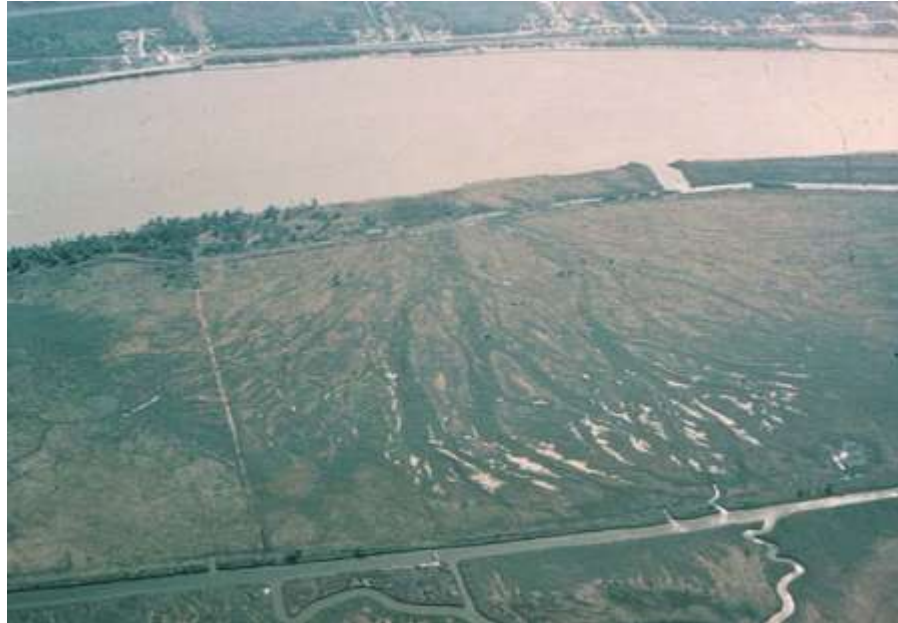
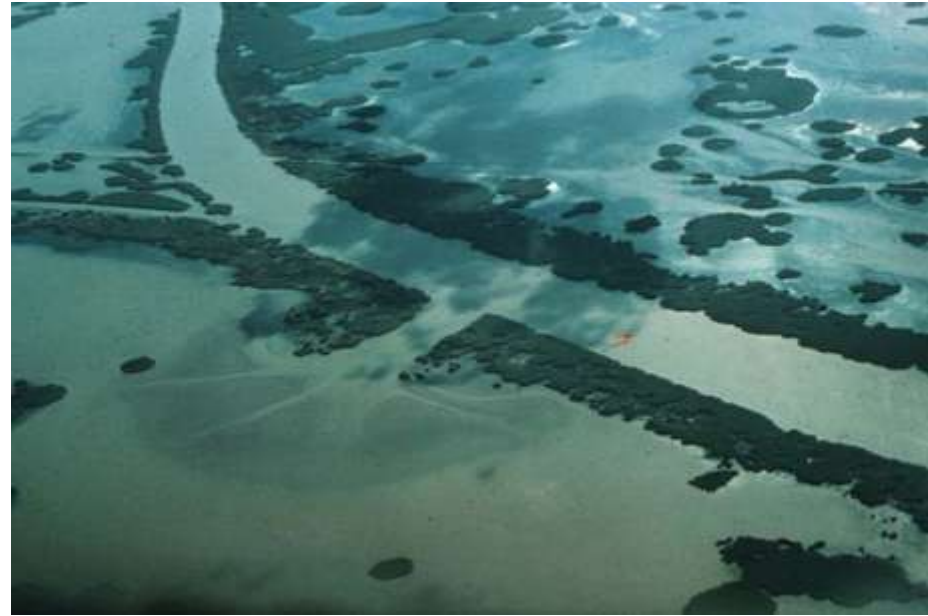
# Crevasse Splays common

**Meandering low-gradient channels tend to breach their own natural bank levees at crevasse splays, often along an outboard turn of the channel. These become prime locations for future seepage problems and repeated bank failures because of the pervious sands that are deposited in the outbreak troughs, as seen above.**

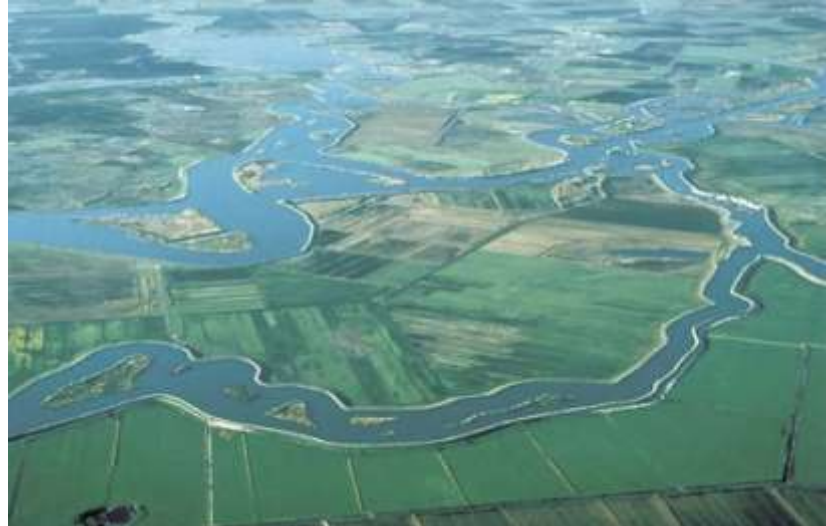
The delta's interconnected system of **man-made levees** are superposed on an **intricate network of abandoned channels**, filled with a variety of sediments.

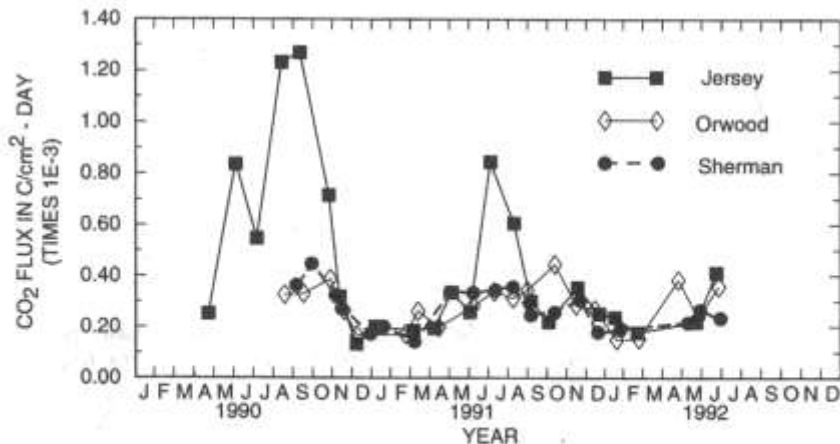
Figure 4. CO<sub>2</sub> flux measured on Jersey Island, Orwood tract, and Sherman Island, March 1990 to May 1992. The points represent the arithmetic average of measurements at five sites on each island or tract.

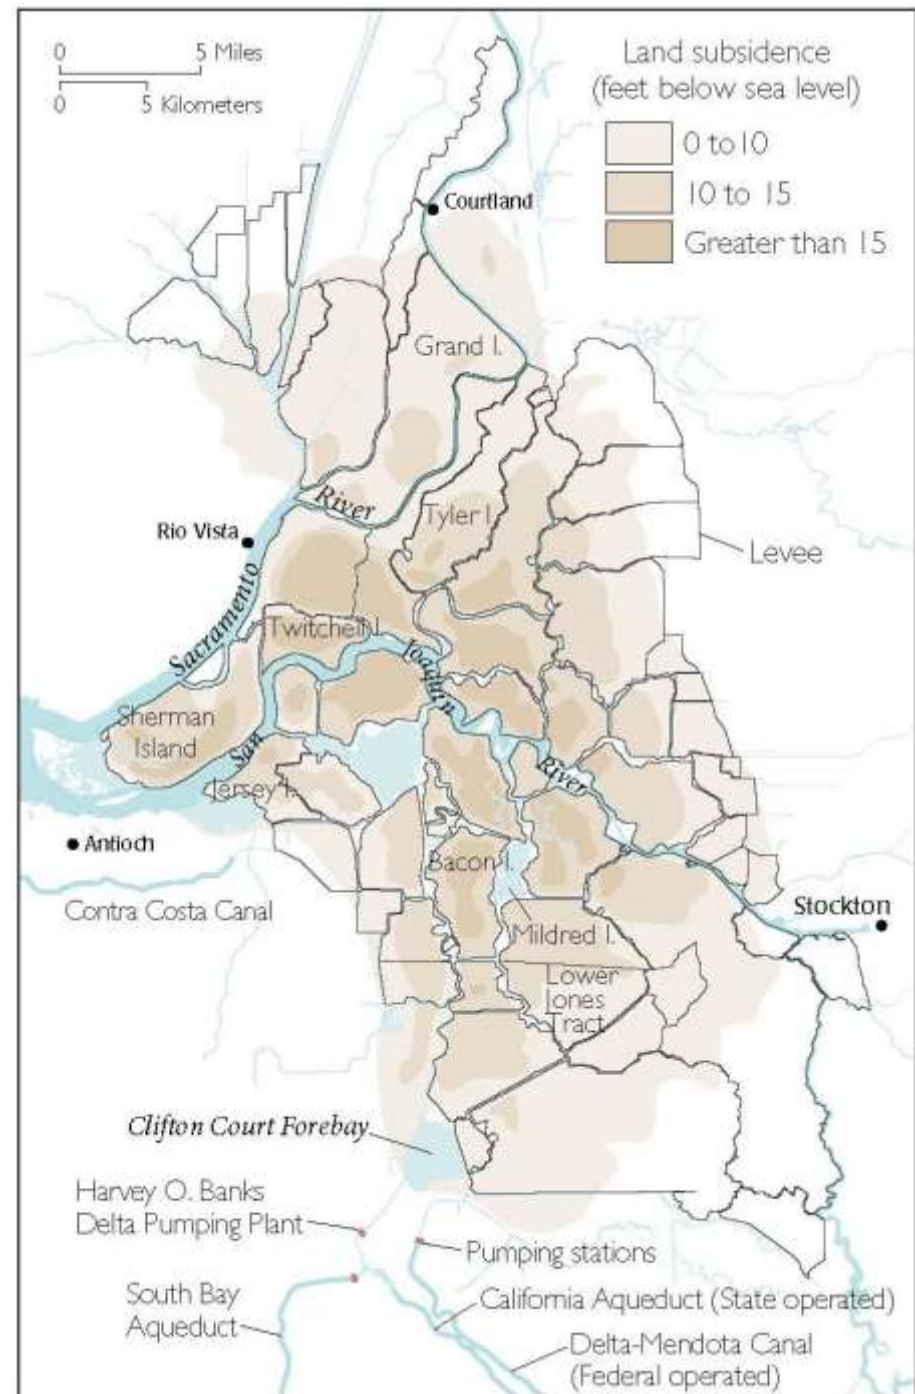
Ground settlement in the peaty soils is caused by biochemical oxidation; which is exacerbated by farming, wind erosion, fires, and subsidence due to compaction of underlying units (increased effective stress triggered by groundwater withdrawal)

Deep-measurement compaction recorders are needed to permit differentiation between ground settlement caused by surface oxidation and compaction of the peaty soils from deeper subsidence resulting from groundwater and/or gas withdrawal

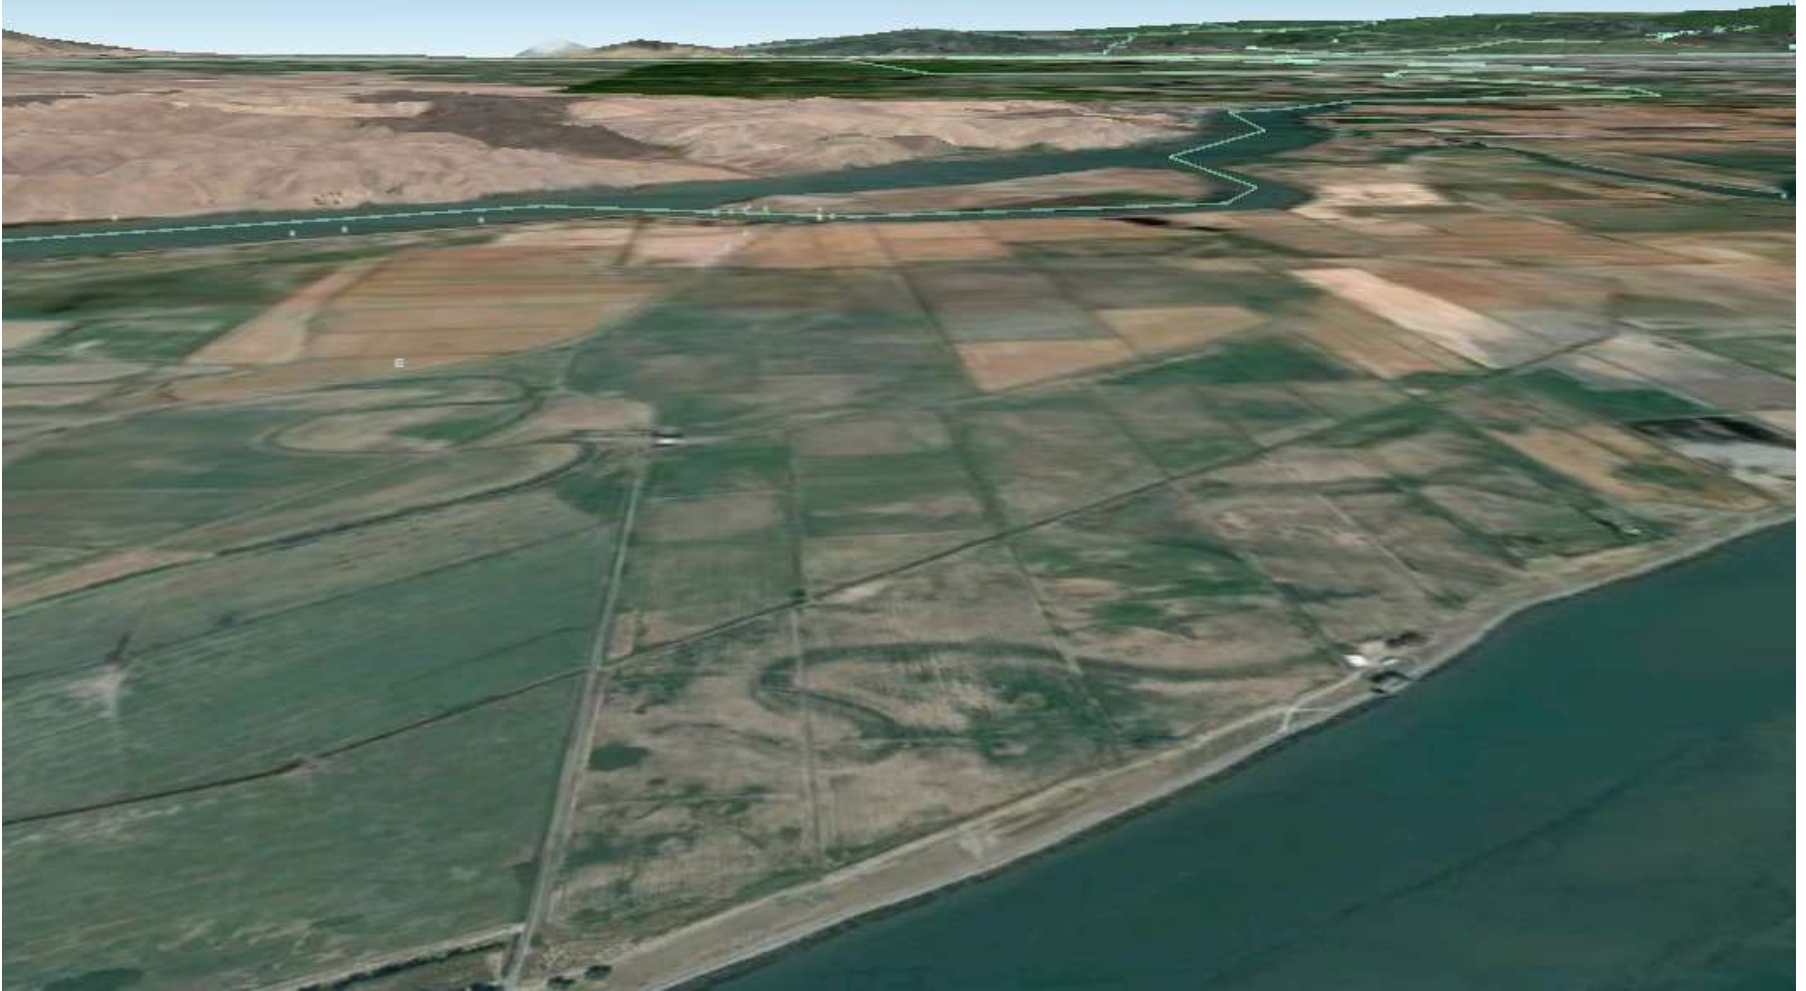
## The delta's evolving “inverse topography”

As the organic soils settle across the delta, the relict topography is being increasingly revealed, as the natural levees begin to “push” themselves up, revealing the positions of the most recent distributary channels.

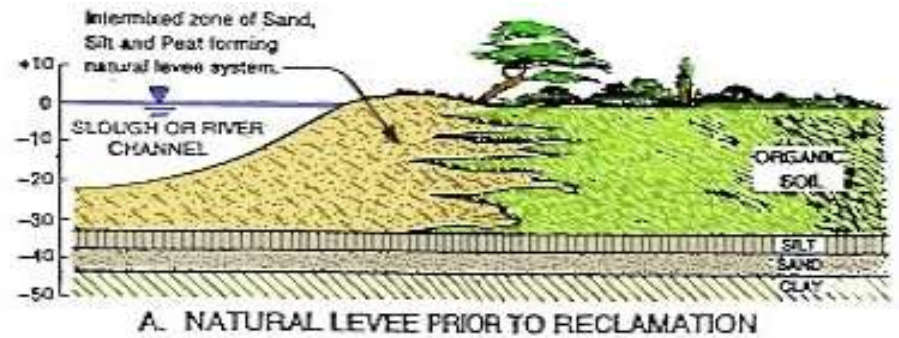
The dredged channel at left lies *outboard* of the natural channel, so the levee lies upon compressible peats rather than upon the natural levee bordering the river channel.

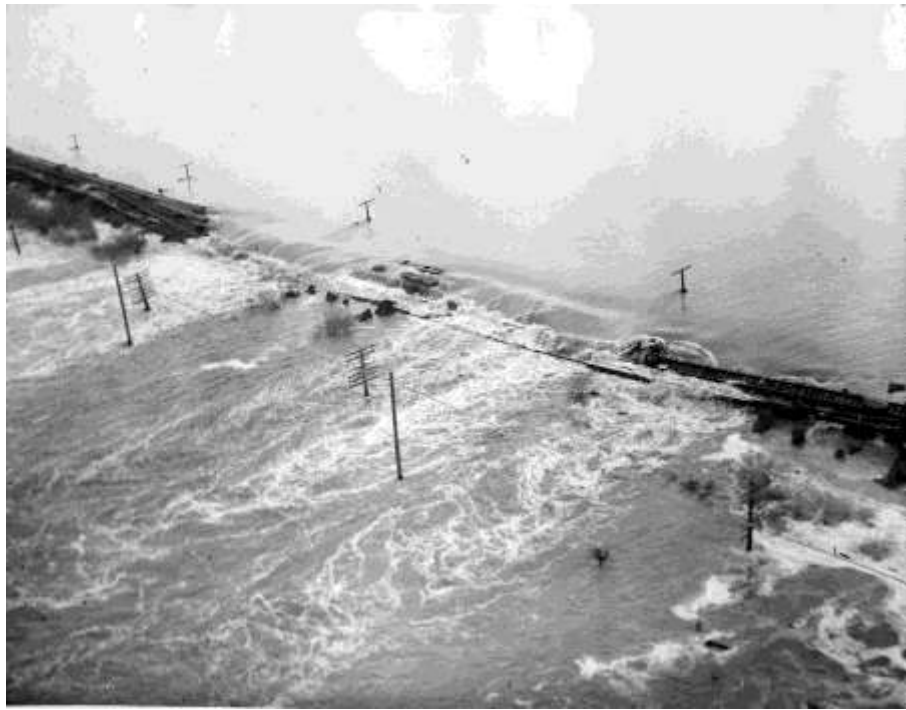
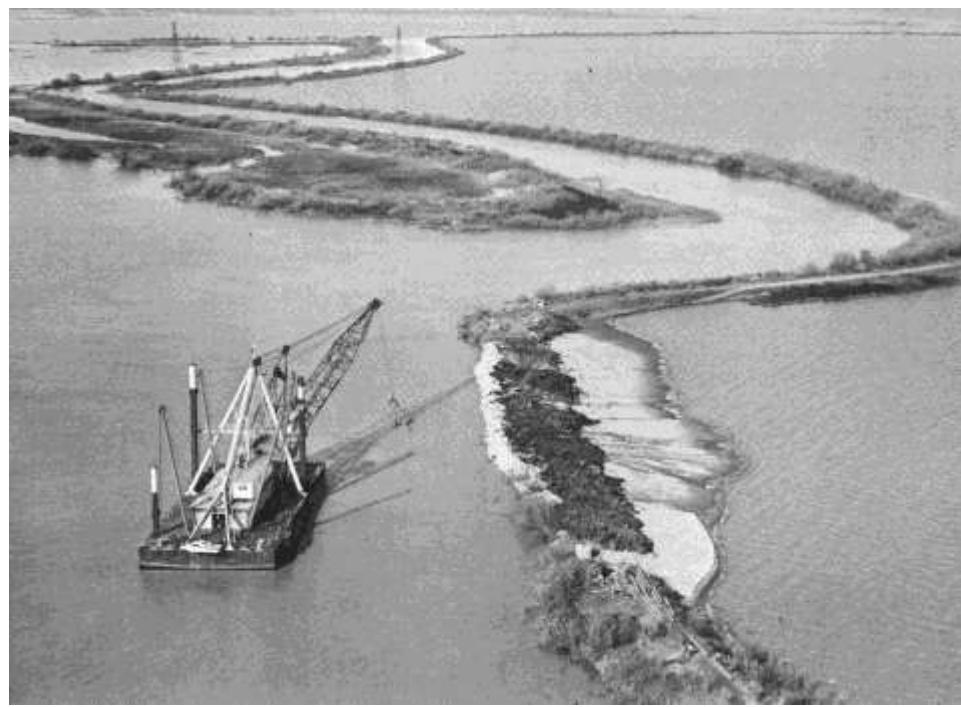
**Levee failures can be triggered by any number, or combination of factors. The most common is overtopping, followed by underseepage and piping. Aging effects and the variability of channel geometry, foundation materials, and penetrations through embankment materials combine to make reliable stability analyses difficult.**

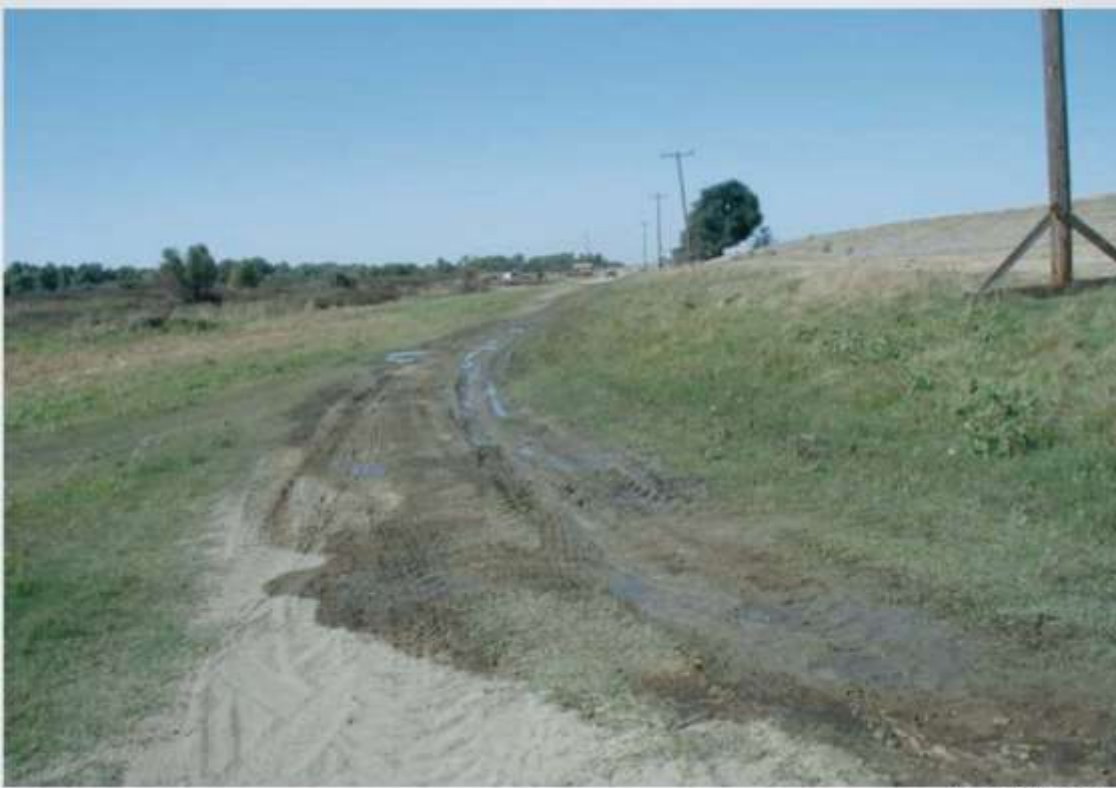
*Preferential seepage paths* are a given in a sinuous, low-gradient tidal marsh environment, but can also be induced by the **multiple generations** of fill placement (lower left); and **structural “penetrations,”** such as pipes, trenches, pole holes, roads, and animal burrows.

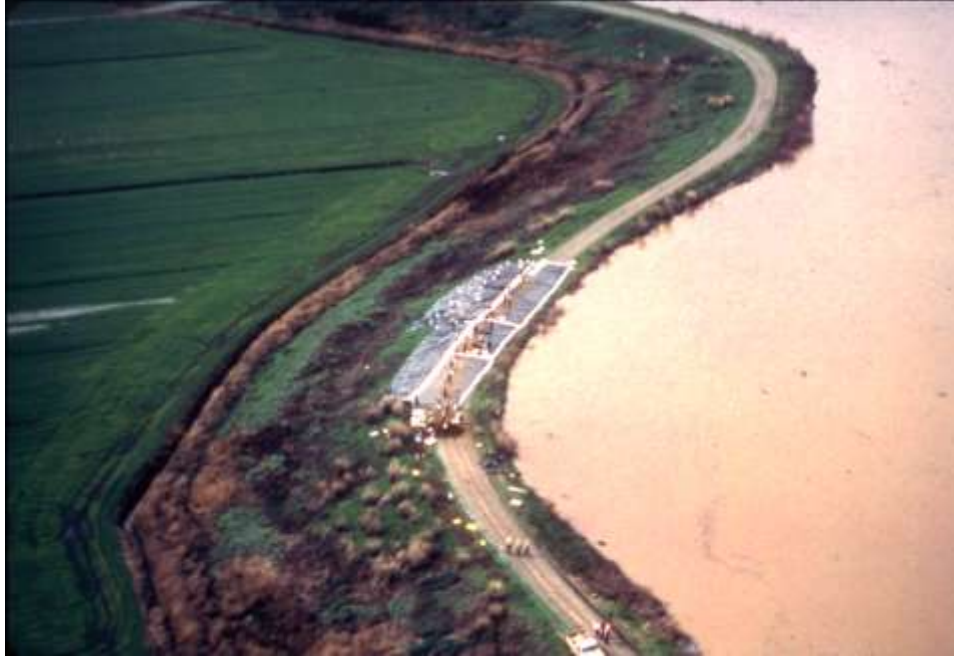
Constant-Slope Buttress

Levee stability degrades with increasing settlement of the protected islands, as levees become higher and erosion scours the water side of the embankment. Stability berms can be added to increase the levee cross section; and uplift relief wells can be installed on the land side.

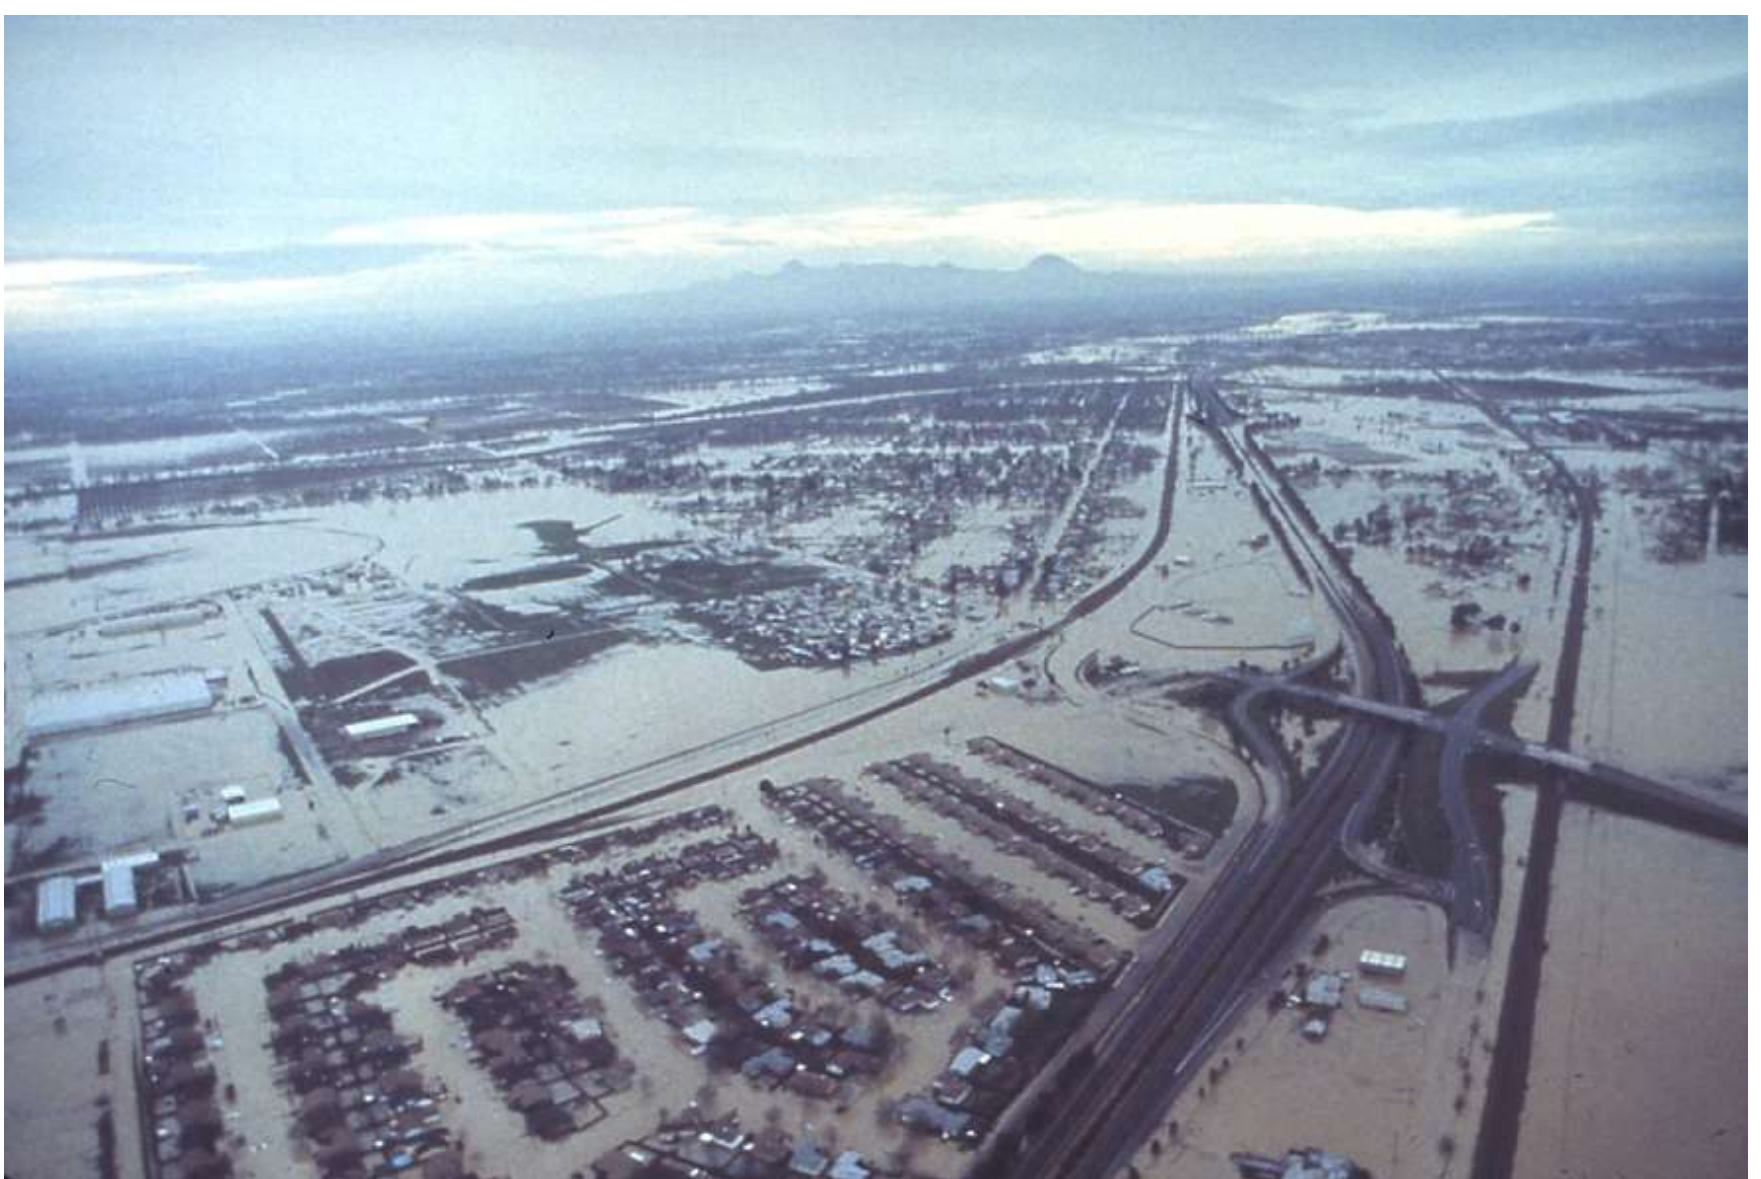
- The breach of the Linda Levee along the south side of the Yuba River near its mouth on the evening of February 20, 1986. The break was *only 170 feet wide*, even after flood waters had poured through the opening for five days.

- The Linda Levee suddenly broke around 6 PM on February 20, 1986, on the south side of the Yuba River about half a mile above its junction with the Feather River.

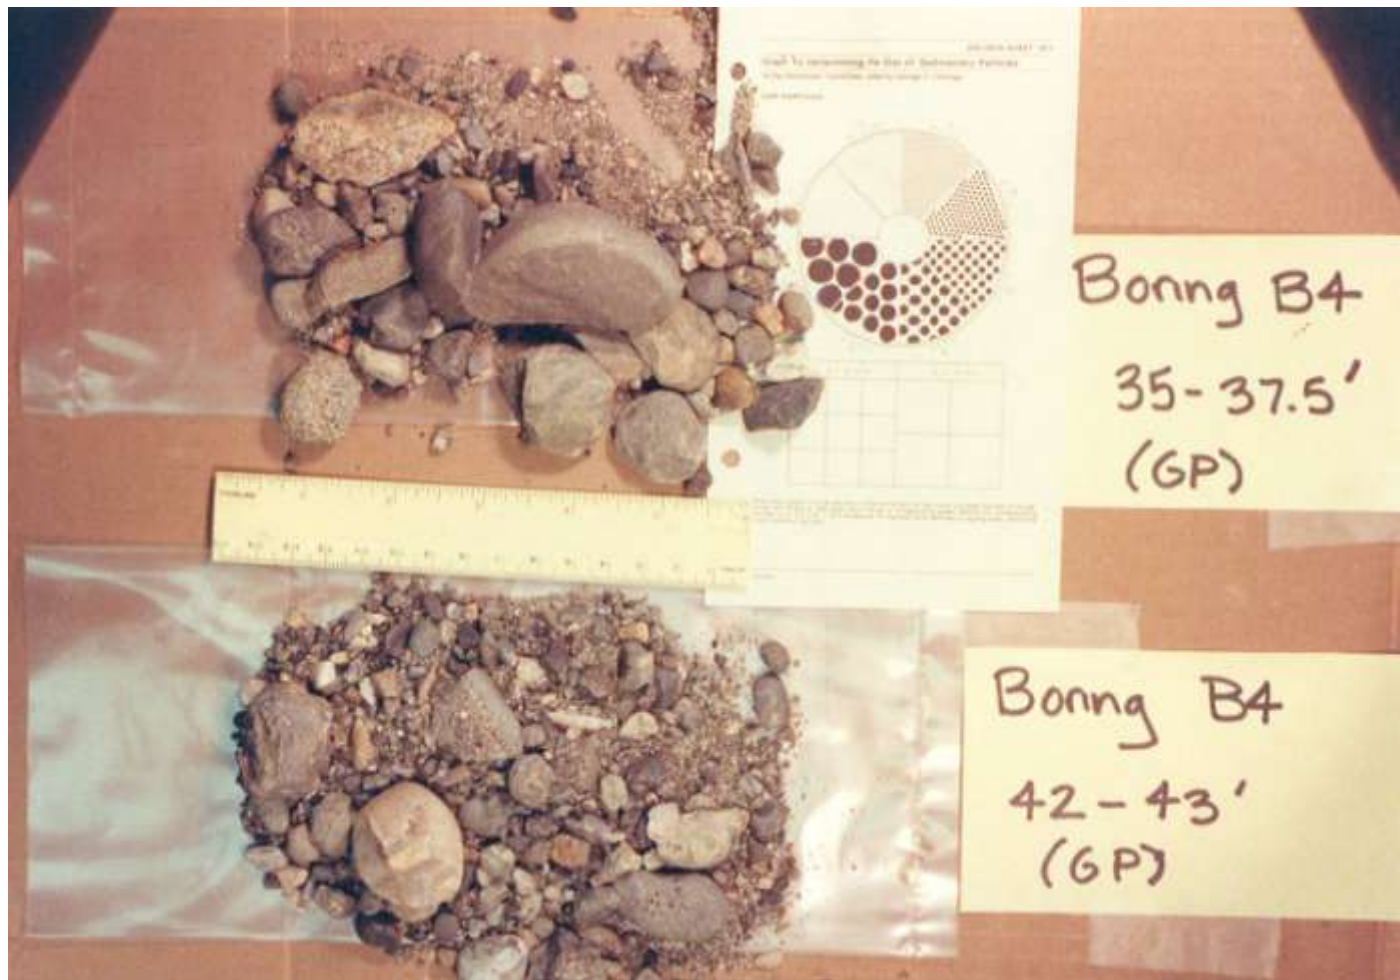
- Section A parallels the line of expected seepage and surface flow, from NE to SW. This was extended 1800 ft, to the Speckert Gravel Pit. Note slope of the alluvial materials between the pit and the levee.

- The coarse channel gravels had not been detected in any of the previous geotechnical investigations, not even those FOLLOWING the 1986 levee failure! Ouch!!

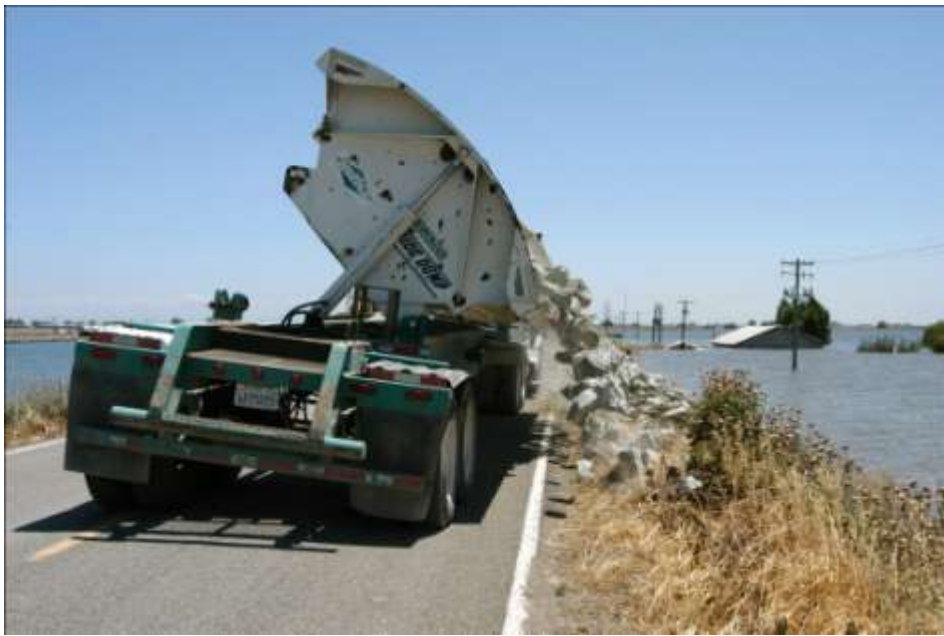
Most of the reclamation districts mitigate oversteepened slopes by trimming the levee crest and infilling the land side of the levee crown, as sketched here
