# Geologic Setting of the Sacramento-San Joaquin Delta

J. David Rogers, Ph.D., P.E., P.G., C.E.G., C.HG.

Berkeley NSF RESIN Project Meeting

January 26, 2011

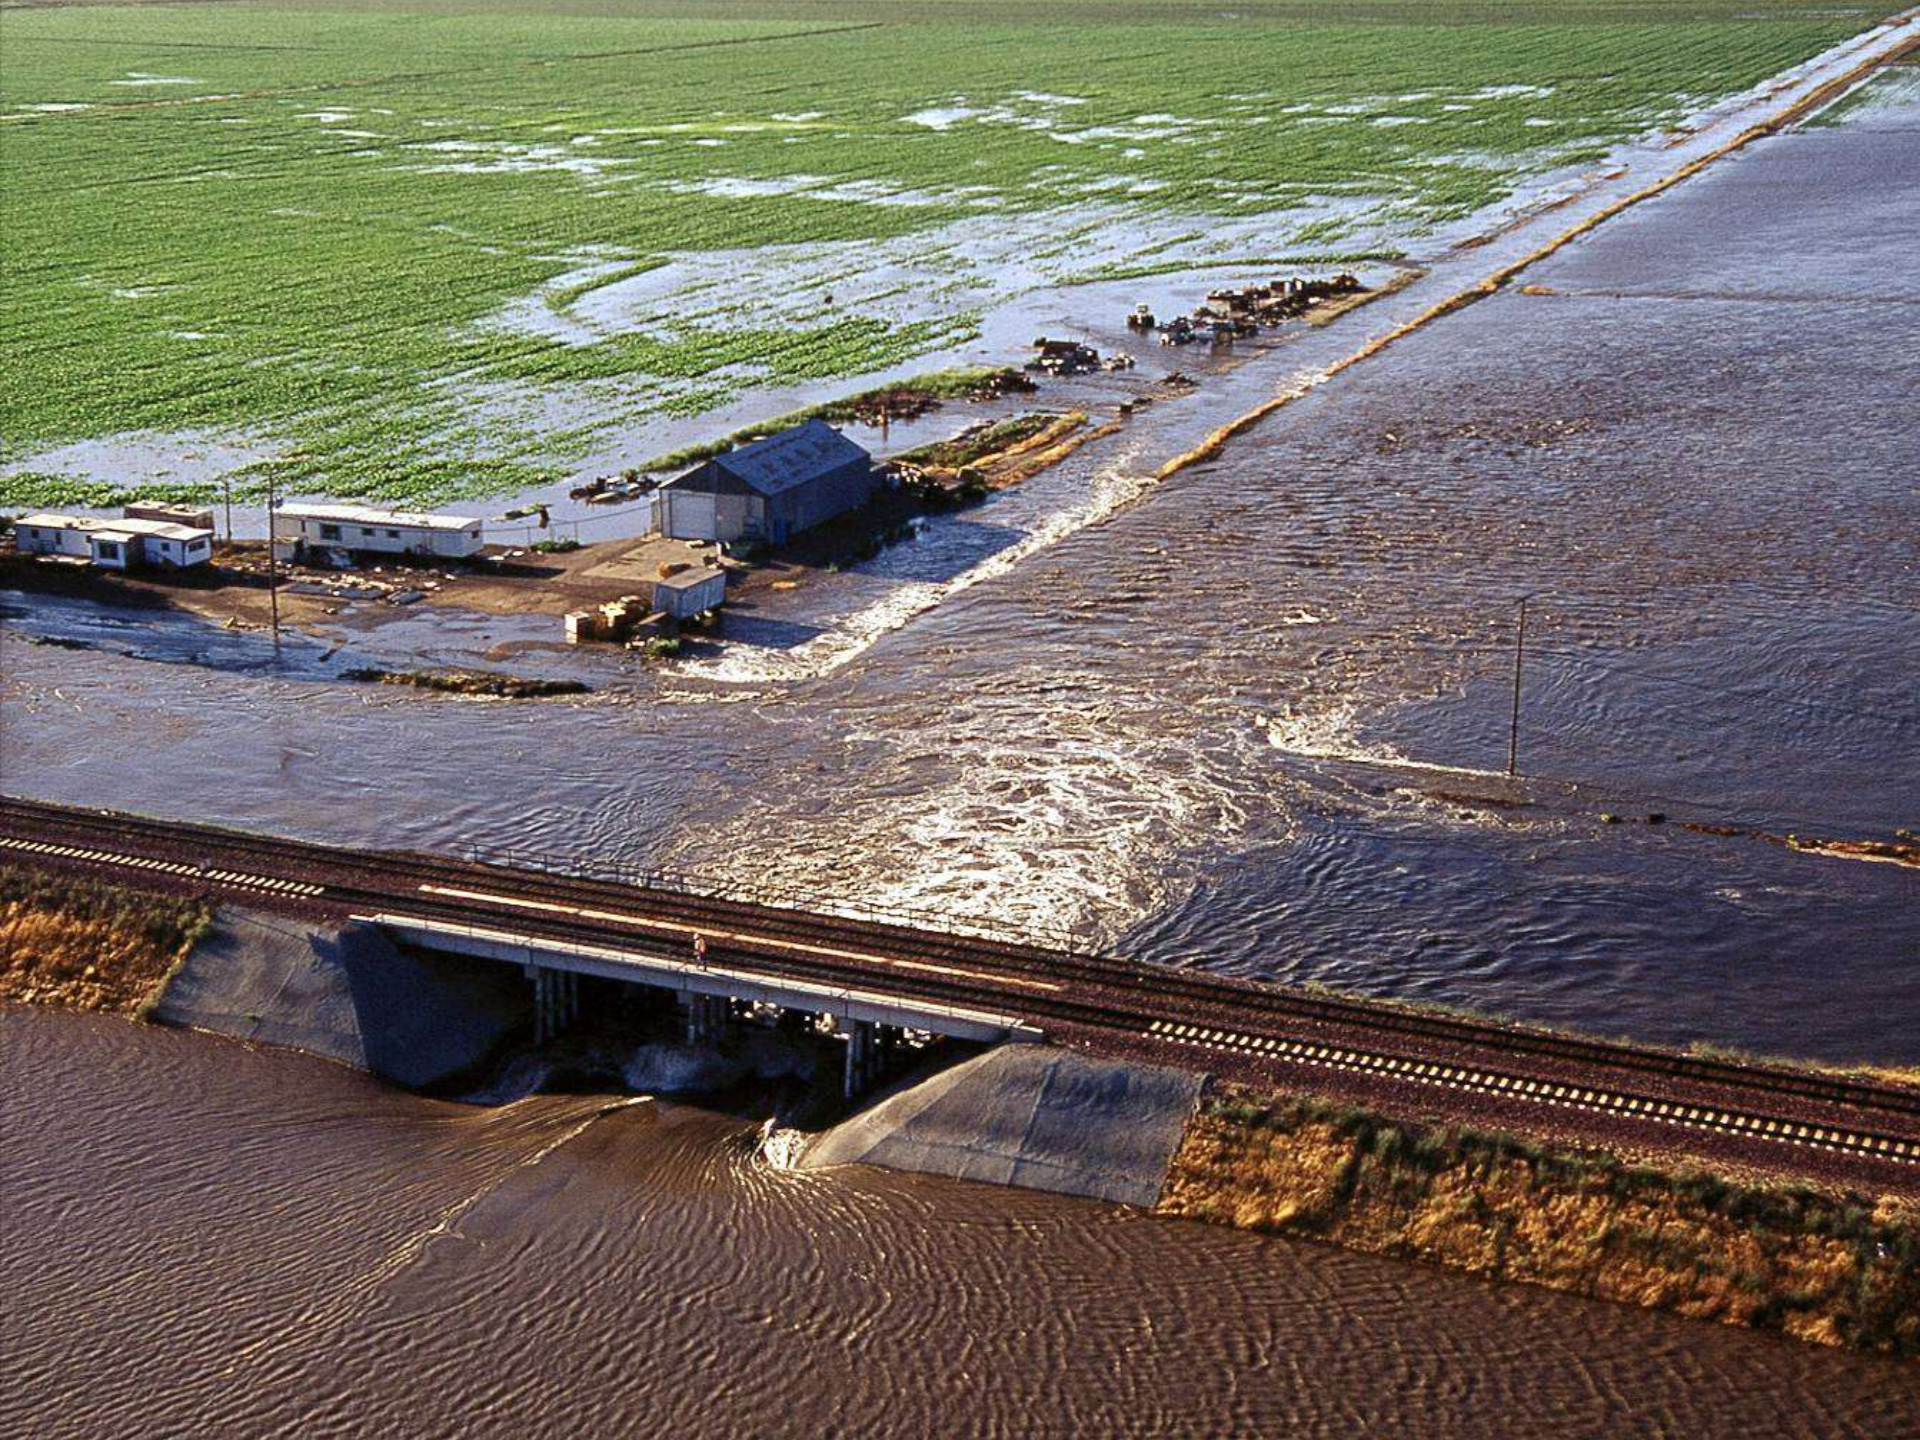
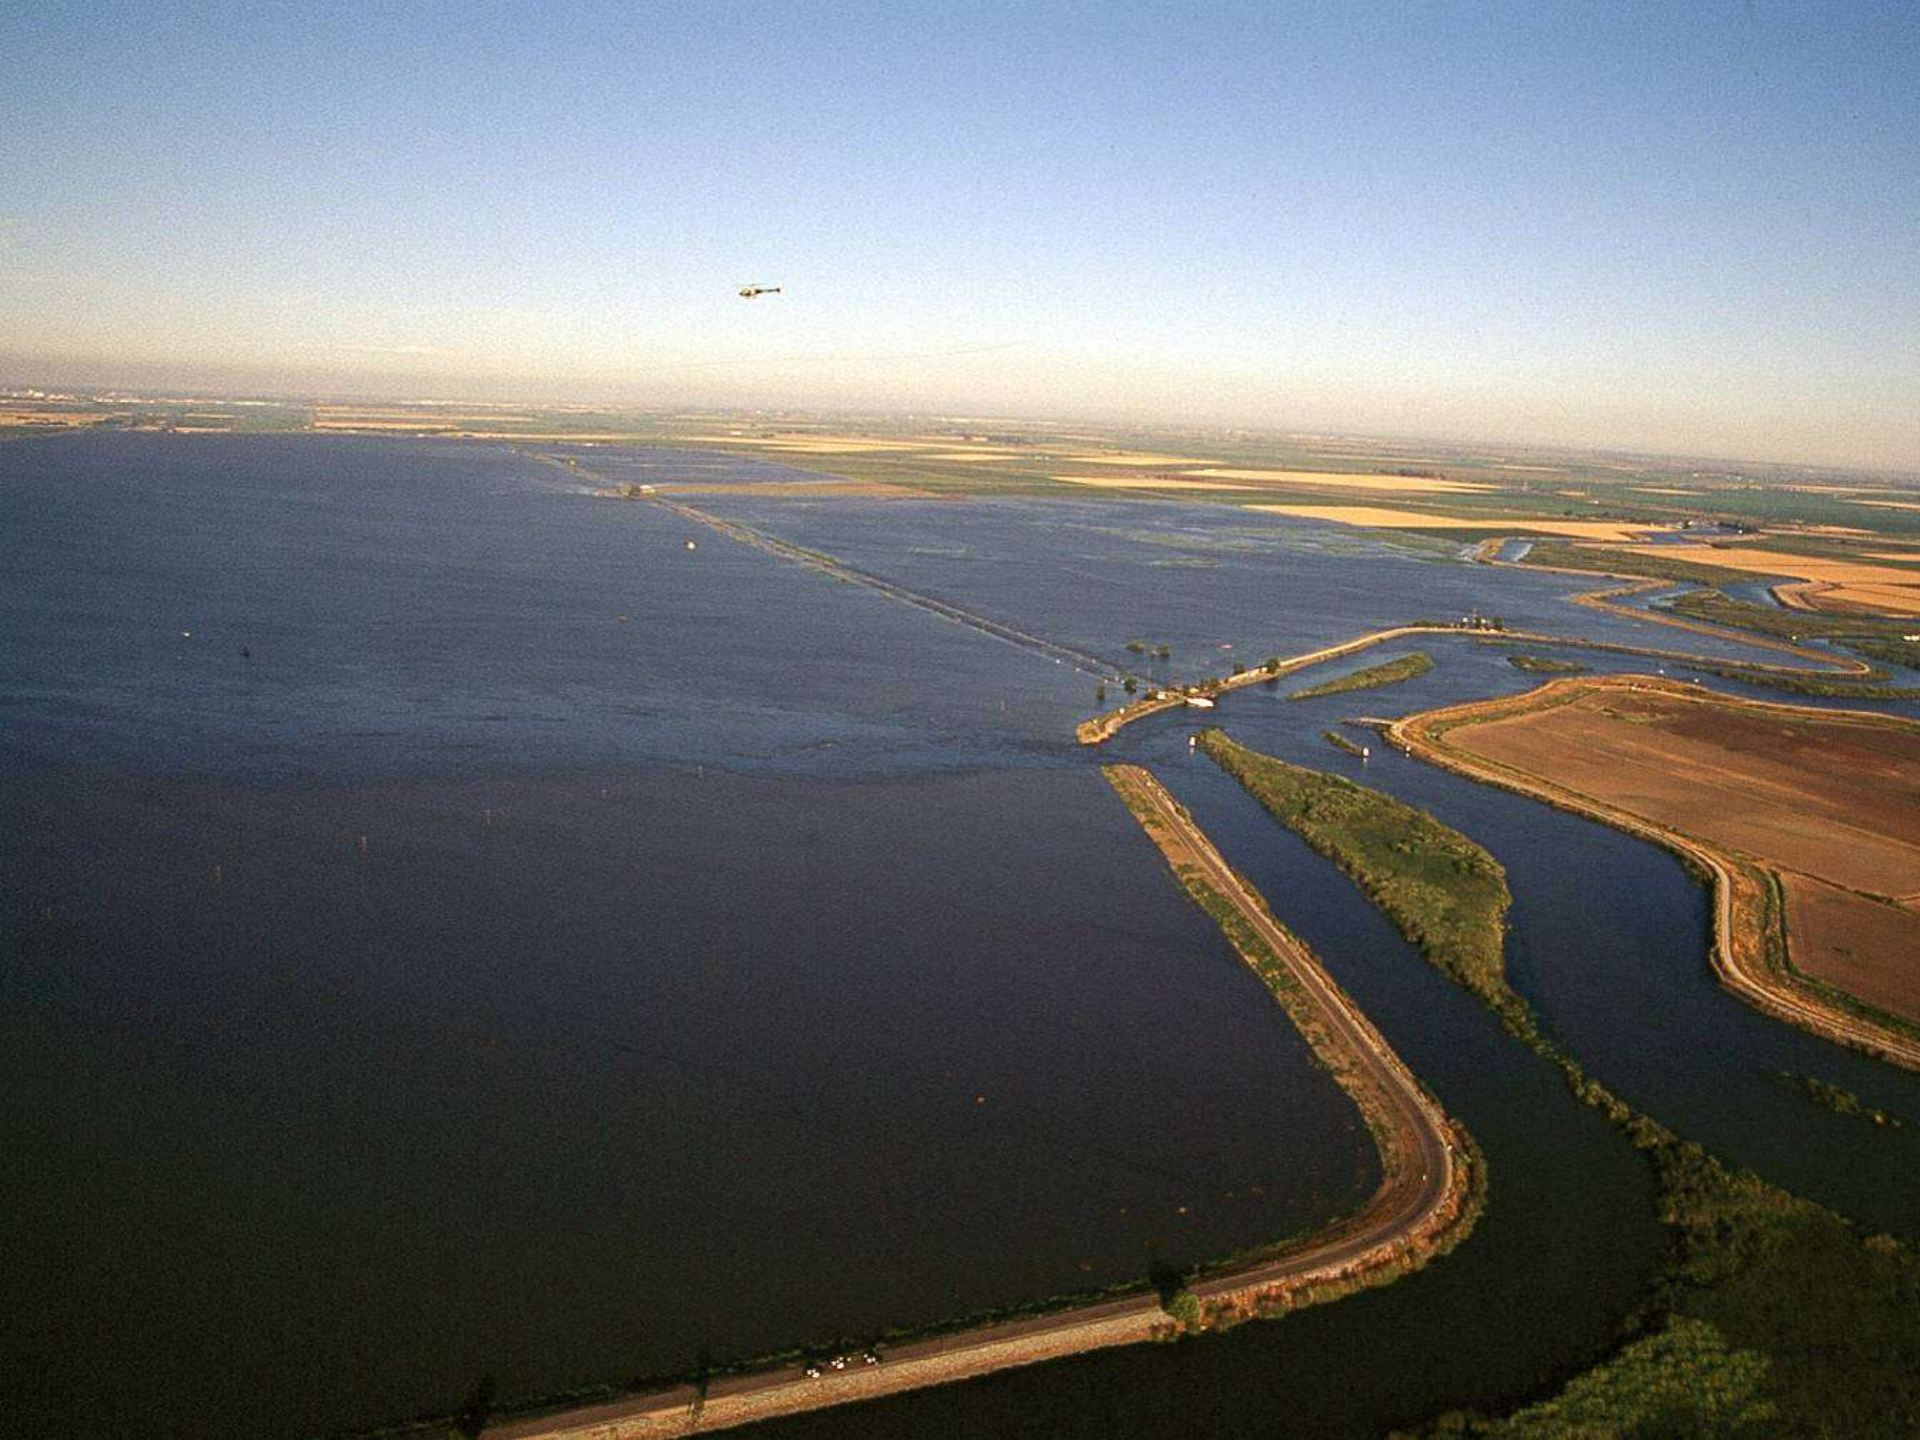
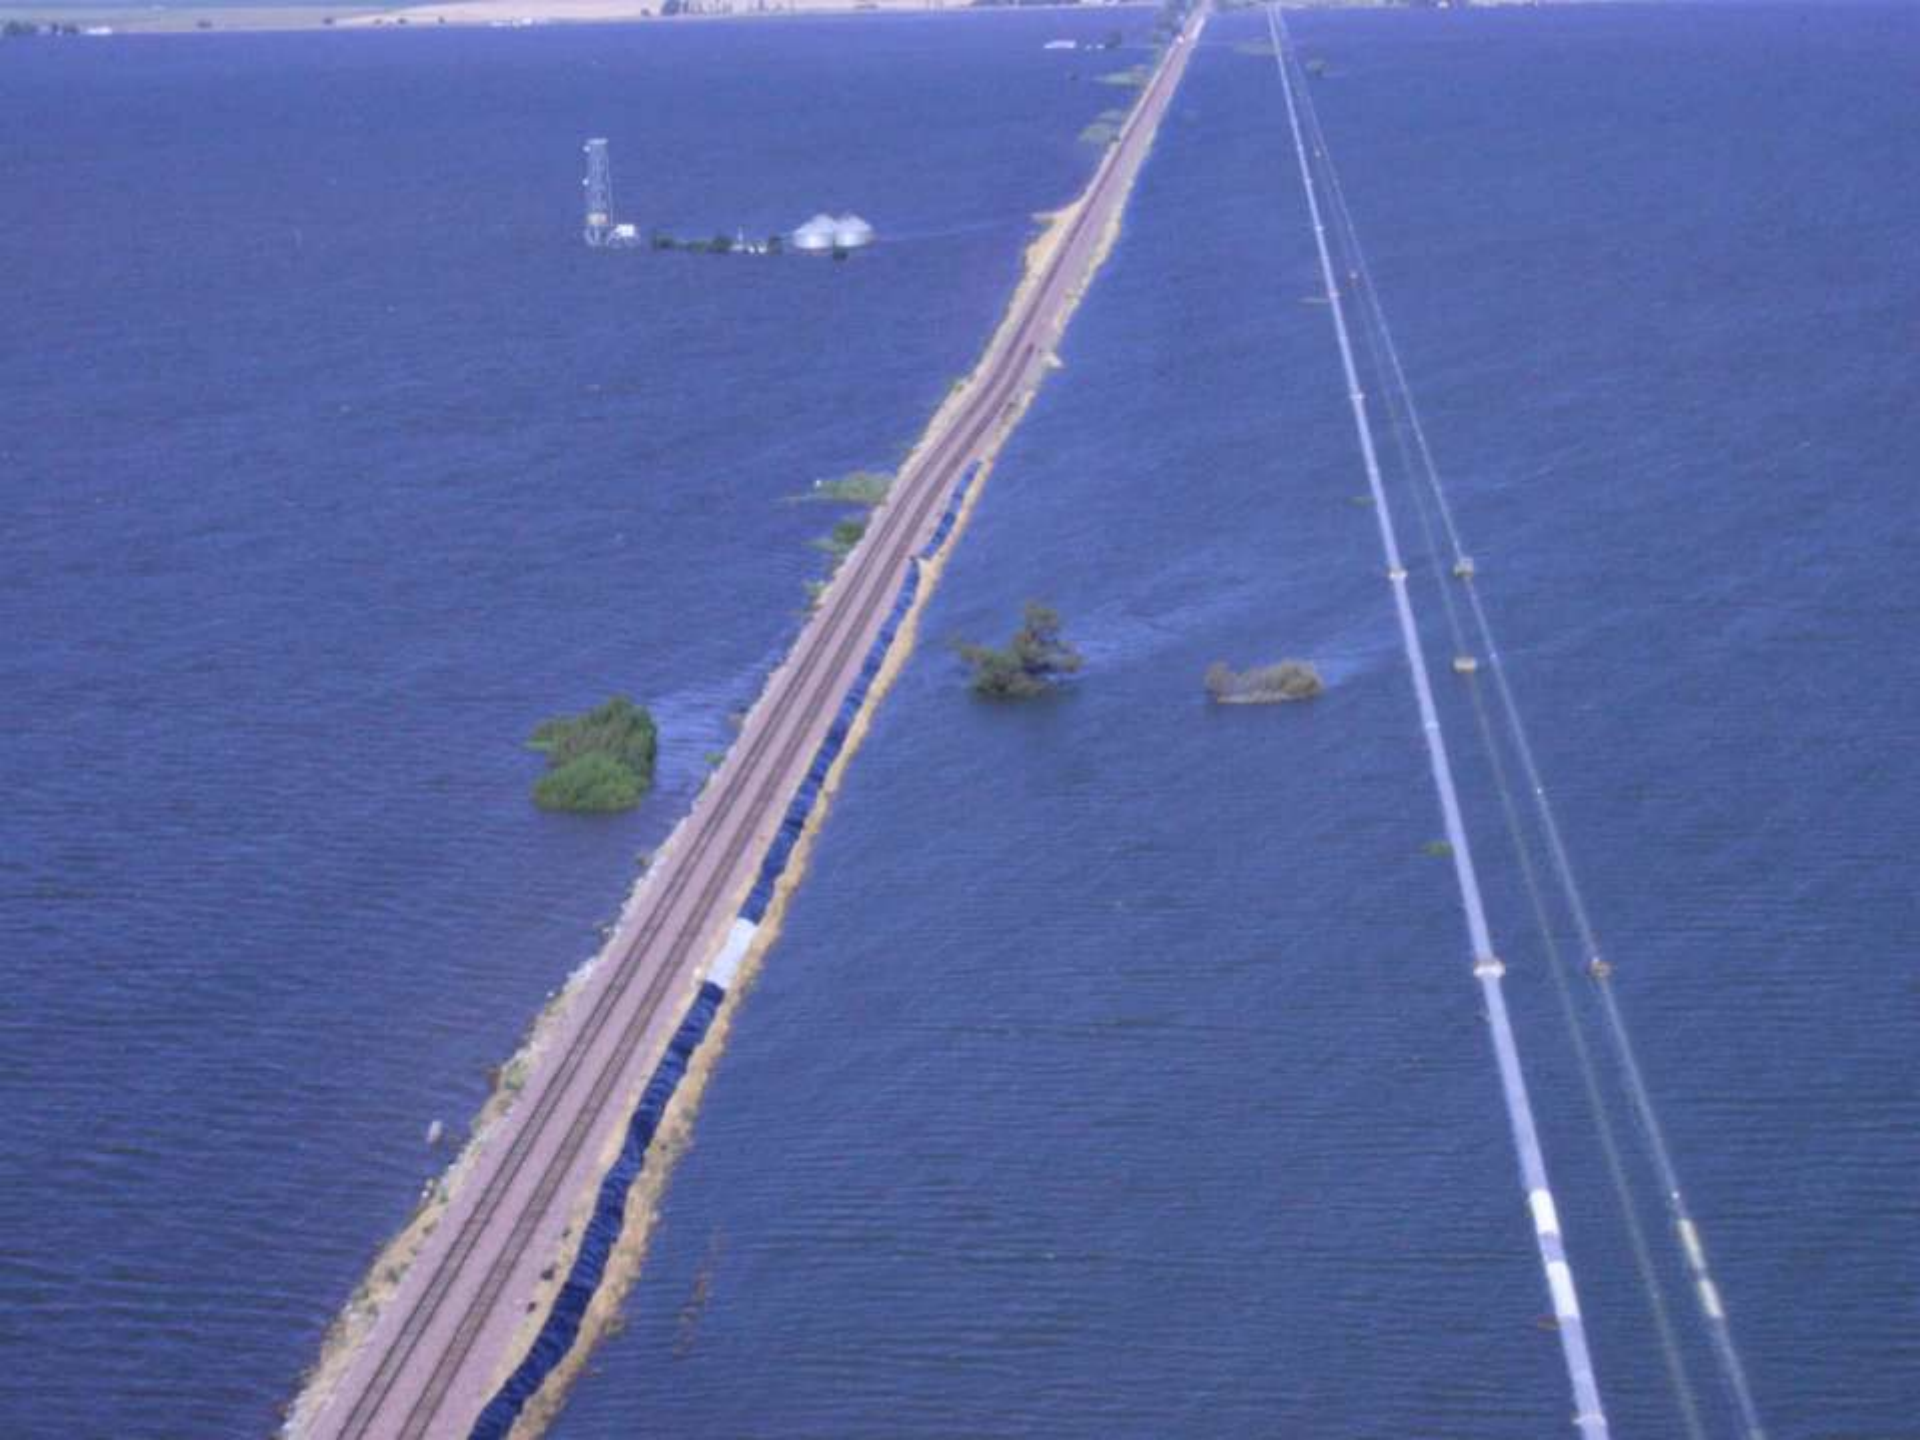
To: HARRY ASAP

NGVD29?

0' 20' 40' 60' 80' 100'  
SCALE: 1"=20'

Survey Date: 6 June, 2004

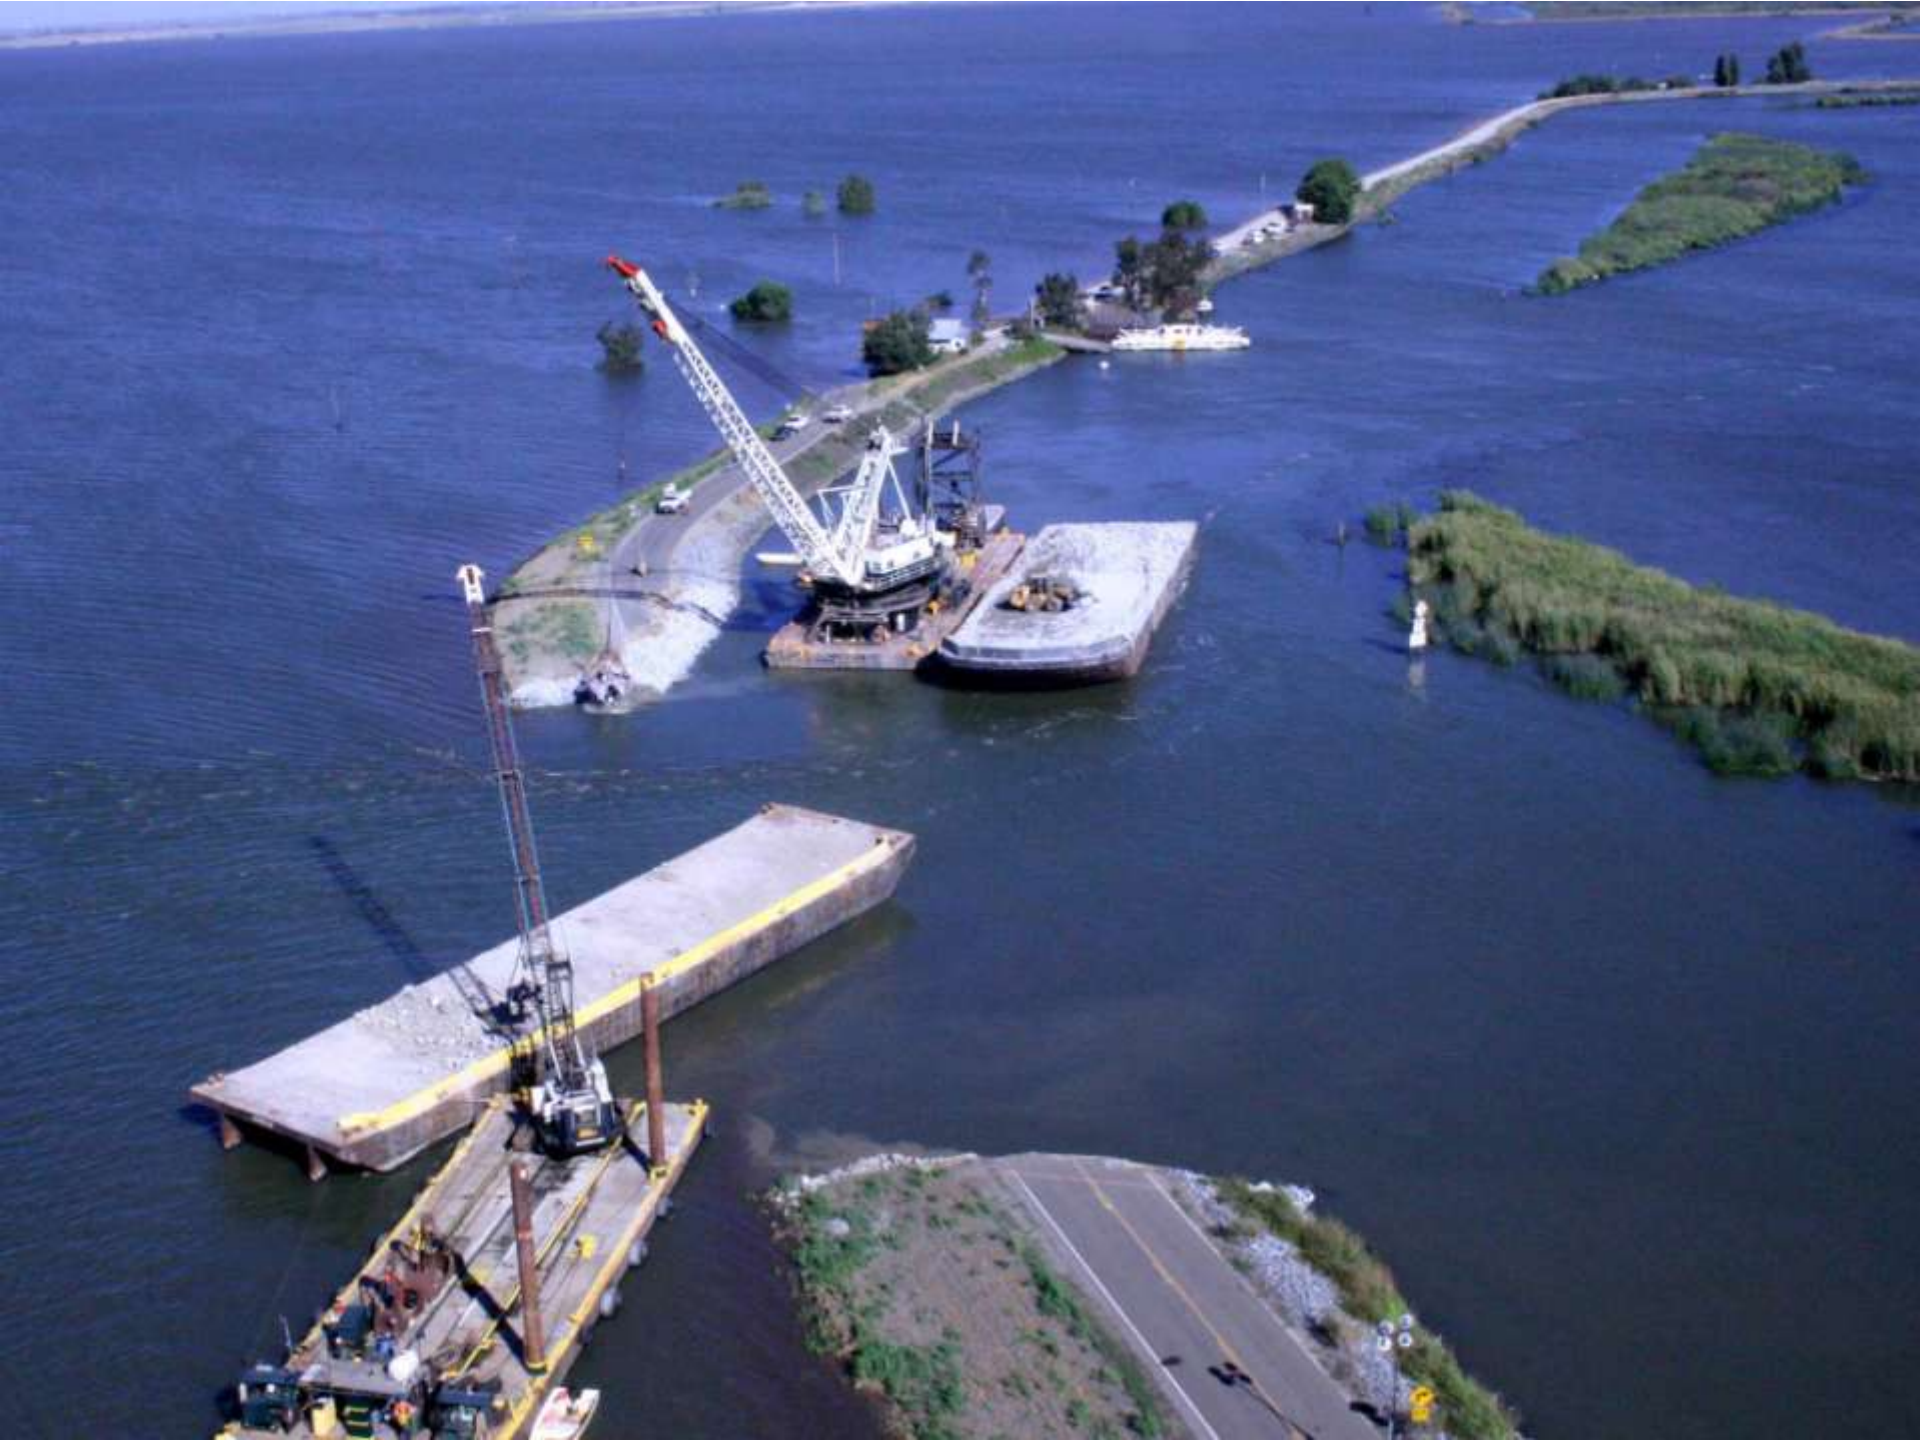
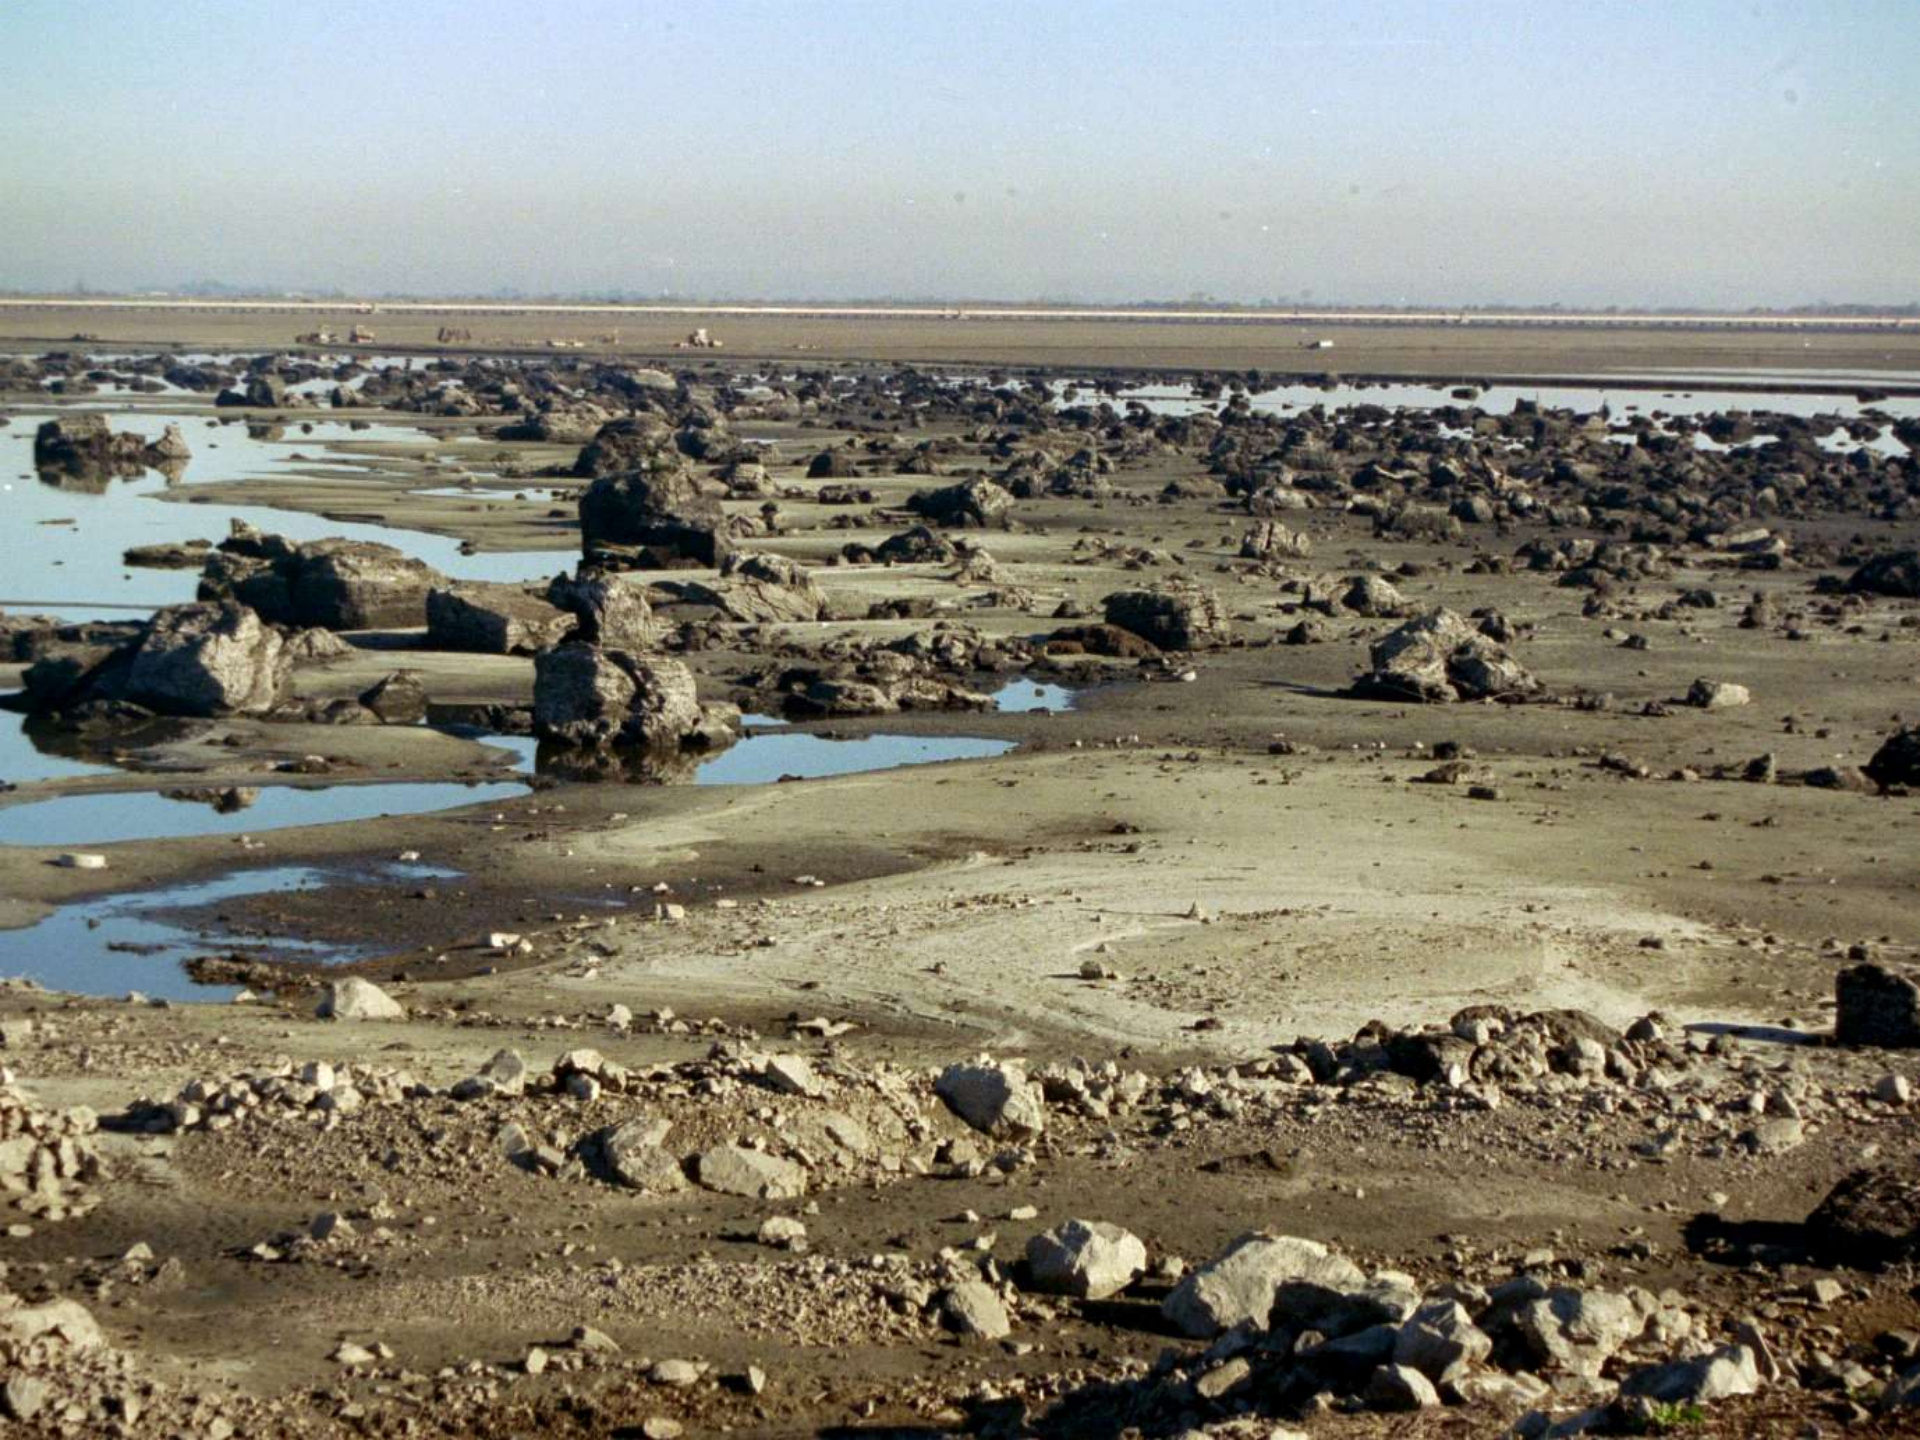
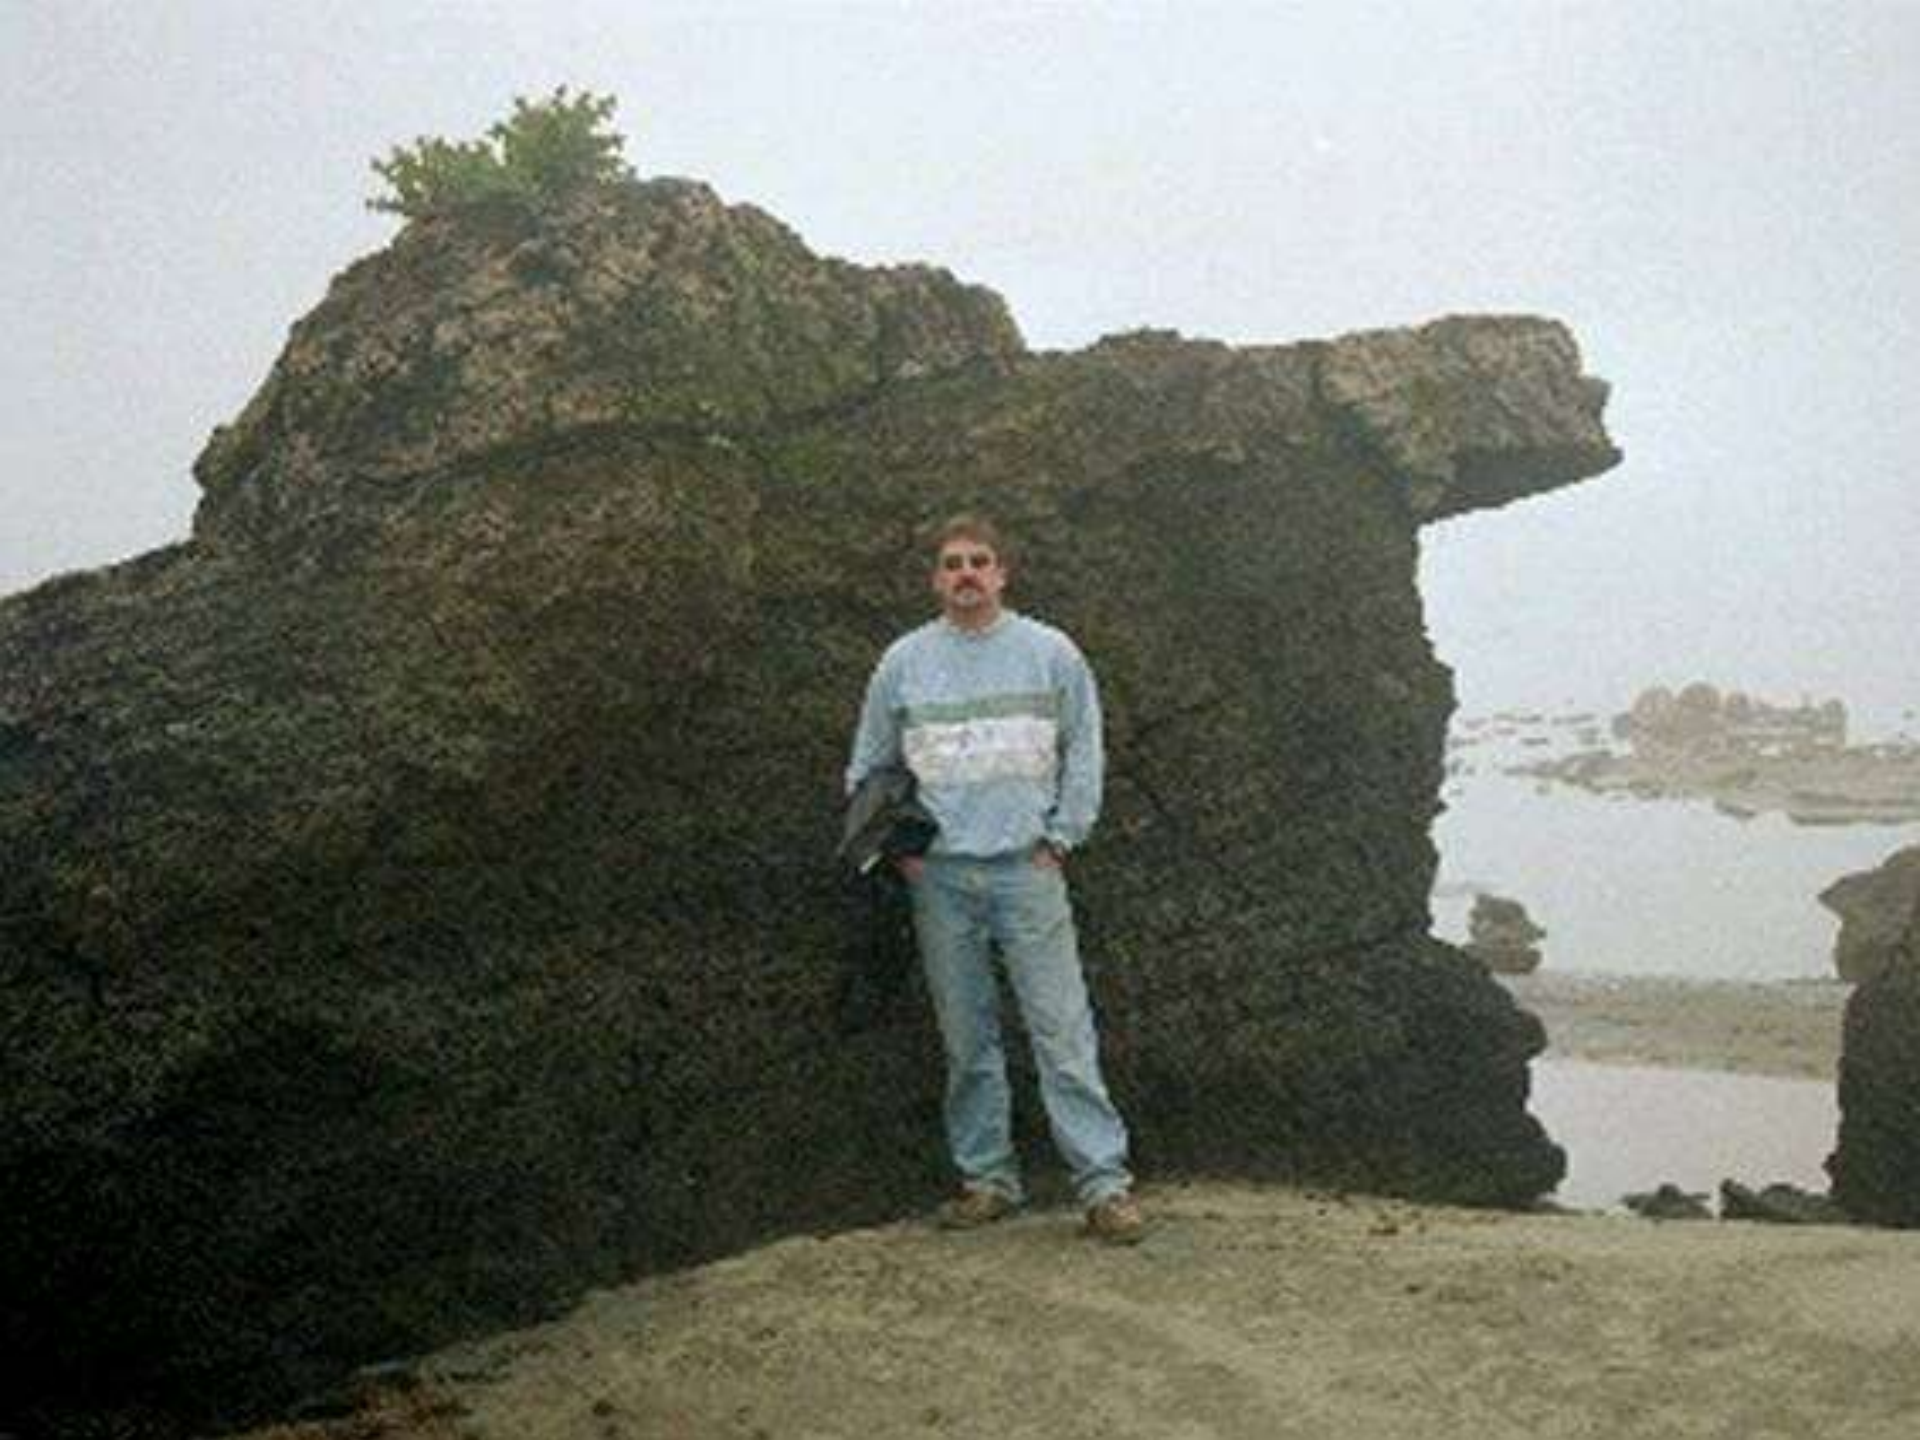
# Air Mailing fill at the breach

Delivering the minus 36-inch rock mixture via “air-mailing” (shown at right) allows the fines to be swept away by the intrushing current (shown at left). This can result in an overly very pervious dike closure. This is what appears to have occurred at the north end of the 2004 closure, which leaked.

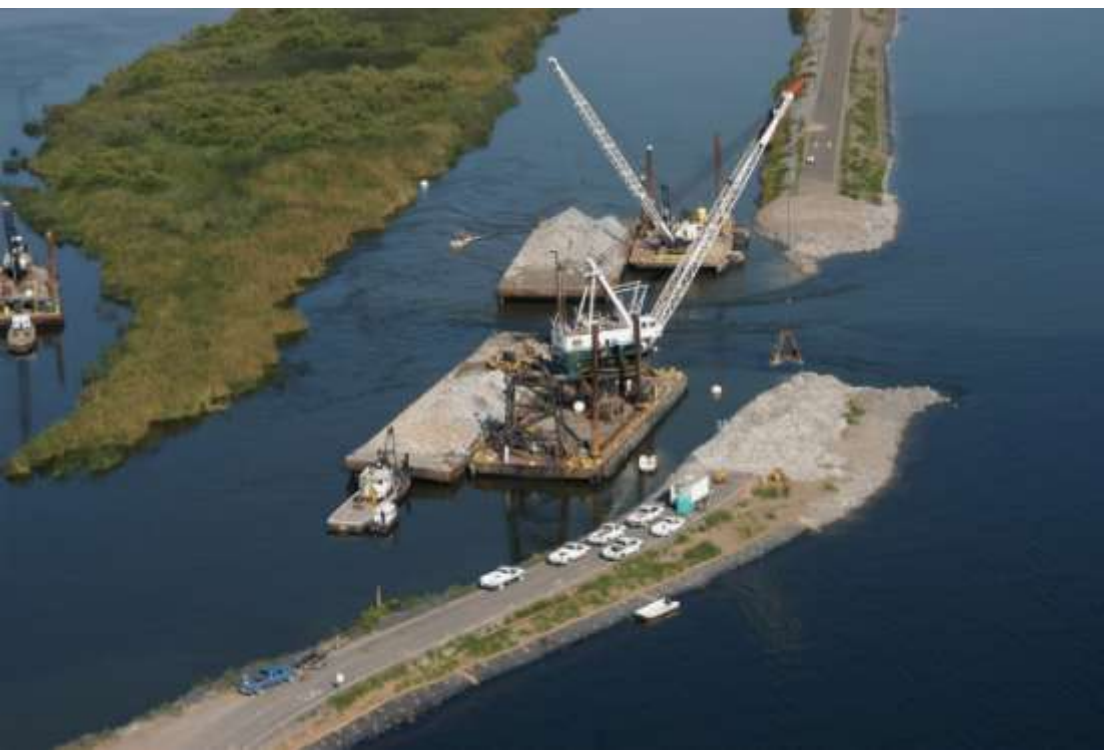
# Jones Tract was one of the deepest breaches in delta history

By beginning the filling several days before the inflow equilibrated, a scour hole more than 55 ft deep was excavated between the two end caps, shown at left
