A GRAVEL BUDGET FOR THE LOWER AMERICAN RIVER

THESIS

CALIFORNIA STATE UNIVERSITY, SACRAMENTO

SPRING
2007

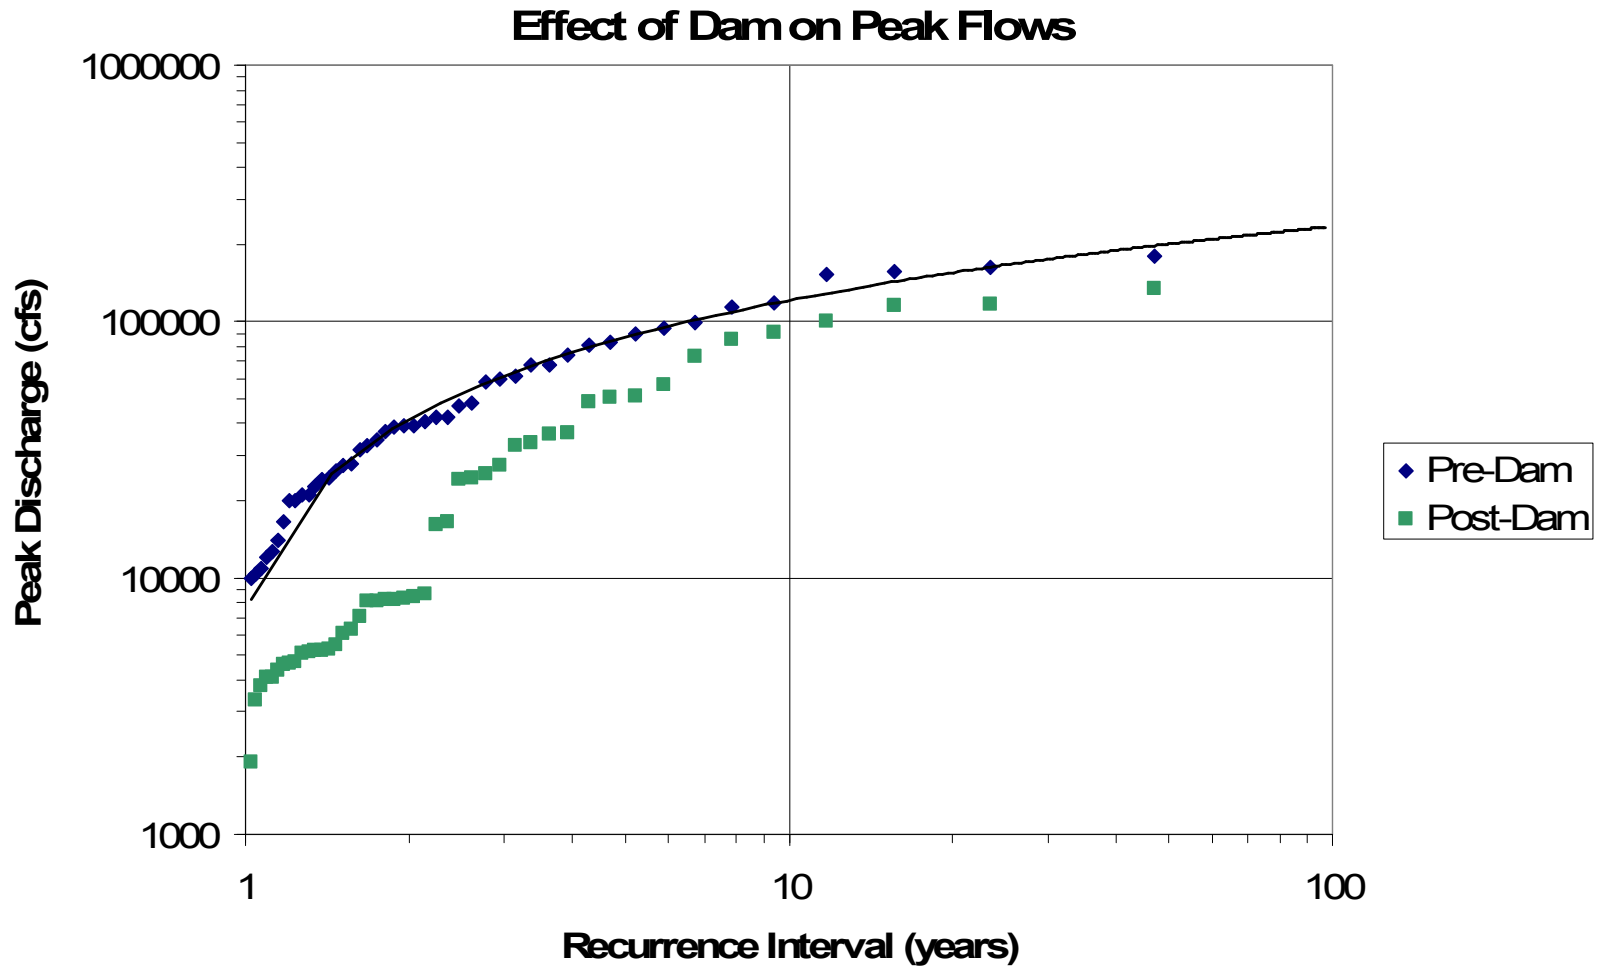
Figure 1-8 Effect of Folsom Dam on peak flows. Events with recurrence intervals (RI) greater than 8 years have been affected less than those with RI less than 8 years (data obtained from CDEC).

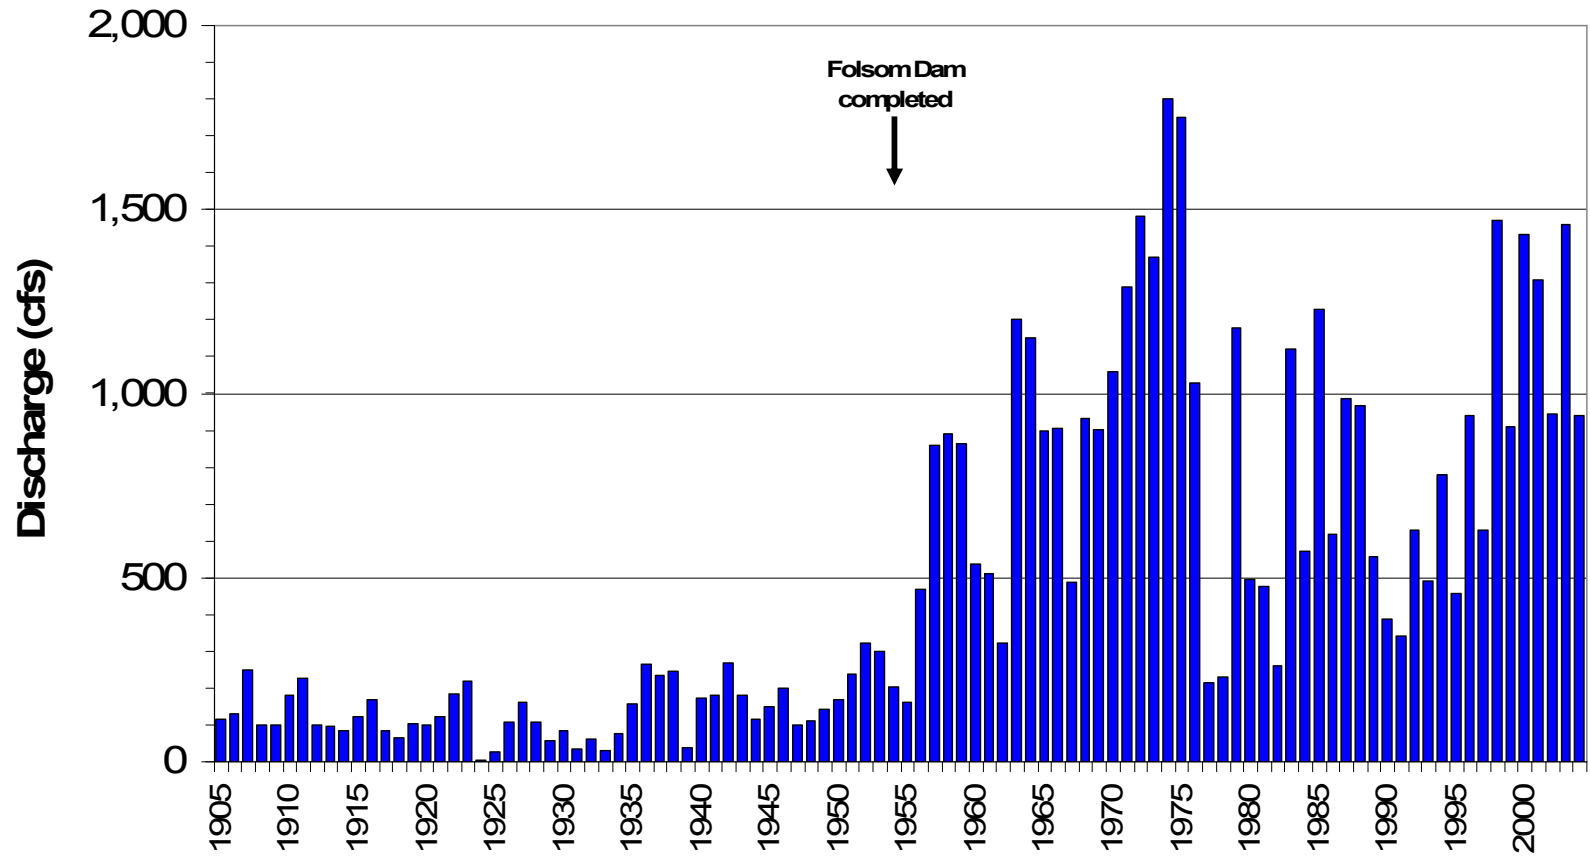
Annual Minimum Streamflow at Fair Oaks

Figure 1-9 Hydrograph of minimum streamflows on the LAR

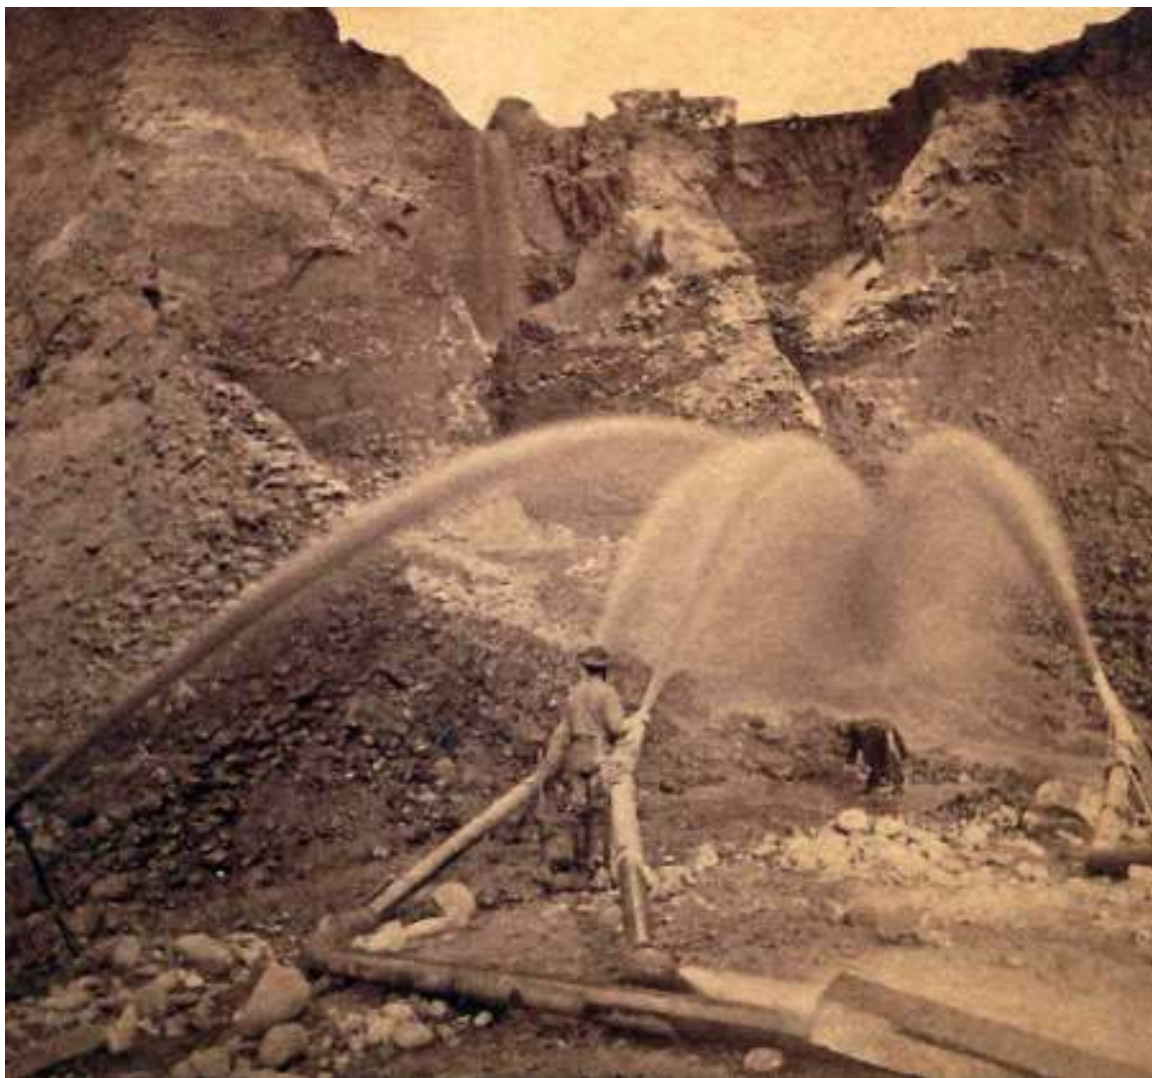
Figure 1-11 Hydraulic mining in the Sierra Nevada (Photo: Central Pacific Railroad Photographic History Museum)

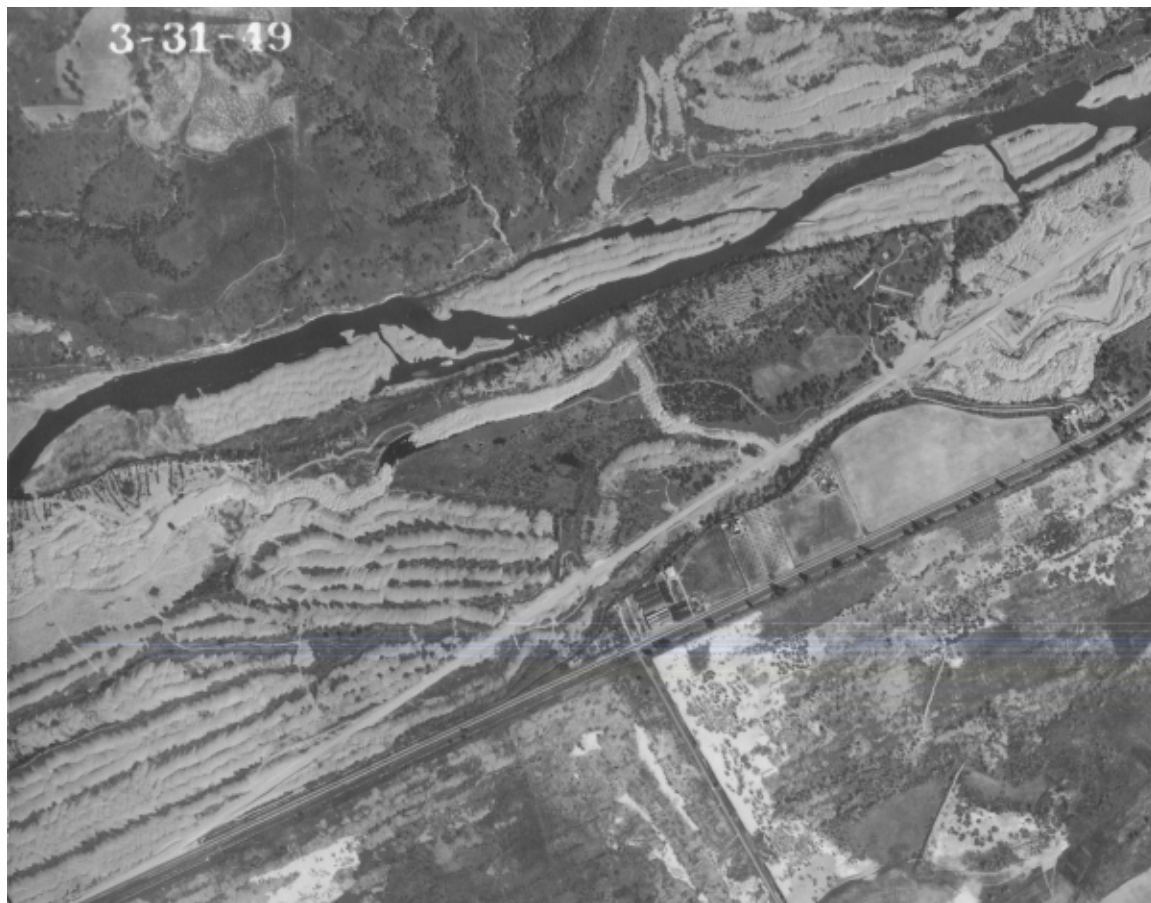
Figure 1-12 Aerial photo (1949) of the LAR near the current location of Nimbus Dam showing dredge tailings in and around the channel (Photo courtesy Bureau of Reclamation)

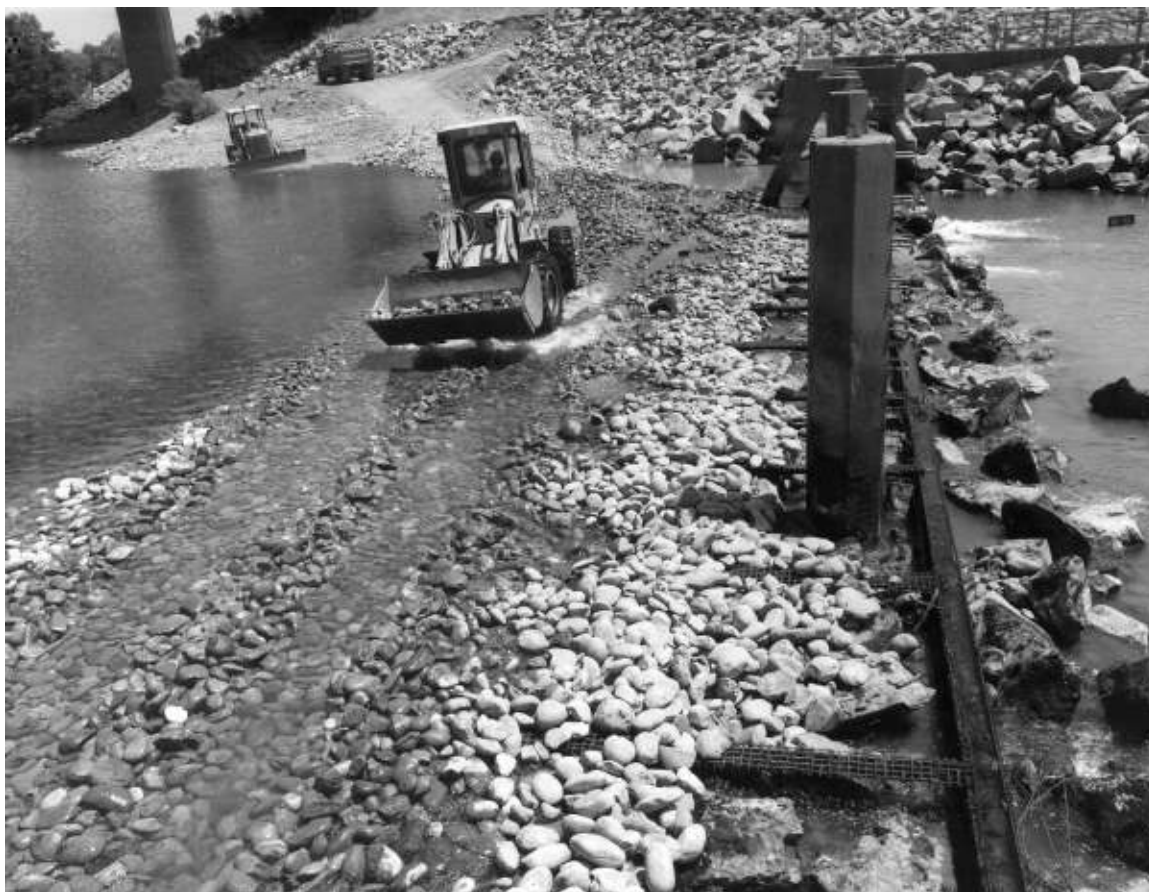
Figure 1-14 Repair of the fish diversion structure at Nimbus Fish Hatchery (photo: D.M. Westphal, Bureau of Reclamation, 8/3/1982)

To mitigate the reduction of available spawning habitat caused by the construction of Nimbus and Folsom Dams, the Nimbus Fish Hatchery (Figure 1-13) was built in the years following dam completion. As part of its structure, there is a removable screen that is used to divert fish into the hatchery during spawning season. This structure is frequently damaged by large flow events, and has often been reinforced with boulders at the site, although the volume of sediment added is likely not a significant source to the LAR (Figure 1-14).

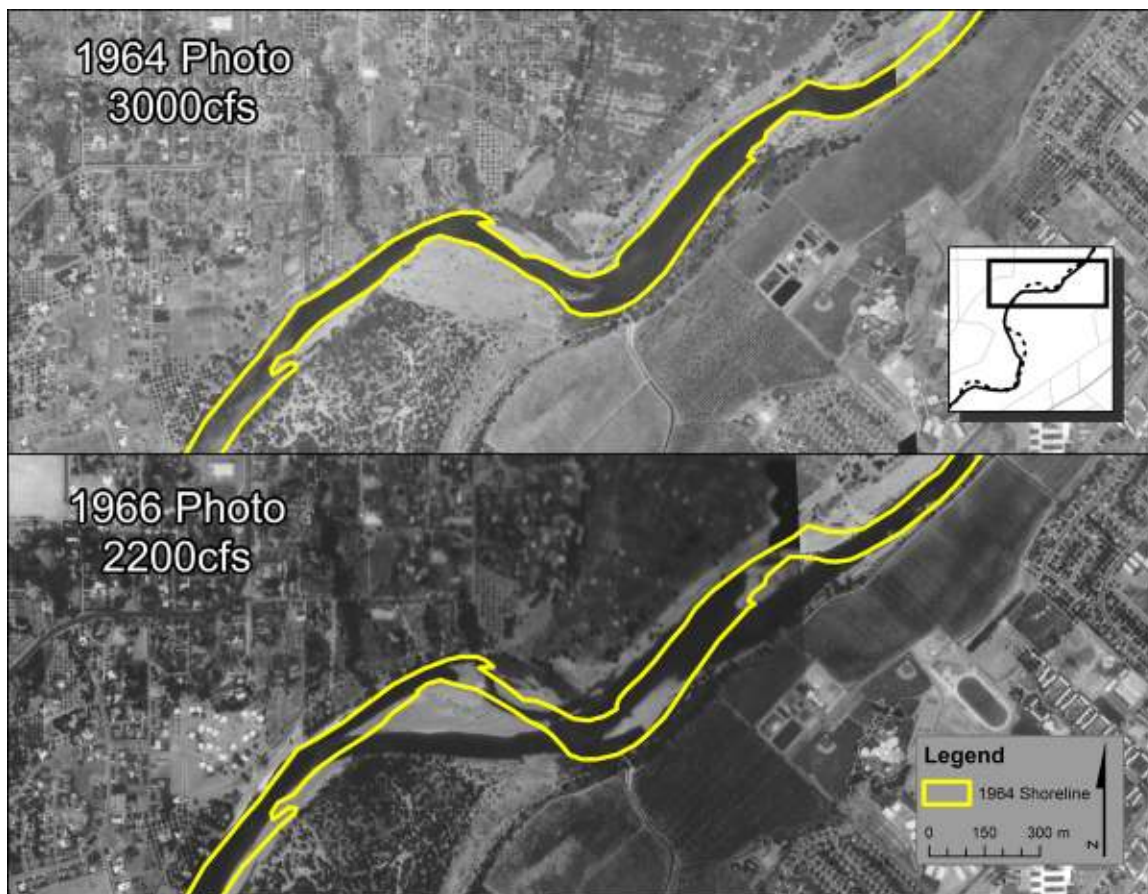
Figure 2-4 Aerial photos showing the channel changes that occurred between 1964 and 1966 between Goethe and Ansel Hoffman Parks. A peak flow of 115,000cfs in 1965 is likely responsible for the straightening of the channel.

The geometry of the channel was digitized using the georeferenced images. This was done in two ways. For analysis on the scale of the entire LAR, the path of the river in each photo was digitized by approximating the middle of the visible channel with a line feature, while for more detailed analysis (e.g. shorelines and barforms), polygon features were used to locate the edge of the water, which allowed the centroid of features (such as gravel bars) to be located. Changes in channel geometry were then observed on various scales using the georeferenced images and digitized channel geometries. For changes on the scale of the entire LAR, three sets of images were used: 1865, 1900, and 2002. The oldest (1865) and newest (2002) data sets were used in order to analyze changes on the longest time-scale possible (Figures 2-1 and 2-2). The 1900 data set was also used because the 1865 set only covers reaches 3 and 4, and the 1900 set covers the entire LAR (Figure 2-2). Changes on the scale of a few kilometers only occurred at Goethe Park, and therefore the channels from data sets were plotted at this location to observe general trends over time (Figure 2-3). For changes on the scale of less than a kilometer (e.g. barforms), the actual images were used with the digitized shorelines overlain to see small changes to shorelines and downstream movement of gravel bars (Figure 2-4).

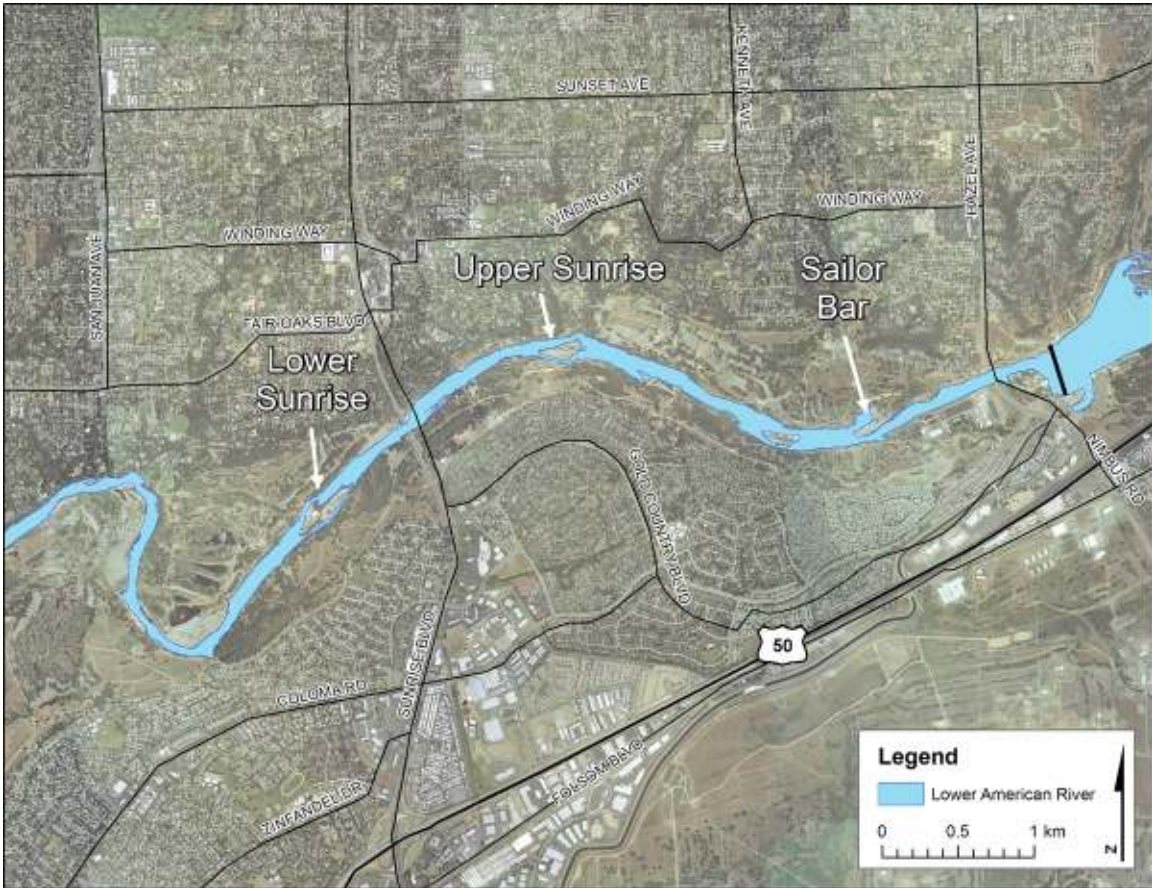
Figure 2-11 Map of reach 4 of the LAR showing three locations where gravel bars have shown significant movement.

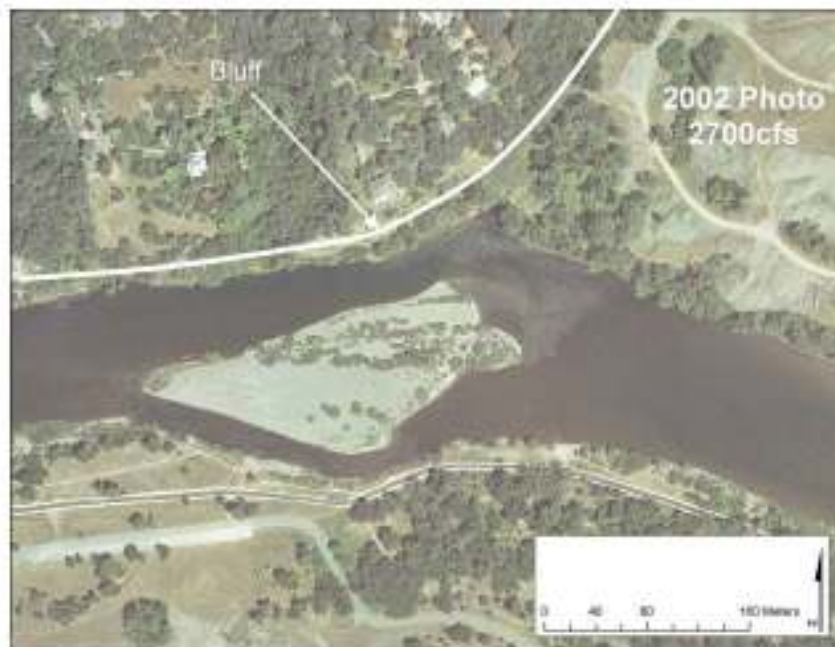
Figure 2-13 Photo of Upper Sunrise showing the location of the gravel bar island in 2002. The shape and location changed significantly, but there is no consistent downstream migration due to the localized control of the bluff.

Figure 2-11 shows locations in reach 4 where gravel bars have moved significantly since 1957. The Upper Sunrise locality (Figures 2-12 and 2-13) lies at the end of a long, straight section of river where the channel turns to the left as it encroaches on the bluffs of the north bank. The bluff reduces stream velocity and forces gravel to be deposited in nearly, but not exactly, the same position over time. The geometry of the bar has changed over 45 years, but the general size and location is similar (Figures 2-12 and 2-13).

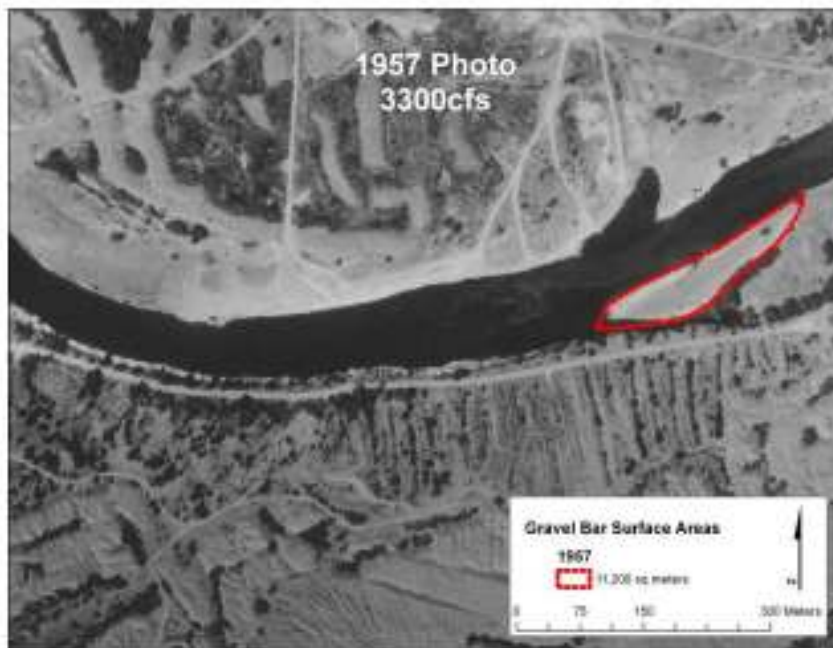
Figure 2-14 Georeferenced photo of Sailor Bar from 1957. The dashed line identifies the likely source of the sediment that forms the island in the 2002 photo (Figure 2-15).

Other gravel bars such as at Sailor Bar (Figures 2-14 through 2-16) and Lower Sunrise (Figures 2-17 through 2-19) have shown downstream migration over time. At Sailor Bar, the 2002 photo shows an in-stream island bar in a location where there was no bar in the 1957 photo (Figures 2-14 and 2-15). The bar outlined in the 1957 photo shows the nearest potential source for the new island. A rate of movement was calculated using the area of the bar, the approximate bar thickness estimated from 1998 bathymetry (Figure 2-16), and the distance between the new island and the potential source.

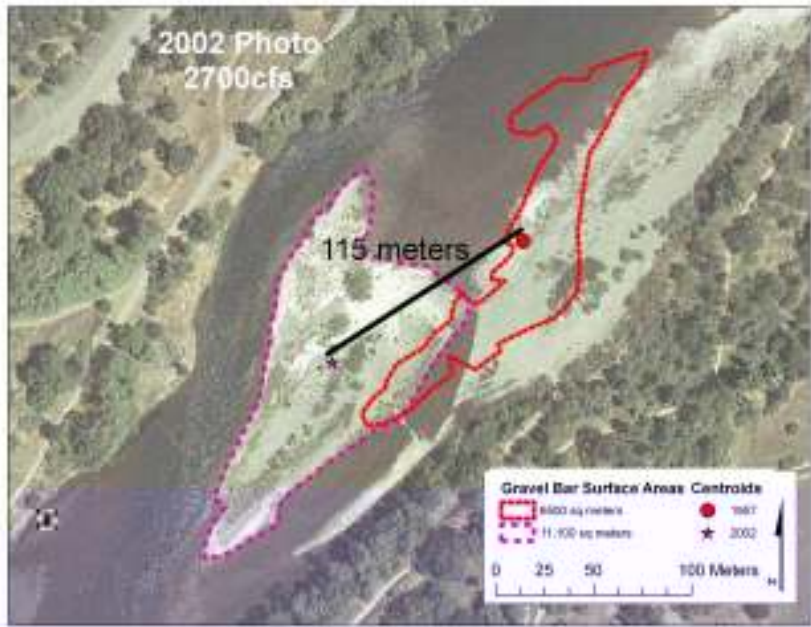
Figure 2-18 Georeferenced photo of Lower Sunrise from 2002. The dashed line on the left shows the modern location of the island. The surface area of the two bars and the distance between the centroids were measured.

These calculations were repeated using the bar movement at Lower Sunrise (Figures 2-17 through 2-19), and give a preliminary approximation of minimum gravel volume movements on the order of 210,000 to 470,000m³ over the 6.4km of reach 4 from 1957 to 2002 and a time-averaged rate of 4,600 to 10,000m³/yr (Table 2-3). It should be

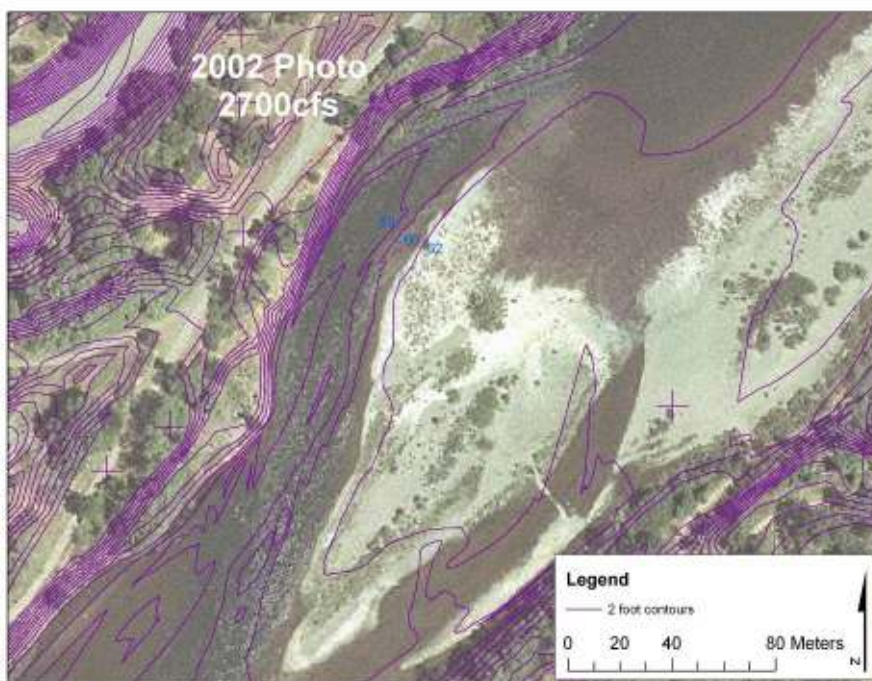
Figure 2-19 Bathymetric contours used to determine the 1.2m (4ft) estimated thickness of the island.

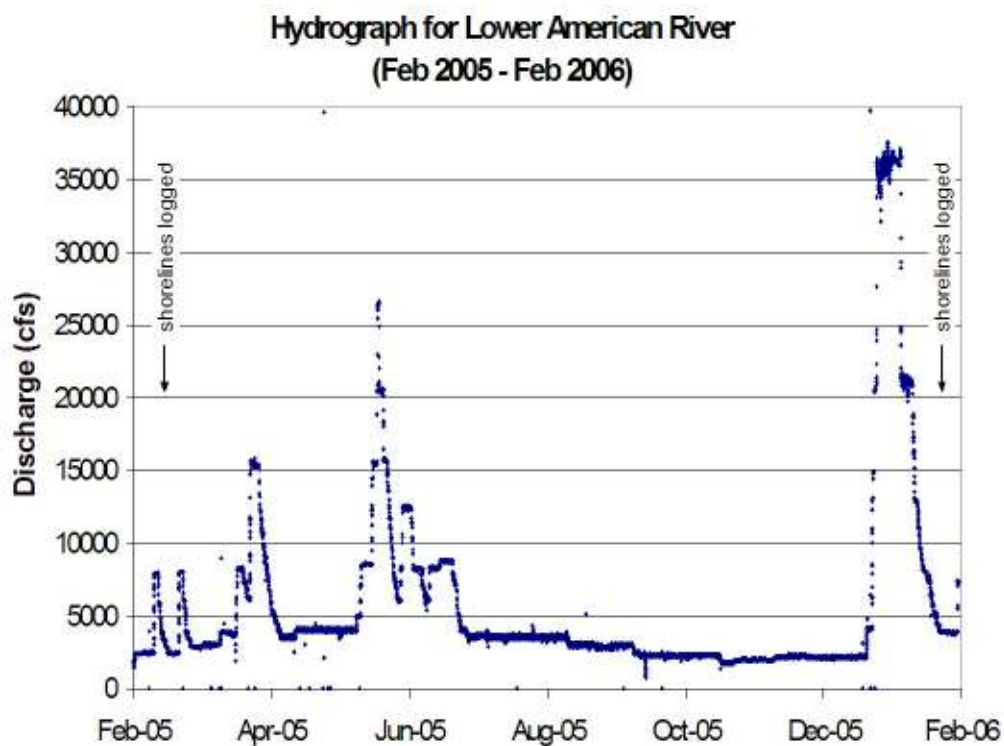
Figure 3-1 Hydrograph showing the flood control releases in December 2005 to January 2006.

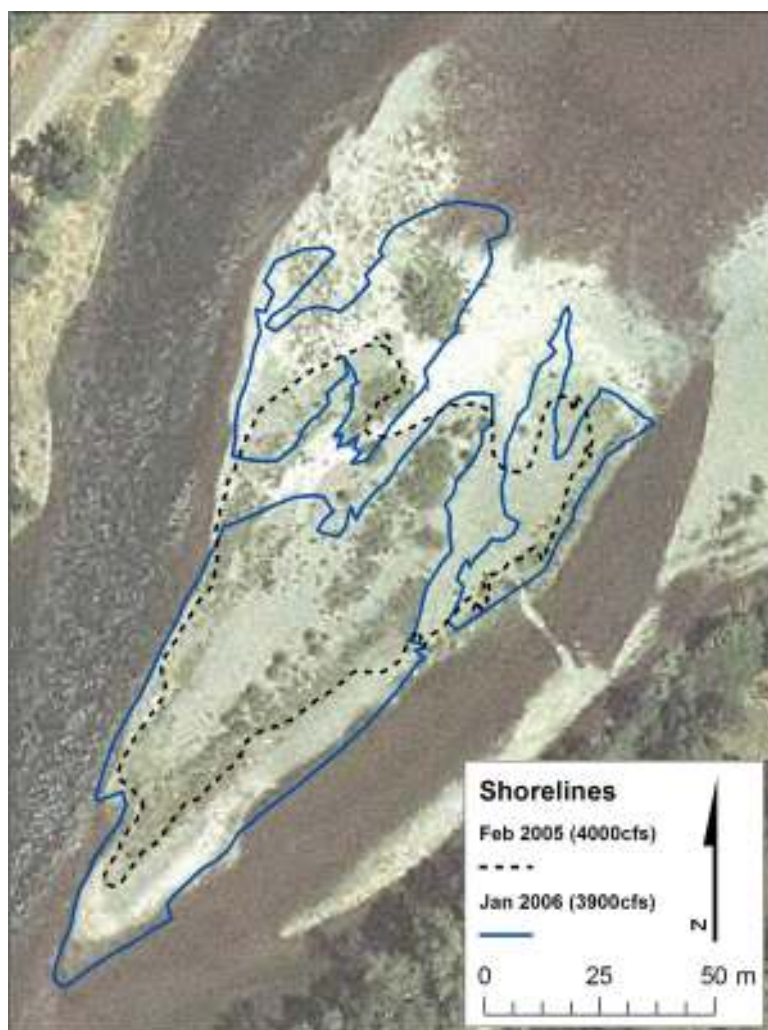
Figure 3-2 Changes in the shorelines during the 36 tcs event of December 2005 to January 2006. Gravel was deposited on the downstream end (lower left) of the bar and two small channels were incised in the gravel bar.

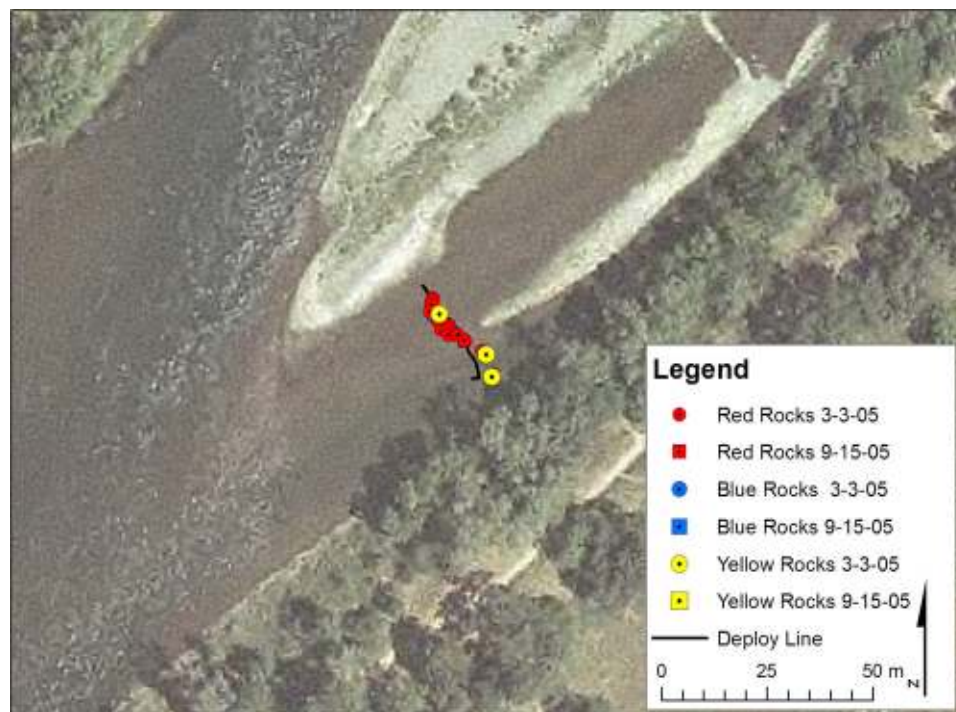
Figure 3-8 Tracer rocks found at Lower Sunrise side channel site.

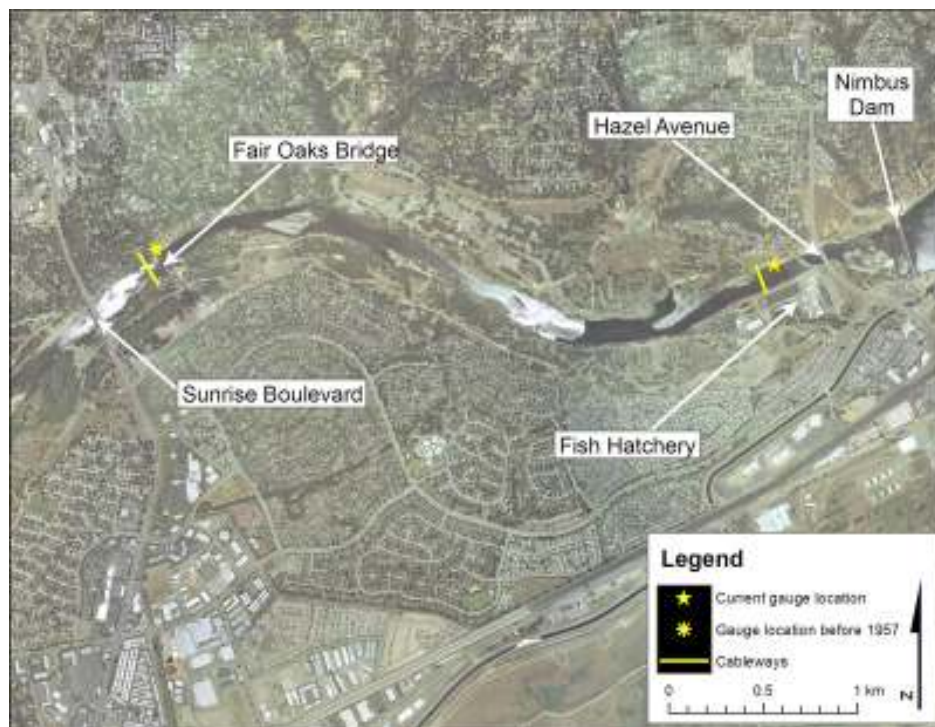
Figure 3-11 Location of Fair Oaks gauge. Prior to 1957 it was located near the Fair Oaks Bridge. The modern location is Near Hazel Avenue.

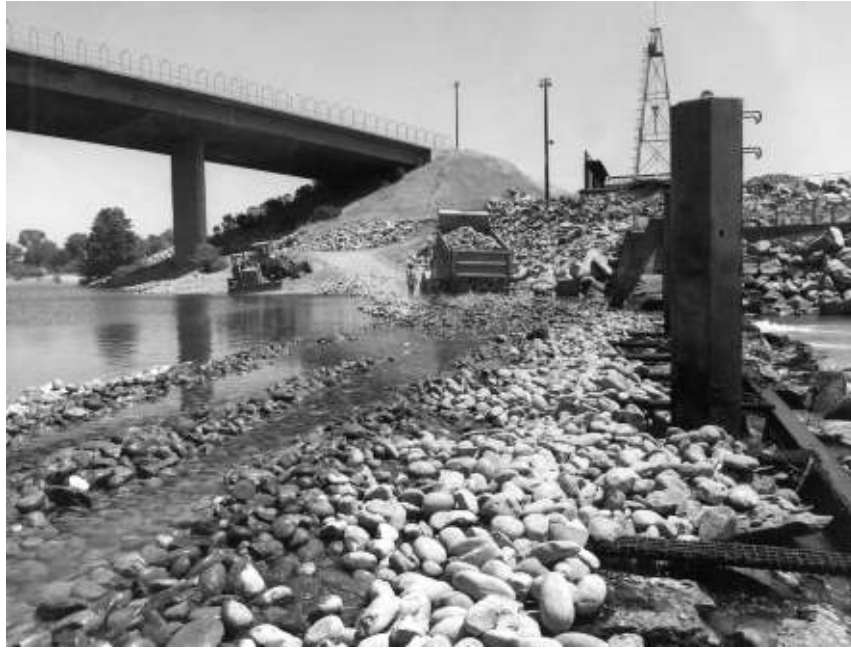
Figure 3-17 Rock fill being placed upstream of fish weir to facilitate repair. 8/3/82 D.M. Westphal, Photo (Bureau of Reclamation).

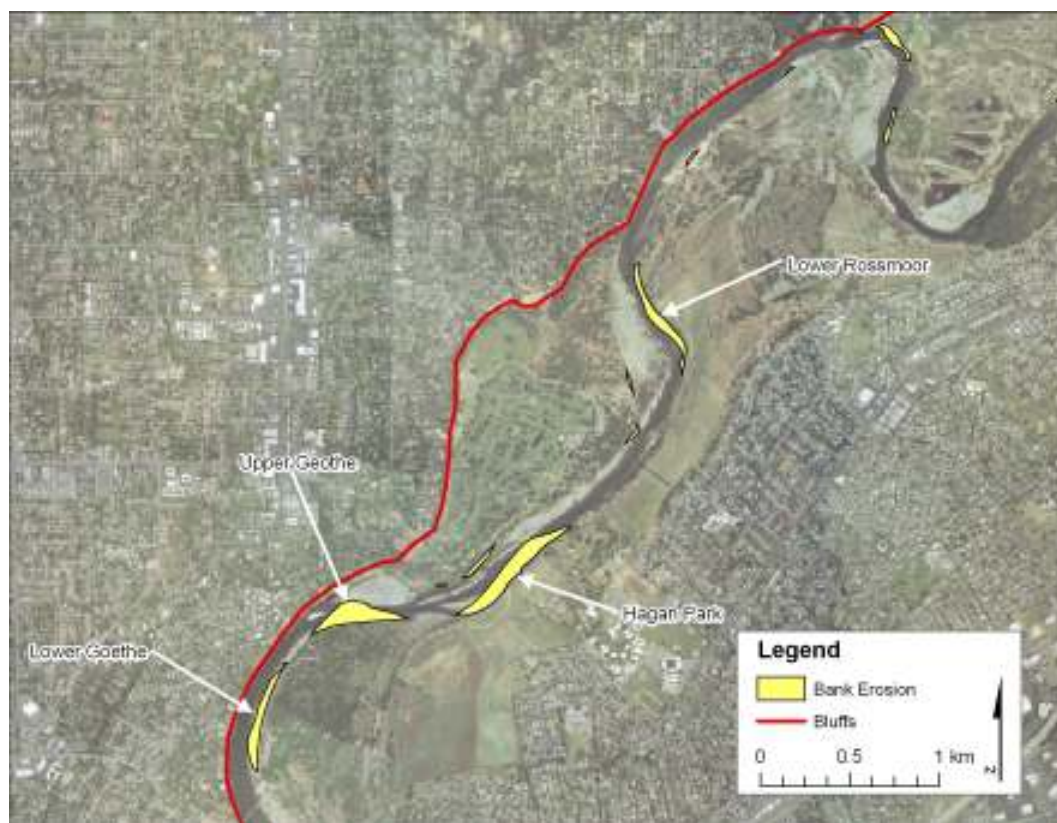
Figure 4-2 Locations of significant bank erosion in reach 3 of the LAR. The location of the bluffs to the north are indicated.

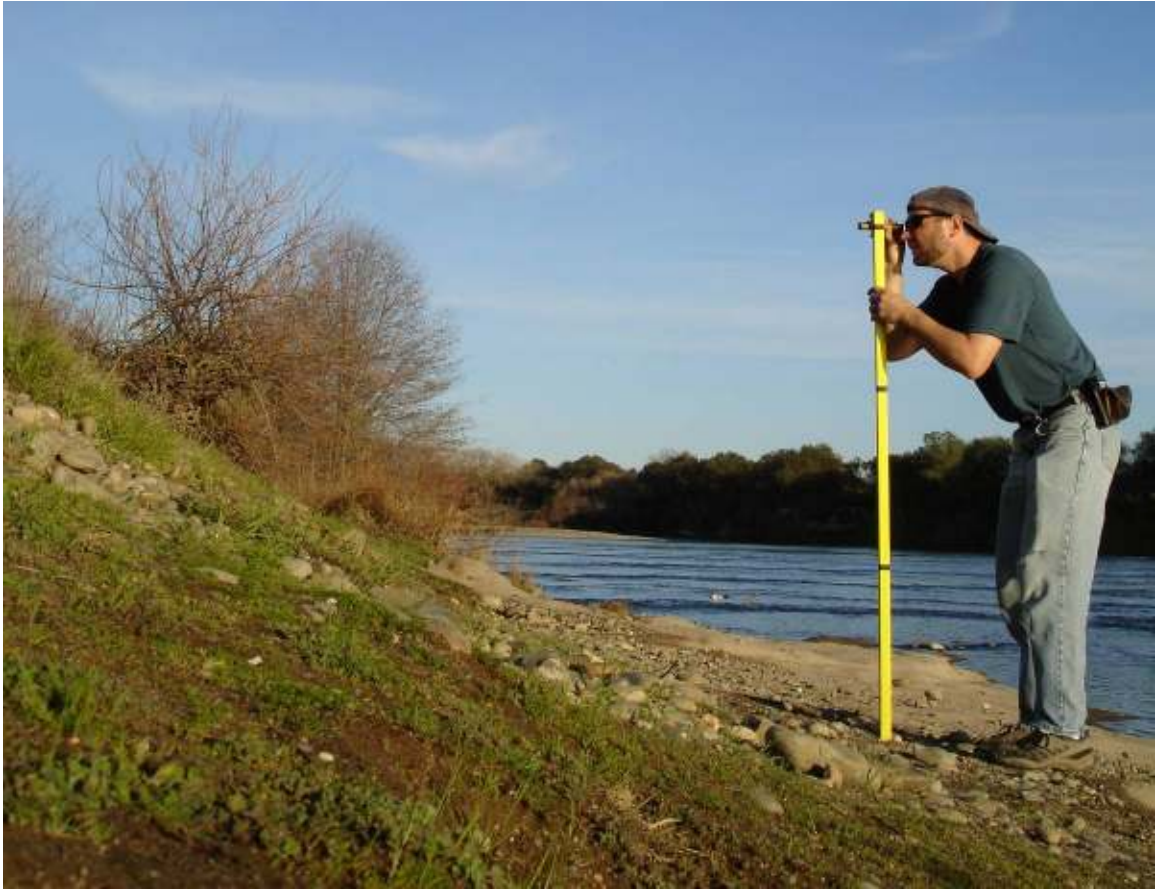
Figure 4-6 Bank heights were measured using a Jacob's Staff and hand level. Black marks on the staff are 50 cm apart.

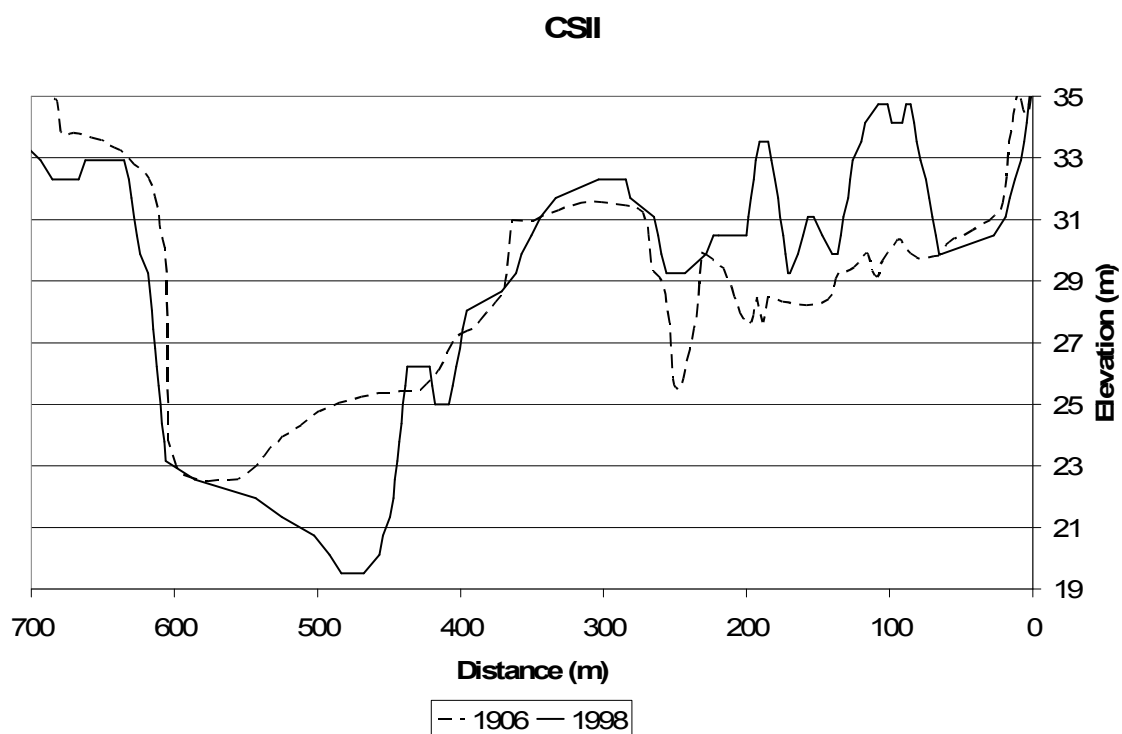
Figure 5-5 Cross-sections showing erosion between 1906 and 1998 in reach 4 at river kilometer 34.1 (CDC 1907; USACE 1998).

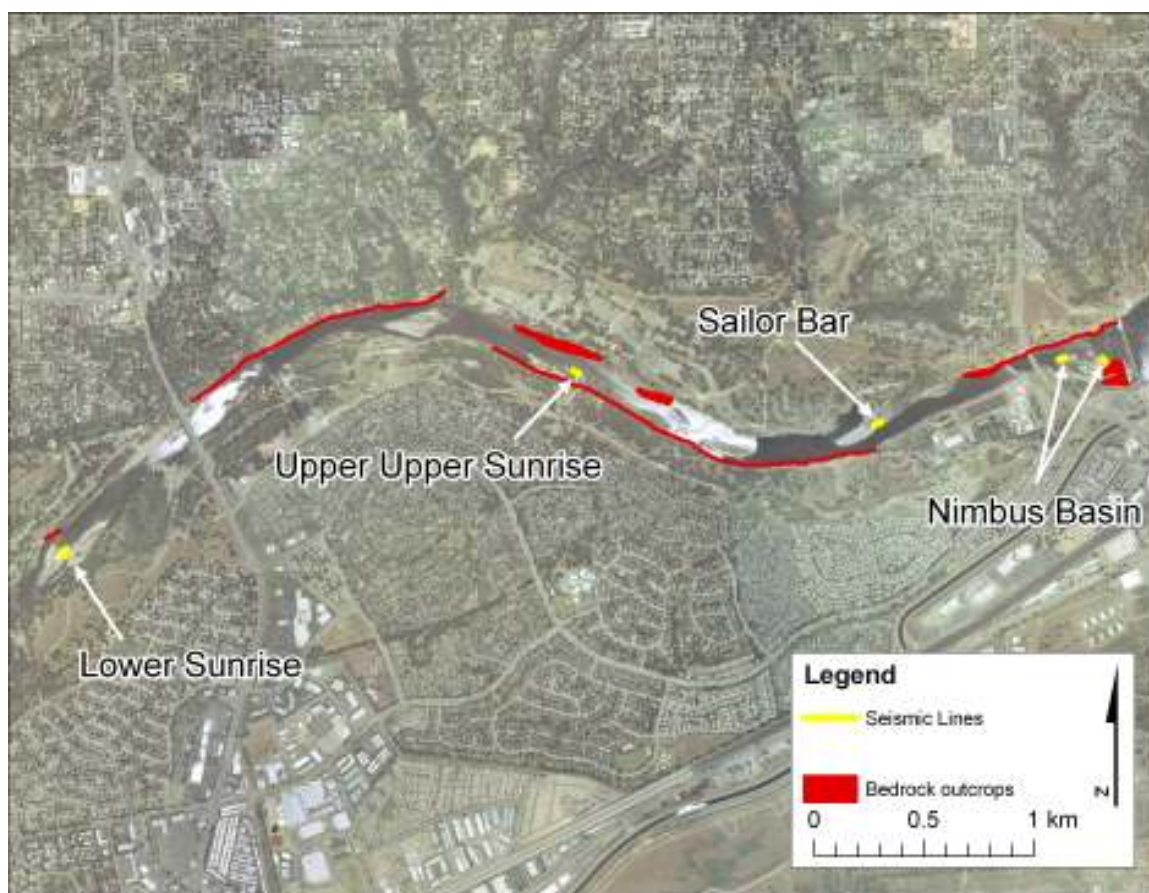
Figure 6-1 Location map of the seismic surveys on the upper 7 km of the LAR.

Bedrock outcrops in and near the channel can be observed in various places throughout reaches 3 and 4 (upper 15 km) of the LAR (Figure 6-1). Most of these outcrops are on the banks where the channel is eroding laterally. Clearly the range of gravel depths starts at zero, but how deep is it in other areas? Is the channel bottom on the LAR simply a thin veneer of gravel overlying bedrock, or are there areas where the gravel is many meters deep? Seismic refraction was used to address this question.

Seismic surveys were performed at 4 locations in the upper 7km of the LAR (Figure 6-1). Surveys were done parallel to the river at all locations with additional surveys perpendicular to the river in two locations (Nimbus Basin and Lower Sunrise).

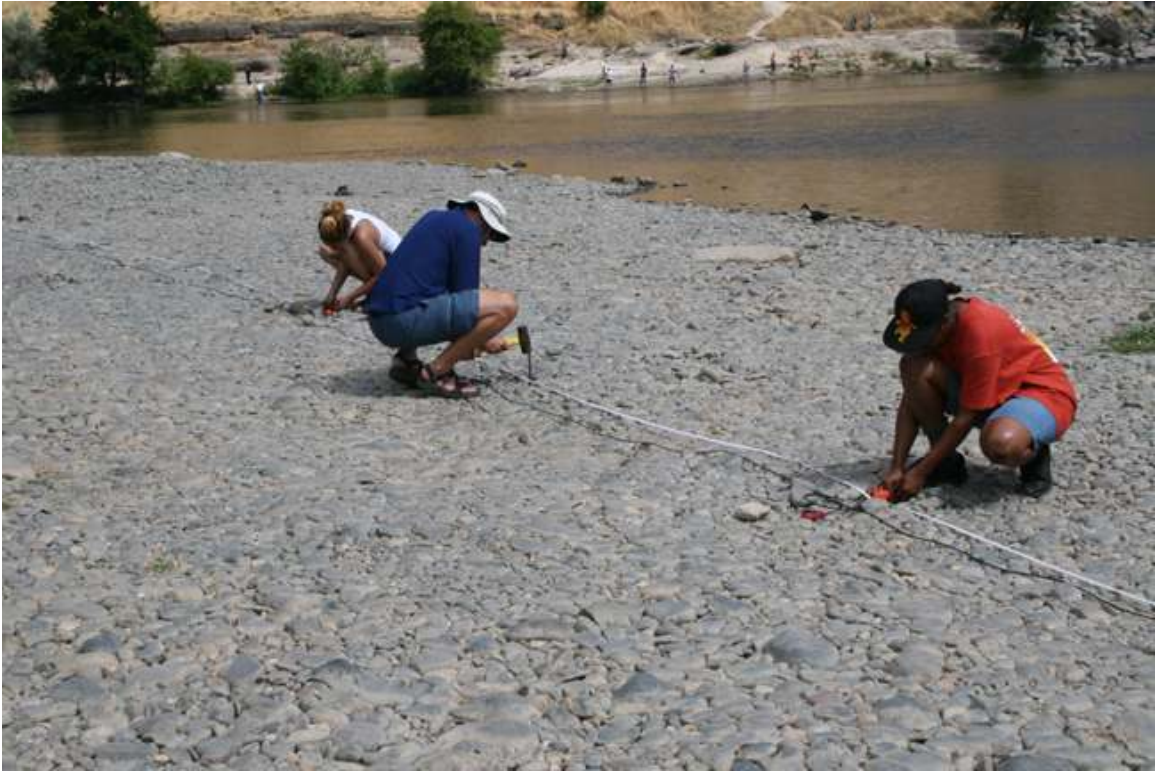
Figure 6-2 Installation of the geophone array. The geophones were secured to 0.3m long rebar pounded into the gravel to ensure good coupling between the geophone and gravel.

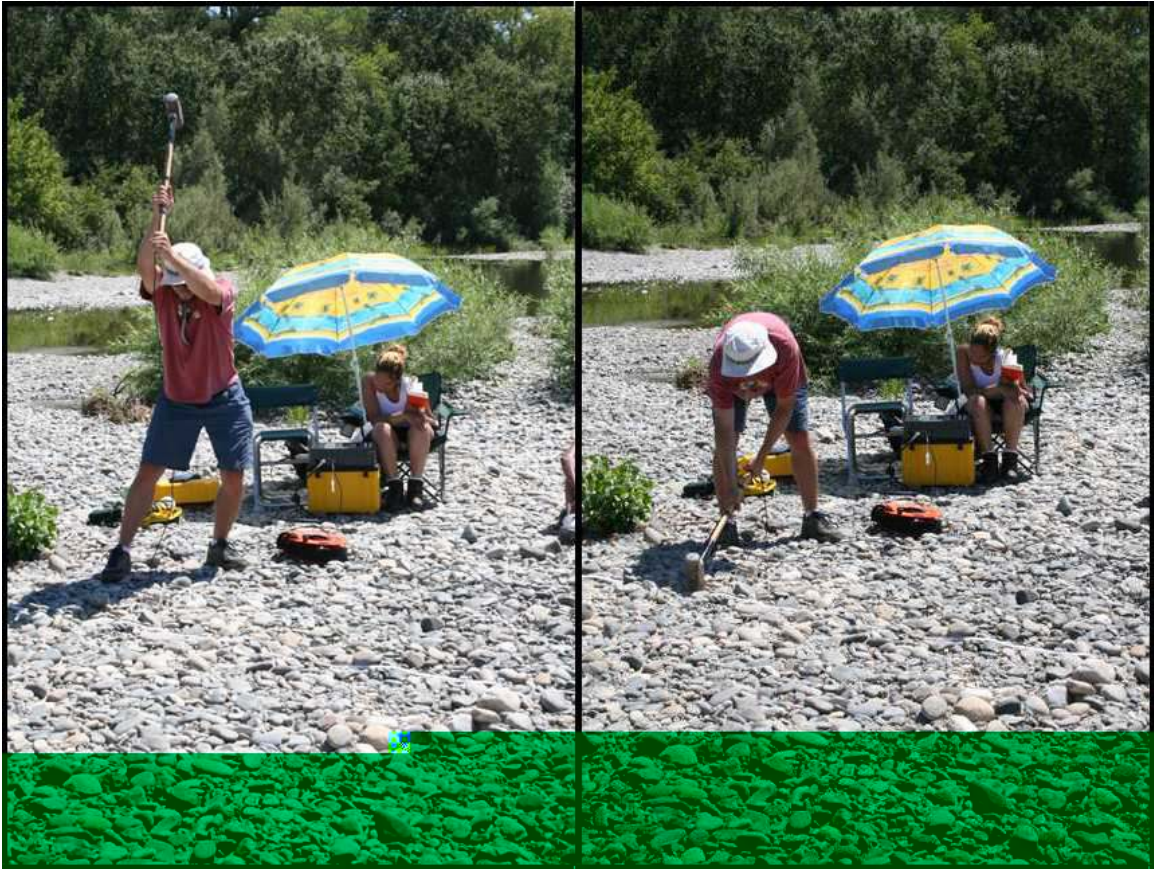
Figure 6-3 Seismic wave generation. The plate was struck many times and the results stacked to minimize ambient noise.

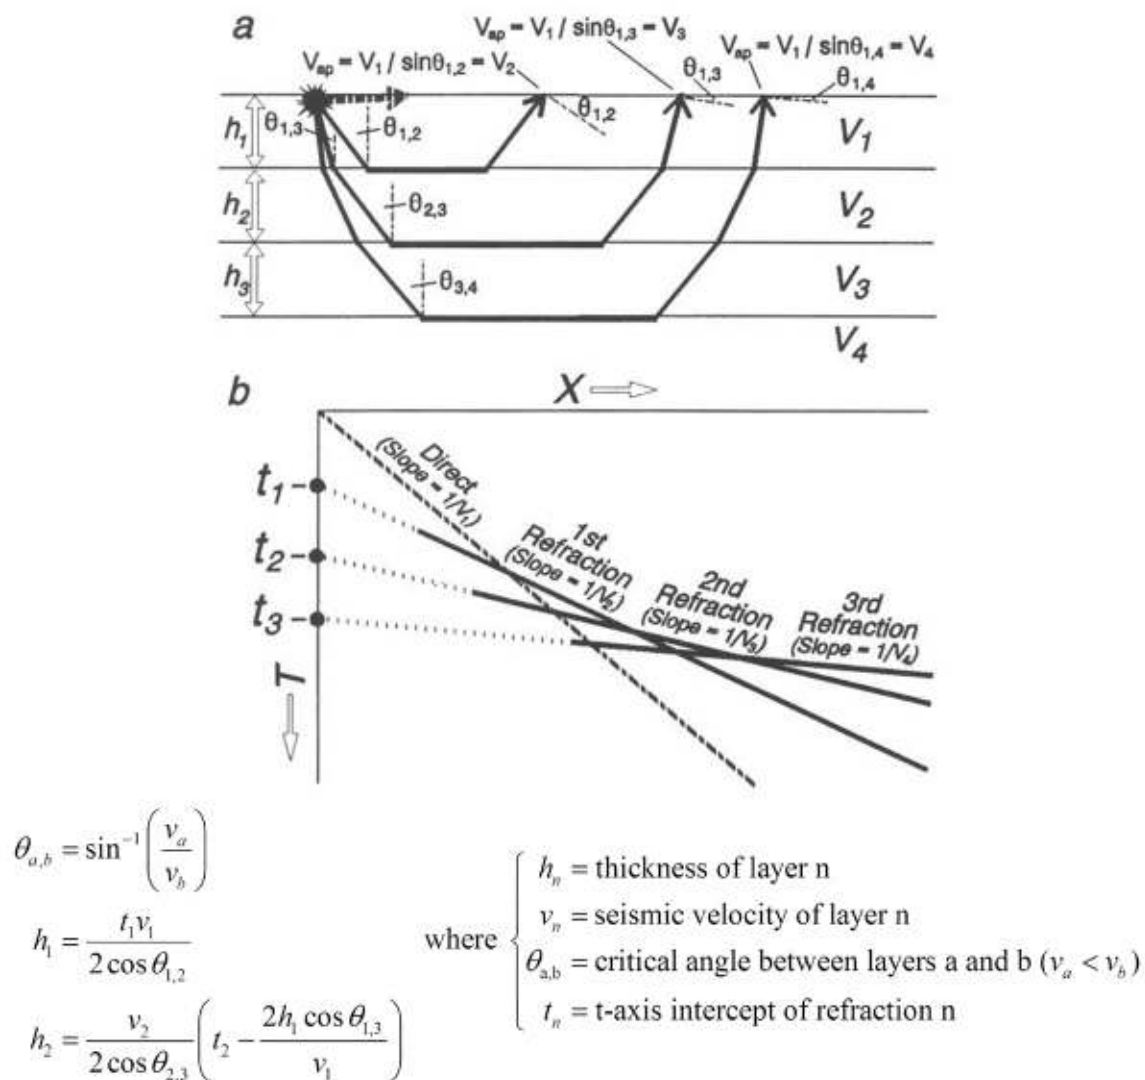
Figure 6-4 Interpretation model for horizontal layers with seismic velocities that increase with depth ($v_1 < v_2 < v_3 < v_4$) (from Lillie 1999)
