A GRAVEL BUDGET FOR THE LOWER AMERICAN RIVER

THESIS

CALIFORNIA STATE UNIVERSITY, SACRAMENTO

SPRING
2007

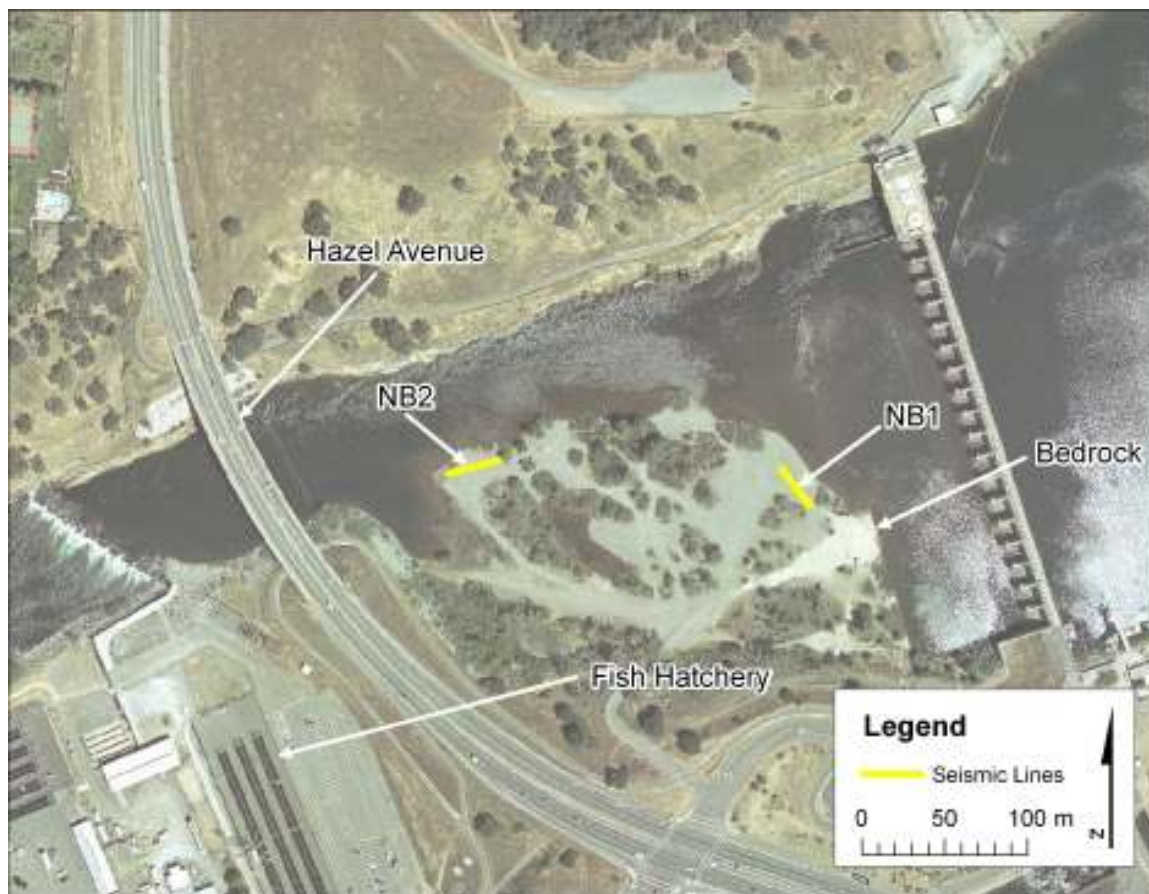
Figure 6-5 Location map for seismic surveys at Nimbus Basin

Nimbus Basin is located at river kilometer 37.0, just downstream from Nimbus Dam (Figure 6-5). The area has been highly modified for construction of the dam, fish hatchery, and Hazel Avenue bridge. The exposure of bedrock near NB1 and the armoring of the streambed provide evidence that the area has degraded since the dam was constructed in 1955. Two seismic surveys were performed at this location, one perpendicular to the river on the upstream end of the bar closest to the dam (NB1) and one parallel to the river on the downstream end of the bar close to Hazel Avenue (NB2). Both surveys were performed in early August of 2006 during flows of 3300cfs. Results from NB1 were inconsistent with a simple horizontal layer model (Figure 6-6). The shot locations on the north end of the array show seismic waves arriving at more distant geophones sooner than at closer ones. This indicates that the bedrock surface is likely to be undulating, perhaps shallow at either end of the array and deep in the middle. NB2 was the only location on the LAR to produce results indicating a horizontally-oriented bedrock surface within the depth range of the method (Figure 6-6). Seismic velocities for layer 1 averaged 450m/s, consistent with dry gravel. Velocities for layer 2 averaged 1600m/s, consistent with wet gravel. Finally, velocities for layer 3 averaged 2700m/s

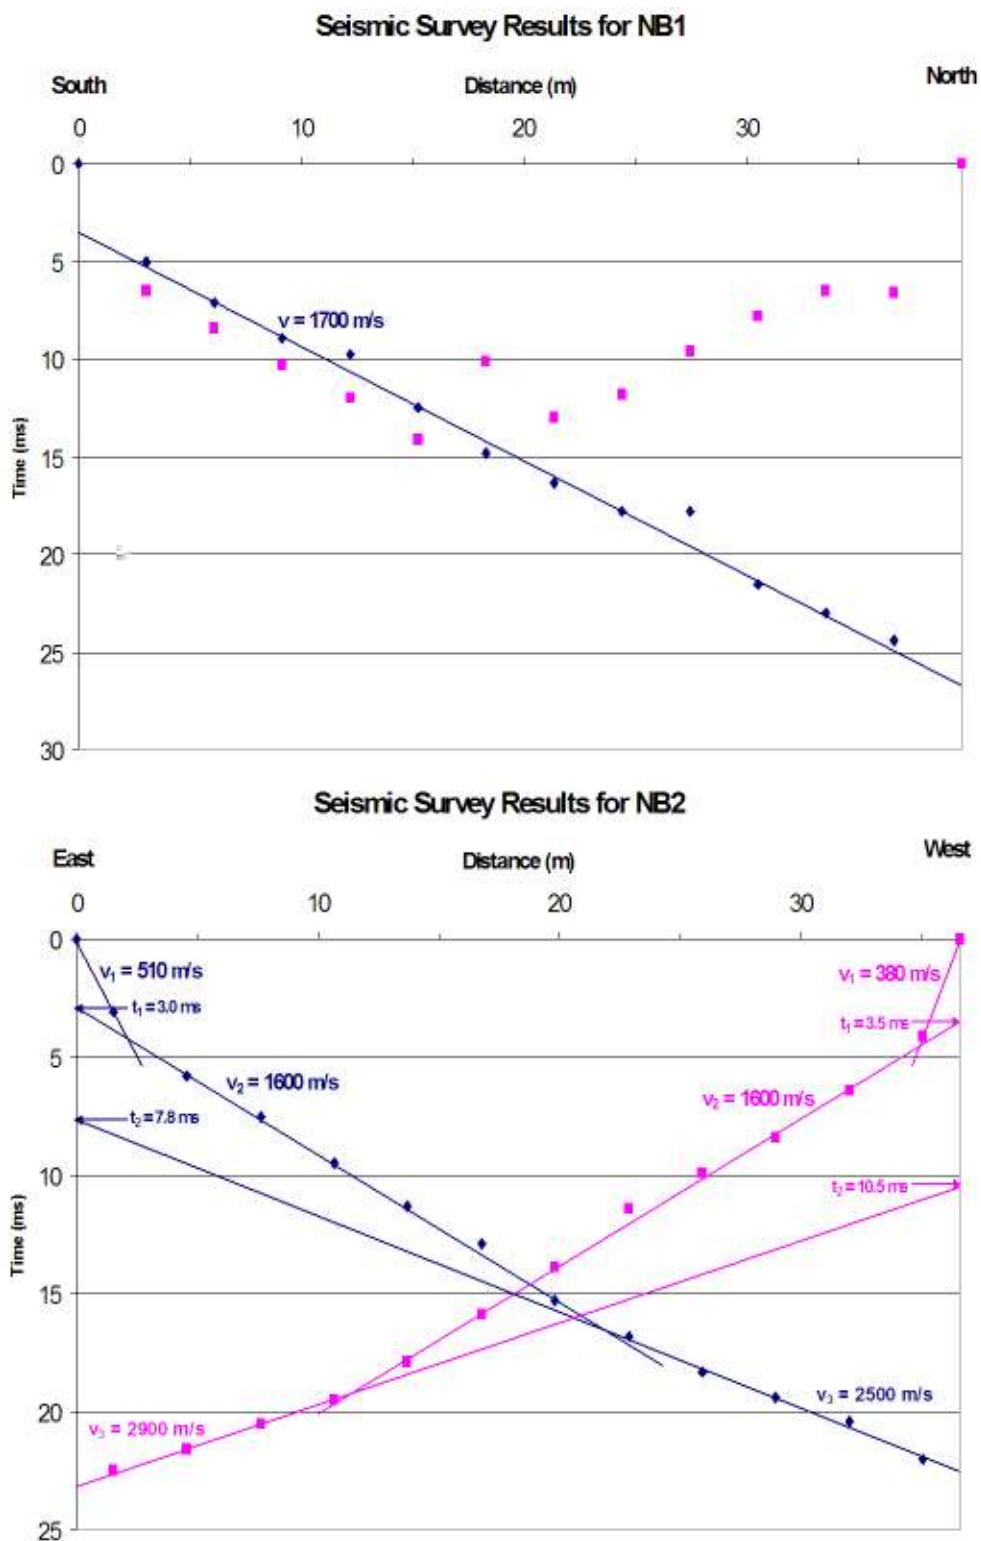
Figure 6-6 Seismic survey results for Nimbus Basin

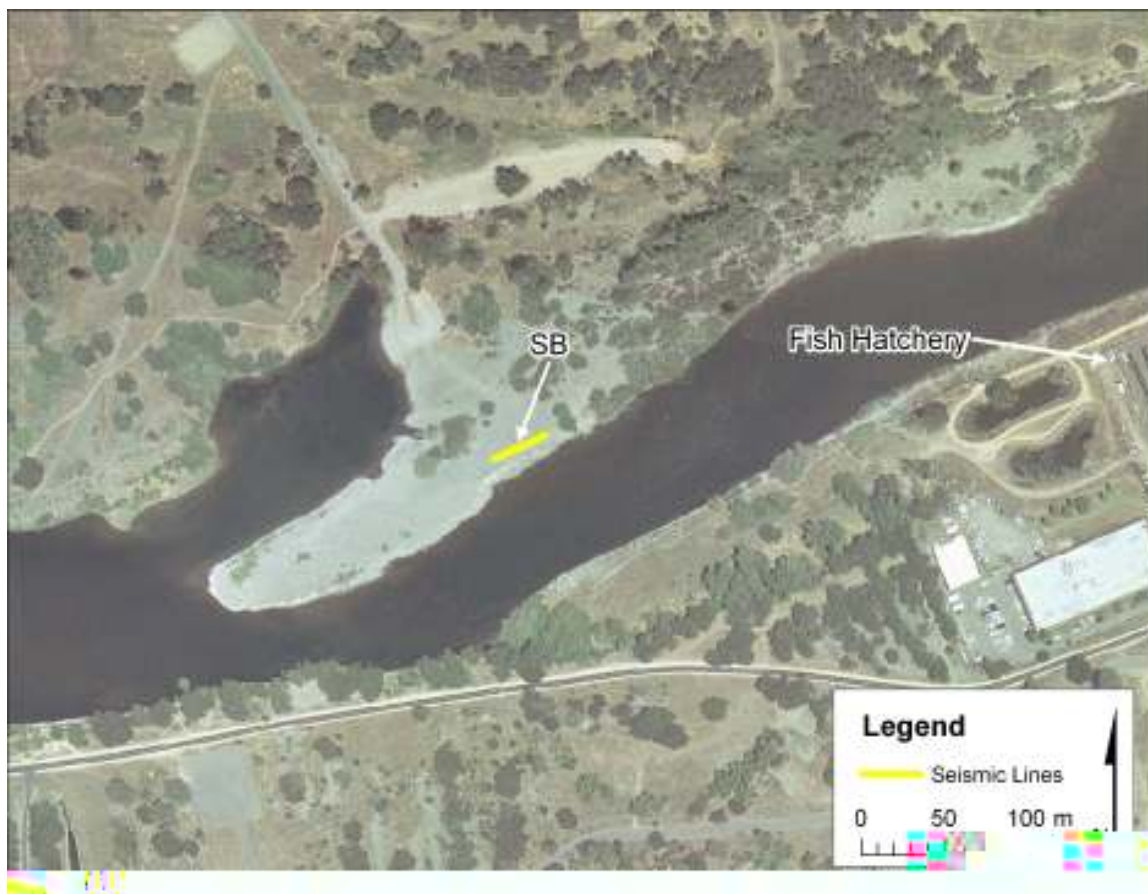
Figure 6-7 Location map for seismic survey at Sailor Bar

Sailor Bar is located at river km 36.0, downstream of the fish hatchery (Figure 6-7). The survey (SB) was done on a bar feature parallel to the channel on the north bank in early August of 2006 during flows of 3300cfs. Results from SB indicate a change in seismic velocity (410m/s to 1800m/s) at a depth of about 1.1m which is consistent with the water table at that depth (Figure 6-8). No other changes in velocity are apparent. If we assume that the bedrock was slightly deeper than the depth of the survey and that the bedrock in this location has a velocity close to that measured at NB2 (2700m/s), we can calculate a minimum gravel depth of 8.5m.

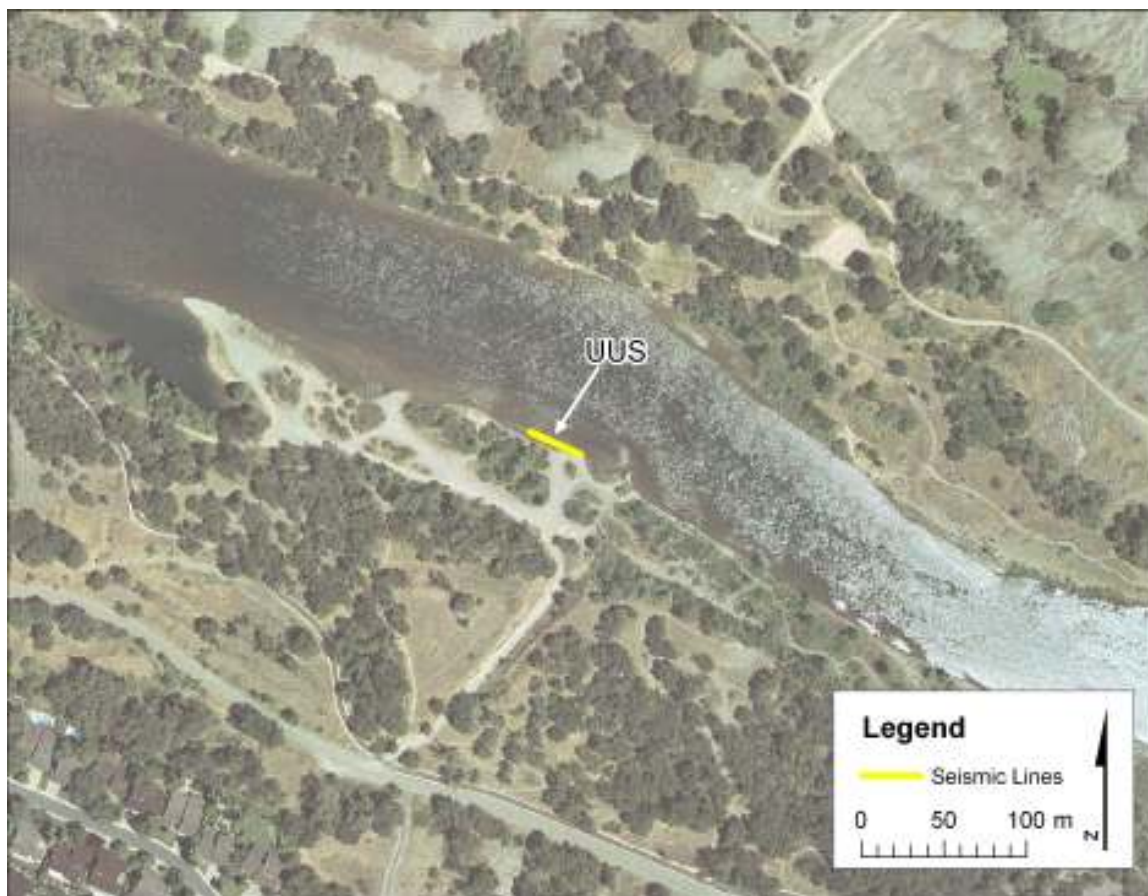
Figure 6-9 Location map for seismic survey at Upper Upper Sunrise

The Upper Upper Sunrise site (UUS) is located at river km 34.5, between Sailor Bar and the Upper Sunrise island (Figure 6-9). The survey was done parallel to the channel on the south bank in mid-April of 2007 during flows of 1800cfs. Results from UUS indicate no changes in seismic velocity (Figure 6-10). If we assume that the bedrock was slightly deeper than the depth of the survey and that the bedrock in this location has a velocity close to that measured at NB2 (2700m/s), we can calculate a minimum gravel depth of 9.2m.

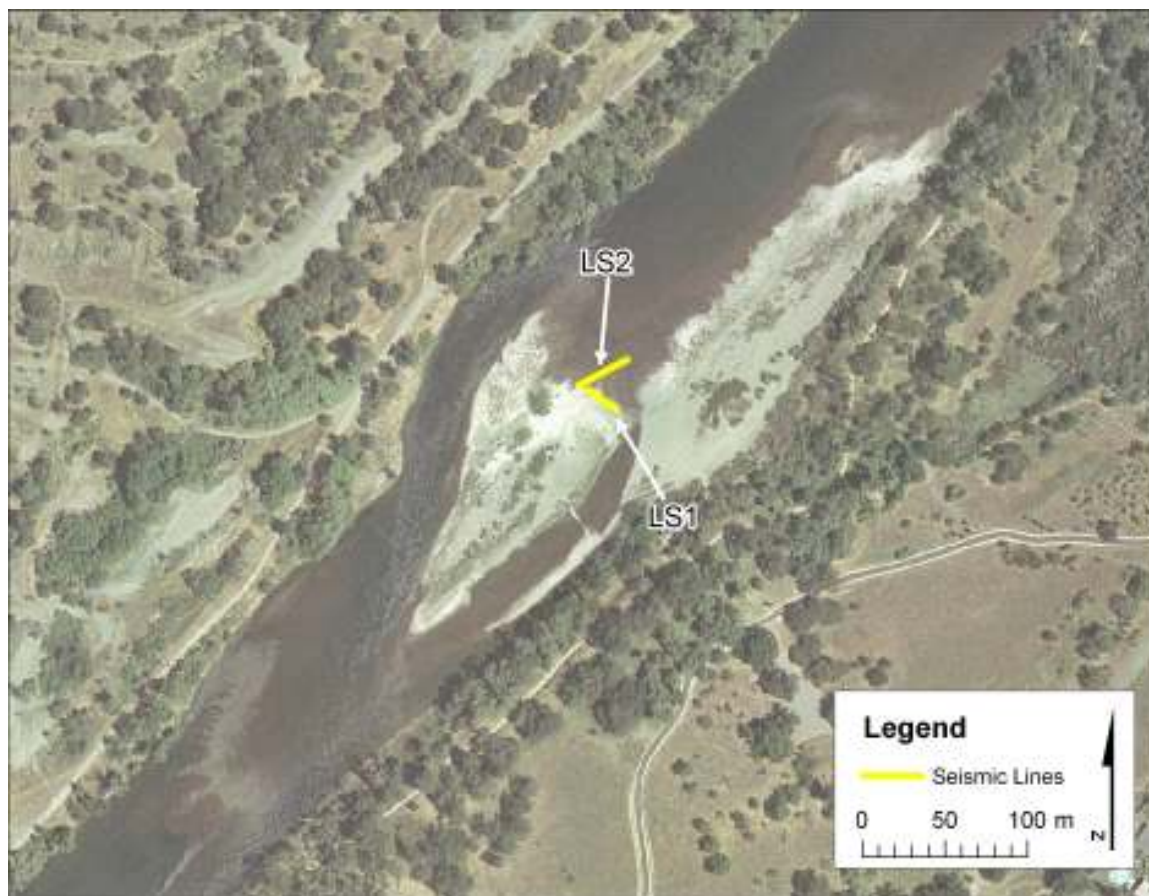
Figure 6-11 Location map for seismic surveys at Lower Sunrise

Lower Sunrise is located at river km 31.7, downstream of Sunrise Boulevard (Figure 6-11). Two seismic surveys were performed at this location, one perpendicular to the channel (LS1) and one parallel (LS2). The survey at LS1 was performed in early August of 2006 during flows of 3300cfs and LS2 was performed in early April 2007 during flows of 2000cfs. Results from LS1 showed changes in seismic velocity, but were

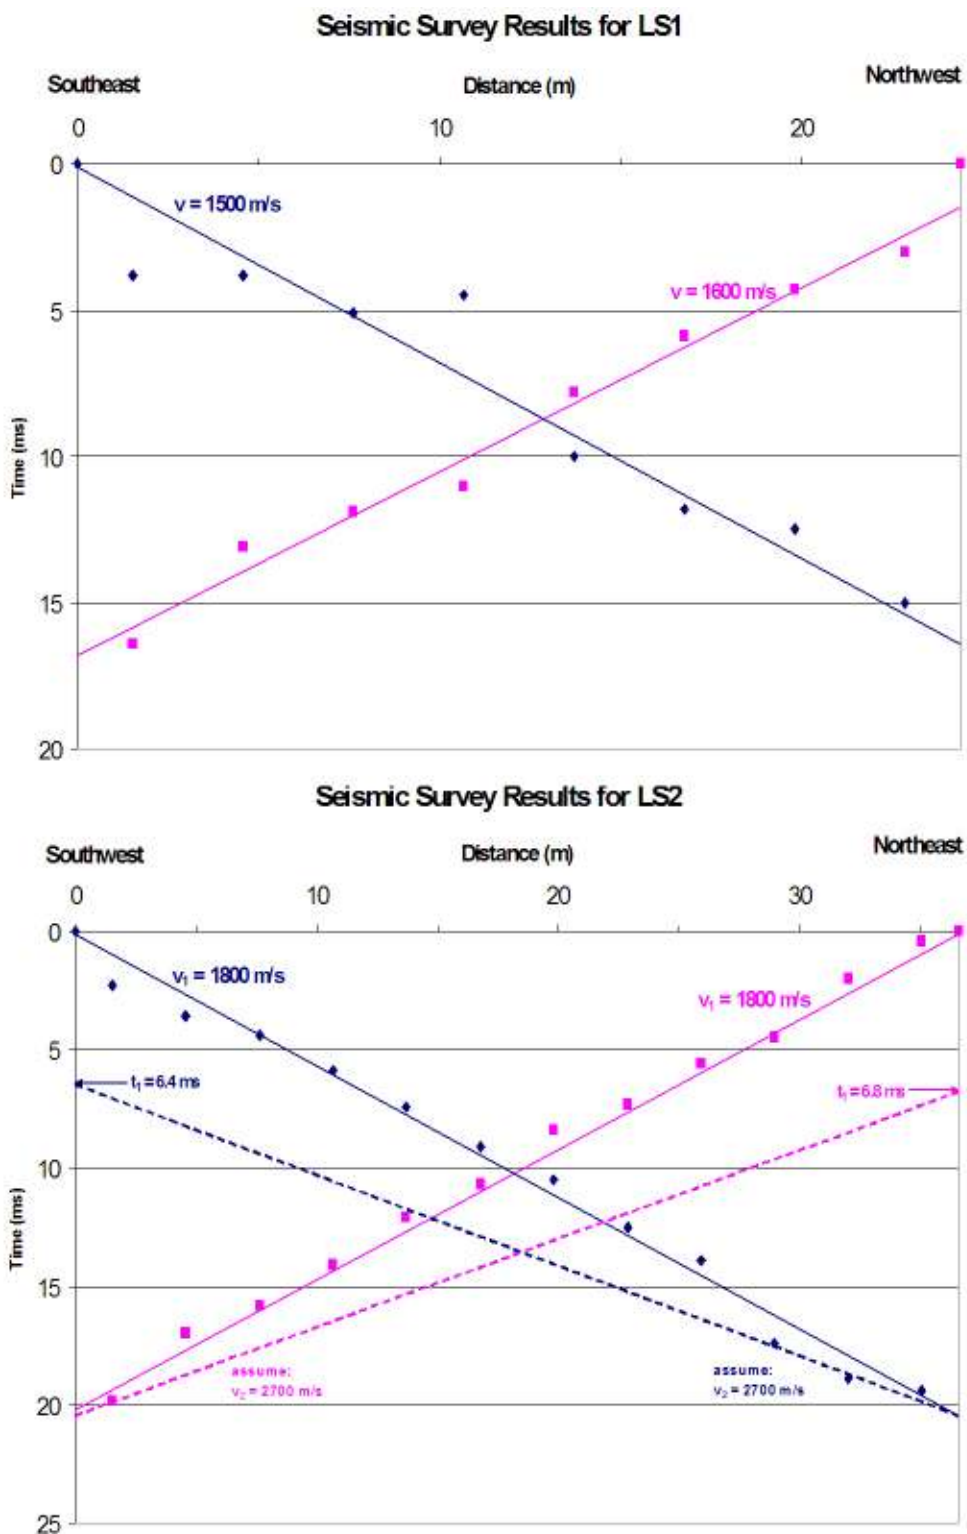
Figure 6-12 Seismic survey results for Lower Sunrise
