**STATE OF CALIFORNIA
REGIONAL WATER QUALITY CONTROL BOARD
SAN FRANCISCO BAY REGION**

SUBJECT: **EXECUTIVE OFFICER'S REPORT**

EXECUTIVE OFFICER’S REPORT: *May 2019*

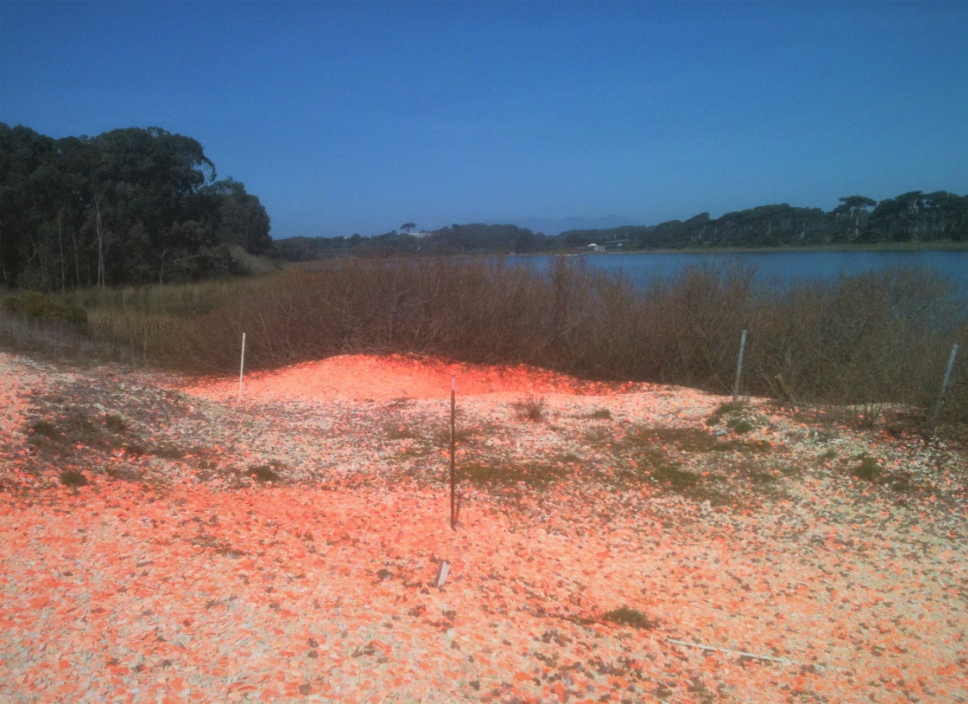
BEFORE CLEANUP:

Below are some pictures of the site before and after the upland soil cleanup.

Following approval of the RAP, the Gun Club members vacated the Club and excavation started in the uplands area in the spring of 2015. A total of 88,000 tons of contaminated soil was excavated and removed from the Site. Confirmation sampling showed that in all locations, save for two where further excavation was not feasible, the cleanup goals were met and the site future use is suitable for residential or unrestricted use. The cleanup cost \$22 million.

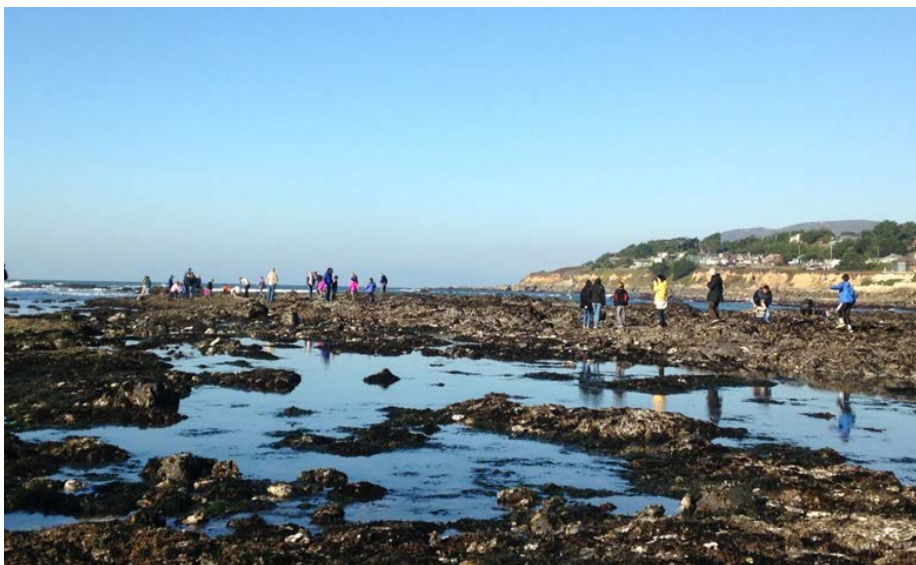
Figure 2. San Vicente Creek flowing into Fitzgerald Marine Reserve at the Pacific Ocean

The Plan's primary purpose was to reduce bacteria levels to meet recreational water quality objectives in the creek, especially considering the high public use near the creek mouth and tidepools located in Fitzgerald Marine Reserve (Figure 2). To accomplish this, the Plan identified bacteria sources of and implementation actions to reduce bacterial pollution. The high priority bacterial pollution sources included the following: horse waste from commercial horse facilities, pet waste, human waste from onsite wastewater disposal systems (OWTS), and municipal stormwater runoff. The implementation actions in the Plan consist of measures required by existing local, regional, and statewide regulations and Water Board orders to reduce or eliminate waste discharges from the high priority sources.

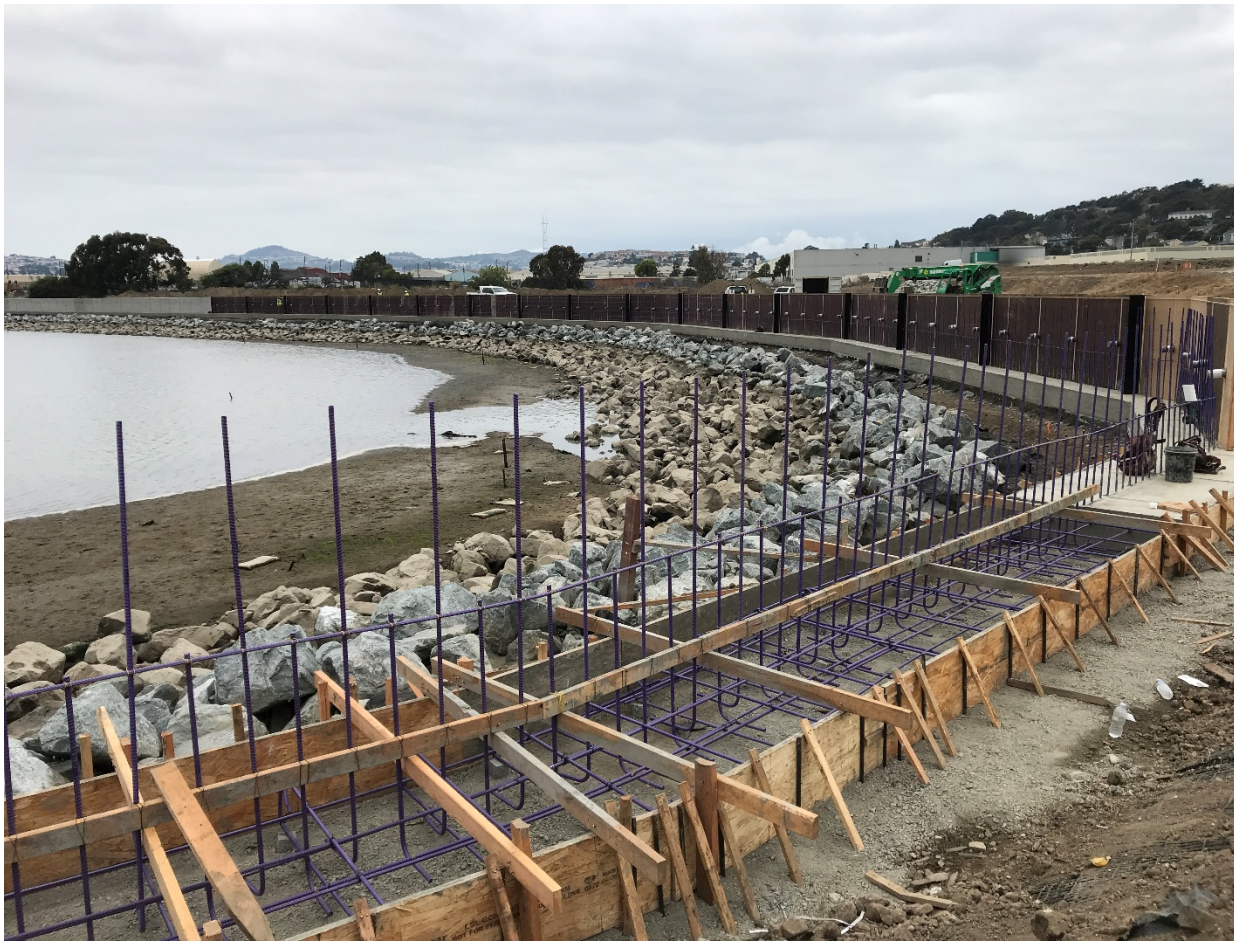
Figure 2. Construction of the parcel E-2 seawall and revetment (August 30, 2018)

Parcel E-2 is the site of the Shipyard landfill. The Navy's remedy for the landfill includes closing the landfill in place with a prescribed low-permeability cover, conducting long-term monitoring, excavating hotspots, installing a slurry wall between the landfill and the shoreline, and constructing a shoreline revetment structure and a seawall to protect against future sea-level rise and wave-induced scouring/erosion that could undermine the landfill remedy. The Navy completed hotspot excavations in 2016 and the slurry wall, shoreline revetment, and seawall were completed in 2018. The seawall is 1,800 feet long, 35 feet wide, and 12 feet high (above mean sea level). Water Board staff visited the site last August during seawall construction and took the photo shown in Figure 2.
