TOTAL MAXIMUM DAILY LOAD
TECHNICAL SUPPORT ANALYSIS FOR MERCURY
IMPAIRMENT
OF
CLEAR CREEK AND HERNANDEZ RESERVOIR

Central Coast Regional Water Quality Control Board

March 10, 2004

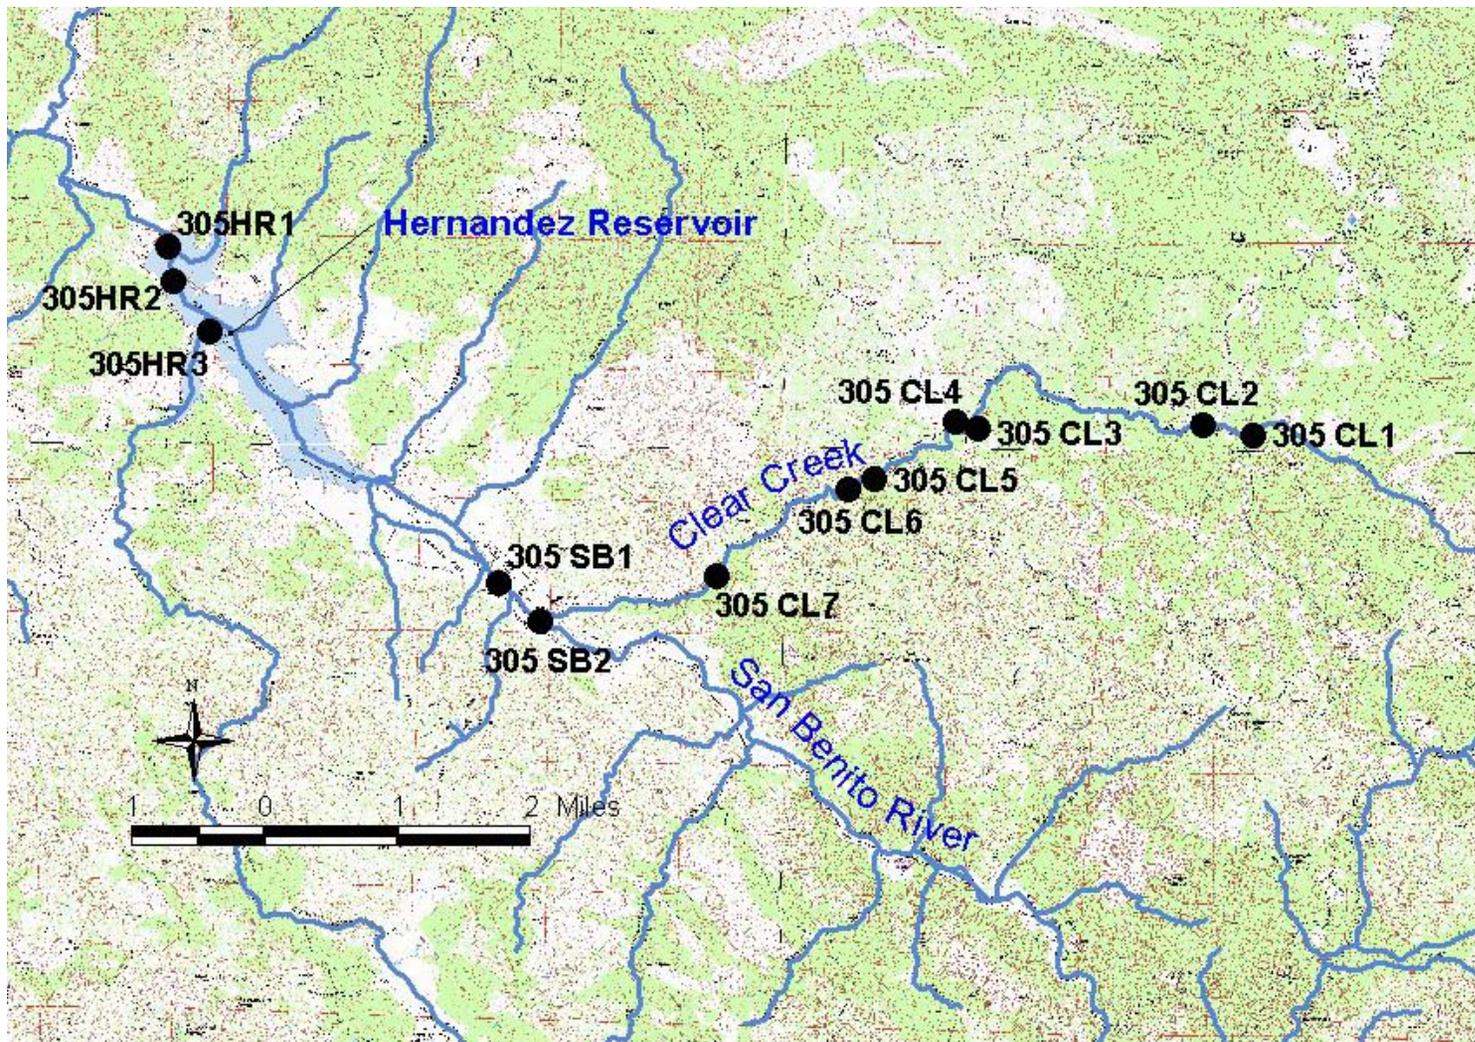
Figure 2. Map of Clear Creek area showing 2002 Sample Locations.

A limited number of samples in the database have been collected from areas upstream of anticipated mercury-rich mineral zones. Locations of samples collected by Regional Board staff in 2002, shown on Figure 2, are numbered 305CL"x" where "x" is a location number along the creek from the upstream site, CL1, to the USGS gage site, CL7. The three locations believed to be upstream of any significant impact from mercury mineralization are: CL1, CL2, and CL3. Maximum values of water and sediment samples from these locations suggest that background conditions in Clear Creek may be slightly less than 0.05 µg/L mercury in water and approximately 0.16 mg/kg mercury in sediment. The Regional Board database also includes two sediment samples from Clear Creek collected in 1998 with mercury levels of 0.18 and 0.19 mg/kg. The US Bureau of Land Management (2002a) has reported a local "background" concentration of mercury in "native bedrock (non-mercury ore)" as 0.2 parts per million (equal to 0.2 mg/kg), although the report does not detail how this number was determined. Considering the Regional Board 2002 samples, CCAMP samples from 1998, and the USBLM report, a reasonable estimated background mercury content of sediments in the Clear Creek watershed is about 0.2 mg/kg, which is slightly above the NOAA TEL (0.174 mg/kg) and well below the NOAA PEL (0.486 mg/kg). Background water column levels of mercury appear to be just below the 0.050 µg/L CTR objective.

For the 2002 sampling, seven locations were selected on Clear Creek and positioned to evaluate potential water quality impacts from the two major categories of activity. Sample locations were mostly located in pairs to evaluate water quality immediately upstream and downstream of a targeted area. For example, sites CL1 and CL2 were located upstream of any mining influences and bracketed an area of extensive OHV activity. Similarly, sample sites CL3 and CL4 were located just upstream and

downstream of side drainages entering the creek in the vicinity of the Alpine mine and the Clear Creek mine. A third set of sample sites, CL5 and CL6, was located in the vicinity of OHV Staging Area Two.

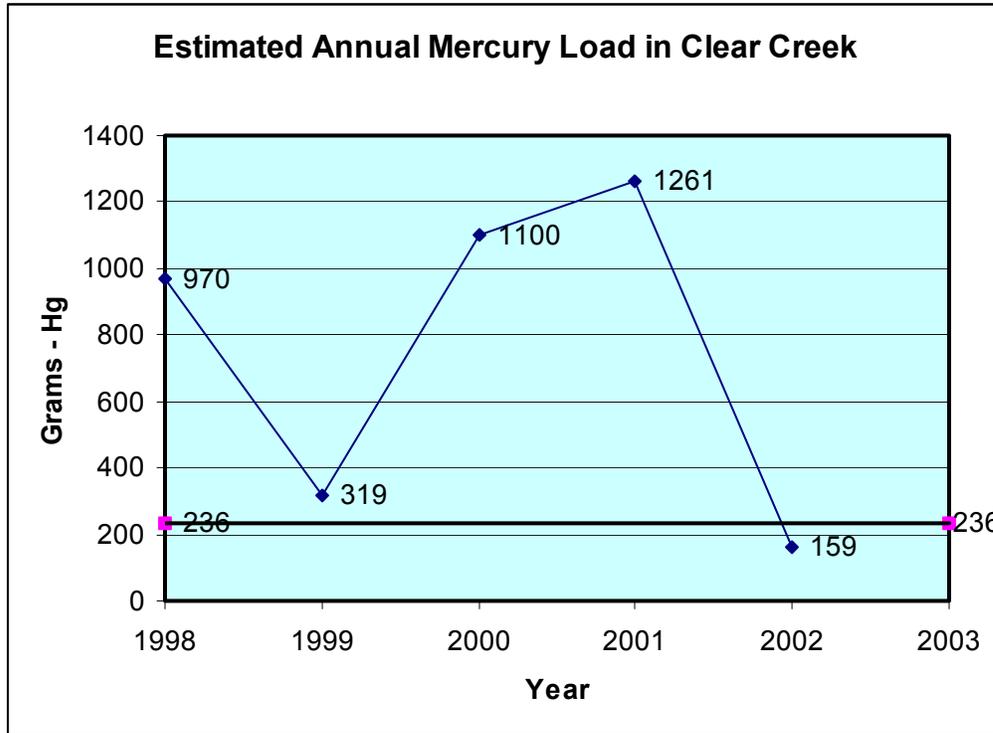
Figure 3. Estimated Clear Creek Loads in Recent Years.

The pattern of the data is a little clearer if some minor assumptions are made and the estimated current loads are plotted. This is shown in Figure 3, where estimated loads from the last 5 years are shown. These estimated loads were calculated using the average monthly flow data for the Clear Creek USGS gage, the water-column mercury level averaged from samples reported in Table 3, or, for those seasons where no water sample data were collected, assuming the water column mercury was at the 0.05 µg/L level. Although this assumption may impact the estimated loads shown in the graph, the fairly

consistent timing of sample collection during the years 1998 – 2002 make it a reasonable aid to understanding the available data.

From Figure 3, one can see that, although the 2002 estimated load (159 grams) is below the target for Clear Creek (236 grams), the 2002 load estimate is a marked improvement from previous years and suggests that the target load may be maintained in the future.

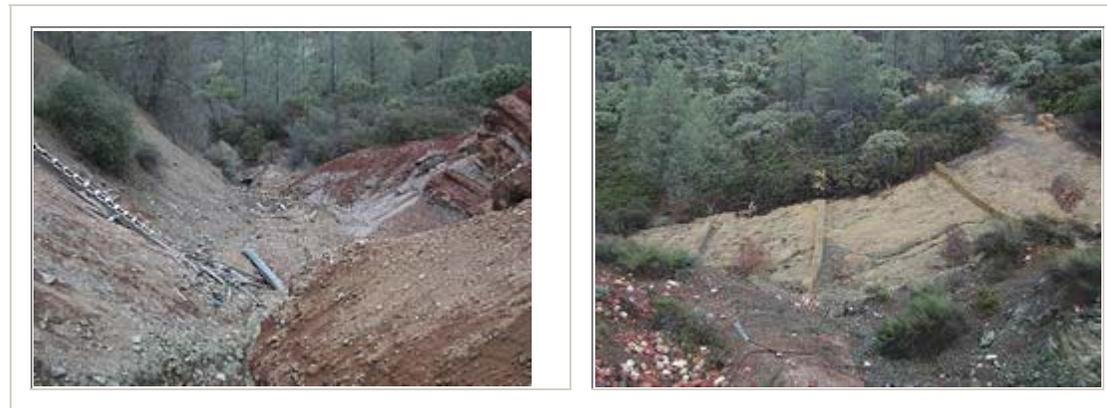
Alpine Millsite before and after cleanup and restoration

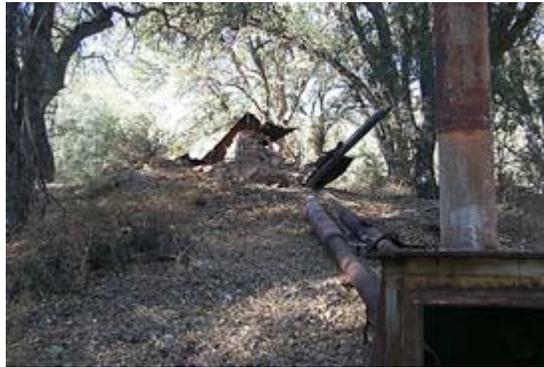
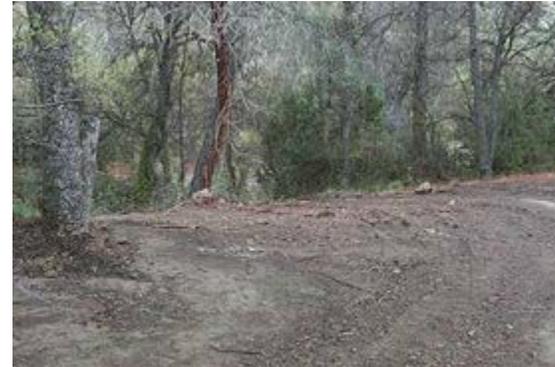
Jade Millsite before and after cleanup and reclamation

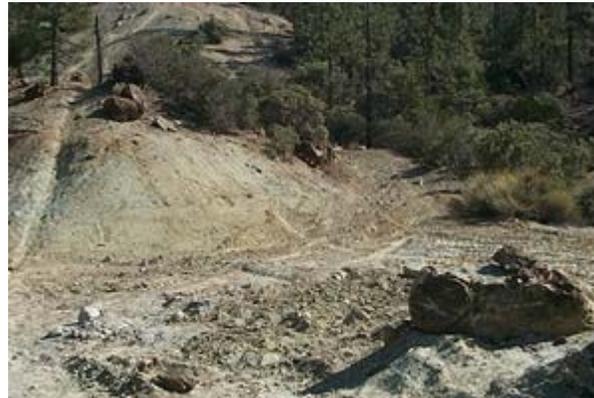
Xanadu mill site after restoration

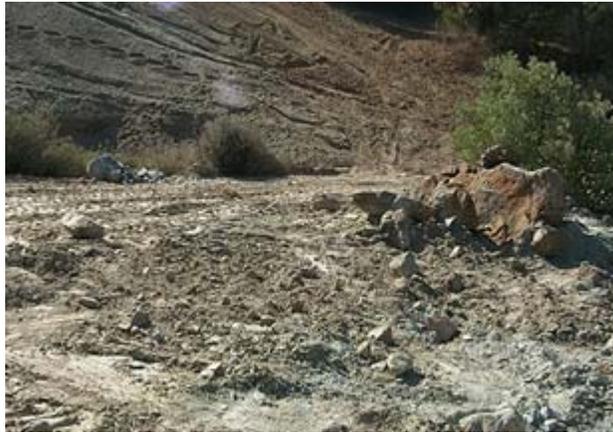
Xanadu mill site after restoration

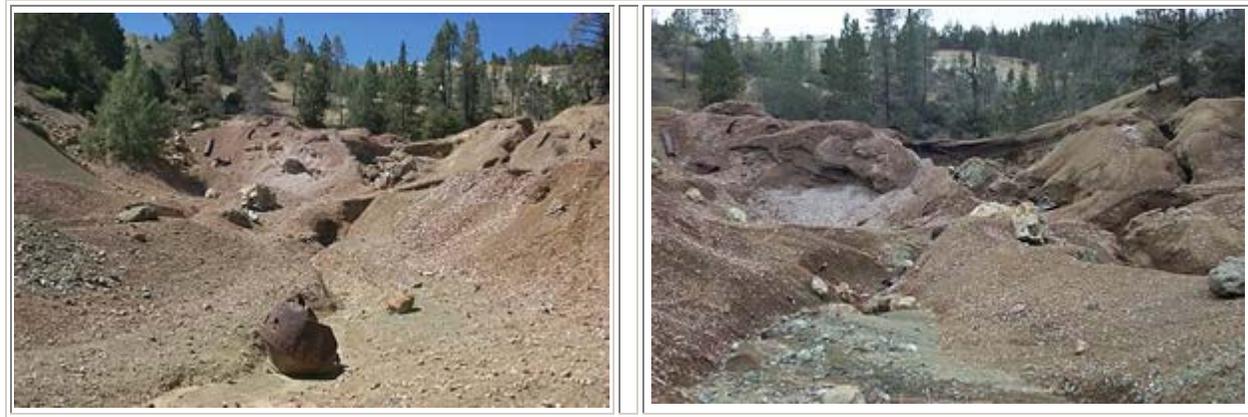
Calcine tailings before reclamation and cleanup
