# **Phase 6: Regulatory Action**

## **Final Project Report**

### **Total Maximum Daily Load for Nutrients and Dissolved Oxygen in Chorro Creek, San Luis Obispo County, California**

**July 2006**

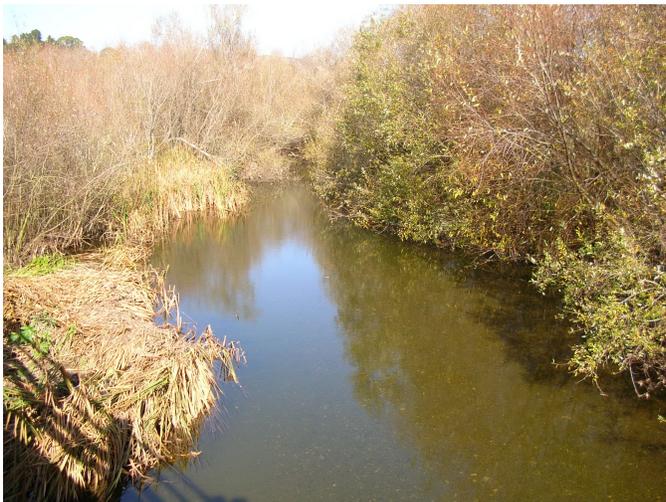
Reduced slope in lower reaches also plays a role in minimizing re-aeration, and could counteract the increased flow. Reduced slope, and therefore reduced turbulence, is apparent at monitoring sites TWB and CCR. Figure 4.1 is a photograph of site TWB. Note the smooth water surface and absence of turbulence. Re-aeration of oxygen at this site and site CCR is minimal. *We will discuss, in a subsequent section, the resulting dissolved oxygen level at site TWB.*

**Figure 4.1 Site TWB, illustrating lack of re-aeration due to absence of turbulence.**

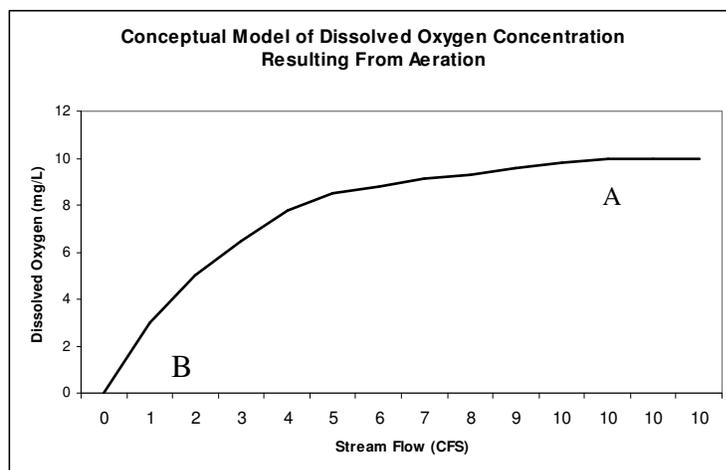
Dissolved oxygen concentration can rise to a saturation level under high flow conditions, noted at letter “A.” Conversely, dissolved oxygen concentration will be lower under decreasing flow conditions, noted by letter “B,” eventually reaching zero when flow ceases completely. *It is therefore reasonable to conclude that under decreasing flow conditions, there will be some point at which dissolved oxygen will be less than the desired 7 mg/L protective of the COLD beneficial use.* As such, excursions of the dissolved oxygen water quality objectives are inevitable in streams where flow gradually diminishes to zero. Such is the case in Chorro Creek and its tributaries. Water flow is minimal in the late summer months.

Figure 4.2 Conceptual model of dissolved oxygen concentration as a function of flow.

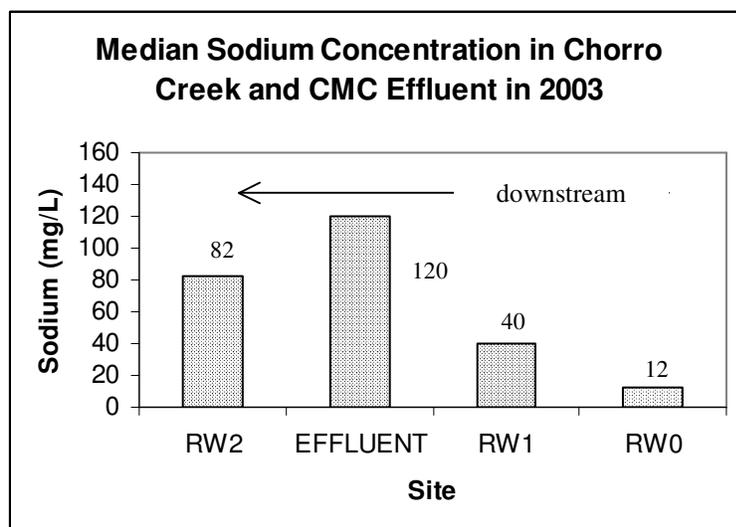
Developed from 2003 CMC monitoring reports.

**Figure 4.3 Median sodium concentration in Chorro Creek and effluent in 2003.**

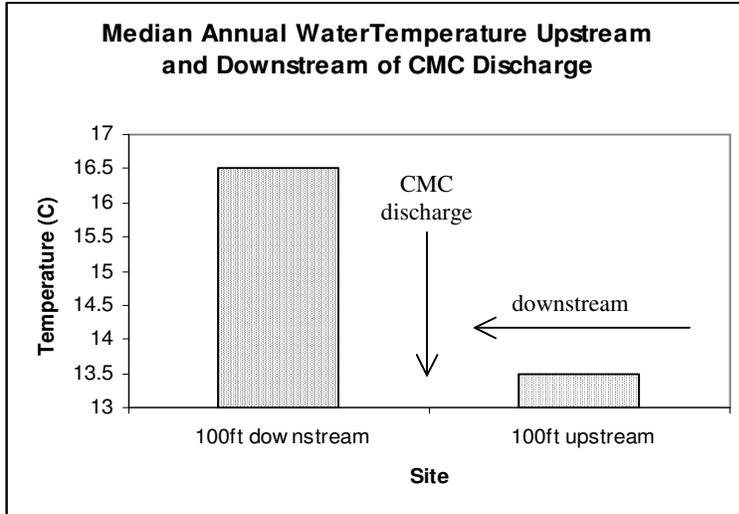
Receiving water temperature, like sodium, is affected by the CMC discharge. The CMC discharge increases receiving water temperature. Figure 4.4 illustrates the increase in temperature downstream of the CMC outfall.

Figure 4.4 Receiving water temperature downstream and upstream of CMC discharge

*The increase in temperature resulting from the CMC outfall reduces oxygen solubility in downstream waters.*

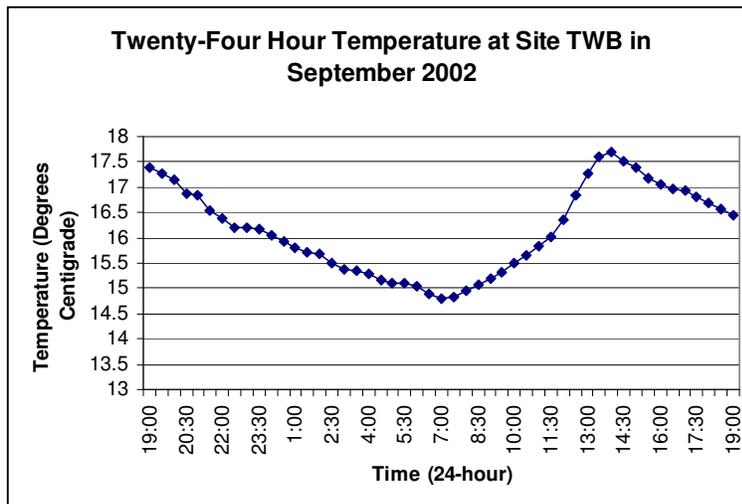
Discharge from the CMC is not the only source of temperature increase in Chorro Creek (Creek). Some sites along the Creek have minimal or absent overhead canopy. Solar radiation on the Creek is not interrupted, thereby causing stream temperatures to rise during peak solar hours. Figure 4.5 illustrates 24-hour stream temperature at site TWB. Please see in Figure 4.1 that site TWB receives direct solar radiation on the water surface and stream bottom at this site.

Figure 4.5 Twenty-four hour stream temperature at site TWB.

Note from the temperature graph that peak temperature occurs during mid-day hours. The data indicates that solar radiation is causing increased water column temperature. The increased temperature affects dissolved oxygen levels in the Creek by reducing oxygen solubility. In

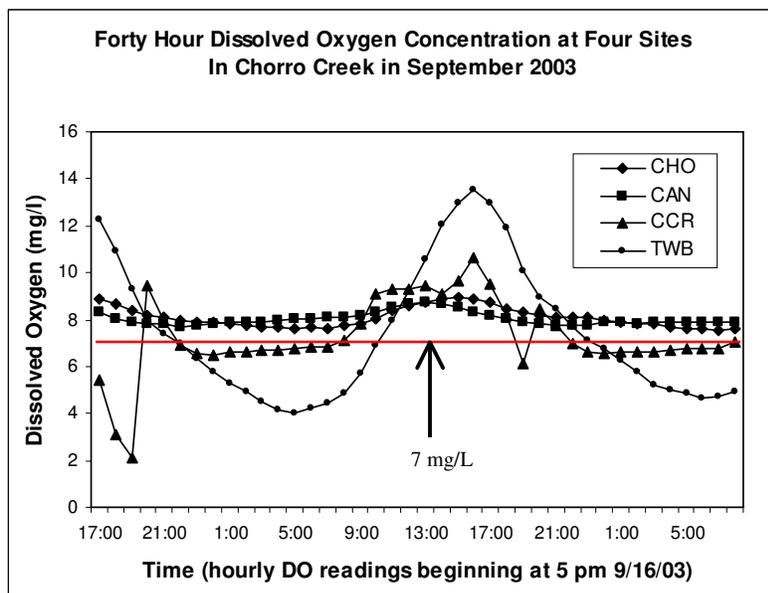
Recall that the water quality objective for dissolved oxygen is 7 mg/L; dissolved oxygen concentration is not to fall below this level in order to be protective of the COLD beneficial use. Staff compiled predawn and daylight hour dissolved oxygen data. Figure 4.6 illustrates dissolved oxygen levels in Chorro Creek during a 40-hour period in September 2003. Table 4.6 shows the number of exceedences of the dissolved oxygen objective at each site during this 40-hour period.

Please refer to Figure 4.10 for an illustration of the site locations in Figure 4.3. Site TWB is near the mouth of Chorro Creek. Site CCR and TWB are downstream of the confluence with San Bernardo and San Luisito Creeks. Site CAN is upstream of these tributaries, but downstream of the CMC discharge. Site CHO is in the upper watershed, and is upstream of the CMC discharge.

Figure 4.6 Forty Hour Dissolved Oxygen Concentration in Chorro Creek

It is clear from Figure 4.6 and Table 4.6 that the dissolved oxygen objective is not being achieved at sites TWB and CCR during the early morning hours. Site TWB, located near the mouth of Chorro Creek watershed, displays evidence of dissolved oxygen affected by the presence of algae. Note that dissolved oxygen levels fall well below the 7 mg/L threshold at this site during the evening and predawn hours, whereas afternoon levels are an order of magnitude higher, relative to predawn hours; an oxygen curve as this is typical of waters affected by photosynthesis and respiration of aquatic plants. Also note that the benthic algal cover at site TWB reaches as high as 99%. No quantified data for algal cover is available for site CCR. However, anecdotal information suggests that site CCR carries maximum algal levels similar to that of site TWB.

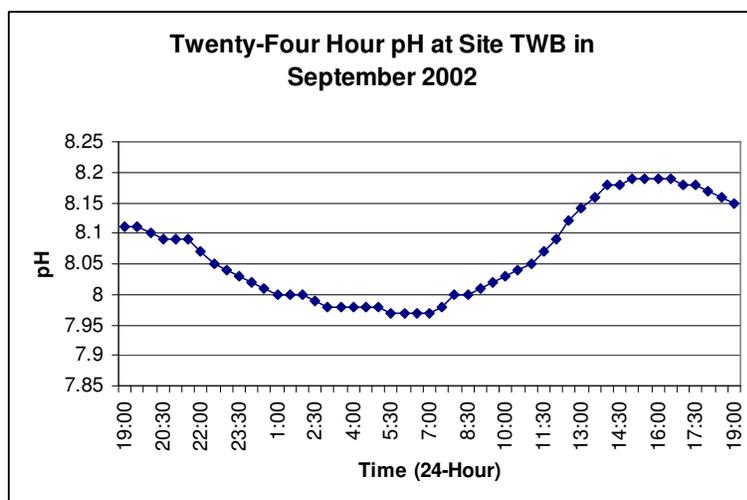
Respiration of aquatic plants, e.g. benthic algae, affect water column pH. Photosynthesis is accelerated during afternoon hours when peak solar radiation is present. Photosynthesis by algae uses water column carbon dioxide. The reduced carbon dioxide has a net affect of increasing pH. Therefore, accelerated respiration during daylight hours is indicated by a corresponding increasing pH during these hours. Figure 4.7 illustrates water column pH at site TWB during a 24-hour period in September 2002. Note that pH rises during mid-to-late afternoon hours, corresponding to peak solar radiation hours.

Figure 4.7 Twenty-four hour pH levels at site TWB.

The diurnal dissolved oxygen curve of Figure 4.7, in combination with the algal levels observed in the lower part of the watershed (sites TWB and CCR) and pH fluctuations at this site, indicates that low dissolved oxygen levels are, at least in part, driven by benthic algae.

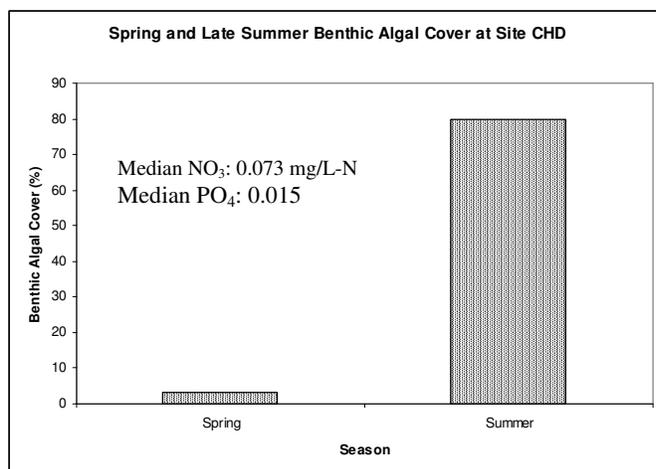
Figure 4.8 illustrates typical benthic algal cover at site CHD. Note that benthic algae cover rises dramatically in the summer to 80%. This algal cover occurs in the presence of background levels of nitrate-N and orthophosphate. Therefore, an increase of nutrient availability above the current level at site CHD will not be met with corresponding increase in algal cover, since algal cover is nearly 100% at background nutrient levels.

**Figure 4.8 Benthic algae cover at reference site CHD in Chorro Creek**

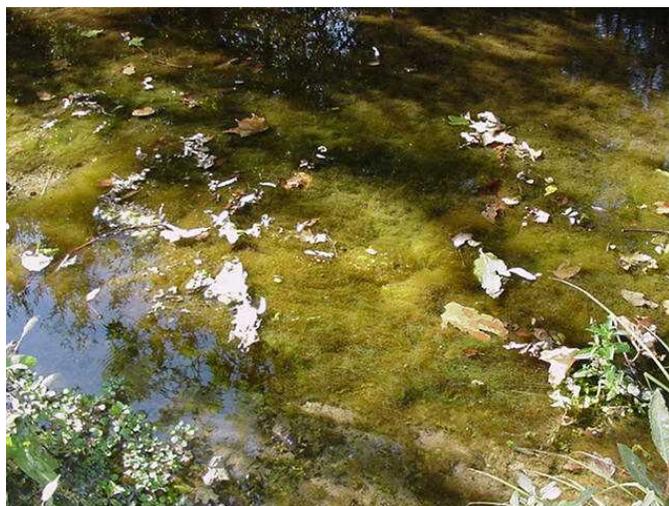
The phenomenon of high algal cover in the presence of background nutrient availability is noted not only in the Chorro Creek watershed, but also in other watersheds in the Central Coast Region. Figure 4.9 is a photograph illustrating nearly 100% algal cover in Stenner Creek Watershed, which is adjacent to the Chorro Creek watershed. The site of the photograph carries median nitrate-N levels of 0.05 mg/L-N and median orthophosphate levels of 0.03 mg/L-P. Staff observes that as flow is reduced during the summer months, water temperature rises, algal density increases, and dissolved oxygen levels are reduced.

**Figure 4.9 High algal cover in waters with background nutrient levels. Stenner Creek.**

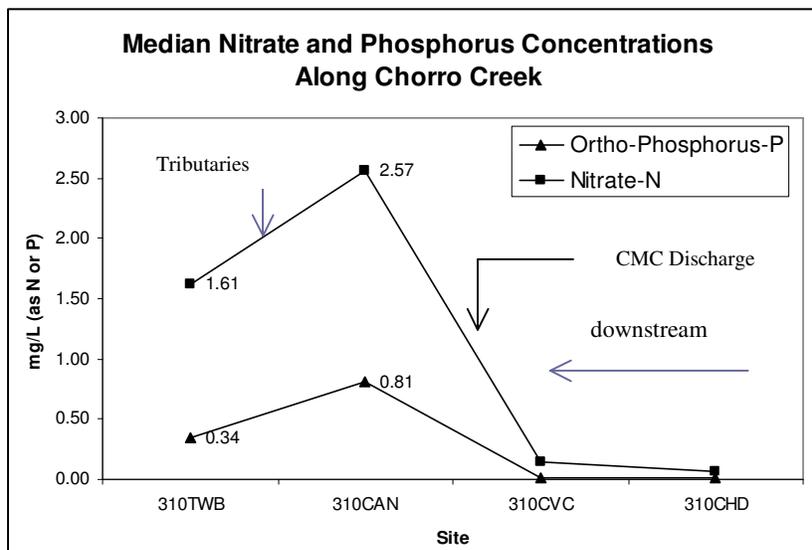
Figure 4.11 Median and Maximum orthophosphorus and nitrate-N concentration at main stem sites of Chorro Creek

Note from the figure above that nitrate-N concentration at site TWB is 1.61 mg/L, which is within 0.11 mg/L-N of upper end of the range (0.2 – 1.5 mg/L-N) suggested to protect against nuisance algal growth. This is an important fact, because recall it is site TWB that is not achieving the dissolved oxygen numeric target, which is in part driven by algal levels present here. Conversely, the orthophosphorus-P concentration at TWB (0.34 mg/L-P) is within the suggested range (.038-.4 mg/L-P). Finally, the tributaries of San Bernardo and San Luisito have a confluence upstream of site TWB. Note that both nitrate-N and orthophosphorus-P concentrations are lower downstream of these confluences, relative to site 310CAN, indicating that discharge from these tributaries are not causing a rise in nitrate-N and orthophosphate-P concentration. Discharges to Chorro Creek from these subwatersheds are discussed below.

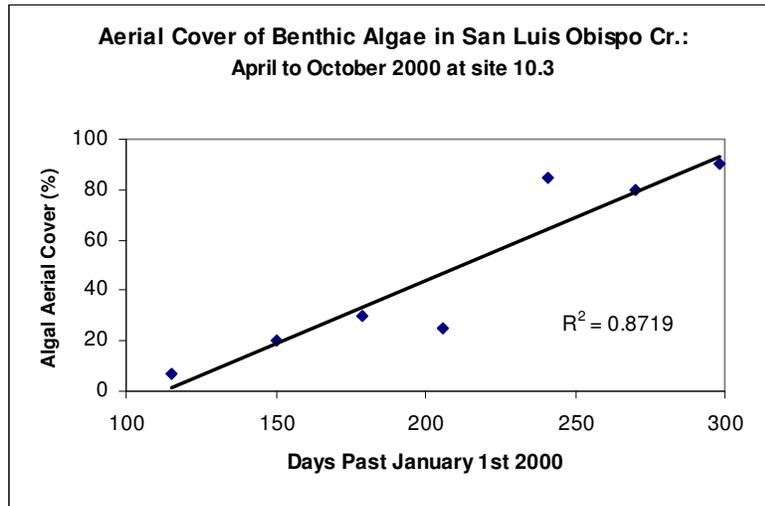
Days of accrual is an apparent factor in benthic algae presence in central coast streams. Staff compiled monitoring data associated from a watershed adjacent to Chorro Creek watershed that confirms the  $D_a$  factor of algal growth. Figure 4.12 illustrates algal cover as a function of the number of days since January 1<sup>st</sup>.

**Figure 4.12 The  $D_a$  affect: Benthic algae cover in San Luis Obispo Creek as a function of number of days since January 1.**

Note from Figure 4.12 that algal cover continues to increase further in time away from winter rain months. The same phenomenon occurs in Chorro Creek. A strong correlation exists between the number of days of accrual and algal cover. The Mediterranean climate of the central coast of California does not produce flows during summer months adequate to scour algae from stream substrate. Scouring does occur in isolated areas of local stream systems, such as along riffle areas where elevation gradients cause increased flow velocity. However, for many reaches in Chorro Creek, summer brings decreasing flow velocity and corresponding increasing algal cover.

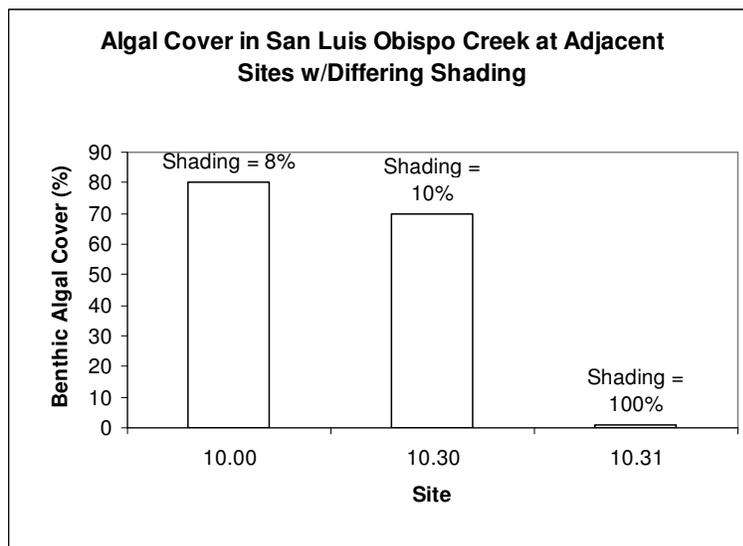
Figure 4.13 illustrates how algal cover responds to varying shading through canopy cover at adjacent sites in San Luis Obispo Creek, a watershed adjacent to Chorro Creek watershed. All other factors are held equal between the sites, i.e., the stream substrate, nutrient regime, temperature, hydraulics, etc. are equal at the sites. Only canopy cover is variable at these sites.

Figure 4.13 Benthic algae cover in San Luis Obispo Creek with varying canopy cover.

Note the dramatic decline in algal cover when overhead canopy is 100%. The same phenomenon occurs in Chorro Creek, as illustrated in Figure 4.14.

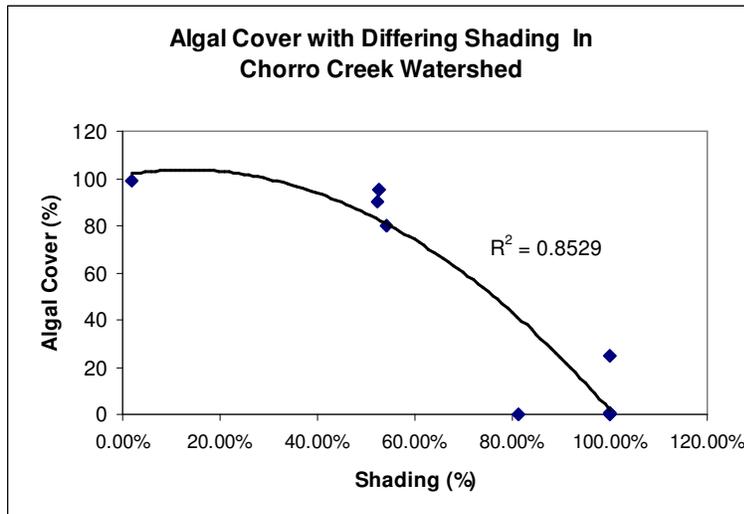
Figure 4.14 suggests that an inverse relationship between algal cover and shading exists in Chorro Creek; areas with higher shading carry lower algal cover. This relationship is consistent with the strong correlation between algal cover and days of accrual because as days of accrual increases, so does water temperature. Similarly, as overhead canopy decreases, water temperature increases, and algal cover increases.

**Figure 4.14 Benthic algae cover in Chorro Creek with varying canopy cover.**

Note in Figure 4.14 that algal cover in excess of the desired 40% (see Chapter 3) cover occurs when shading is about 70% or less. Recall from Table 4.6 that dissolved oxygen concentrations fall below water quality objectives at monitoring sites TWB and CCR. The canopy cover and corresponding algal cover at site TWB during late summer is:

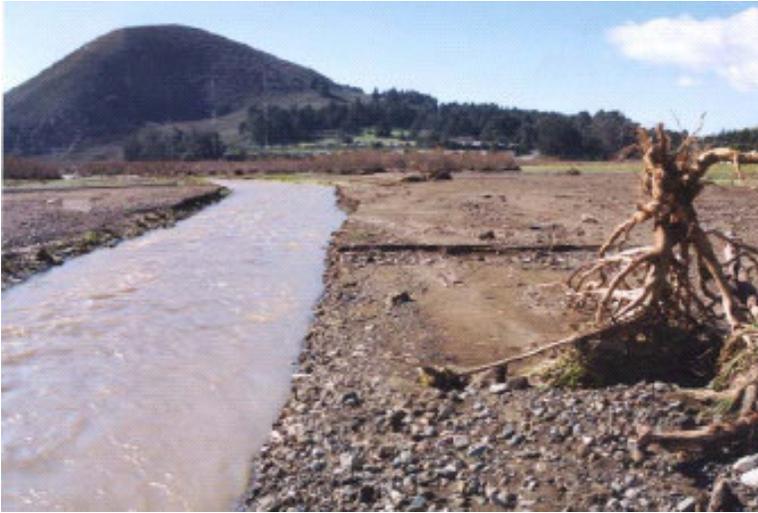
Figure 7.1 illustrates a section of Chorro Creek at Chorro Flats in 1998, before revegetation efforts. Note the hill on the left side of the photograph. Figure 7.2 illustrates the same location

**Figure 7.1 Photo of Chorro Flats in 1998.**

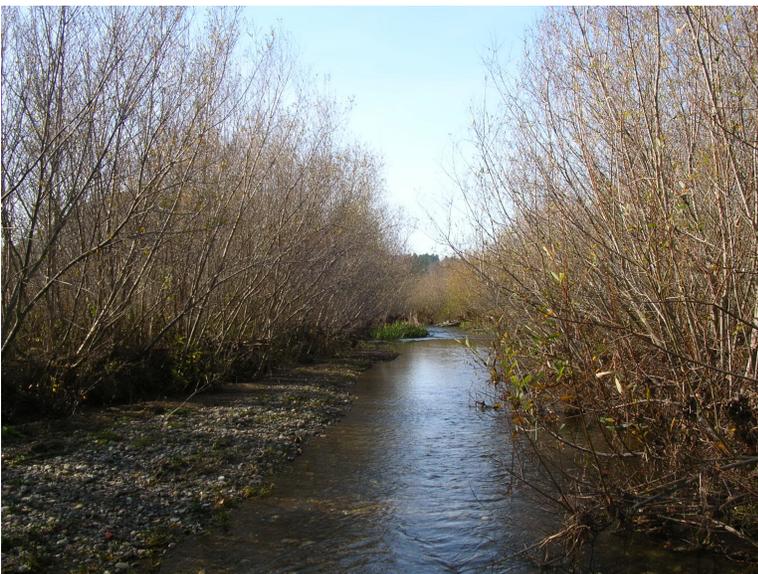
in January 2006, again note the hill on the left of the photograph, now behind riparian canopy. Also note in Figure 7.2 that a gravel bar has formed on the left due to reduced flow velocity brought on by greater sinuosity. The deposited gravels produce riffle areas where oxygen is aerated into the water column. Finally, note from Figure 7.2 that although the canopy has dramatically increased since 1998, the canopy area directly over the channel is not yet completely filled in. Staff is confident that the stream will be fully shaded as the riparian forest matures, thereby limiting algal growth with the net result of increasing dissolved oxygen over current levels.

**Figure 7.2 Photo of Chorro Flats in 2006.**

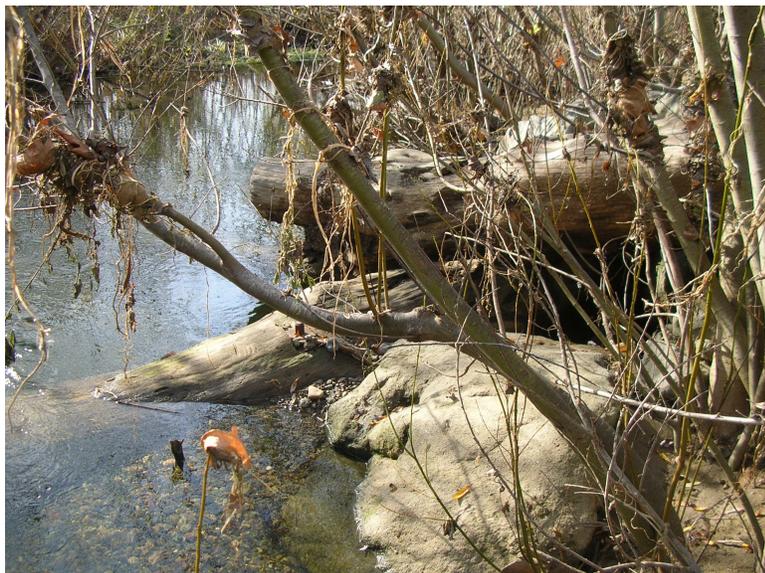
Over thirty engineered rock and log structures were constructed in the Chorro Flats area to enhance fish habitat. The structures are creating more turbulent flow, deeper pool areas, and the deposition of gravels, all of which will create conditions for the opportunity of increased dissolved oxygen. Figure 7.3 illustrates one of the rock-log structures in Chorro Flats.

Figure 7.3 Instream rock and log structure.

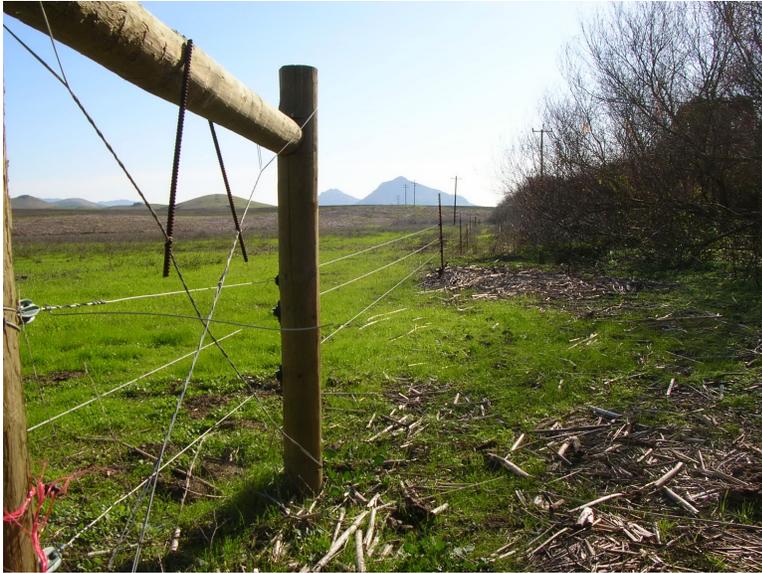
The fencing has created a riparian buffer zone of approximately 50-feet on each side of the channel, creating an overall 100-foot riparian buffer along Chorro Creek. Figure 7.4 is a photograph of the newly constructed fencing.

**Figure 7.4** Chorro Creek Ecological Reserve.

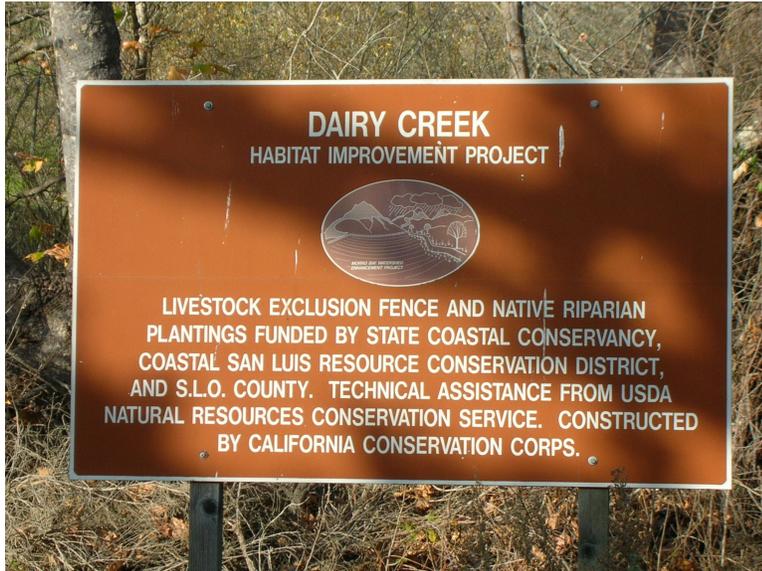
Gap-fencing was installed in 1995 along Dairy Creek for approximately one and a half miles of stream length. In addition, native willow and oak trees were planted in the riparian area of the fencing. A mature riparian forest is developing in the protected areas. Figures 7.5 and 7.6 are photographs of the gap-fence project area. Note in Figure 7.6 the clear distinction in the riparian forest between the protected fenced area and the open (gap) area. As with the Chorro Flats and Chorro Creek Ecological Reserve, the riparian forest along Dairy Creek is not yet mature, but staff is confident that given time, the riparian vegetation will limit algal growth, thereby limiting oxygen demand, while at the same time increasing oxygen input and solubility.

**Figure 7.5 Entrance of gap-fence area along Dairy Creek.**

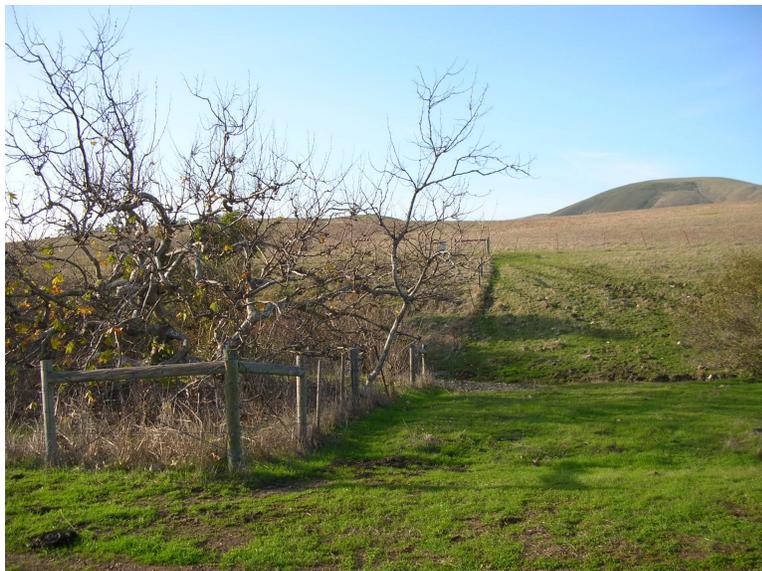
**Figure 7.6 Gap and fenced area of Dairy Creek.**

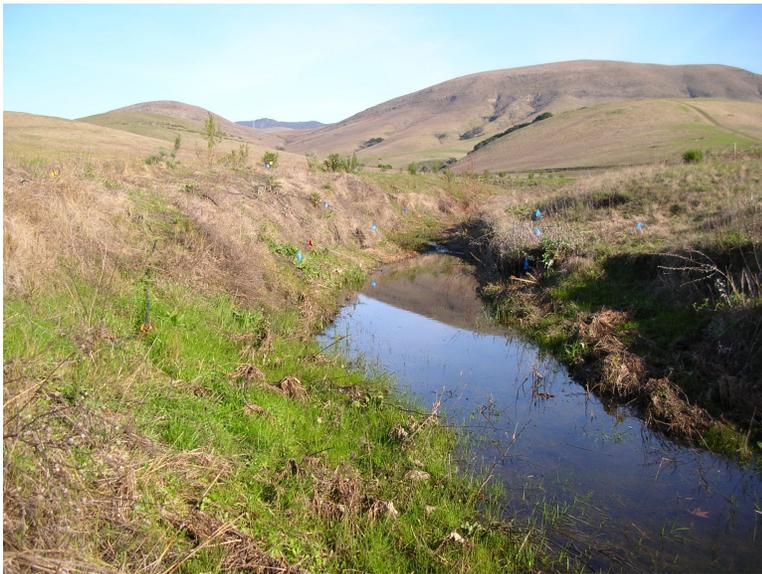
Figure 7.7 is a photograph of the fencing and revegetation project along Walters Creek. Note the blue flags along the creek bank indicating tree plantings. Figure 7.8 is an installed rock structure. When flows are present, water will plunge over the structure, thereby causing increased dissolved oxygen in flowing water.

**Figure 7.7 Walters Creek fencing and revegetation project.**

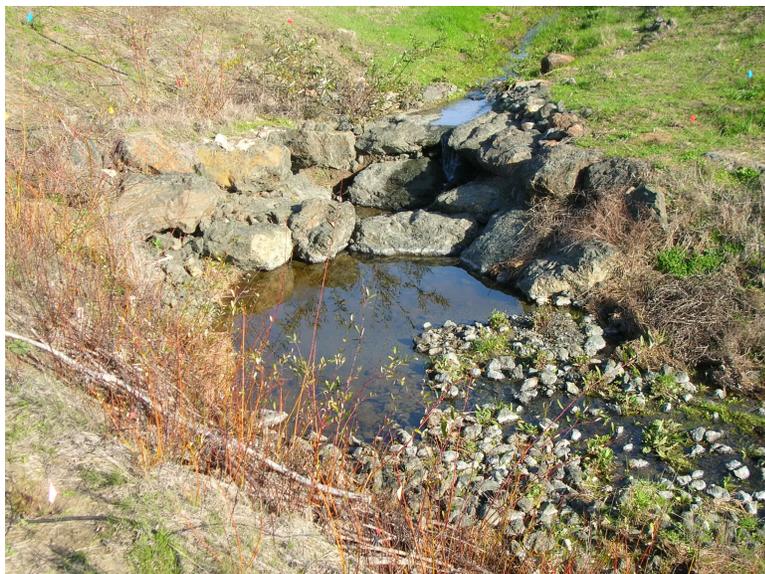
Figure 7.8 Installed rock structure in Walters Creek.
