Montecito Sanitary District's Response to the Thomas Fire 1/9 Debris Flow Event

RWQCB June 28, 2018

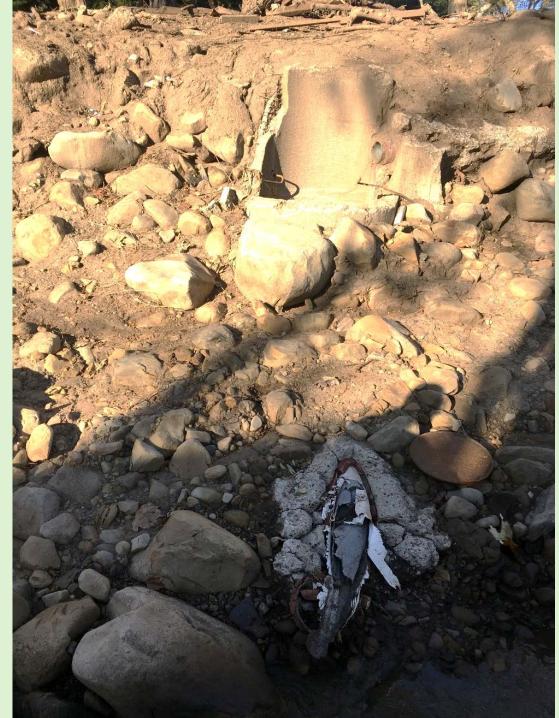
Montecito Creek

DAMAGED
MANHOLE AND
PIPELINE

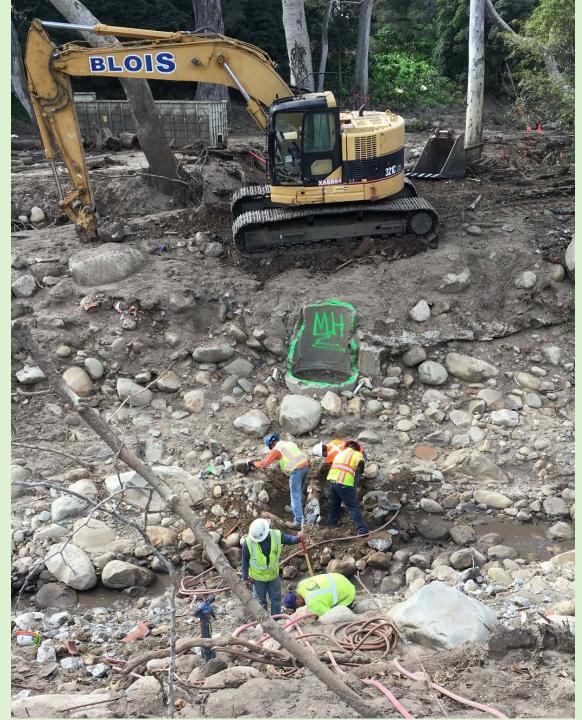
Montecito Creek

REPAIRS UNDERWAY

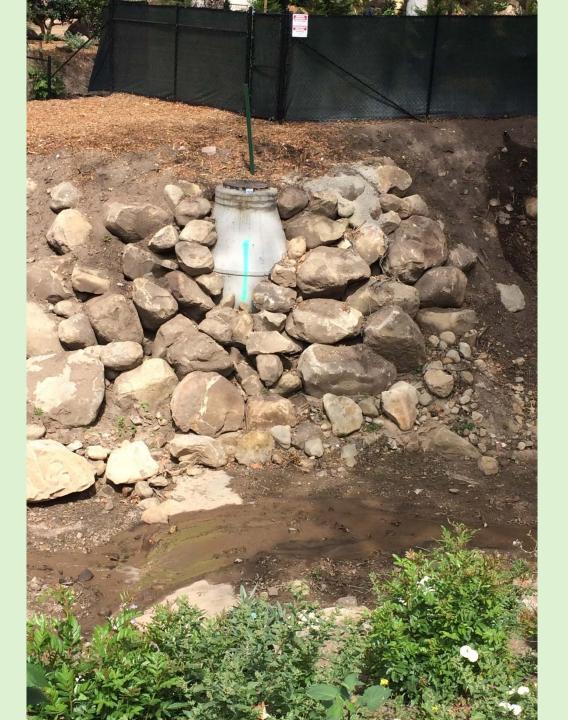
Montecito Creek

TODAY

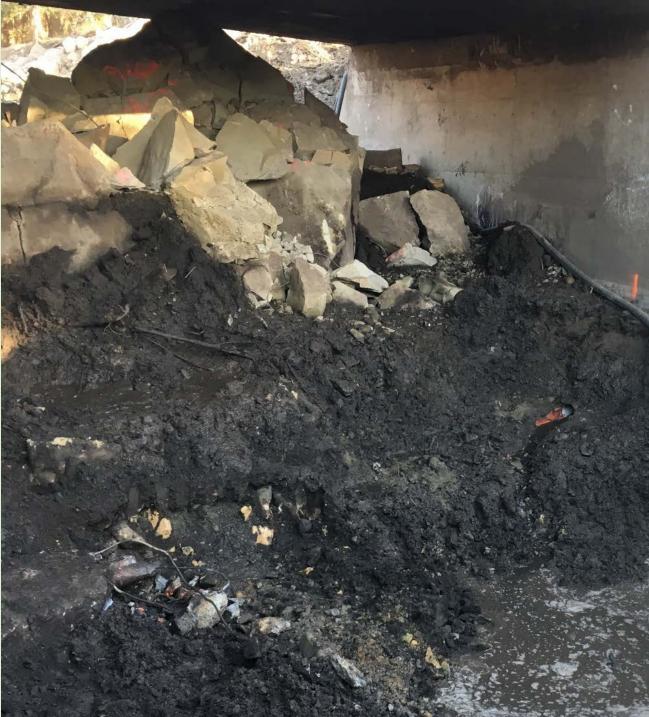
DAMAGED PIPELINE

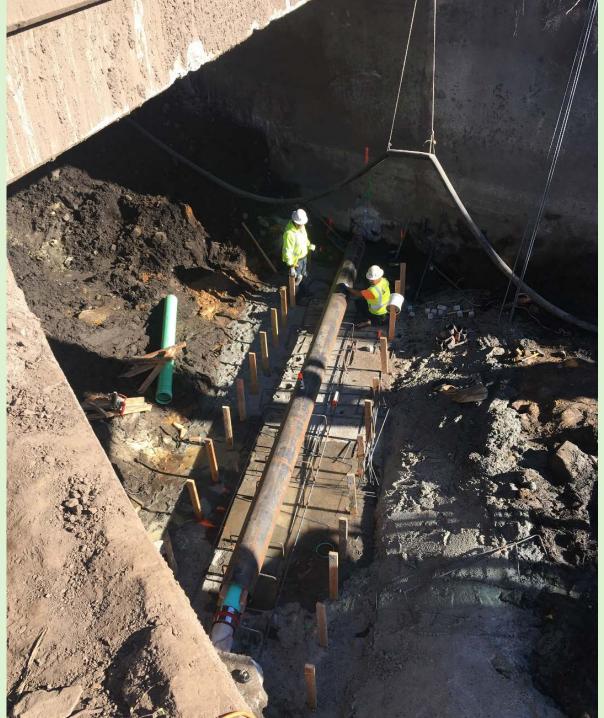
REPAIRS UNDERWAY

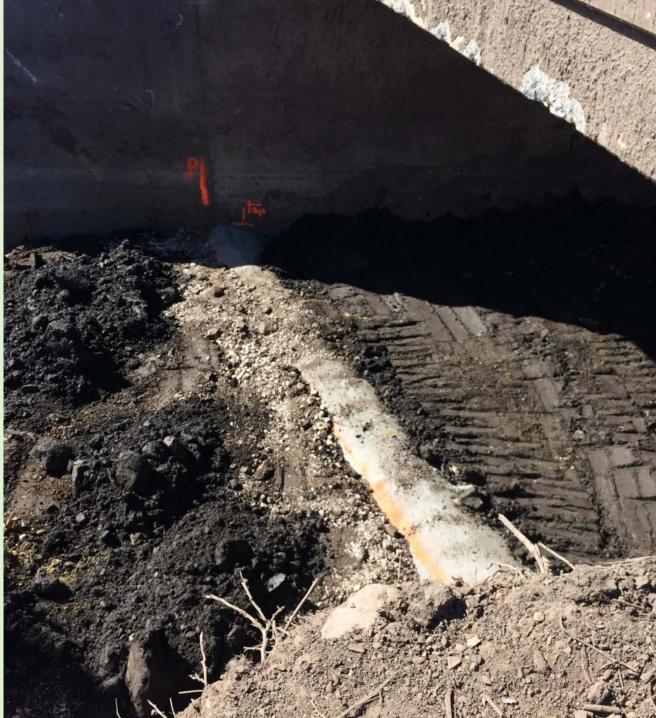
ENCASED PIPELINE

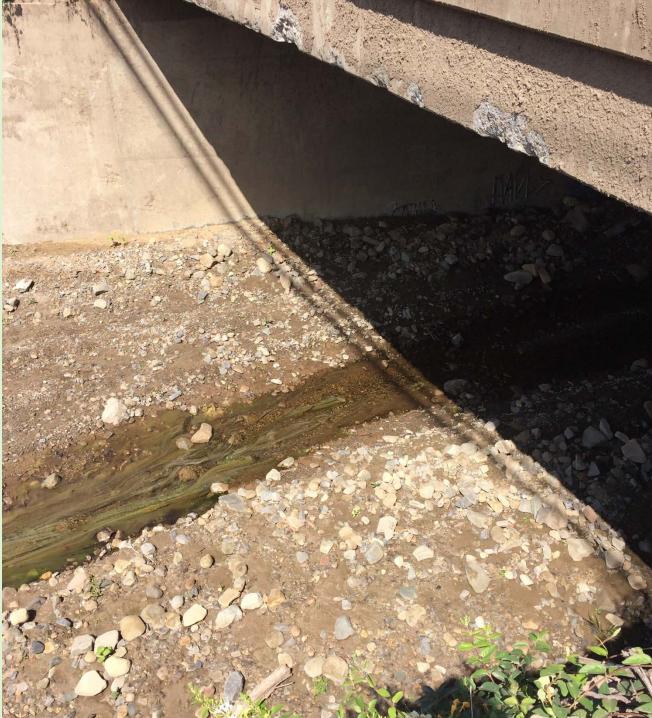
TODAY

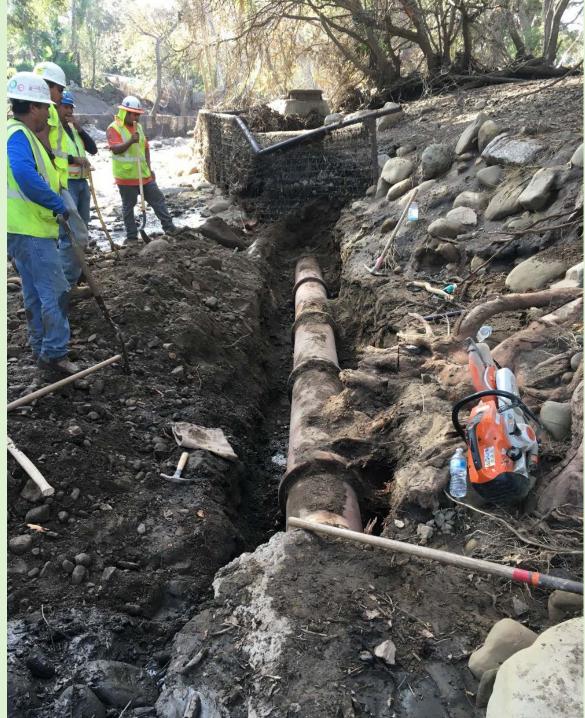
Romero Creek

DAMAGED PIPELINE

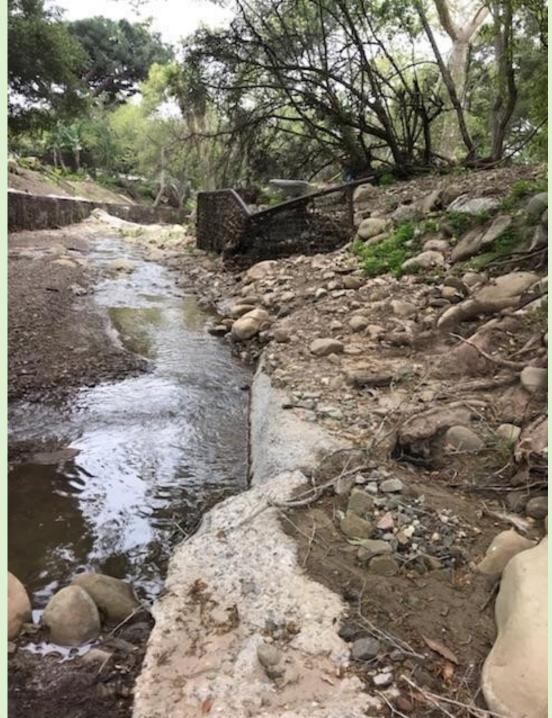
Romero Creek

ENCASED PIPELINE

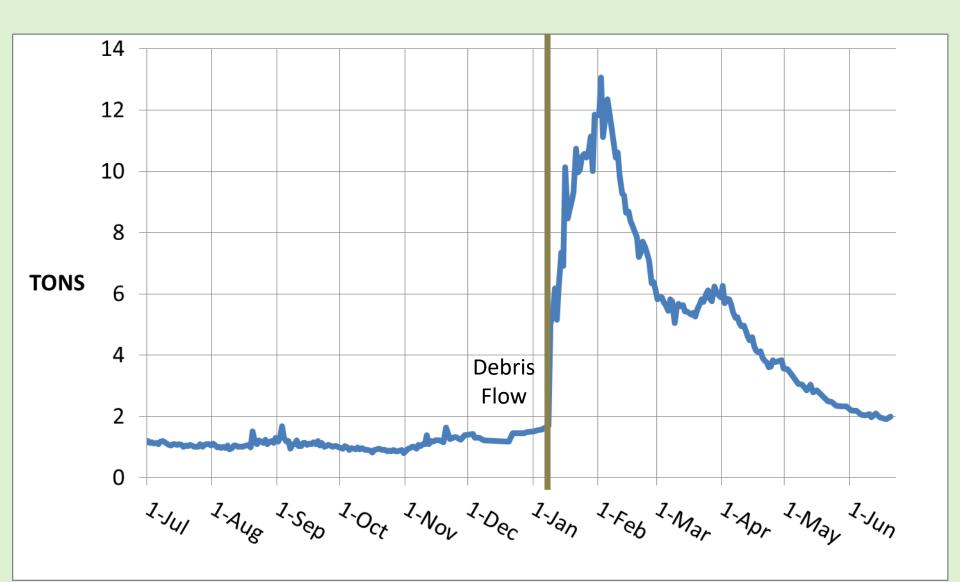
Inorganic Material in Treatment Plant

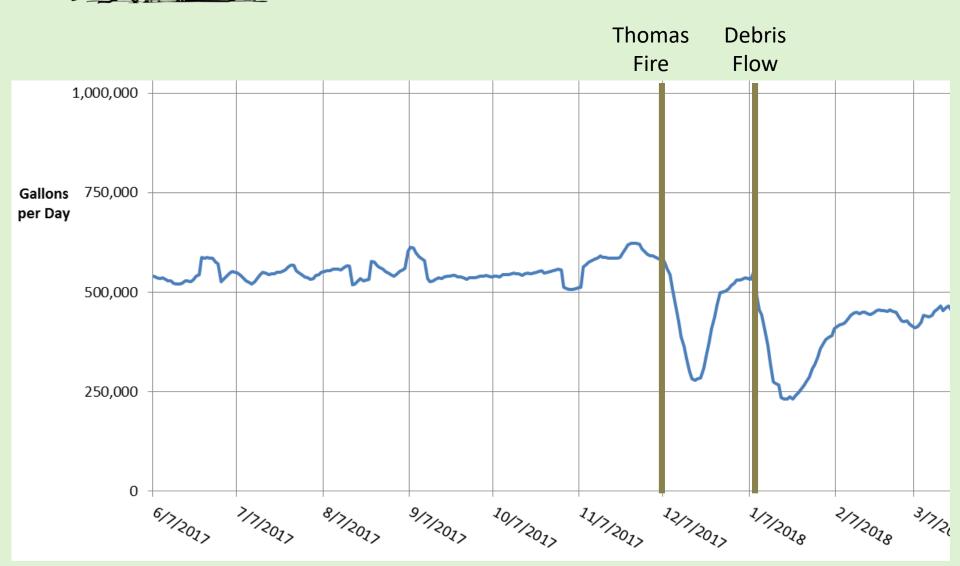
Plant Flow (gallons per day)

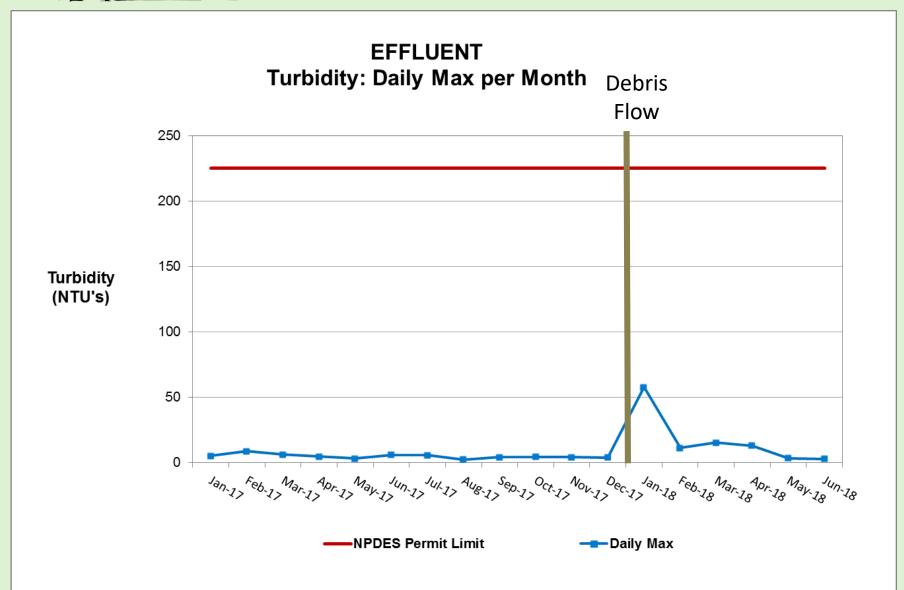
Effluent Turbidity

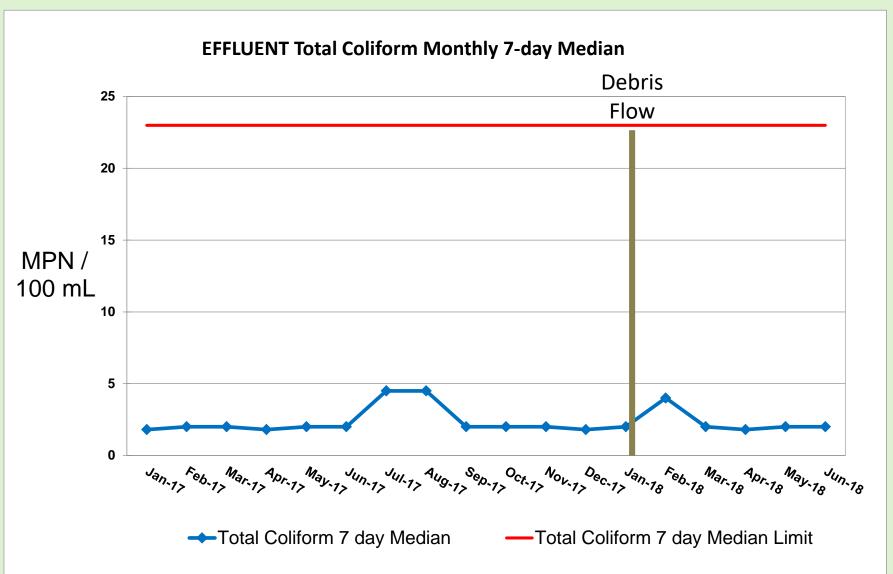
Total Coliform

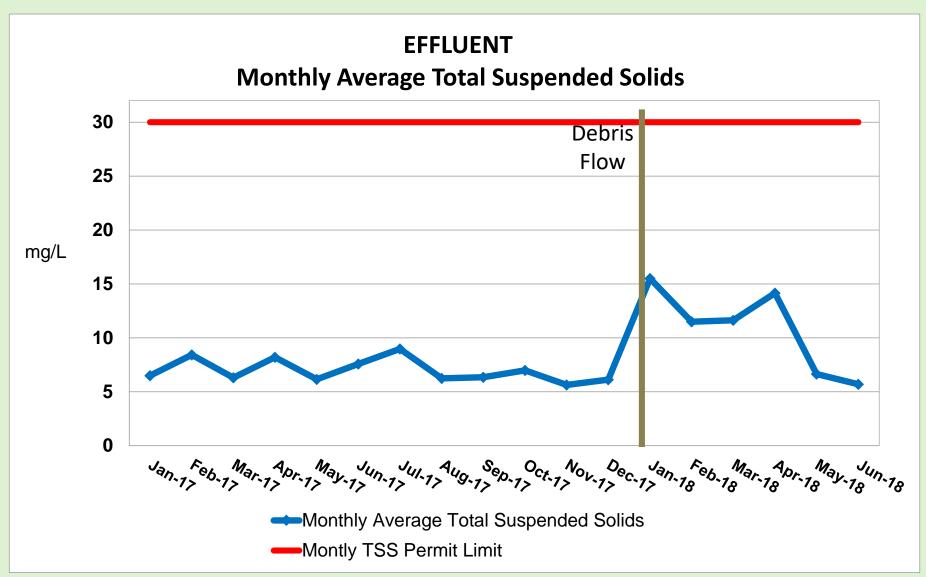
Effluent TSS

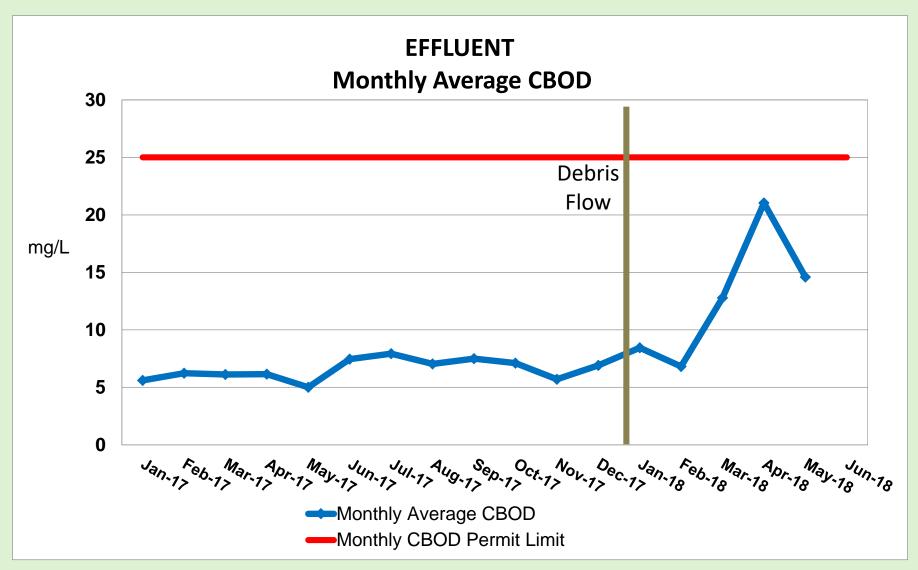
Effluent CBOD

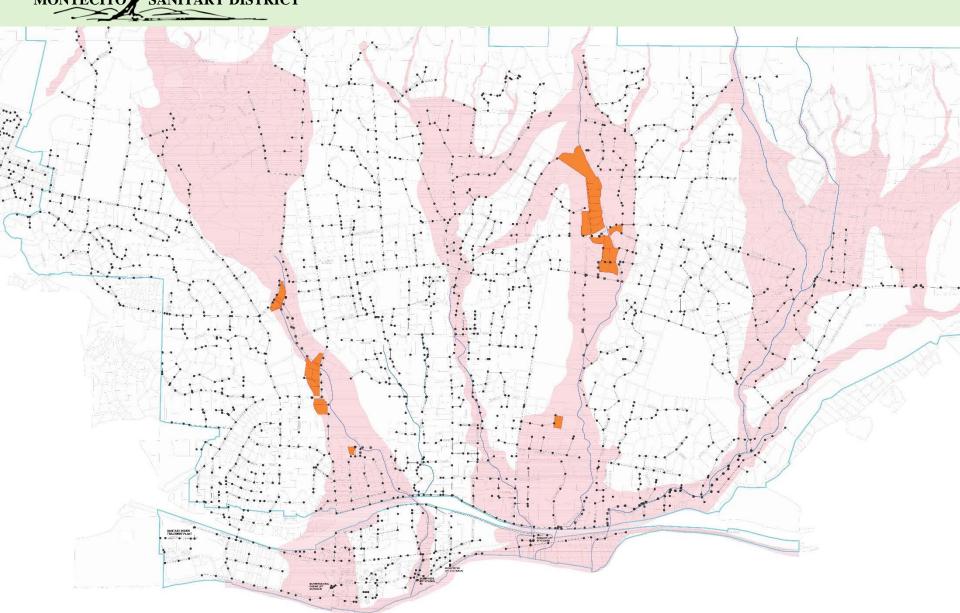
Capped Laterals

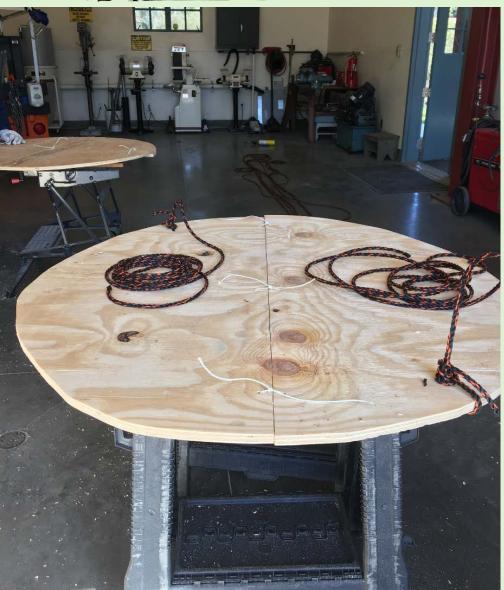
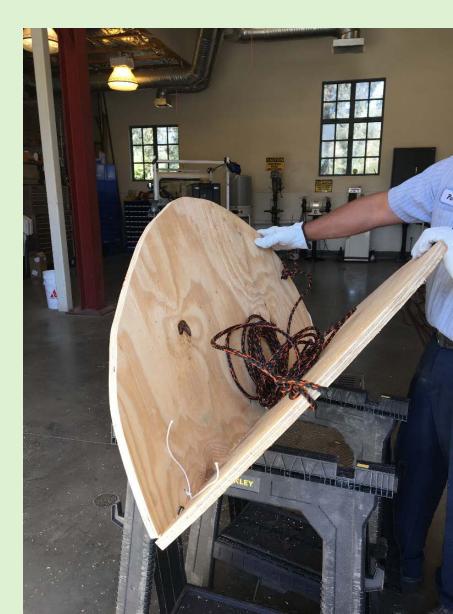
Pipeline Protectors

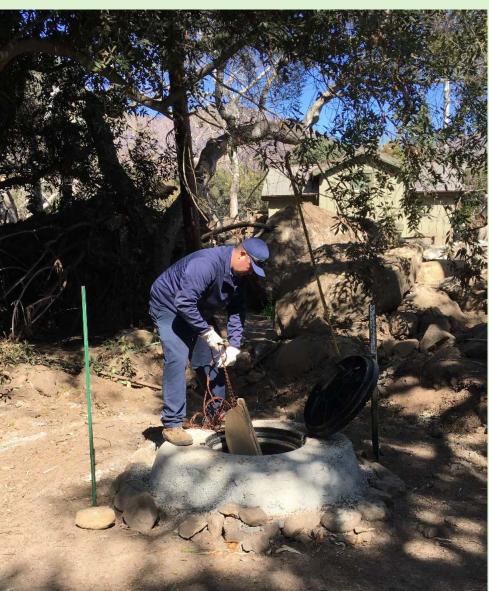
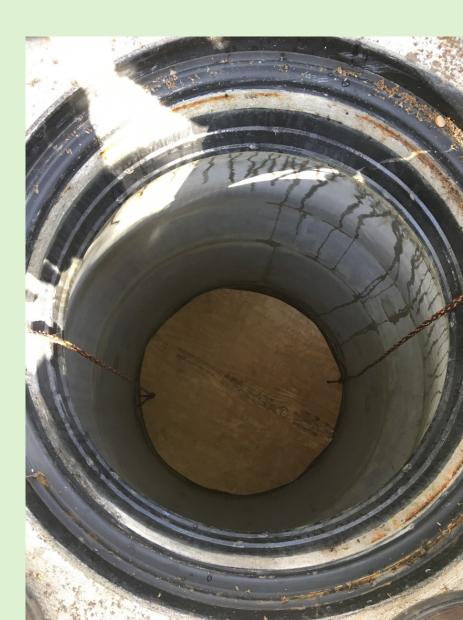
Pipeline Protectors

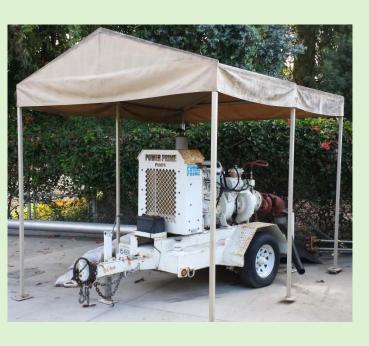
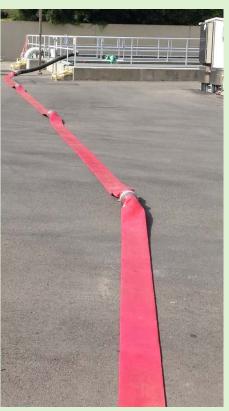
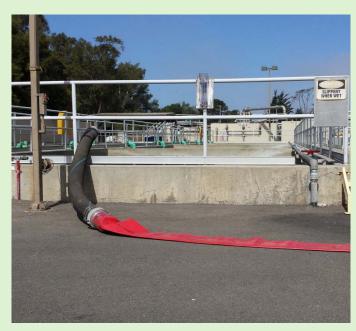
Auxiliary Pump and Piping
