**STATE OF CALIFORNIA  
REGIONAL WATER QUALITY CONTROL BOARD  
CENTRAL COAST REGION**

**STAFF REPORT FOR REGULAR MEETING OF APRIL 17-18, 2025**

**SUBJECT:** Executive Officer's Report to the Board

**MOSS LANDING ENERGY STORAGE FACILITY LITHIUM-ION BATTERY FIRE**

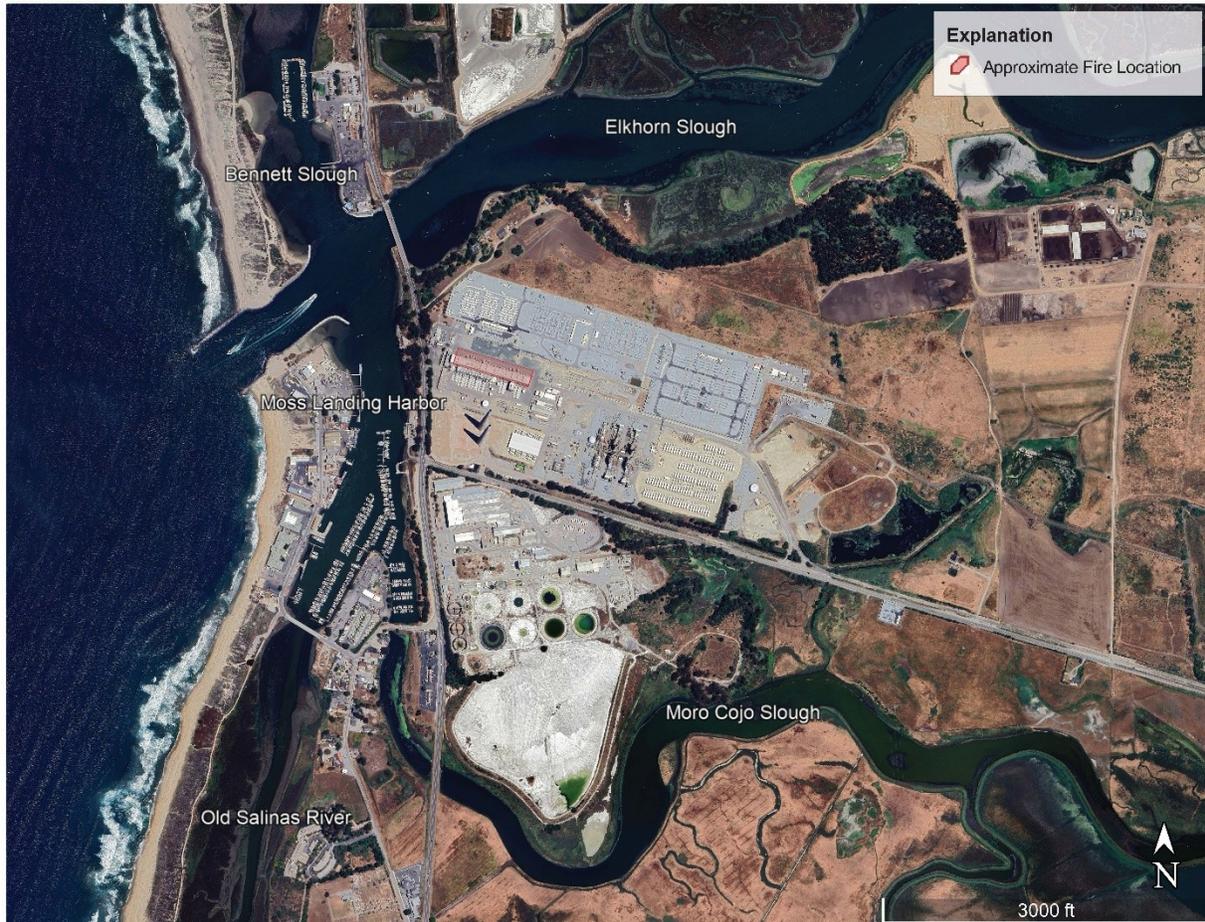
**Figure 1: Aerial photograph showing the Moss Landing Energy Storage Facility, Vistra Corp. lithium-ion battery fire location and nearby surface waters.**

On January 16, 2025, a Moss Landing Energy Storage Facility lithium-ion battery fire occurred, at 7301 Highway 1, Moss Landing in Monterey County. The Moss Landing Energy Storage Facility is operated by Texas-based Vistra Corporation (Vistra) on the site of a historic natural gas and oil power plant. The fire location is approximately 0.25 mile east of Moss Landing Harbor and adjacent to where the Old Salinas River, Moro Cojo Slough, Elkhorn Slough, and Bennett Slough converge with the Monterey Bay National Marine Sanctuary and the Pacific Ocean (Figure 1).
