**City of Paso Robles**  
**Routine Vegetation Maintenance Project**  
 Map Center: 120.67625°W 35.63282°N  
 Templeton, San Luis Obispo County

### Exhibit 3: Fire Fuel Load Reduction Areas

**Revegetation Plan**  
for  
**Annual Flood Control and Fire Fuel Load Reduction Project**  
**Order No. R3-2021-0012**

City of Paso Robles, San Luis Obispo County

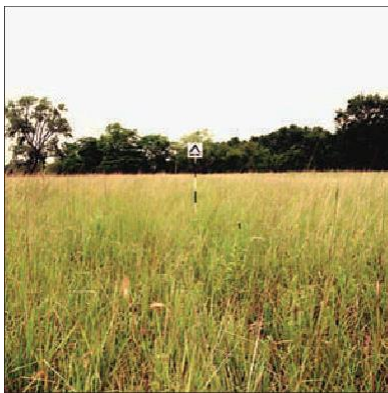
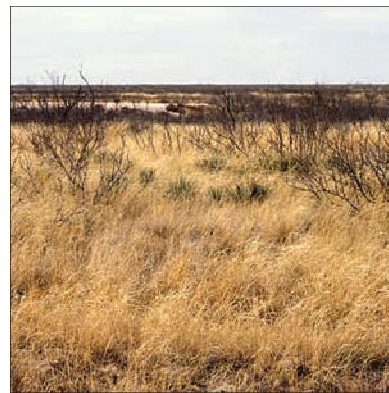
### GR4 (104)

**Description:** The primary carrier of fire in GR4 is continuous, dry-climate grass. Load and depth are greater than GR2; fuelbed depth is about 2 feet.

Fine fuel load (t/ac)	2.15
Characteristic SAV (ft-1)	1826
Packing ratio (dimensionless)	0.00154
Extinction moisture content (percent)	15

Fuel model GR4 represents the continues grass fuel bed within the Salinas River, though there are areas with a higher load than GR4, we do not feel it is enough to push it to GR7. The characteristics of fuel model GR1 are the desired conditions for these fuel beds within the project area. Reducing the tons per acre below .5 lowers the flame length to less than three feet during peak fire season. As a general rule, fires with flame lengths of four feet or less can be suppressed by ground personnel and limits the need for heavy equipment and aircraft.

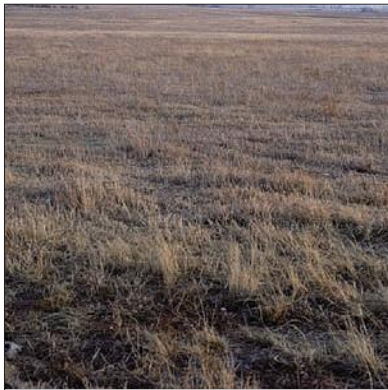
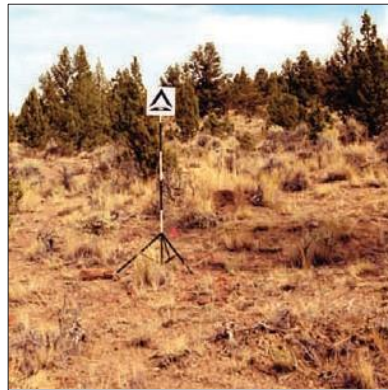
### GR1 (101)

**Description:** The primary carrier of fire in GR1 is sparse grass, though small amounts of fine dead fuel may be present. The grass in GR1 is generally short, either naturally or by grazing, and may be sparse or discontinuous. The moisture of extinction of GR1 is indicative of a dry climate fuelbed, but GR1 may also be applied in high-extinction moisture fuelbeds because in both cases predicted spread rate and flame length are low compared to other GR models.

Fine fuel load (t/ac)	0.40
Characteristic SAV (ft-1)	2054
Packing ratio (dimensionless)	0.00143
Extinction moisture content (percent)	15

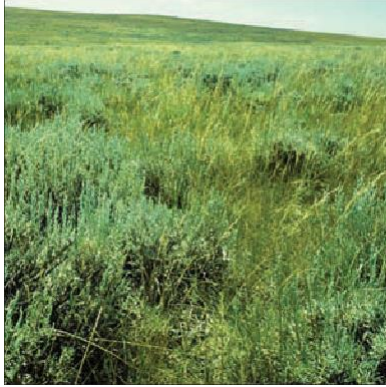
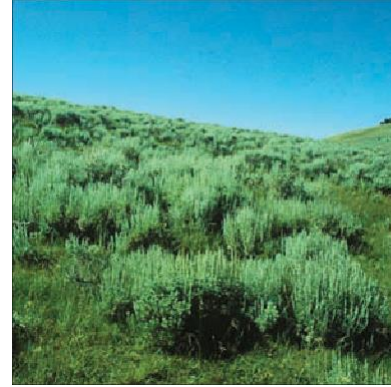
## GS2 (122)

**Description:** The primary carrier of fire in GS2 is grass and shrubs combined. Shrubs are 1 to 3 feet high, grass load is moderate. Spread rate is high; flame length moderate. Moisture of extinction is low.

Fine fuel load (t/ac)	2.1
Characteristic SAV (ft-1)	1827
Packing ratio (dimensionless)	0.00249
Extinction moisture content (percent)	15

Fuel model GS2 best represents the grass-shrub fuel bed in areas of the Salinas River. Reducing the fuels to represent the characteristics of GS1 would lower the flame lengths from 10-15 feet to 8 feet or less during peak fire season. The reduction in fuels can be accomplished primarily through grazing. Fires with flame lengths of 8 feet or less can generally be effectively suppressed using heavy equipment, aircraft, and ground personnel.

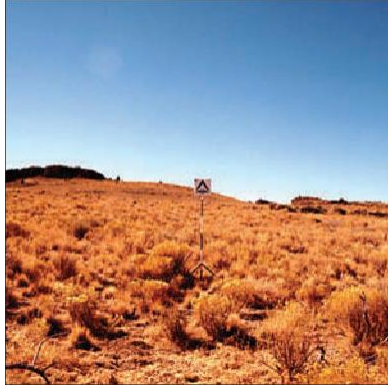
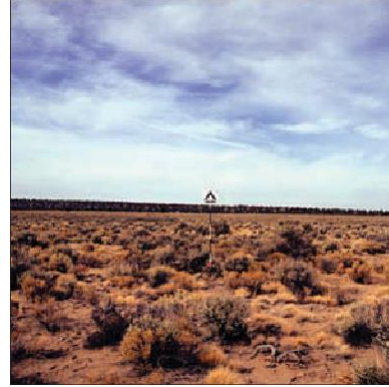
## GS1 (121)

**Description:** The primary carrier of fire in GS1 is grass and shrubs combined. Shrubs are about 1 foot high, grass load is low. Spread rate is moderate; flame length low. Moisture of extinction is low.

Fine fuel load (t/ac)	1.35
Characteristic SAV (ft-1)	1832
Packing ratio (dimensionless)	0.00215
Extinction moisture content (percent)	15

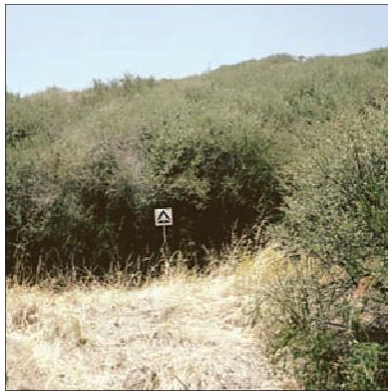
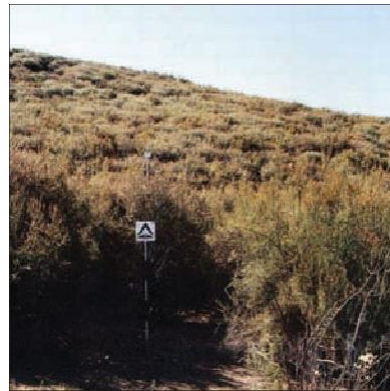
### *SH5 (145)*

**Description:** The primary carrier of fire in SH5 is woody shrubs and shrub litter. Heavy shrub load, depth 4-6 feet. Spread rate very high; flame length very high. Moisture of extinction is high.

Fine fuel load (t/ac)	6.5
Characteristic SAV (ft-1)	1252
Packing ratio (dimensionless)	0.00206
Extinction moisture content (percent)	15

Fuel model SH5 best represents dense areas, primarily interior islands within the Salinas River and areas without tree canopy cover. Fires that become established within these fuel beds are extremely resistant to fire suppression efforts. Treating the denser areas of this fuel model, while focusing on the fuel reduction of the vegetation that exhibits a higher dead to live fuel ratio, will reduce fire intensity and spotting potential. There is not a current fuel model that best represents the conditions we are striving to achieve within the project area for this fuel model. The desired conditions within this fuel model is a reduce fuels loading by 50% to three tons per acre. We seek to achieve this objective mainly by removing the high concentrations of dead fuels while leaving a mosaic fuel bed with a higher concentration of live vegetation.

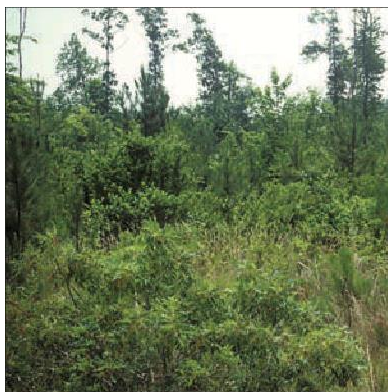
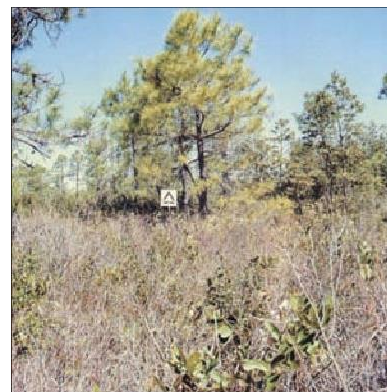
### SH8 (148)

**Description:** The primary carrier of fire in SH8 is woody shrubs and shrub litter. Dense shrubs, little or no herbaceous fuel, fuelbed depth about 3 feet. Spread rate is high; flame length high.

Fine fuel load (t/ac) 6.4  
Characteristic SAV (ft-1) 1386  
Packing ratio (dimensionless) 0.00509  
Extinction moisture content (percent) 40

Fuel model SH8 best represents areas within the Salinas River with tree canopy cover that have dense shrub and grass understories. Fires that become established in this fuel bed move quickly through the understory, also known as latter fuel, and transition into the tree canopies. These fires are extremely resistant to fire suppression efforts by both ground and air resources and produce fires with long range spotting. By reducing the latter fuels beneath the tree canopy, we can reduce tree mortality among the larger trees due to fire and reduce flame lengths. By reducing the latter fuels reaching from the ground to the canopy there will be a reduction of spotting. This reduction in spotting will equate to a safer and more effective fire response. The desired condition is to reduce the tons per acre in this fuel model to less than two tons per acre.

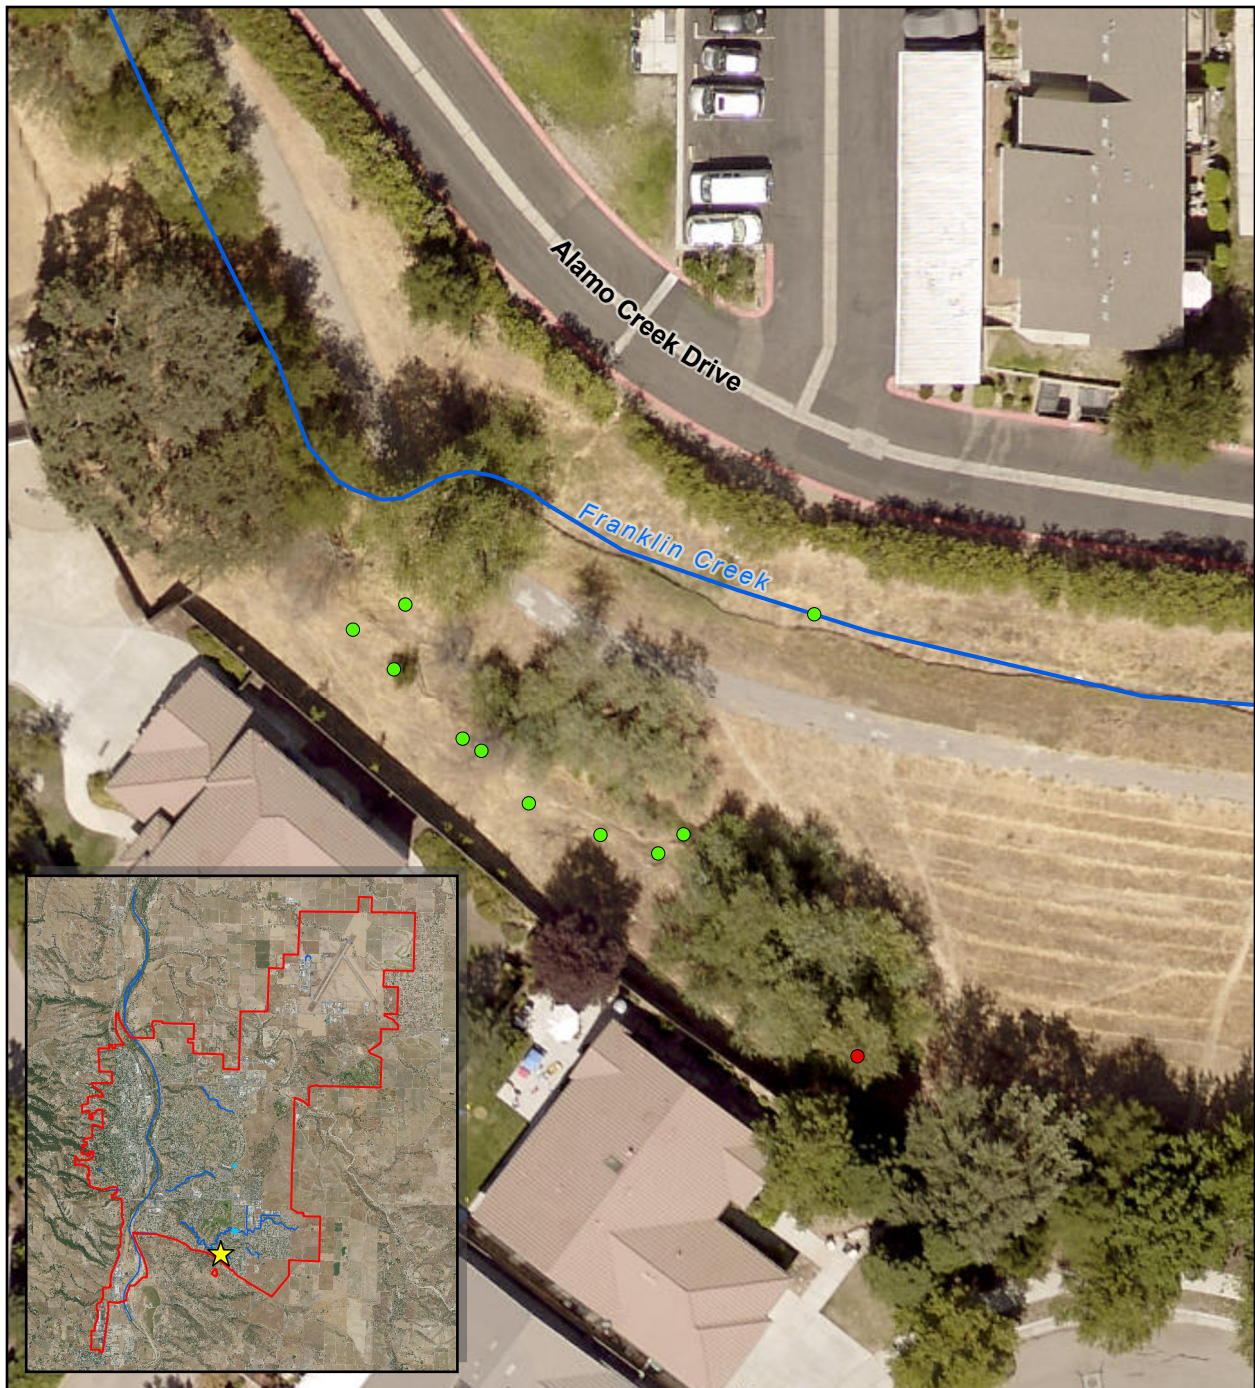
**Figure 2. Flood Control Mitigation Site**

One red willow tree greater than 4-inches diameter breast height (DBH) was removed in 2022 because it was compromising and in front of a box culvert, causing the area in front of the culvert to erode. Cuttings were harvested and planted in the Franklin Creek area, north of Sleepy Hollow Road and south of Alamo Creek Terrace (Figure 2). Althouse and Meade, Inc. (A&M) will continue to monitor planted cuttings/saplings and if needed will replant new cuttings, in-kind, and within the same drainage feature; per the requirement in **Order #40e** (page 21), which states:

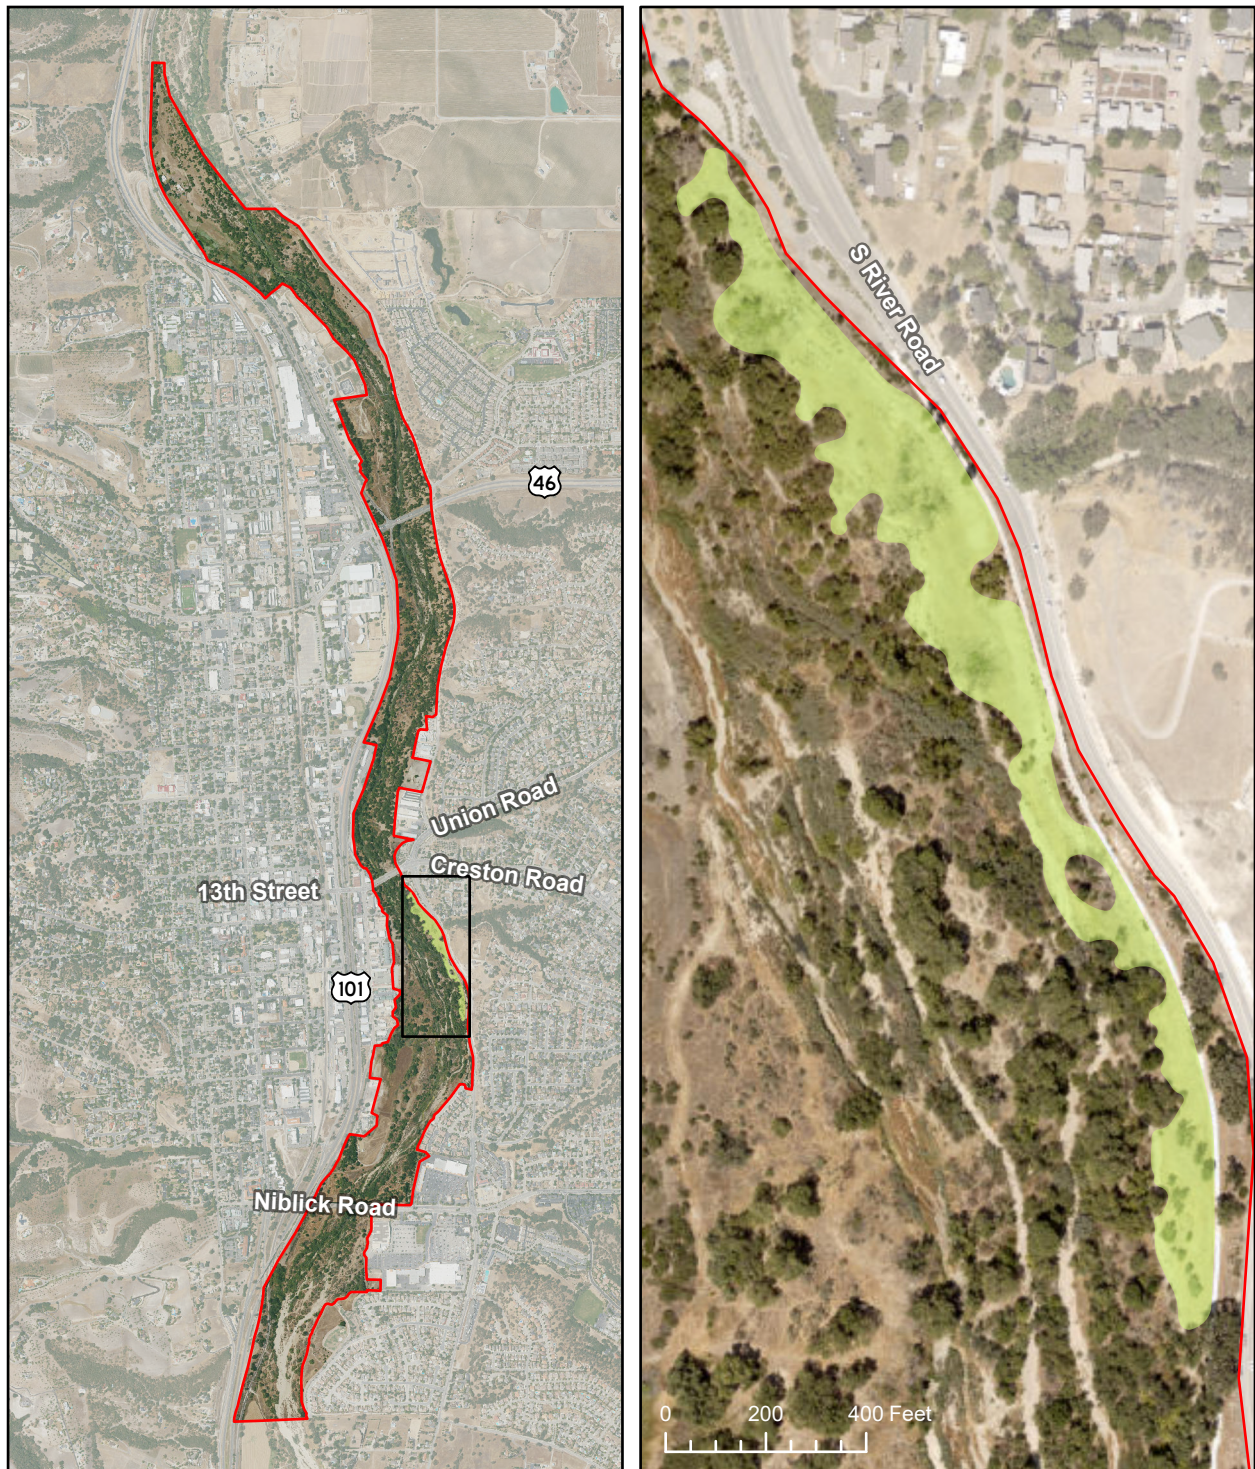
**Figure 3. Fire Fuel Load Reduction Mitigation Site**

- Fuel Reduction Area
- Revegetation Area (4.65 acres)

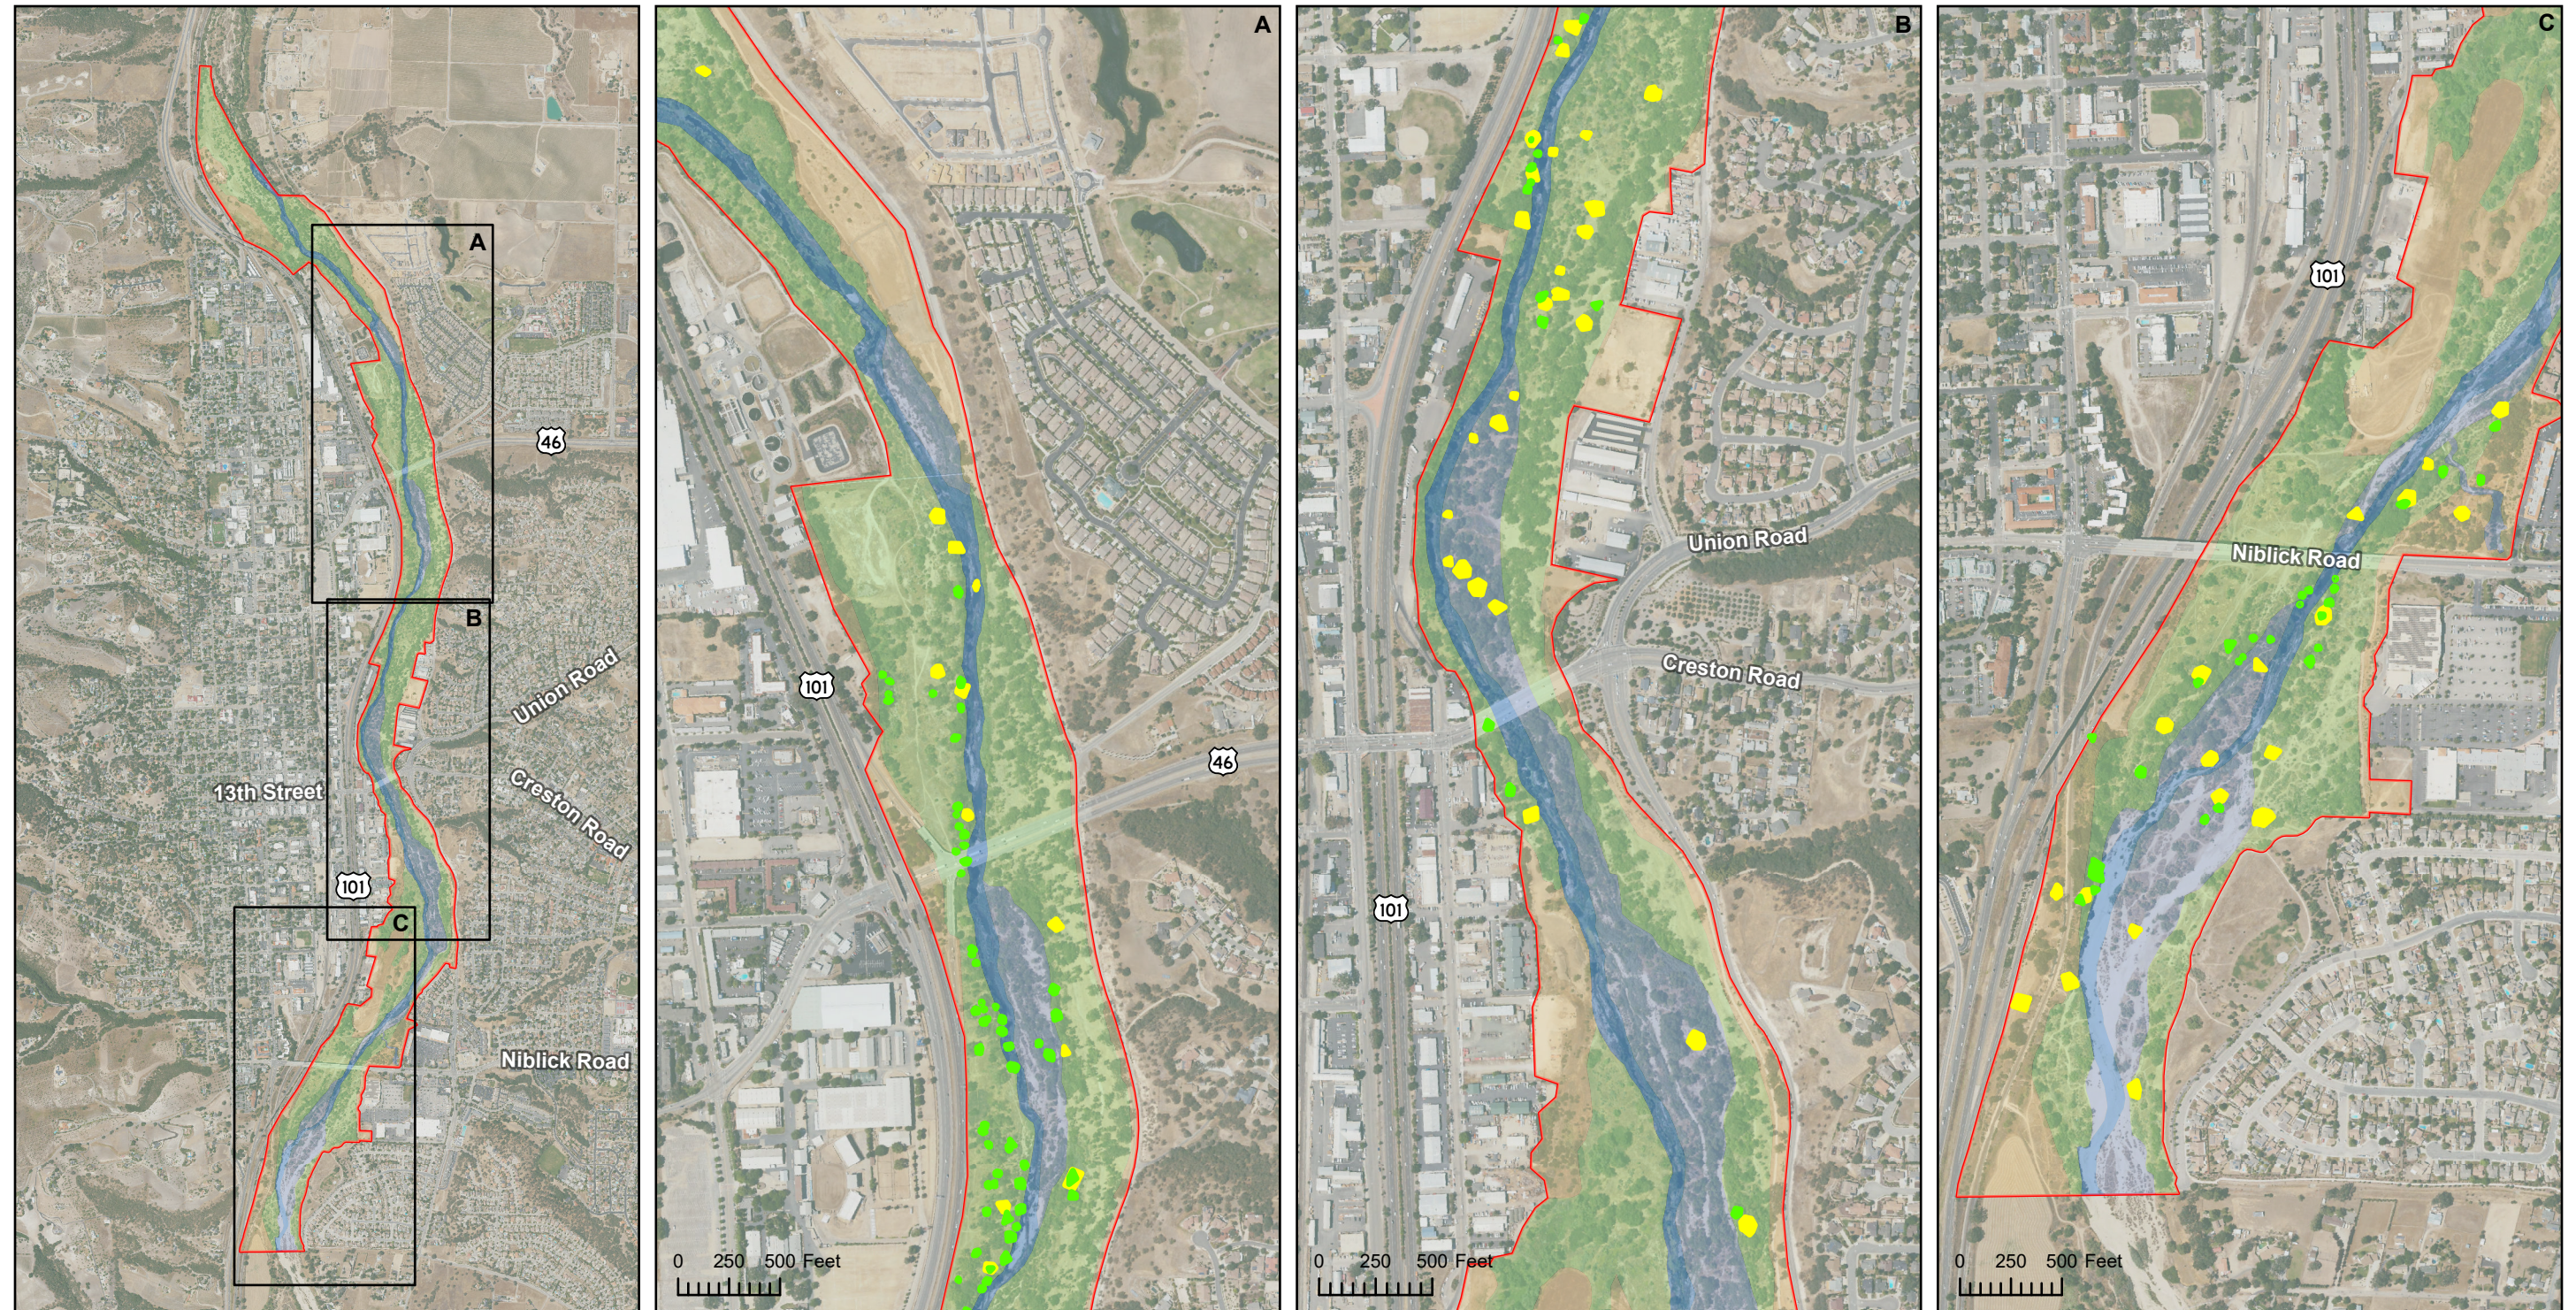
Figure 4. 2022 and 2023 Trash Removal Locations

- Fuel Reduction Area
- 2022 Trash Removal Sites (2.2 acres)
- 2023 Trash Removal Sites (1.0 acre)
- Channel
- Low-Flow Channel
- Floodplain
- Upland

0.12-acre of trash was removed in low-flow/active channel (2023; Figure 4).

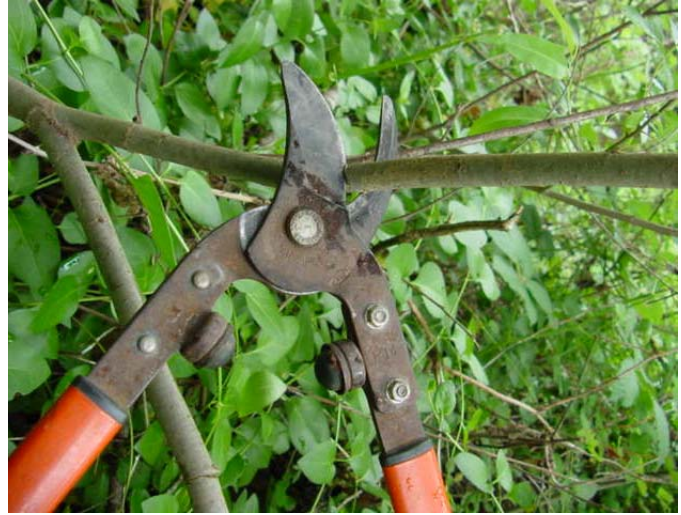
*Sharp, clean loppers produce high quality sprigs and cuttings*

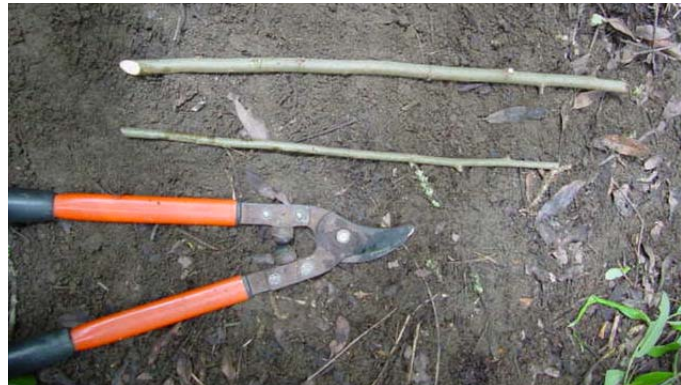
*Typical dimensions for willow and cottonwood sprigs*

may be collected at a range of sizes (i.e., ½ inch to 4 inches diameter and up to 8 feet long). It is important to select material that has not become too woody, and that has several viable buds along the stem.

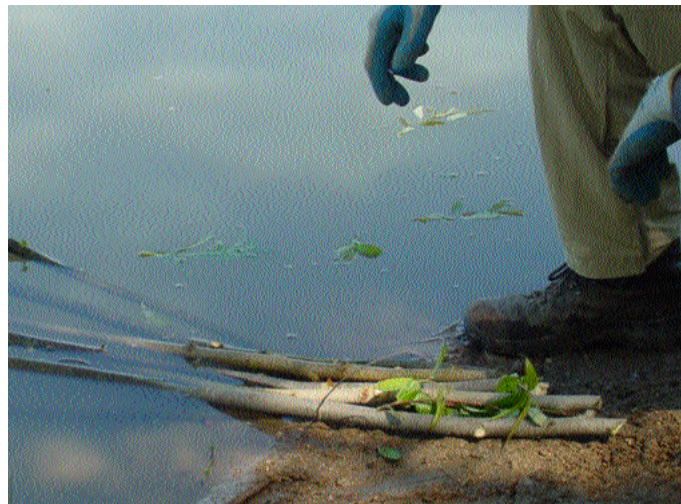
*Store cuttings in a moist environment*

- Cuttings may be used immediately, stored on-site in the stream, or stored off-site in a bucket of cool water. Ideally, material should be harvested and installed the same day.
- Sprigs should be installed with buds pointing up, with approximately  $\frac{3}{4}$  of the cutting in the soil, and  $\frac{1}{4}$  exposed. Holes may be dug with a pick, with a piece of rebar, with an auger, or a backhoe (for large material). In areas with soft soil, you may avoid digging a hole by cutting the bottom at an angle and pounding it into the ground with a small sledge hammer. If the top is damaged by the hammer, cut off the top of the sprig to allow for clean healing or place a driving shield over the top to drive in the sprig.

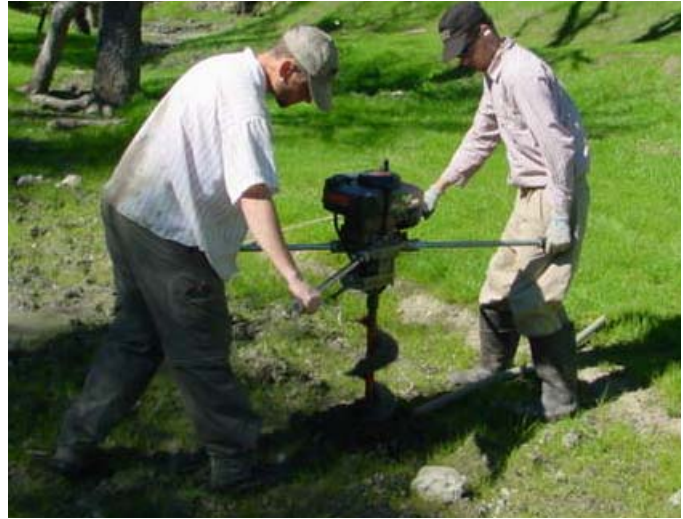
*Auger used for planting holes*

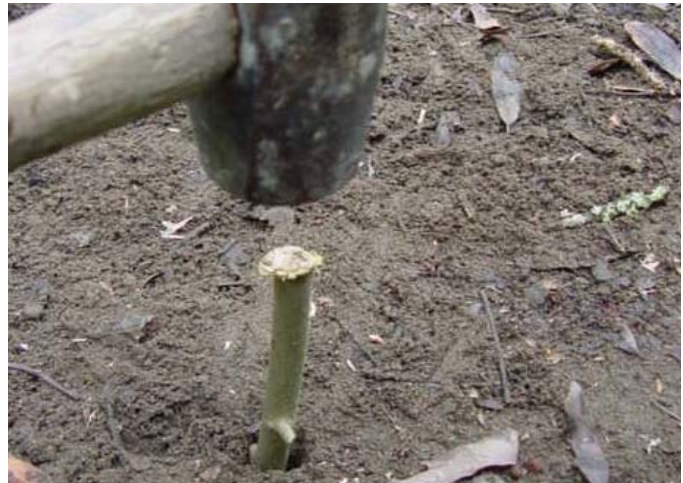
*Small sledge hammer for installing sprig*

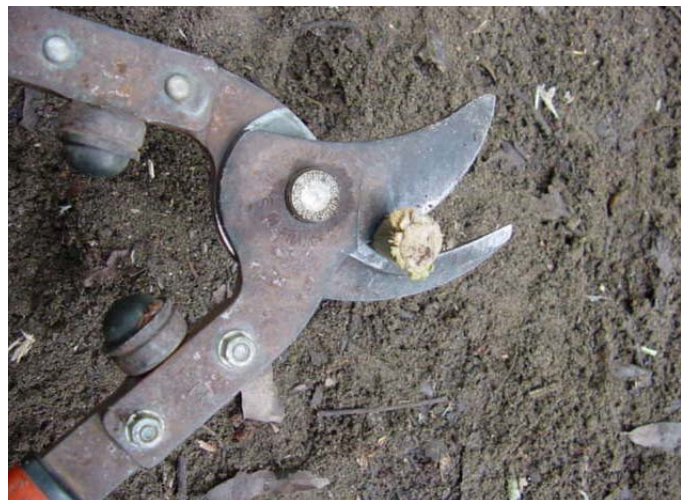
*Clean, sharp loppers cut off damaged top of sprig*

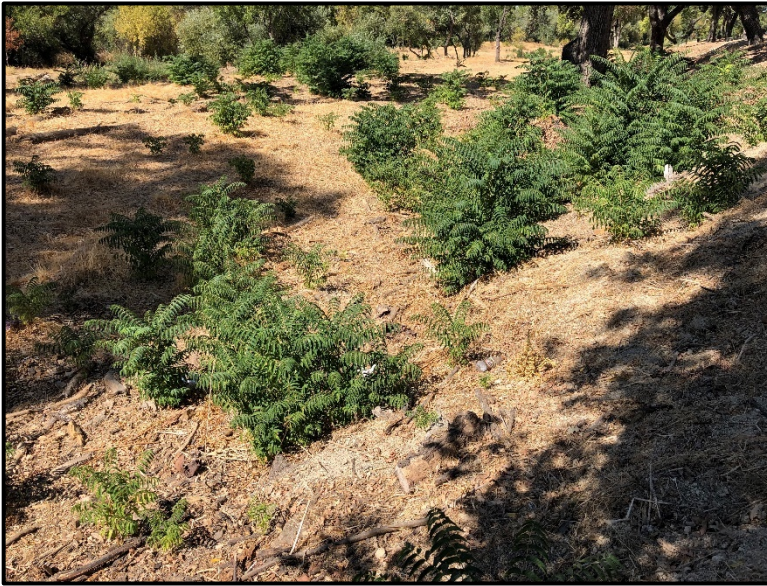
Photo 1. Tree of heaven saplings growing in the Salinas River floodplain, west of River Road, October 2021.

- Tree of heaven (TOH) would be removed by hand with chainsaws and/or loppers. A tracked chipper may be used to break down cut material onsite. Many tree of heaven plants have resprouted as young sapling/shoots (Photo 1).
