SOIL GAS INVESTIGATION WORKPLAN

BUCKLEY ROAD VICINITY
San Luis Obispo, California

Submitted to:
Central Coast Regional Water Quality Control Board
895 Aerovista Place, Suite 101
San Luis Obispo, California

Prepared by:
Roux Associates, Inc.
5150 East Pacific Coast Highway, Suite 450
Long Beach California 90804

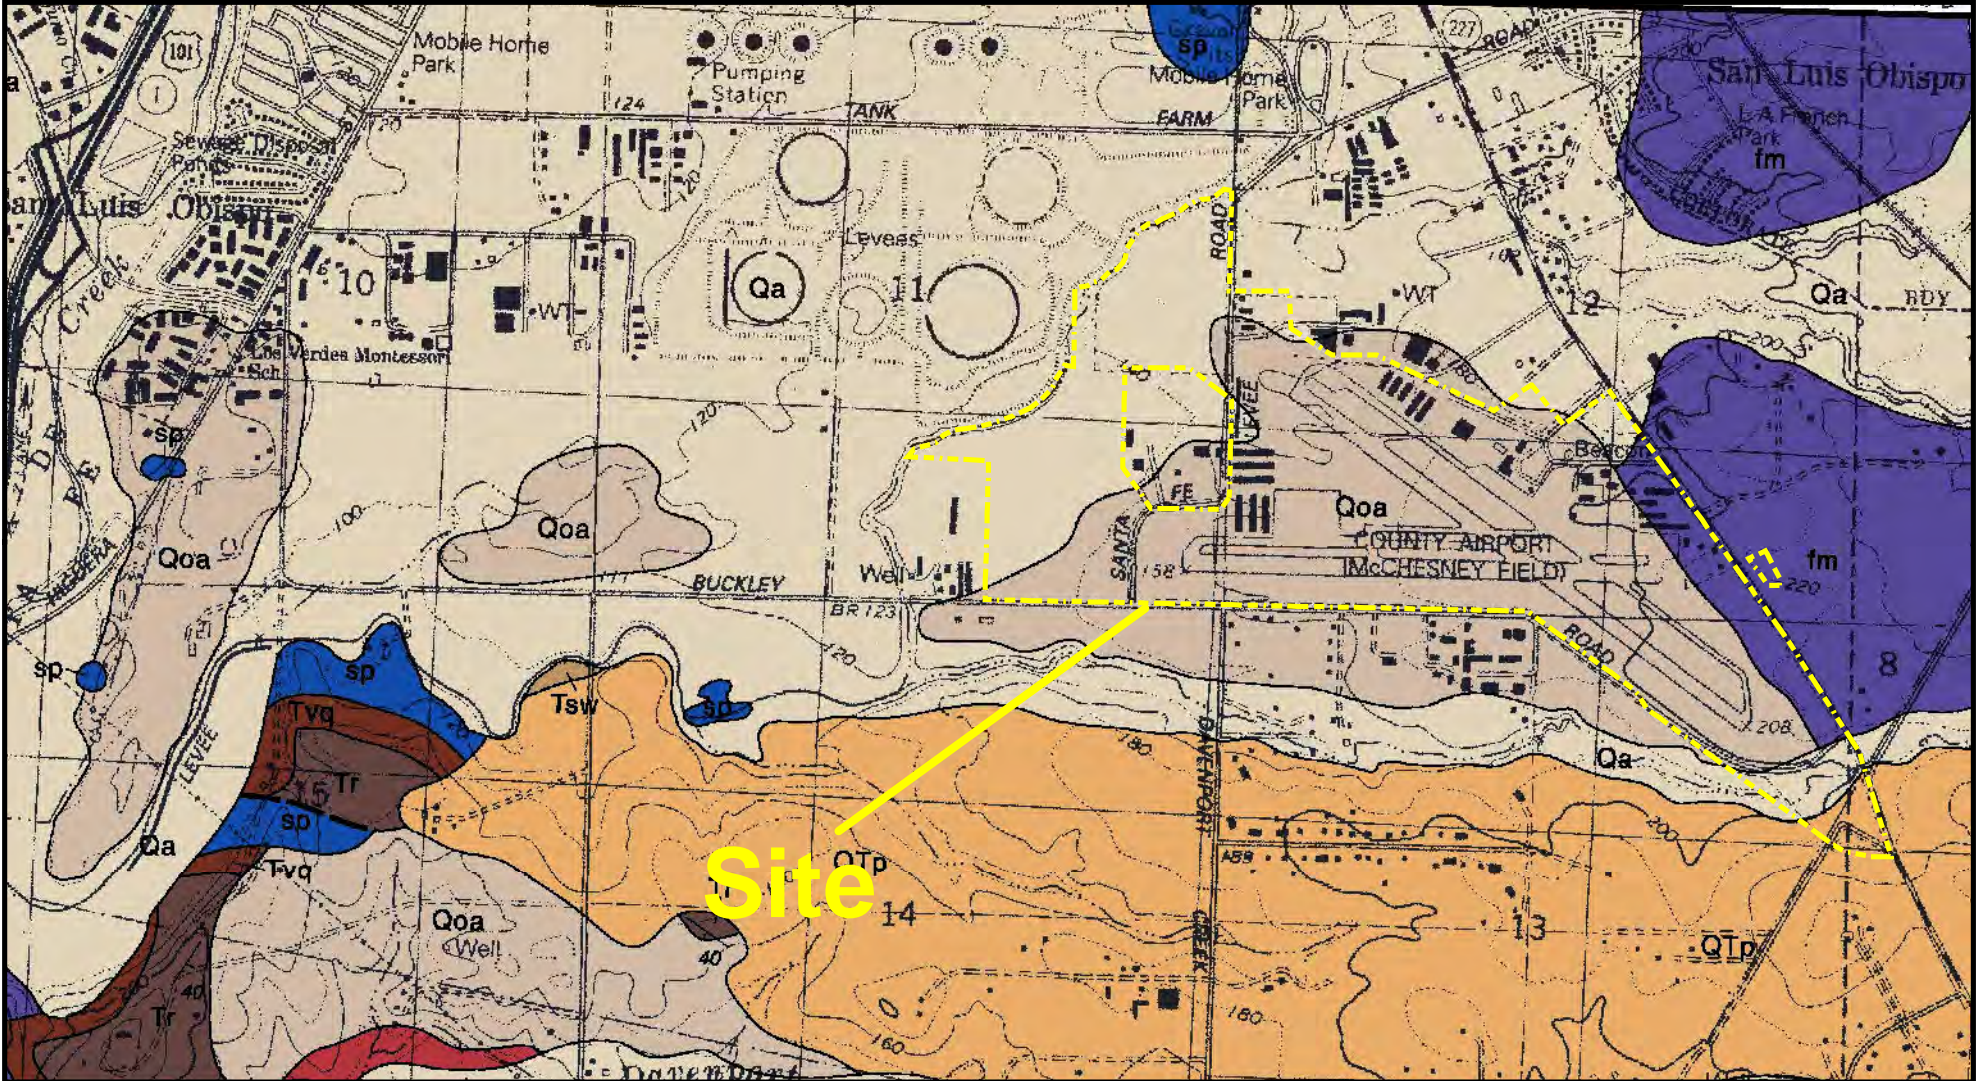
Compiled by: PDF	Date: 4/14/2016
ROUX ASSOCIATES, INC. Environmental Consulting & Management		Prepared by: PDF	Scale: 1:19,434
		Project Mgr: KJ	Office: LA
		File No: F(AL)	Project: 2744.0001L001
			FIGURE 3

- Site Boundary
- Qa: Surficial sediments
- QTP: Paso Robles Formation
- Qoa: Older Alluvium
- fm: Franciscan Rocks

Title:			
REGIONAL GEOLOGY			
SAN LUIS OBISPO, CALIFORNIA			
Prepared For:			
COUNTY OF SAN LUIS OBISPO

The Site and vicinity are located in the northeastern portion of the Pismo Beach Quadrangle. The Site and businesses on Buckley Road are situated on older alluvium consisting of clay, dissected gravel, and sand (Dibblee, 2006). The alluvium is thickest (more than 160 feet thick) in the western portion (Cleath, 1987). Immediately to the east of the Site is described as consisting of Franciscan Rocks, pervasively sheared melange, primarily dark claystone and sandstone, marine sedimentary and volcanic rocks from the Jurassic and Cretaceous periods. To the south is described as the Paso Robles Formation from the Pliocene to Pleistocene, consisting of older alluvial gravel, sand, and clay.

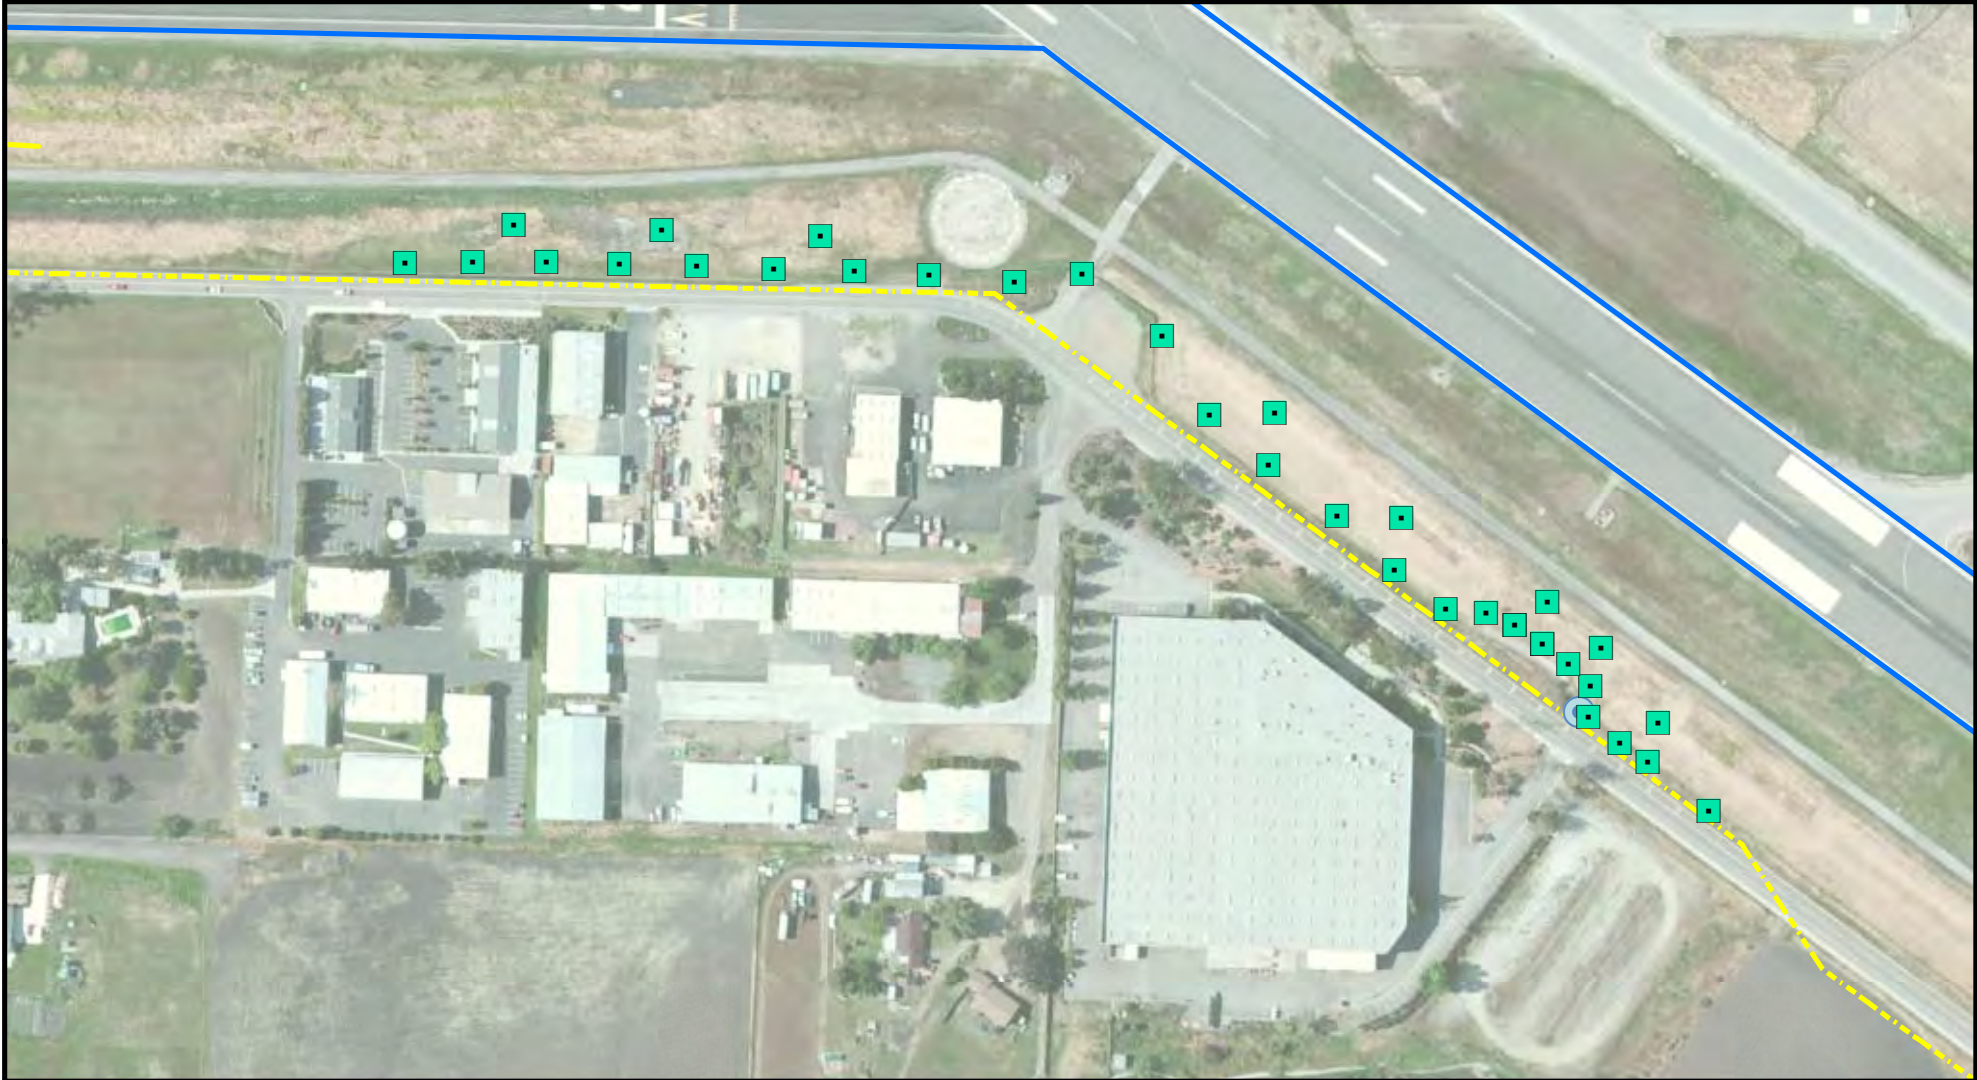
**PROPOSED PHASE I SOIL GAS
SAMPLE LOCATIONS**

As shown in Figure 5, the proposed scope of work for Phase I, involves the collection of passive soil gas samples from an area spanning approximately 2,000 feet south of the runways and parallel to Buckley Road. Passive sampling modules will be spaced in a transect with approximately 100-foot spacing in most areas, per manufacturer recommendations. In the area immediately surrounding the drainage channel, passive sampling modules will be spaced approximately 50 feet apart. A secondary transect line will be stepped back approximately 50 feet to the north and will be spaced approximately 200 feet apart. See Figure 5 for proposed sample locations. As requested by RWQCB in the February 26, 2016 letter (RWQCB 2016A), this initial scope of work (Phase I) will be scheduled immediately after approval of this workplan. Phase I will be prioritized over Phases II and III in scheduling.

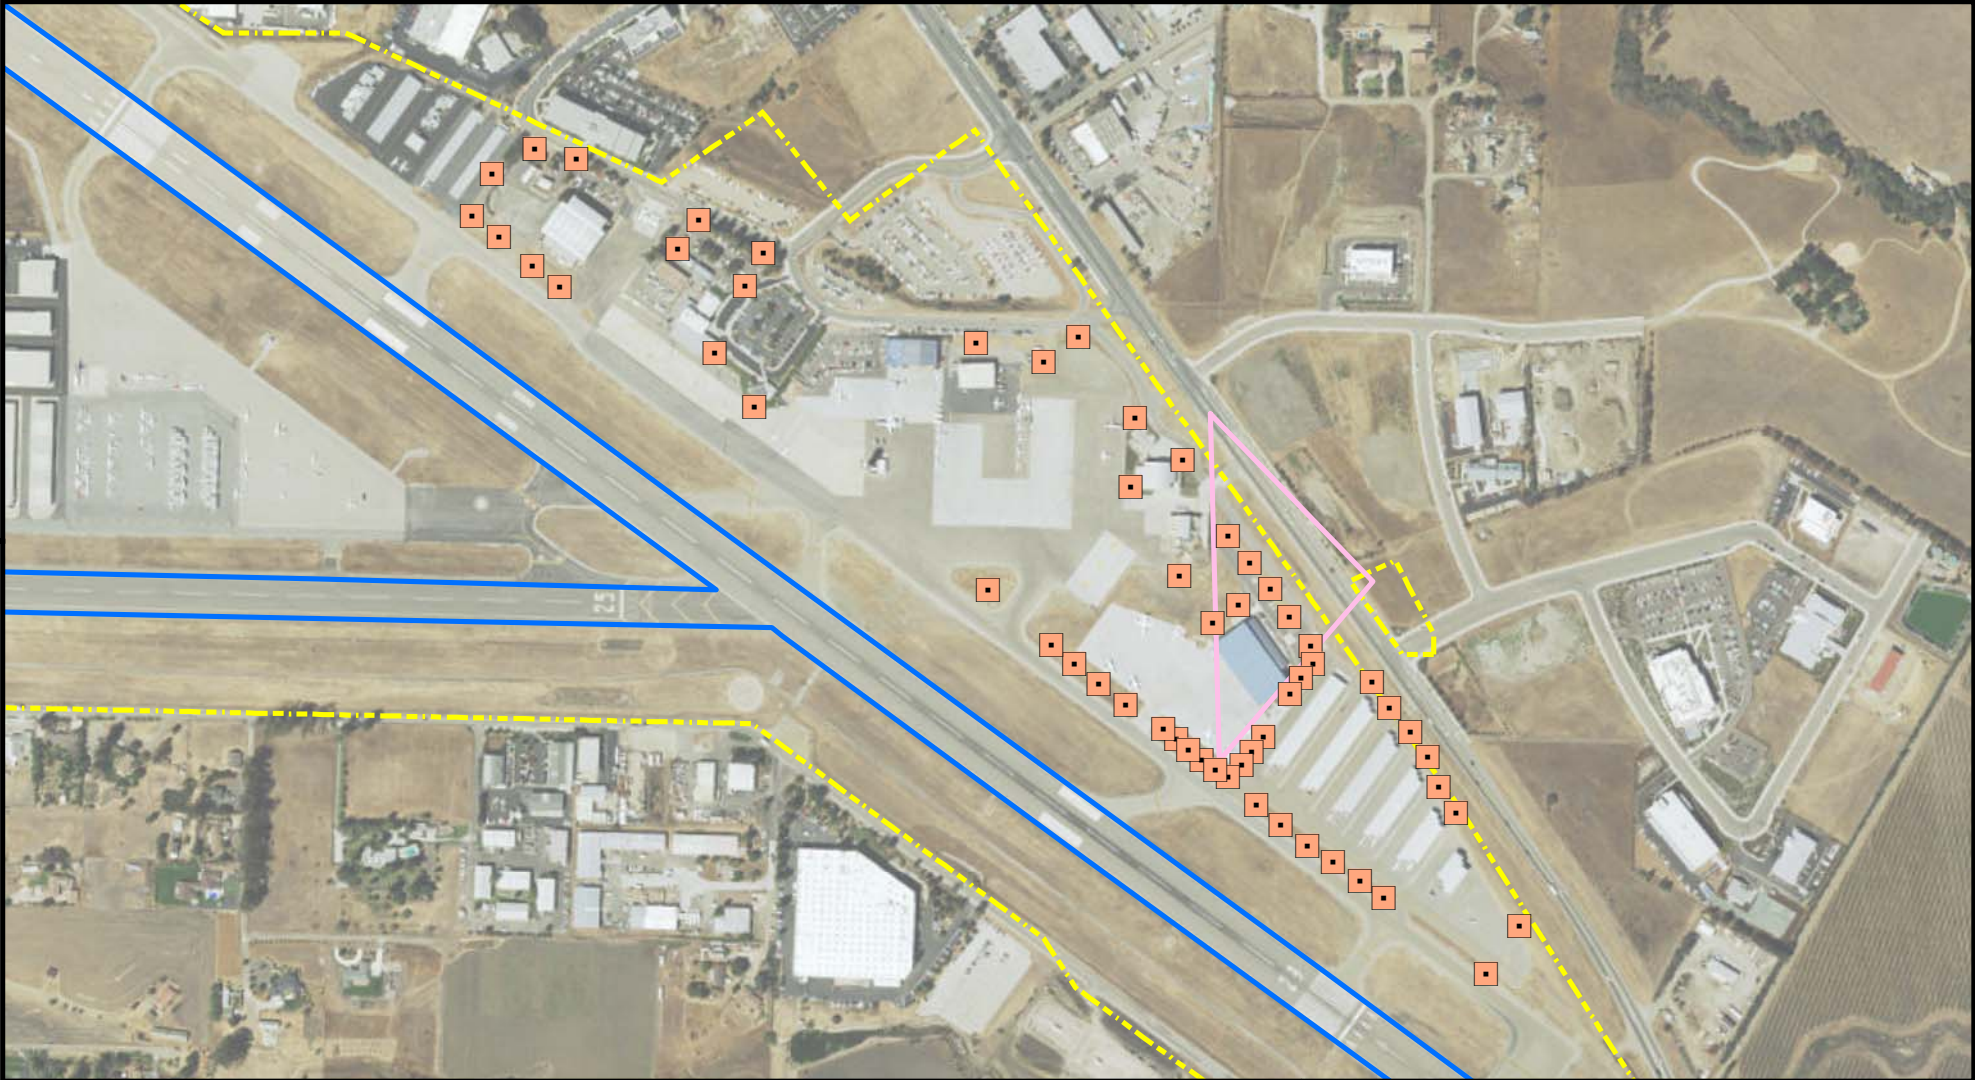
Title: PROPOSED PHASE II SOIL GAS SAMPLE LOCATIONS SAN LUIS OBISPO, CALIFORNIA			
Prepared For: COUNTY OF SAN LUIS OBISPO			
 ROUX ASSOCIATES, INC. Environmental Consulting & Management	Compiled by: PDF	Date: 5/25/2016	FIGURE 6A
	Prepared by: PDF	Scale: 1:7,200	
	Project Mgr: KJ	Office: LA	
	File No: F(AL)	Project: 2744.0001L001

As requested in Item Number 4 of the workplan requirements, soil gas samples will also be collected in the primary current and historical operational areas of the Site (Figures 6A and 6B, respectively). As described in Section 3.0 and noted in historical aerial photos and current Site layout maps, operations and maintenance activities have almost exclusively been located north of the runways. In addition to these operational areas, the former Aircraft Rescue and Fire Fighting (ARFF) facility, also known as Fire Station 21, will also be targeted in this phase of investigations. This facility was approximately located within the former leach field along Highway 227 (Figure 6B).
