## **SITE CONCEPTUAL MODEL**

Former Avila Terminal  
10 San Rafael Road  
Avila Beach, California

Revised April 12, 2013

Avocet Environmental, Inc.  
16 Technology Drive, Suite 154  
Irvine, California 92618-2327

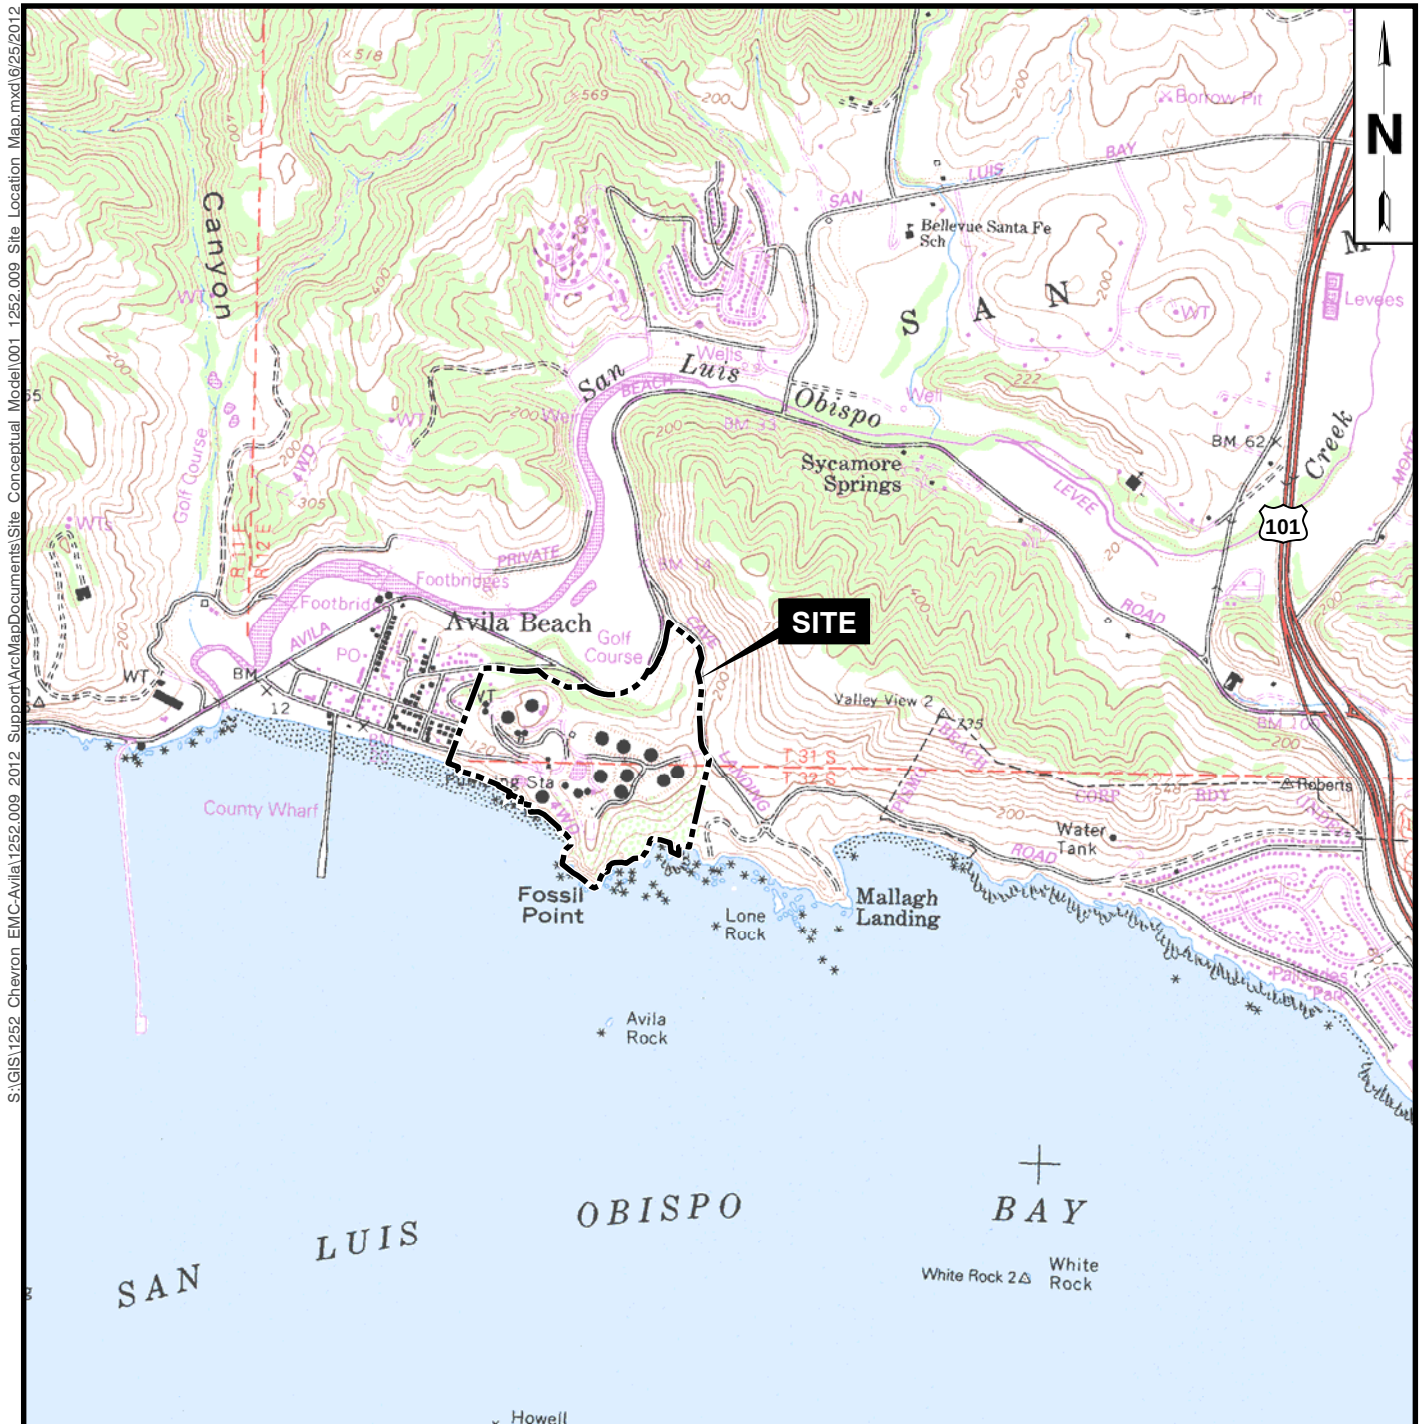
FIGURE 1

## SITE LOCATION MAP

The Avila Terminal is a 95-acre facility located adjacent to the community of Avila Beach (Figure 1). It is bordered by the Pacific Ocean along most of its southern boundary. Avila Beach Drive forms most of the northern boundary of the site, and Cave Landing Road most of the eastern boundary (Figure 2).

The Avila Terminal is located on a hill directly east of the community of Avila Beach, California, in an unincorporated portion of San Luis Obispo County (Figure 1). The site encompasses approximately 95 acres and is bordered by the community of Avila Beach to the west, San Luis Creek and a golf course to the north, open space to the east, and the Pacific Ocean to the south.

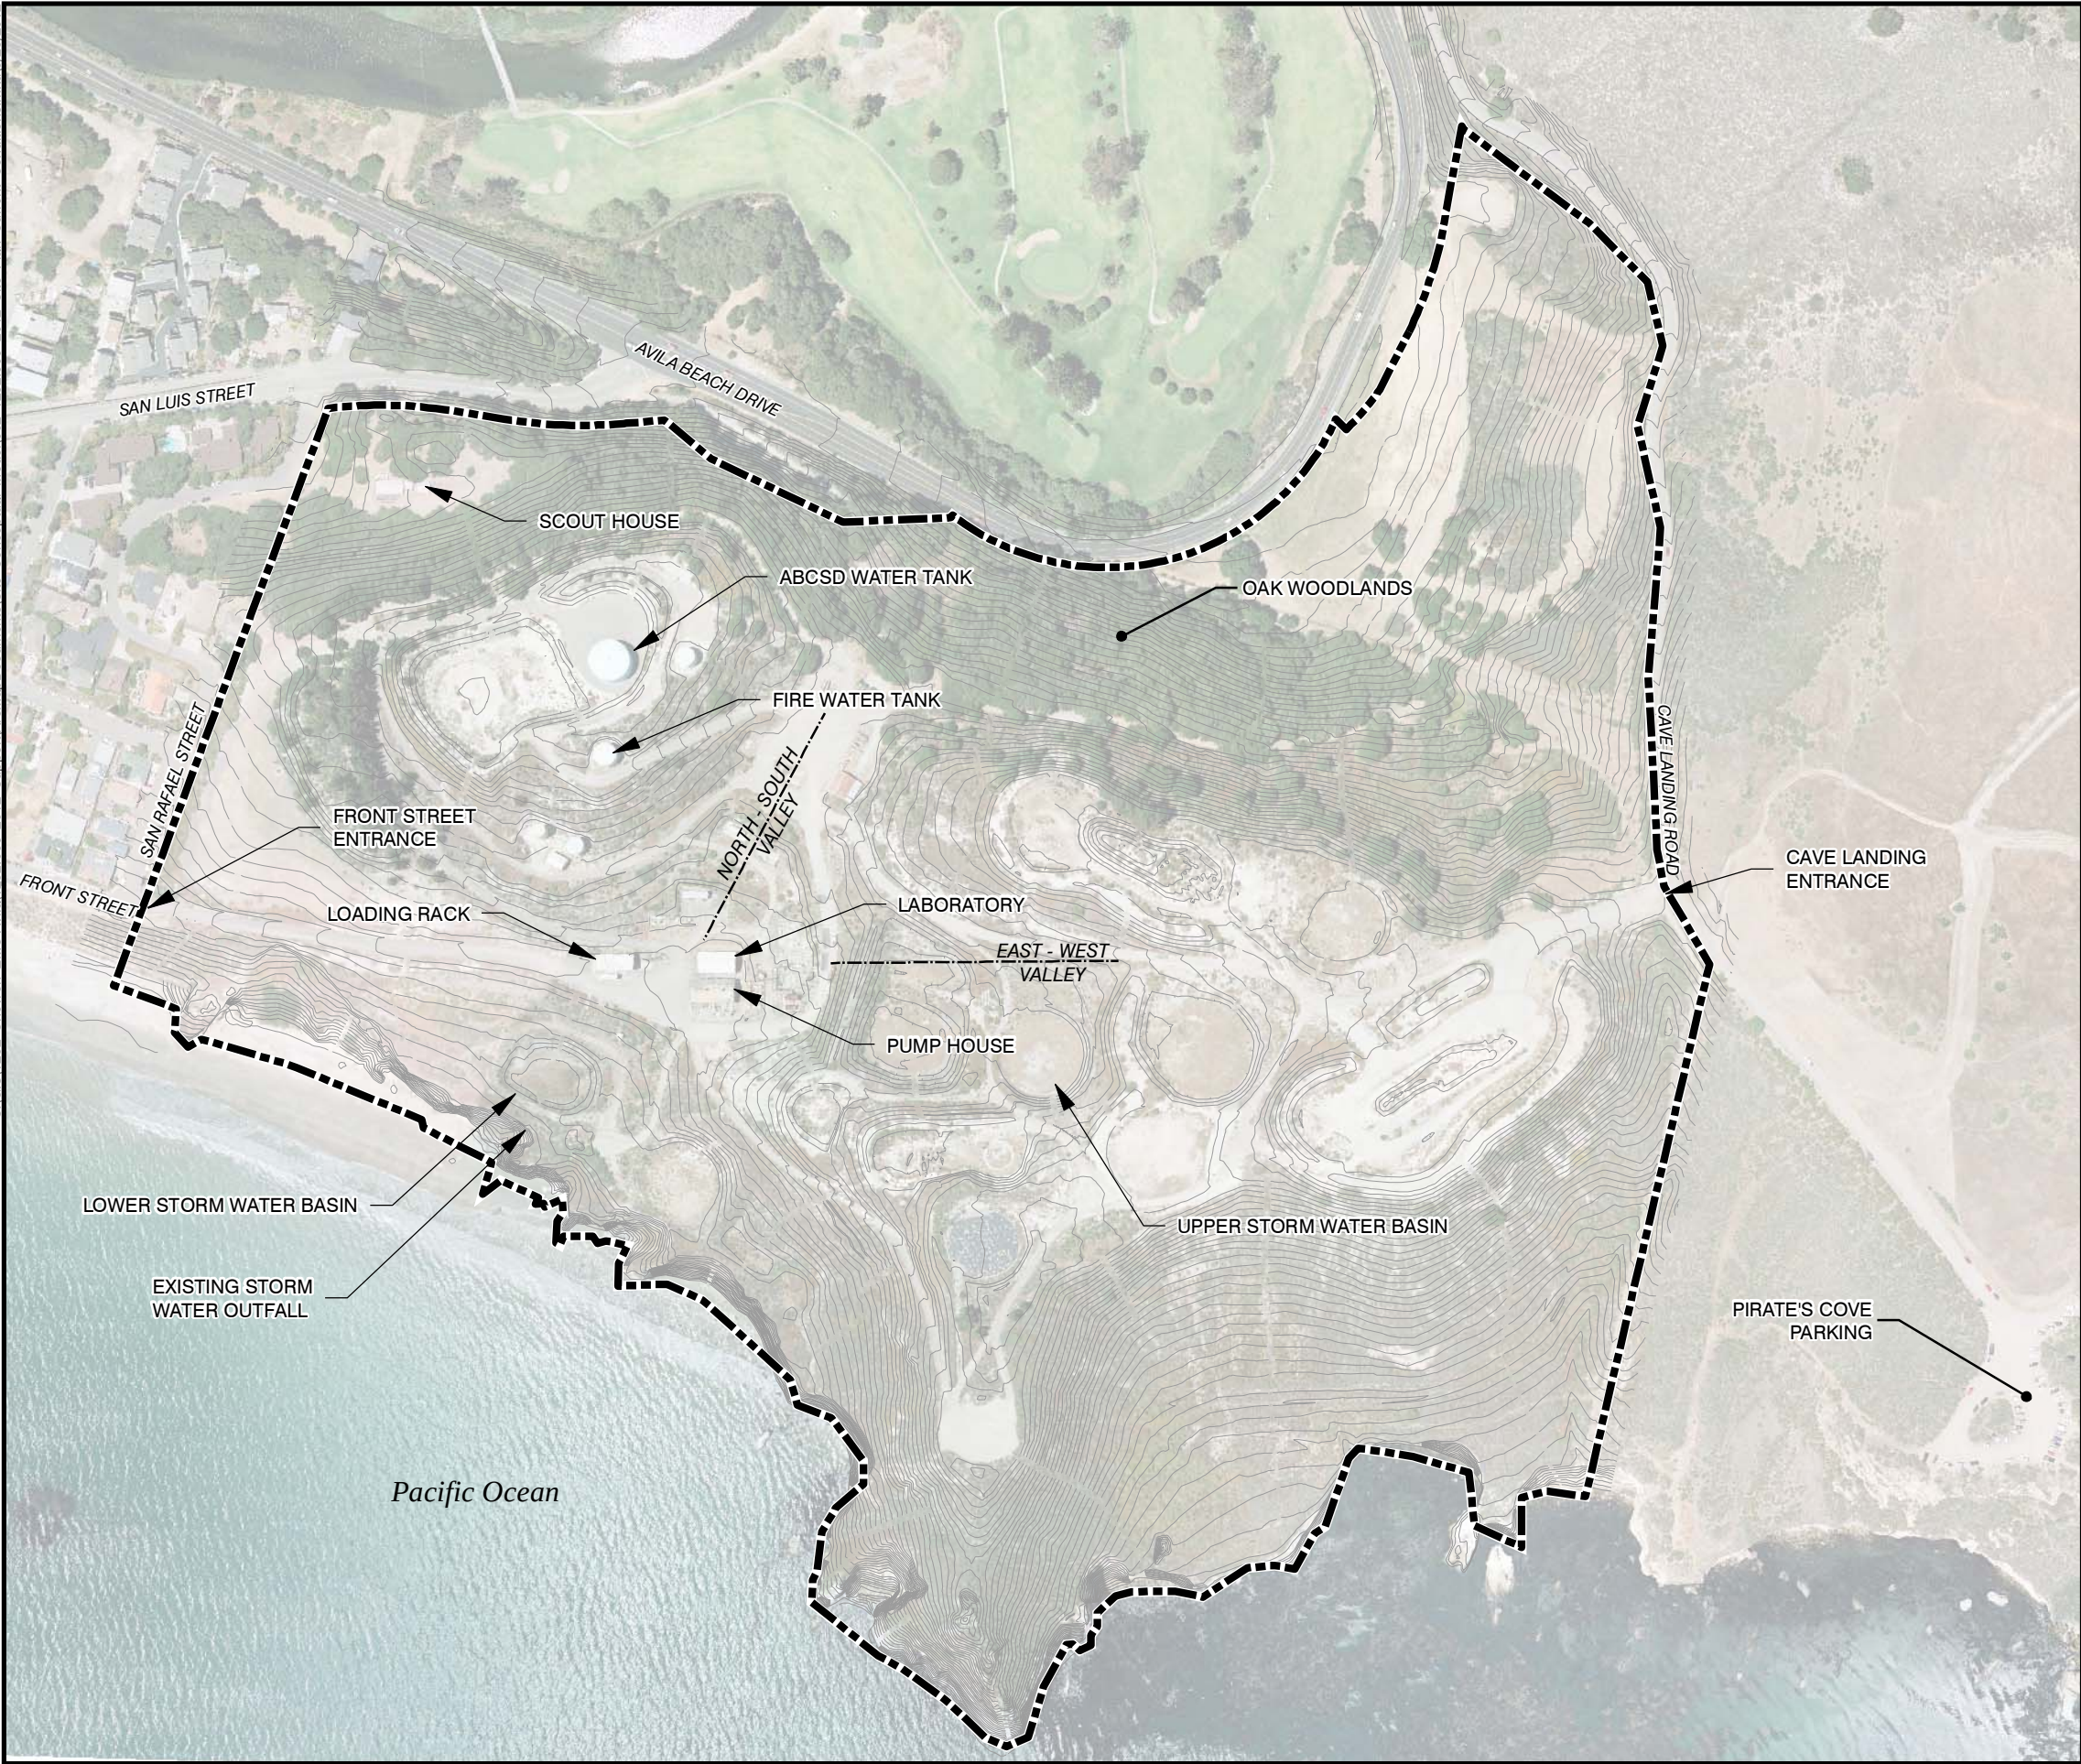
FIGURE 2  
**SITE PLAN - CURRENT CONDITIONS**

A site plan for the Avila Terminal, depicting its current condition and highlighting the physiographic features, is shown in Figure 2. The facility is no longer active and has been decommissioned. Relative to the site conceptual model:

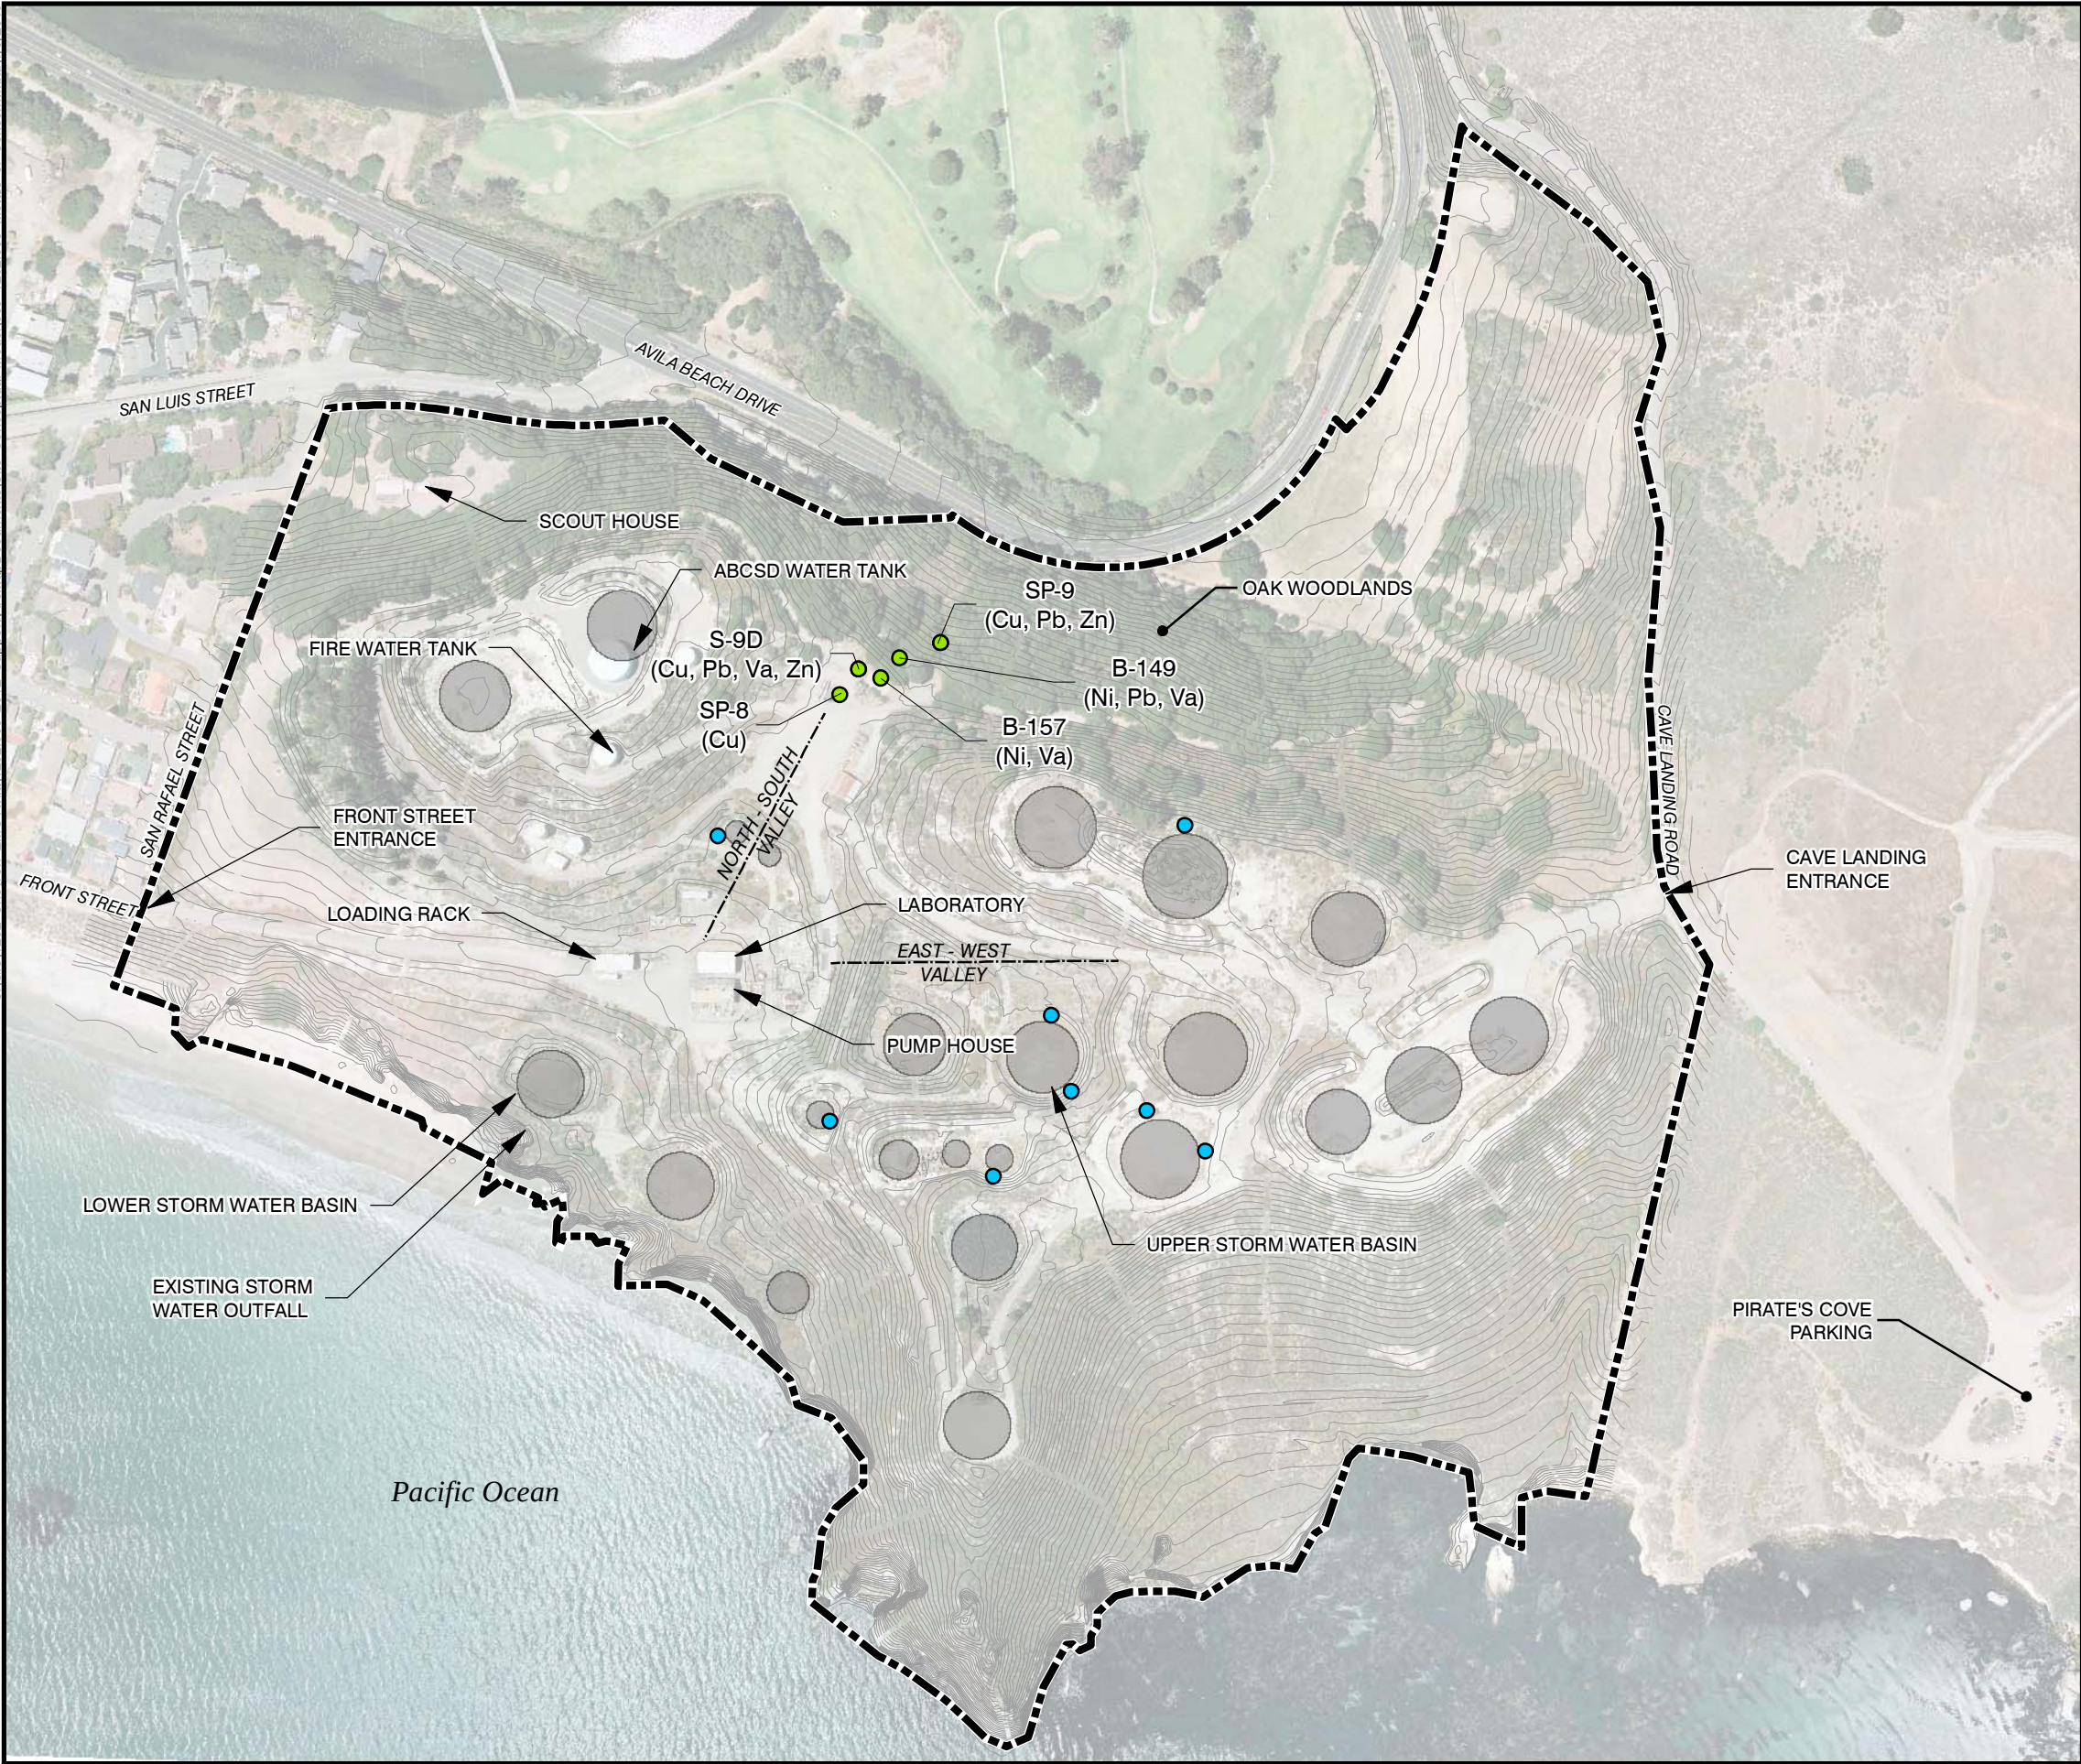
**Explanation**

- Soil Sample with a Least 1 Metal Concentration above Background
- Soil Sample with Lead Exposure Risk
- Approximate Site Boundary
- Storage Tanks / Areas

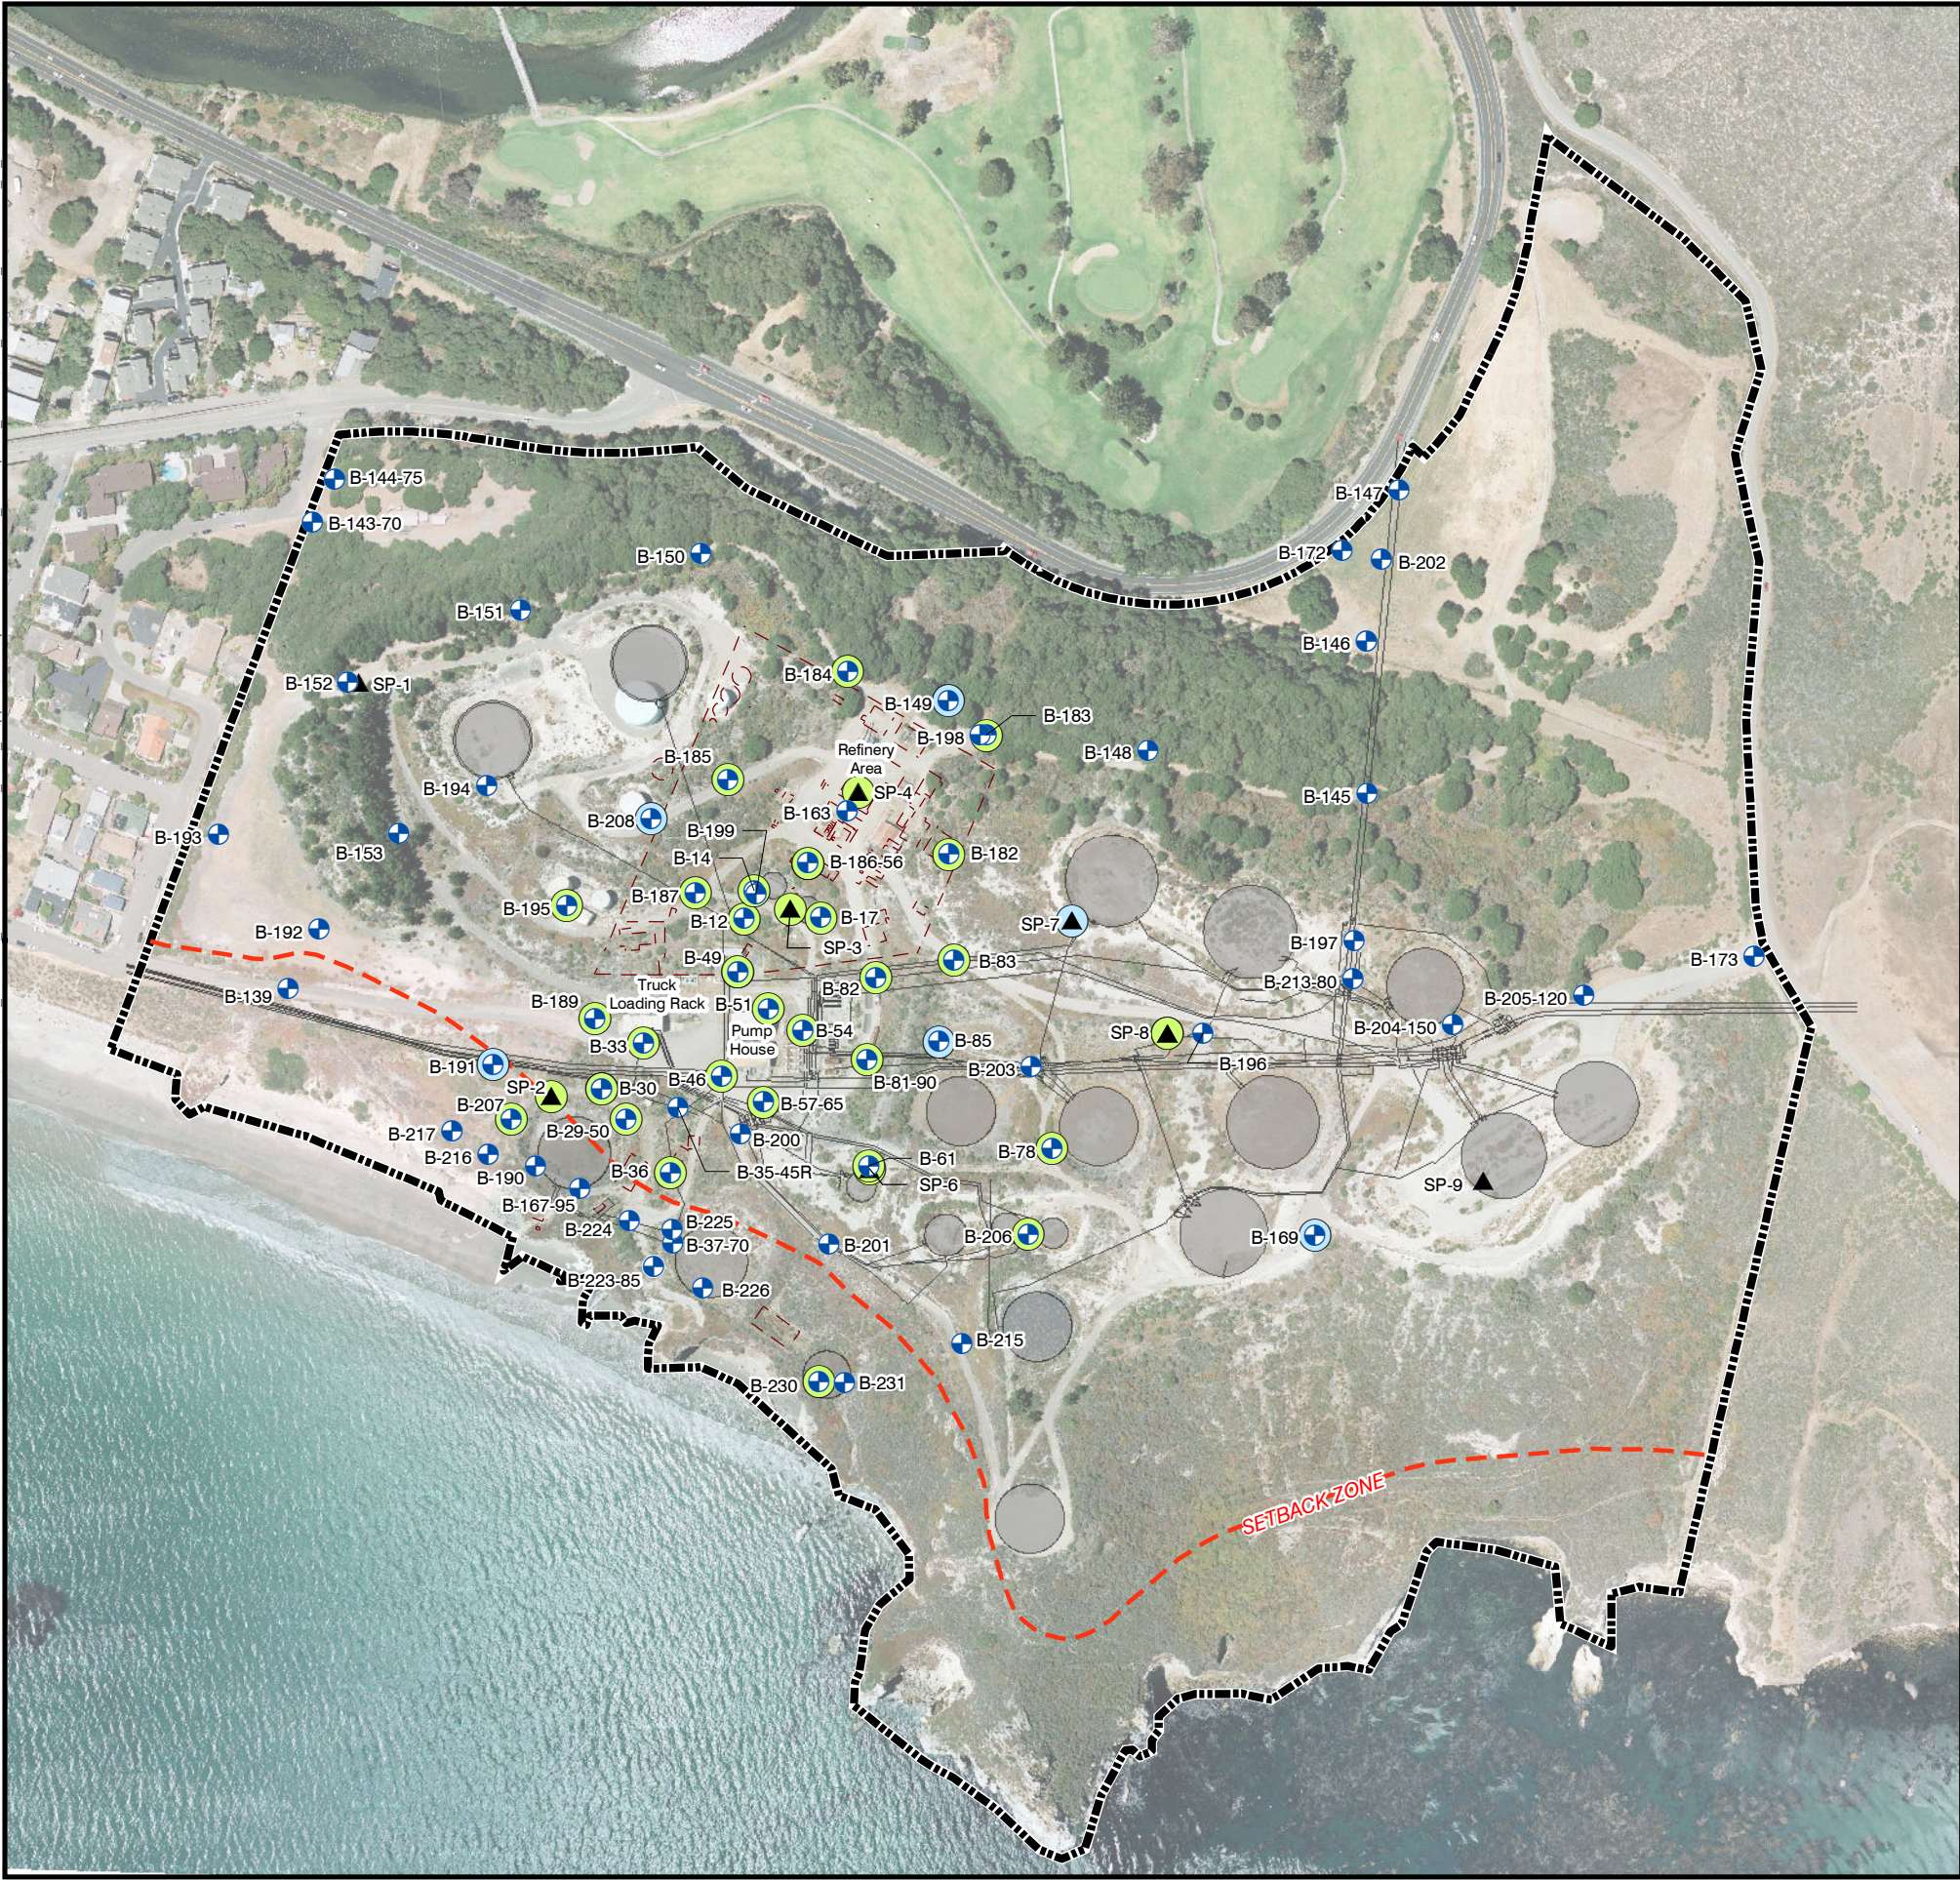
FIGURE 17  
**DISTRIBUTION OF LNAPL**  
SITE CONCEPTUAL MODEL  
FORMER AVILA TERMINAL  
AVILA BEACH, CALIFORNIA  
PREPARED FOR  
CHEVRON  
ENVIRONMENTAL MANAGEMENT COMPANY  
SAN LUIS OBISPO, CALIFORNIA

NOTES:  
1. FIGURE ILLUSTRATES MOST SIGNIFICANT LNAPL OCCURRENCES OVER ENTIRE MONITORING PERIOD.  
2. NOTE THAT B-223-88, AND B-32-40 EACH HAD ONE OCCURRENCE OF SHEEN REPORTED. SHEEN HAS NOT BEEN OBSERVED IN THOSE WELLS IN OVER 50 OTHER MONITORING EVENTS.

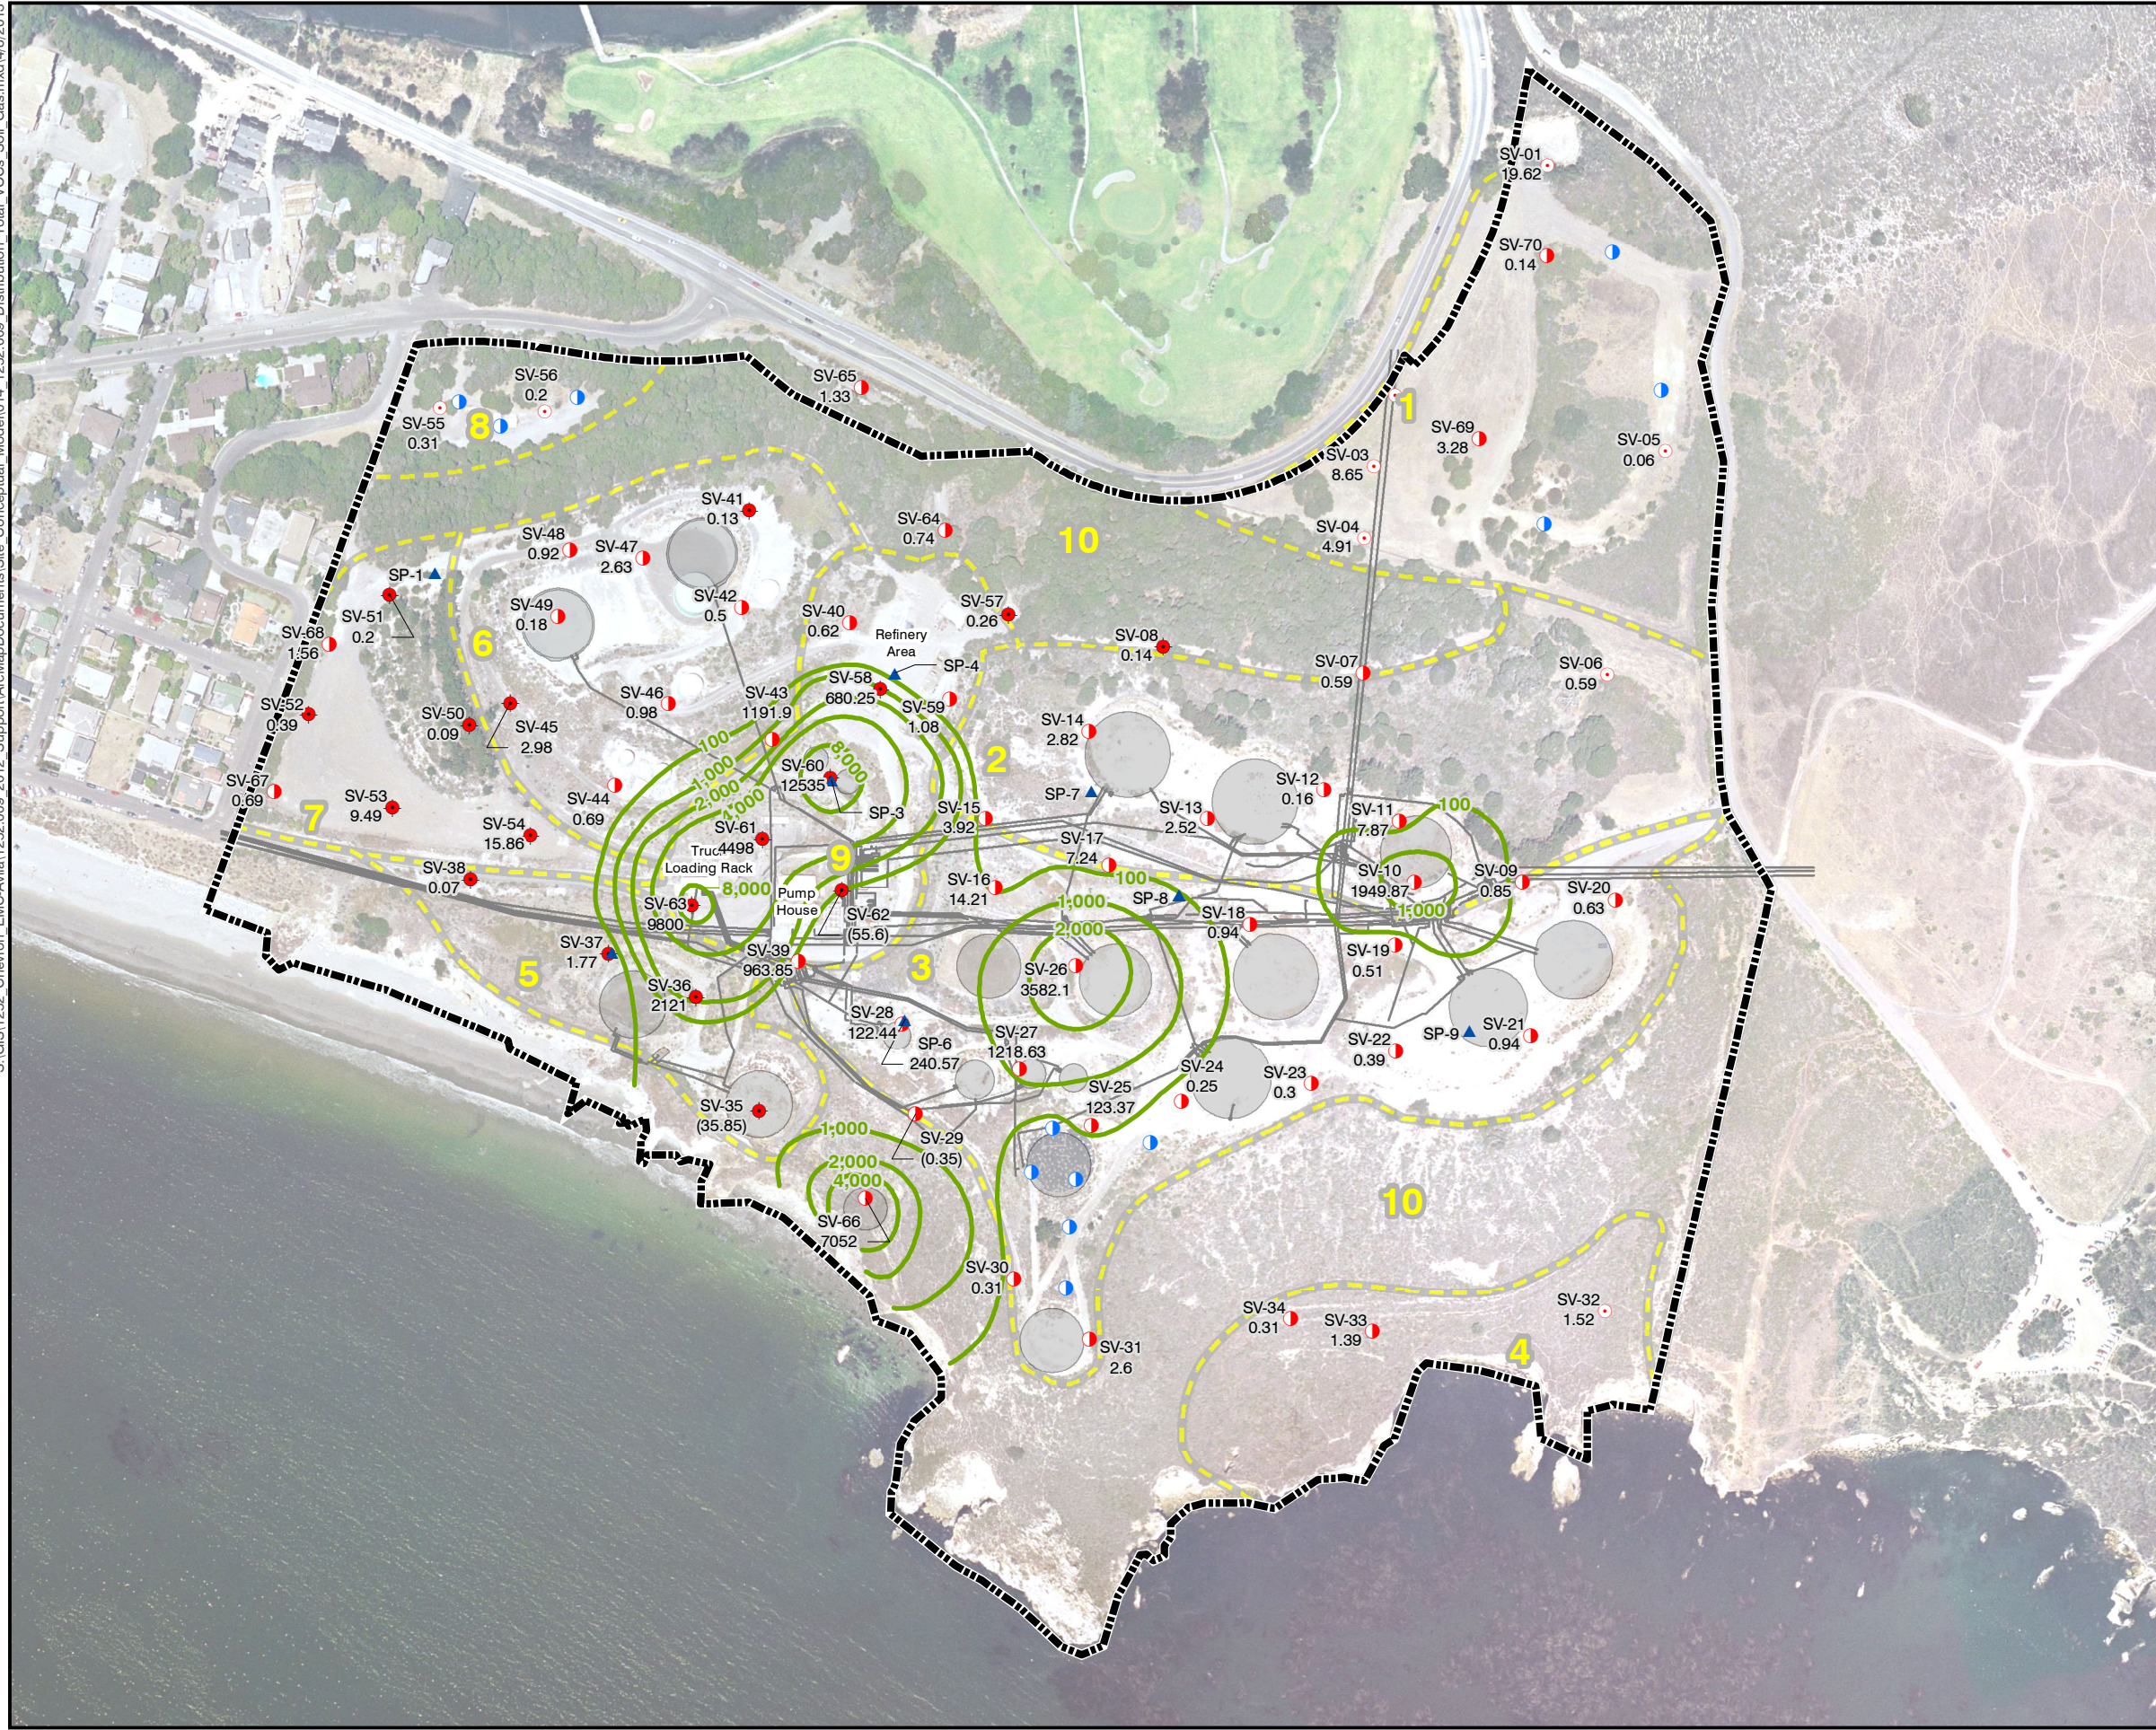
FIGURE 20  
**DISTRIBUTION OF TOTAL VOCs  
IN SOIL GAS**  
SITE CONCEPTUAL MODEL  
FORMER AVILA TERMINAL  
AVILA BEACH, CALIFORNIA  
PREPARED FOR  
CHEVRON  
ENVIRONMENTAL MANAGEMENT COMPANY  
SAN LUIS OBISPO, CALIFORNIA

- 3) Together, these assessments found the following:
  - The lateral extent of VOCs in soil gas were similar in shallow (5 feet below ground surface) and deep (15 feet below ground surface) probes, although concentrations were about an order of magnitude greater in the deeper samples, suggesting a soil gas attenuation factor of about 0.1 between 15 and 5 feet below ground surface. Attenuation may include some degradation or breakdown of products but is primarily mixing with atmospheric air.

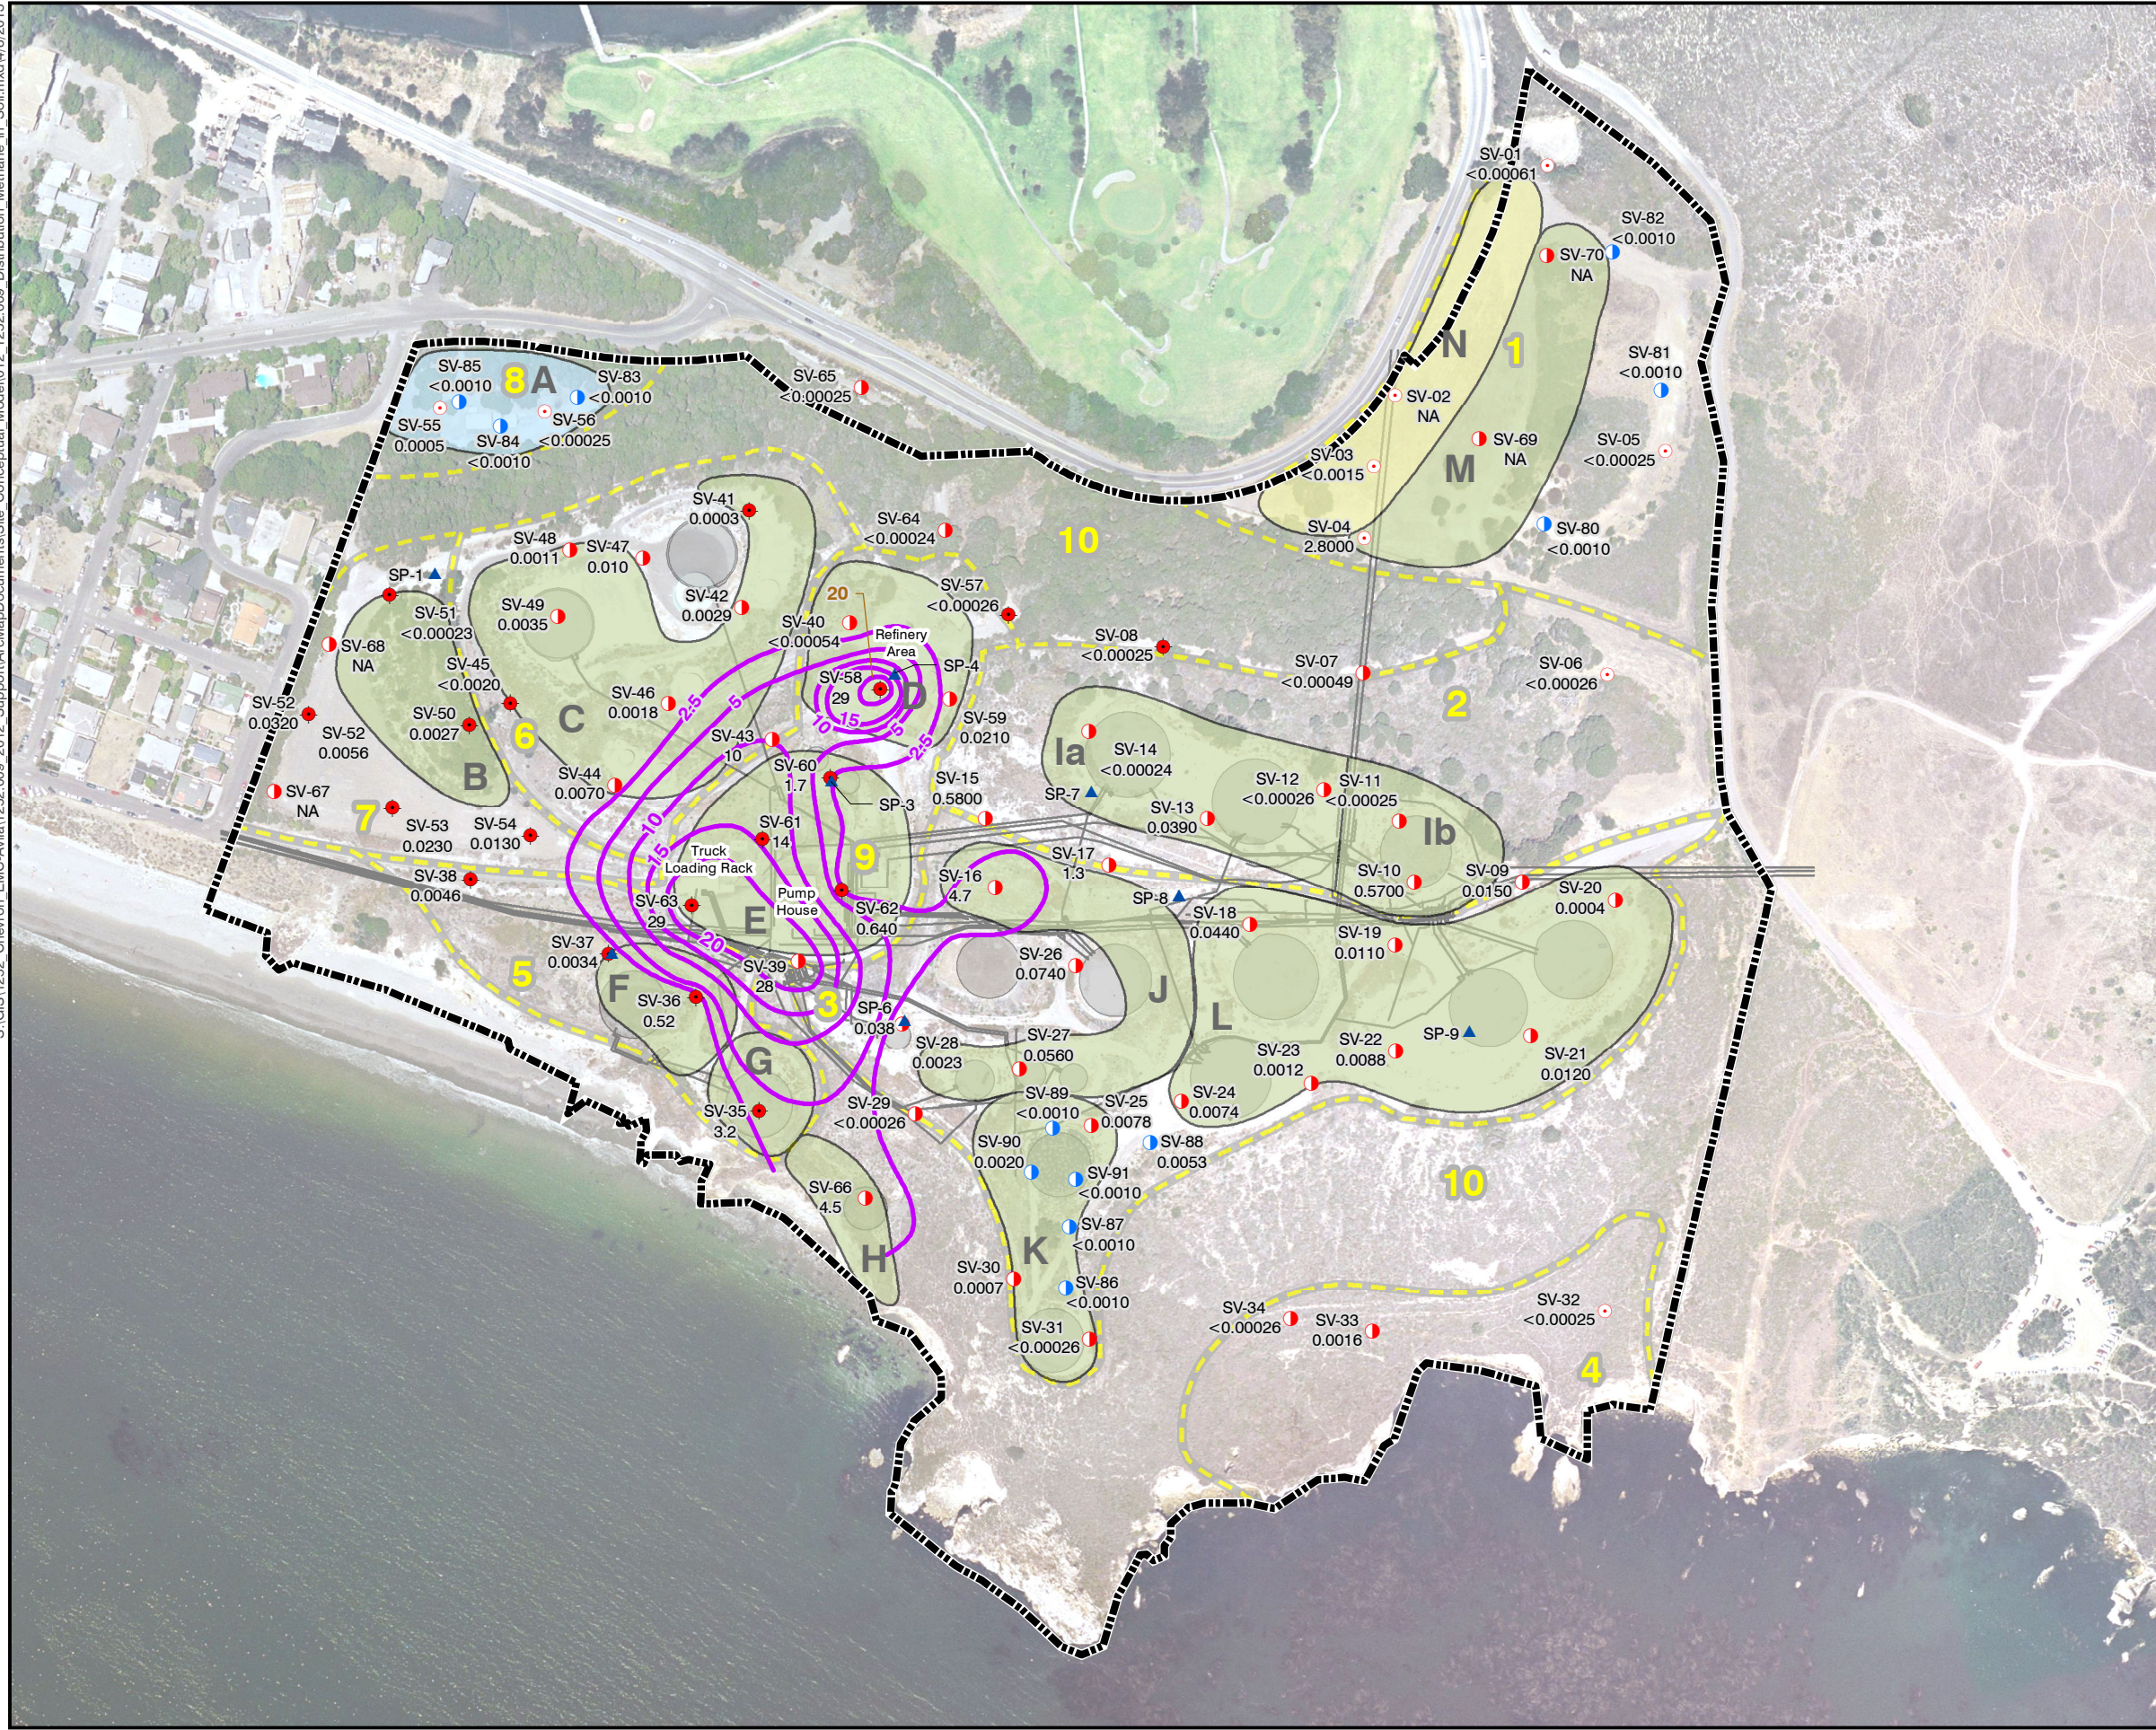
- Elevated methane concentrations are considered an indirect evidence of anaerobic hydrocarbon biodegradation.
  - The extent of VOC in soil gas has been delineated and has been shown to not extend offsite.
