Development and Implementation of Hydromodification Control Methodology

Watershed Characterization Part 2: Watershed Management Zones and Receiving-Water Conditions

Central Coast Regional Water Quality Control Board
895 Aerovista Place, Suite 101
San Luis Obispo, CA 93401

October 14, 2011

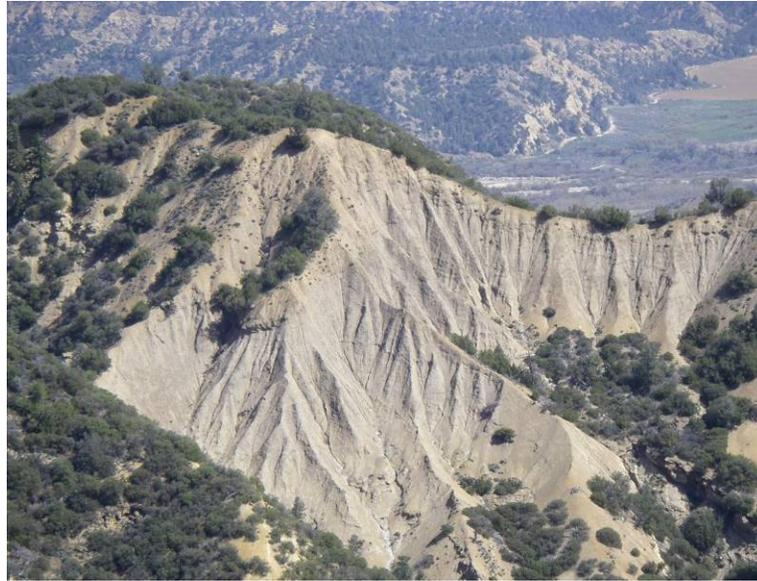
Figure 2-1. Rilling and gullying of weak sedimentary rock along the Maricopa Highway (SR 33) providing clear evidence of active overland flow during rain events, just south of Lockwood Valley in the southeastern part of the Region (in older Tertiary sediments, >40%).

Note that most of the hydrologic processes (left-hand column) can only be inferred, given the limitations of one-time observation in non-rainy conditions. However, some of these processes are virtually certain to occur to *some* extent in every part of the landscape (e.g., evapotranspiration and surface infiltration); subsequent analyses, however, might be necessary to quantify their relative or absolute magnitude. In addition, the portions of the landscape where overland flow has (and will again) occurred are typically apparent, because any significant overland flow will give rise to persistent rills and/or gullies (Figure 2-1) on all but the most non-erosive of hillsides.

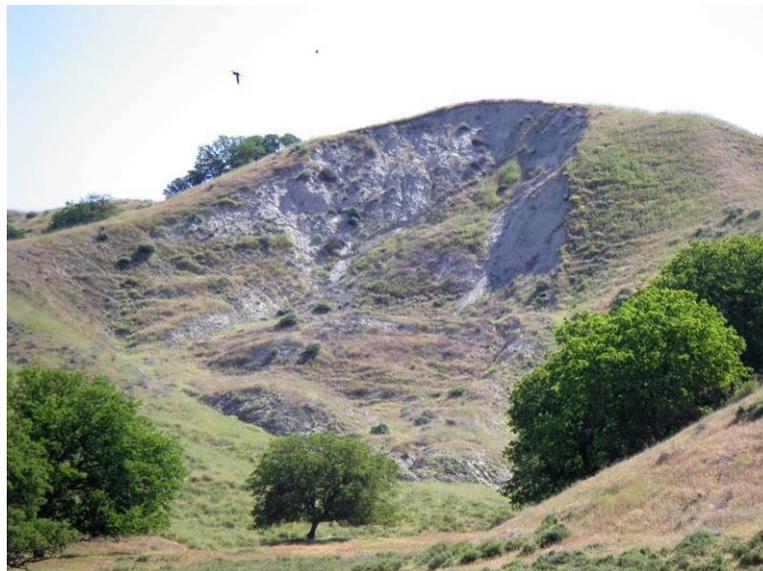
Figure 2-2. Mass failure (landslide) along Bitterwater Road, east of Paso Robles in the east-central part of the Region (in Quaternary sedimentary deposits, 10-40%).

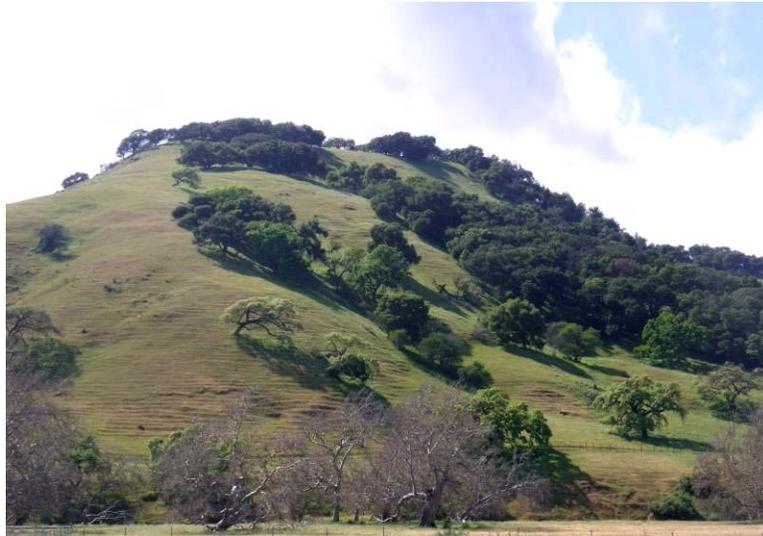
Figure 2-3. Hillslopes dominated by creep, as evidenced by the lack of apparent rills, gullies, or discrete mass failures. Rates of sediment delivery from this landscape are likely one to several orders of magnitude slower than from those shown in Figures 2-1 or 2-2. Site is along Pacheco Pass Highway in the Diablo Range, east of Gilroy (in Franciscan mélangé, >40%).

In contrast, most of the “hillslope” processes (we recognize that runoff also occurs on hillslopes but use this term to identify those processes responsible for sediment movement and delivery) typically have direct field expression even if the process is not active at the time of observation. Gullies (Figure 2-1) are one such example; mass failures (Figure 2-2) are another. Creep is generally just inferred by the absence of other expression, but it is known to be ubiquitous across nearly all landscapes and can be the dominant sediment-delivery process where other modes of sediment movement are not active (Figure 2-3).

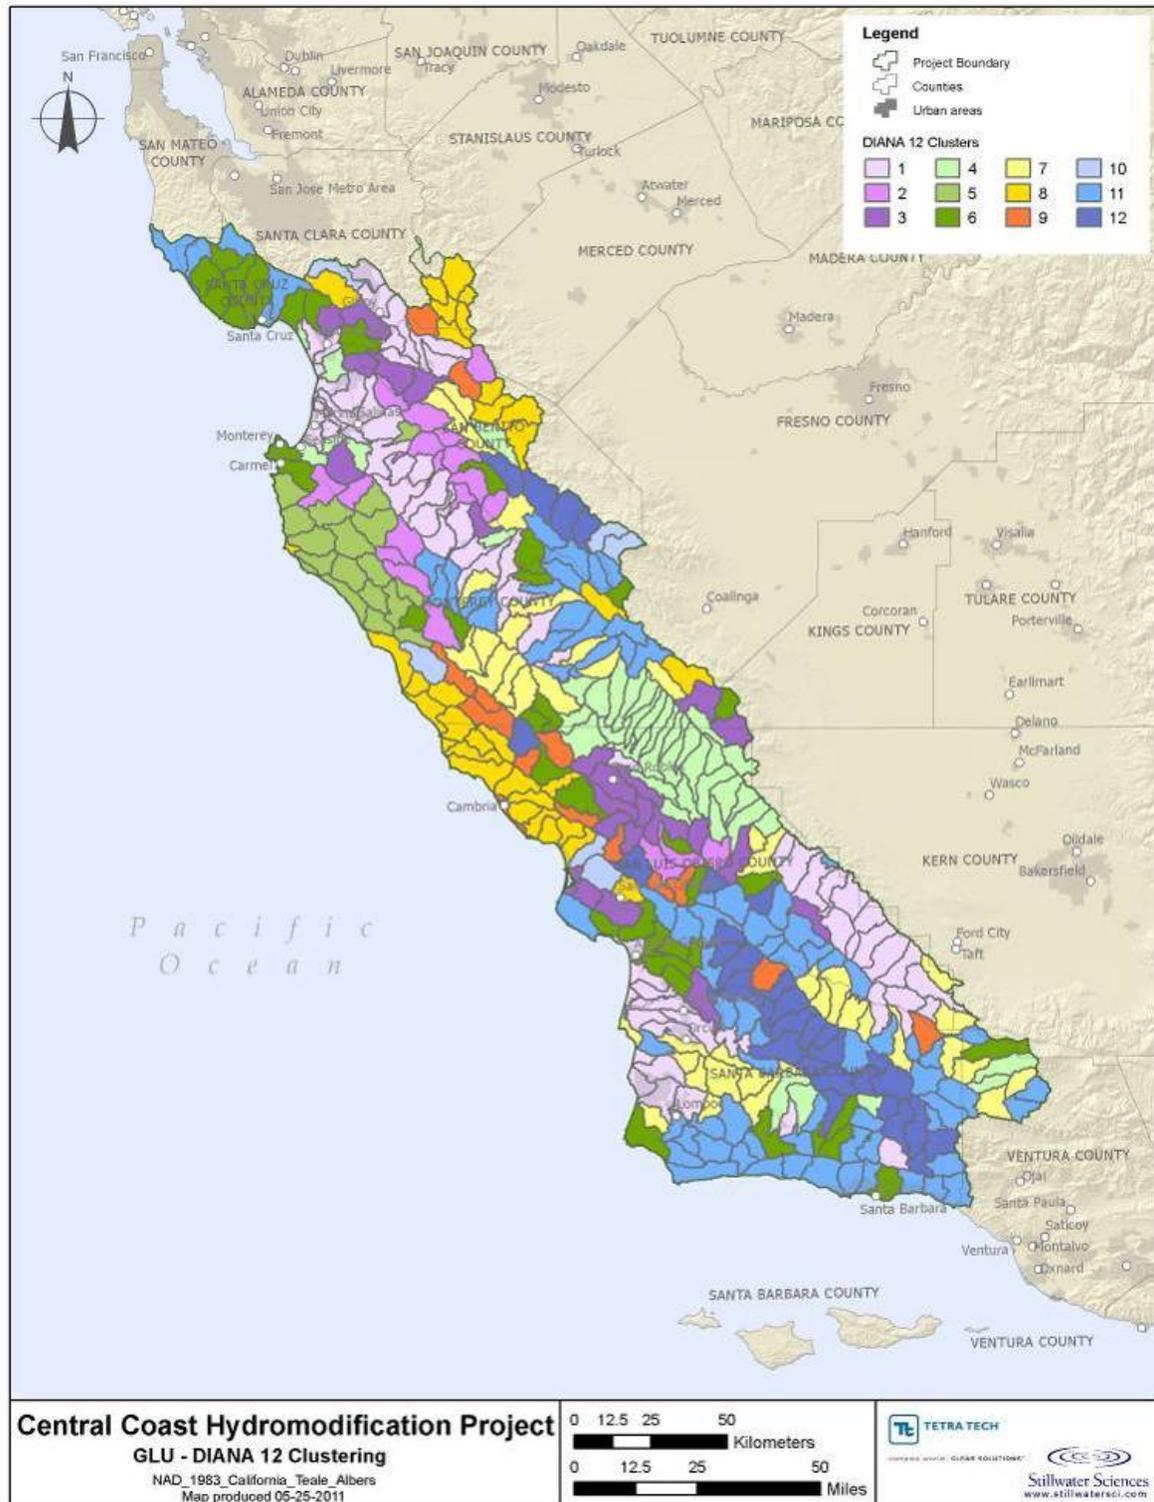
Figure 3-1. Initial landscape zones, identified by statistical analysis of GIS data within 406 sub-watershed areas (outlined colored polygons). The 12 “clusters” identify broadly similar areas with respect to geology, hillslope gradient, and land cover (reproduced from the Task 2 report, *Watershed Characterization Part 1: Precipitation and Landscape*; Figure 3-10).

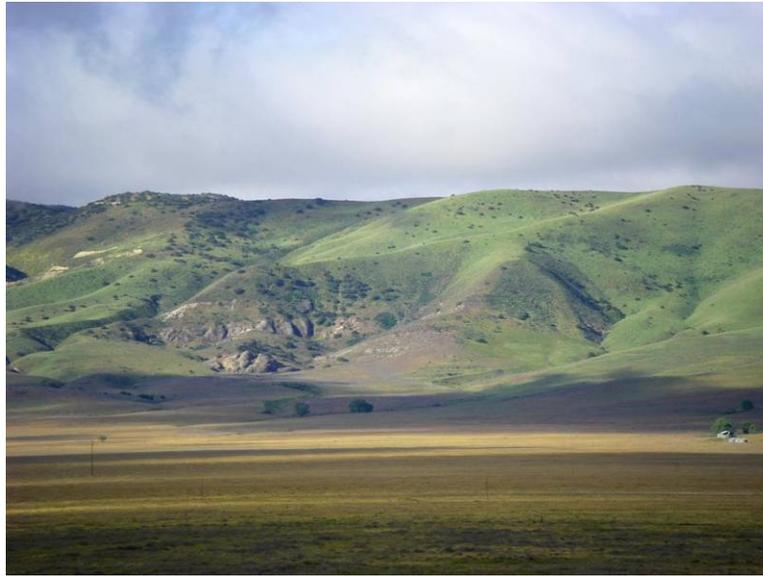
Figure 3-2. View of the west side of the Carrizo Plain. This entire area is included in Cluster 1 (the light pink areas of Figure 3-1, here along the eastern edge of the Region near its south edge), but even a cursory inspection suggests that the watershed processes likely to dominate across the flat Quaternary sediments in the foreground are unlikely to correspond to those of the Tertiary mountains in the background.

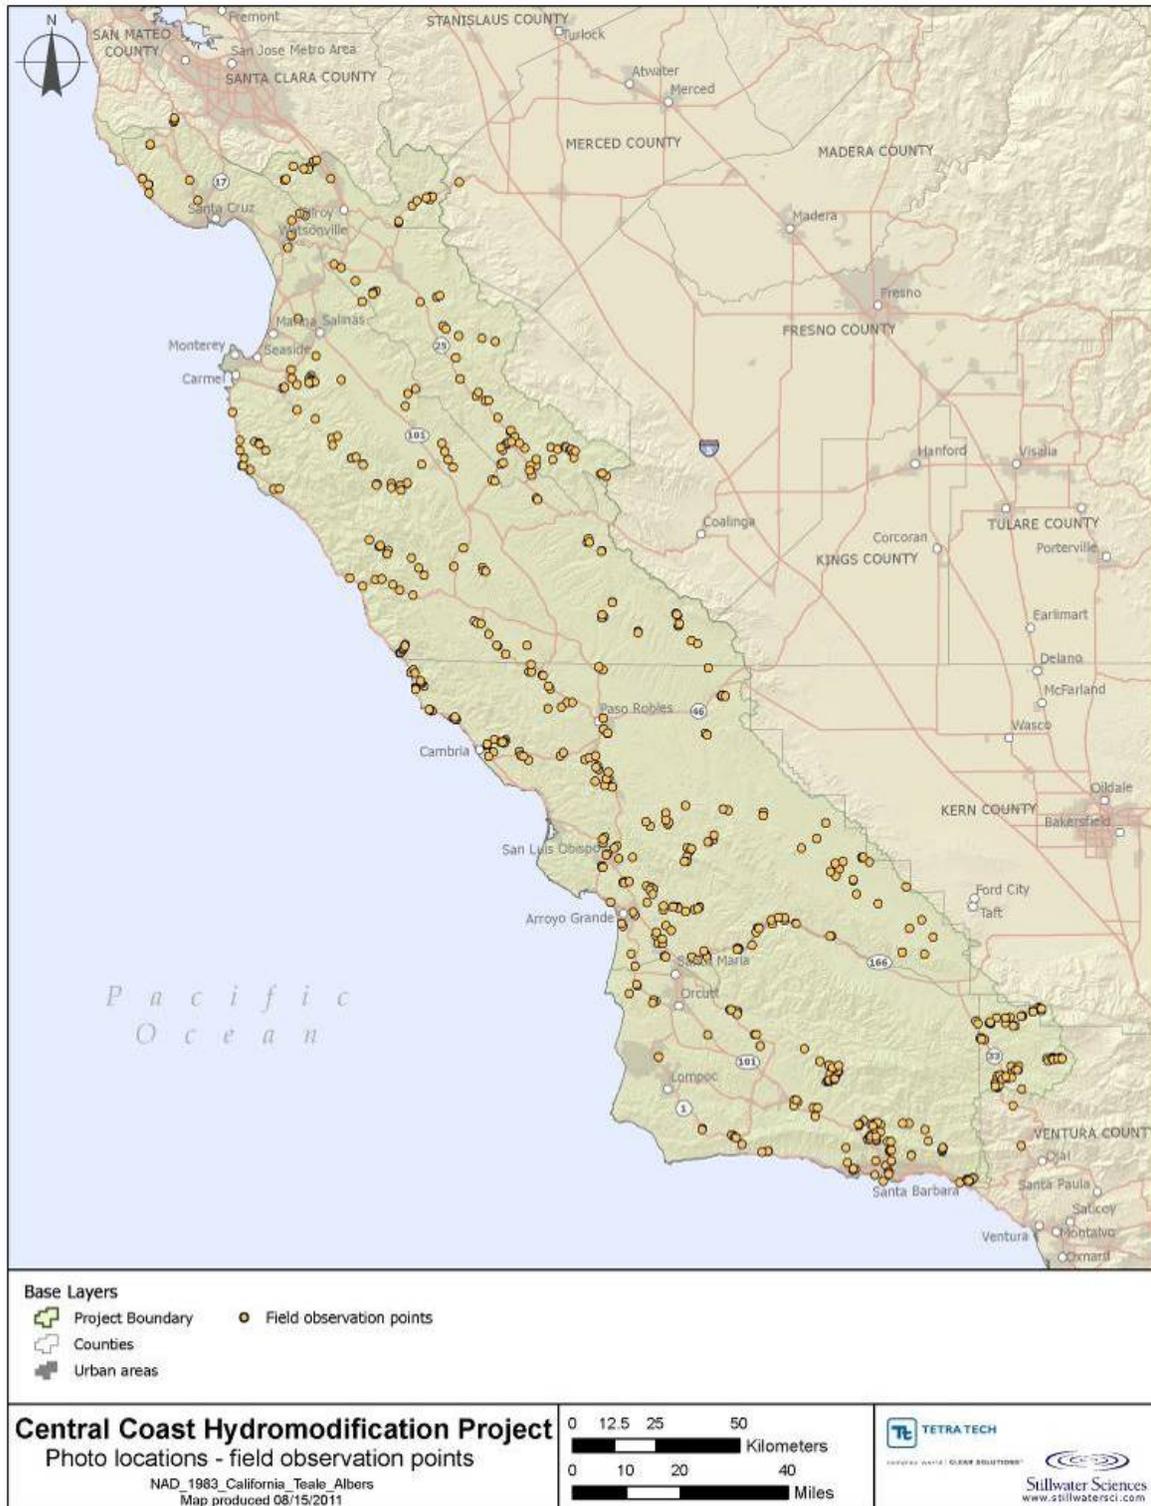
Figure 3-3. Observation locations (photo points) from the spring 2011 field work.

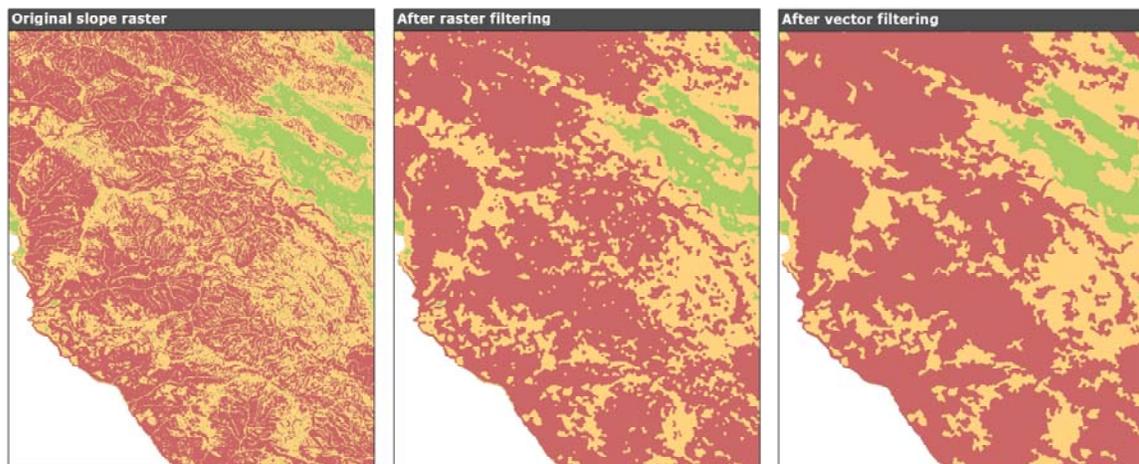
Figure 3-4. Progression from the original slope classes determined from the “raw” topographic data (left-hand panel), through the raster and vector filtering steps described in the text, to the final result (right-hand panel) used to create the provisional Watershed Management Zones (Figure 3-5).

Geoprocessing of the slope data translated directly into the final boundaries of the initial WMZ’s, and so the results of this procedure merit inclusion here. They are best illustrated by example of the changes that result from the two main steps of the procedure described above, namely the class-boundary and neighboring-cell filtering (the “raster filtering” of Figure 3-4) and the removal of small slivers (“vector filtering”).

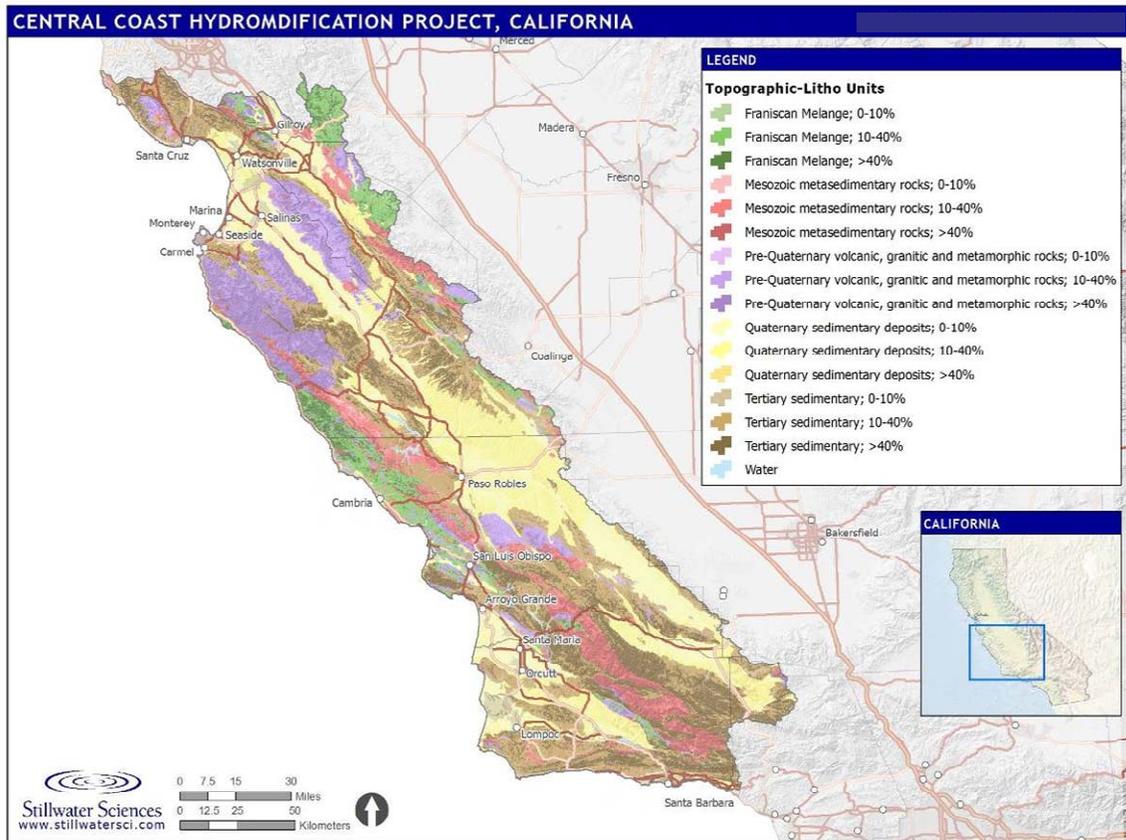
Figure 3-5. Preliminary map of the provisional Watershed Management Zones, based on the smoothed slope polygons and the generalized geology units of Jennings et al. (1977). The broad belts of coastal and interior mountains are readily visible in this map, together with the intervening valleys of young, low-gradient sedimentary deposits (yellow shades) in which most of the cities and towns of the region are located.

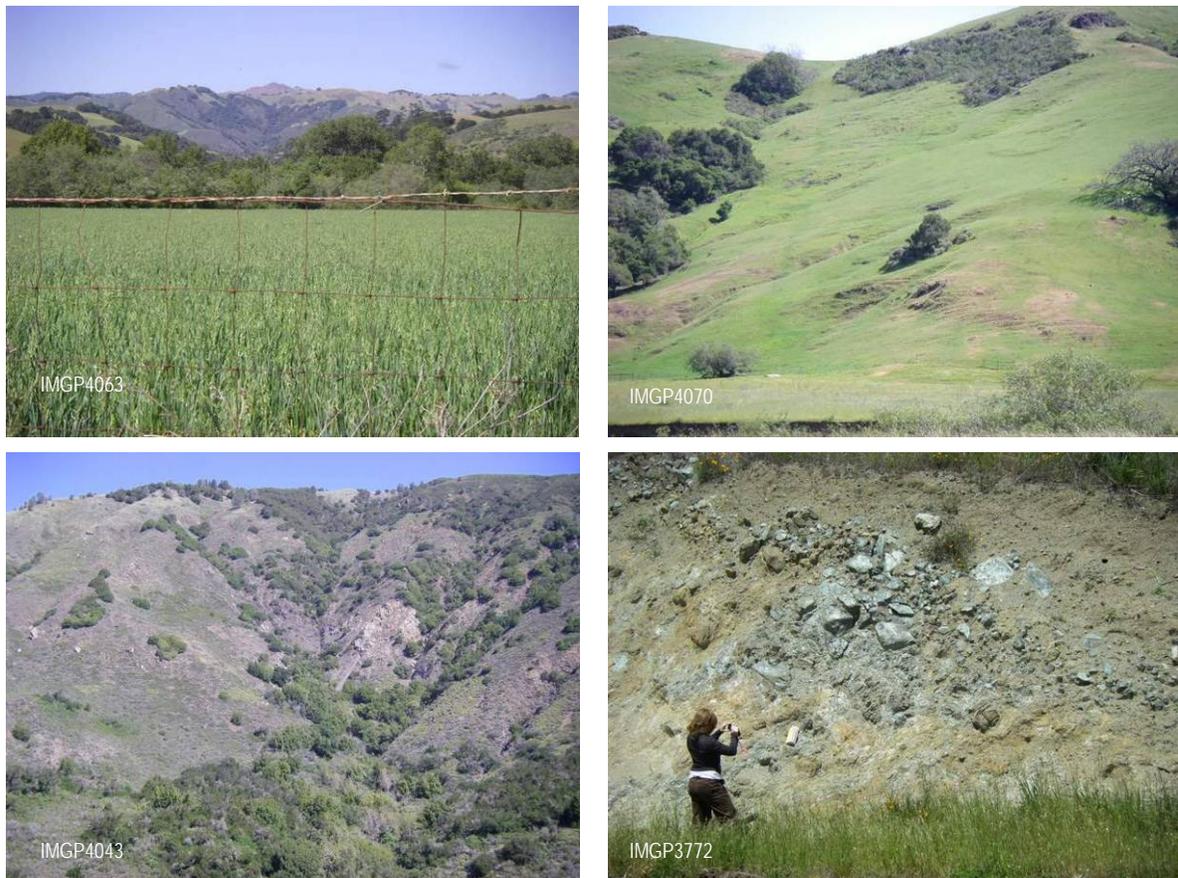
Figure 3-6. Franciscan mélange: 0-10% (upper left), 10–40% (upper right), and >40% (lower panels). A roadcut of serpentinite is well exposed at lower right.

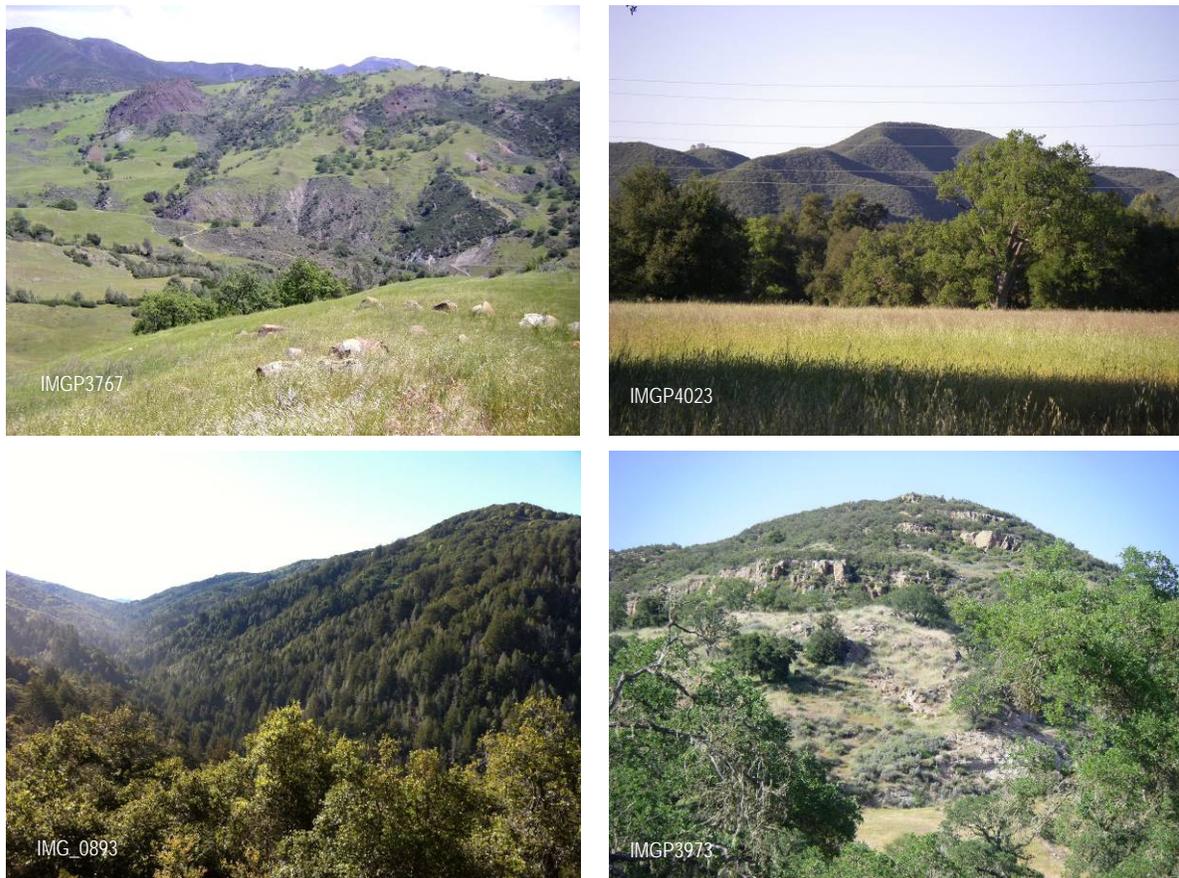
Figure 3-7. Pre-Quaternary crystalline rocks: 10–40+% (upper panels; note flat Quaternary valley fill, foreground of upper right panel), and 10–40% (lower panels)

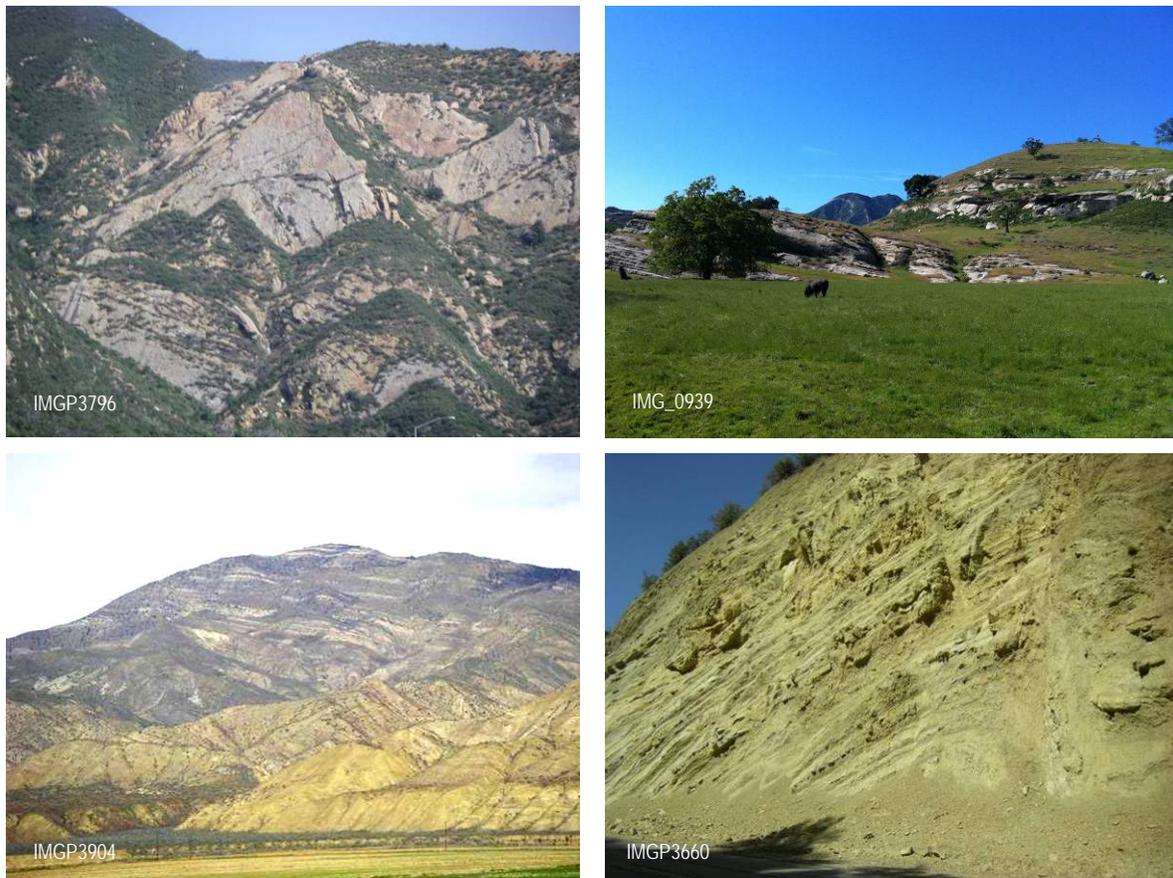
Figure 3-8. Early to Mid-Tertiary sedimentary rocks: upper (>40%) and lower (10–40+%) left panels showing outcrops of well consolidated sandstone outcrops; minimally erosive vegetated and bare-rock outcrops 0–10% (upper right) contrasted with sandy less well-consolidated material in roadcut with relatively high erodibility (lower right)

Watershed processes in this lithologic group are as varied as the materials themselves, with a predominance of well-cemented sandstones that are relatively resistant to most erosive processes and weather to produce sandy soils with good infiltration and moderate susceptibility to gullyng on moderate and steep slopes, particularly where devegetated. Most of these strata have been tipped, folded, and fractured, providing abundant preferential pathways for infiltrating groundwater. However, the less well-consolidated sediments, particular those with a high silt or clay fraction, exhibit abundant surface runoff and associated rilling and gullyng. Examples of both sets of watershed processes are illustrated in Figure 3-8.

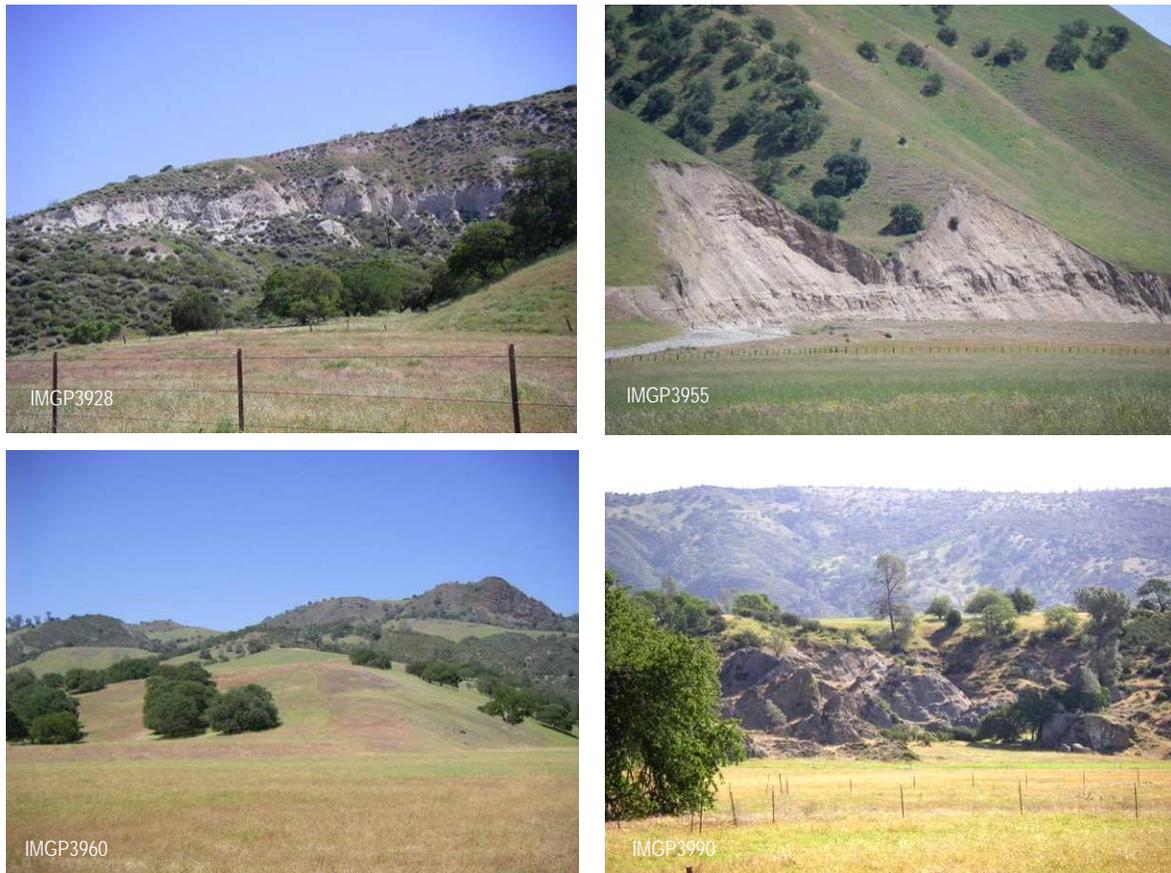
Figure 3-9. Late Tertiary sedimentary rocks: >40% (upper panels), 10–40% (lower panels). Note the lack of expression of surface runoff on the uneroded hillslopes (left-side panels), in contrast to the severity of gulying where surface runoff has occurred

Quaternary sedimentary deposits are the single most abundant geologic material in the Region, cropping out across one-third of the Region. This is almost certainly an underestimation, since narrow stream valleys and the toeslopes of most hills are also mantled in Quaternary-age sediments but are rarely mapped as such, particularly at a regional scale. These deposits generally underlie the coastal terraces and river valleys that separate the mountain belts formed of older, more resistant material. Indeed, over 80% of the flat (i.e., <10% slope) land of the Region is underlain by this deposit (the balance is almost exclusively Tertiary sediments). We have 185 photographs recording this deposit; in contrast to the other units, about two-thirds of these are of flat (0–10%) topography, where the unit is most commonly expressed. Because of its intrinsic weakness, steep natural deposits are not common and cover only 1% of the area of the Region; they typically exist only where either natural (e.g., river erosion) or human (e.g., road cuts) processes are actively creating a steepened face (Figure 3-9, lower panels).

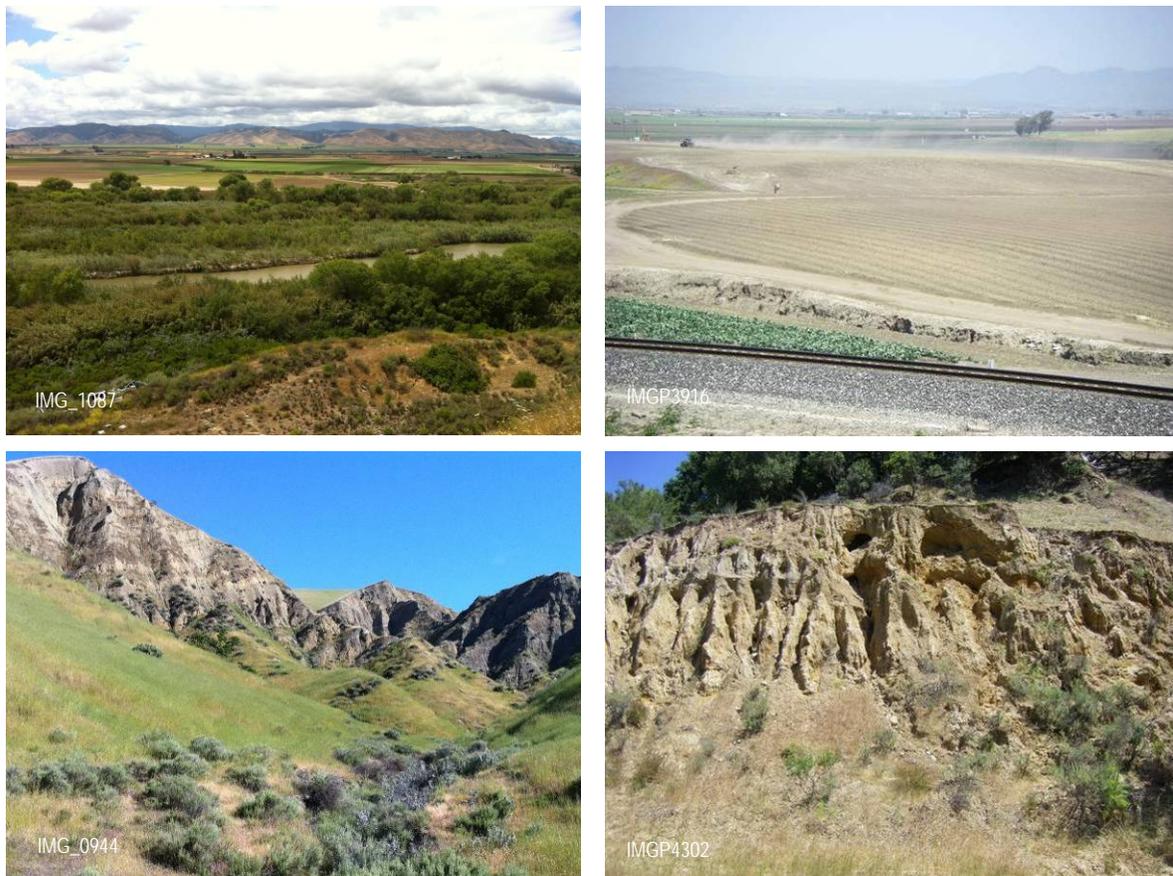
Figure 3-10. Quaternary deposits: 0–10% (upper panels), 10–40+% (lower panels)

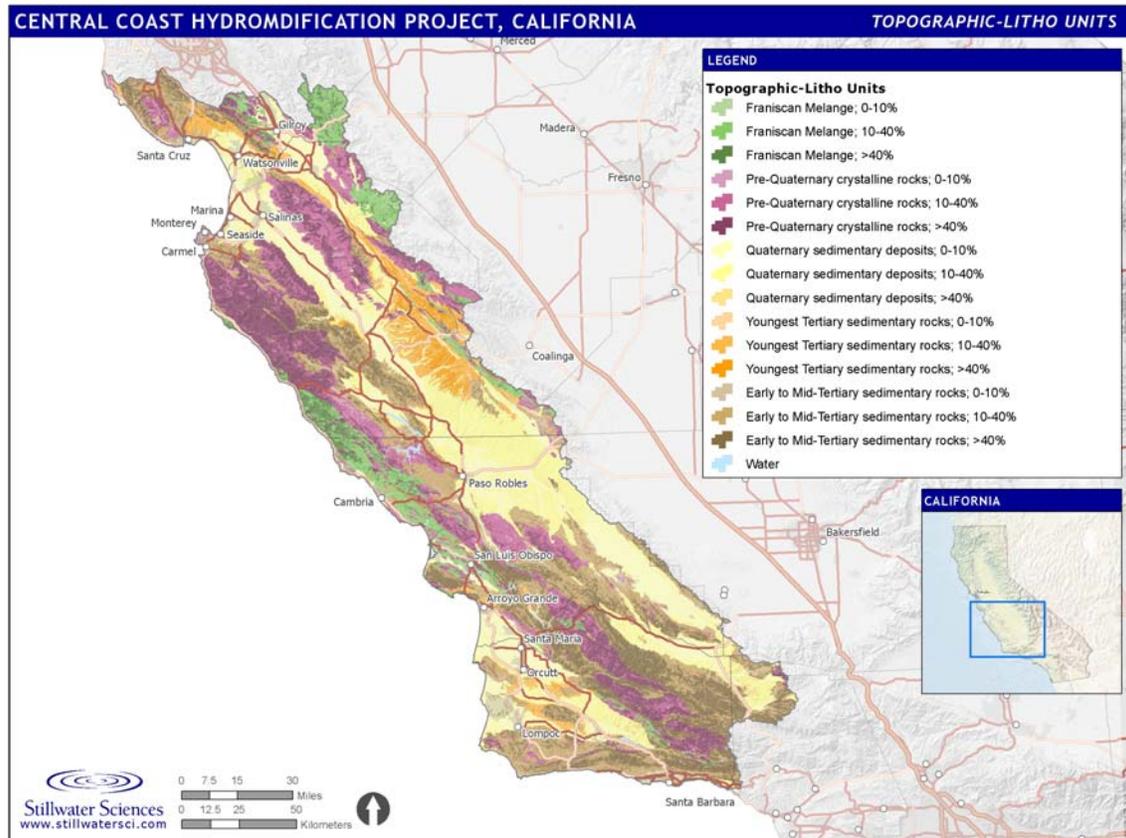
Figure 3-11. Final map of the Watershed Management Zones, based on the smoothed slope polygons and generalized geology units of Jennings et al. (1977) as developed from undisturbed watersheds with relatively intact vegetation cover. Final lithologic groupings have been informed by the results of the Task 3 field work. Relative areas as tabulated in Table 3-2.

Based on observed conditions across the broadly undisturbed landscape areas of the Central Coast Region, we judge that five geologic categories, well-defined at a regional scale, provide a useful basis for discriminating dominant watershed processes. The overlay of three slope zones is a somewhat artificial but nonetheless worthwhile stratification of the landscape that appears to correspond relatively well to the expression of differing degrees of surface runoff, surface erosion, and landsliding (although the same conditions do not necessarily occur on the same slopes in different geologic categories). In combination, these fifteen combinations of slope and geology have led us to a minor modification of the Watershed Management Zones developed in Task 2 and mapped above in Figure 3-5. The relative proportion of these revised zones in the Central Coast Region is tabulated in Table 3-2; their distribution across the Region is displayed in Figure 3-11.

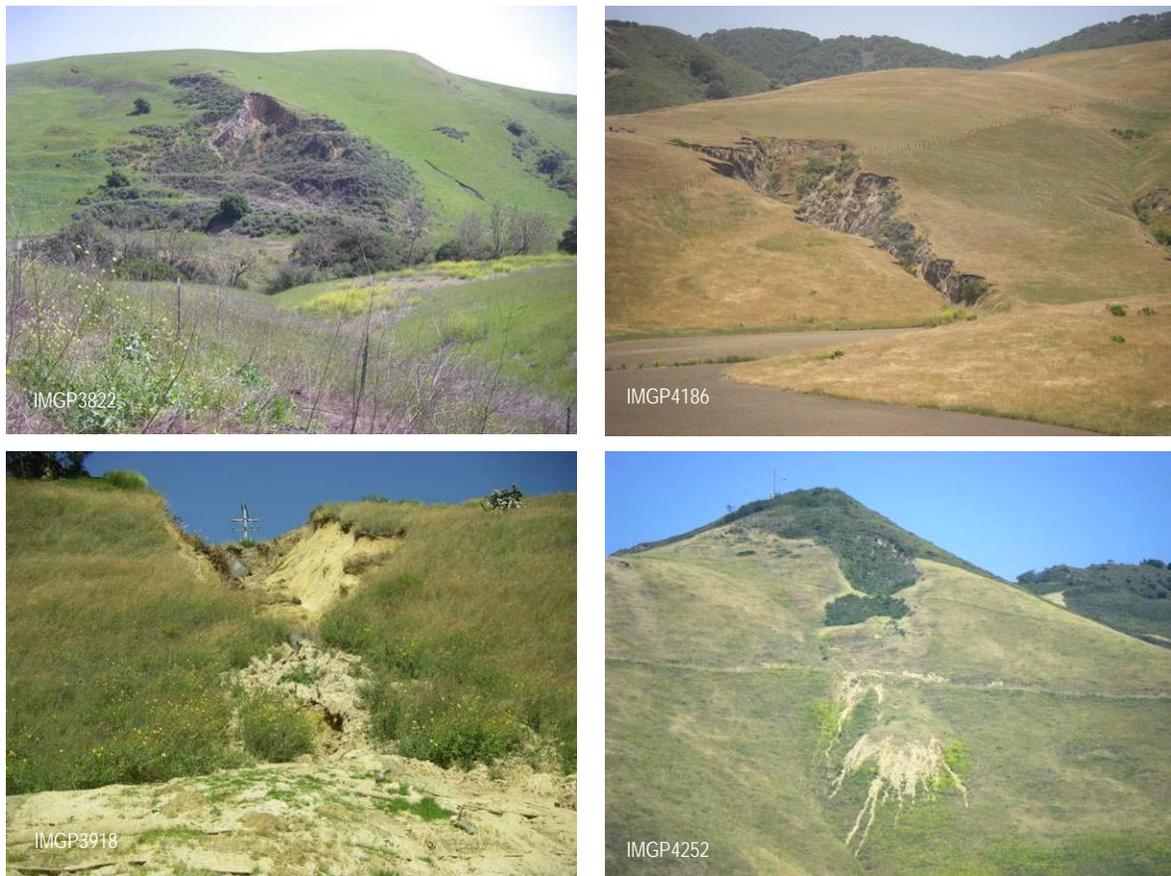
Figure 3-12. Examples of altered watershed processes in response to disturbance. Upper panels, Tertiary deposits express landsliding west of Twitchell Reservoir (left) and gullying south of Guadalupe (right) in response to vegetation changes and soil compaction from grazing; lower panels show effects of concentrated runoff in the form of severe gully-cutting through Quaternary deposits above the Santa Maria River (left) and debris flows below a service road in Franciscan mélange north of Arroyo Grande (right).

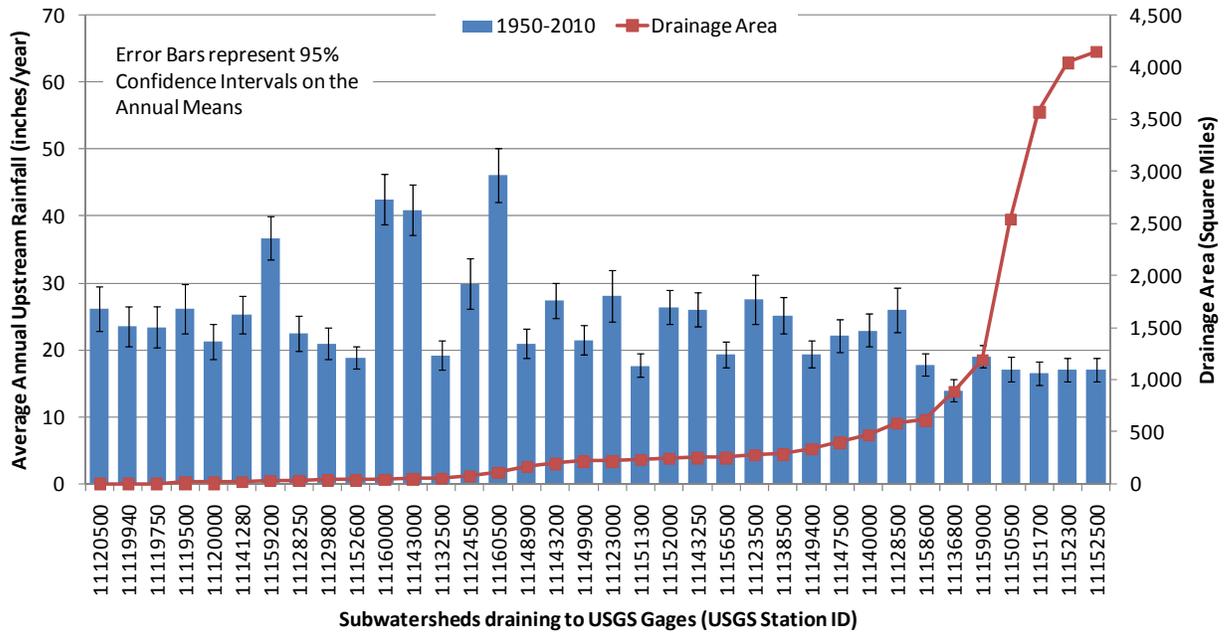
Figure 4-1. 61-year average annual rainfall (blue bars, LH axis) and drainage area (red squares, RH axis in mi²) for the 36 selected USGS gages in the Central Coast Region. Error bars show 95% confidence intervals on the annual average rainfall.

Of the entire population of 183 USGS gage stations, 36 had ample coverage of good-quality data for the period of interest (1951–2010). Average annual rainfall totals in the watershed upstream of each gage (based on the PRISM dataset) were evaluated for the entire period of record (Figure 4-1) and the two decadal periods coinciding with the selected land-use profiles (1981–1990 and 2001–2010) (Figure 4-2). Because the period of time for the decadal comparison is relatively short (10 years, versus 61 years for the entire period of interest), the 95% confidence intervals are relatively wide. A statistical test suggests that no individual station has a significantly different annual average rainfall totals between the two decadal periods, because the confidence intervals overlap at every station.

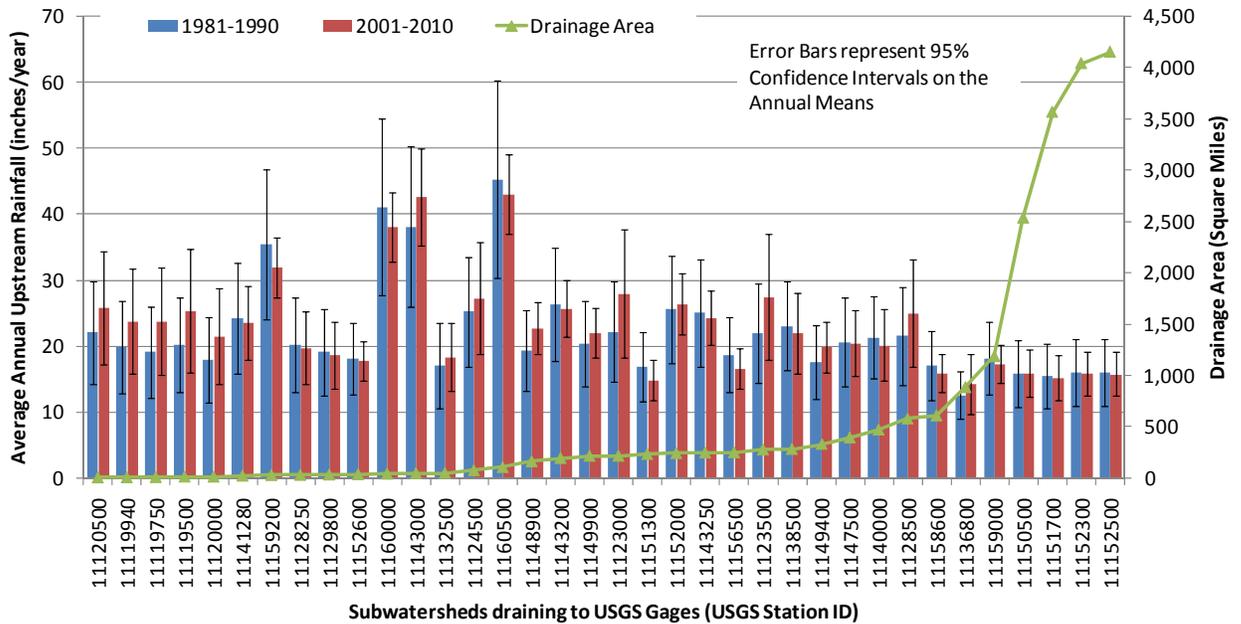
Figure 4-2. 10-year mean annual rainfall totals (with 95% confidence intervals on annual mean rainfall) and cumulative area upstream of each USGS gage (green triangles).

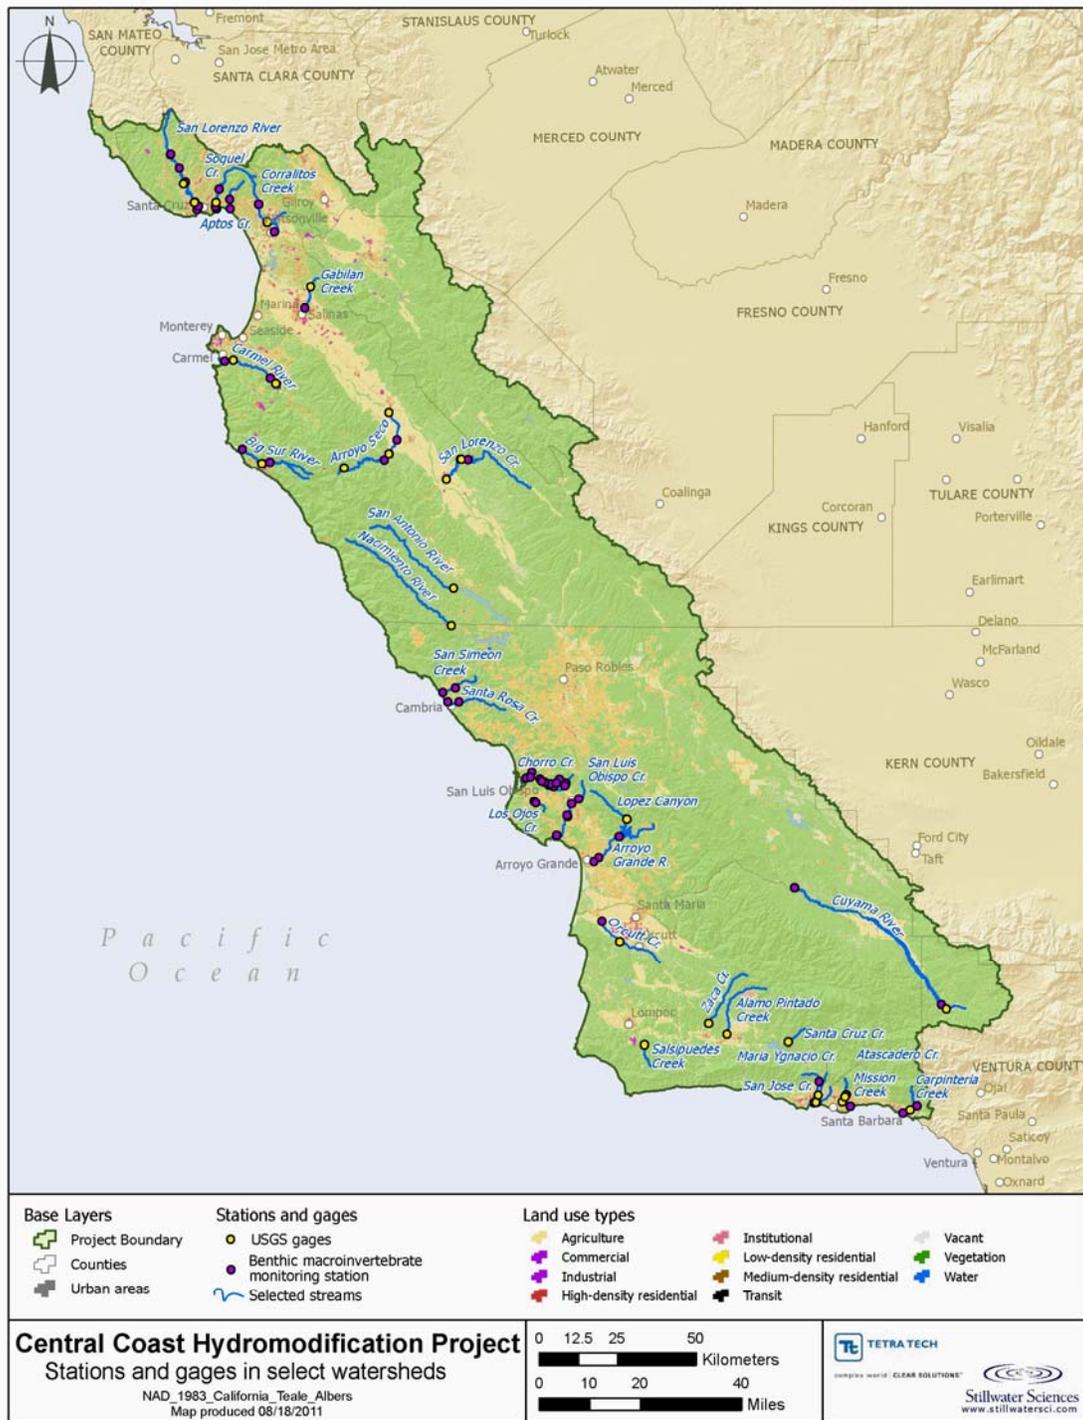
Figure 4-3. Map of selected receiving waters and locations of data.

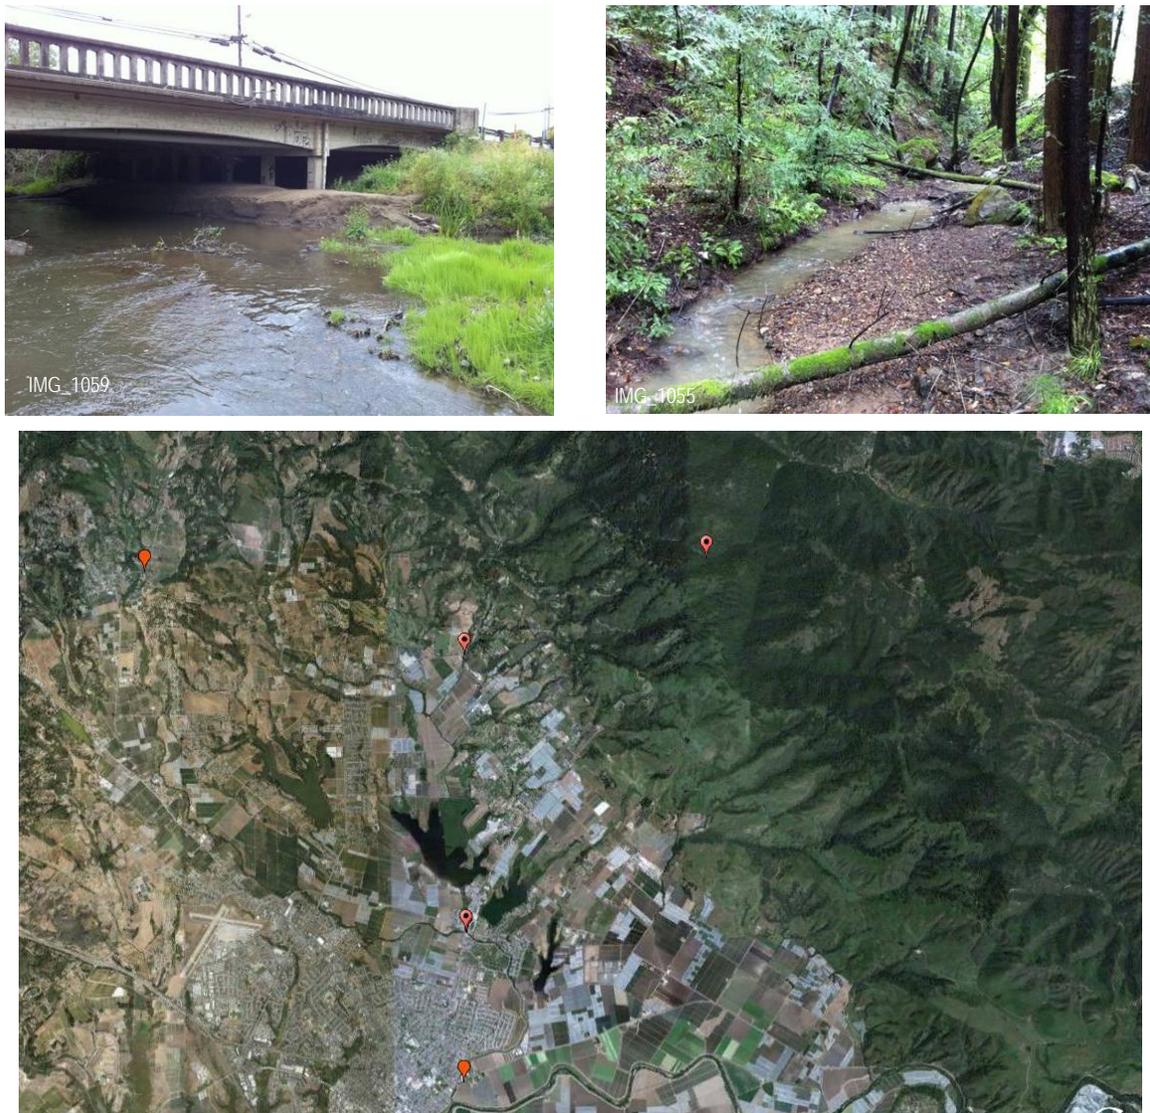
Figure 4-4. Corralitos Creek and the city of Watsonville (urban area at lower edge of bottom image, from GoogleEarth). Upper left red pin is BMI station 305COR2; downstream about 10 river miles is station 305COR. Upper left photo is of the lower river (red pin with black dot, between the two BMI stations and just southwest of Kelly Lake); upper right photo taken at the pin in the mountains to the north-northeast of town.

primarily forested, but downstream the creek flows through agricultural zones and finally through the densely populated urban area of Watsonville. Corralitos Creek was listed on the 2006 Federal Clean Water Act section 303(d) List of Water Quality Limited Segments. A BMI station (305COR2) lies significantly upstream of the USGS gage, while another site (305COR) lies in the midst of development (Figure 4-4). Visually, the creeks are deeply incised and impaired by an enormous influx of fine sediment and agricultural runoff; and all channels in the lower reach are confined and straightened and many are leveed. A CRAM evaluation near 305COR2 inferred significantly altered hydrology and compromised buffers.

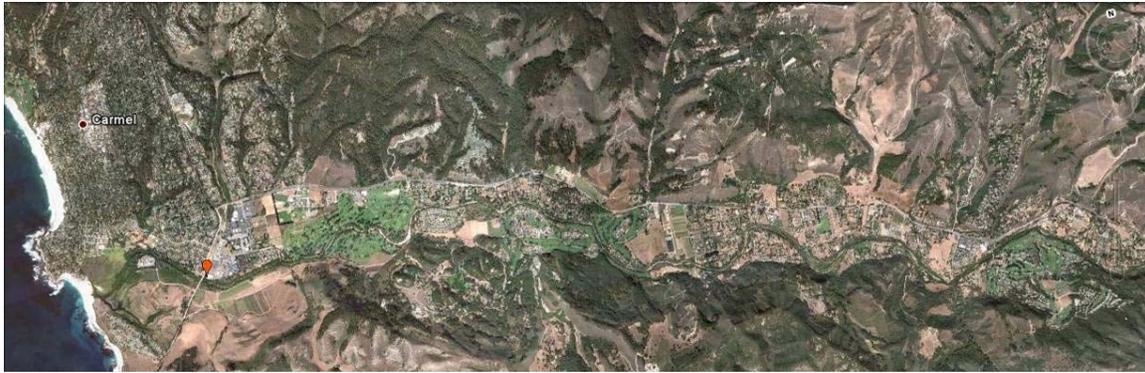
Figure 4-5. Aerial view of the lowermost 6 miles of the Carmel River (from GoogleEarth), showing most of the land-use disturbance that contributes runoff to BML station 307CML (at red pin near left edge of image). Nearly all of the rest of this 247-mi² watershed is minimally disturbed by human activity.

Carmel River is an elongate east–west trending river draining the steep, resistant granitic and metasedimentary slopes of the Santa Lucia Range. Though the river is partially constrained by roads following the narrow floodplain along much of its course, the Carmel River watershed as a whole has relatively less land-use impairment than other rivers in the region. Two BMI stations, closely associated with USGS gage stations, have been established along the mainstem—one upstream of essentially all development (307CMU, with gage 11143200) and one 11 miles downstream at the US Highway 101 crossing (307CML, gage 11143250; see Figure 4-5). Despite rather modest land-use impacts, both sites reported consistently “very poor” biological conditions through two (upper) and six (lower) years of monitoring. In contrast, CRAM assessments report near-average conditions near the lower BMI site and above-average conditions near the upper site.
